ENGINEERING APPROACH TO RESPONSIBILITY FOR UNEXPECTED PROBLEMS IN FOUNDATIONS

by
George F. Sowers*

(Presented before the Geotechnical Group of the BSCES/ASCE; also at Piletalk Seminar, St. Louis, Missouri, September 1974.)

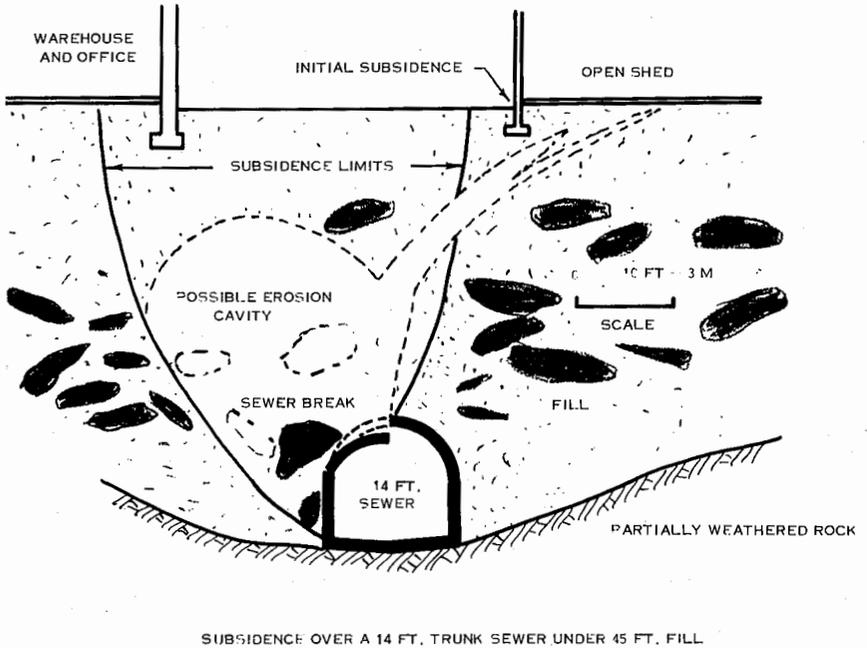
Figure 1 — Ground subsidence and building failure produced by collapse of a cavity generated by a damaged sewer flowing under pressure

The failure was caused by erosion of soil into the 50-year old sewer. It was plain concrete designed only for a nominal soil cover. It was laid in an old narrow creek valley, then partially covered with soil and cinders shortly after it was built. Although the City had obtained a sewer easement before construction, it had failed to record it on the property deed. The dairy, which bought the land a decade later, was only vaguely aware of a sewer; its size and exact location had been forgotten. Thirty-five years later the ravine was filled with the boulder and soil waste and the surface leveled for parking. By that time, the sewer had been entirely forgotten. The developer-builder, who finally purchased the site, was unaware of any boulders or sewer.

The sewer had cracked from 45 ft of soil and rock cover it had never been designed to support. One boulder had punched into the old fill and had forced in a part of the crown. The sewer was far too small for the storm water loads which had increased with the increase in street and building density after a half-century of urban development. During storms the sewer water surged upward 10 to 20 ft into the fill softening the soil. After the flow subsided, the softened soil eroded through the sewer cracks and was

carried away. A dome-shaped cavity developed in the soil, probably with "fingers" stretching upward. The hole found under the shed footing was probably such an extension of the main cavity. Eventually, the cavity roof became so thin that it fell in.

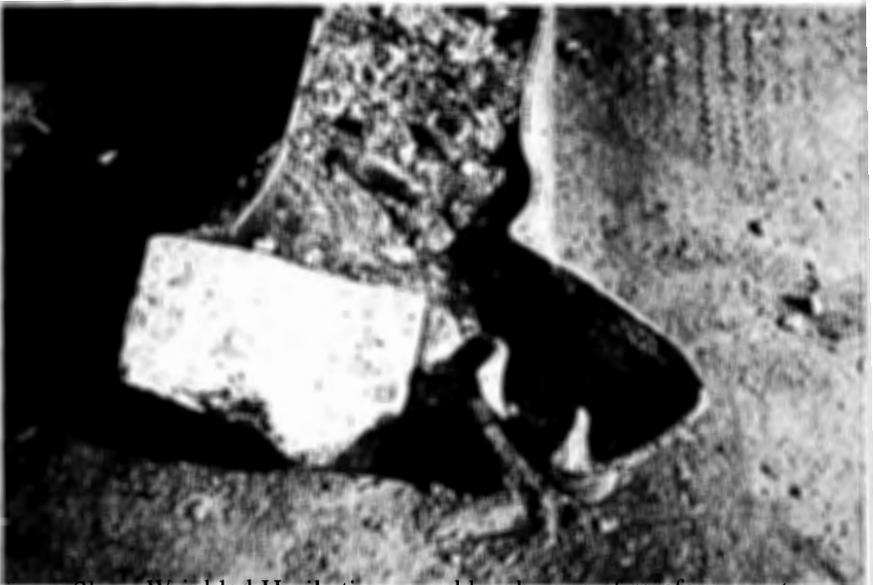
Figure 2b — Wrinkled H-pile tip, caused by absence of reinforcement

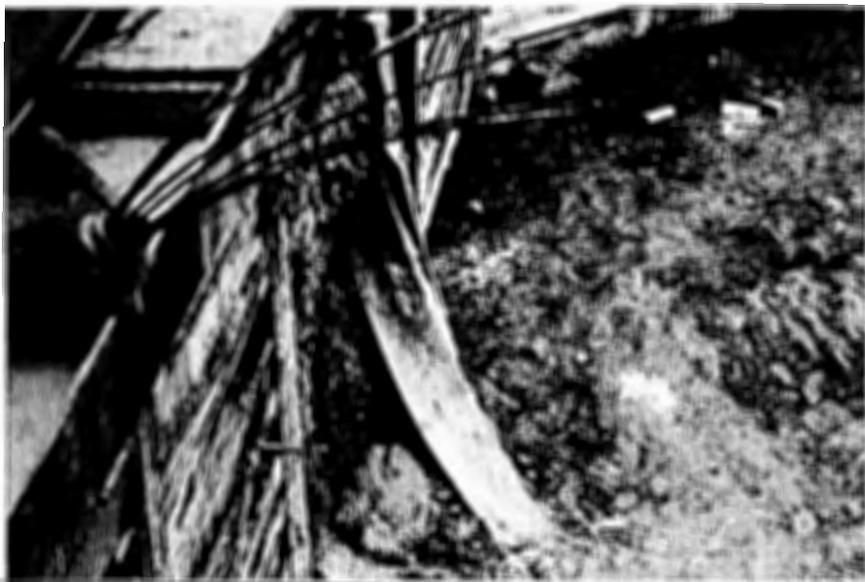
Figure 2c — H-pile bent by boulder-like mass of partially weathered rock

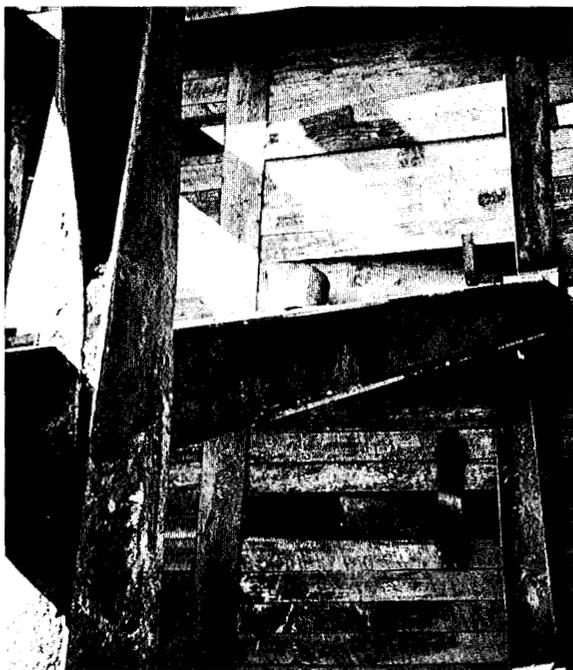
Figure 2d — H-pile twisted until opposite flanges touch due to rubble in fill

effects. Fig. 2d shows an H-pile badly twisted by old masonry so that the opposite flanges touch.

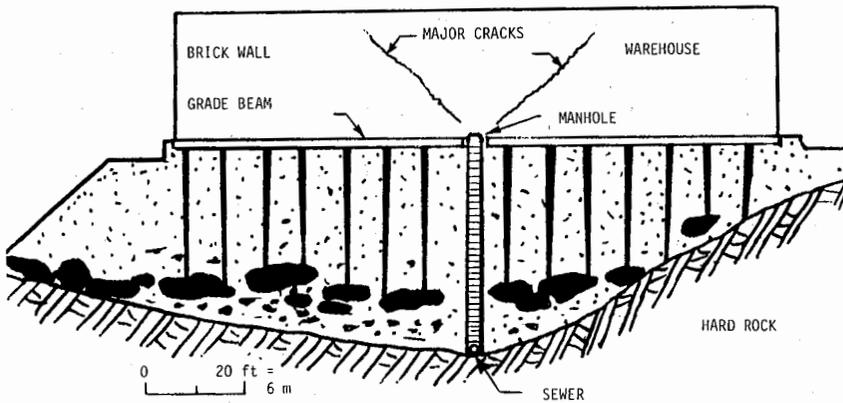
DIFFERENTIAL SETTLEMENT OF WAREHOUSE SUPPORTED ON WOOD PILES DRIVEN ONTO BOULDER LAYER IN FILL

Figure 3 — Building settlement due to pile tips supported on boulders within a fill

Within a year, the end of the building had cracked badly with the manhole providing the most rigid support. Twenty-four-in. diameter auger holes were drilled adjacent to several of the wood piles. The tip of each

rested on a boulder 10 to 15 ft above bedrock. A comparison of the engineer's record of pile lengths installed with the contours of the rock surface and the estimated level of boulders in the fill showed that most of the piles were 10 to 15 ft short of their required length. The designer-contractor was held liable; his own records showed the cause of the settlement. The design did not fit the known site conditions (boulders) and there was no follow-through between office and field. This shows that the unexpected can come from lack of good liaison between design and construction. It also demonstrates the importance of checking construction records with design data.

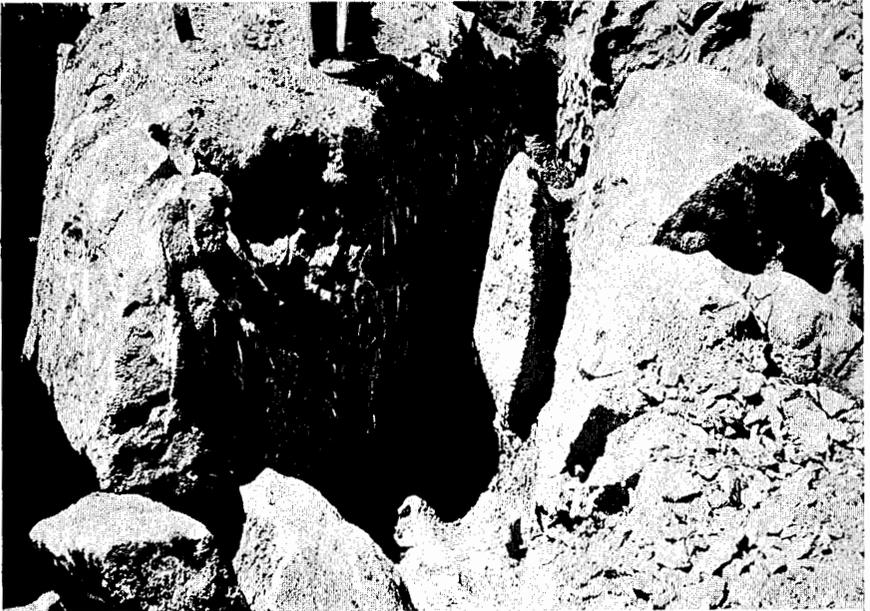
Figure 4a — Solution slots in hard limestone, North Georgia

These deep slots are problems for both pile and caisson foundations. While most piles will be of nearly equal length, a few that hit the slots may be driven to extraordinary depths. One in Birmingham reached 150 ft while the adjoining piles all stopped at 40 ft. At that, it did not carry the design load. Possibly, it was twisted and poorly wedged in an irregular slot. Caissons excavated to such a mud-filled slot below the water table may defy unwatering. One project that attempted to unwater and clean two 48-in. caissons led to subsidence of the soil above rock and settlement of an adjoining building. In this case, the contractor was experienced in the area yet he continued to pump muddy water from the caisson after the soil around it commenced settling. Eventually, he was forced to complete the caisson by tremie concrete through water. The condition was unforeseen at this particular point; however, such conditions should have been expected on the basis of his past experience and from the boring data. If he had heeded the warnings of his own men, he could have used a different procedure for installing the caisson, such as pre-grouting the slot or using drilling mud to balance the water pressure in the seam.

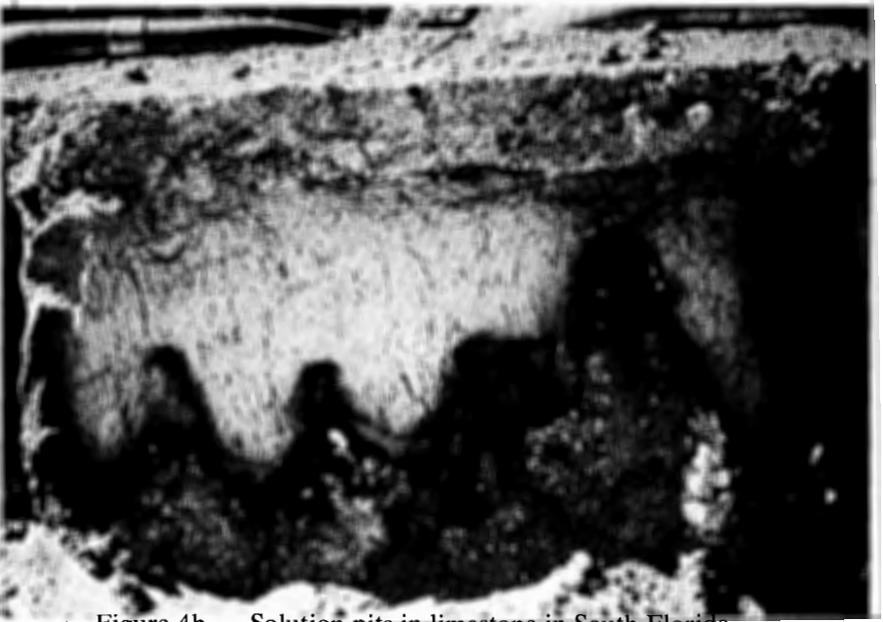
Figure 4b — Solution pits in limestone in South Florida

Irregular solution depressions (Fig. 4b) and occasional deep holes in the rock surface (Fig. 4c) are typical of the soft, porous limestones of the tropics. In a site near Nassau, Bahamas, holes 1 to 2 ft in diameter were found in each footing excavation (typically 6 to 8 ft square). Each footing excavation was rejected by the resident engineer, sitting on his camp stool, watching the workmen dig. Finally, when the resident engineer checked with the structural engineer, he found that the holes had been anticipated in the design pressures. It was only necessary to plug each hole with concrete to a depth of twice its width and then pour the footing as designed. This lack of response to what the resident engineer thought was an unexpected condition caused two months delay and thousands of dollars. This again illustrates the importance of liaison between construction and design where the design was good, but its intent was not transmitted to the field, either to the engineer's resident or the contractor.

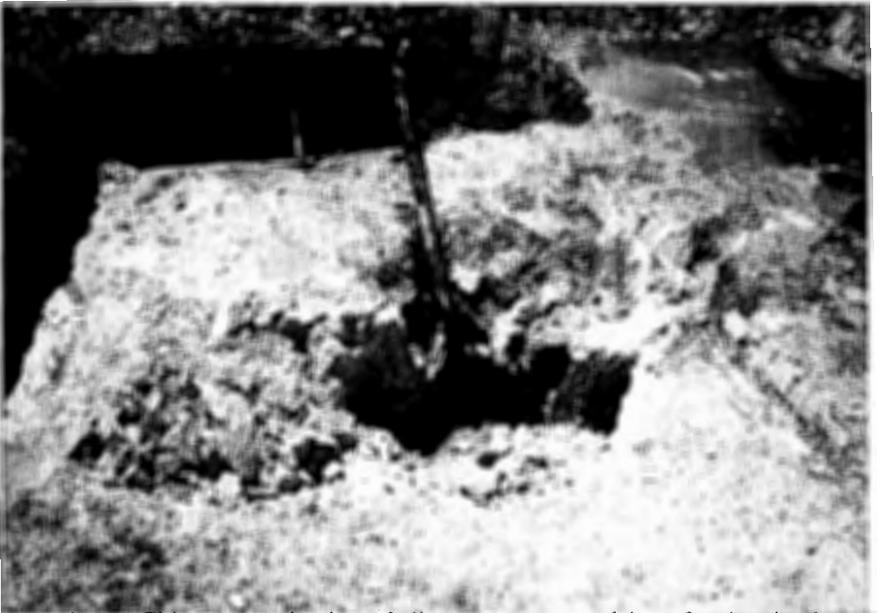
Figure 4c — Chimney cavity in soft limestone exposed in a footing in the Bahamas

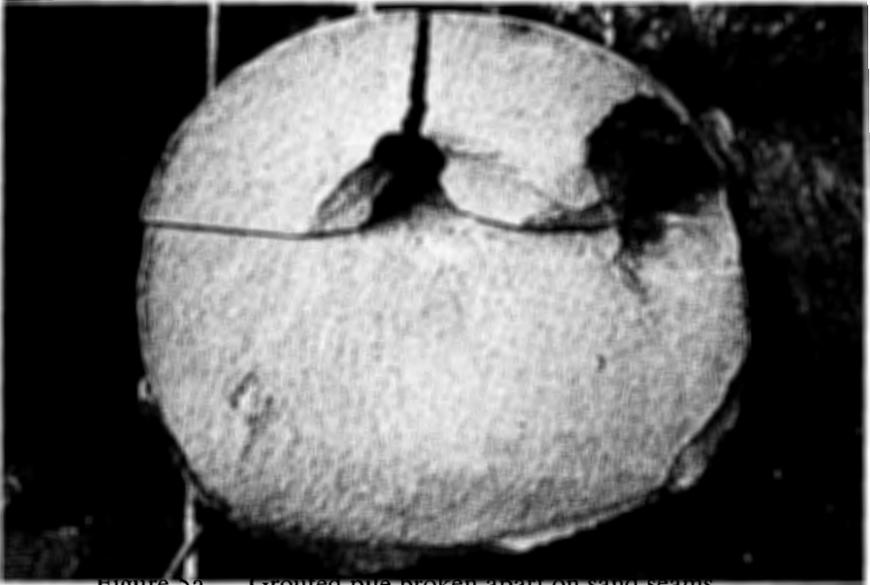
Figure 5a — Grouted pile broken apart on sand seams

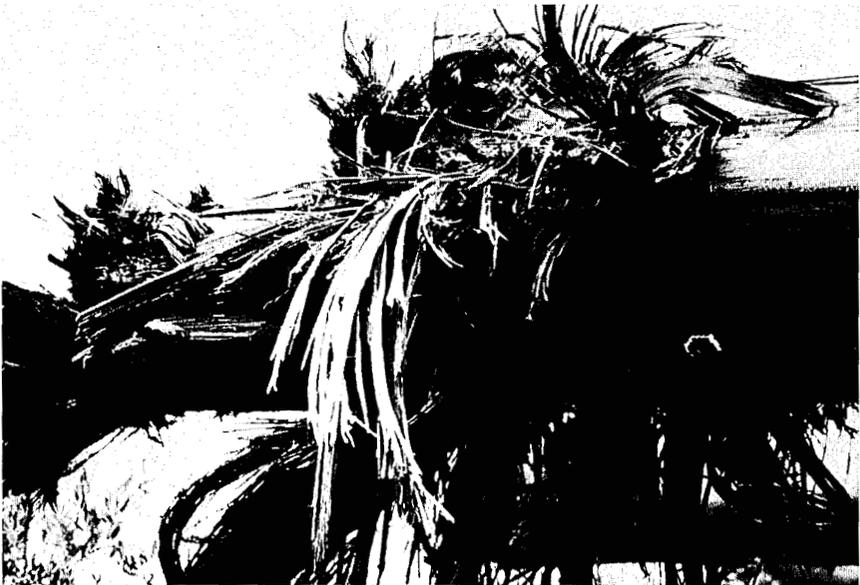
Wood piles are highly variable in quality despite visual inspection for defects. On one project, nearly $\frac{1}{3}$ of the piles broke when they were driven into dense sand (Fig. 5b). Sections of the new piles delivered to the job

Figure 5b — Wood pile tips broomed due to over-driving or poor wood quality

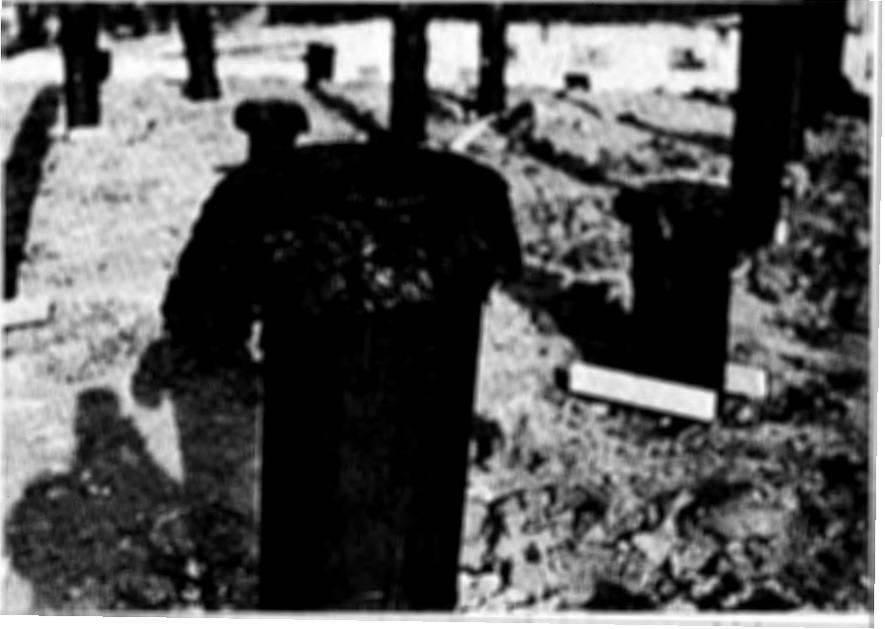
Figure 5c — Tops of wood piles damaged by excessive driving

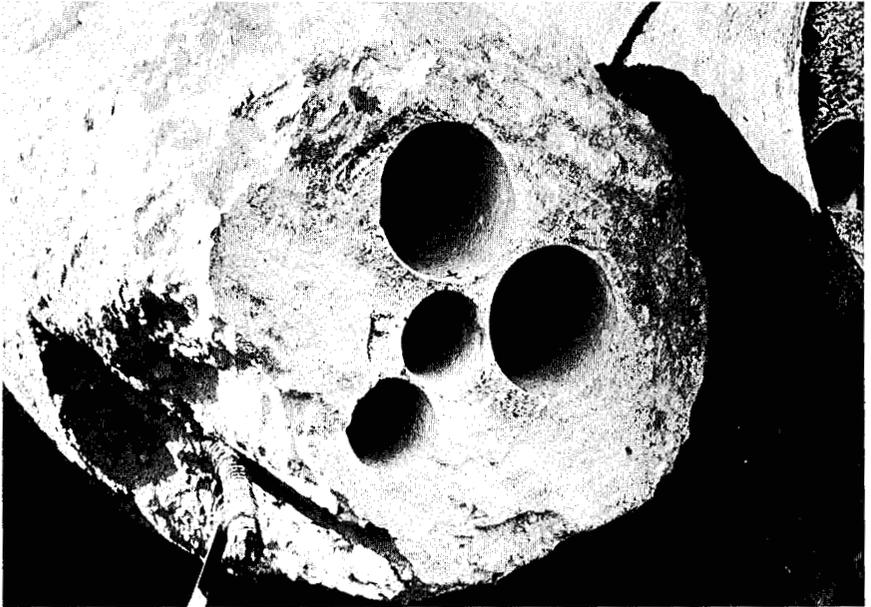
Figure 5d — Reinforcing bar at edge of cast-in-place concrete pile instead of center (holes made by coring concrete)

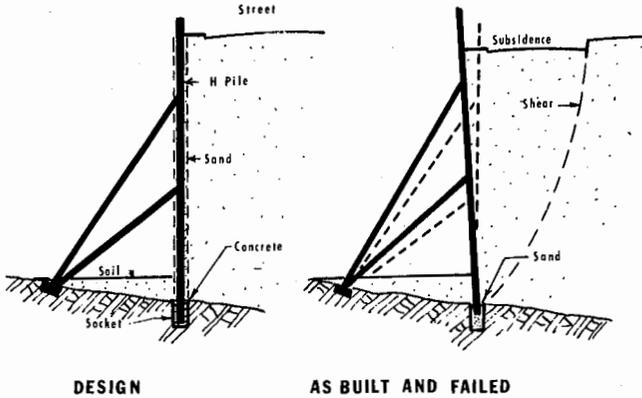
Figure 6a — Rotation of bracing system from failure to anchor soldier piles in concrete

ances. Because the thrust of the steep rakers produced much uplift, the design required that each soldier pile be concreted into a socket drilled in rock just below the excavation bottom. After the first tier of rakers had been placed and while the site was being excavated to the level of the second tier, the soldier piles suddenly rose and the bracing system rotated in, as shown in Fig. 6. The street cracked and subsided 18 in. An investigation found that the contractor's foreman had substituted sand for concrete in the

soldier pile sockets. His reason was that it would make it easier to remove the soldier piles later. Not even the contractor's general superintendent was aware of this unauthorized change.

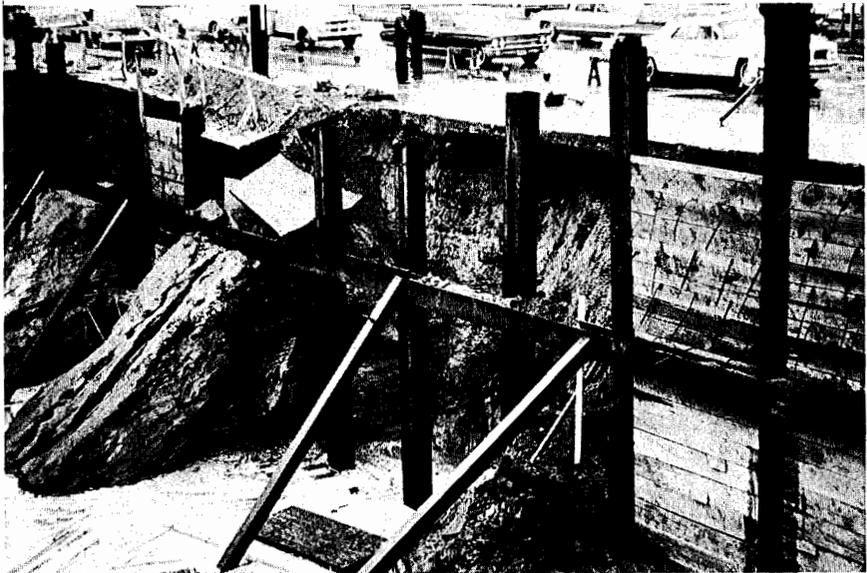
Figure 6b — Collapse of soil under street due to failure to install specified lagging

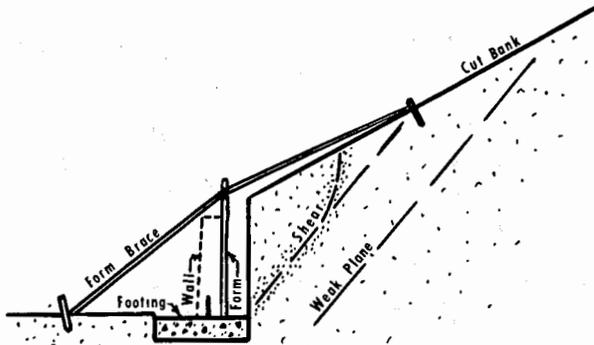
Cut Bank With Slicksided Weak Planes Focusing Shear

Figure 7a — Failure of toe of cut bank due to slicksided planes of weakness

then notched the toe of the slope to build the retaining wall. He failed to recognize several black slickensided planes of weakness in the soil that dipped steeply downward into the toe cut. A wedge of earth slid down on the slickensided surface (following a heavy rain) demolishing the formwork and the vertical steel that was being set. Local experience has shown the dangers of such black slickensided surfaces in the residual soil. The site borings showed that slickensides were present on the site. Such weaknesses should have been expected and the contractor should have been on the lookout for them. On the other hand, there was no practical way to determine in advance that those particular slickensides were present and dipping toward the toe excavation. The general condition, therefore, should have been expected; the local weakness of that point was unexpected, but was obvious to anyone experienced in local excavations once it was exposed. The failure to respond to the unexpected led to a structural failure.

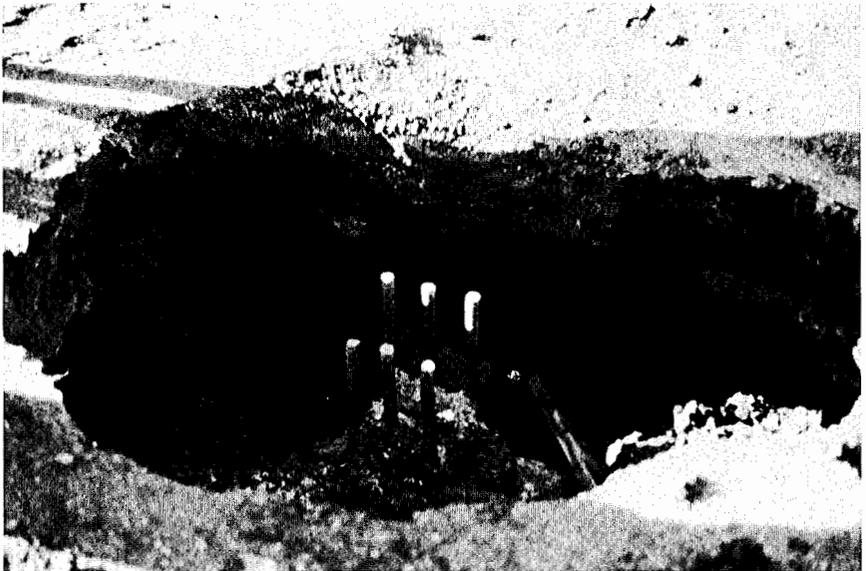
Figure 7b — Collapse of soil around a concrete caisson due to pumping mud from clay seams in rock

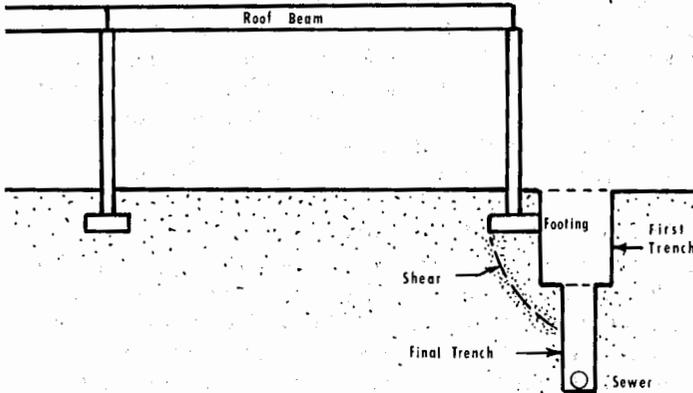
Figure 8a — Cross section of sewer trench which undermined a footing and caused a “row of dominos” collapse of 50,000 sq ft of building

The wall of the deeper second trench sheared from the footing load and 50,000 sq ft of completed precast-prestressed concrete columns and roof collapsed. Three workmen were crushed to death (including the sewer subcontractor) and several more were injured. Suits for negligence totaling nearly \$750,000 were filed against all involved including the architect-engineer. This failure points out that the unexpected can occur because of failure to coordinate construction activities (the sewer should have been built first) and failure to observe or take action on hazardous job conditions.

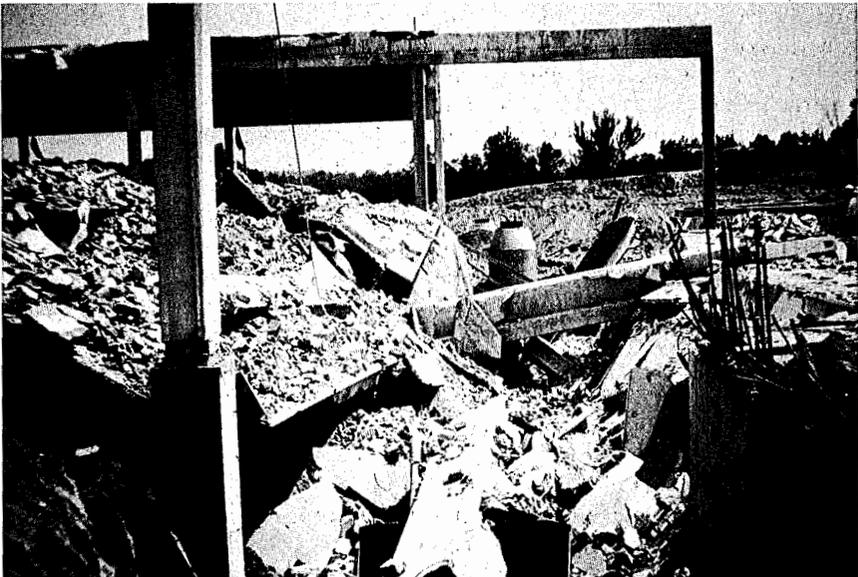
Figure 8b — Photograph of trench and building remains

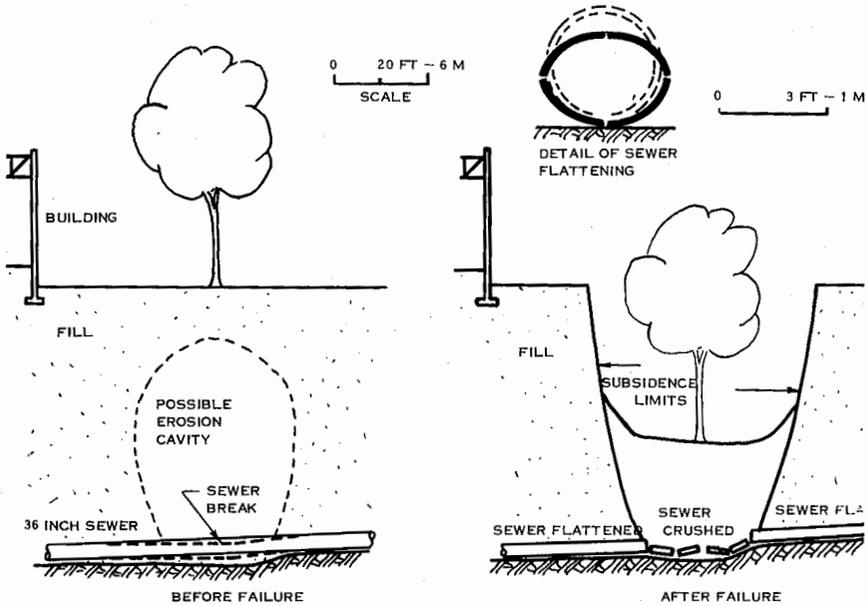
SUBSIDENCE OVER 36 INCH STORM DRAIN UNDER 60 FOOT FILL

Figure 9 — Earth dropout over a collapsed sewer

The subsidence occurred overnight following a hard rain. Immediately beneath was a 36-in. concrete storm sewer. The hole slowly filled with water to within a few feet of the ground surface and then drained even more slowly during the ensuing week. A braced steel cofferdam was constructed around the hole to protect the building and to permit excavating to the sewer. In the area of the collapse, the sewer was broken. Upstream it had been laid on rock; downstream on soil. It had not been placed on any bedding for the soil below its spring line was very loose. By way of contrast, the fill above was a compacted silty clay.

The sewer broke by shear where it went from rock to soil support. Moreover, the remaining 36-in. pipe upstream and downstream had been flattened into an ellipse with a vertical opening of only 2 ft with appropriate cracks at the top, bottom and sides. The sewer capacity was inadequate for the storm runoff. During large rains, water rose in the open cofferdam showing that the sewer was under pressure. Water pressure in the sheared zone saturated the soil above. After the storm, the water drained back into the sewer eroding the soil with it. A cavity was slowly created in the soil with the tree roots above possibly helping to reinforce the cavity roof. Eventually, it became large enough that it collapsed. Possi-

The cost of the failure exceeded a half million dollars. The cause was poor design, poor workmanship in installing the sewer and poor supervision of the work. The costs were shared by the present land owners and the original developer; the others involved were beyond the court's jurisdiction.

bly preventive maintenance could have prevented failure because a 36-in. sewer can be inspected easily.

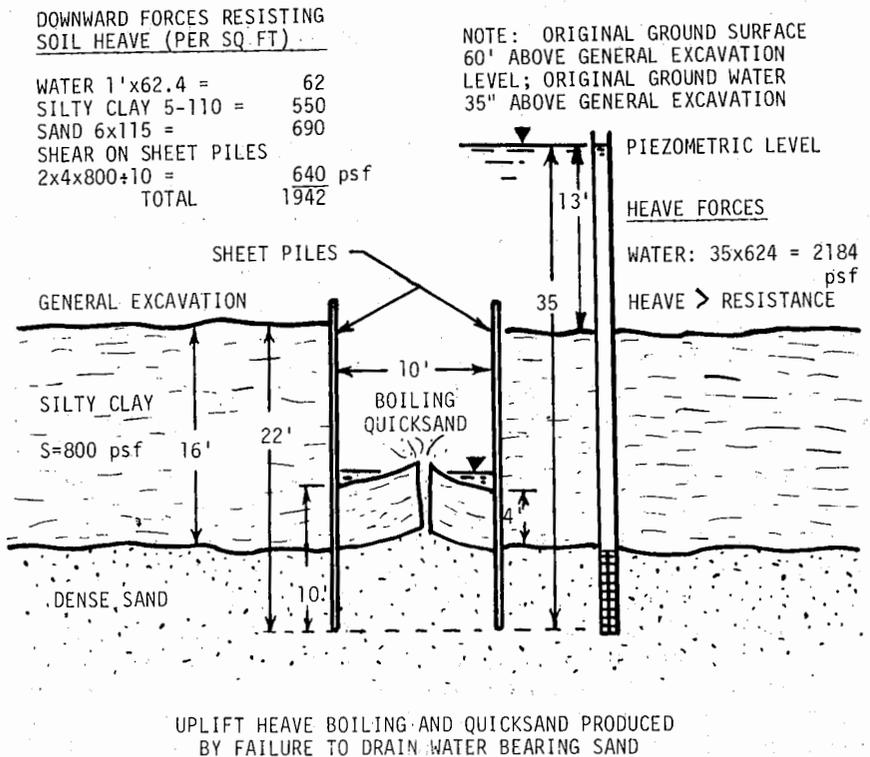
Figure 10 — Quicksand: An “unexpected” condition that should have been foreseen and easily prevented

At the site illustrated by Fig. 10, the contractor was furnished borings showing that the ground-water table was 35 ft above the general excavation. Within the general excavation were several deeper excavations, 10 ft wide and 20 ft deep, to be protected by steel sheet piling. The boring data showed a previous sand stratum 16 ft below the general excavation level. The specifications required that the contractor install piezometers to measure the water pressure level in the deep sand so he could coordinate excavation with site drainage.

Because of the low permeability of the silty clay, the ground water in the general excavation was easily controlled by sumps. Further, the water pressure level in the deeper sand fell slowly until it was only about 13 ft above the general excavation level (the combined effect of sump drainage and dry weather). When the excavation between the sheet piles reached a depth of 12 ft, the silty clay rose and sand boiled into the excavation. Two workmen (and the author) had to scramble for safety. Calculations showed that the excavation bottom was unstable. The uplift forces of water pressure in the sand below the sheet pile tips exceeded the weight of soil and water above.

Despite the contract data on ground water and the contract requirement for control of the ground water in excavations, the condition was created by lack of drainage. Wellpoints in the sand corrected the problem quickly.

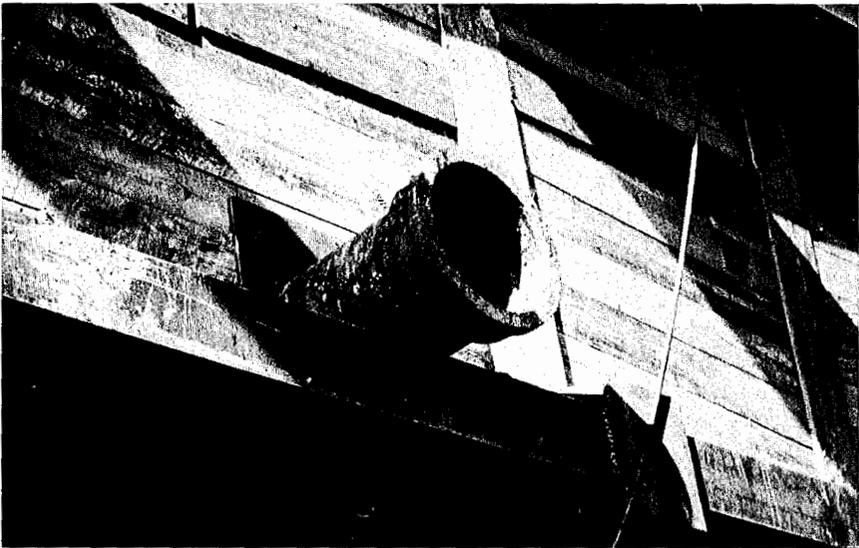
Figure 11 — Response to an unforeseen condition: Lagging around a sewer through an excavating bracing system
