Rehabilitation of the Otis Reservoir Dam: Improving Cost Effectiveness by Including Bridge Placement

Matthew A. Taylor¹, John G. DeLano¹

¹ GZA GeoEnvironmental, Inc., Norwood, Massachusetts

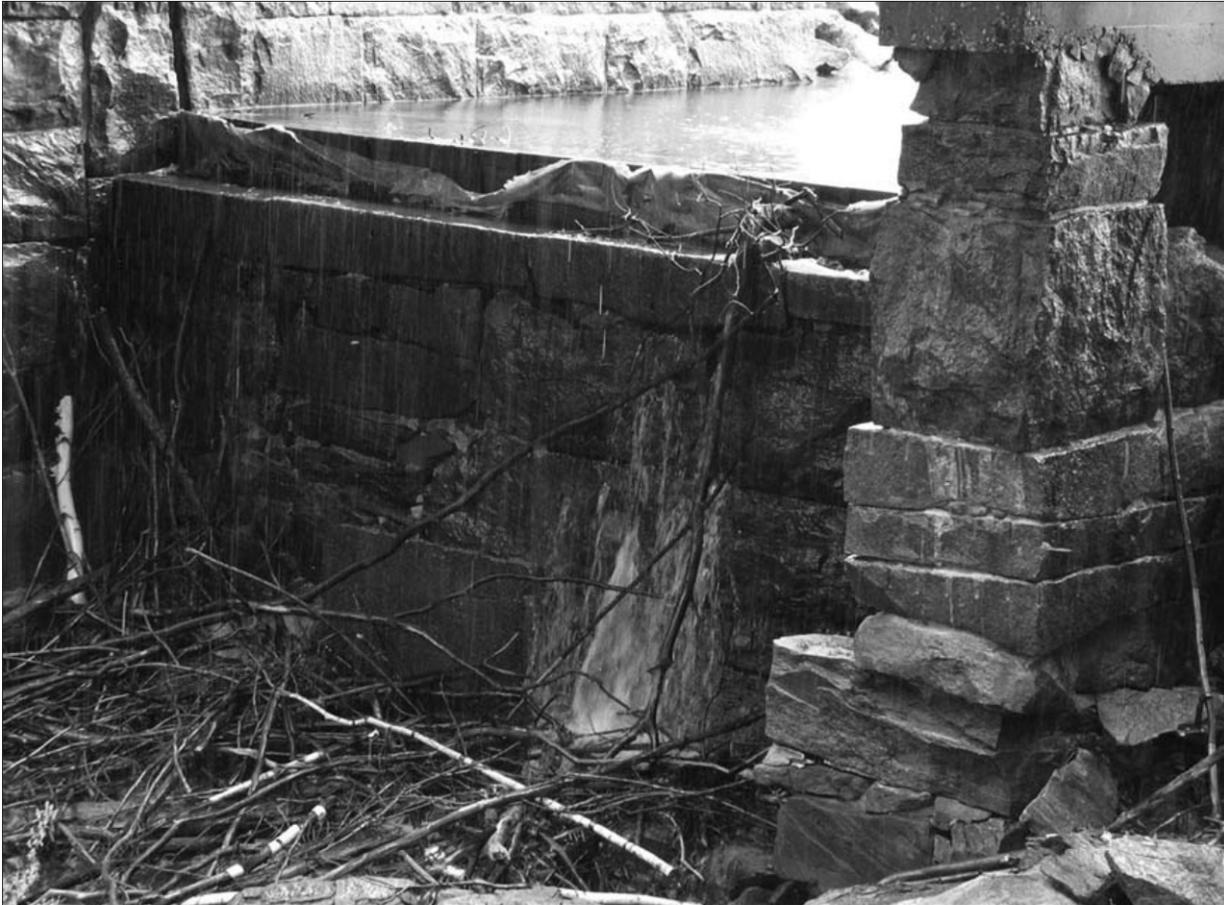
- The deteriorated masonry and leakage conditions at the spillway (see Figure 2) and the downstream masonry wall; and,
- The erodibility of the "emergency spillway" over the main embankment section of the dam.

Figure 2. View of the deteriorated and leaking conditions at the spillway prior to rehabilitation.

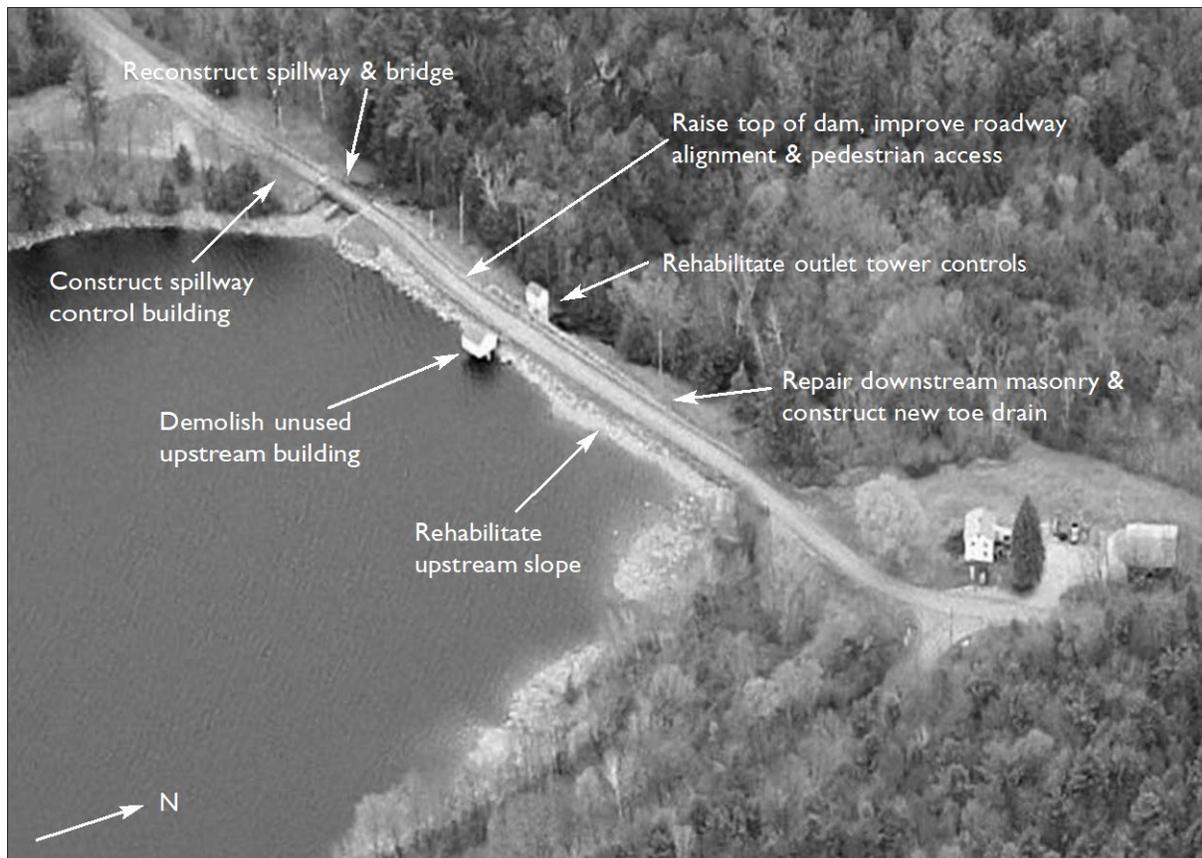
Figure 3. The locations of repairs/improvements on the dam.

- adding a new gatehouse on the left abutment of the dam;
- raising the top of the dam by adding up to 3 feet of embankment fill;
- repointing the downstream masonry wall;
- extending the downstream toe drain;
- adding a reinforced concrete splash pad at the base of the downstream masonry wall;
- restoring the rip-rap slope protection on the upstream and portions of the downstream slopes; and,
- installing new slide gates on the inside upstream face of the downstream outlet tower.

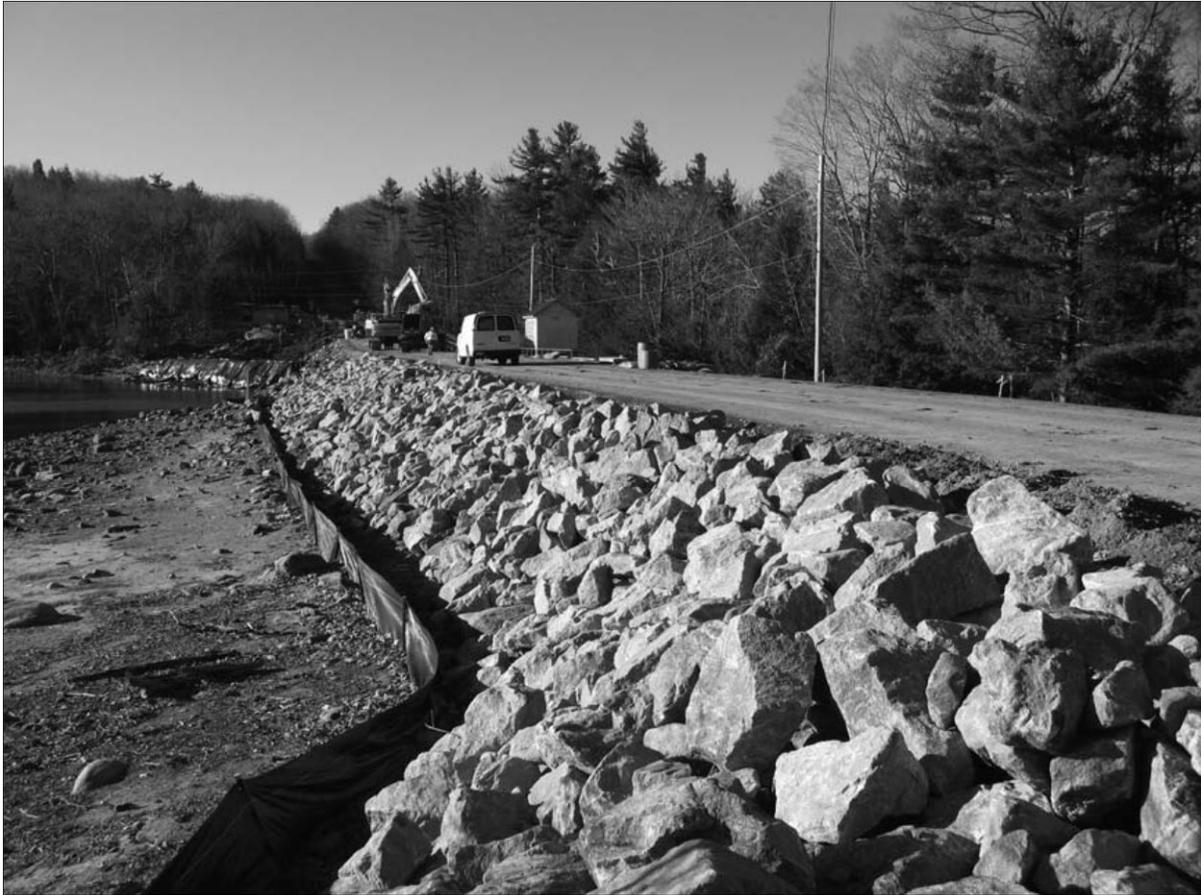
Figure 5. Improvements to the dam crest and upstream slope.

- placement of new upstream and downstream riprap slope protection (see Figure 5);
- demolition of the masonry spillway;
- construction of the new reinforced concrete spillway/bridge abutments;
- installation of the new stop logs;
- installation of the new bridge;
- demolition of the upstream gatehouse; and,
- construction of the new crest gate gatehouse at the left abutment.

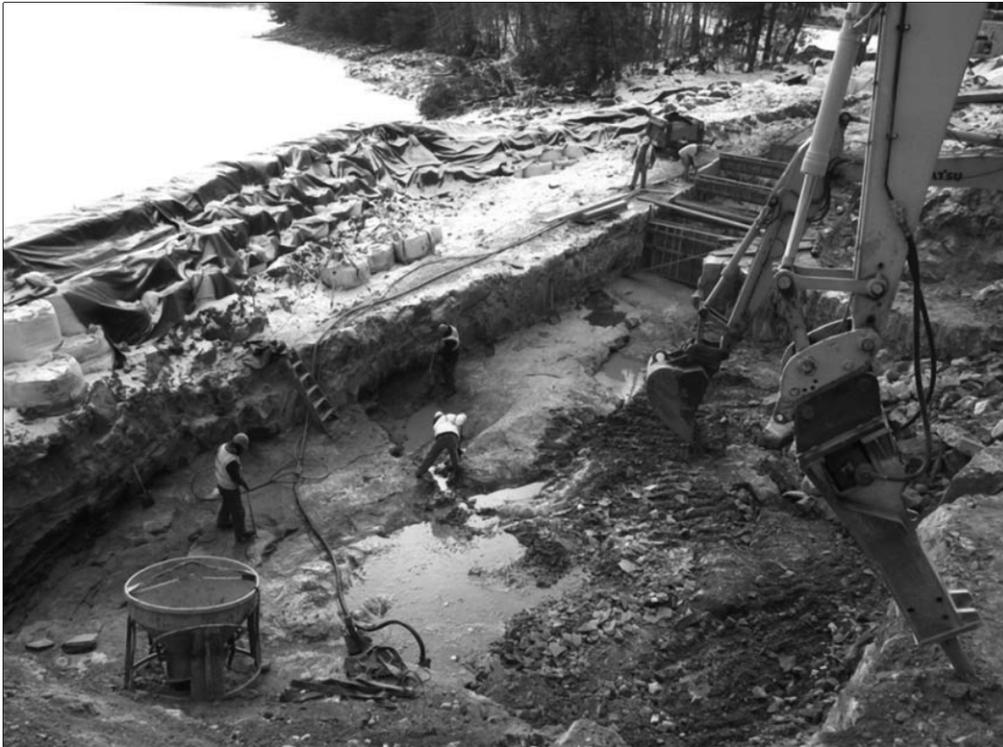
Figure 6. Bedrock excavation at the spillway.

Because the invert of the new crest gates was almost 8 feet lower than the original spillway crest, bedrock excavation and removal within the spillway footprint was required for foundation construction. The excavation required for the new

Excavation of the gneissic bedrock was accomplished with a combination of ripping with an excavator and hoerammimg. Due to the fracture patterns in the bedrock, controlled blasting was not required. Figure 6 shows an example of typical rock excavation at the spillway. Because the bedrock was fractured and rippable, the contractor utilized line drilling techniques on the outer perimeter of the excavation area to control the limit of the rock removal. Construction-induced vibrations were limited to the criteria set forth in 527 CMR 13.00, which provide vibration limits based on a relationship between peak particle velocity and frequency. Continuous and event-specific vibration monitoring was performed for the existing downstream masonry face of the dam, the downstream gate ouse/outlet tower, and at locations where new concrete was being poured.

The bedrock conditions in the area of the spillway were generally less competent than it was anticipated during design. Because the top of competent bedrock was generally about 1 to 4 feet deeper than the design bottom of footing grades, approximately 150 additional cubic yards of concrete were required to reach the design footing subgrade elevations. The final bedrock surface was cleaned out with compressed air prior to the placement of the concrete. At the east bridge abutment, a “shear key” into the bedrock subgrade was added because of the lower than anticipated competent bedrock surface. This shear key was added to increase the passive resistance for the training wall/bridge abutment foundation.

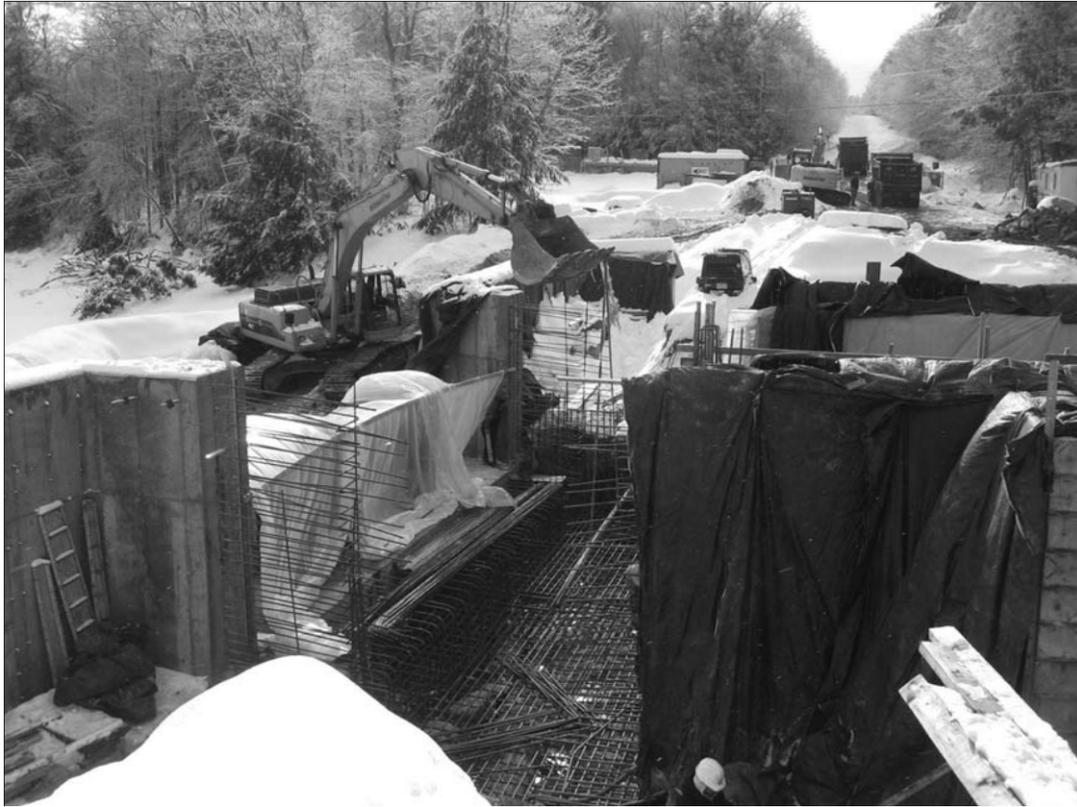
Figure 7. Concrete work during winter 2010 / 2011 at the spillway.

As shown on Figure 7, concrete was formed and poured in heated tents, and was typically allowed to cure for at least three days within the heated tents prior to stripping forms. Diligent maintenance of the heating system by the contractor allowed for concrete placement to occur relatively unimpeded despite the cold weather. Rock excavation was not allowed for 24 hours after concrete had been poured on the site, and backfilling was not permitted until the concrete had achieved its required 28-day compressive strength. Field-cured cylinders were used to determine whether required 28-day compressive strengths were achieved, which, thus, allowed backfilling to be performed at an accelerated schedule. The stop log bays foundations, crest gate foundation, as well as upstream and downstream training walls/bridge abutments were all poured throughout the winter in this manner with great success. Side seals and heating elements for the hydraulic crest gate were installed as part of the training wall construction.

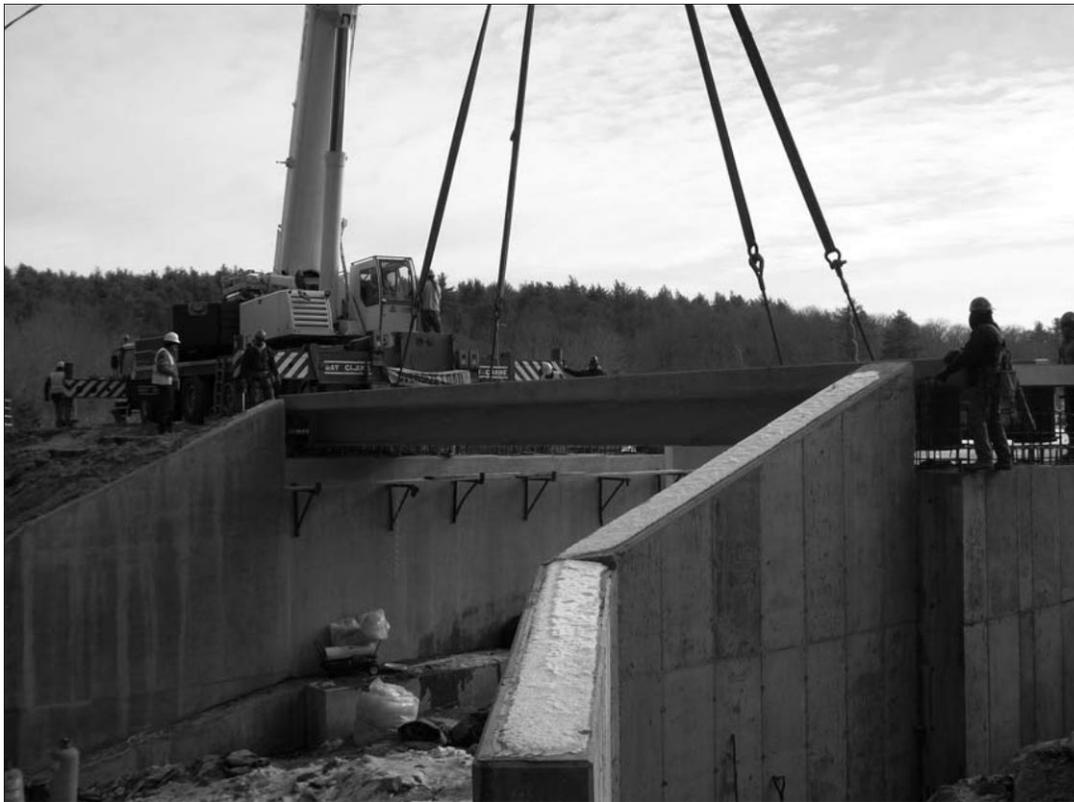
Figure 8. New spillway bridge installation.

The bridge installation was performed using a 60-ton crane set up at the east (right) abutment of the spillway (see Figure 8). Completing the spillway backfilling operation was critical since it needed to be completed ahead of the bridge installation in order for the bridge and Tolland Road to be reopened to the public by March 2011. The bridge was fabricated in the three sections, which were trailered individually to the dam and staged on the dam crest. The crane was able to set each bridge section into place in one day. The grouting of the bridge sections and the installation of the bridge railings were completed over a two-week period and the bridge was opened on schedule on March 18, 2011.
