Curved Steel Girder Integral Abutment Bridges in Vermont, USA

Abstract

Keywords: bridge, jointless, integral abutment, curved, performance, inspection, case study

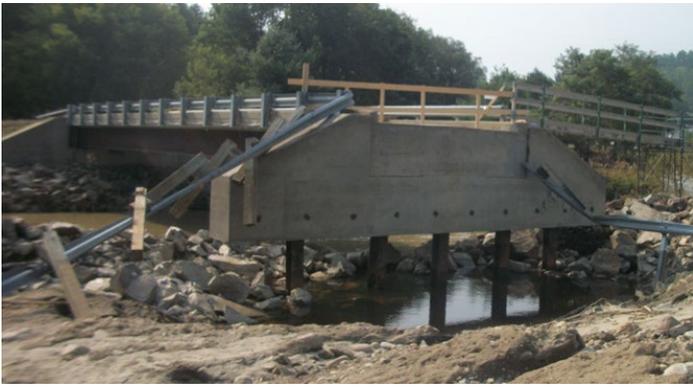
Figure 2. Resilience of an IAB in Vermont after 2011 Tropical Storm Irene (Photo Courtesy of VTrans)

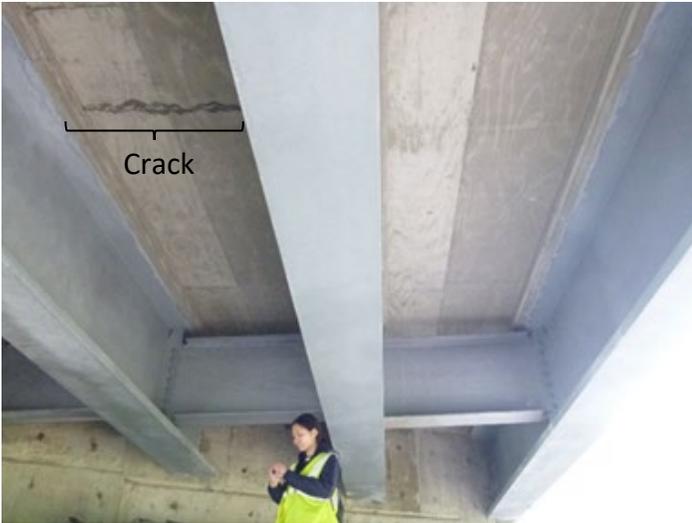
The bridge had been in service for 2 and 4 years when evaluated. The overall condition is very good. There are some minor deck cracks approximately 15 feet and 30 feet from the West abutment and at midspan (Figure 4). These do not progress across the entire deck but are allowing some moisture penetration (there is no waterproofing on this deck).

Figure 5. Typical Deck Cracking at Bradford Bridge

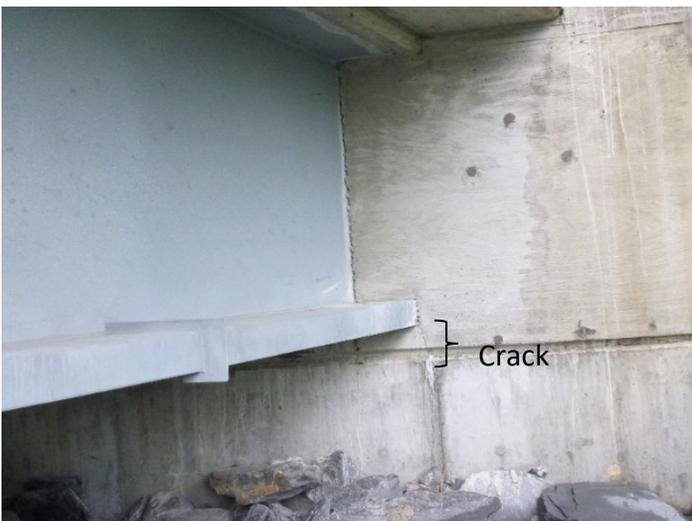
As is typical in many IAB abutment backwalls, a 45 degree crack propagating from the bottom flange of most girders was observed, on the side of the obtuse angle between girder and abutment (Figure 5). There is a filled joint between the abutment and precast wingwalls, with dowels between the two components providing rigidity. No distress was noted in these details (Figure 6). Due to cost, an asphalt plug joint was used rather than an installed joint option at the end of the approach slab. These joints are failing due to the high skew (Figure 7), and would normally not be used for this skew angle. The joint condition is not attributed to the curved IAB design. The follow up evaluation in 2021 observed slightly more scaling on the top of the abutments (Figure 8), continued deterioration of the asphalt plug joint (Figure 7b), and a very slight increase in efflorescence at cracks, though cracks were less noticeable due to the dry conditions.

Figure 6. Crack in Abutment at Girder Bottom Flange at Bradford Bridge

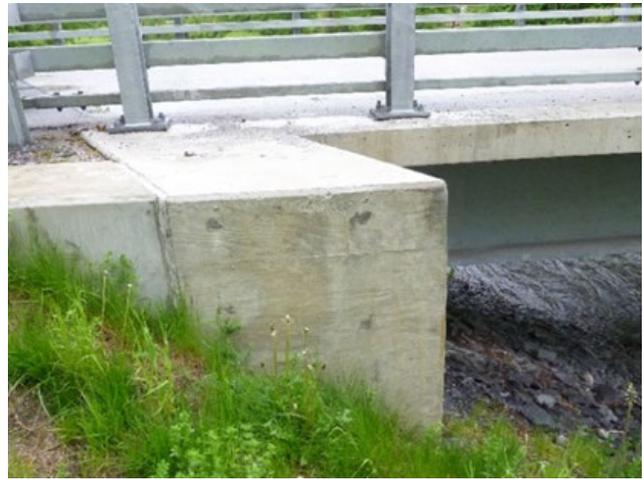
Figure 7. Doweled Precast Wingwall to Abutment at Bradford Bridge

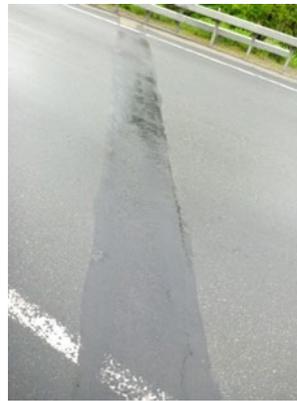
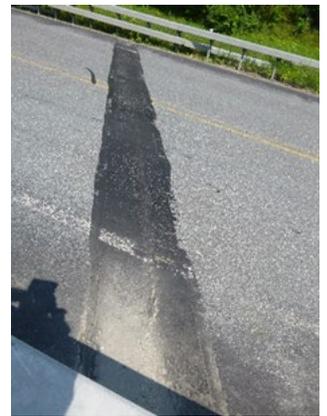
Figure 8. Deteriorating Asphalt Plug Joint at Skewed Bradford Bridge

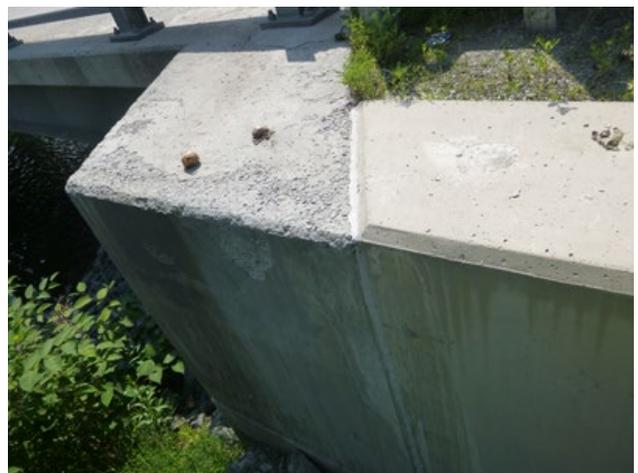
Figure 9. Scaling at Top of Abutment at Bradford Bridge (2021)

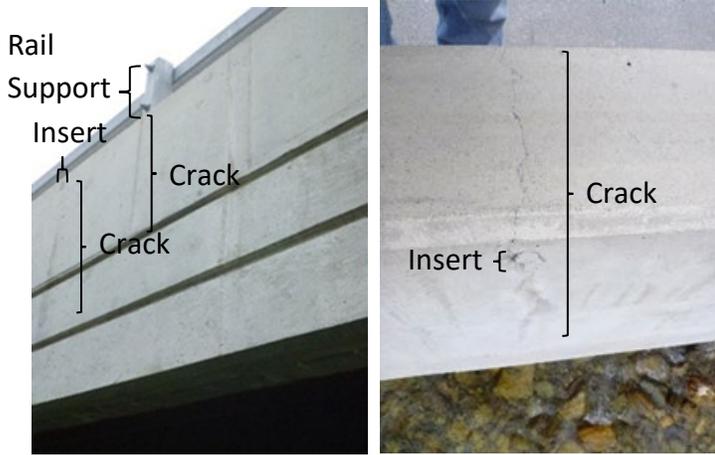
The bridge had been in service for 6 and 8 years when evaluated. The overall condition is very good. The bridge includes a partial concrete barrier below the railing, curb, and sidewalk. As appears typical of these designs for both IAB and non-IAB bridges, cracks have formed at approximately 6 ft. spacing that are wider at the top of barrier and narrower as they extend toward the deck, with some extending to the bottom of deck (Figure 11). At these crack locations, there is efflorescence at and below the top of the road surface. These cracks are at almost every location of form inserts and at a few intermediate rail anchor locations (noted in Figure 11). Additional cracking is found at the sharp transition in concrete barrier height near the abutments. The underside of the deck exhibits some minor map cracking, which may indicate deck curing problems (Figure 12), but was far less noticeable in dry conditions. Both of the in-line wingwalls at Abutment 1 do not show any signs of distress. At Abutment 2, wingwalls are at right angles to the abutment and integral Wingwall 2 at the interior of the curve has minor cracking at 45 degrees at the interior of the abutment and wingwall interface, typical of other IABs (Figure 13a). Wingwall 1 on the outer exterior of the curve has a mechanical splice, epoxy filler and bevel. A large crack has formed at this location, extending through the entire interface, though not following the cold joint, along with some chipped concrete along the outer edge of the abutment and wingwall (Figure 13b). No change was noted in 2021. This detail has poor results and should not be used. It is noted that a relatively similar detail was used at the Bradford Bridge with no distress noted. It should be further investigated whether the difference is due to the tapered wingwall design or detailing implemented. The asphalt plug joints are performing adequately though the thin asphalt seal at the approach slab to bridge deck connection is showing some deterioration. The follow up evaluation in 2021 observed an increase in crack size on parapet locations, slight increase in efflorescence at cracks, though cracks were less noticeable due to

Figure 12. Typical Barrier Cracking at Jamaica Bridge

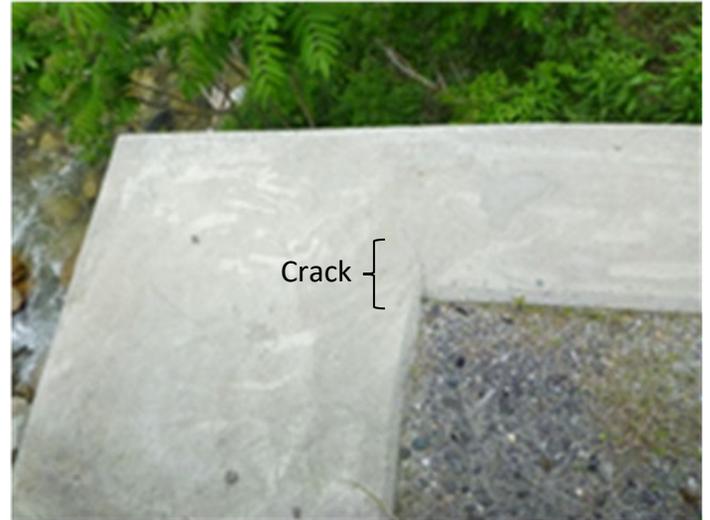
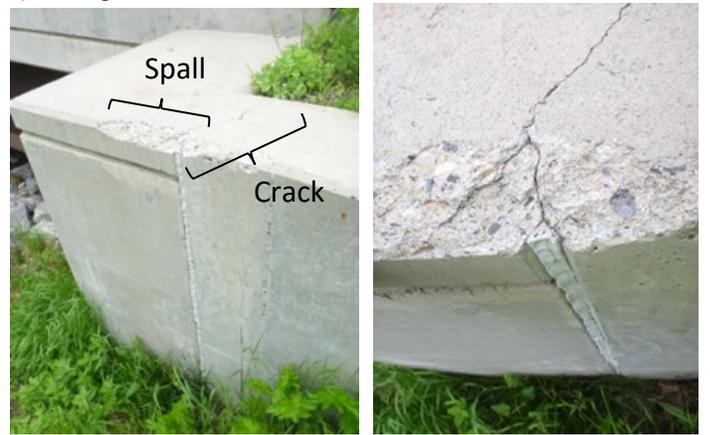
Figure 14. Wingwall to Abutment Cracking at Jamaica Bridge

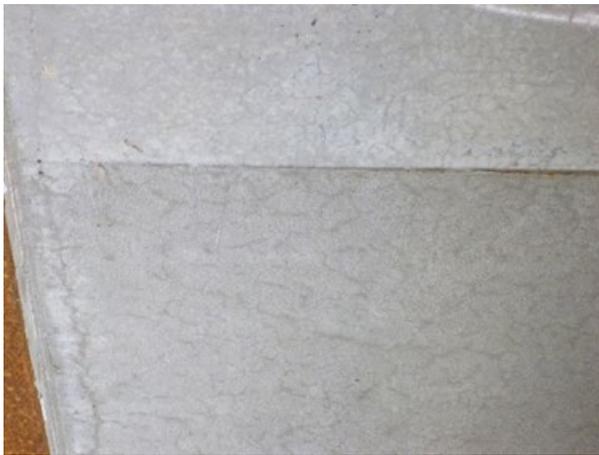
the dry conditions. It was noted that the cracks in the underside of the deck were far less noticeable in the dry conditions.

Figure 13. Underside of Deck at Jamaica Bridge

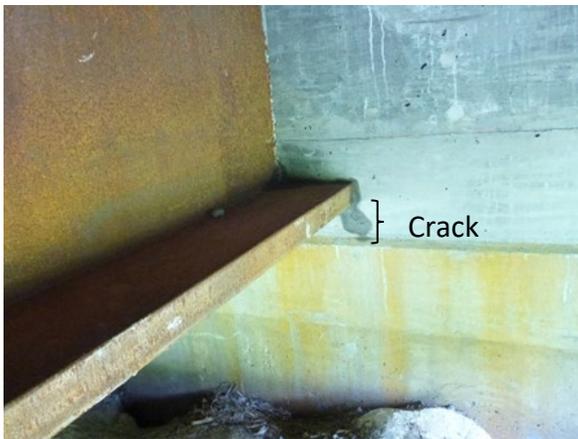
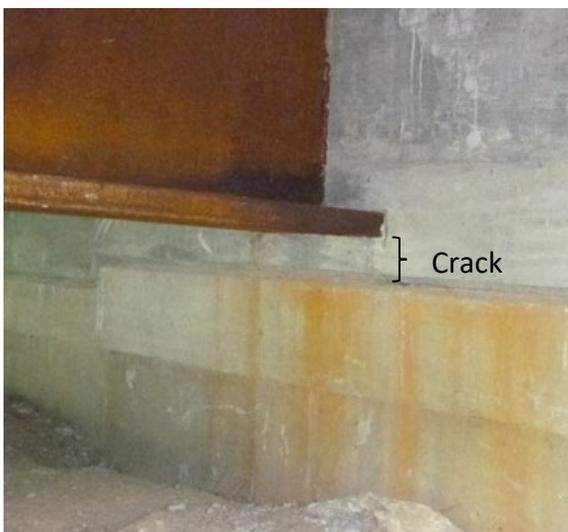
The bridge had been in service for 1 and 3 years when evaluated. The overall condition is excellent with only a few minor cracks at the girder bottom flange (Figure 16). To date, there is no cracking at the integral wingwall to Abutment 2 detail (Figure 17). The retaining walls at Abutment 1 are not flush with the back wall, with vertical misalignment approximately 1 in. at the top of the abutment (Figure 18). It appears that this was the condition at the completion of construction as there is no distress of the sealant between the components or soil at the base of the walls. The follow up evaluation in 2021 noted that the misalignment was nearly identical (at similar ambient temperature), with the only change being that the sealant had dried and pulled away from the joint. This will be monitored in future years to look for signs of bridge twisting in plan view. Some new, but minor, efflorescence at cracks bottom flange corners and staining from weathering steel was also observed.

Figure 17. Crack in Abutment at Girder Bottom Flange at at Danby Bridge

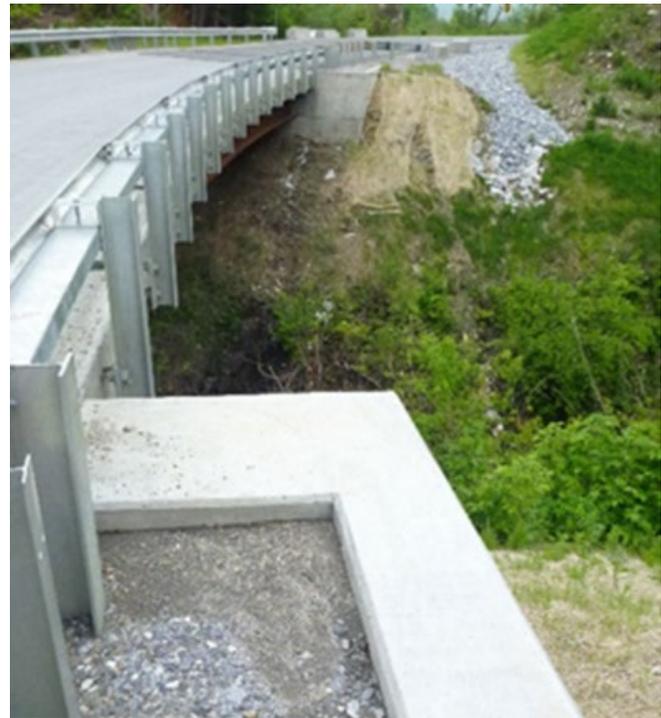
Figure 18. Wingwall to Abutment 2 Connection at Danby Bridge

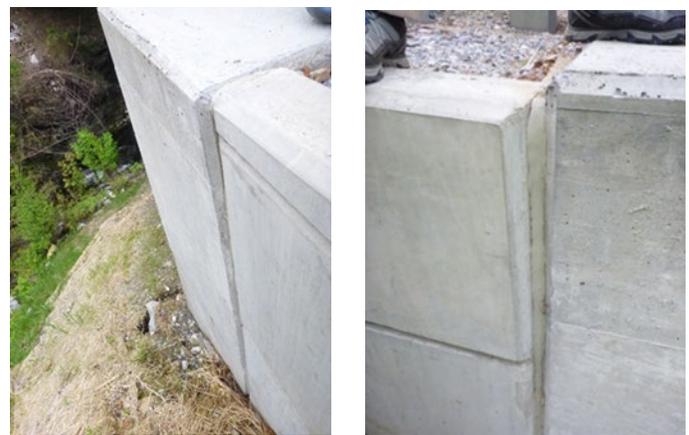
Figure 19. Retaining Wall to Abutment 1 Detail at Danby Bridge

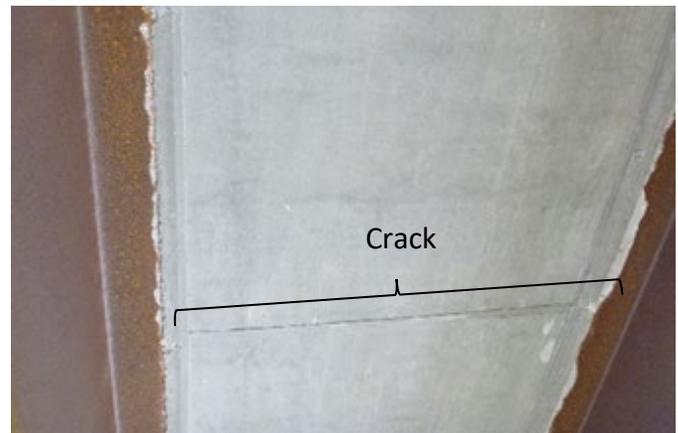
The bridge had been in service for 10 and 12 years when evaluated. The overall condition is very good. The underside of the bridge shows some transverse deck cracks (Figure 21) that are larger near the abutment. These appear to line up with the cracking in the concrete barrier (Figure 22), regularly spaced approximately every 4 ft. to 8 ft. and often originate at the location of guardrail anchors. Vertical cracks in the abutment backwall between the girders were noticed (Figure 23), but were not significant. Newer VTrans designs decrease the spacing of abutment reinforcement to 6 in. in order to prevent these cracks in all IABs (Structures Engineering Instructions SEI 17-001 (2017)), and newer designs appear to avoid this cracking. At the abutments, which are integral with the structure, there is typically cracking at the intersection between the wingwall and abutment (Figure 24). Erosion prior to Tropical Storm Irene and greatly exacerbated by the event is apparent at the upstream precast boxes used to house instrumentation adjacent to the abutment. The asphalt plug joints are failing, which is typical for this type of joint after 10 years of service (Figure 25). As noted, geofoam was placed behind the

Figure 22. Deck Crack at Stockbridge Bridge

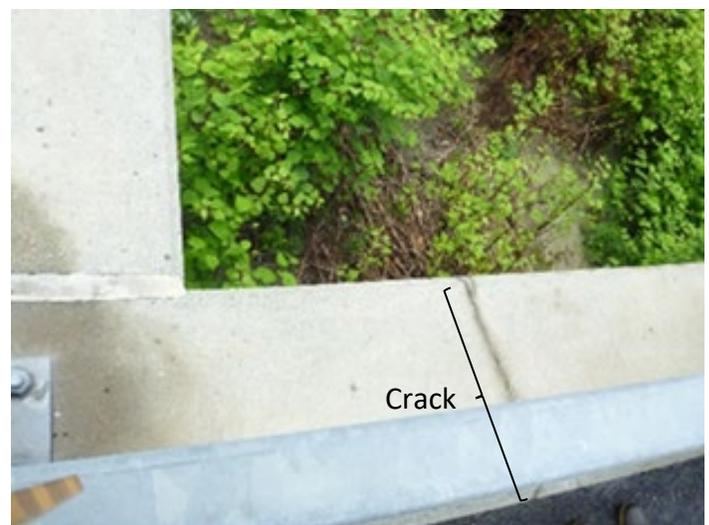
Figure 23. Barrier Crack at Stockbridge Bridge

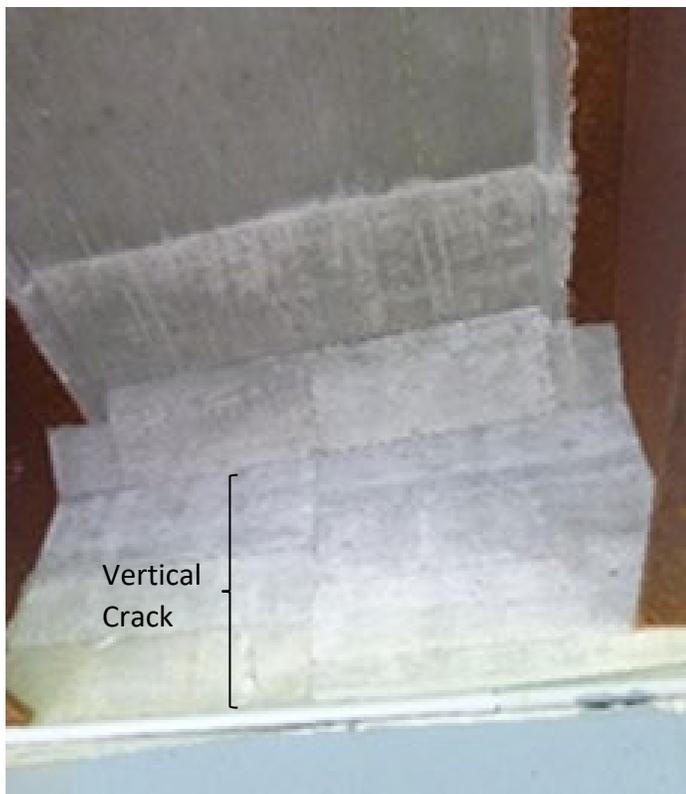
Figure 24. Vertical Abutment Crack at Stockbridge Bridge

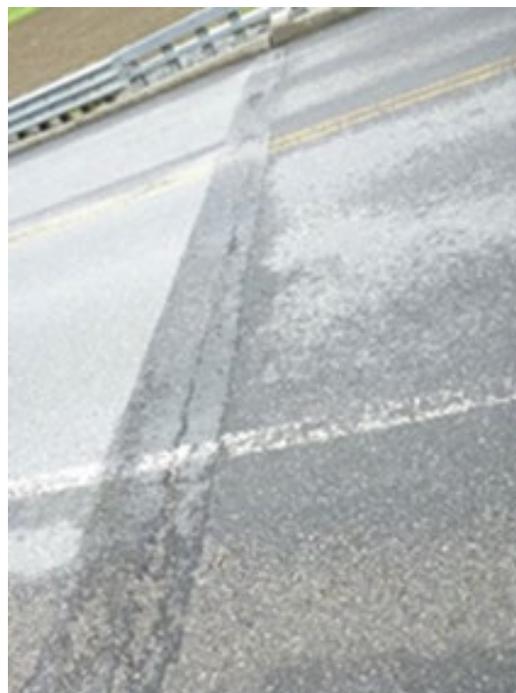
abutments in this structure and data indicates that it reduced backfill soil pressures from those expected without geofoam and avoided peaks in backfill pressure values. There is no indication that this geofoam has any deleterious effects on bridge durability at the backwall and approach slab locations. Most significantly, all signs of distress (cracking) aside from the asphalt plug joint was nearly identical to that reported at the conclusion of the instrumentation project in 2014, indicating that the cracking is stable after the first few years of service pending any corrosion of reinforcement. While efflorescence was present at some cracks, no other staining was observed. The follow up evaluation in 2021 indicated minimal if any changes to condition from 2019 (cracks were less noticeable due to the dry conditions), with the following exceptions. At the intersection between the wingwall and retaining wall the closed cell foam was slipping out of the joint, resulting in some sluffing of ground cover aggregate at this location (Figure 26). The plug joint and end of approach slab both showed expected continued deterioration of the asphalt materials.

Figure 26. Deteriorated Asphalt Plug Joint at Stockbridge Bridge

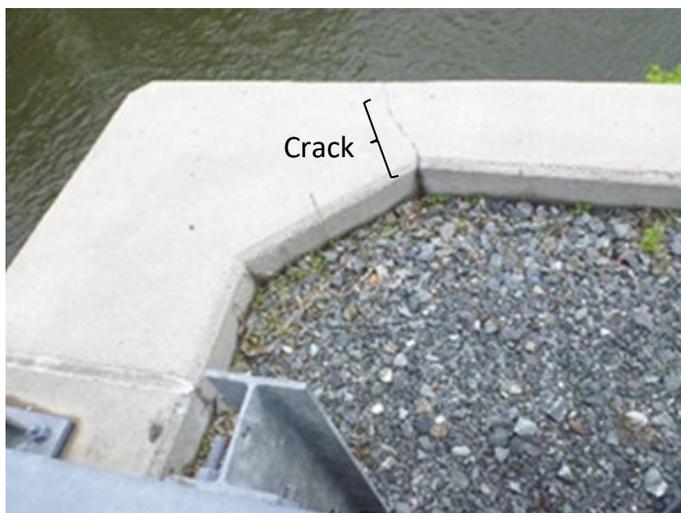
Figure 25. Abutment to Wingwall Connection Crack at Stockbridge Bridge

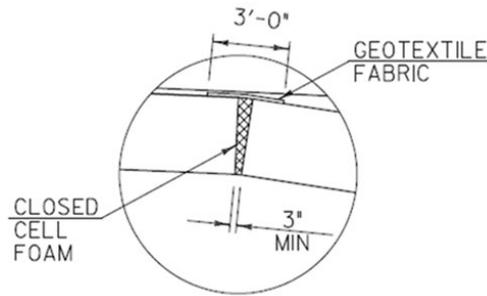
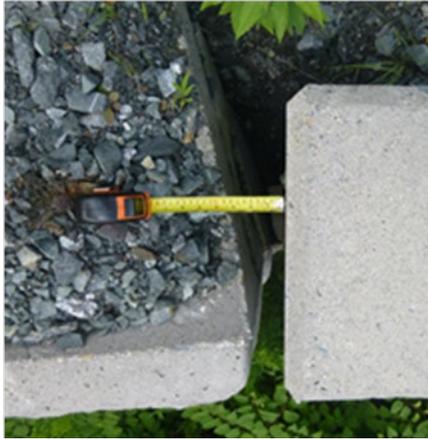
b) Missing Foam 2021

Figure 27. Abutment to Wingwall 2021 at Stockbridge Bridge
