# Protecting Our Legacy: MWRA Dam Management

John J. Gregoire, Program Manager, Reservoir Operations

Published August 15, 2023

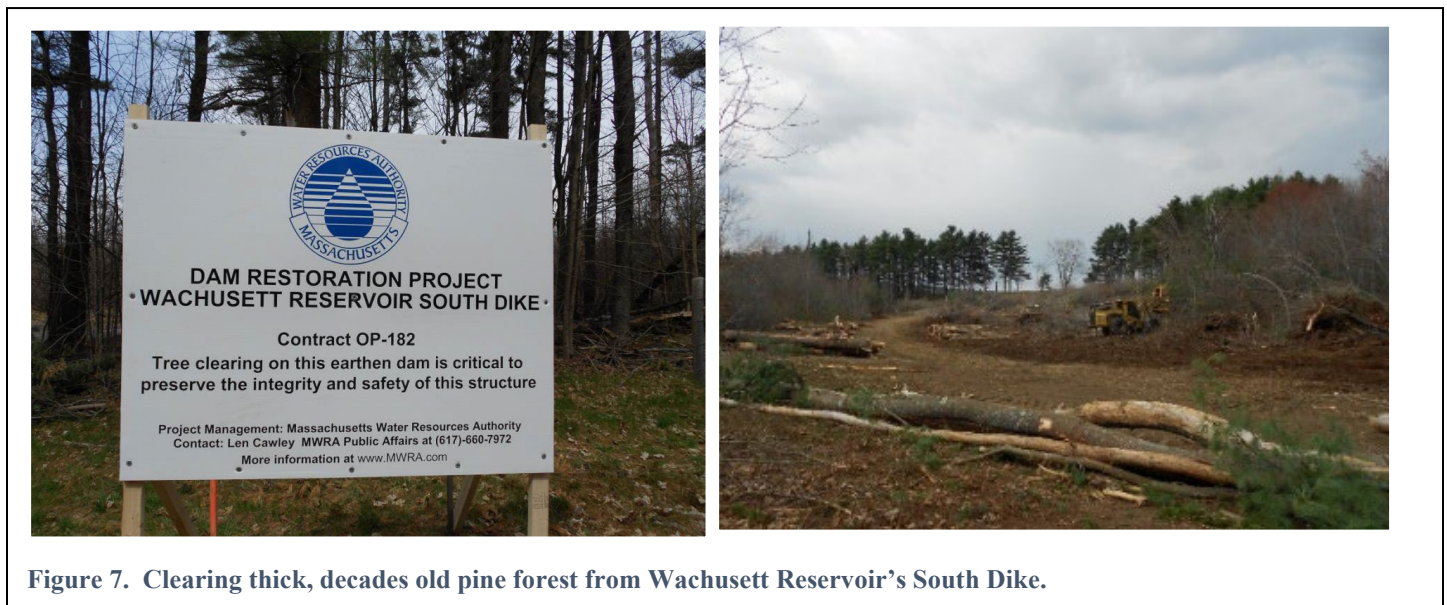
One of the first and most obvious challenges for MWRA was to address the literal forests of trees that had been allowed to grow on several earthen dams (Figure 7, South Dike at Wachusett Reservoir). This was imperative to provide the unobstructed view of the embankments necessary for inspection work, identification of deformities, seeps and other potential issues, as required to meet the MA Office of Dam Safety *Policy on Trees on Earthen Dams*. MWRA developed in-house contract specifications for tree and

Figure 7. Clearing thick, decades old pine forest from Wachusett Reservoir's South Dike.

stump removal across several dams. This was followed by restoration of the embankments by loam and seeding to establish a durable and maintainable turf.

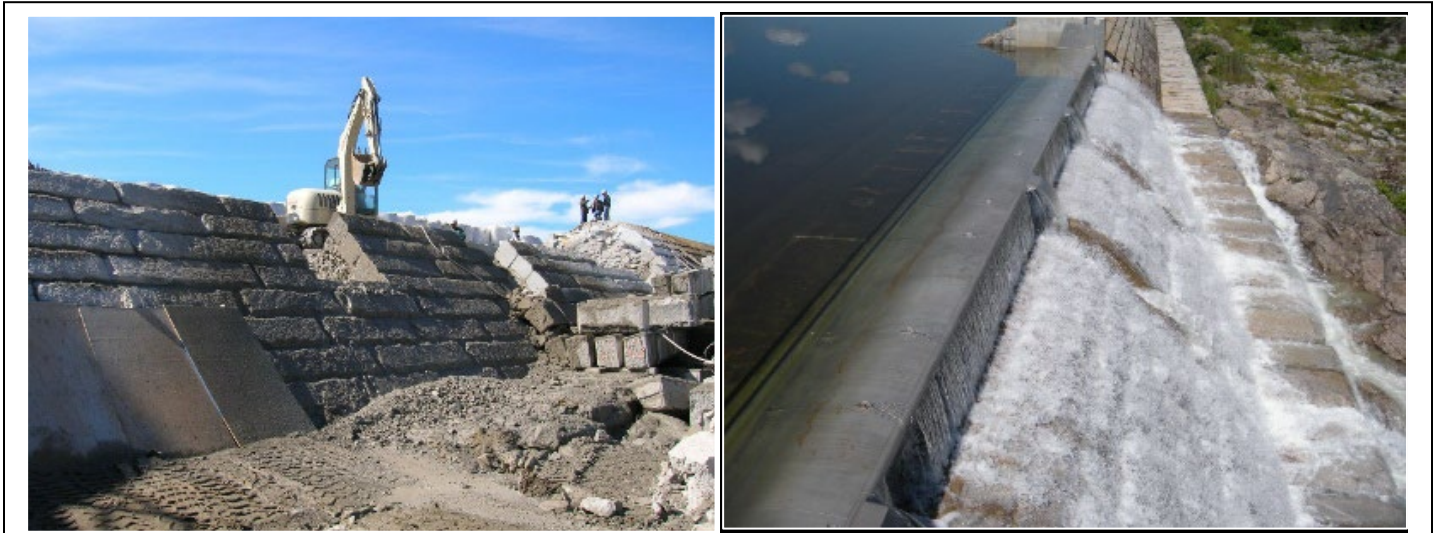
**Figure 8. Lower Wachusett Dam spillway (L) to accept new 100-foot-long Crest Gate (R)**

The findings of this H&H study determined the design aspects of the project and allow construction of the spillway improvements to pass the design flood (PMF). This included removal of old stop log structures, lowering the existing 100 ft. long lower spillway bay by two feet (Figure 8, left photo), installing a hydraulically-operated stainless steel Crest Gate in that lower bay (Figure 8, right photo), creation of an auxiliary spillway to pass flood water, and creation of a berm adjacent to the spillway to prevent overtopping of the Wachusett Dam's left abutment. This work was completed in 2008. Use of the Crest Gate has become a fairly routine spillway operation at higher reservoir

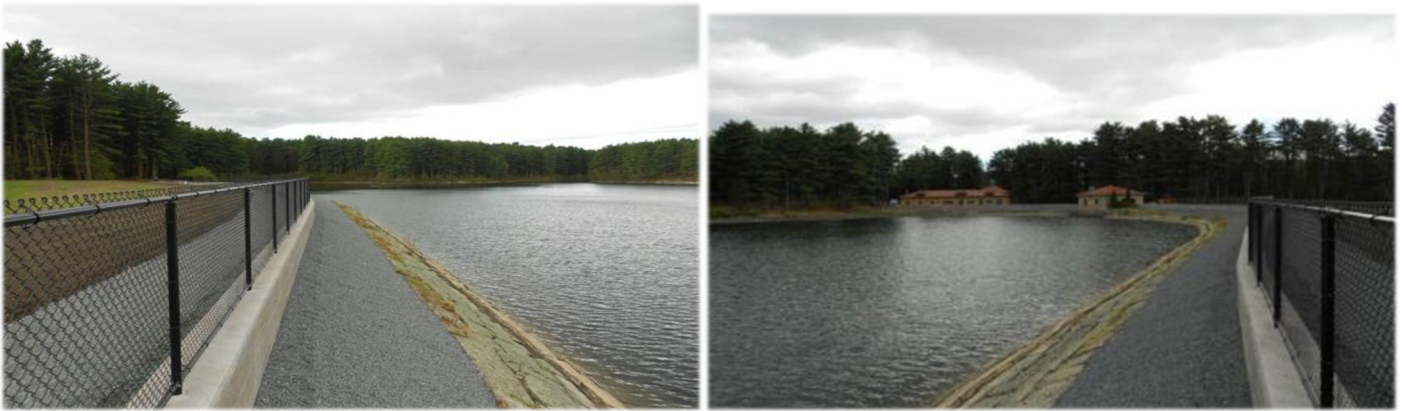
Figure 9. Weston Dam Parapet Wall

At Weston Dam there is no spillway. In this case the H&H assessed the ability of the reservoir to *store* the  $\frac{1}{2}$  PMF. The H&H study found that, while the reservoir could indeed store the PMF, wind generated wave run up on a full reservoir would cause the dam to be overtopped, potentially leading to crest erosion and ultimately dam failure. This finding required an evaluation of alternatives, from which MWRA ultimately selected a wave run up (or parapet) wall (Figure 9). This was completed in 2009.

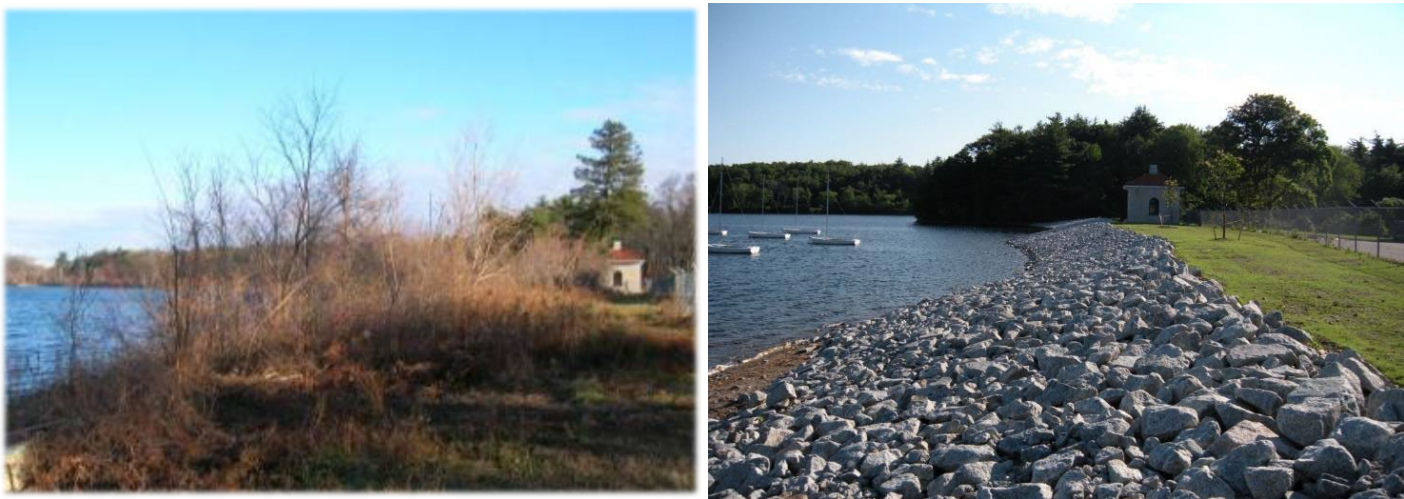
Figure 10. Spot pond dam upstream before tree clearing (L) and after armoring (R)

H&H findings can also result in the need to armor dams to prevent higher reservoir elevation erosion. In this case, based on the elevation of the core wall at Spot Pond Dam #1, the findings recommended a full upstream slope armoring. This was completed as an in-house project in 2014 (Figure 10, right photo).

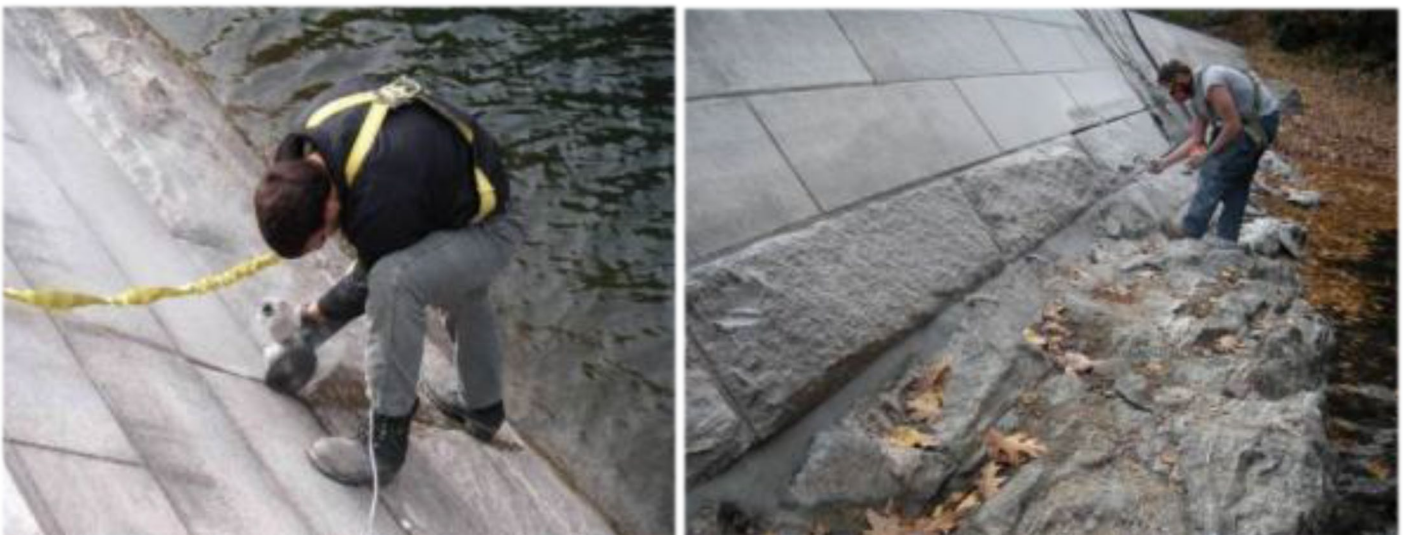
Figure 11. Quabbin Spillway masonry repairs in 2010

Masonry mortar degradation is a common spillway issue, particularly if the spillway sees frequent activation. In cases with rare activation, vegetation and weathering also takes a toll on the mortar. MWRA has done a number of repointing projects on spillways as needed, typically resulting from dam safety inspection findings (Figure 11 shows Quabbin Spillway repointing during low reservoir elevation). And more projects are to come.

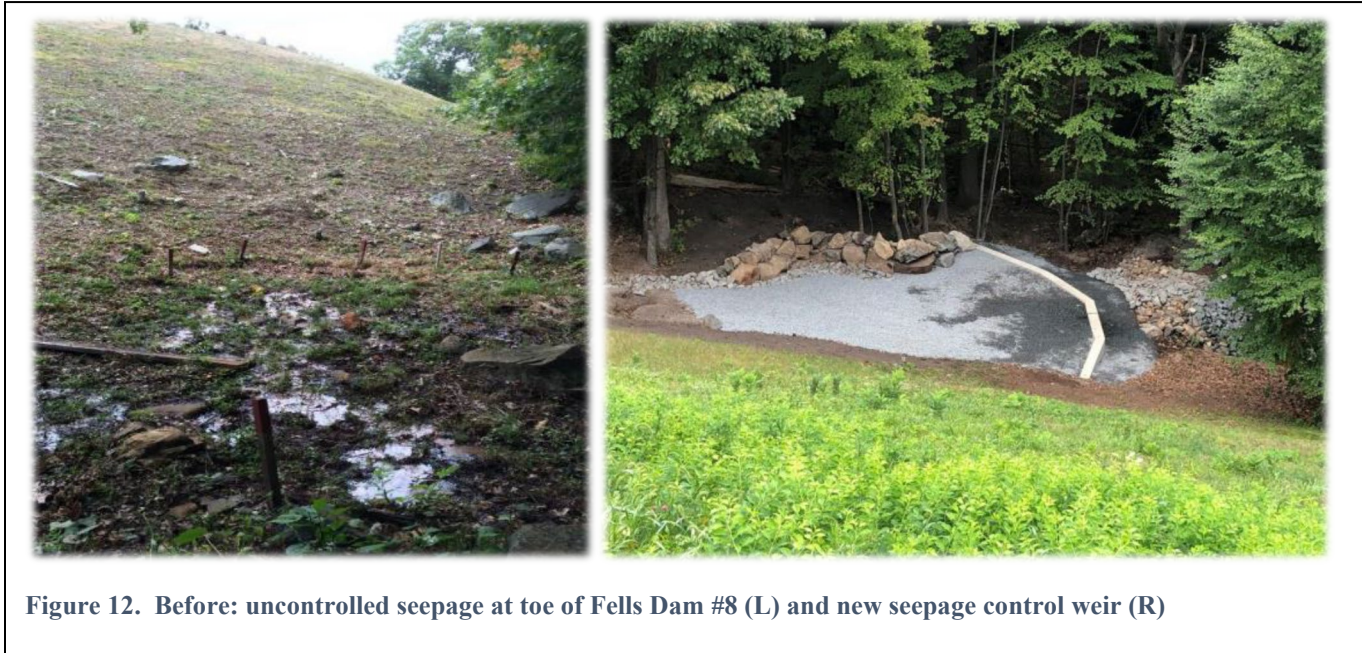
It's a common adage that all dams leak. It is when the seepage becomes uncontrolled that problems, such as *pipng*, can occur. In that case, seepage water carries soil particles along with it which can lead to internal erosion of the dam and, if unchecked, potentially to even greater problems. After clearing trees and heavy growth from the dams, MWRA inspections found some seeps that had been flowing unseen because they were obscured.

Figure 12. Before: uncontrolled seepage at toe of Fells Dam #8 (L) and new seepage control weir (R)

Ultimately, MWRA installed seepage control weirs to collect and filter the seepage locations discovered at Fells Dam #8 (Figure 12), Weston Dam (three weirs) and at Foss Dam. Occasionally seepage may occur due to internal issues such as a high reservoir elevation intersection with a problem stratum in the dam embankment. At Chestnut Hill Dam, MWRA's oldest, such an event occurred in 2019. A prior construction project unknowingly cut into the top of the dam's impervious core material. High water during a wet winter penetrated this breached zone and caused both a seepage boil and a diffuse seep at the dam toe. Initial emergency response actions by MWRA included lowering the reservoir to reduce the seepage pressure. Subsequently, MWRA restored the damaged core zone with impervious fill, installed a seepage filter blanket at the toe, and reduced the reservoir operating band to ensure water will not reach that zone.

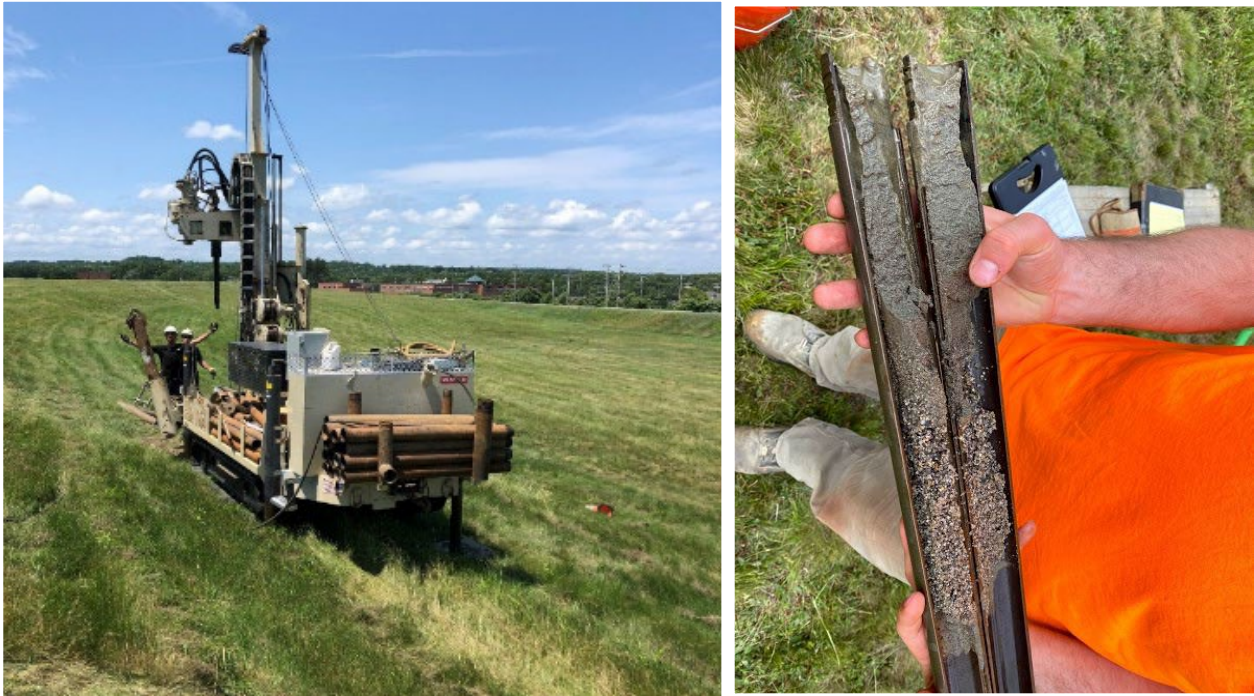
Figure 14. Borings for piezometer installations at North Dike (L), subsurface data collection (R)

An additional component of this instrumentation work is the collection of subsurface geotechnical samples from the borings for use in revised Seepage & Stability analyses where that actual data was unknown. The first project was recently completed at the Wachusett North and South Dikes (Figure 13). The next contract at Weston Dam and Chestnut Hill Dam is nearing completion. The required instrumentation at the remaining dams is in planning and design,

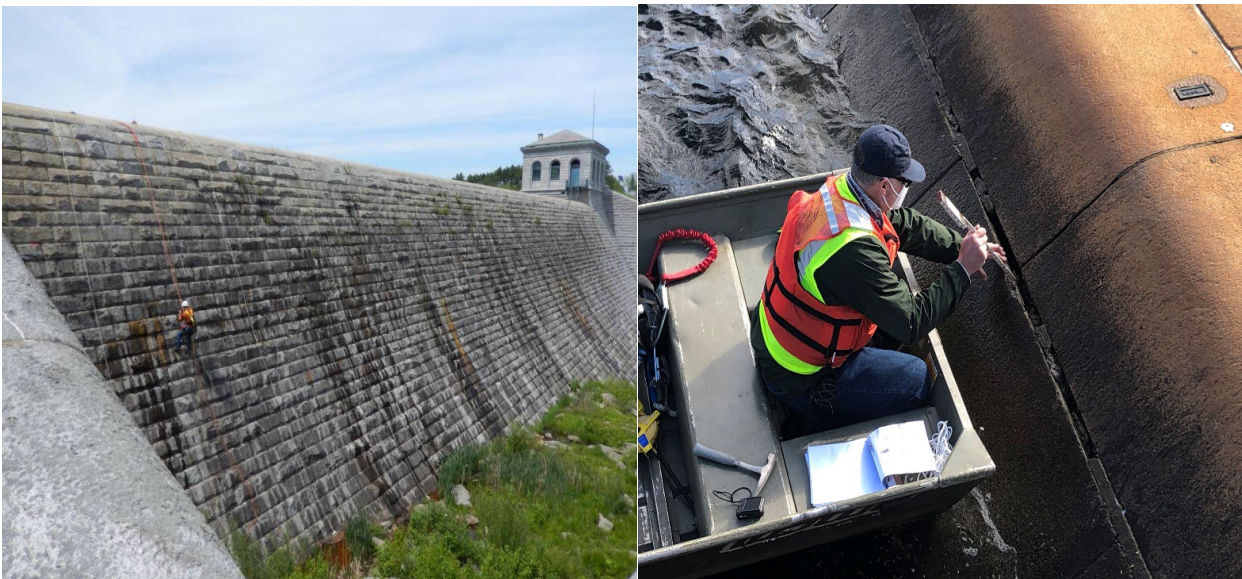
Figure 13. Current condition of Sudbury Dam Spillway downstream face (L) and upstream crest (R)

A number of other dam improvements are presently under design for MWRA dams. This includes major masonry repairs at Sudbury Dam Spillway (Figure 14), armoring Foss Dam for overtopping protection, a parapet wave wall at Wachusett Reservoir's North Dike where a small area of Dike was removed in the 1960's to build a pump station, and evaluation of new seepage locations.

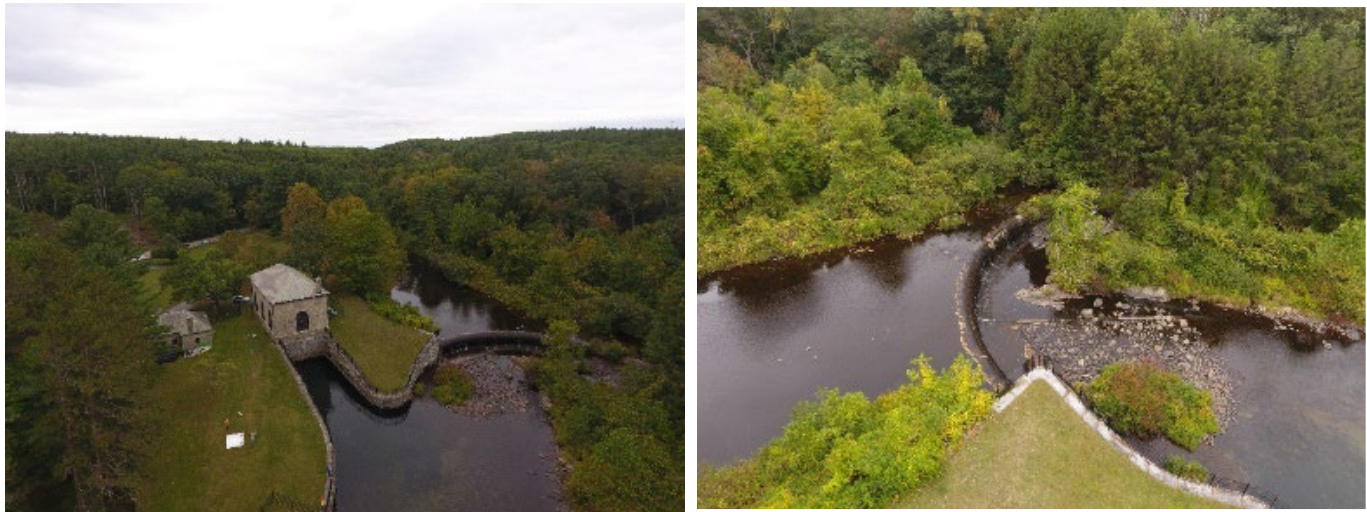
Lastly, MWRA is also embarking on the physical removal of an obsolete dam. The Quinapoxet Dam on the Quinapoxet River (Figure 15) was originally designed to permit sediment accretion in the downstream over-widened channel before the river entered

a series of basins at Wachusett Reservoir. Due to modern reservoir operating regimes, the original function of that dam system is no longer applicable. This project is presently under design for removal of the dam and restoration of the river channel. This will also allow the land-locked salmon in Wachusett Reservoir to migrate back up the Quinapoxet River for spawning.

Figure 15. Obsolete Quinapoxet Dam at Wachusett Reservoir slated for removal. (MWRA, 2023)
