Truss Bridge Rehabilitation Using Local Resources

Imaginative use of local resources including materials, expertise and labor can result in cost efficient projects.

The Stuyvesant Falls Bridge

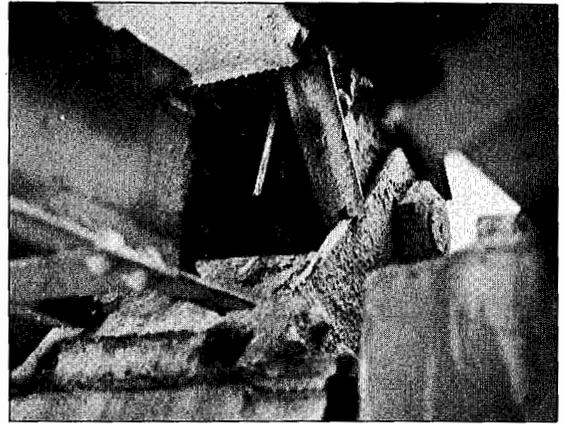
FIGURE 2. A view of the broken lower chord on the east truss ($L_0 - L_1$).

1. The bottom chord was entirely severed by corrosion at the south bearing, and the inclined truss member and shoe had moved outward longitudinally 9 inches, and the rocker had twisted. See Figure 2.

In order to begin repairs, the first order of business was to jack up the south end of the trusses approximately one foot (0.3 m) and remove the load from the twisted shoe (see Figure 5). Once the jacking was completed, the repair could be effected. The truss member and rocker were pushed horizontally by another jack to a calculated point and a chord mending device was installed to keep them there permanently. The jacks and auxiliary beams were then removed. The verticals and floorbeams were reconnected with permanent-type details, and the sub-verticals of the two trusses were reinforced with special "horseshoe"-shaped collars (see Figure 6).

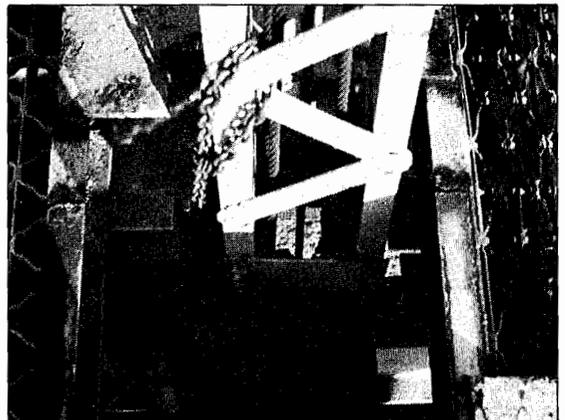
2. The connections of three vertical members to the floorbeams at the panel points were corroded to the point of uselessness. See Figure 3.

FIGURE 3. Broken vertical on the east truss ($L_{11} - O_{11}$).

Following the consultant's inspection, the county decided to effect immediate temporary repairs for deficiencies in the broken bottom chord and in the corroded connections of three vertical truss members. The County Maintenance Department, under direct instruction of the consultant, first placed wire ropes tensioned by turnbuckles between panel points and load posted the bridge for 2 tons. With this expedient approach the bridge could then be used to some extent while the county and the consultant studied alternative methods for upgrading the bridge.

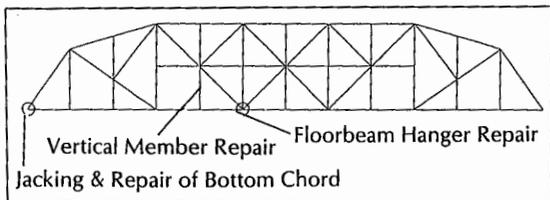
FIGURE 4. Elevated view of the east truss noting repair locations.

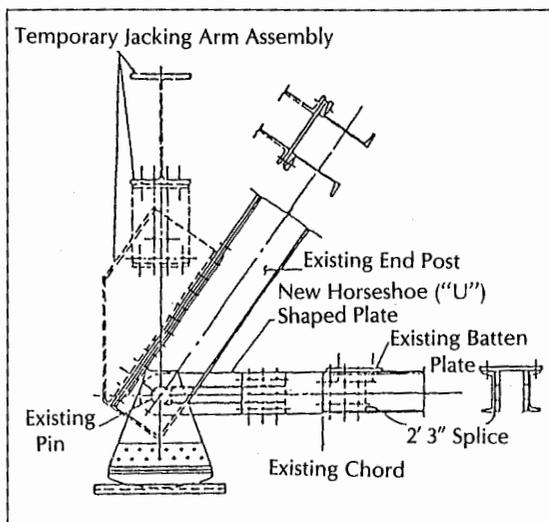
FIGURE 5. Jacking details and repair of the bottom chord.

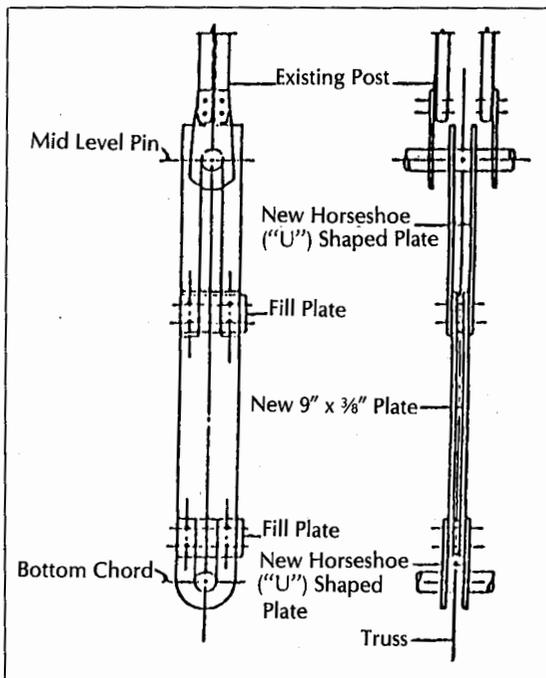
5. The trusses rated well, except for 16 subpanel verticals whose rating was 9 tons.

FIGURE 6. Vertical member repair.

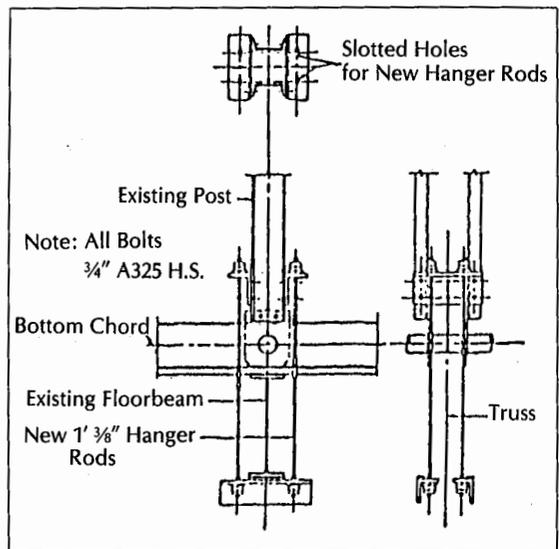
4. All floorbeams were in good condition, but could only carry a 7 ton live-load safely.

FIGURE 7. Floorbeam hangers.

The next repair in line was the strengthening of the floorbeams. Without removing the grating (which was in fair condition) and stringers, a platform was erected under each floorbeam (see Figure 7). Four angles were bolted onto the webs of the beam as close to the flanges as possible. The corroded stringers

were then left in place, but beams of similar depth were set alongside the bad ones and shimmed into place. The railing and sidewalks were repaired in spots where needed. Since cleaning and painting were not priority tasks, they were deferred to the following season. The bridge was reopened to traffic with a capacity of 15 tons — adequate to handle all traffic including buses, fire engines, ambulances and other community vehicles. For the occasional runaway heavy truck, the bridge's operating rating is 20 tons.
