# The Performance of Highway Bridges in the Northridge, California, Earthquake

*Bridge seismic retrofit programs exhibited a high degree of success. However, additional requirements for retrofit programs and initial design are needed.*

NATIONAL CENTER FOR EARTHQUAKE  
ENGINEERING RESEARCH

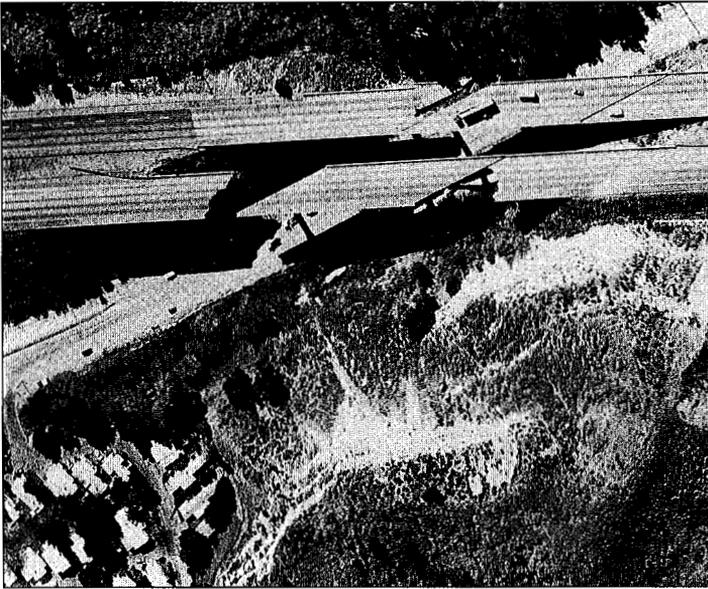
**FIGURE 6.** An aerial view of the damage at the Gavin Canyon Undercrossing.

*Observed Earthquake Damage.* Both structures suffered failures due to total or partial loss of support at the expansion joint hinges. The acute corner of the supported span tended to become unseated first due to a counterclockwise rotation of each of the structural sections about a vertical axis (see Figure 6).

The movement of the superstructure caused restrainer cables to be pulled at an angle to their principal axis as evidenced by spalling at the edges of cored holes through which the restrainers passed. In some cases, restrainer cables snapped as the expansion joints separated. In other cases, they pulled through the expansion joint diaphragm. Some cables remained intact, helping support the partially unseated spans and preventing the unseating of the span at one of the hinges.

*Failure Analysis.* The failure of this bridge can be attributed to large lateral and rotational movements of the superstructure sections that caused the narrow expansion joint hinges to become unseated. Rotational movement of the end spans was probably induced by the eccentricity between the center of mass of the superstructure and the center of stiffness of the end frame that tended to be shifted toward the rather stiff diaphragm abutments. The strong shock measured at the Newhall Fire Station was oriented in a direction transverse to the bridge. Motion in this direction would have resulted in maximum excitation of the rotational response of the end spans.

*Issues/Questions.* This failure illustrates the difficulties associated with large skews and with multiple expansion joints. A major lesson is the importance of eliminating and/or minimizing skew and expansion joints, especially in high structures where the vibration charac-

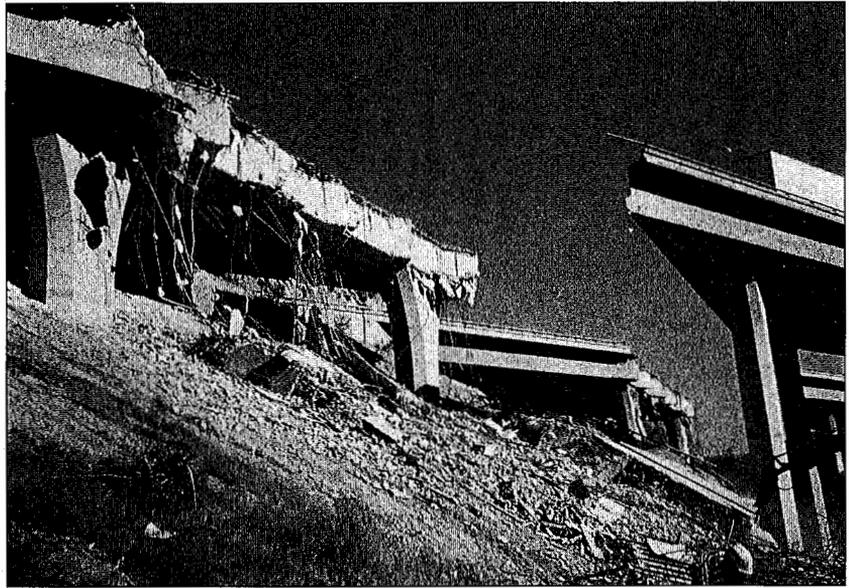
**FIGURE 7. Collapsed end spans at the Gavin Canyon Undercrossing after demolition.**

Despite the strong ground shaking at the site, the structure suffered very little column damage as can be observed in Figure 7. Only minor cracking was observed at the base of some columns. Cracked pavement at the bridge approaches is evidence that the fills shifted during the earthquake. There was some minor abutment damage.

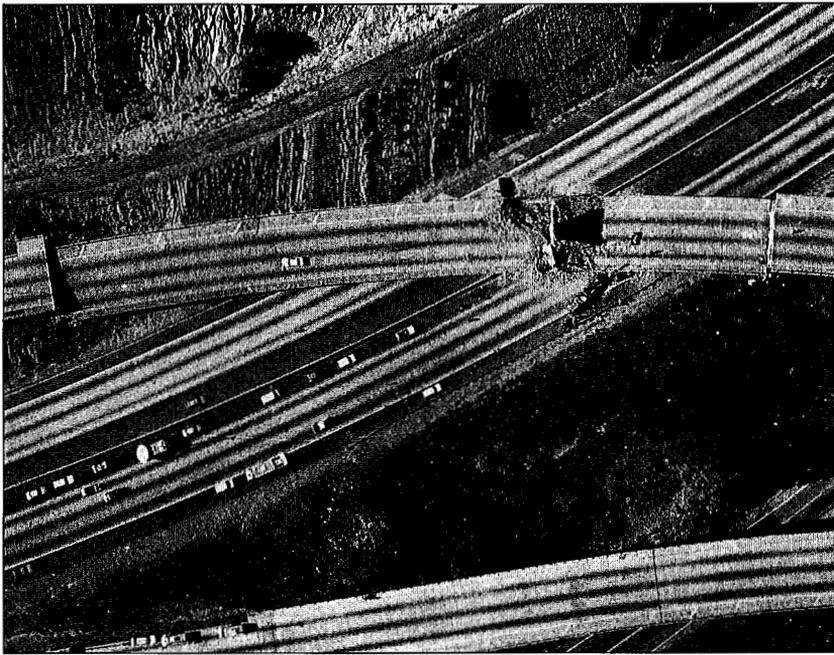
*Observed Earthquake Damage.* As shown in Figure 13, spans 1, 2 and 3 collapsed. In addition, pier 2 was completely crushed and pier 3 sheared through the superstructure. The mode of failure at pier 2 could not be determined by visual observation since it was completely crushed under the superstructure. The three spans that collapsed made up the first frame with piers 2 and 3. Span 1 was supported on a 24-inch seat abutment and frame 1 terminated at an in-span hinge approximately 22 feet from pier 4 in span 3. The in-span hinge seat was 14 inches wide and Type 1 restrainers tied frames 1 and 2 together. Restrainers were not used at either abutment.

The right exterior shear key at abutment 1 was damaged. However, a visual inspection of the left shear key revealed little damage. The superstructure at abutment 1 displaced approximately 10 feet up-station (north) and 10 feet right (east). The pier 3 bent cap was inclined towards pier 4 and the measured ground separation from the column at pier 4 was ap-

proximately six inches north-south and four inches east-west. At the in-span hinge 1, cantilever side, the transverse shear key was damaged. However, the shear key was still in place. At this same hinge, the equalizing bolts failed in tension and the nuts on the restrainer cable studs were missing. The vertical shear planes noted on the faces of pier 3 bent cap appeared to be similar to the web stem and soffit cracks documented at these locations after the 1971 San Fernando earthquake. The piers were not detailed as ductile elements. However, a visual inspection of piers 3 and 4 above grade did not indicate that there was any structural damage. The predominant motion of the structure appeared to be in the north-south direction.

1. Seat loss at in-span hinge 1 caused span 3 to collapse, which overloaded the bent cap and web interfaces at pier 3. The subsequent collapse of span 2 overloaded pier 2, which was followed by the collapse of span 1 and unseating at abutment 1.

The circumstantial evidence available at the site, especially the damage sustained by the face of pier 3, suggests that the first mechanism cited above is the most likely failure mode.

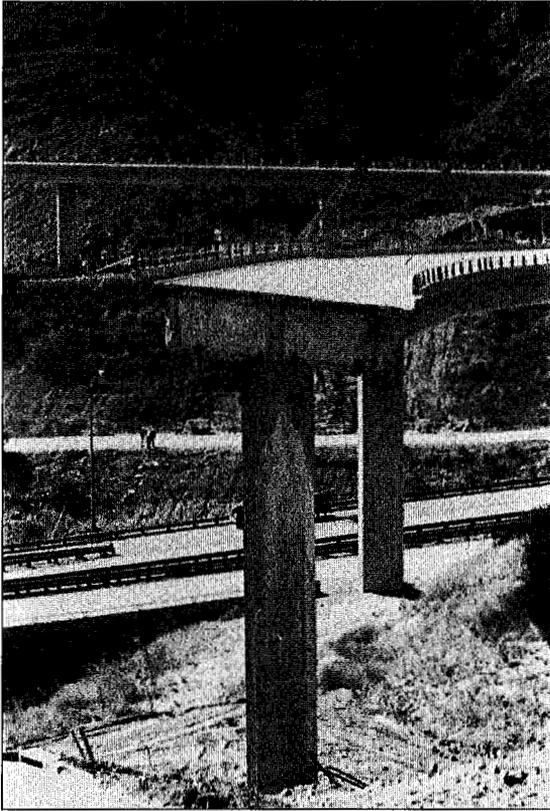
**FIGURE 15.** Collapsed end spans after demolition at the SR14/I-5 north connector.

**Observed Earthquake Damage.** As shown in Figures 15 and 16, spans 1 and 2 collapsed and pier 2 was completely crushed. The mode of failure for this pier could not be determined by visual observation. Span 1 was 188 feet long, and was simply supported at the seat abutment and at the in-span 1 hinge. The hinge and abutment seats were both 14 inches wide and hinge restrainers had been installed at the hinge. (Current Caltrans design specifications require that abutment seat minimum widths be 24 inches). The shear keys at abutment 1 were not severely damaged, indicating that motion was primarily in the longitudinal direction of the bridge at abutment 1 — *i.e.*, in a north-south direction (see Figure 16). Equalizing bolts at abutment 1 failed (see Figure 16). The collapsed pier 2 was supported on a spread footing and was approximately 21 feet high. The other two piers making up frame 1 were pier 3 (which was approximately 73 feet high and supported on CIDH piles) and pier 4 (which was approximately 60 feet high and supported on a spread footing). These pier columns were not detailed for ductile behavior since they utilized #4 ties at 12-inch centers.

1. Seat loss at abutment 1 that caused span 1 to collapse, with subsequent failure of pier 2 followed by collapse of span 2 to pier 3.
2. Non-ductile shear failure of pier 2, followed by the collapse of spans 1 and 2.

Without analysis, the sequence of failure is uncertain. However, it seems likely that pier 2 failed first and then was followed by the collapse of the two spans. It is possible that pier 2 attracted a much higher proportion of the lateral load than assumed in design because of its relatively short height. Furthermore, there was probably a significant reduction in the axial load in the pier due to both the severe curvature in the bridge and the high vertical accelerations in the ground motion. This reduction in axial load may have reduced the capacity of the column to less than the demand and, thus, led to the failure of the pier.

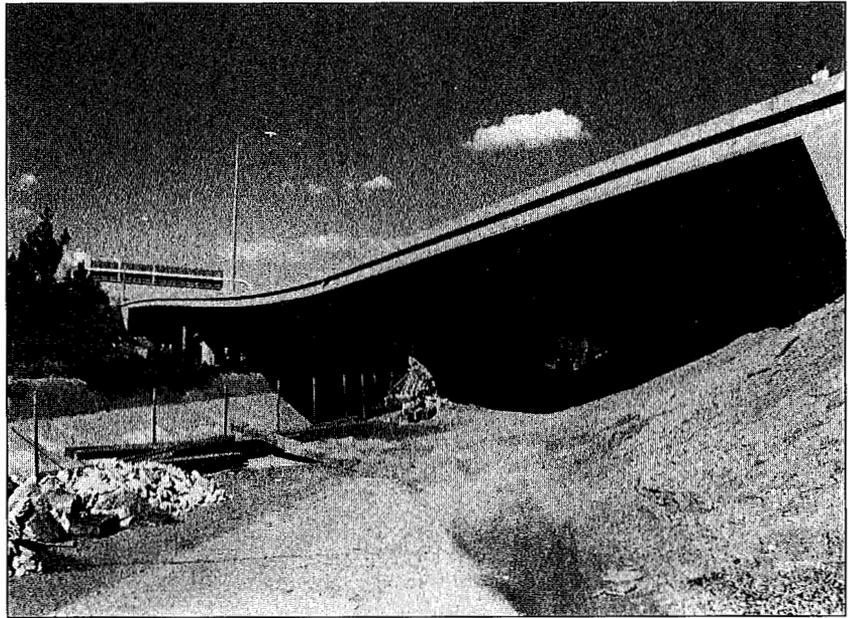
**FIGURE 19.** Side view of the Bull Creek Canyon Channel Bridge.

*Observed Earthquake Damage.* As shown in Figure 19, this bridge sustained irreparable damage to its columns during the earthquake. At bent 2, the two southernmost columns in the eastbound bridge failed just below the well confined section near the superstructure soffit. These failures caused the superstructure to drop several inches at these locations, resulting in

cracking and spalling in the soffit near the location of the failed columns. Some remaining columns in the eastbound bridge exhibited diagonal cracking. Bent 2 columns on the westbound structure sustained far less damage.

Bent 2 failures and possible abutment shear key failures were probably a result of the failed

columns at bent 3 and the subsequent shifting of lateral forces to the remaining supports. The bent 2 column failures were essentially shear failures aggravated by the degradation of shear strength that resulted from flexural yielding. This conclusion is supported by the behavior of the various columns in bent 2.

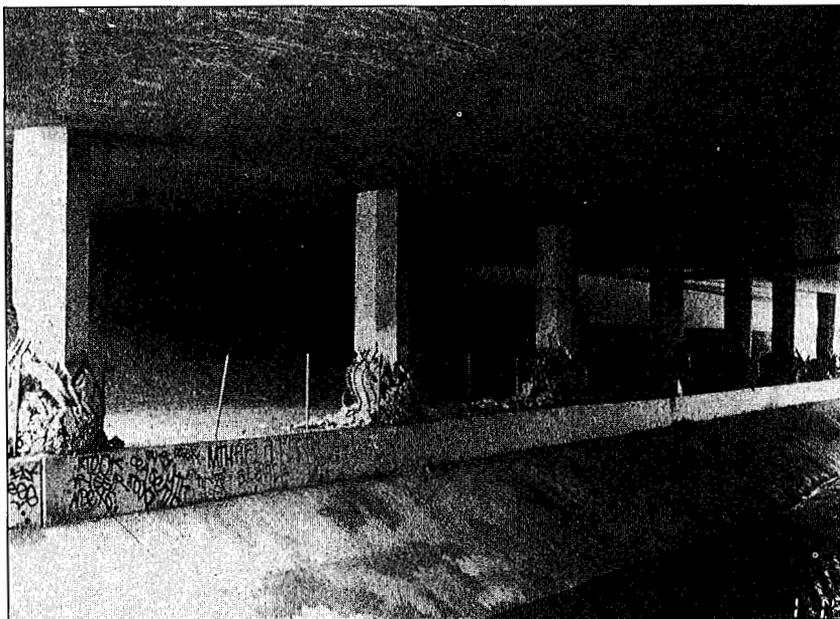
**FIGURE 20. Hinges in all columns of bent 3 immediately above the channel training wall at the Bull Creek Canyon Channel Bridge.**

At bent 3 all columns in both bridges failed just above the training wall as shown in Figure 20. These failures occurred in an area above the well confined section of the column that was near the footing. Disintegration of these columns during the earthquake resulted in a significant drop in elevation at bent 3.

*Failure Analysis.* The failures at bent 3 may be explained by the presence of the training wall that forced the plastic hinge to form at the top of the wall and, thus, above the confined section of the column. The training wall also shortened the effective height of the column, thus increasing the shear forces in the columns due to flexural demands. Some torsional shear forces were also induced because of the eccentricity of the training wall to the centerline of the column.

*Issues/Questions.* The column failures demonstrate the risks of attempting to optimize column designs by trying to predict the location of plastic hinging, even in relatively simple columns such as these. The placement of a training wall forced hinging to occur at a location unforeseen by the designer. Also, it does not appear that the columns were adequately reinforced for shear. Therefore, it would seem prudent to place closely spaced transverse reinforcement over the full length of the columns. It is relatively inexpensive to do so and it will help minimize the effects of unforeseen conditions.
