I-93 Bridge Repair, Memorial Day Weekend 1999

The spirit of partnership among owner, engineering consultants and contractors — especially the cooperative efforts of two competing contractors — ensured that repairs to this bridge were done in a timely manner.

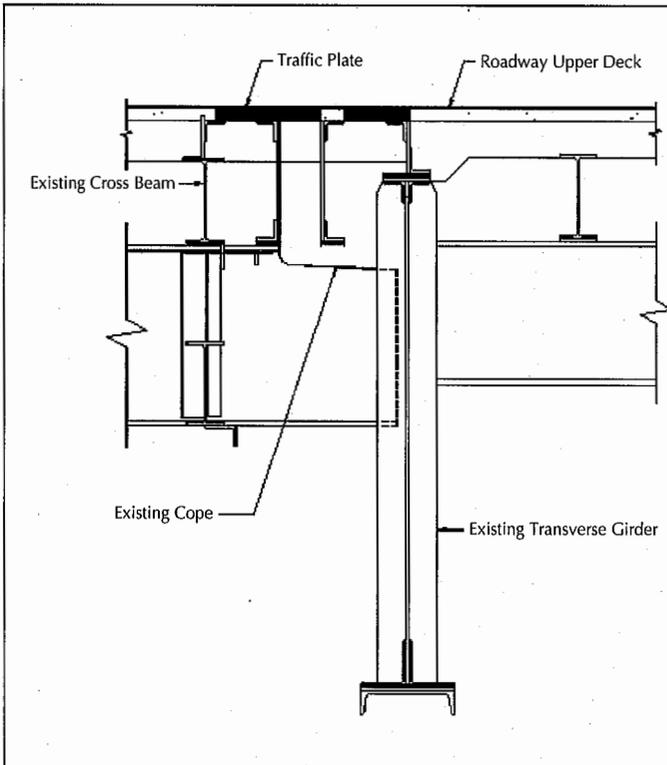
FIGURE 2. The existing W36 cope.

The detailing of the stringer ends and finger joint proved to be the culprit in the Memorial Day emergency. First, the top flange of the stringer end was coped so that it would fit under the plates and channels that made up the finger joint support assembly. This cope effectively created an inverted "T" section (see Figure 2). Although the primary stress in the web was from shear, the reaction created a second-order bending moment that the "T" section had to carry. This bending moment put the unbraced coped web into compression.

As it happened, the coped stringer ends lost section after 40 years of corrosion, while at the same time increased traffic loads and heavier trucks produced larger compressive loads on the web from the second-order moment from the reaction. After years of pounding, the unbraced stringer end buckled on that fateful Friday. As it buckled, the stringer

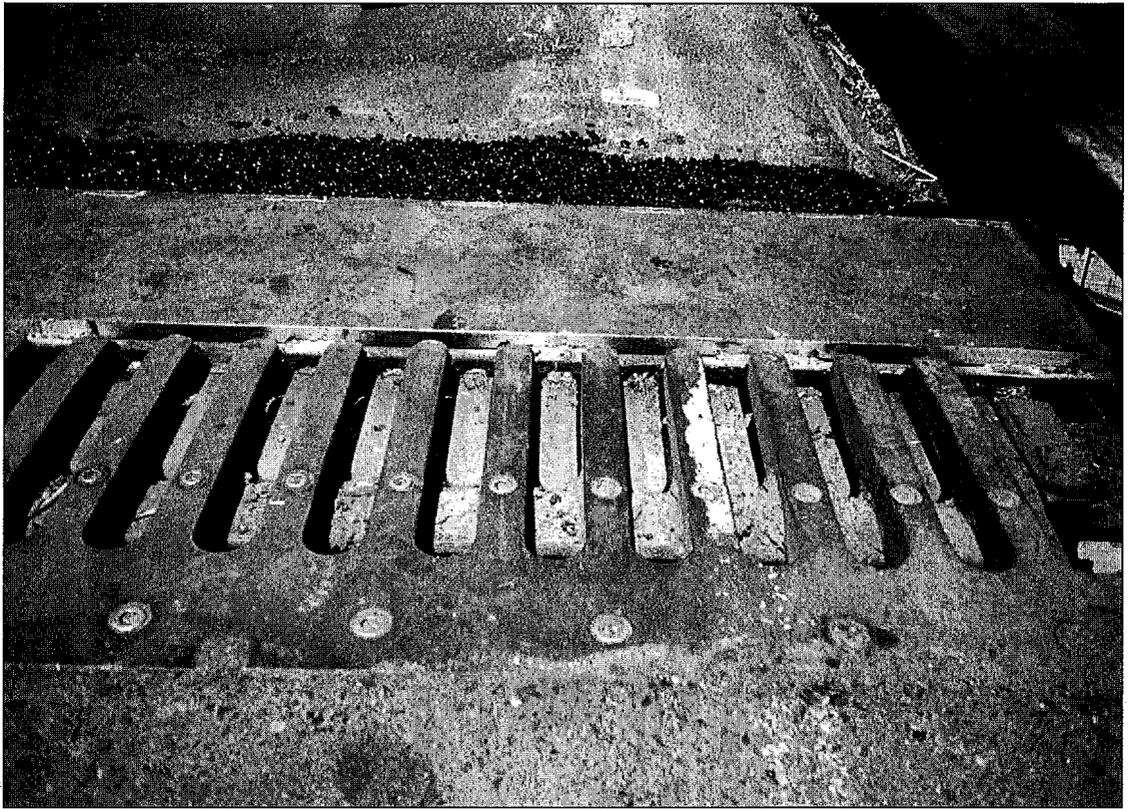
FIGURE 3. The traffic plate on the upper deck of the bridge.

After the jacking operation was completed, the upper deck roadway surface was still uneven across the expansion joint. A steel plate was used to create a transition between the two sections of the bridge deck that were uneven. Most of the unessential equipment and material were removed from the site by 12:00 P.M. on Monday. Soon after jacking the transverse girder, the temporary shoring of the upper deck was sequentially removed from the site. The upper deck was opened to traffic at 2:00 P.M. on Monday, a half-hour earlier than the lower deck in order to assess the impact of the traffic on this retrofit.

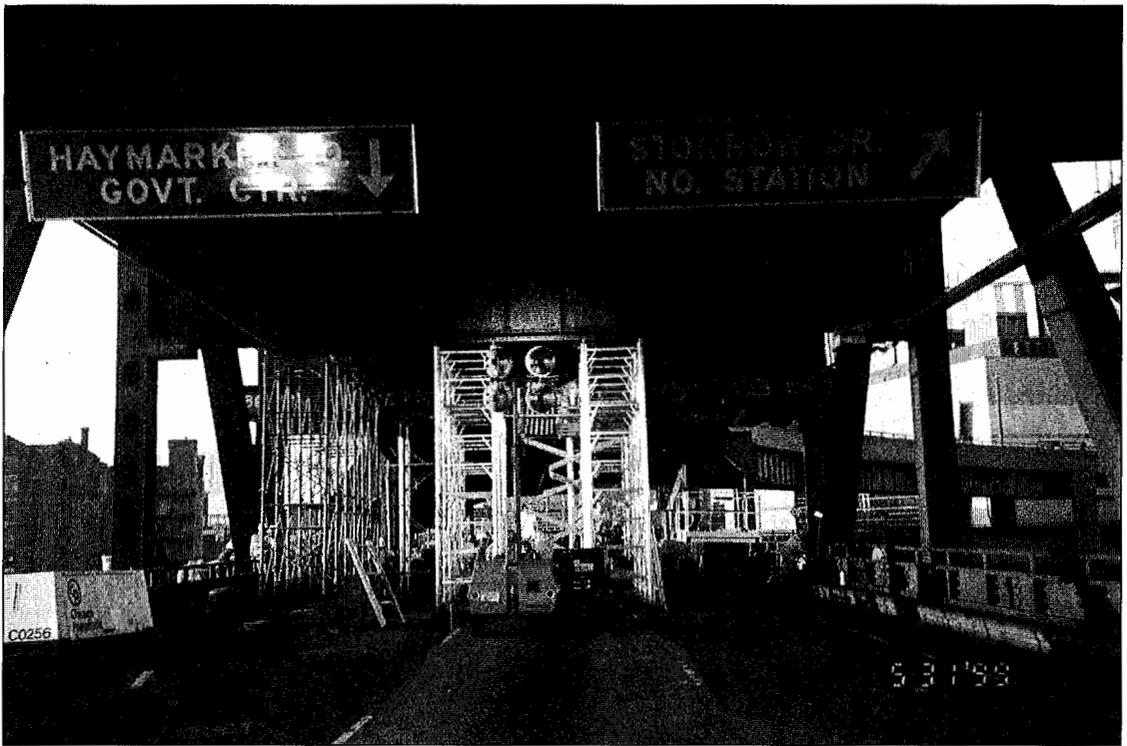
FIGURE 4. I-93 southbound at the Charles River Bridge showing the shoring towers.

Shoring towers were also erected below the affected stringers in order to unload the stringer ends so that the splice plates could be installed (see Figure 4). The shoring towers were located over the stringers of the lower level. A study of the original dead and live design loads for the stringers, which were given on the construction plans, showed that they had sufficient capacity to carry the dead load of the upper level stringers in addition to their own dead load.

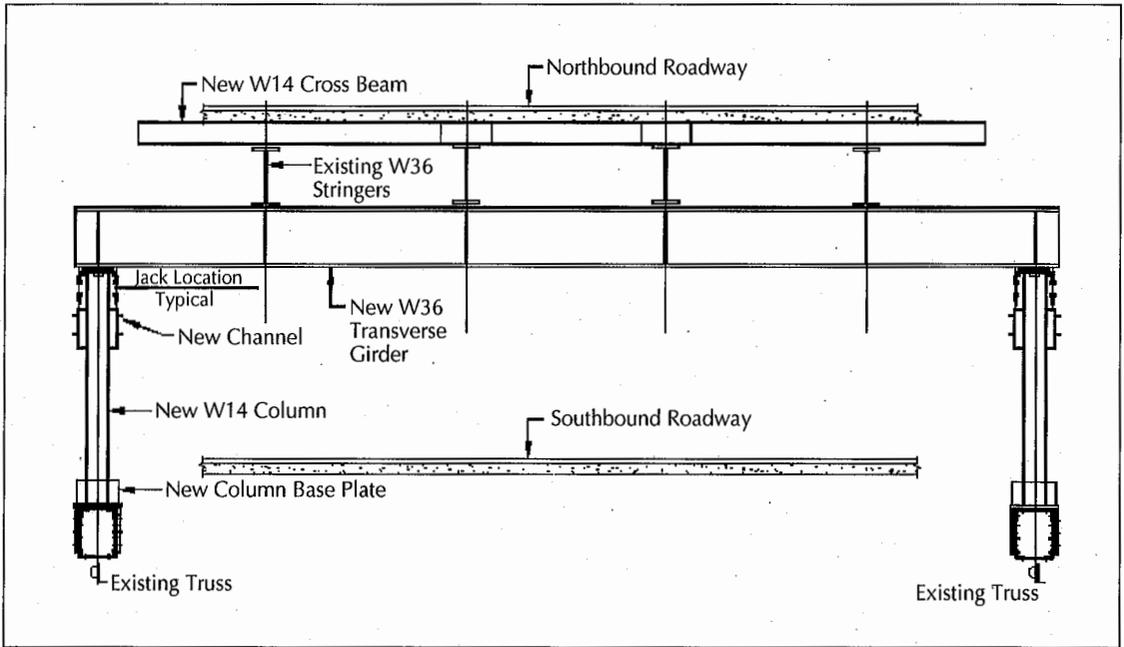
FIGURE 5. Elevation view of the new support beam and column.

the columns would be placed closer to the stringer ends and eccentric to the W36 girders (see Figure 5). After performing preliminary analyses and computations for the two approaches, it was determined that the impact of the selected concept would be minimal on the existing truss members and connections.

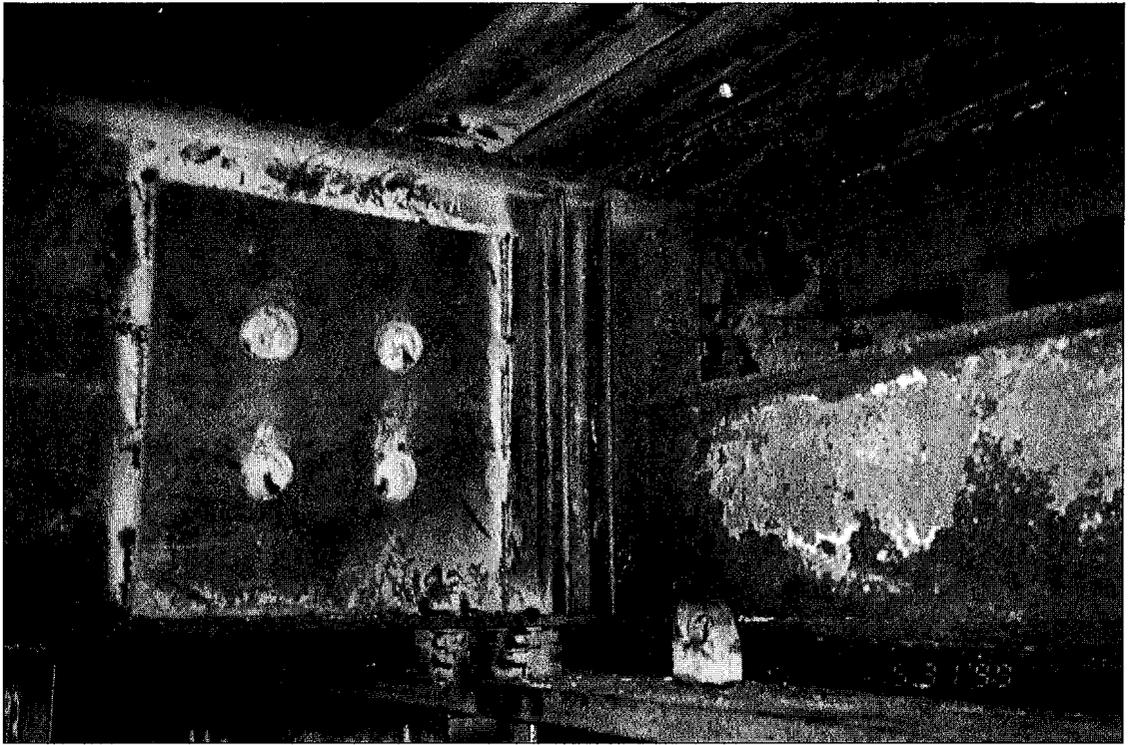
FIGURE 6. Web doubler plates.

The existing W36 stringers were ground smooth using metal grinders and all rust and loose material was removed. This preparation was necessary for the installation of the web doubler plates (see Figure 6). At the truss connection, all plates were ground using a metal grinder in order to prepare the surfaces to receive the column base plates.

this review, along with the assessment of the existing web condition, new web doubler plates were installed and secured with plug weld at mid-depth, along with continuous welds at the fillets between the web and the flange.

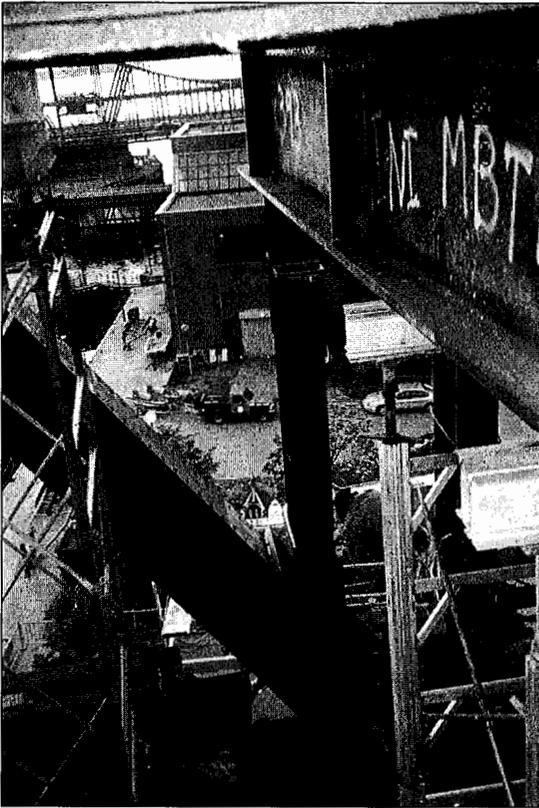
FIGURE 7. The new W14 columns and the W36 traverse girder.

After the columns and the transverse girder were installed and secured in place, base plate side elements were installed and welded to the cap plate (see Figure 7). All spaces between stringers and the W36 transverse girder were shimmed with steel plates. After completing

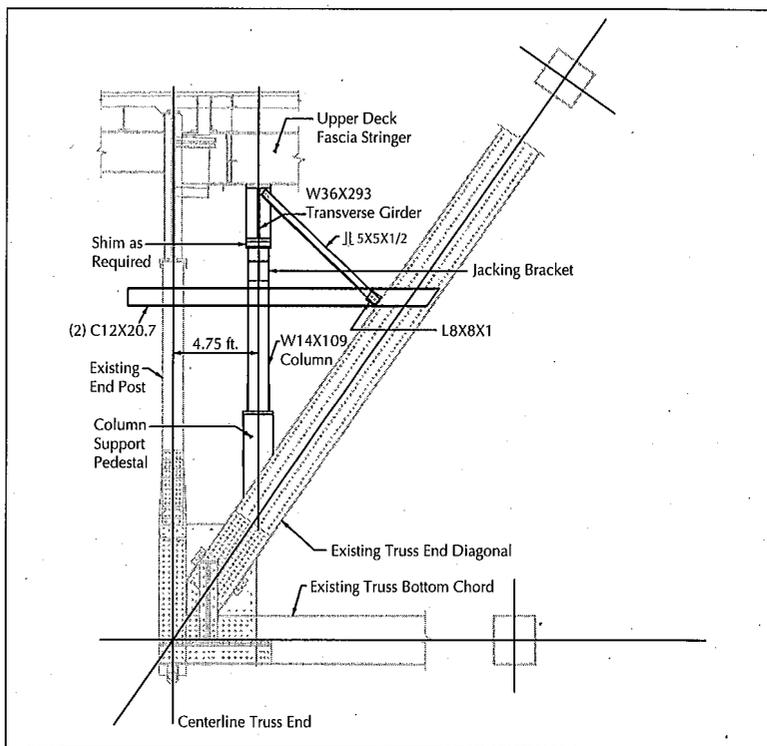
FIGURE 8. Repair bent at the north finger joint.

For the northern end, MHD engineers decided to place the column base plate horizontally. The saddle side plates were fabricated with five sides so that, when installed, the top edges were level (see Figure 8). The column with its base plate would be placed on top of these plates and welded in place. This way, the column could be moved somewhat, if needed, so that it would line up with the transverse girder.

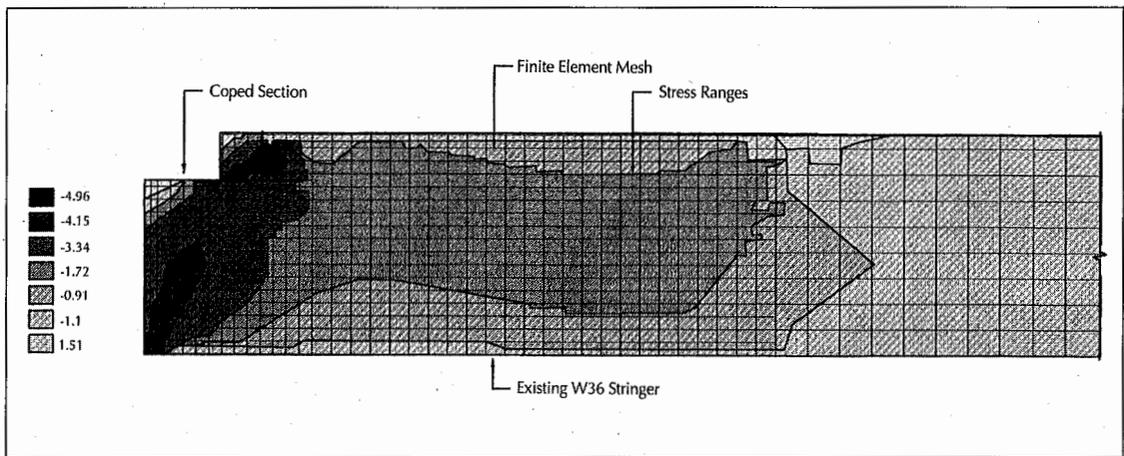
FIGURE 9. Finite element mesh of the existing W36 stringer with coped top flange.

Stringer End Detail — Finite Element Model. A finite element model of the W36 stringer was developed to better understand the behavior of this beam under the loading condition it had encountered over the past 40 years (see Figure 9). The computer model considered the as-built geometry of the W36 beam, particularly the end cope details as it exists on the bridge today.

Analysis results of this finite element model provided stress ranges and identified a region of high stress concentration in the web of the W36 stringer (see Figure 9). Next, a model was produced with the beam web weakened, as was the case with the corroded end conditions. Shown in Figure 10 are the stress ranges in the beam at the mid-span and the end condition where the W36 beam has a top flange cope.

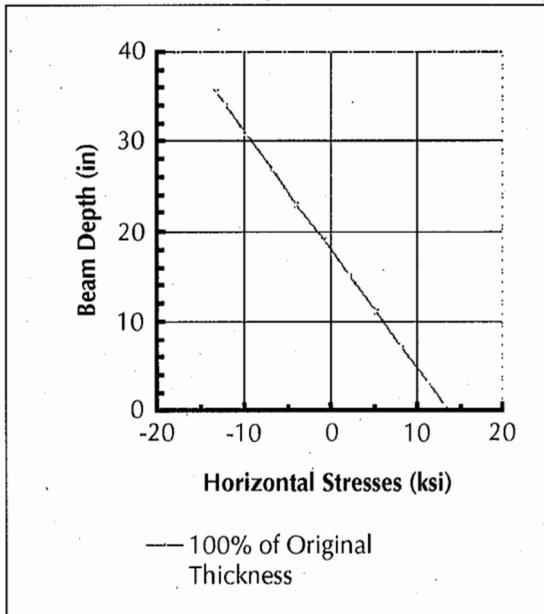
FIGURE 10. Horizontal stresses at mid-span.

Based on the results shown, it is clear that the beam was designed properly for maximum loading at mid-span and maximum shear at end condition. However, when the coped section is examined more closely, high horizontal

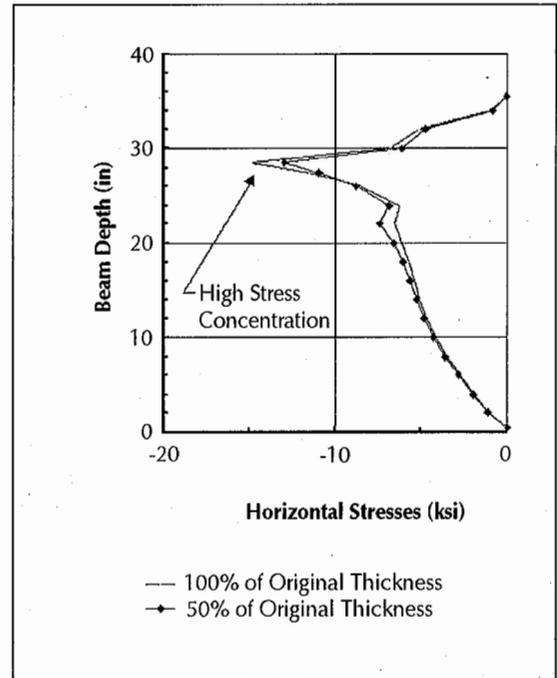
FIGURE 11. Horizontal stresses at the cope area.

stress concentrations near the corner of the cope can be observed. This high stress concentration coupled with corrosion and loss of section in the web were the two main factors in the buckling of the web (demonstrated by the stress range shown in Figure 11).

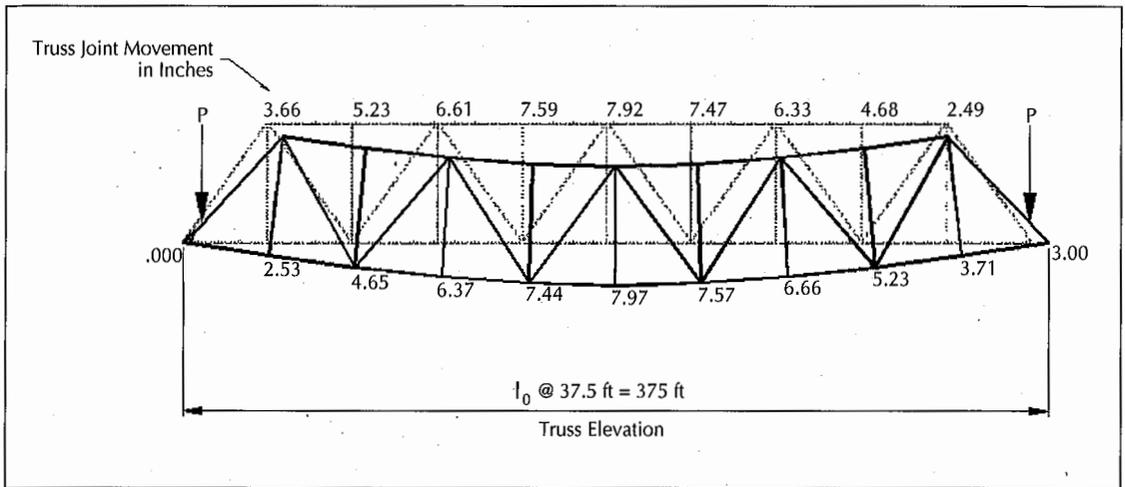
Truss Analysis. The truss was modeled and analyzed using STAAD computer software. The gravity loads (dead and live) from lower deck level and upper deck beams were imposed on the truss at the appropriate locations. Additionally, the new loads from the W14 columns were placed at the exact locations on the respective diagonals (see Figure 12). Large end plates, near the support point of the trusses, provided additional stiffeners for the diagonal members. This effect was also modeled in this analysis. The member stresses derived from the results were studied in order to validate the initial assumption that the repair concept minimally affected the capacity of the truss members.

FIGURE 12. Truss deflected shape resulting from the dead and live loads.
