Replacement of the Sandy Hook Front Range Light

A thorough understanding of geographic, hydrographic and meteorological environments, as well as improved contracting procedures, can result in more timely and less costly construction of offshore structures.

NOAH J. ELWOOD & CHRIS LUND

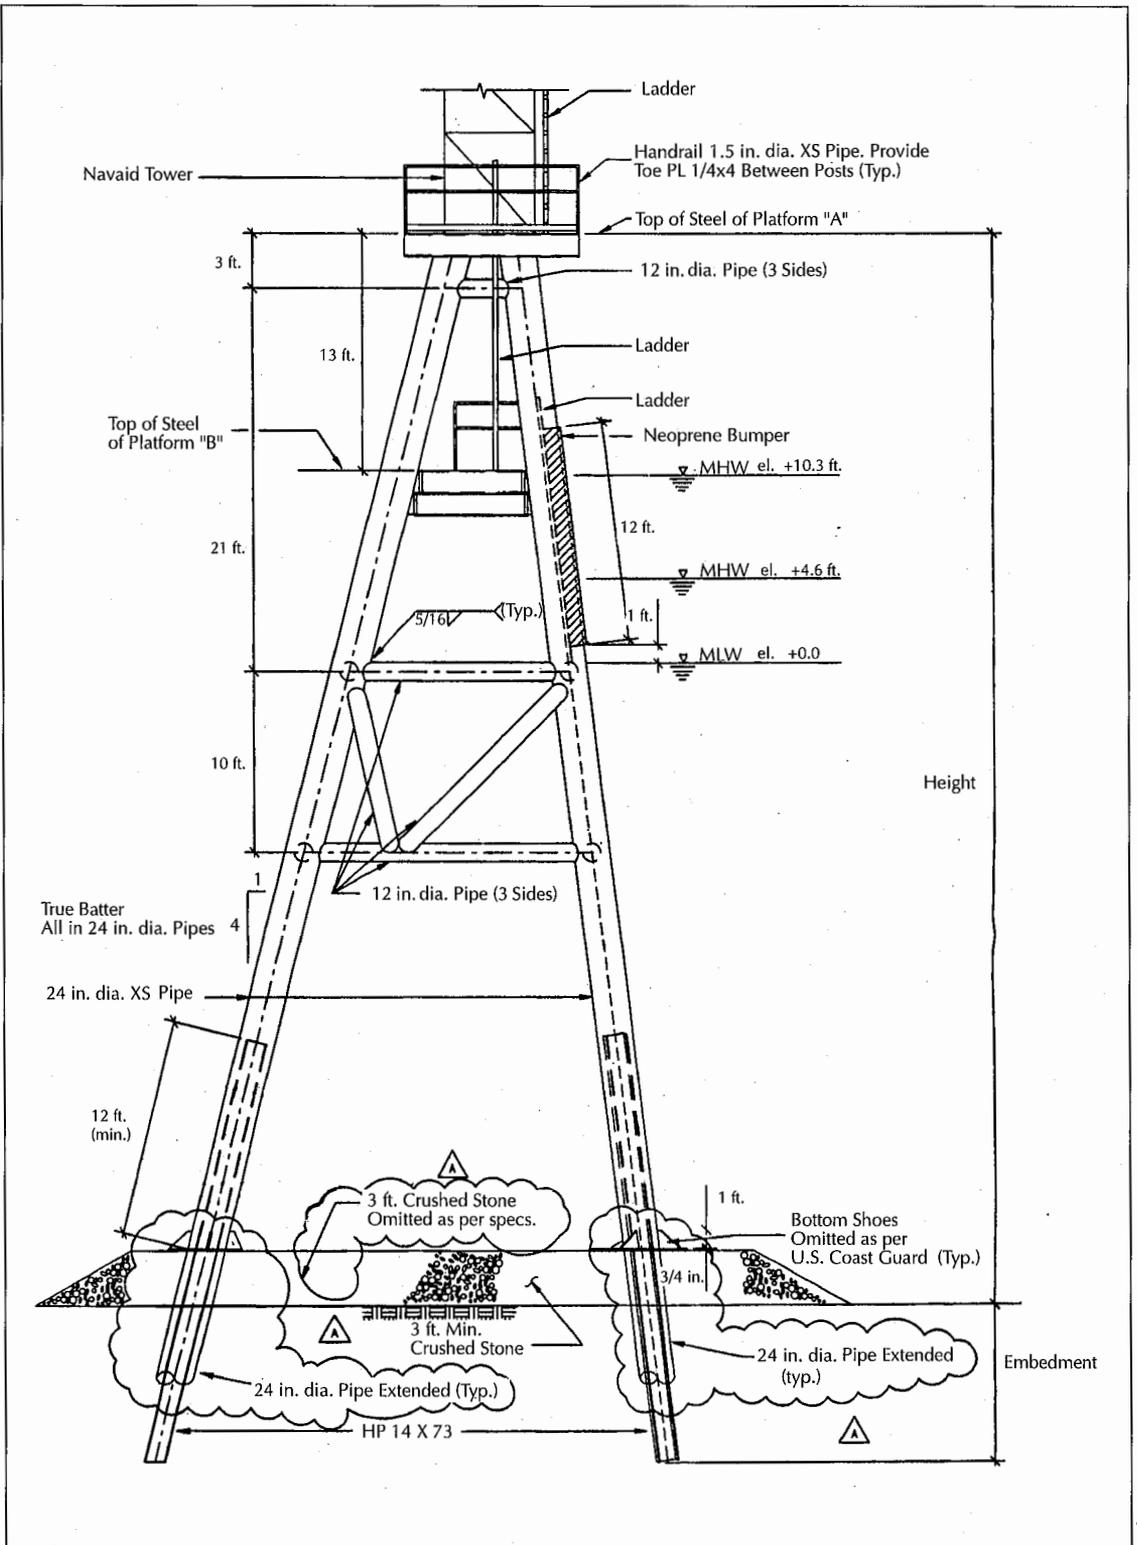
FIGURE 2. As-built construction drawing of the damaged tower (typical tripod elevation).

and horizontal 12-inch-diameter pipe bracing from mean low water to 10 feet below. The tripod supported a platform used for boat landings 10 feet above mean low water and another platform at the top of the tripod. The boat landing platform allowed personnel to access the range structure by sea for maintenance. A ladder connected the boat landing platform to the tower platform where the tower ladder provided access to the ranges instruments (see Figure 2).

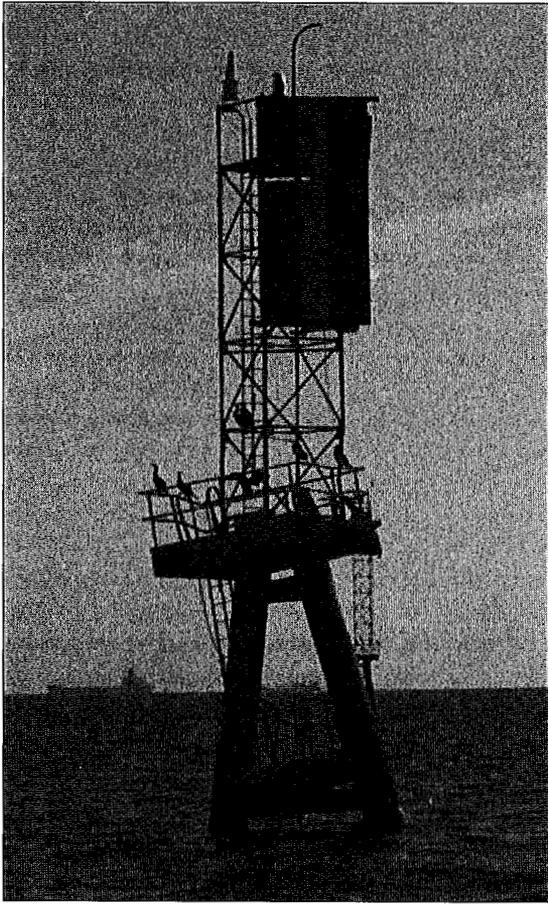
FIGURE 4. A view of the damaged navigational range after adjusting the tower position.

Interim repairs were performed to the structure by cutting and refitting the pipe tower in a plumb position (see Figure 4). Due to the critical nature of this type of navigational aid, the USCG decided to replace the front range structure and solicited bids based on the original construction drawings since time did not permit exploring repair alternatives. However, the contractor that was awarded the project defaulted before con-

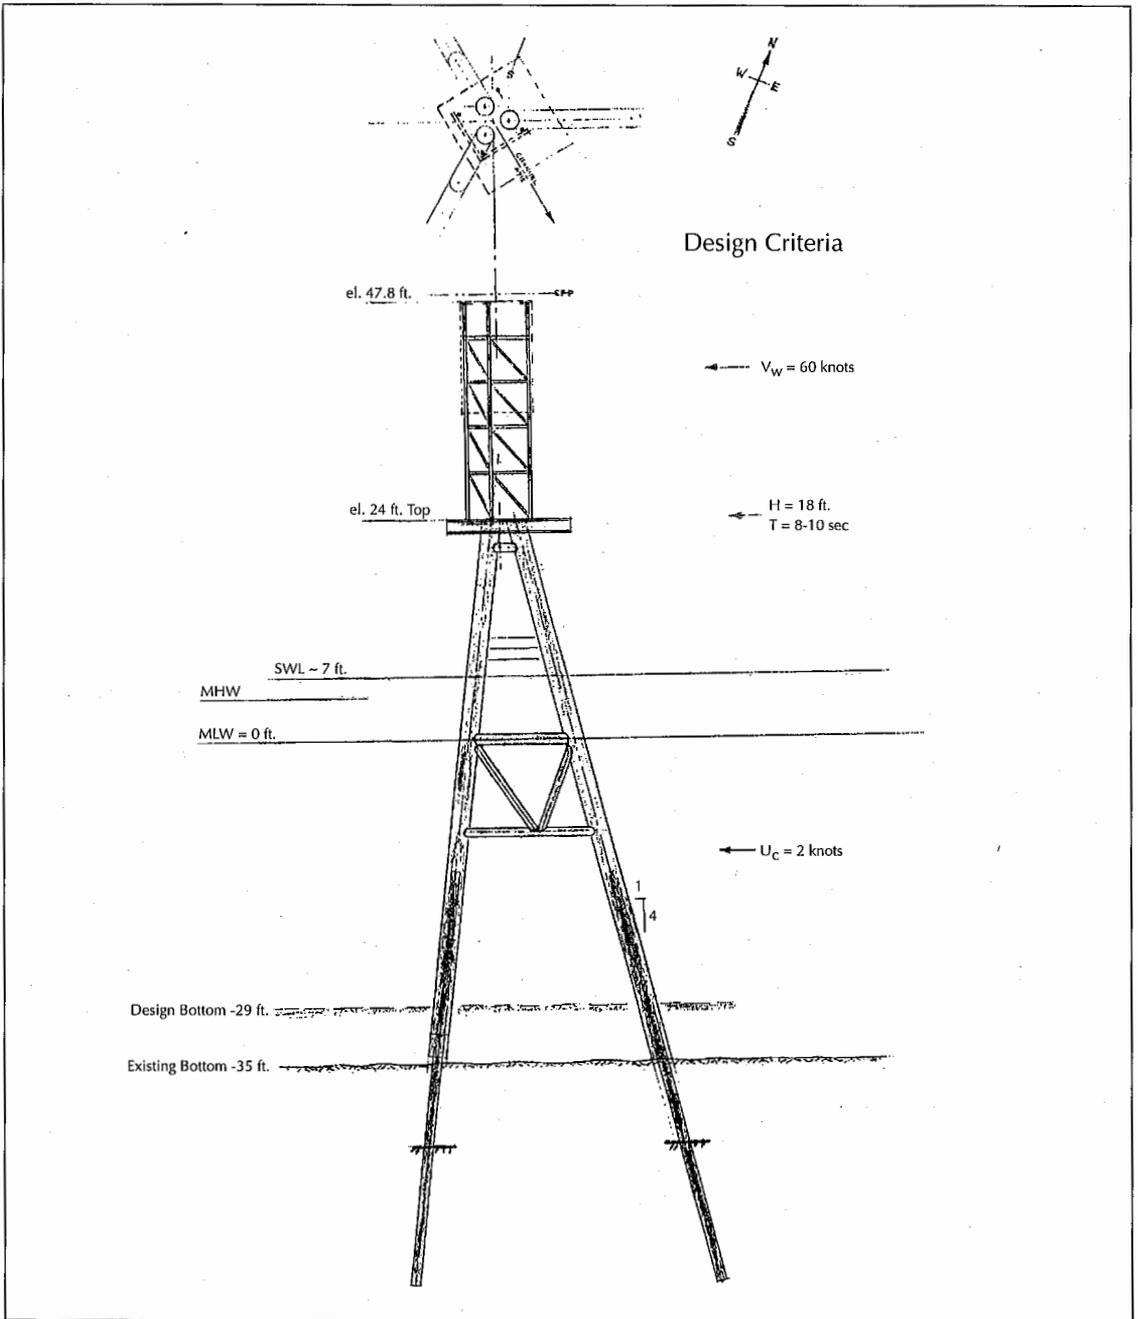
Historical wave and water levels were taken from the National Oceanic and Atmospheric Administration (NOAA) data, based on the nearby Ambrose Light Station. For that location, the significant wave height (H_s) for the 50-year storm event is 24 feet. The design wave was determined to be the largest wave that could propagate over the shoals surrounding the tower. The design wave was determined to be an 18-foot wave with an 8- to 10-second period. The other forces acting on the structure consisted of wind and current.

The combined lateral forces were determined to be 45,000 pounds (see Figure 5).

FIGURE 5. Environmental forces acting on the tower.

The redesign of the replacement structure eliminated all bracing by sizing the piles to resist bending forces. Vertical plates were designed to connect the pile heads and resist shearing forces between the individual piles. The steel pipe pile legs extended 50 feet below the seabed, eliminating the additional HP foundation piles as well as the need for a scour mat. Portions of the original platforms were salvaged from the damaged structure to reduce overall construction costs. The contract required that the tower be completed within a five-day period because of the importance of this navigational range.

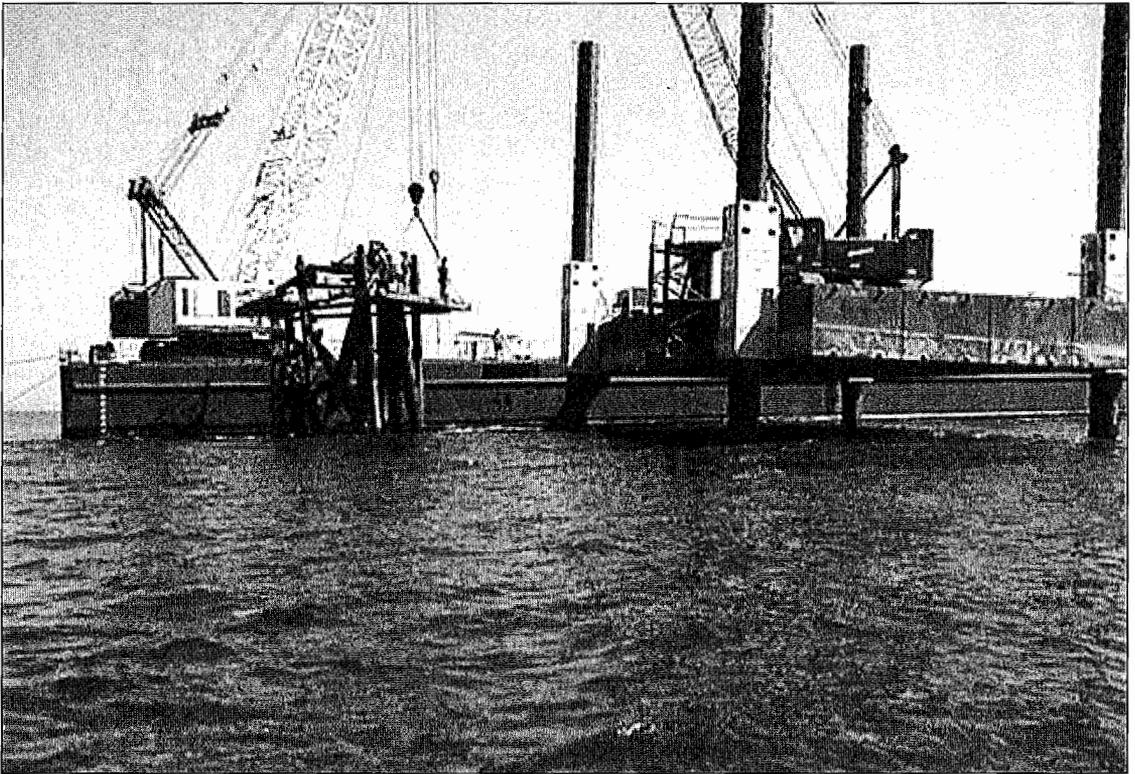
FIGURE 6. Construction progress on the new navigational aid.

bearing piles were driven to depth without incident. However, the falsework, as expected, needed to be cut and reassembled to accommodate the third pile. Once the piles had been installed, the contractor's staff was able to work on both the new and old structures simultaneously (see Figure 6). Several pieces of the old tower, including the boat landing, were salvaged for reuse. As the pieces were removed, they were inspected, cleaned and repaired as necessary. The piles were cut to near-final elevation, and the remaining upper tower platform work that could be done prior to concrete pour was completed and the upper falsework was removed. During this stage of the work, the contractor's staff was busy performing a significant amount of welding.

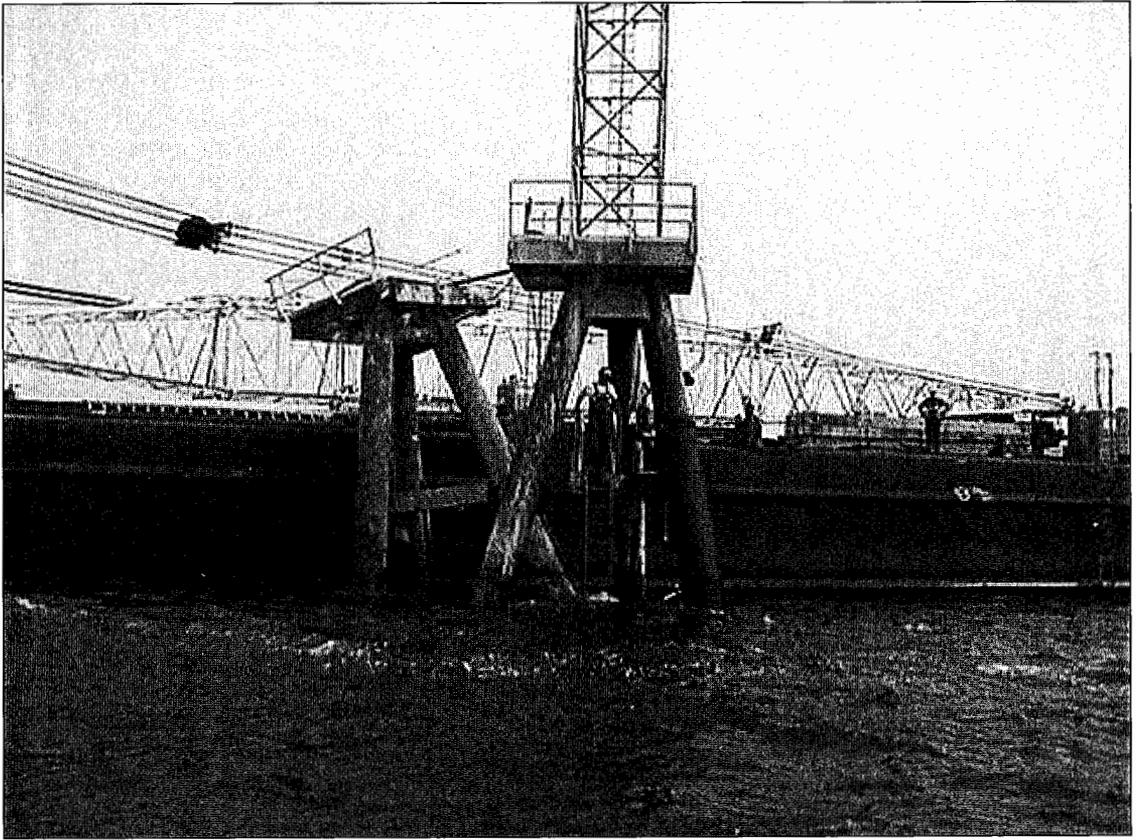
FIGURE 7. The new navigational aid nearing completion.

As soon as the upper platform was installed, the contractor removed the remaining falsework and focused on the lower platform. The access ladder from the lower to upper platform, lower platform clip angles and the lower platform channels were welded to the structure and the lower platform was reinstalled. The USCG tower was then mounted to the upper platform. With the platforms and tower installed, the jack-up barge was no longer required on site and it left on June 30. As the structure neared completion, the contractor focused on touching up the corrosion protection coating system while the remaining welding and installations were being done (see Figure 7).

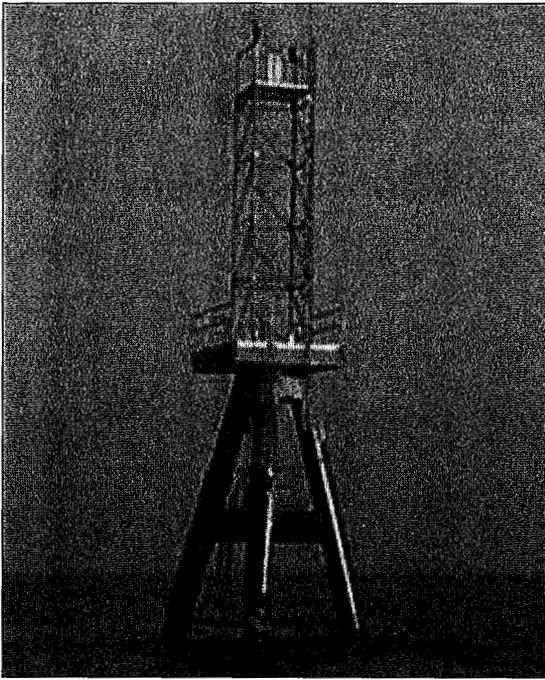
FIGURE 8. The completed navigational aid.

light, power equipment and range boards. However, the team found that the tower was rotated slightly and, using the previous brackets, the boards did not face perpendicular to the channel midline. The contractor was notified and, after various discussions and delays, agreed to fabricate and install new brackets. The new brackets were finally installed and construction was completed on November 21, (see Figure 8). Final contract cost was \$438,772.
