# Evaluation of the Canoe Creek Bridge Abutments

*Effective repair of bridges experiencing structural distress requires a well-planned evaluation of the bridge based on site characteristics.*

BOHDAN I. CZMOLA

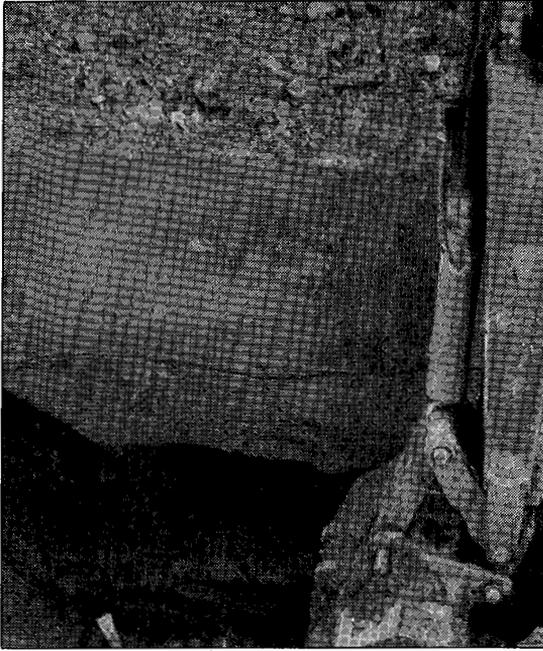
Prior to the geotechnical investigation, the bridge consultant had been involved in designing a remedial maintenance plan consisting of replacing the bridge decks, repairing erosional damage, bridge painting, etc. Upon thorough inspection, however, it was noted that both bridges had experienced, and were continuing to experience, significant structural distress. Backhoe excavations adjacent to the Pier 5 foundations revealed severe pile cap cracking (see Figure 4). The wingwalls of the two west abutments were severely cracked, and all of the bridge expansion dams were completely closed (see Figure 5). Both bridge Pier 5s exhibited considerable tilt (see Figure 6).

**FIGURE 4. Cracked Pier 5 pile cap.**

- Replace all four abutments
- Replace Pier 5 for both bridges

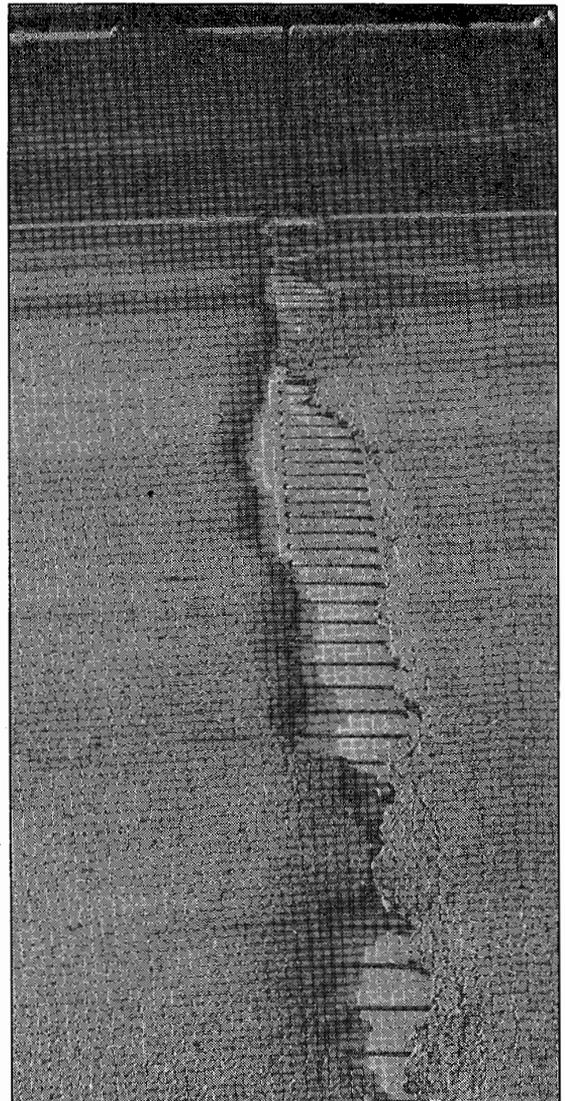
**FIGURE 5. Closed expansion dam.**

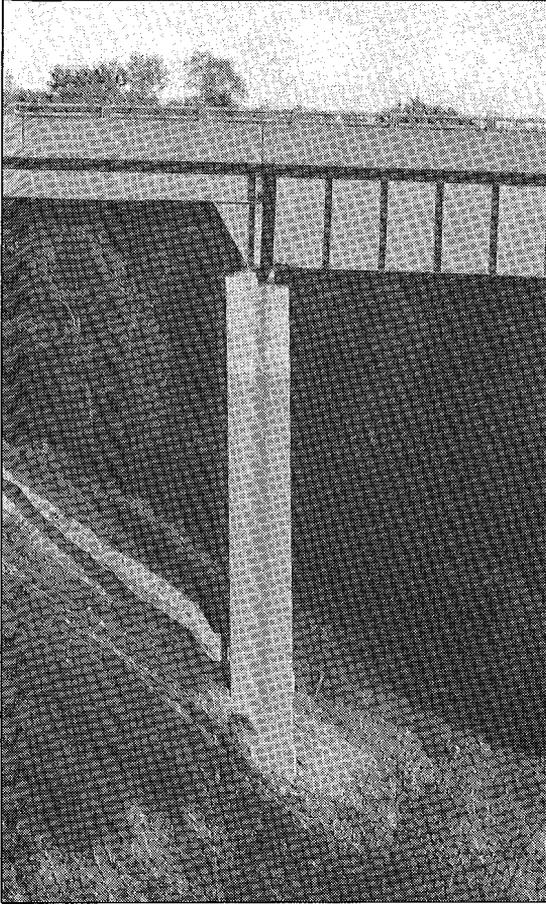
**FIGURE 6.** A view of the eastbound bridge's Pier 5.

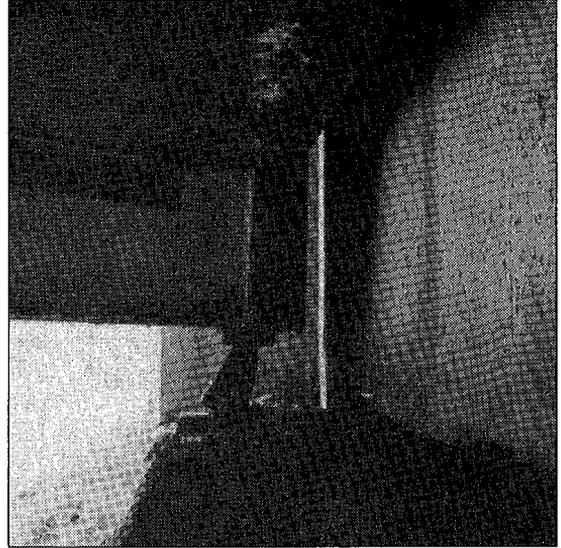
Certain sections of the two bridges appeared to have undergone considerable movement. This movement was evident from observations made at several locations. The rocker bearings at the two west abutments were in a severely tilted position (see Figures 7 and 8), indicating that the abutments had moved at least several inches towards the creek. The wingwalls of these two abutments had undergone considerable cracking. The two Pier 5s had tilted to such an extent that the tilts were noticeable to the eye. Because simply-supported spans were pinned to the east abutments, relative movements between these two structural components were not possible. The extent of lateral abutment movement was noticeable at both Pier 5s, however, where it was evident that the simply-supported beams had been pushed hori-

**FIGURE 7.** Eastbound bridge rocker expansion bearings at its west abutment.

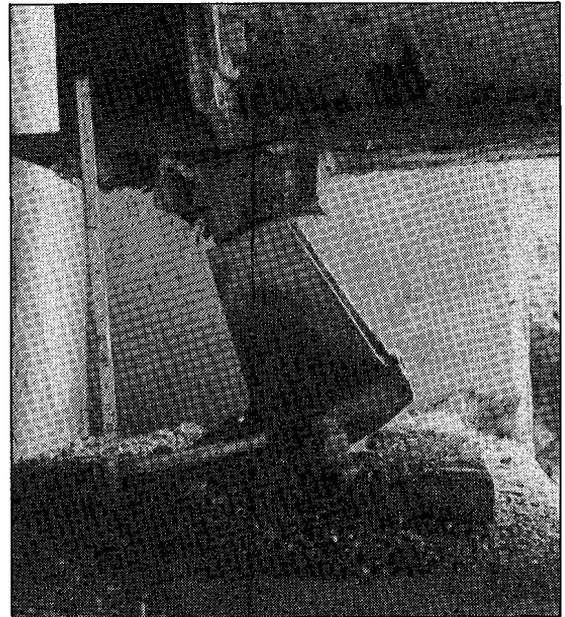
**FIGURE 8.** Eastbound bridge rocker expansion bearings located at its west abutment.

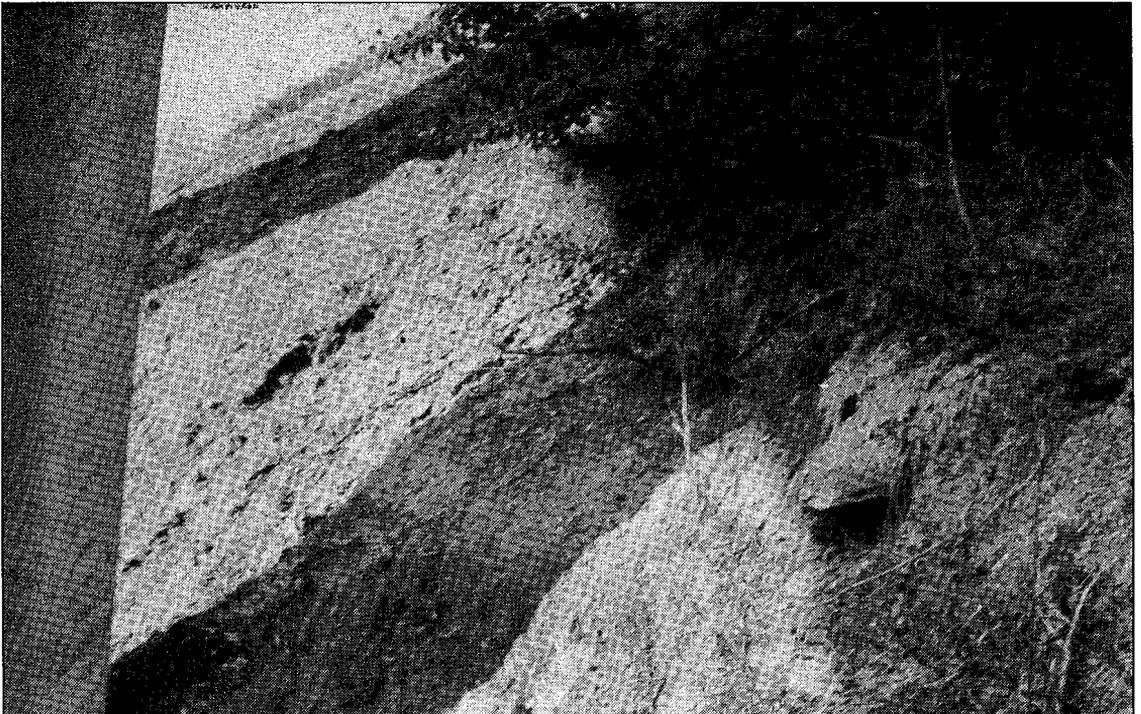
There were numerous indications that the fill (originally placed at a slope of 1.5 horizontal:1 vertical) was in a state of movement. Slides were visually noted at many locations, varying from small localized sloughs to massive, although relatively shallow, failures. The largest such slide was noted at the south side of the west abutment embankment on the eastbound highway. In this area, virtually the entire face of the fill from the bridge to the embankment corner had slid away. The depth of the slide was approxi-

mately 10 feet (see Figures 11 and 12). At some locations, the fence that had been installed near the toe of the fill was completely covered by slide material. Other areas where slides were noted included: the north side of the west abutment embankment below the westbound highway; the south side of the east abutment embankment below the eastbound highway; an area between the two bridges at the east side; an area north of the westbound highway on the east side; and areas adjacent to the two Pier 5s where some backhoe exploratory work recently had been conducted. The only area that appeared to be relatively stable occurred between the two highways on the west side, where the embankment was constructed at a slope of approximately 1.7:1.

**FIGURE 11. Slide scarp at the west side embankment of the eastbound highway.**

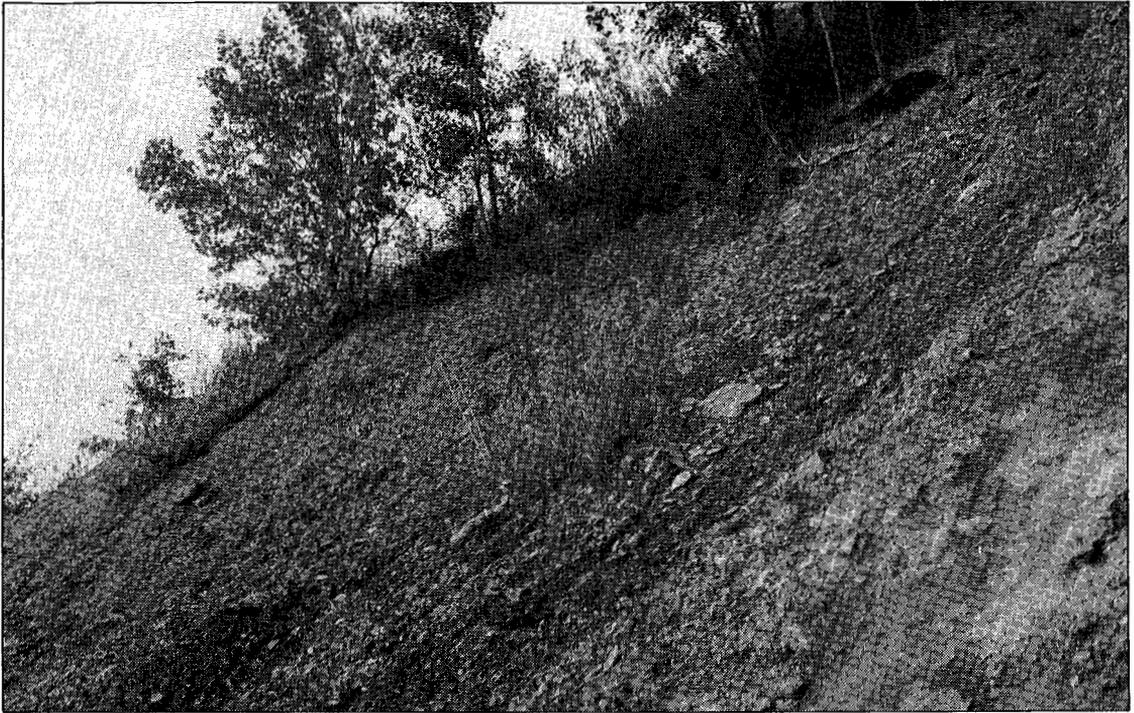
**FIGURE 12.** Slide scarp at the west side of the eastbound highway.

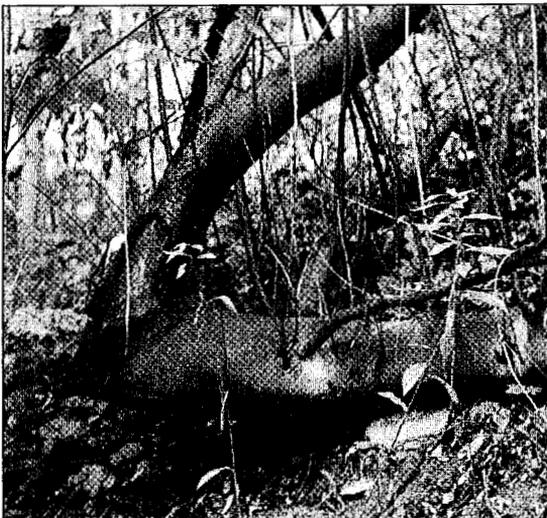
where sloughing had occurred, leaving large portions of the embankment uncovered. Where vegetation still remained, the trunks of many trees exhibited significant curvature that was caused by the trees' attempts to remain vertical as their roots slowly crept down the embankment with the unstable surficial soil

**FIGURE 13.** A curved tree trunk due to slope instability.

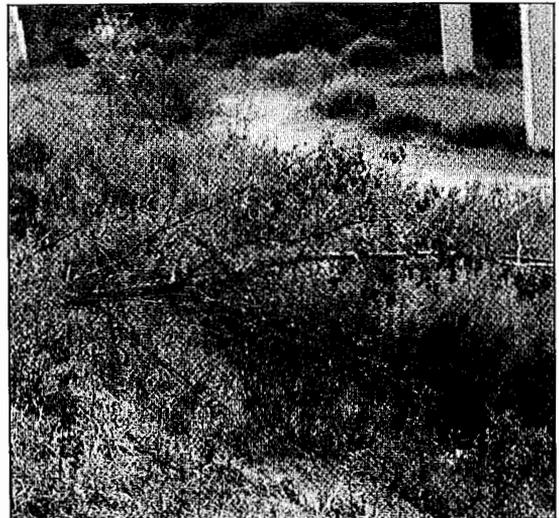
**FIGURE 14.** A tree recently toppled by slope instability.
