The Rehabilitation & Modernization of Fitting Out Pier 2 at Portsmouth Naval Shipyard

A well-thought-out plan for inspection and repair, integrated with occasional re-examination of design needs, can sometimes obviate the need for replacement.

CHERYL W. COVIELLO

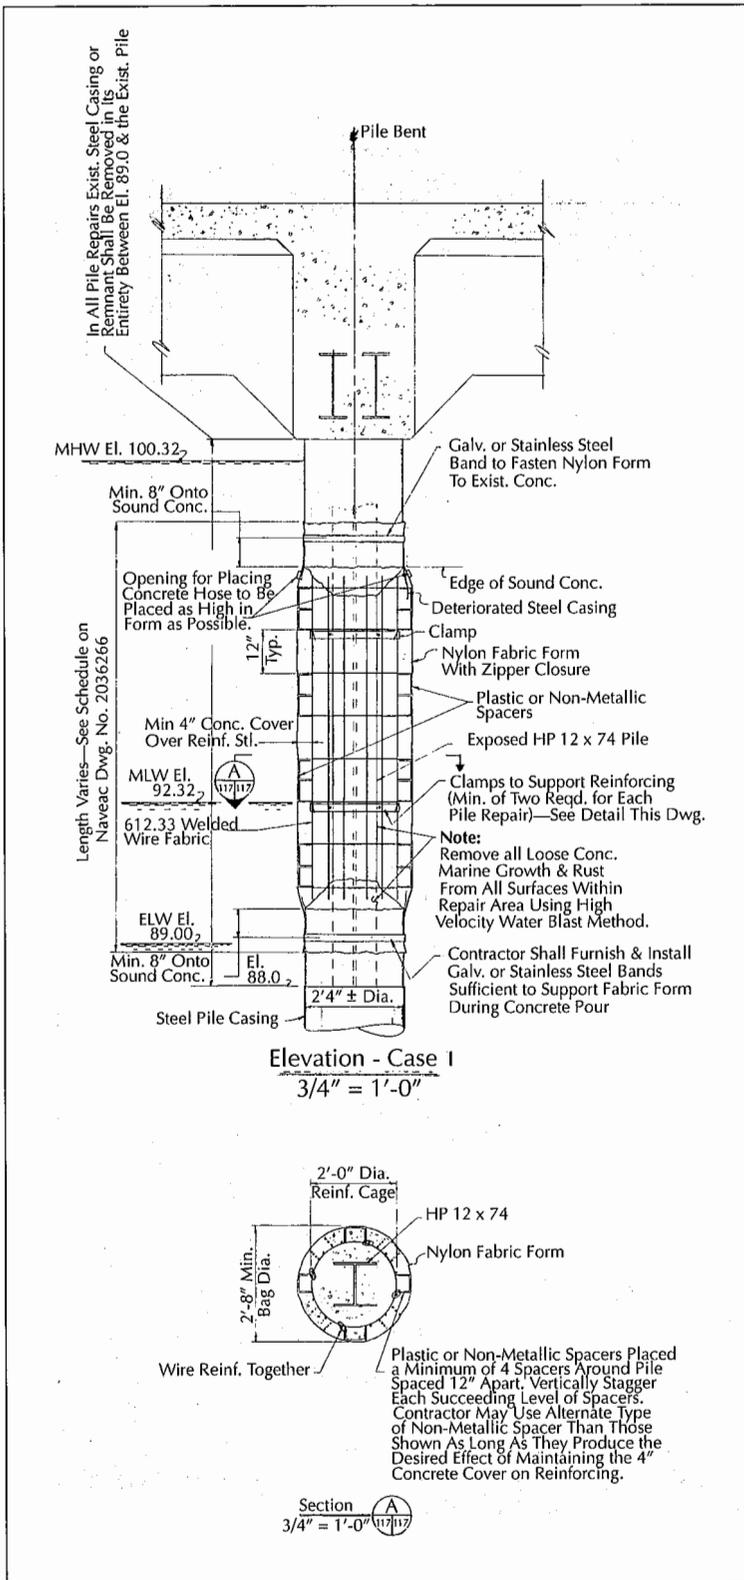
The nylon fabric pile jackets installed in 1980 were generally intact with isolated areas of moderate deterioration. However, the original concrete encasements had significant deterioration. Nearly 30 percent of the piles along the facility had major or severe deterioration of the concrete encasement (see Table 2). Those piles with severe deterioration had extensive failure of the encasement that

FIGURE 5. Pile jacket detail (from 1983 archive drawings).

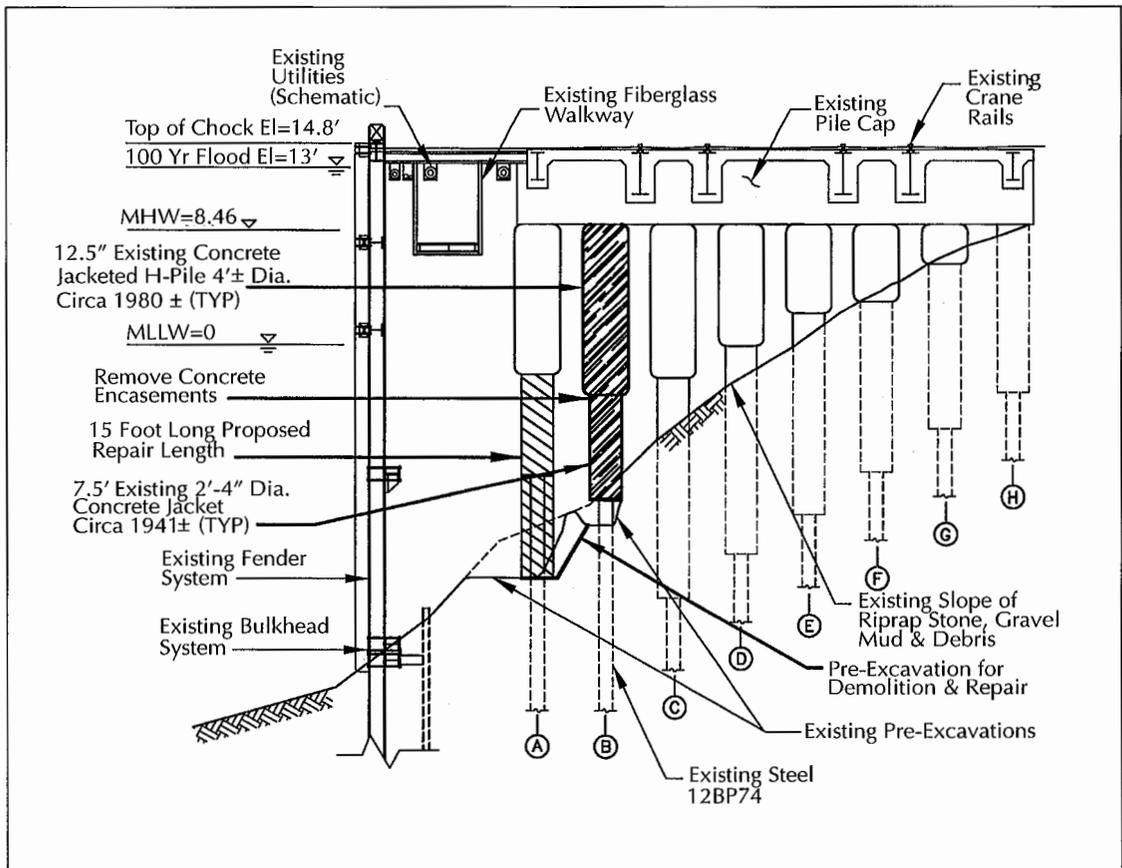
FIGURE 6. Concrete encasement/pile jacket repair (from a 1997 archive drawing).

The interim repairs to the most severely deteriorated steel piles were completed in 1997. The repairs removed the concrete encasement and either the entire nylon fabric jacket (or a portion of the jacket) and installed anodes to the exposed steel pile in order to arrest pile corrosion (see Figure 6). In addition, the repairs included strengthening the H-piles with steel channels along the outside face of the flanges (see Figure 7). By completing these interim repairs on the piles with the most obvious immediate structural concerns, operations on the facility were allowed to continue.

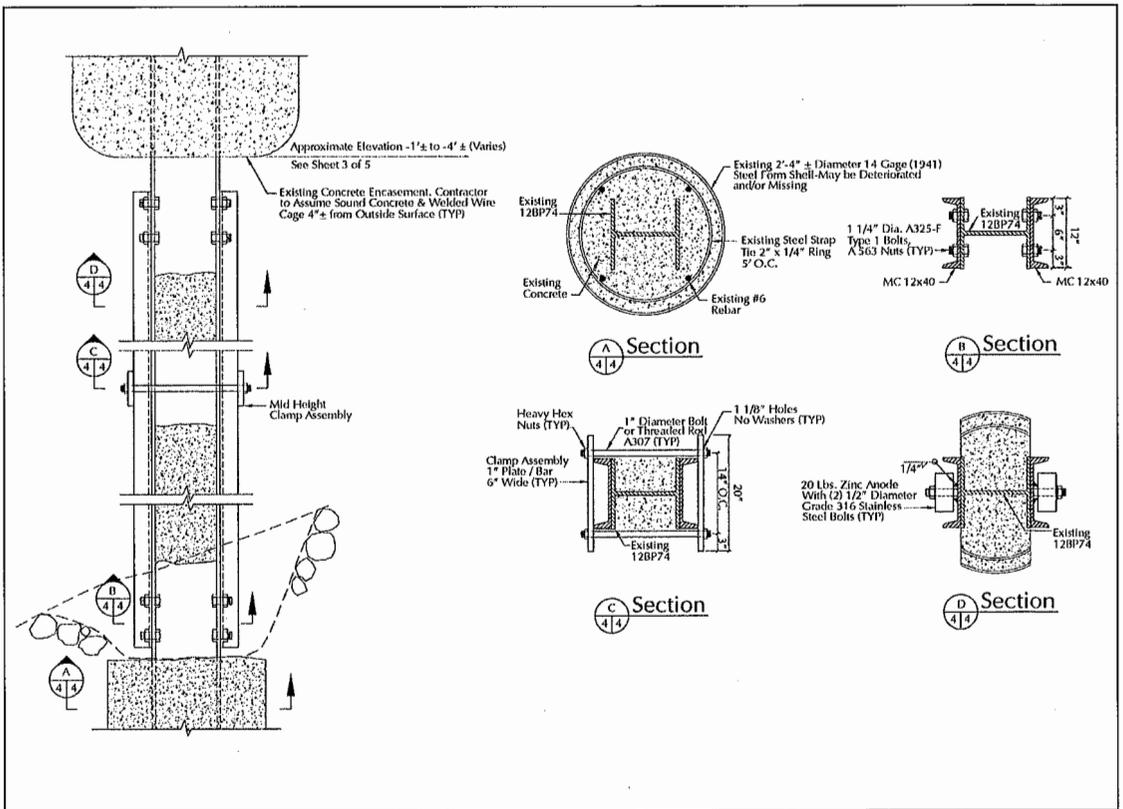
FIGURE 7. Steel pile repair detail (from a 1997 archive drawing).

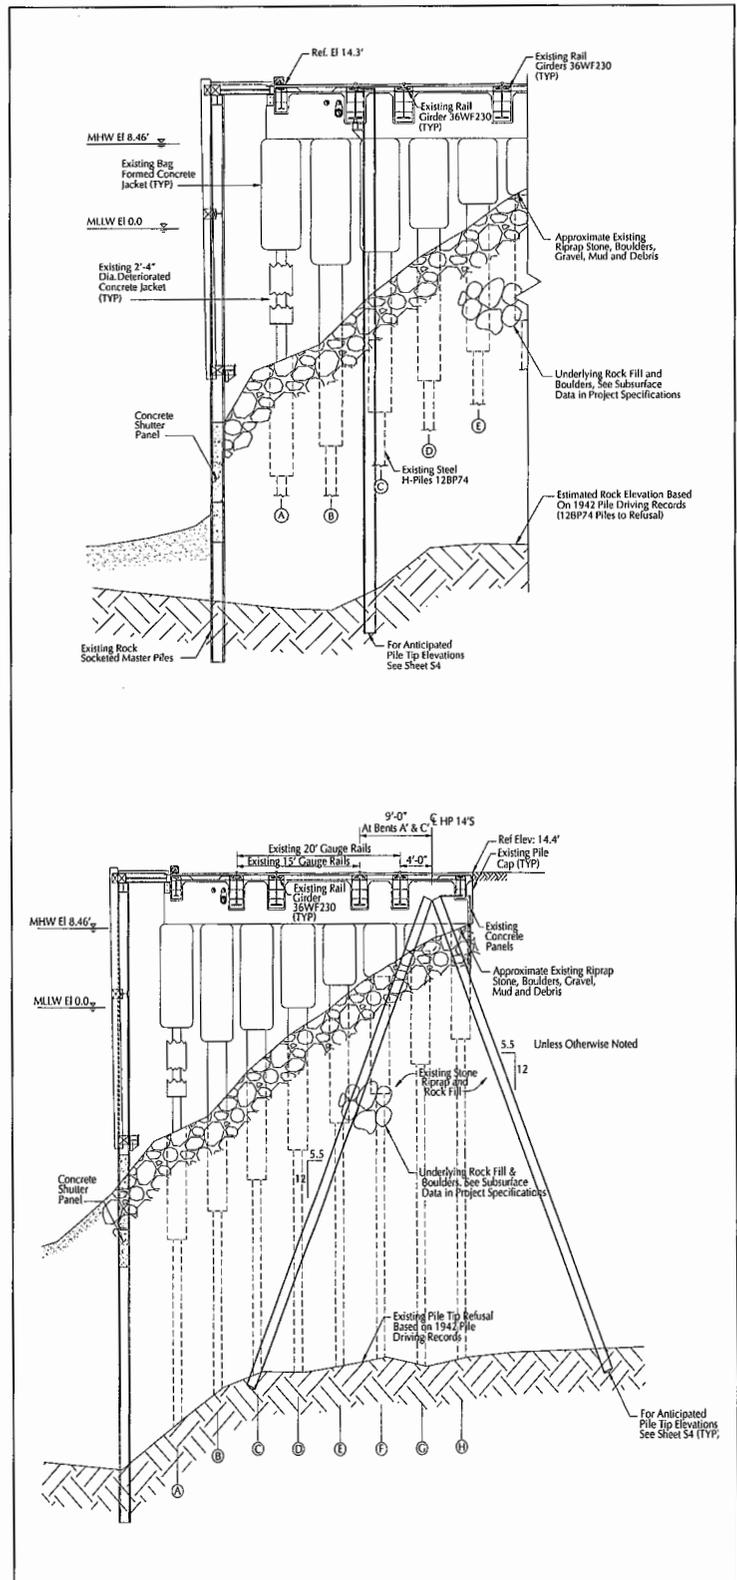
FIGURE 8. Interim repairs (from 1998 archive drawings).

Between 1998 and 2000, the recommended additional piles were installed. New vertical piles were installed at mid-bay between pile bents, approximately in line with the outboard (outermost) crane rail beam, and pairs of batter piles were placed at each bent adjacent to the existing support piles at the inboard

(innermost) crane rail beam (see Figure 8). The new piles, designed for the operating portal cranes, reduced the load transferred to the original piles and, therefore, created, in effect, a corrosion allowance for the original piles (see Table 3). Nevertheless, a sacrificial cathodic protection system (zinc anodes) was incorporated throughout Fitting Out Pier 2.

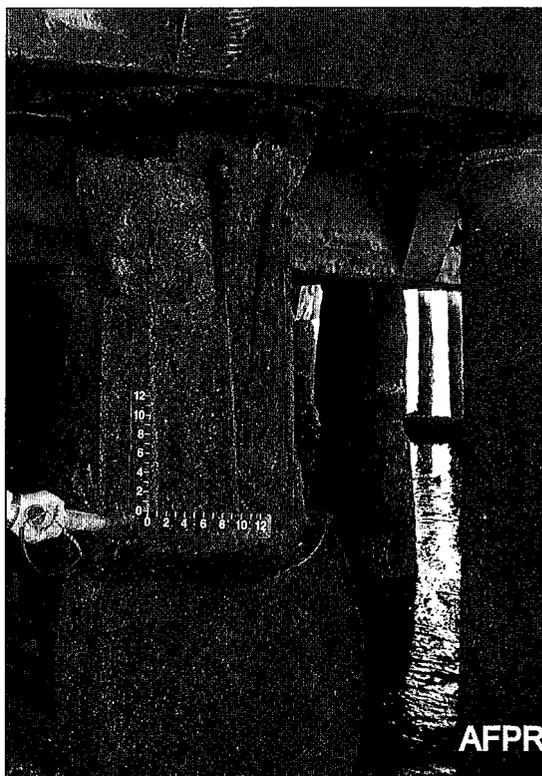
A few years later, in 2004, routine inspections of the majority of the shipyard's waterfront facilities were completed. The inspection of Fitting Out Pier 2 found the facility in overall fair condition with continued deterioration of the original components (concrete-encased support piles and framing members, concrete deck) and the fender systems. Minor to advanced deterioration of the concrete pile encasements and the nylon fabric formed pile jackets had exposed between 27 and 55 percent of the original steel H-piles (see Table 4 and Figure 9). Of the exposed piles, approximately 60 percent had both the flanges and web exposed (see Figure 10) and 40 percent had only the flanges exposed.

FIGURE 9. Pile jacket deterioration.

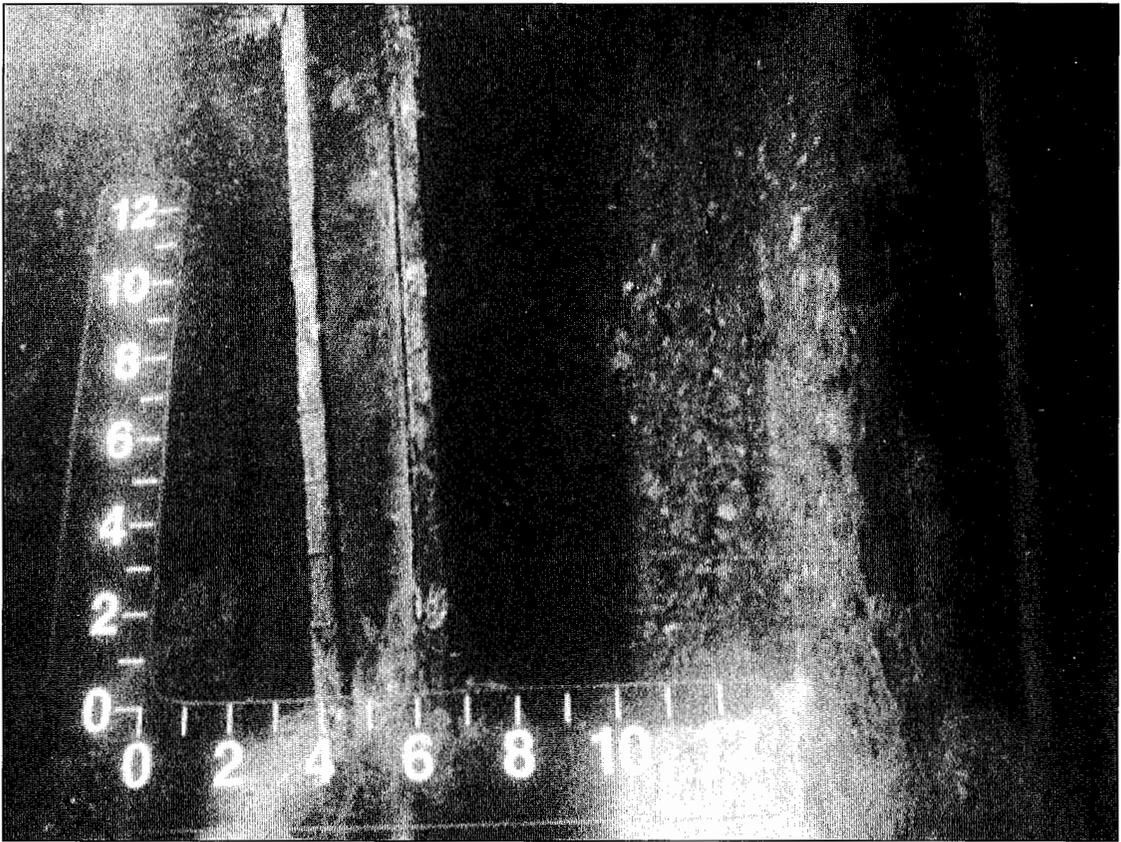
The degree of deterioration of the exposed H-piles varied depending on the berth and on the zone in which the exposed steel occurred (see Table 5). Within the submerged zone and at the mudline, the piles had average thickness losses between 10 and 30 percent, and maximum losses as great as 40 percent (submerged zone) and 46 percent (mudline). Although the thickness losses were substantial, the resulting cross-sectional area losses were within the effective corrosion allowance that was created from the installation of the additional support piles between 1997 and 2000. The two outermost

FIGURE 10. Underwater concrete encasement deterioration.

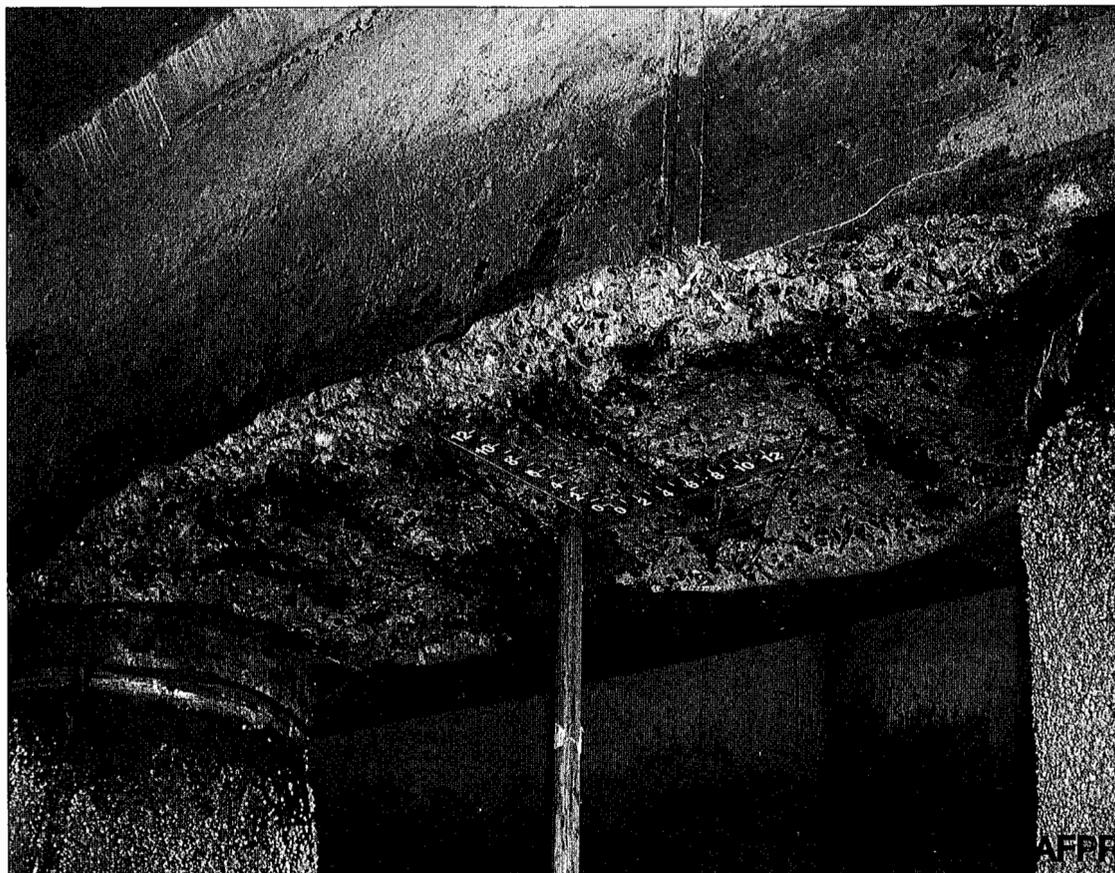
Nearly all of the pile caps (approximately one hundred and thirteen) had fine longitudinal cracks or map cracking with rust staining and efflorescence present at approximately 30 percent of the pile caps. An additional 20 to 30 percent had large spalls with exposed reinforcing steel (see Figure 11).

FIGURE 11. Concrete deterioration along the bottom of a pile cap.

Similar to the under deck repairs of the mid-1980s, the concrete repair project addresses the deterioration of the concrete encasements along the pile caps and beams. During the routine inspection of 2004, the presence of alkali-silica reaction (ASR) was suspected because of the appearance of the deteriorated concrete. As part of the repair design, concrete samples were tested and the presence of ASR was confirmed. Understanding that ASR in the parent concrete would compromise the longevity of concrete repairs, the repair design incorporates lithium-based products to help reduce the potential of ASR in the repair material and at the repair interface with the parent concrete and to help mitigate ASR within the parent concrete. A lithium-based coating applied to the parent concrete, combined with a lithium-based admixture in the repair mate-

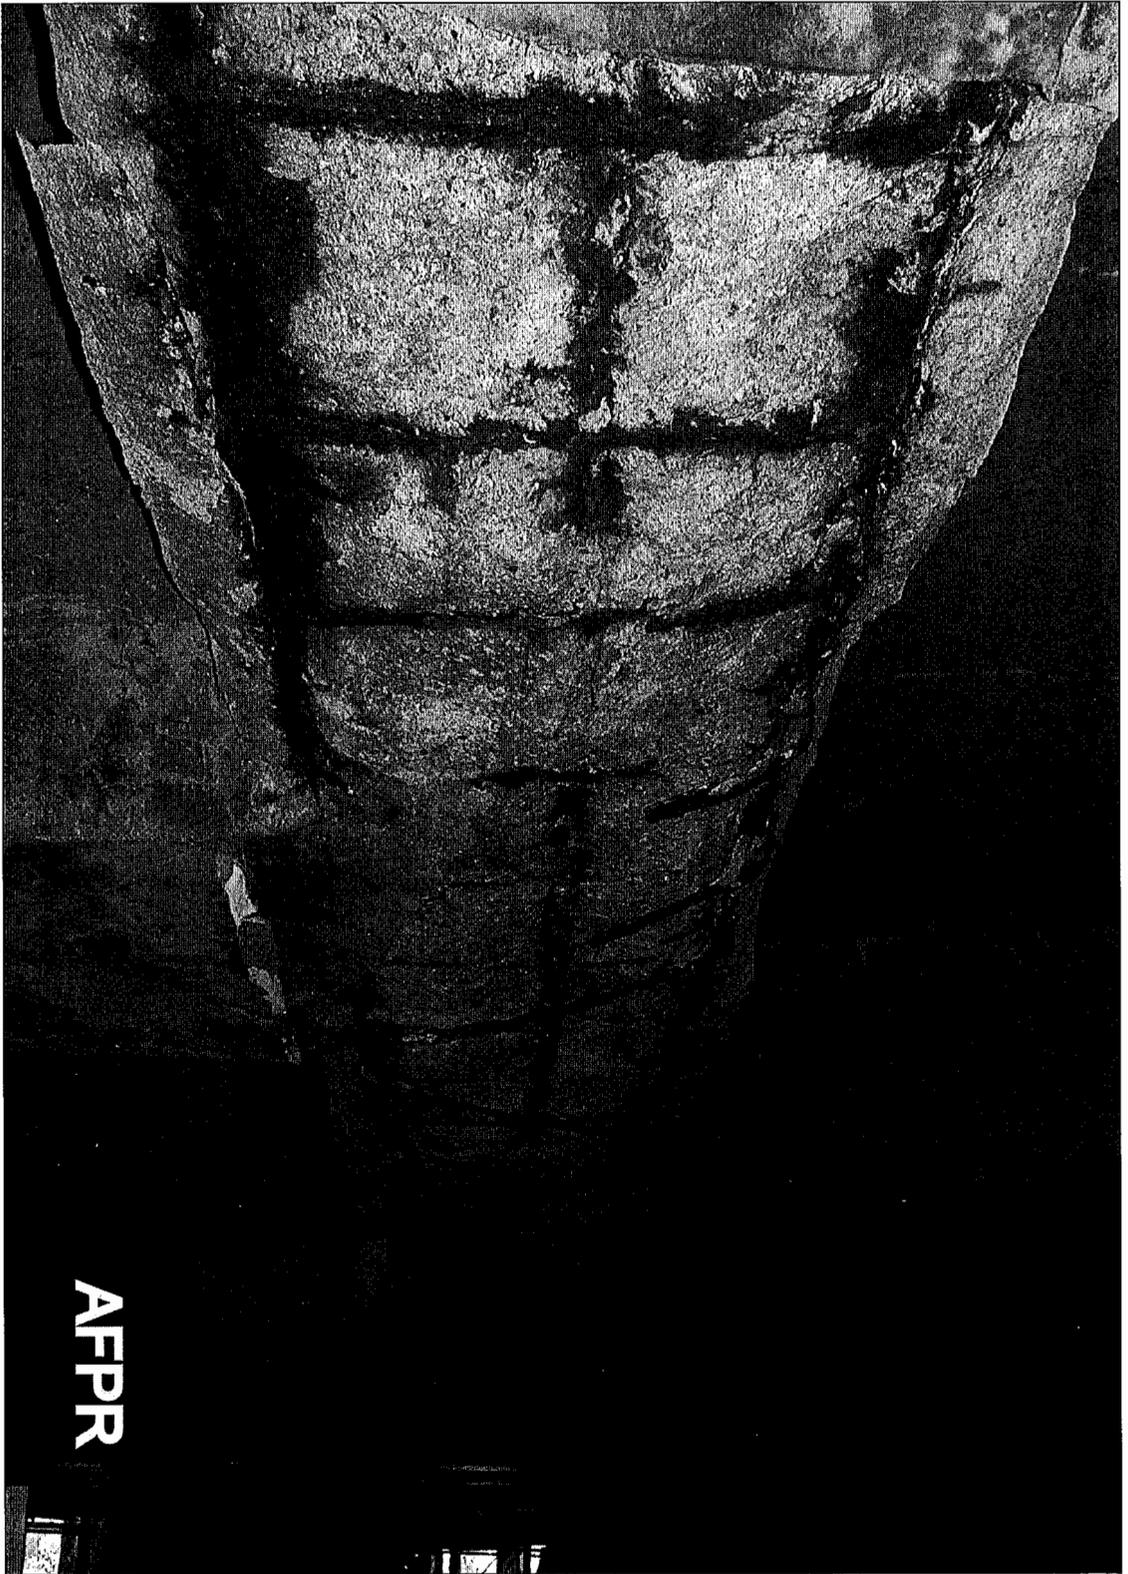
Similar to the pile caps, approximately 30 percent of the longitudinal beams had fine to wide cracks with rust staining and efflorescence. An additional 11 percent had large concrete spalls with exposed reinforcing steel (see Figure 12). Although at least one of each type of longitudinal beam had spalls, the vast

FIGURE 12. Concrete deterioration along the bottom of a longitudinal beam.

majority of the spalls were located on the common crane rail beams (see Table 7). At three beams, the concrete spalls were significant enough to expose the bottom of the encased steel beam.

The repair design drawings also identify locations for reinforcing steel repair and bottom flange beam repairs. For bidding purposes, approximately 3,000 pounds of reinforcing steel replacement (stirrups and longitudinal bars) and 3,850 pounds of steel repairs to the bottom flange of the beams with deterioration were estimated. Not knowing exactly what extent of internal deterioration will be uncovered during removal processes, the repair design drawings include guidance for determining when to complete additional reinforcing steel and bottom flange repairs.
