The Place of Stability Calculations in Evaluating the Safety of Existing Embankment Dams

Thorough investigations of site conditions and construction records should have precedence over stability analyses for determining the safety of embankment dams.

RALPH B. PECK

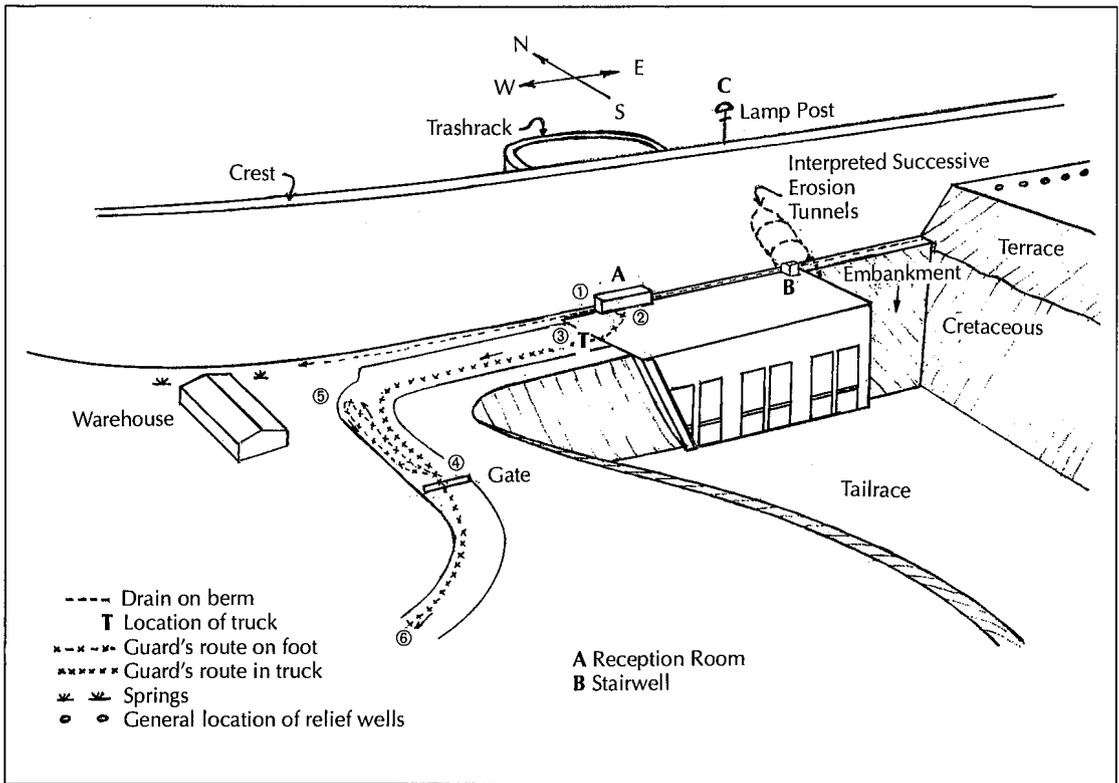
FIGURE 1. Principal features of the Walter Bouldin Dam as related to its failure.

The chronology of Sanford's activities on the cloudy, moonless night of the failure can be traced with reference to Figure 1, a simplified sketch of the power house and dam as seen from downstream. He went on duty about 9:45 p.m., made his first routine inspection starting at his office in the reception room (A) at the northwest corner of the roof of the power house, and returned about midnight without having observed anything unusual. After reading the Sunday paper for some time in the reception room, he glanced out a west window

Sanford's account is fully compatible with the progressive collapsing of the roof of an erosion tunnel that had penetrated through the dam at the east end of the power house, as suggested schematically in Figure 1. When the elevation of the tunnel reached that of the berm, water was able to flow over the power house roof. As erosion progressed, one of the successive collapses partially blocked the tunnel and the flow decreased, prompting Sanford to return as far as the warehouse. The final collapse, accompanied by falling riprap, breached

In short, the failure of Walter Bouldin Dam occurred because of piping by backward erosion. As no other example of catastrophic failure and loss of reservoir has been attributed to an upstream slide, it may be concluded that a dam that has successfully survived construction will not experience a catastrophic upstream slope failure. Any analysis that indicates otherwise must be erroneous. Further, a stability analysis to investigate the safety of the upstream slope under full reservoir is irrelevant. If an upstream slope does not fail during construction, its factor of safety must exceed unity under the more favorable condition of reservoir loading. Rapid drawdown may induce a failure, but such a failure is shallow and has never been known to cut back into

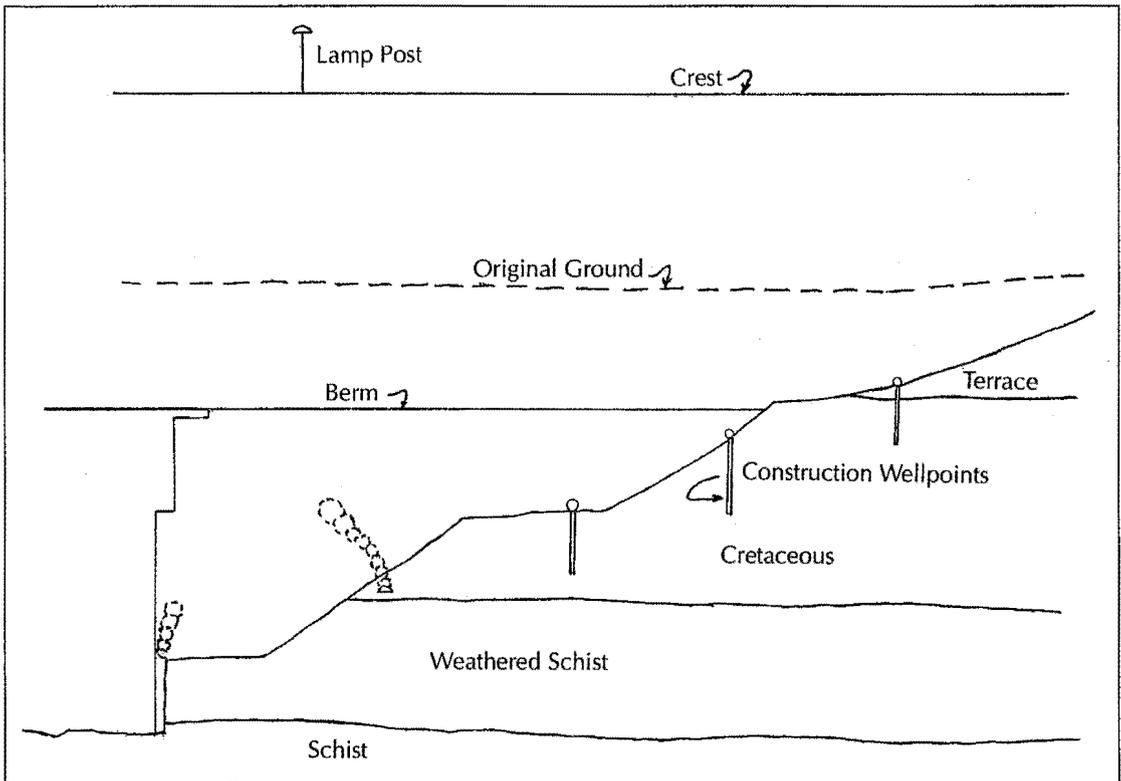
FIGURE 2. Longitudinal section through the east end of the Walter Bouldin power house and the junction with east wing dam.

The essential features of the project included an earth dam about 165 feet high across the deepest part of a valley, flanked on the west and east by wing dams founded on Pleistocene terrace deposits at a higher level. A power house was embedded in the downstream slope of the highest part of the dam; the roof of the power house was at the same elevation as a berm on the downstream slope. The power house's foundation extended into Precambrian schist bedrock overlain by Cretaceous sediments consisting largely of slightly cohesive sands and silts with layers of stiff clay. Beneath the wing dams these sediments were overlain in turn by the terrace deposits. The relationships are shown diagrammatically in Figure 1. Figure 2 depicts a longitudinal section of the area through the east end of the power house and its junction with the east wing dam; it shows the excavation made through the Cretaceous soils

into the schist to reach suitable foundation support for the power house raft.

The foundation raft of the power house was cast inside formwork in an excavation extending a few feet into somewhat weathered schist underlying the Cretaceous beds. An approximate section through the edge of the raft and adjacent materials is shown in Figure 2. The geometry of the backfilled zone would have favored seepage along its boundaries. Seepage could also have developed readily through the joints and more pervious zones in the Cretaceous deposits. Indeed, the excavation for the power house and intake structure required dewatering by well points; three tiers were installed, the lower two of which were entirely in the Cretaceous beds. Thus, avenues for

seepage were undoubtedly present. Backward erosion could have gone unobserved below tailwater level for a long time until finally an erosion tunnel reached the reservoir and permitted concentrated destructive flows to cause rapid enlargement and failure.

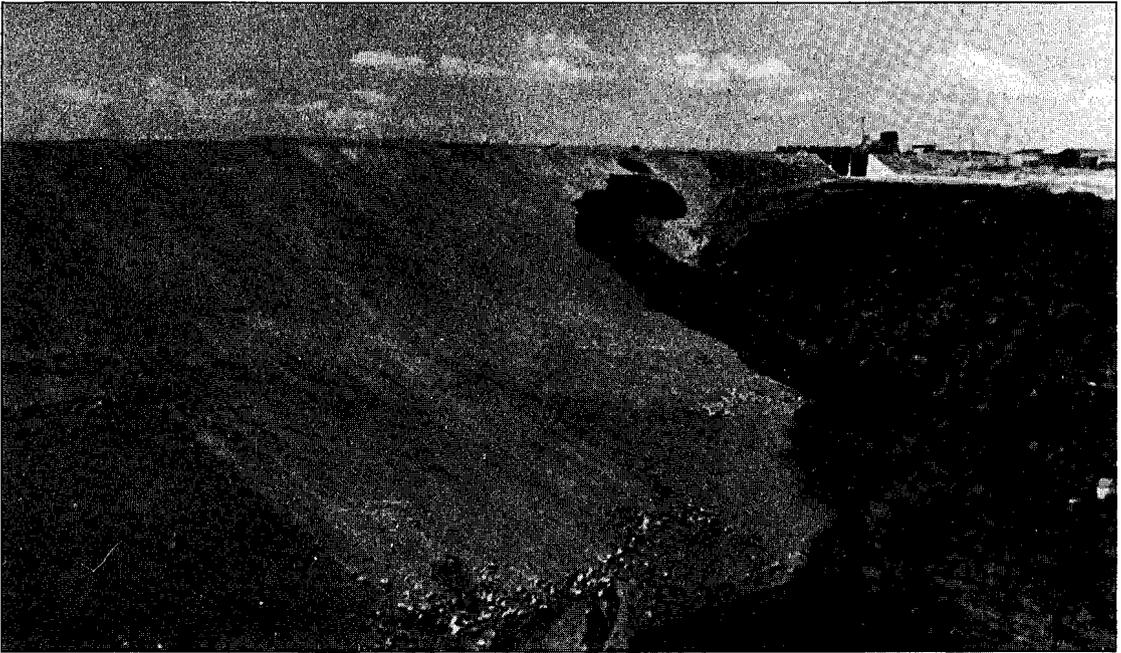
FIGURE 3. Development of erosion tunnel through Teton Dam. (USBR photo.)

the crest. The similarity of the events to the development of the erosion tunnel through Teton Dam is evident (see Figure 3).

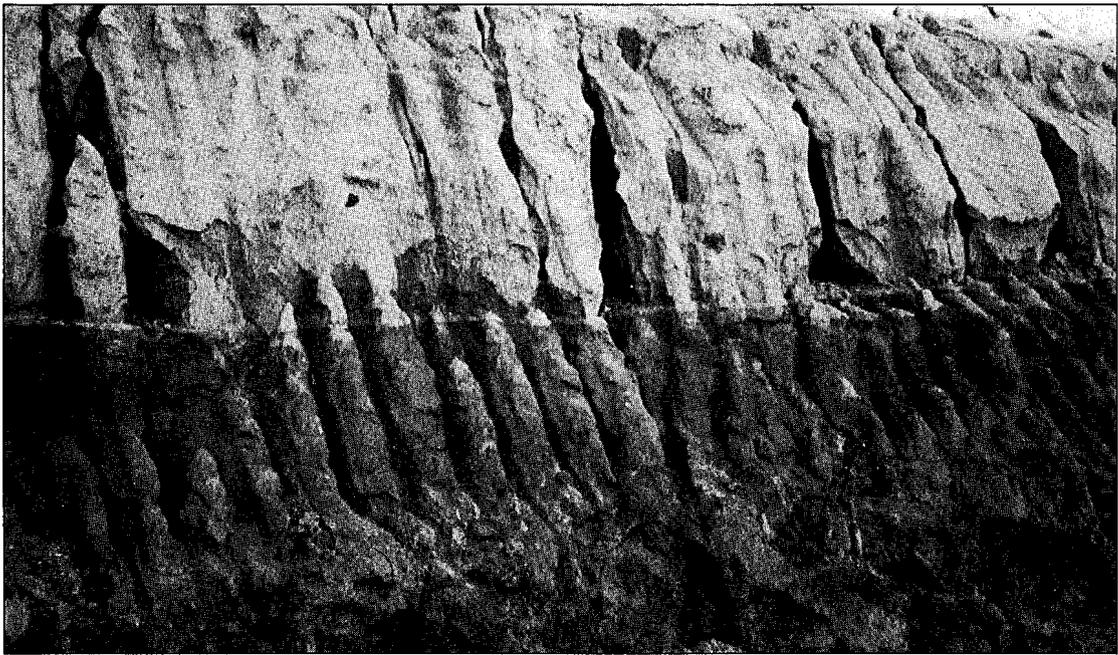
FIGURE 4. Erosion of cut slope in Cretaceous soils during Bouldin Dam reconstruction.

possibility of piping in the underlying Cretaceous materials, although these materials contained many slightly cohesive, highly erodible sands and silts (see Figures 4 and 5).

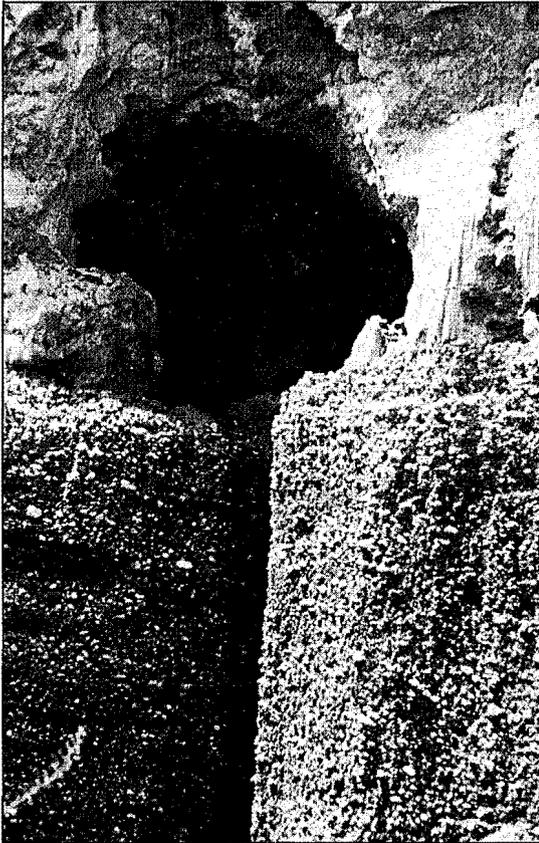
FIGURE 5. Erosion tunnel at the contact of two layers of Cretaceous soils in excavation at the Bouldin damsite. Note the vertical joint in the cohesive gravelly material.

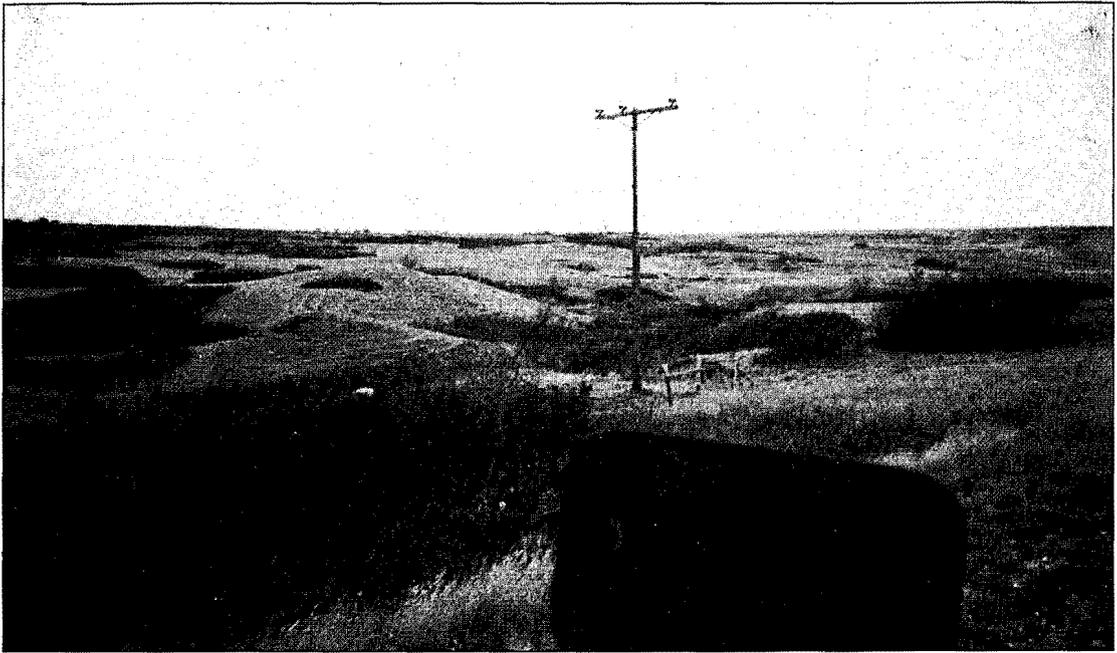
At the site the South Saskatchewan River flows in a valley cut into the Cretaceous Bearpaw formation, of which the main shale member at the site, the Snakebite, is of high plasticity and contains bentonite or bentonitic zones with liquid limits ranging up to about 300. The depth of the shale bedrock valley at the site is about 75 m, but the bottom 30 m are filled with alluvium. The valley is bordered by wide zones of slump or landslide topography giving testimony to the propensity for stability problems during excavation and fill placement (see Figure 6).

FIGURE 6. Landslide topography downstream of Gardiner Dam.

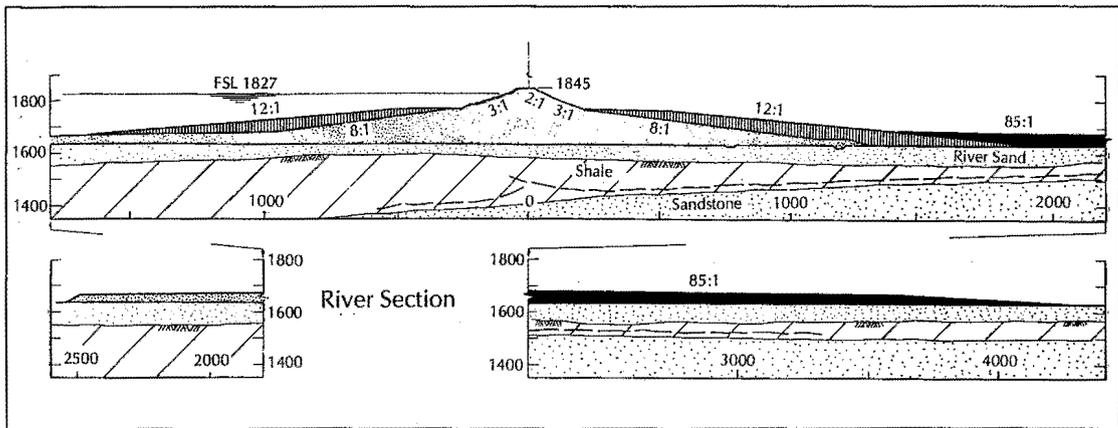
FIGURE 7. Successive stages in flattening of slopes of Gardiner Dam (after PFRA 1980).

prevent an overthrust from developing from the ancient shear zone located some 50 m below the valley floor. Three of the successive stages in the flattening of the slopes are shown in Figure 7. Although the increment of fill near the crest had produced a disproportionately large increment of movement, the rate slowed rapidly, and the embankment was completed to its designed crest elevation. In all, a maximum displacement of over 2 m occurred in the region about 150 m downstream of the center line. The displacement was associated with an upstream-downstream compression of the downstream shell, as the displacement at the toe of the embankment 1,200 m downstream of the center line was less than 1 cm during the same time interval.

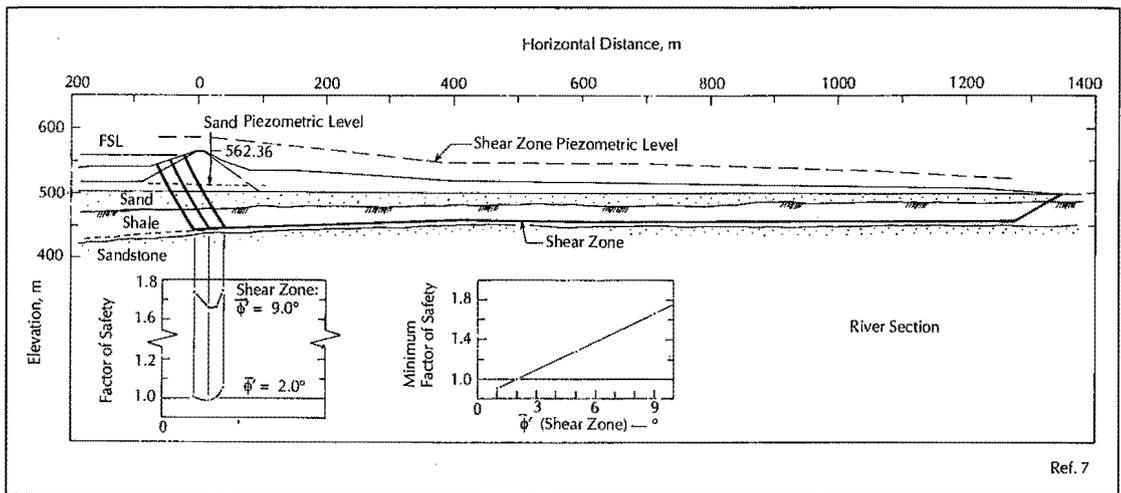
FIGURE 8. Results of stability calculation for the river section of the Gardiner Dam on the basis of the best information available in 1979.

One of the most recently published examples of such a calculation for the river section is illustrated in Figure 8.⁷ It represents a parametric study in which the factor of safety was calculated for various residual friction angles from 2° to 9° . The composite surface of sliding included the observed shear zone in the foundation, an active segment (taken at 3 different positions) along which peak strength was assumed, and a passive segment at the downstream end at a location corresponding to observation. Measured piezometric levels along the shear zone and in the embankment were used. The results show that for $FS = 1.0$ a residual friction angle of only 2° is needed, but even at this small value a maximum shearing displacement of over 2 m occurred during construction. The calculations illustrated are for full pool, but similar calculations for low pool,

corresponding to conditions at the end of winter, show a negligible influence of pool elevation on the factor of safety. Inasmuch as each application of the reservoir load has actually produced a distinct increment of displacement amounting to several millimeters, it is apparent that even these calculations are not yet at a stage where they are definitive predictors of behavior.
