Developments in Foundation Renovation: Les Promenades de la Cathédrale Project

Reinforcing and replacing an unstable foundation system without disrupting the structure's function poses a problem that requires an inventive solution.

JOHN MARCOVECCHIO

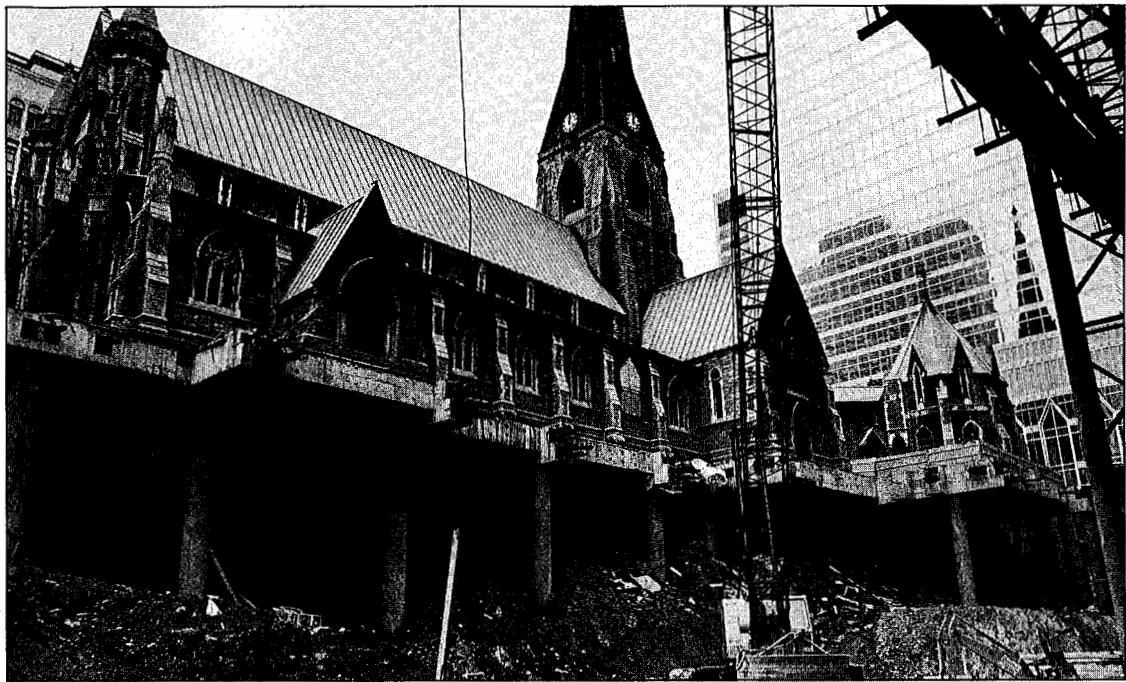
FIGURE 1. View of the cathedral from the bottom of the excavation.

developed by the structural engineers met the challenge in a creative fashion. The cathedral would rest on a concrete shelf that was to be composed of secondary reinforcing beams constructed on both sides of the existing masonry foundation walls and secured through post-tensioning (see Figure 1). The masonry walls were sandwiched between the new beams and the building load would be supported through friction. These secondary beams framed into the six-foot deep, T-shaped primary post-tensioned girders which, in turn, rested on the perimeter caissons at both ends. The beams connected the piles from one side to the other, and the perimeter caissons would transfer the loads down to the bedrock fifty feet below. This concrete shelf was to be constructed within the cathedral's basement where the headroom was limited to a maximum of seven feet.

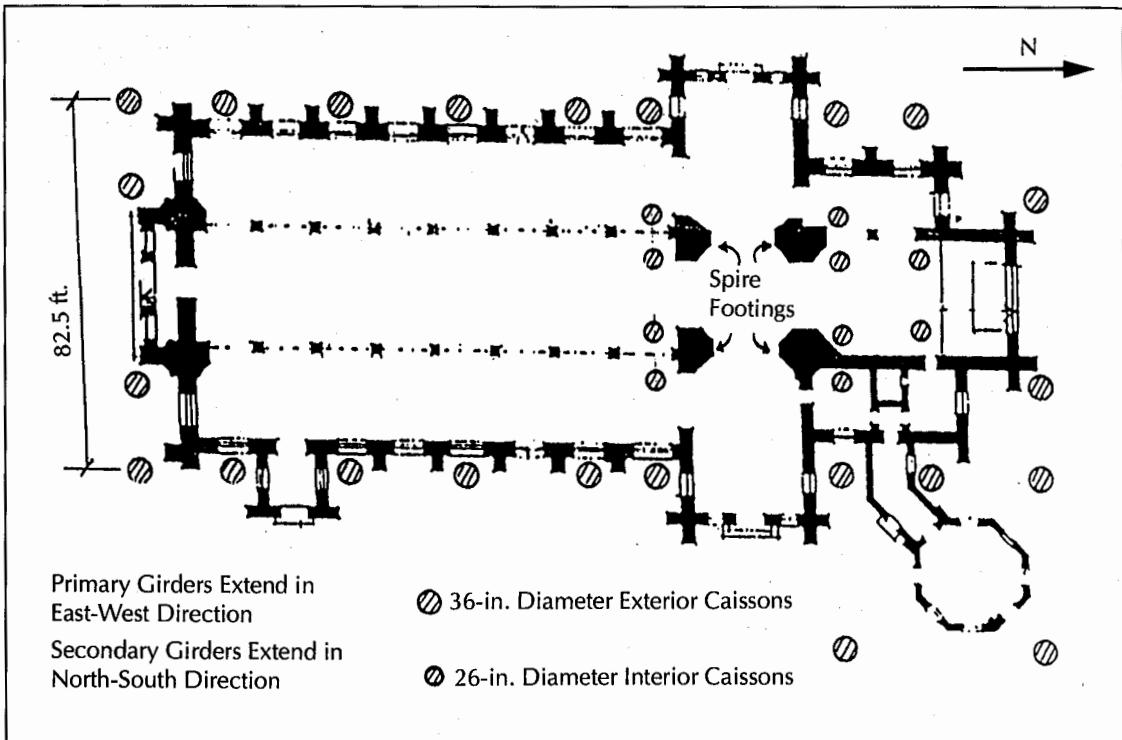
FIGURE 2. Plan view of the existing cathedral foundations and location of new support caissons.

A total of 33 caissons were socketed into bedrock to transfer the cathedral's weight. Twenty-three of these caissons were 36 inches in diameter and the remaining ten were 26 inches in diameter. Figure 2 shows the location of these caissons. The 36-inch diameter caissons that surrounded the exterior of the cathedral were driven just one foot away from the existing walls, thus clearing the edge of the existing masonry continuous walls. All caissons were driven and drilled by use of conventional methods of hammering and drilling.

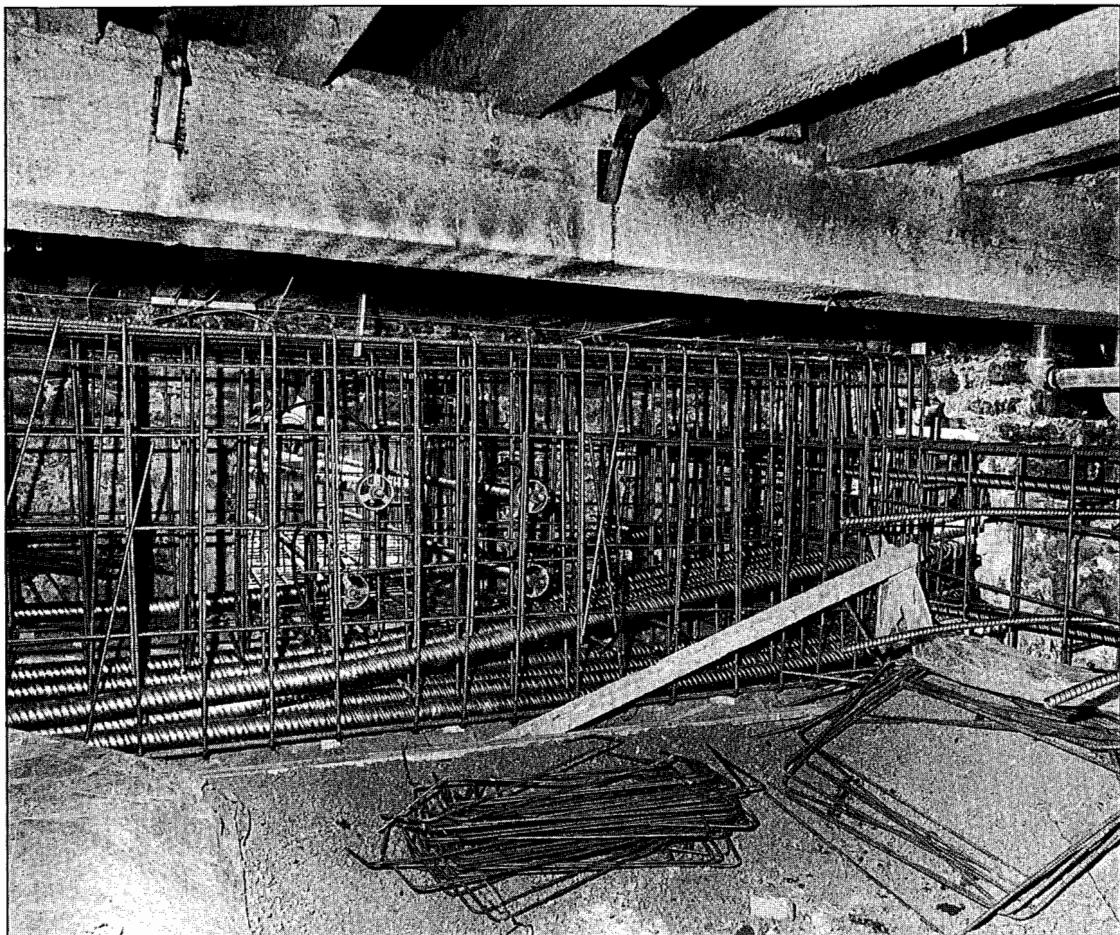
FIGURE 3. A primary beam within the cathedral's basement. Note the limited headroom.

The 26-inch diameter caissons were to be installed within the cathedral's basement where the headroom was confined to a maximum of seven feet (see Figure 3). For these caissons a special pile driving rig was fabricated that consisted of a platform on steel beams upon which a winch, motor and boom were placed (see Figure 4).

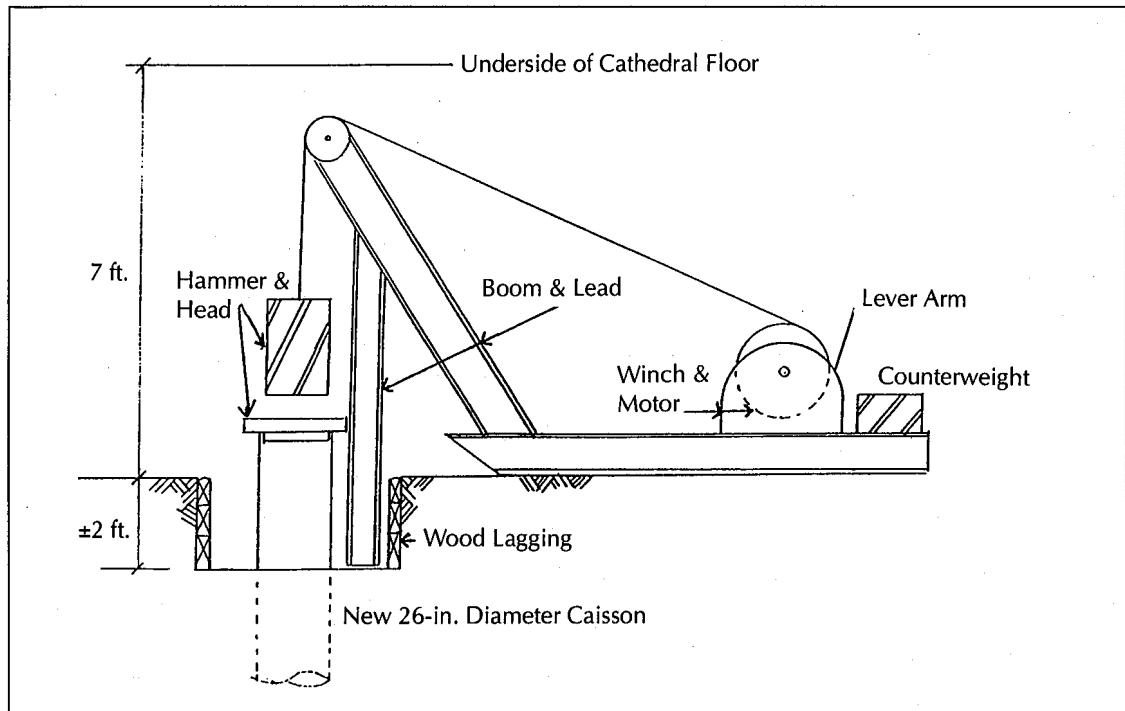
FIGURE 4. Special piling rig.

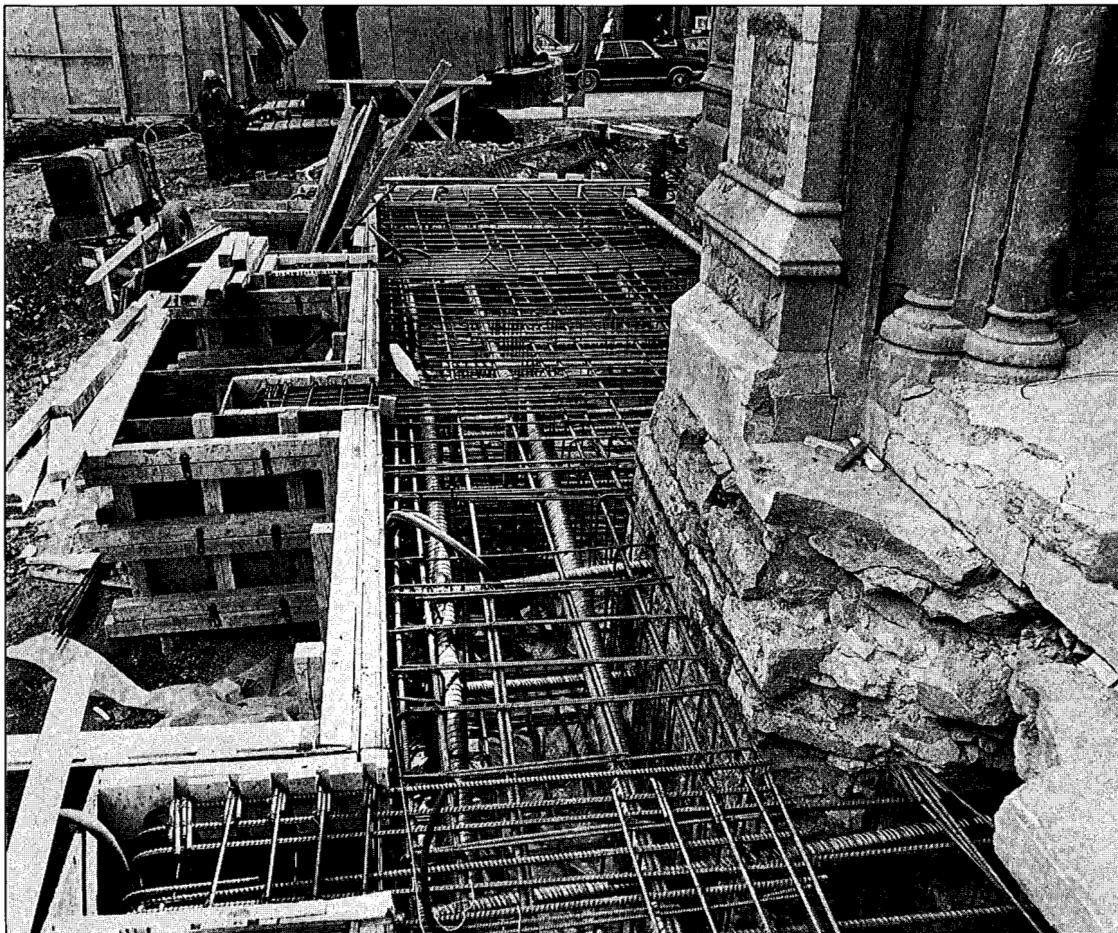
FIGURE 5. Beam surrounding the existing cathedral foundation prior to pouring concrete.

When the caissons were installed in position on either side of the cathedral's exterior walls, outlining the grid system for cast-in place primary transfer girders and secondary beams, preparatory work was started to clear the way for fabricating the concrete shelf (see Figure 5). The new girders and beams were cast in place within the cathedral's basement that was being used as a storage area. The basement floor, which was anywhere from one to three feet higher than the bottom elevation of the girders, was composed of a slab on grade over 50 percent of the area and just earth over the remaining area.

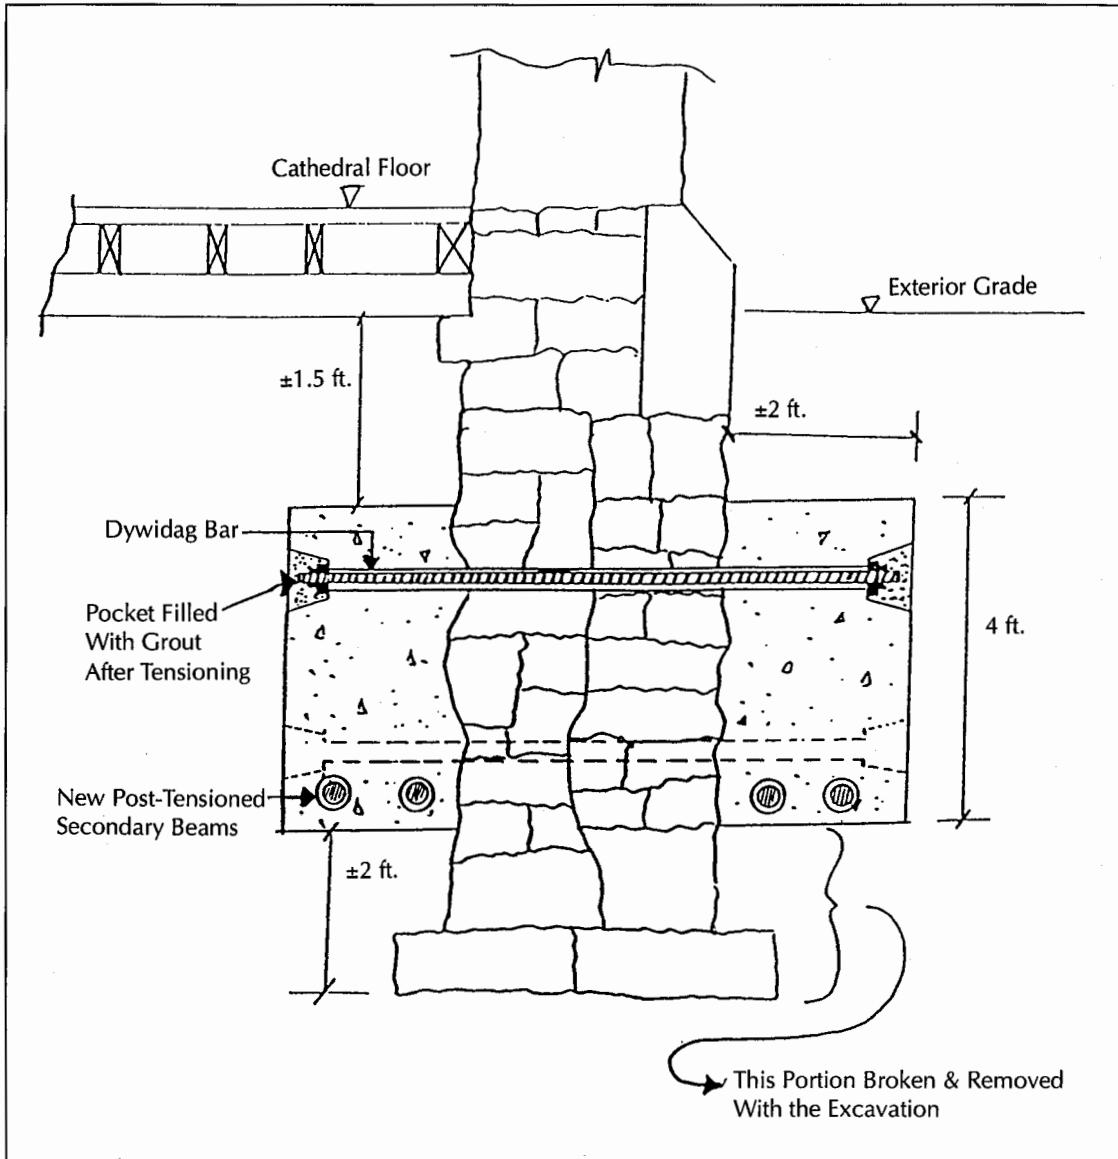
FIGURE 6. Typical section of the existing foundation walls and column bases showing the load transfer system.

In the existing foundation walls and column bases, which were embedded in the new concrete, two-inch holes were drilled through and dywidag bars were placed into the holes and then post-tensioned as the concrete attained the required strength. These post-tensioned dywidag bars sandwiched the existing foundation walls between the new concrete beams and thus ensured proper friction hold and load transfer between the old and the new foundation systems (see Figure 6).

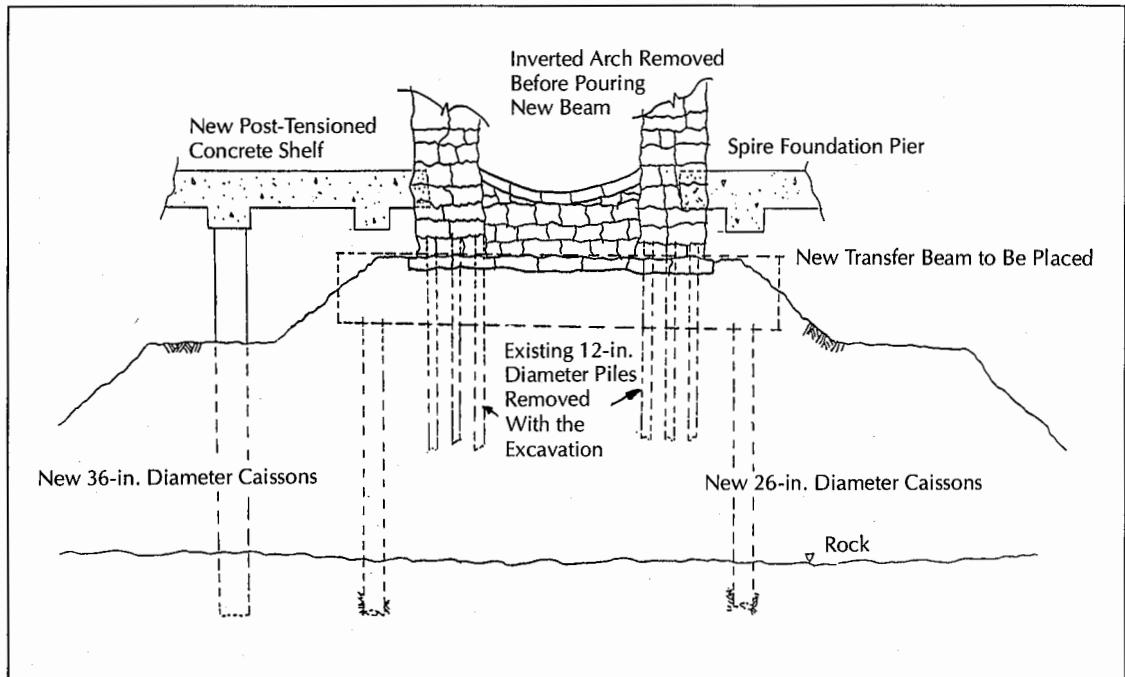
FIGURE 8. A section through the spire.

In following the construction method established in the first phase, excavation of the earth beneath the cathedral began. In the region around the spire footings, a working earth shelf was left (see Figure 8). This shelf was accompanied by a one to one soil berm in order to maintain stability.

the secondary post-tensioned beams (which had been completed in the first phase) had been socketed into the spire masonry piers to act as brackets and replace the potential skin friction loss that would occur by exposing the piles (see Figure 8).

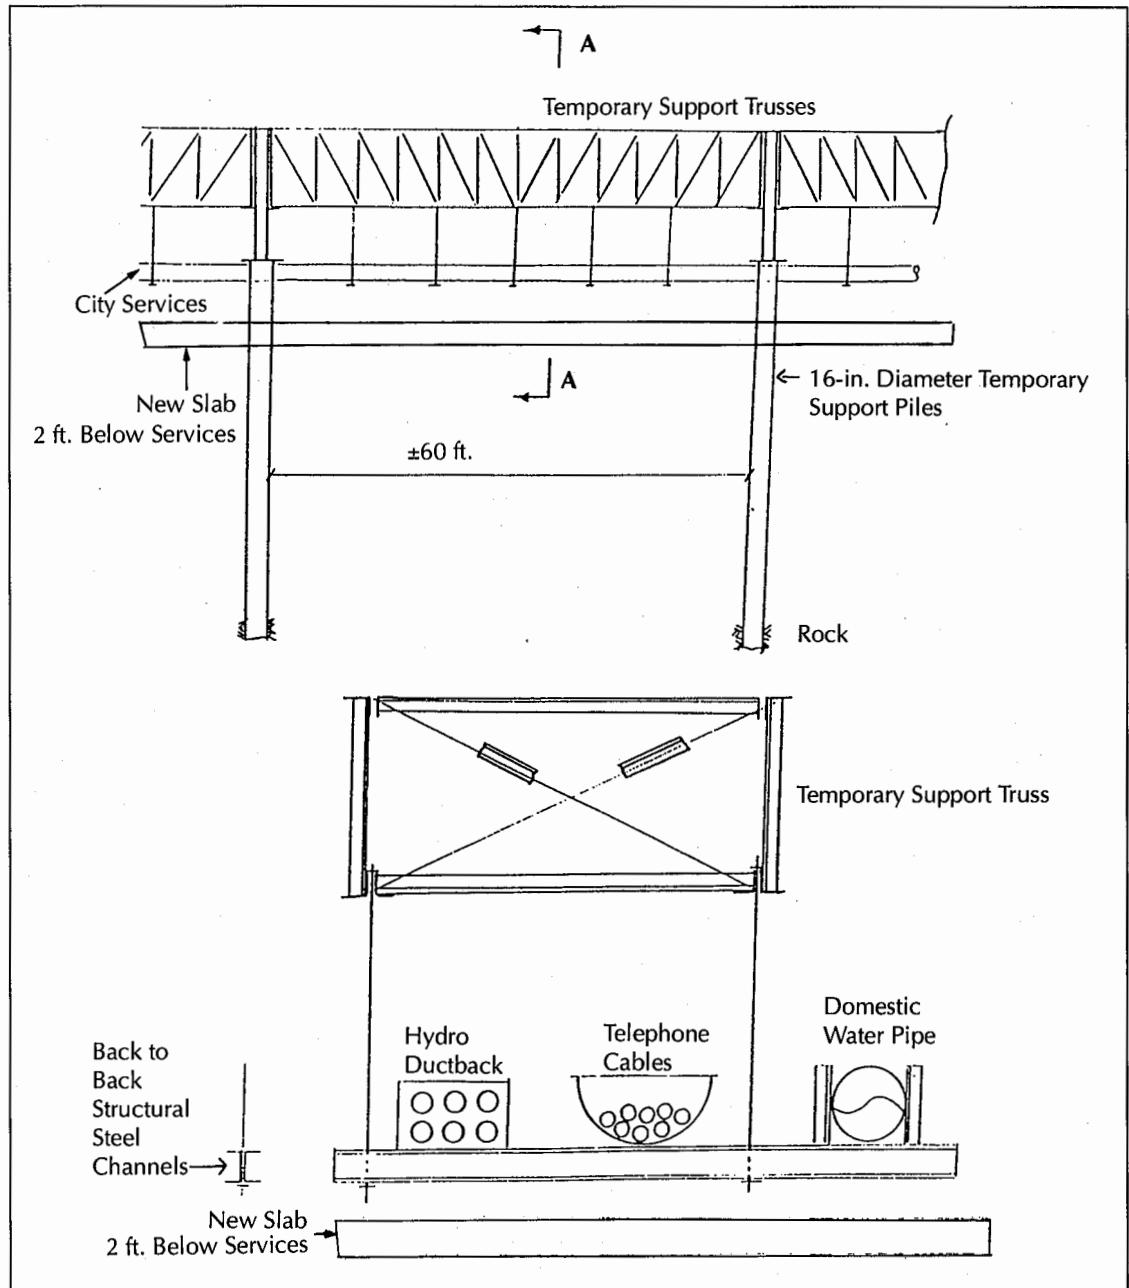
FIGURE 9. Details of the temporary support structure for city services.

The general contractor conceived and had a supporting system designed that would solve this problem. This system consisted of placing support piles spaced at 60-foot intervals longitudinally on either side of the services. Trusses were then placed on the piles to support the loads of the services (see Figure 9). The 60-foot spacing, chosen to allow the excavation equipment to work efficiently and cost-effectively, worked out very well. In addition, the structural slab, spanning between the trusses, served as the new roadway (see Figure 10).

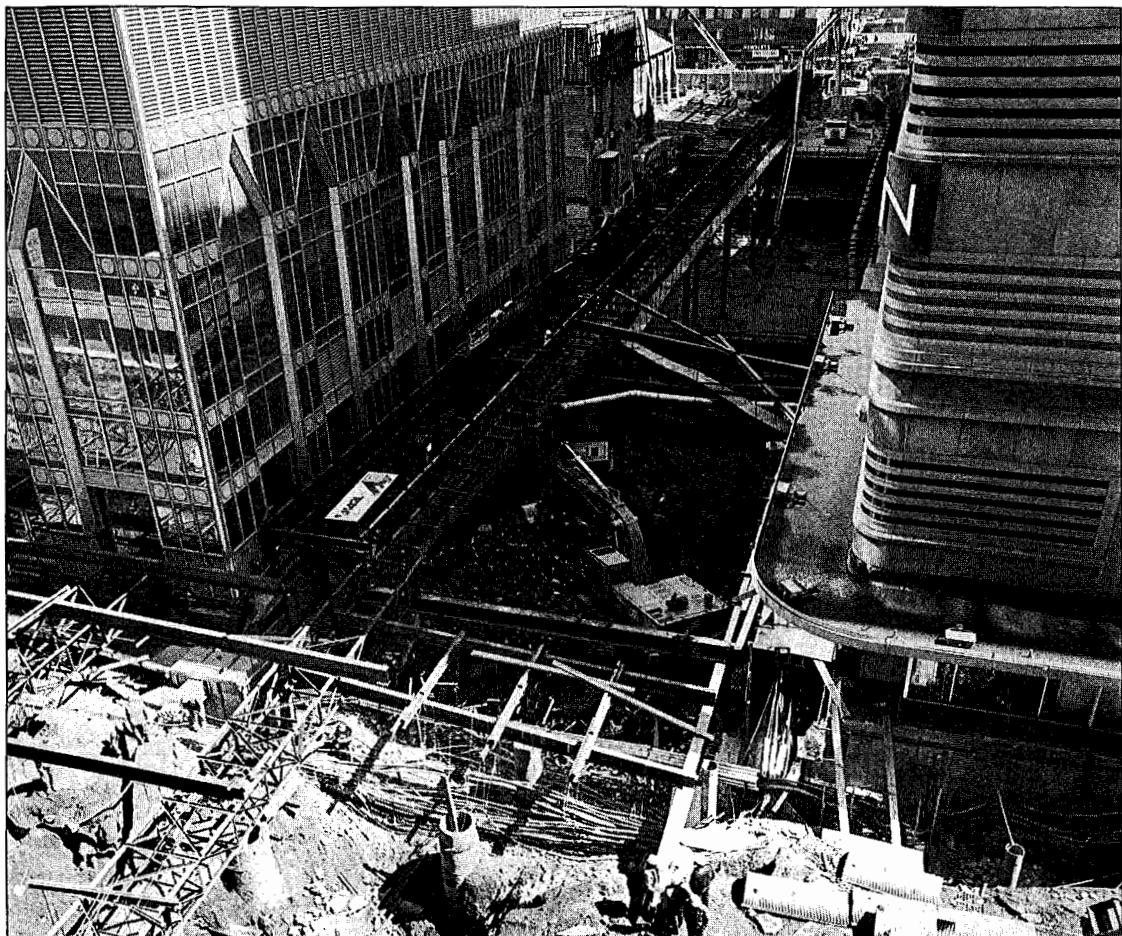
FIGURE 10. A view showing the temporary support system of city services along with the excavation in progress and the pouring of concrete in the background.

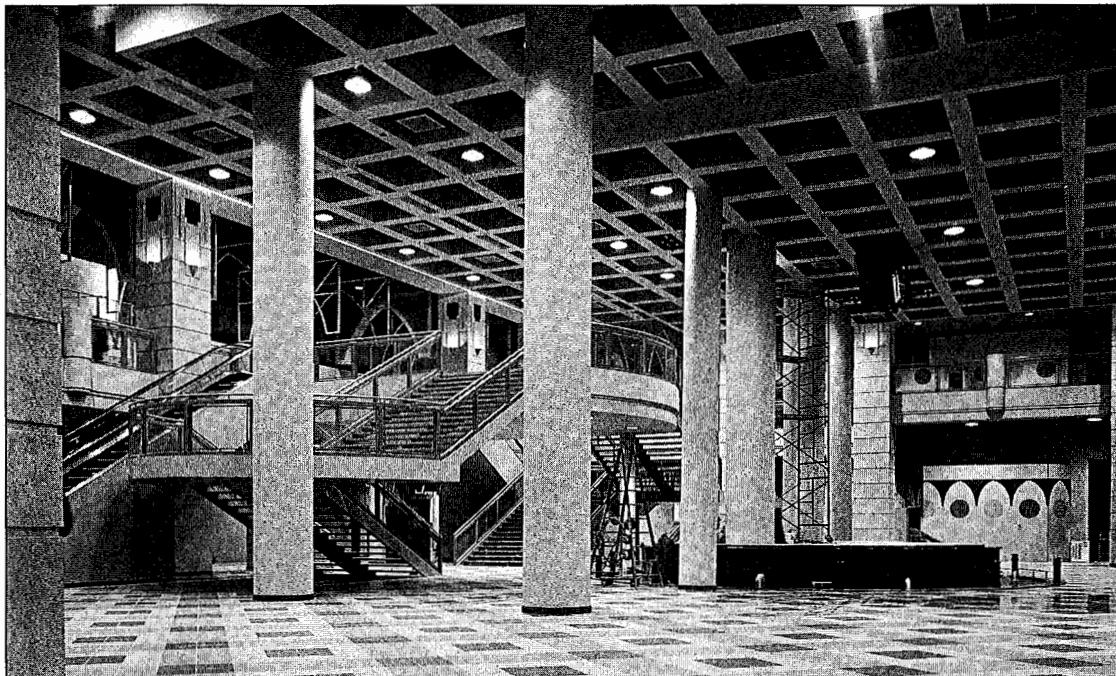
FIGURE 11. A view of the interior of the new shopping complex and the open grid ceiling below the new concrete shelf.

The underpinning of the cathedral began in February 1987 and was completed in September 1987. The excavation under the cathedral and the neighboring streets was completed in April 1988 and the shopping complex was opened to the public in September 1988 (see Figure 11). All of these dates were well within the construction schedule that was established before the commencement of work on the project. In addition, no appreciable settlement was found for the new foundation system
