Lessons from Hurricane Hugo: The Need for Codes & Performance Criteria in Marinas & Coastal Structures

Formulating much-needed codes & standards for marina & coastal structure design requires the cooperative efforts of public agencies, engineers, building officials, legislators & insurers.

JON GUERRY TAYLOR

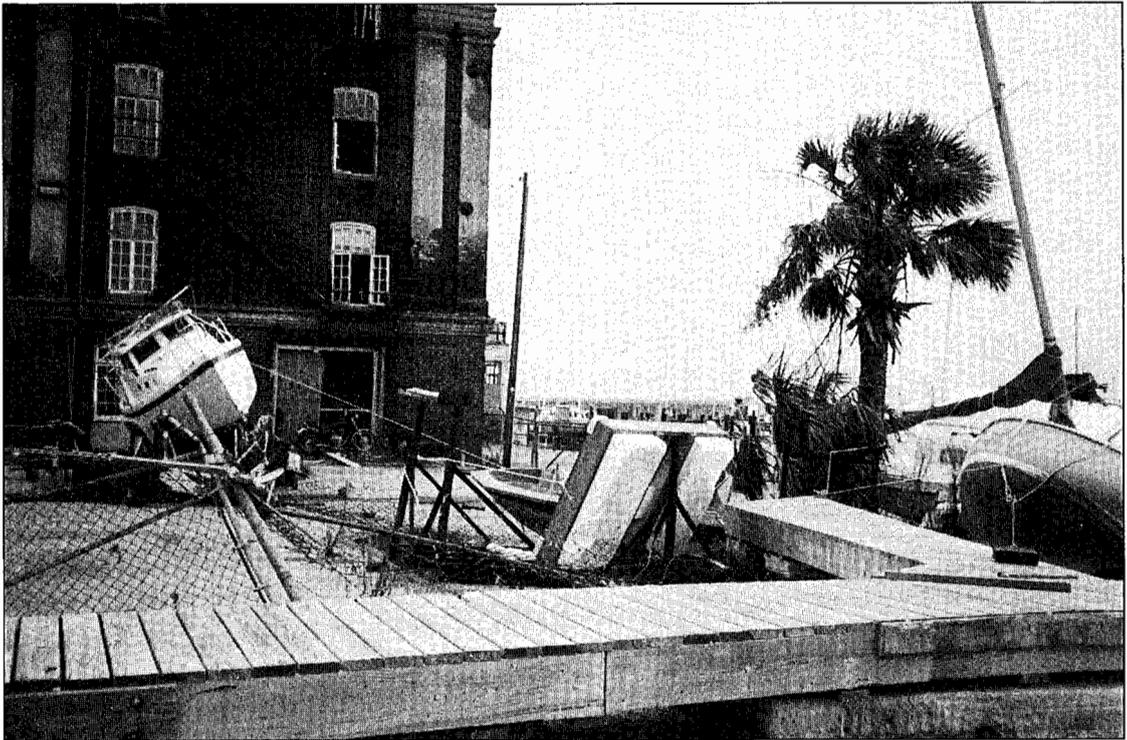
By far, the most frequent failure in coastal and marine structures in South Carolina during Hurricane Hugo was pile failure. Both independent piles and piles within systems experienced a disproportionate number of failures. Many of the piles in fixed-pier systems failed from "pullout" due to uplift forces from wind and tidal surge. Others either broke at or near the mudline or leaned over from horizontal force. A final failure of piles in floating dock systems was found when piles did not have adequate height to restrain the floating docks during the tidal surge (see Figure 2).

FIGURE 2. Hugo's storm surge took floating docks over the top of anchor piles and washed them ashore.

Recommendations. A minimum timber pile size (tip) in coastal structures should be 25 inches in circumference for timber piles, and 12-inch square for prestressed concrete piles. Minimum pile penetration requirements based on local soil conditions should be developed. Pile penetrations of 20 feet for clay and 15 feet for sand should be the absolute minimum, regardless of local soil conditions. The minimum height of piles for floating dock structures should be set to withstand a designated hurricane's wind intensity and storm surge — e.g., the minimum height for piles experiencing a 50-year storm occurring at high tide would be the mean high water elevation plus the height of the 50-year storm surge plus 1.5 feet for dock free board and two feet for wave action. Driven

piles should be preferred over jetted piles and the jetting of piles in marinas and commercial pier construction should be permitted only under the supervision of a professional engineer. The use of old telephone poles for piles in salt and brackish waters should be prohibited. Piles for marina structures and commercial pier structures should be designed by a professional engineer.

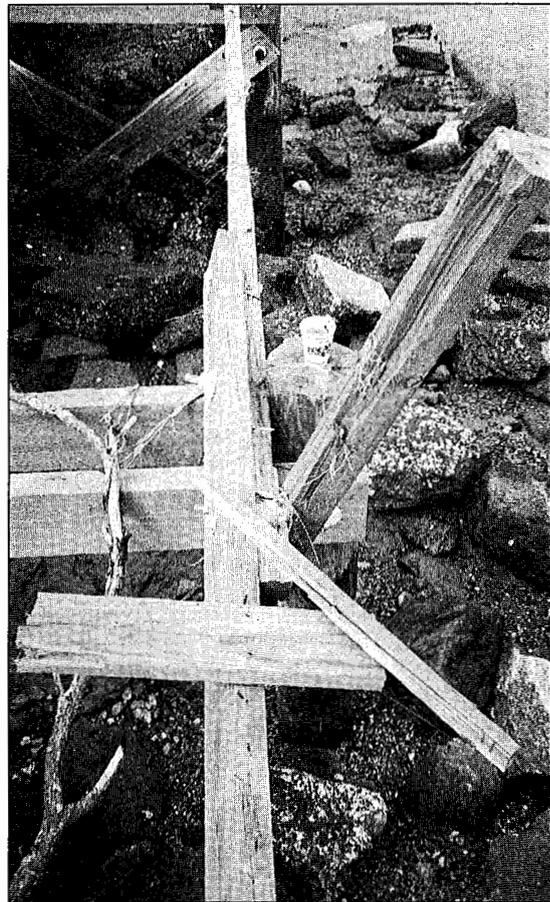
handrails on the fixed piers were the first to go (see Figure 3). In some cases, if the pile cap connection was not adequate, the total deck structure (including stringers) with the hand-rail intact lifted off the pile or pile cap. Often, where pile penetration and size were not adequate to withstand the uplift forces, the entire structure, including piles, rolled over. This type of failure was especially prevalent in residential fixed piers that utilized small jetted piles in marsh areas (pluff mud soil condition).

FIGURE 3. The decking and handrails fail first while the split pile cap and cross bracing have remained intact.

Recommendations. There are many individual site conditions that have to be addressed on numerous residential installations. Because of their small scope, these projects usually do not have the involvement of a professional engineer. Often, a local building permit is not even required, so residential pier and dock projects escape local inspection by code enforcement officers. There should be some minimal standards for fixed-pier design. The only entities that are involved with all of these projects are the environmental permitting agencies (U.S. Army Corps of Engineers, Coastal Zone Man-

agement, etc.). These agencies could promulgate suggested minimum guidelines of construction for these facilities.

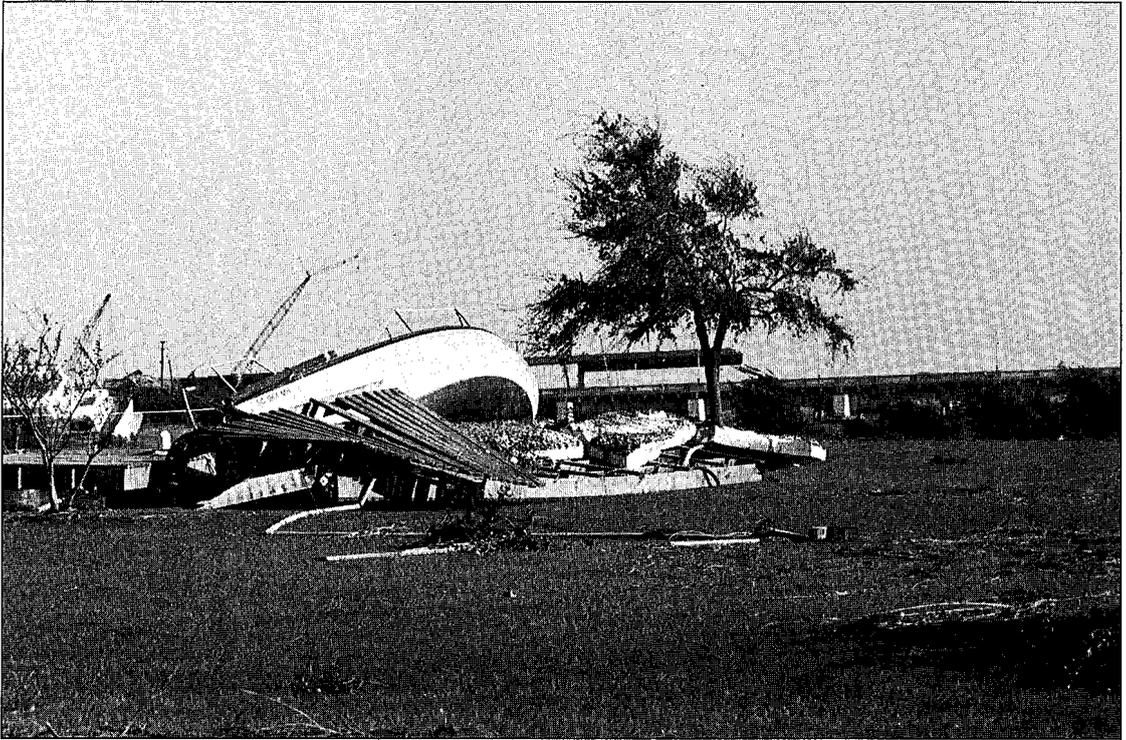
When anchored adequately, floating docks can move, deflect and relieve stresses. As previously mentioned, some floating docks floated over the tops of piles during Hugo's storm surge. Many floating docks failed from the loads transmitted by the boats that were tied to them. In addition, if the boats were not properly secured, they rubbed the docks, tore away from their moorings and caused impact damage throughout the marinas. Some floating docks failed as a result of impact from heavy floating debris (one floating tire breakwater broke away from its anchor and caused substantial damage in the marina it was supposed to protect). All floating docks suffered damage during Hurricane Hugo. However, the commercial "factory produced" docks fared better than locally produced docks and they were easier to repair or replace after the storm. Connections at the finger/main walkway junction exhibited weakness. Properly designed knee braces helped to sustain the lateral and twisting loads from boats anchored in the berths. Even concrete docks sustained damage through the wale system when they heaved against piles. Other dock systems tore apart at the connections between units (modules). From field observations, it appears that most floating docks failed after coming loose from their moorings (piles). Once they were taken out of their alignment, they were torn apart by twisting and bending. In many cases, the flotation billets were torn away from the structure (see Figure 4). Utilities in the dock systems were severed. Small cleats (eight inches and less) broke or were ripped from their moorings. Outside pile guides were torn from their moorings or were twisted when the docks broke loose.

FIGURE 4. Floating docks were torn apart after tearing away from anchor piles.

Recommendations. The attention to adequate mooring (piles) and mooring devices (pile guides) will contribute substantially to the performance of the dock system. The piles must be high enough to restrain the floating docks during the storm surge. The mooring attachments to the docks (pile guides) must allow free movement while keeping the docks in align-

ment. This combination of design considerations will keep the system intact throughout the storm cycle. The stresses caused by boats beating against the floating docks during a storm are substantial, especially on the fingers and at the juncture of the fingers and the main walkway. It is essential that special attention be directed to the joints and connections within the dock system. Design and construction that assures that the flotation devices (floats) stay connected to the dock structure during rough weather is needed.

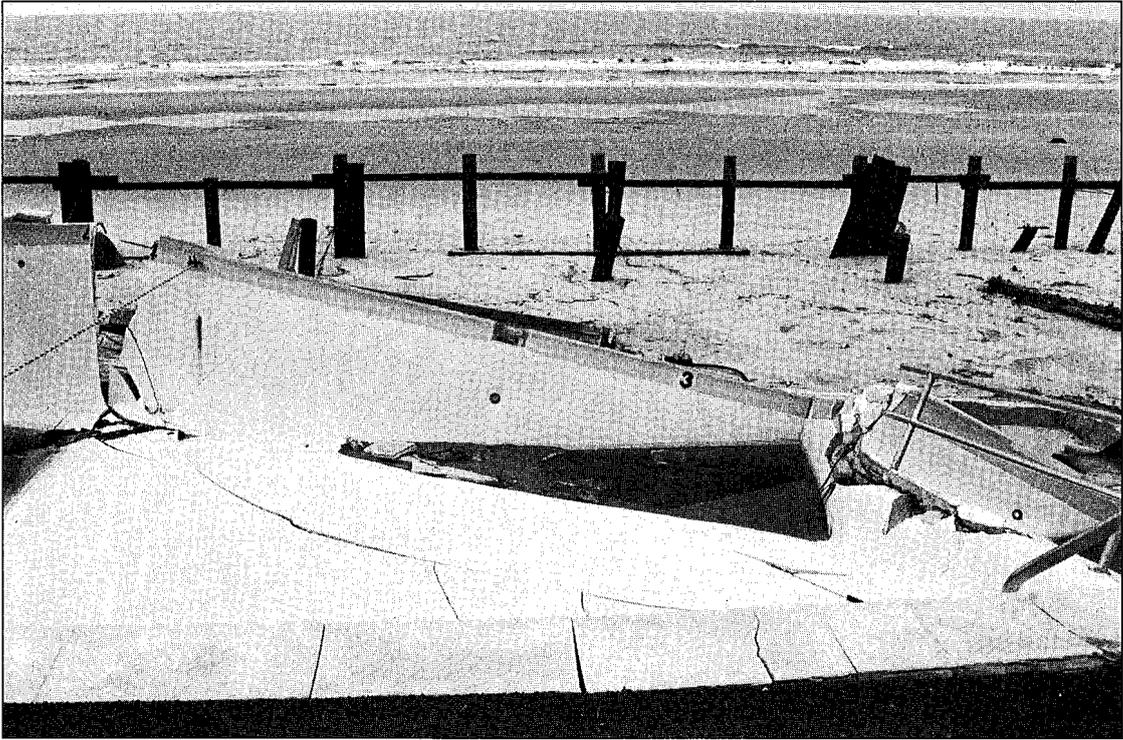
Similar structures near the storm's center (at Isle of Palms, Sullivans Island and Folly Beach) were destroyed by the combination of wind-driven waves and the storm surge. Even heavy stone rip rap structures such as groins on Folly Beach were damaged or destroyed. In all areas that had sand dunes, the damage was minimized because the dunes were sacrificial to the structures behind them. Once dunes were swept away, the structures behind the dunes (retaining walls, rip rap, swimming pools and building foundations) took the remaining force of waves, wind and rising waters, and failed (see Figure 5).

FIGURE 5. Sand dunes were washed away, exposing retaining walls and pools to the storm surge.

Recommendations. The first line of defense for beach front structures is good planning. Locating habitable and commercial structures behind the high hazard zone is economical and effective. The next most effective method of protecting structures is to enhance and improve sand dune restoration and maintenance. In small storms and lunar high tides, this type of protection will be adequate. In larger storms, dune destruction will be sacrificial, but will help in protecting subsequent structures such as retaining walls and rip rap. Stone rip rap can be valuable for attenuating wave forces; however, if small size stones are used, they can

become missiles that can break glass, doors, *etc.*, during the storm. The rip rap should consist of minimum 200-pound each dense armor stone (granite) in conjunction with a geotextile membrane layer and gravel bedding between the heavy armor stone and the geotextile membrane. Where possible, retaining walls should not be utilized as the primary protection. However, if retaining walls are used, the toe should be protected with stone rip rap. If timber retaining walls are used on the beach front, the minimum thickness of sheets should be three inches. There should be returns on the ends of the structure when the retaining wall does not connect to the adjacent property. Special efforts should be made to design the structure in conjunction with the protection available on adjacent property, since the failure of an adjacent neighbor's structure may suddenly mean that the structure could be exposed from a different direction.

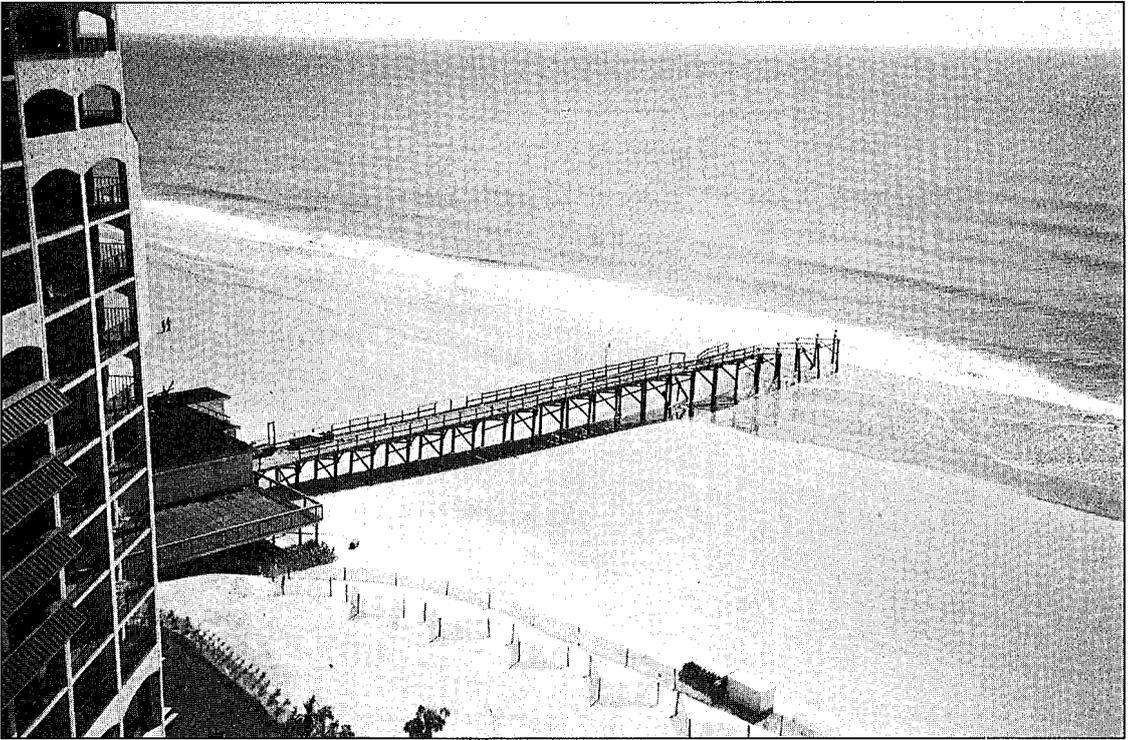
FIGURE 6. Sections of this fishing pier near shore sustained less damage. At the seaward end of the pier, pinned pile caps lifted off with the deck structure, thereby exposing piles and cross members to drag forces during the storm surge.

and wind. Sections near the shore (the first 300 to 400 feet) where pile length exposure (length from the ground line to the bottom of the pile cap) was less did not sustain as much damage as did sections in deeper water (see Figure 6).

The pile caps on many of these fishing piers were pinned through the top of the pile cap into the top of the pile with steel drift pins. The uplift forces lifted the pile cap and deck structure off, leaving piles with no top bracing. Once piles on the fishing piers lost their pile cap integrity, the cross bracing was not adequate to keep the piles intact. Scour at the base of piles exacerbated the problems by increasing the unsupported length of pile. Piles then came out intact, broke in the surf, leaned over or broke at the mud line. Once piles and deck structures were free in the surf, they continued inland to cause more damage to shore structures. From piles that washed ashore, it appears that some piles broke at midspan, probably from drag. The piles on fishing piers had cross bracing just below the deck structure. There were no cross

braces below that point. The pile pairs were cross braced in the transverse direction and were not cross braced in the longitudinal direction. There was little evidence of the use of spiked grid connectors on the cross bracing to pile connection. Many of the galvanized bolts in the intertidal and splash zone had deteriorated (rusted).

Recommendations. There are no existing codes that are applicable to fishing piers. Only references to handrails and live loads are applicable from current building codes (Standard Building Code). Since these structures serve the public, their design should be dictated by professional engineers utilizing state or local agency mandated minimum design standards for materials and performance.

Fishing piers should be designed for a hierarchy of failure as follows:

1. Handrails and decking.
2. Stringers.
3. Pile caps.

4. Cross bracing.
5. Piles.

The handrail and decking failure still leaves a structure that can be made serviceable very quickly and economically. Once pile caps and cross bracing fail, it takes a major effort and outlay of funds to make the structure serviceable again. The minimum bolt size utilized in fishing piers should be 0.75 inches. Spiked grids should be used in the cross bracing and the split cap pile connections to the piles. Connector straps should be utilized if pinned pile cap connections are used. Metal connectors used in the intertidal and splash zones should be coated with coal tar epoxy after installation.

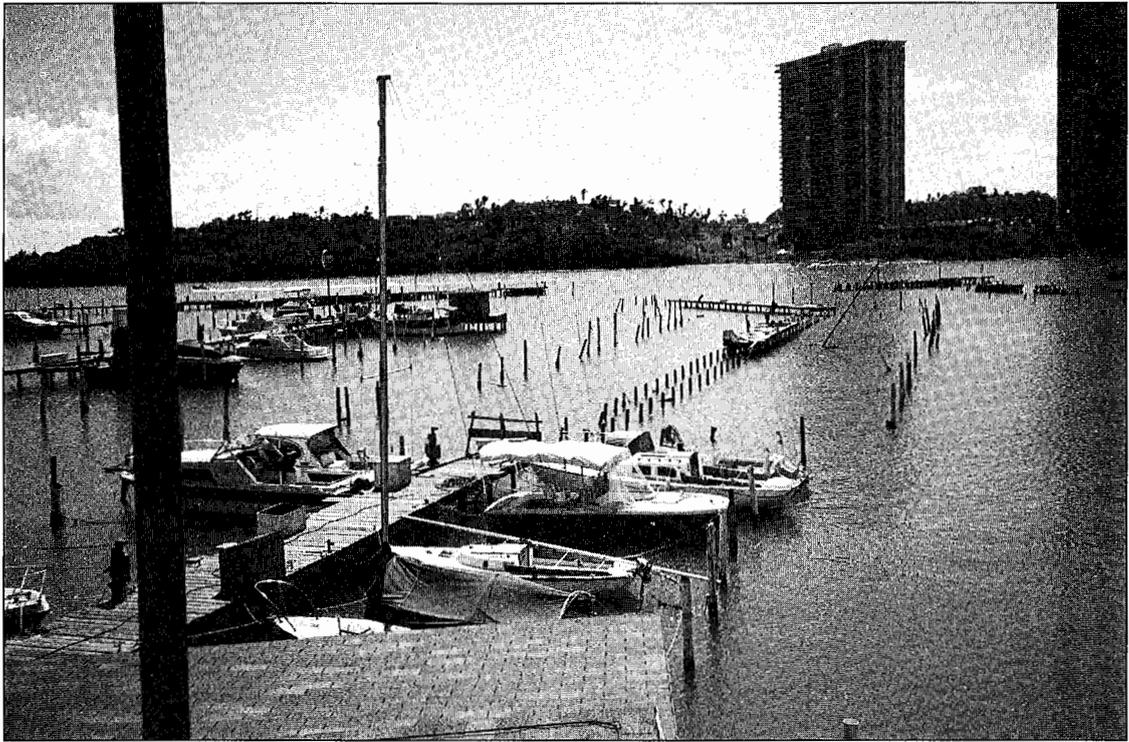
FIGURE 7. A three-foot tidal surge and hurricane-force winds ripped out fixed-pier facilities in Fajardo, Puerto Rico.

Because of the small daily tidal fluctuation, marinas in Puerto Rico utilized fixed piers only. Many of the marina facilities are old and had been modified utilizing piles from existing structures. Hugo's wind and tidal surge ripped out many fixed piers that were located in exposed locations (see Figure 7). Structures — piles, abutments and fixed piers — that had been modified from the original construction often failed because the increased loads on the structures exceeded the original design. Many of the older concrete structures showed excessive deterioration (rust) in steel reinforcing and exposed metal. Recently constructed marinas that utilized professional design and modern materials survived Hugo with little damage.

Recommendations. Fixed-pier marina facili-

ties should incorporate design considerations for the uplift that results from wind and storm surge. If the boats are to remain in the marina, fixed piers and piles should be designed for impact and anchoring live loads. Older marina structures should be reevaluated for their reliability in future similar hurricane events. Additions to older existing fixed-pier and pile structures should be constructed only when designed by professional engineers.
