Reducing Seismic Risk in Massachusetts

A program that evaluates the seismic risk of existing buildings is instrumental in developing structural modifications that will reduce seismic risk.

STEVEN P. MCELLIGOTT, JAMES R. GAGNON
& CHRISTOPHER H. CONLEY

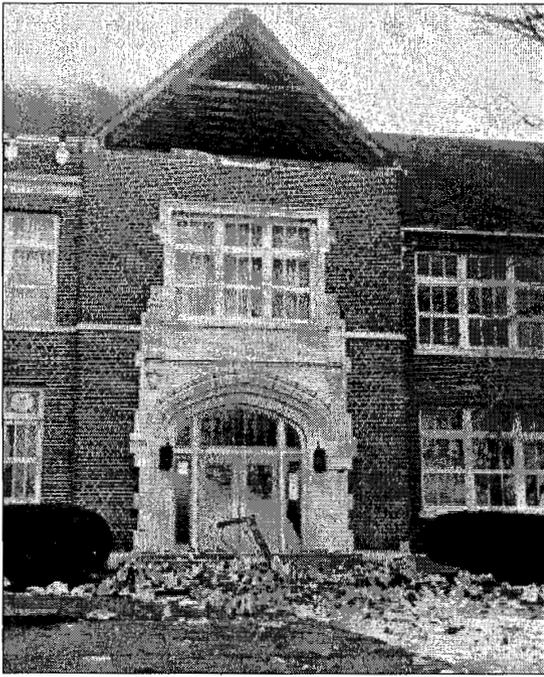
FIGURE 1. Destruction of unreinforced non-bearing structural elements from an earthquake.

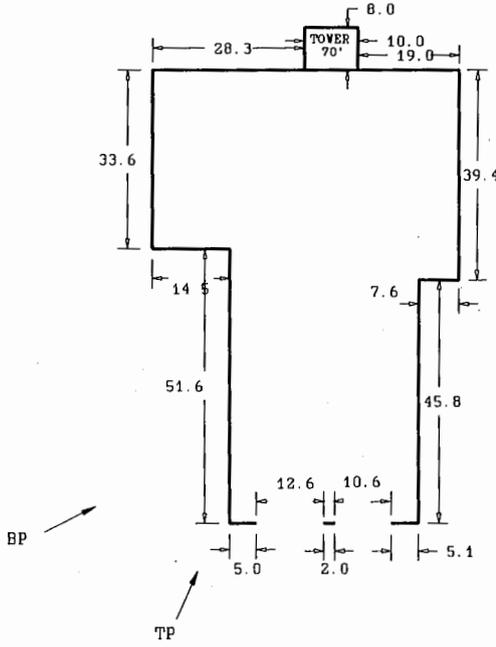
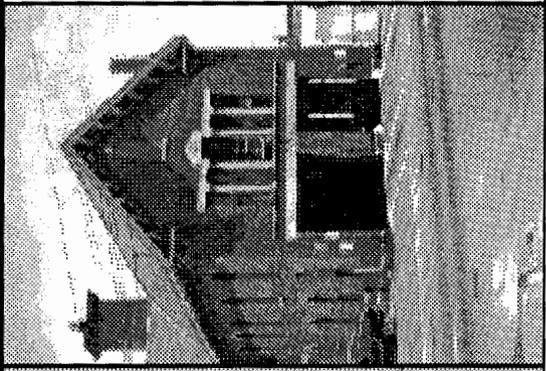
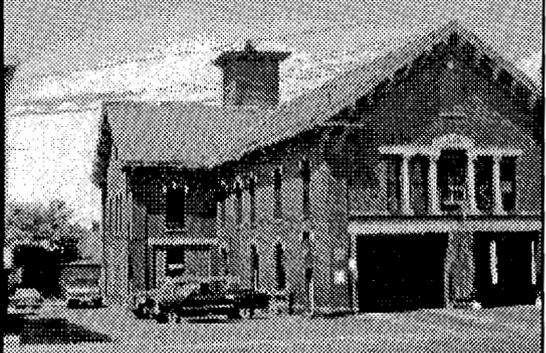
FIGURE 3. A completed RSP form (for the Branch Street Fire Station).

Address Branch Street LOWELL
 Zip 01851
 Other Identifiers Lowell Fire Dept., Station #2
 No. Stories 2 + tower Year Built 1877
 Inspector S. McElligott Date 4-10-92
 Total Floor Area (sq. ft.) 7600 * Use FS
 Building Name Station #2

FINAL SCORE -0.5

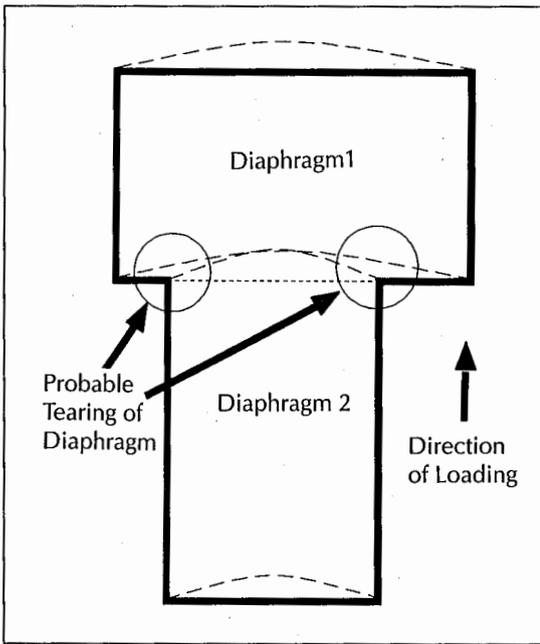
Plan Irregularities. The irregular plan of the structure poses a problem. When exposed to a lateral load in the longitudinal direction, the floor diaphragm will deflect as shown in Figure 9. At the re-entrant corners of the building (the circled regions), the deflection of diaphragm 1 does not coincide with that of diaphragm 2. Unless the dia-

phragm sections have significant tensile capacity to resist their pulling apart in these areas, they will tear. The deficiency is in the strength of the diaphragm in the area of the corners.

FIGURE 9. Diaphragm deflections at re-entrant corners.

- Strengthening the floor diaphragms in the re-entrant corners, thereby eliminating the plan irregularity problem.
- Strengthening diaphragm-to-wall connections by adding more closely spaced and larger masonry wall anchors, thereby stabilizing walls with large height to thickness ratios and providing a continuous load path to the foundation.

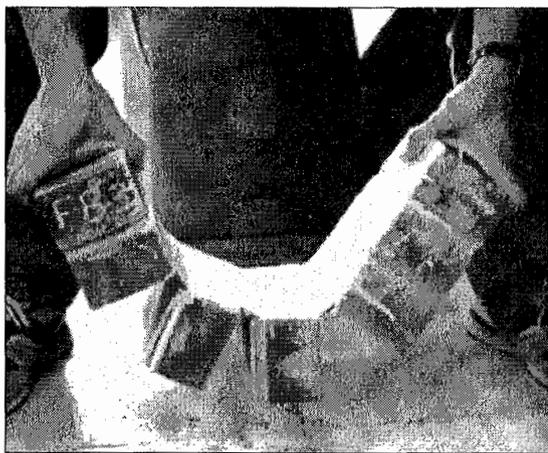
FIGURE 11. Failed polyvinylbutyral reinforced specimen.

cant increases in strength were observed with other reinforcements, the great post-cracking ductility imparted by the film is worth special note. The specimen failed successively in three joints. It was obvious that all the tensile force in the specimen was being developed in the film. Even though complete failure of the mortar to brick bond was observed, the polyvinylbutyral film held the specimen intact, as illustrated in Figure 11.
