Regulated Structural Peer Review

With the trend toward more complex structures and building codes, a properly conducted review of a structure's design can be of great help in avoiding disaster.

GLENN R. BELL & CONRAD P. ROBERGE

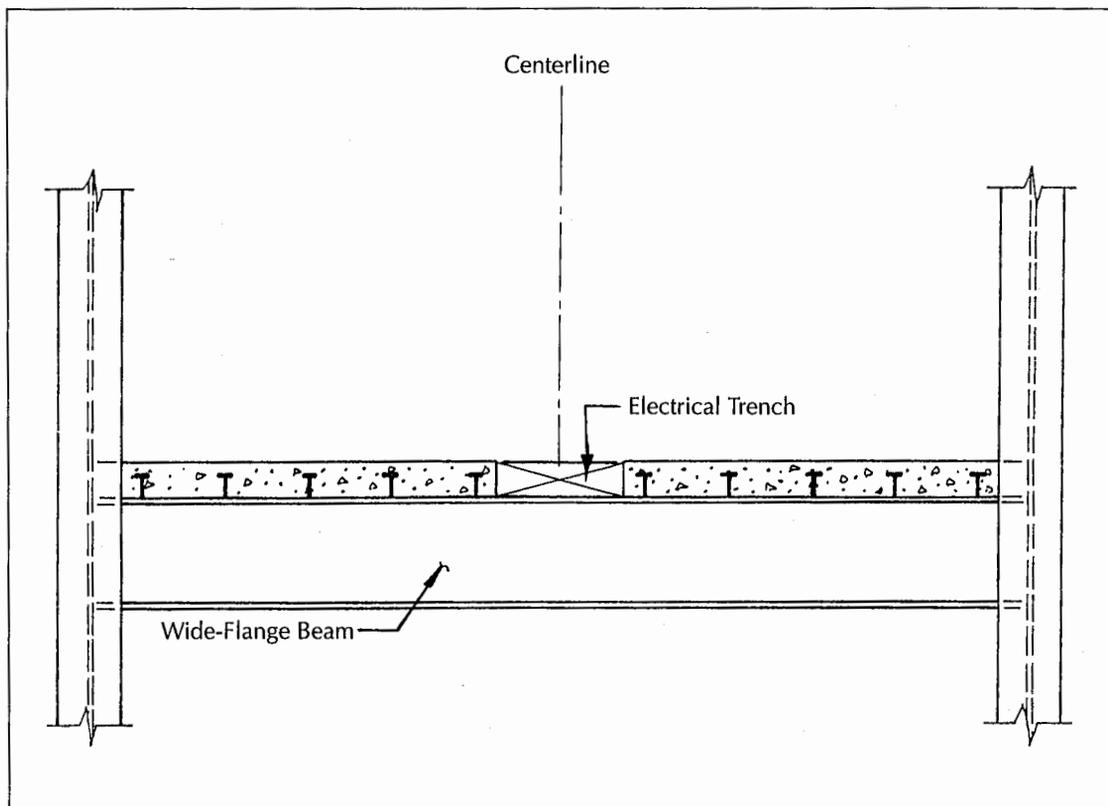
FIGURE 1. Composite action is destroyed by an electrical trench at mid-span.

The steel floor beams were designed to act compositely with the concrete slabs. Due to poor coordination between the structural and the mechanical/electrical drawings, an electrical trench was located perpendicular to the beams near midspan of the beams, essentially destroying composite action and greatly comprising the strength of the beams (see Figure 1).

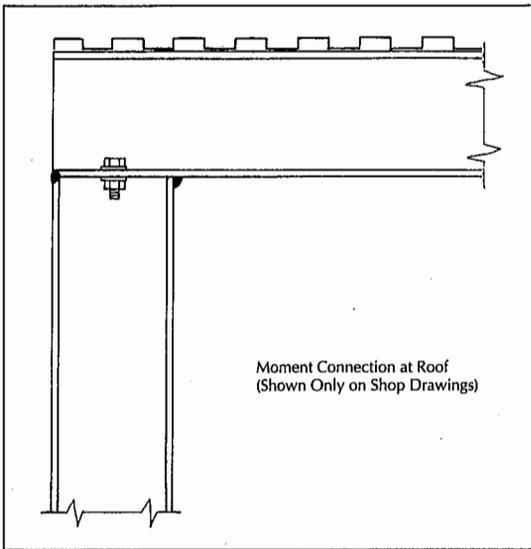
FIGURE 2. No stiffener plates were provided at the connection to transfer moment.

connections required stiffener plates to transfer the design moments. However, the connection design did not provide such stiffeners (see Figure 2).

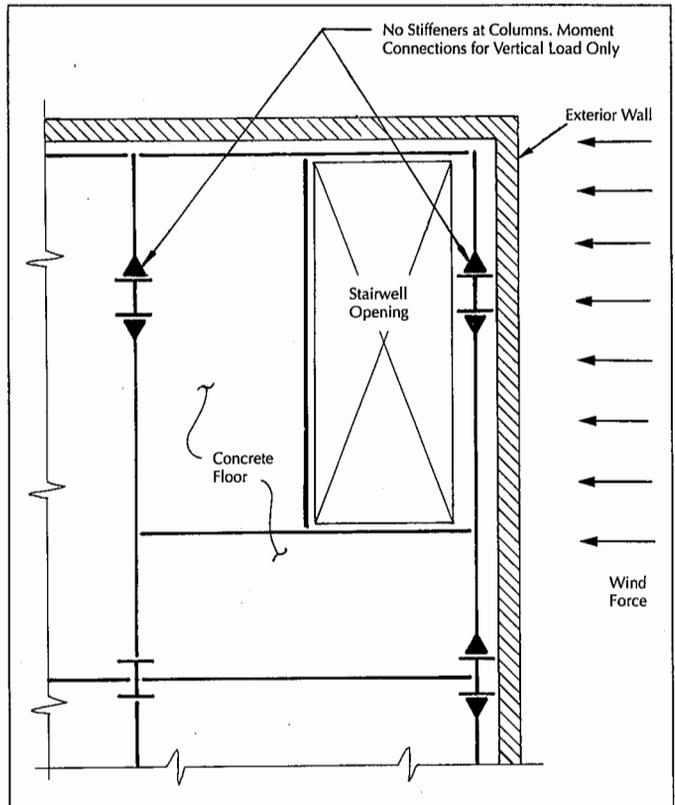
FIGURE 3. An unbraced column at the stairwell opening.

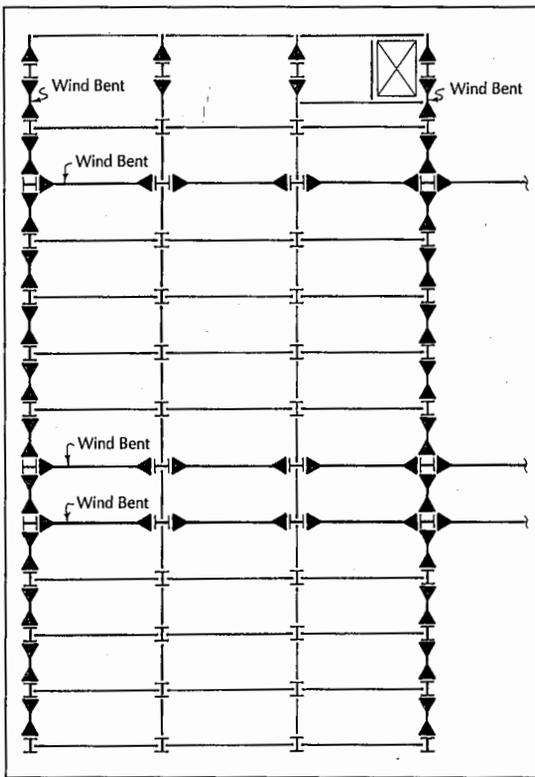
FIGURE 4. Only three of the 12 transverse frames have moment-resisting joints for resisting lateral wind and seismic loads.

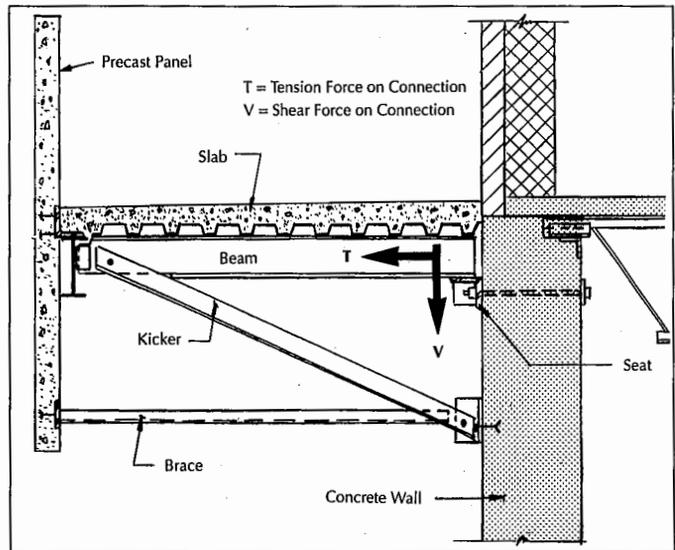
The project involved a substantial renovation and addition to an operating retail mall. A small part of the work involved adding a cantilevered steel and concrete walkway to the side of an existing concrete wall. The walkway ran parallel to the wall. Shortly after construction of the walkway, the contractor and owner noticed that the walkway sagged over the length of its cantilever, and the connections of the walkway beams to the concrete wall were pulling away from the wall. The owner retained an independent reviewing engineer to investigate the problem. That investigation, as well as an investigation by the engineer of record, revealed that the cause of the walkway distress was a design error in the bracket connections that anchored the walkway support beams to the wall. The brackets were designed for shear, but the designer neglected the tension induced in the connection by inclined support struts that propped the ends of the walkway beams (see Figure 5).

FIGURE 5. The design of the beam seat ignored the tension force imposed by the inclined strut.

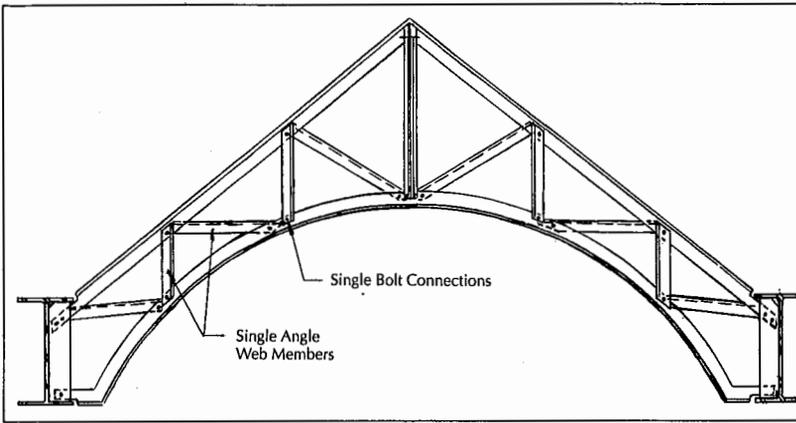
The design of the roof trusses supporting sloped skylight areas of the main mall is shown in Figure 6. The single angle web members were connected to the chords with single bolts. Most of the trusses were fabricated and some were erected at the time of review. The peer reviewer felt that the use of single bolt connections in this application, especially considering the eccentricities involved in the connections, was imprudent. The structural engineer believed that the connections were adequate. All agreed to resolve this problem by welding the

FIGURE 6. Typical roof truss for the shopping mall project.

most highly stressed of the single bolted connections near the ends of the trusses.

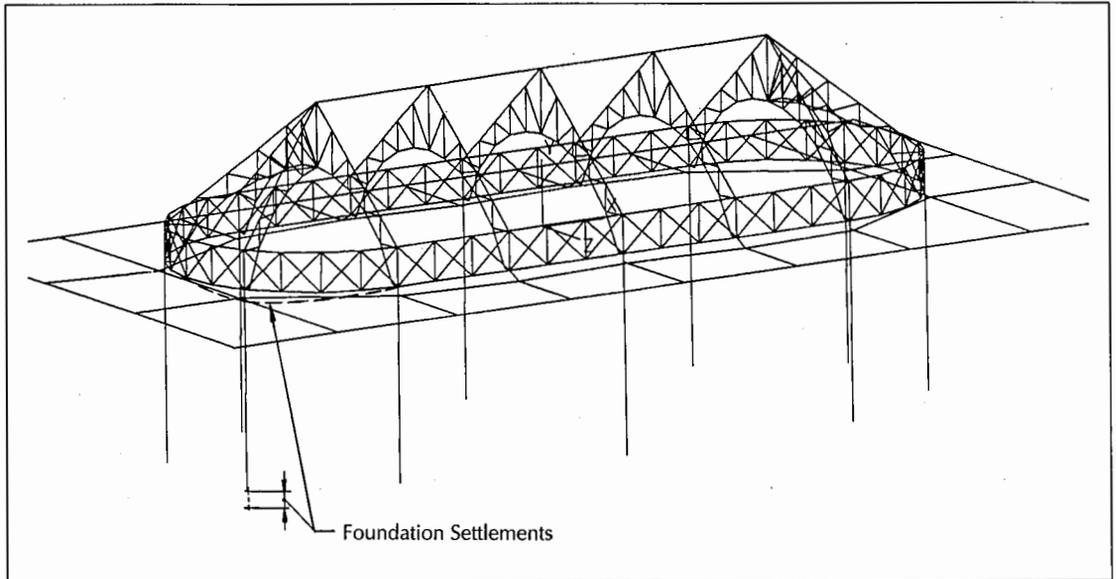
One unusual feature of the structure was a set of large space trusses that spanned open court areas of the mall as shown in Figure 7. The primary gabled arch trusses were supported on ring trusses forming the perimeter of the opening. The ring trusses were supported, in turn, on columns. For architectural reasons, the ring trusses were unusually deep compared to their span, making them quite stiff. As a consequence of this unusual stiffness, the structure was very sensitive to differential foundation settlements at the supporting columns. Small

foundation settlements overstressed several of the truss members. The structural engineer did not consider the effects of foundation settlement in the original design.

FIGURE 7. Small foundation settlements overstress truss members.

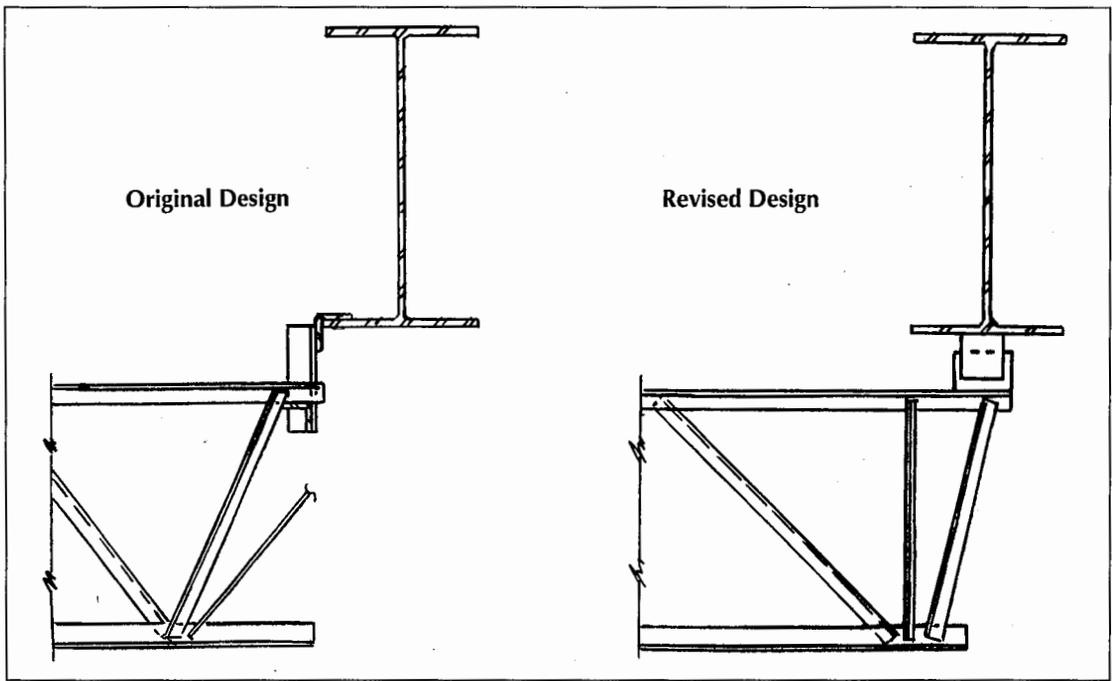
cut and suspended from new longitudinal support beams on each side of the skylight openings. There were several problems with the design of the connections of the truncated joists to the new beams, caused principally by the eccentricities and the lack of lateral stability of the connections.

Another problem that was revealed is shown in Figure 8. In order to provide raised skylight areas over parts of the existing mall roof, the existing roof bar joists were to be

FIGURE 8. Connections were redesigned to eliminate eccentricities and lack of lateral stability.

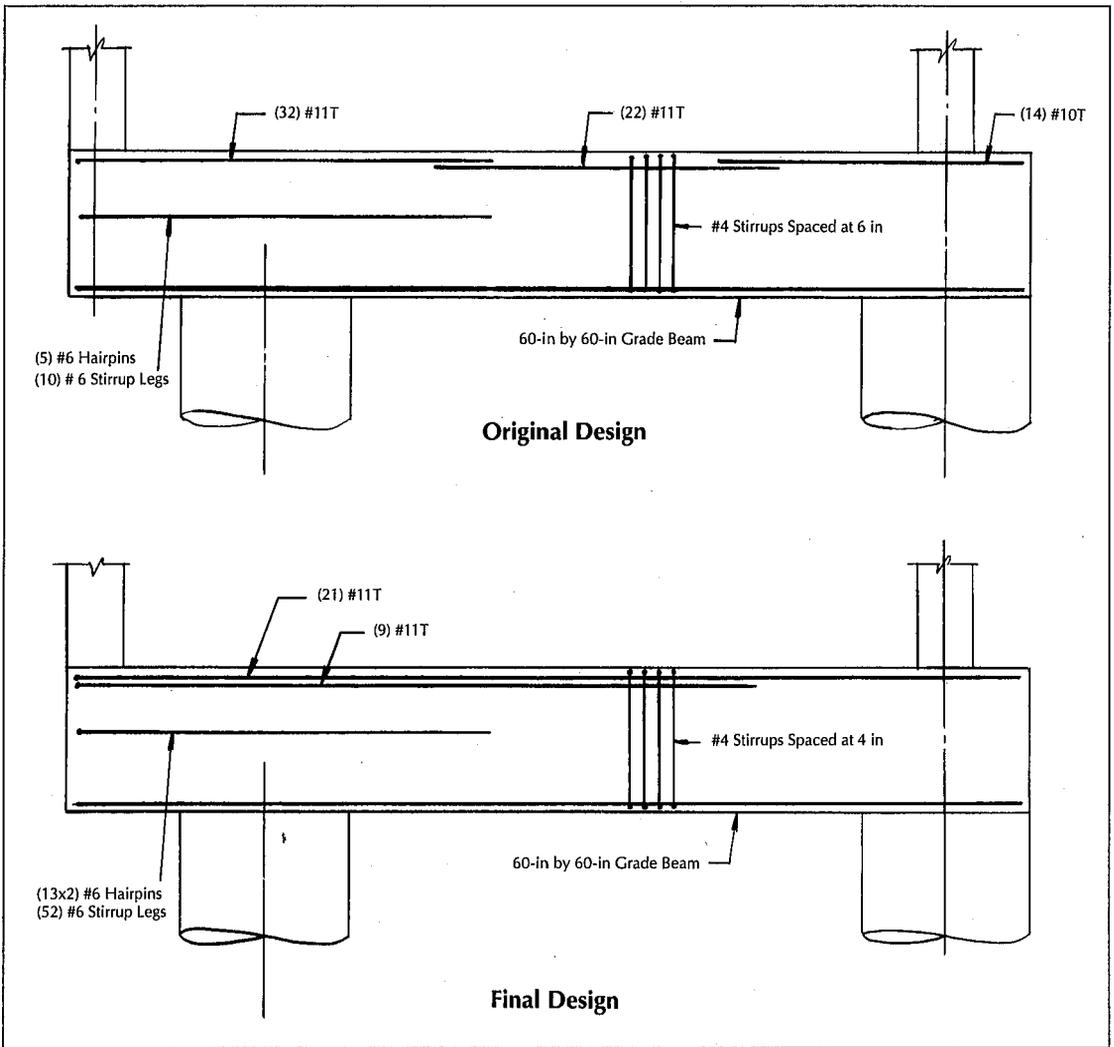
FIGURE 9. Cantilever grade beams were redesigned to correct inadequate stirrups and lap splices.

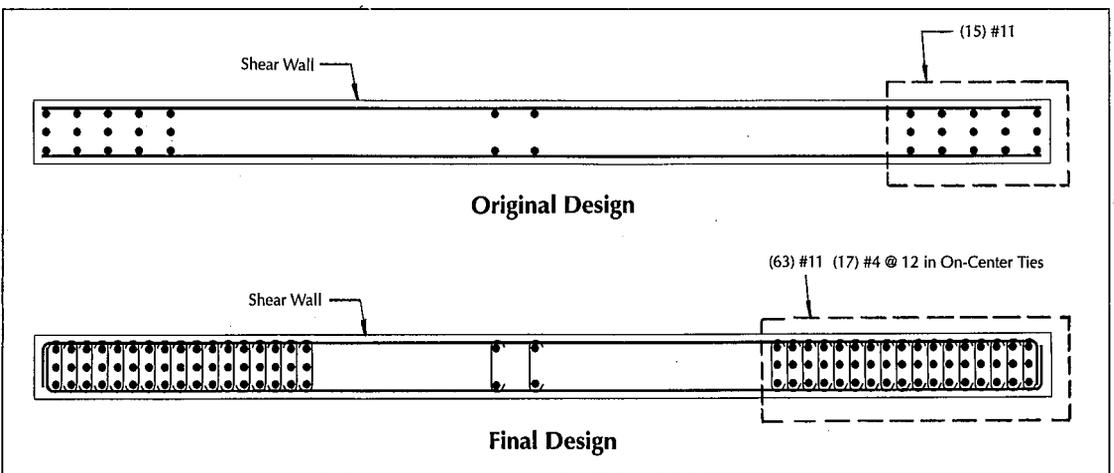
The designer's lateral load distribution to the shear walls was incorrect. The shear walls were designed only for tension forces, neglecting very large compression forces. The shear-wall reinforcement of the original design called for 15 #11 bars with no ties. After correcting the errors, the shearwall reinforcement was 63 #11 bars with ties (see Figure 10).

FIGURE 10. Shear walls were redesigned to account for compressive forces.

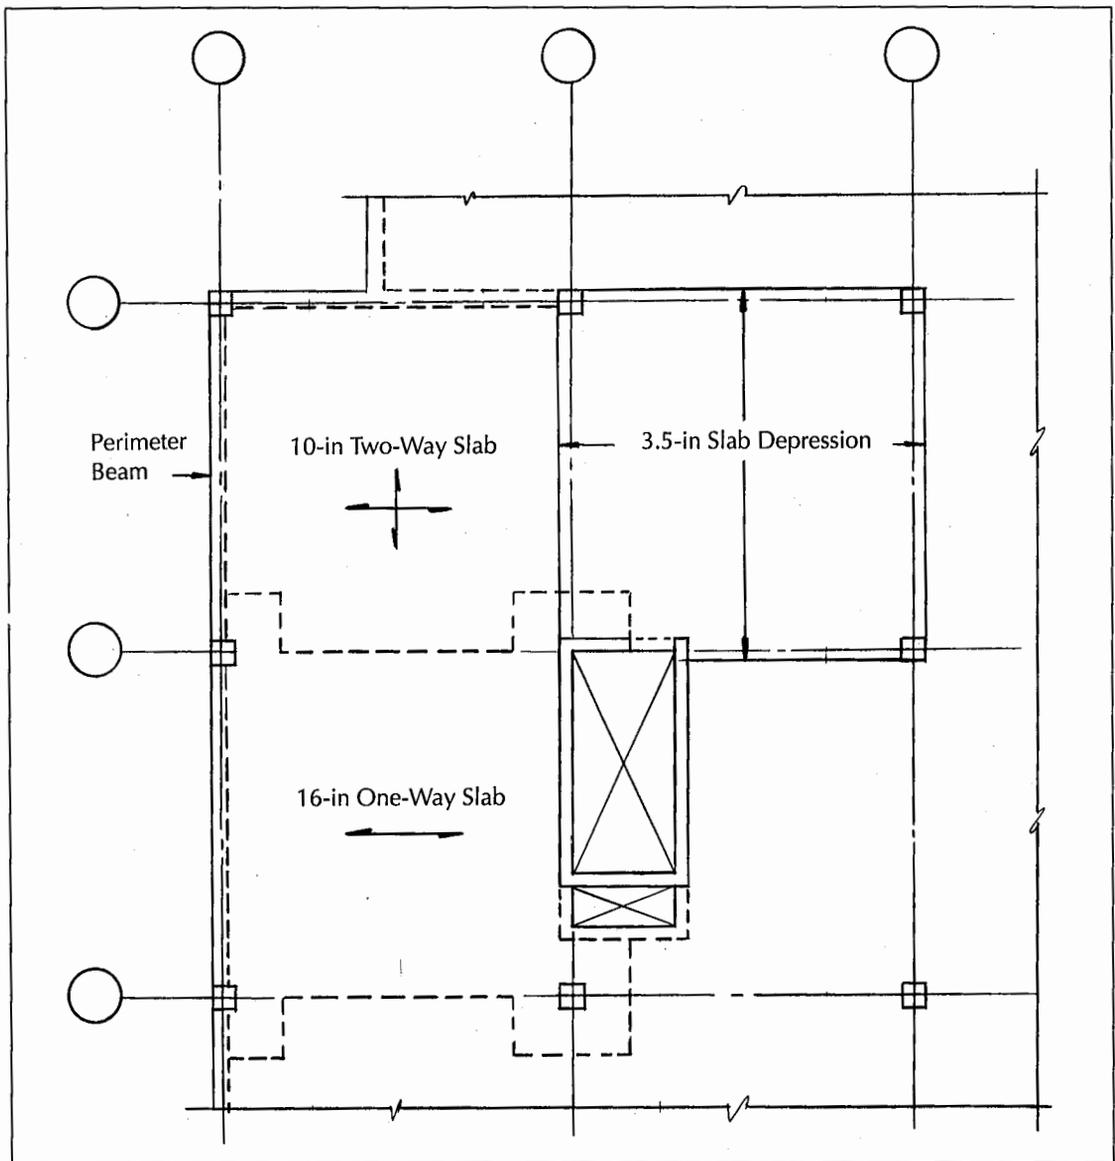
The typical floor framing consists of 10-inch thick two-way flat slabs with a dead weight of 125 pounds per square foot (psf) and 16-inch one-way slabs with a dead weight of 200 psf. There are 3.5-inch slab depressions in the 10-inch two-way slabs. The designer did not consider the additional weight of 75 psf for the 16-inch slabs or the additional 40 psf for finishes in the 3.5-inch slab depressions. The dead load was underestimated by 25 to 50 percent for the design of some columns. The dead load was

FIGURE 11. Typical floor plan for the hospital project.

underestimated by 25 percent for the design of the floor slab at the depressions (see Figure 11).

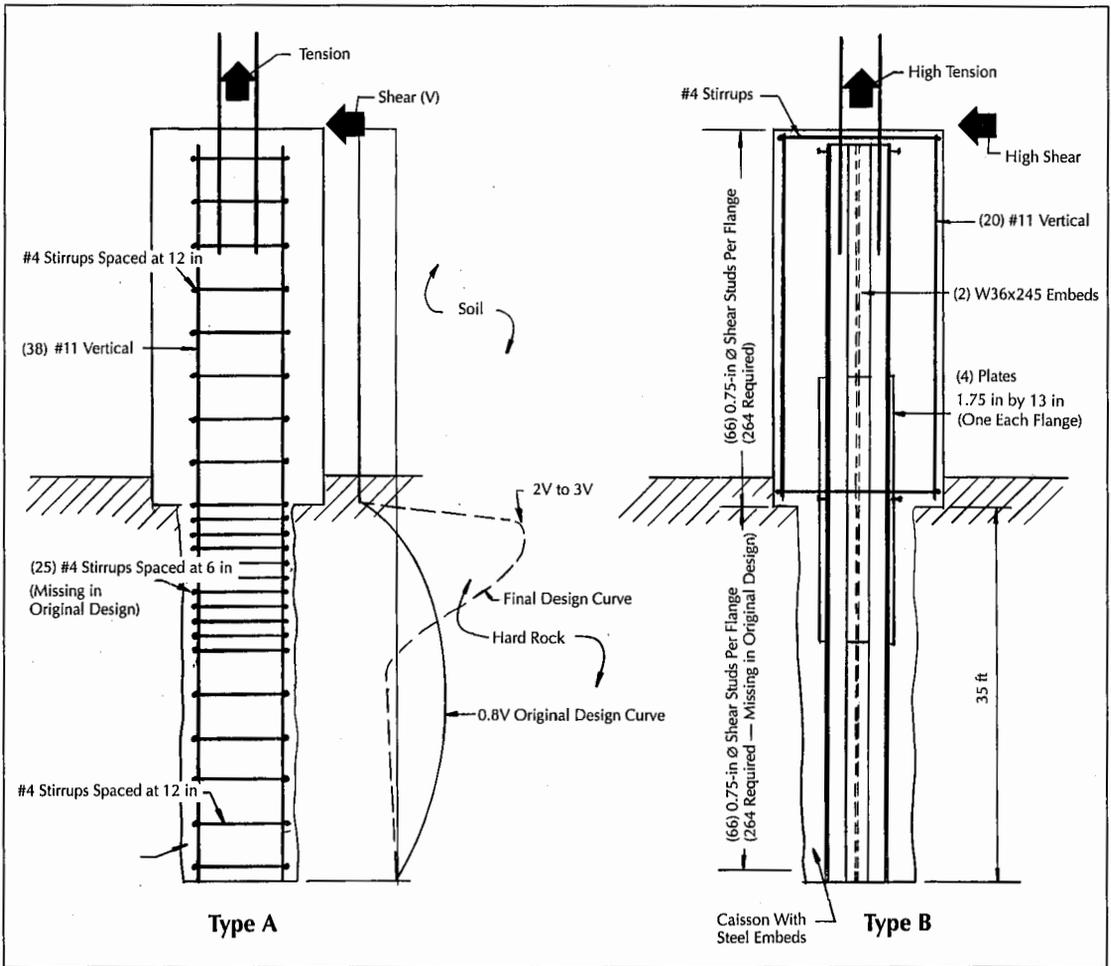
tension loads were missing in the lower half of the caissons (see Figure 12).

FIGURE 12. Caissons were redesigned to account for tension forces neglected in the original design.

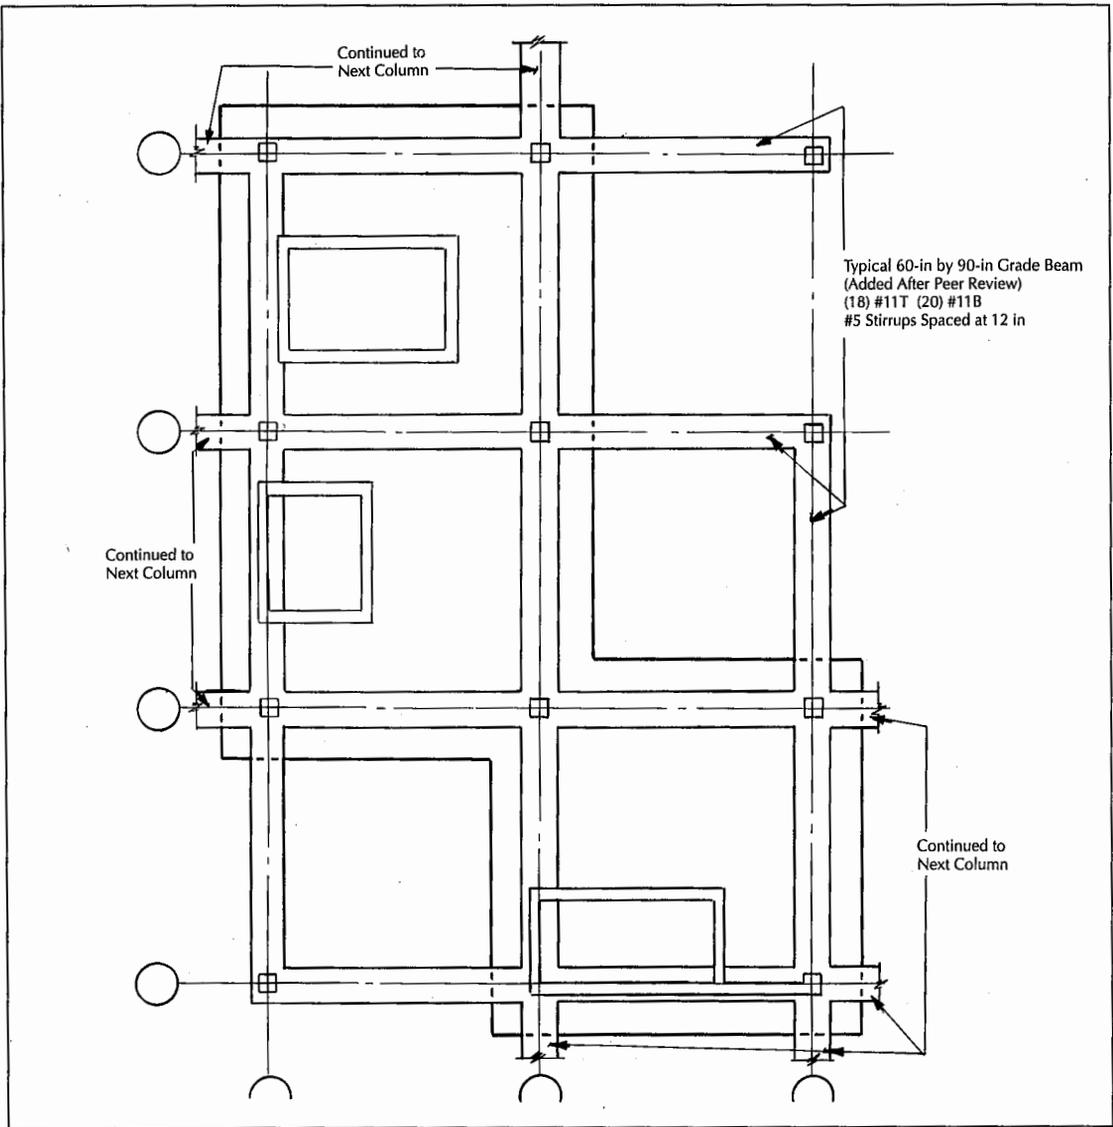
A large combined foundation mat was designed to resist the overturning imposed by three shear wall stair towers. The design analysis did not consider the unsymmetrical shape of the mat and significantly overestimated the overturning resistance of the mat. After the peer review the mat was redesigned to include 60- by 90-inch continuous grade beams spanning to adjacent columns to provide additional overturning resistance (see Figure 13).

FIGURE 13. Plan of the mat foundation for the hospital building.
