JOURNAL *of the*
BOSTON SOCIETY
OF
CIVIL ENGINEERS

JULY - 1957

**NORWEGIAN EXPERIENCE WITH STEEL PILE
FOUNDATIONS TO ROCK***

THE paper reviews 25 years of Norwegian experience in the use of steel piles for foundations. The condition of soft clay overlying a hard and often steeply inclined rock surface which is common in Norway creates a number of problems in the design and driving of point bearing piles to bedrock. Methods of pile driving which have been evolved to ensure a satisfactory sealing of the pile point into rock are described in detail.

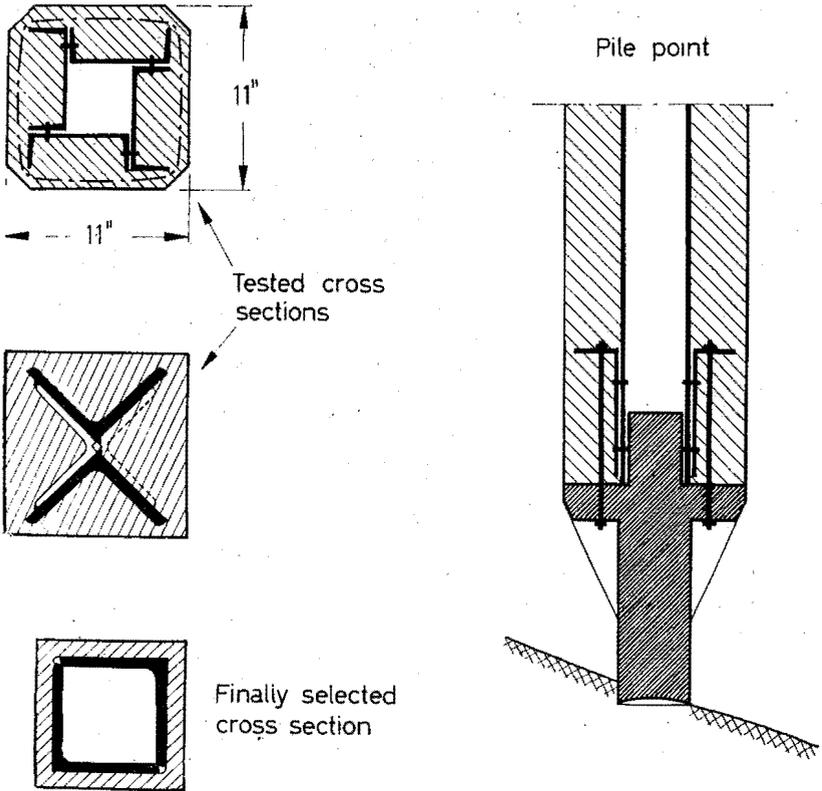
FIG. 1.—CROSS SECTIONS OF STEEL PILES AND PILE POINT USED FOR FOLKETEATERET OSLO 1931. (FOLKESTAD 1934).

The cross sections of the steel piles which were used for the first buildings in Oslo are shown in Fig. 1. The final design was a pile made by welding two angles together to form a box section which was covered by a layer of mortar in order to prevent corrosion. Since it proved difficult to keep the mortar intact during the driving of the piles, the use of unprotected piles was suggested. In this connection the building authority of Oslo made an investigation of the corrosion of some old steel piles, and they came to the conclusion that unprotected piles could be used in clay if the clay showed a basic reaction, expressed by the criterion that the pH be higher than 7.

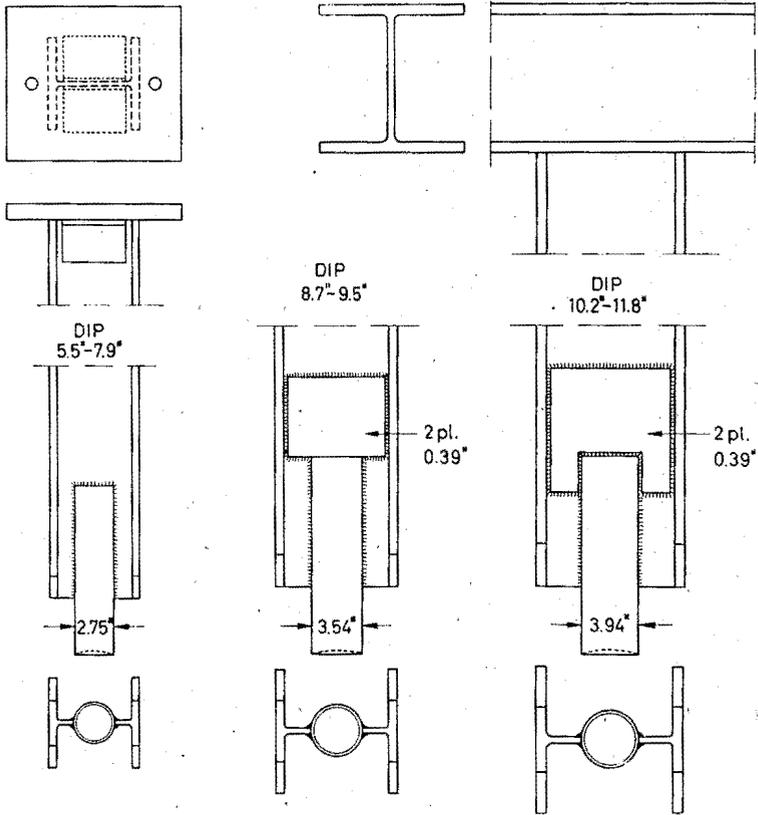
FIG. 2.—H-SECTION STEEL PILES WITH POINTS AND CAPS AS REQUIRED BY THE BUILDING AUTHORITY OF OSLO.

Since then only unprotected steel piles have been used, and the H-sections have found an extensive application. Fig. 2 shows the most commonly used sizes and gives the specification of pile caps as required by the authorities of Oslo.

DIP is the notation of a wide-flanged H-beam in the Deutsche Industrie-Normen (DIN 1025).

driven in Norway and Sweden since 1931. The first points used for the box piles were made of cast iron. For the H-piles the points are made of tempered steel bars of 3 or 4 inches diameter. A slice is cut into the web of the H-section and the bar is welded to the sec-

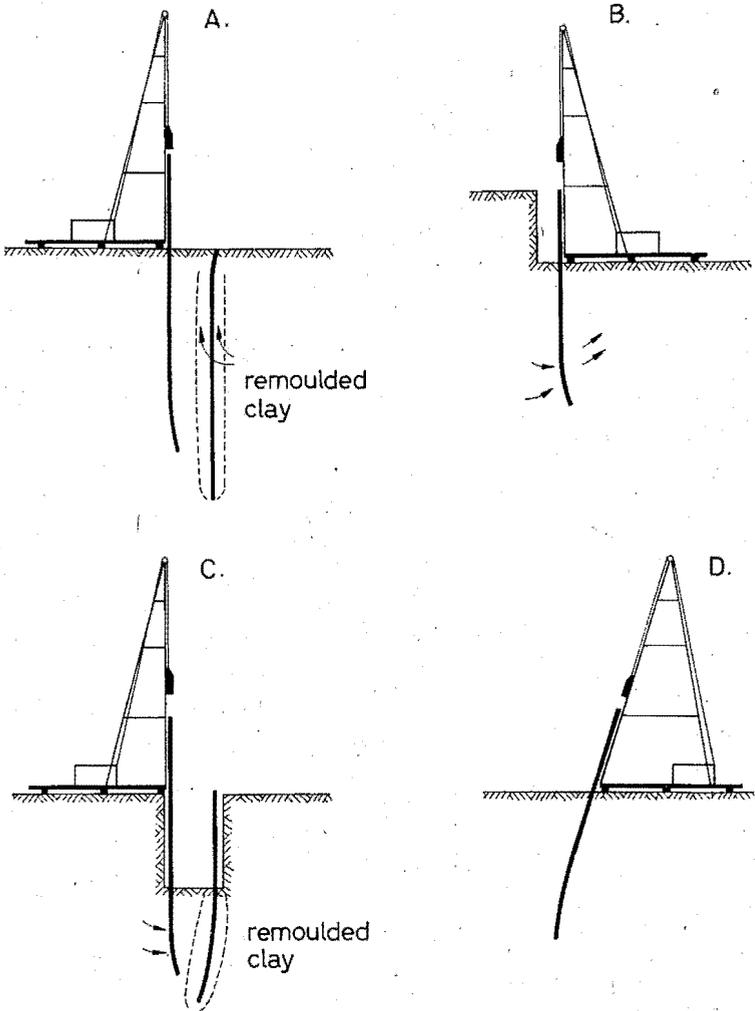
FIG. 5.—FACTORS WHICH CAUSE MISALIGNMENTS OF PILES DRIVEN INTO SOFT CLAY.

- A. The pile will have a tendency to bend in the direction of newly driven neighbouring piles around which the shear strength of the clay is previously reduced.
- B. Along the walls of an excavation the displacement will mainly take place in direction of the excavation and the pile will tend to bend away from the wall.
- C. In trenches and shafts the displaced clay will primarily be squeezed up in the bottom of the excavation and the piles will consequently have a tendency of a curvature against the centerline of the excavation.
- D. Due to their weight batter piles will tend to bend in a downwards direction.

stitute has studied the driving of slender piles and determined those factors which may contribute to misalignments of the piles. Some of these factors are illustrated in Fig. 5.

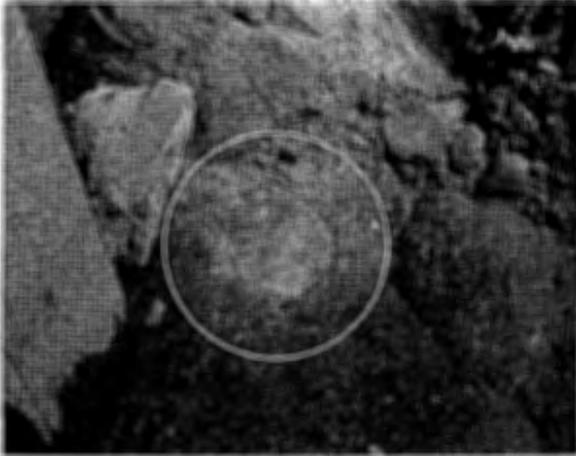
FIG. 7.—PHOTOGRAPH OF THE ROCK BELOW POINT NO. 1 IN FIG. 6. The circle indicates the depression caused by the pile point.

Fig. 7 shows a photograph of the rock below pile No. 1, after the excavation. It illustrates how the point has chiseled a depression in the rock with a concave circular form which gives a direct impression of a satisfactory bearing of the pile. Fig. 8 shows pile No. 1 after the excavation and it can be seen that the point is intact in spite of the

fact that the pile was subjected to 800 blows and that the rock was extremely hard.

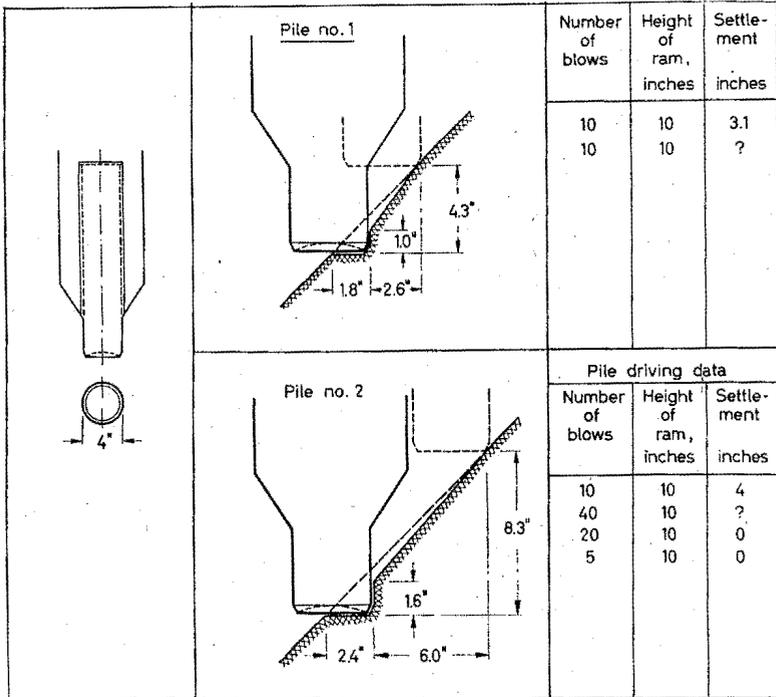
FIG. 9.—TEST DRIVING OF PILES TO HARD ROCK WITH 45° INCLINATION (PETTERSON 1941).

in Fig. 9. In this case the rock was a very hard granite with a smooth surface.

As can be seen from the figure the piles did not bite into the rock immediately after contact. They slid along the surface 4-8 inches before they stopped. With our present experiences this sliding is explained by the relatively large drops of the ram which were used. It

was possible, however, for both piles to establish a toe for the points. In the author's opinion the pile driving was stopped too early. With a sufficient number of blows it would have been possible to continue the chiseling procedure until the total area came into contact with the rock. It is, thus, interesting that pile No. 2, which had the best contact with rock, also is the pile which received the greatest number of blows.

In the described tests the inclination of the pile to the rock surface was 65° - 70° . Some similar tests have, however, been carried out in Gothenburg (Petterson 1941) in which the inclination was 45° . The results of the excavation of the piles after the driving are given

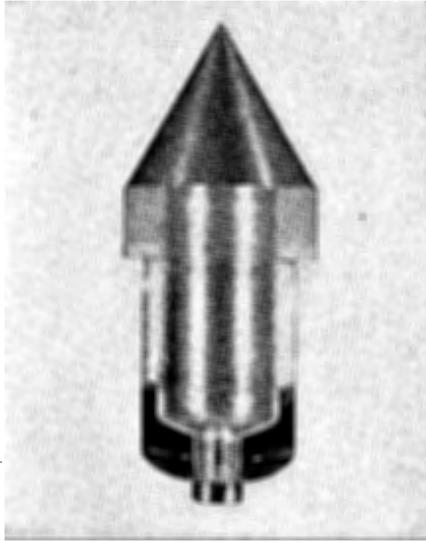
FIG. 11.—PHOTOGRAPH OF THE CORROSION POINT FOR IN SITU MEASUREMENTS OF CONDUCTIVITY AND DEPOLARIZATION OF SOIL.

In order to obtain reliable measurements of the factors controlling corrosion, Dr. I. Th. Rosenqvist at the Norwegian Geotechnical Institute has constructed a sounding device with which the depolarization and the resistivity are measured directly "in situ". The corrosion penetration-device consists of a $1\frac{1}{4}$ " steel tube supplied with a magnesium point insulated from the tube as shown in Fig. 11. The sounding device is driven into the clay and at various depths two types of measurements are made.

The next step is to measure the galvanic current passing from the tube to the magnesium point when they are short circuited. This current indicates how fast the negative electrons are removed from the

surface of the steel tube, and it will, therefore, give an expression for the cathodic depolarization of the clay. If the measured current of the short circuited system is multiplied by its electric resistivity, the "electromotive force" is obtained. Preferably this is expressed by the degree of depolarization, obtained by dividing it by the maximum value, for instance measured in salt water saturated with oxygen.

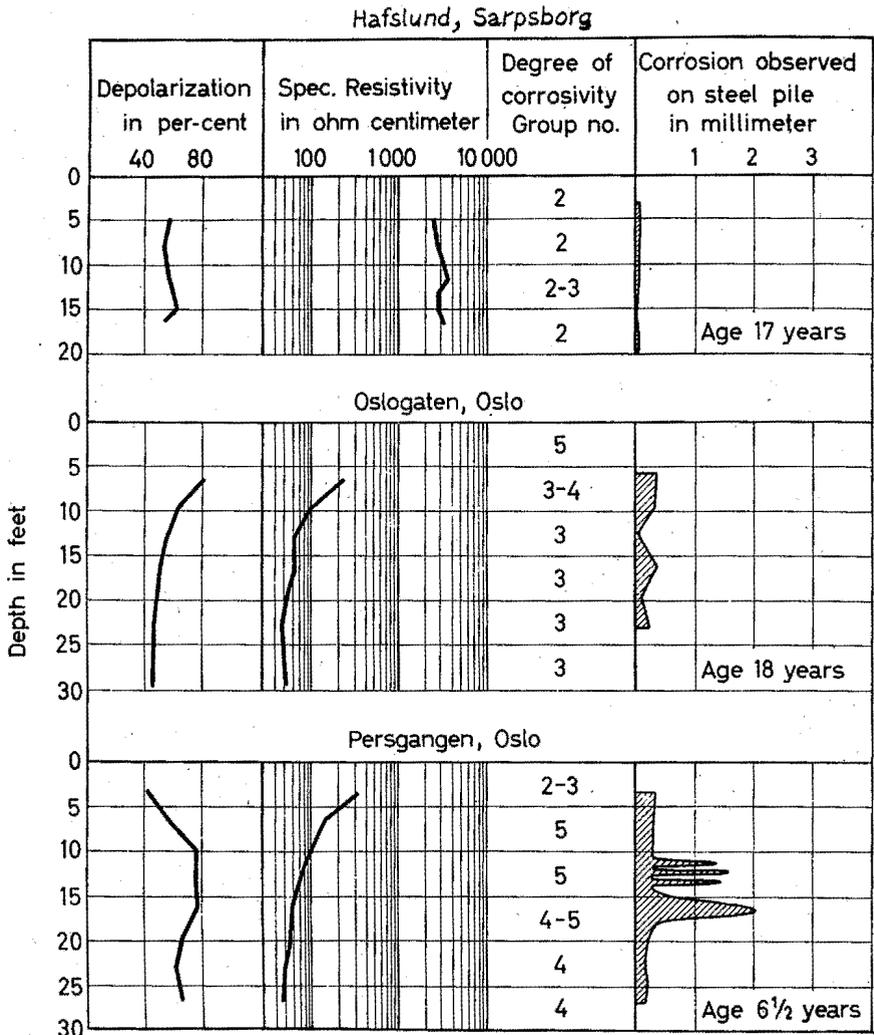
FIG. 12.—EXAMPLES ON RESULTS OF IN SITU MEASUREMENTS WITH THE CORROSION POINT AT THREE DIFFERENT SITES, WHERE ACTUAL CORROSION WAS OBSERVED ON STEEL PILES.

Fig. 12 shows three examples of measurements of the corrosivity from three different sites in Norway. In each profile the measured

The example from Hafslund in Sarpborg is a silty clay with an intermediate degree of depolarization and a relatively high resistivity. According to the values obtained by the corrosion test the clay is classified as having a low corrosivity. This is confirmed by observations from a pulled steel pile which was driven 17 years before the inspection. The steel pile showed an attack smaller than 3/1000 of

depolarization is, however, low to intermediate with a marked increase in the upper crust. In spite of the low resistivity the clay shows an intermediate corrosivity and this was also confirmed from an 18-year-old steel pile which was pulled for inspection. The corrosion varied from 1/100 to 2/100 of an inch, this means 1/2000 of an inch per year.

The third example in Fig. 12, Persgangen, is also a clay from Oslo with the typical low resistivity of the marine clays. In this case, however, the depolarization was as high as 77 per cent. The conditions are very unfavorable in this profile and a 6½-year-old steel pile which was pulled, showed serious corrosion up to 1/10 of an inch. This corresponds to an average corrosion of more than 1/100 of an inch per year.

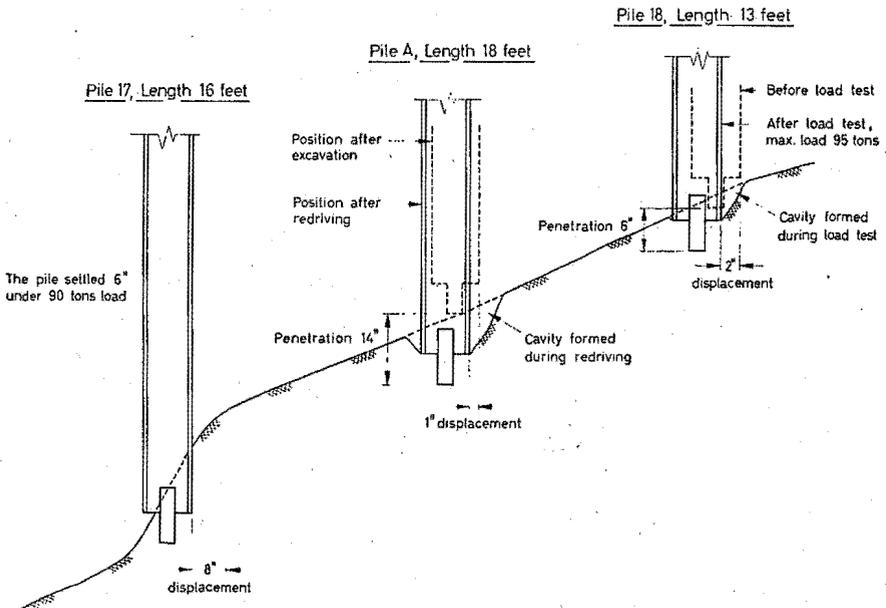
FIG. 15.—STEEL PILES IN SLEMMESTAD EXCAVATED AFTER THE DRIVING (BERNTSEN 1955).

which had a length of only 15 to 20 feet. The result of the inspection of the piles is shown in Fig. 15. It proved that even if the points had slid on the rock surface, they finally obtained a hold in the rock and a bearing was established after 2-4 inches of penetration into the rock. During the loading test of pile number 18, the point of the pile penetrated 6 inches further into the rock, squeezing the rock so that a crater was formed around the point.

Pile number 17 was test loaded after the excavation in order to observe what happened with the piles during a loading test. At 40 tons load the pile started to settle and the point was directly observed to penetrate into the rock. As the point came deeper below the rock surface, a greater load was required to bring the point to failure, and after 6 inches settlement the bearing capacity had increased from 40 tons to 90 tons. The explanation of the small failure loads of the

piles was, thus, that the bearing capacity of the alum shale was exceeded. The 30-40 tons failure loads of the piles correspond to a unit pressure at the rock of 4000-7000 lb/in². This value represents, thus, the bearing capacity for a circular point at a depth of one to two inches. At a depth of 6-8 inches, the bearing capacity increased to double the value.

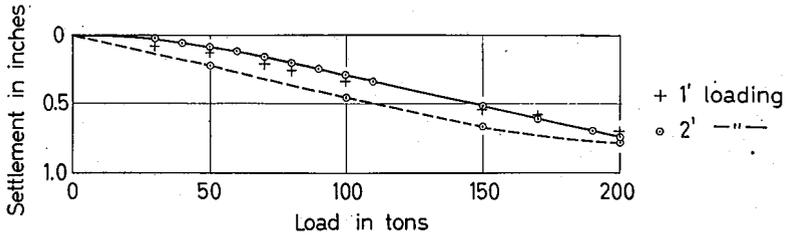
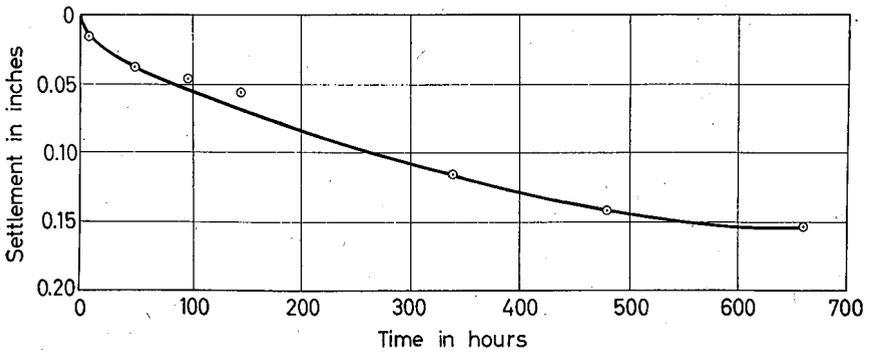
FIG. 16.—LOADING TEST ON A 85 FOOT LONG STEEL PILE TO ROCK AT THE BRIDGE AT FREDRIKSTAD.

Pile number 25 was loaded with 200 tons—which is two times the design load—for a period of a month. The results of the settlement observations are shown at Fig. 16, and, as seen from the figure, the immediate settlement under the 200 tons loading was approxi-

mately $\frac{3}{4}$ inches and the additional settlement during the one month loading amounted to only 0.2 inches. The permanent set of the pile after removing the load was negligible. The total maximum settlement after one month's loading is approximately equal to the elastic compression of the pile, which must be considered as a very satisfactory result.

Pile number 26, which was only loaded over a period of three days, showed similar properties, but the permanent set was 0.2 inches. The straightness of the pile was investigated before and after the test and whereas the pile was straight before the loading test, it showed a slight curvature after the testing.
