CIVIL ENGINEERING PRACTICE •

JOURNAL OF THE BOSTON SOCIETY
OF CIVIL ENGINEERS SECTION / ASCE

SUMMER 2021

VOLUME 29, NUMBER 1

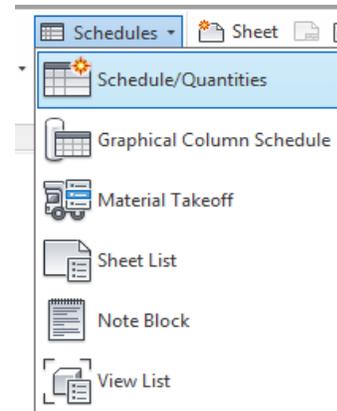
Figure 6. The Schedule/Quantities Revit tool used for computing the QTO structural elements' materials

Schedule/Quantities.

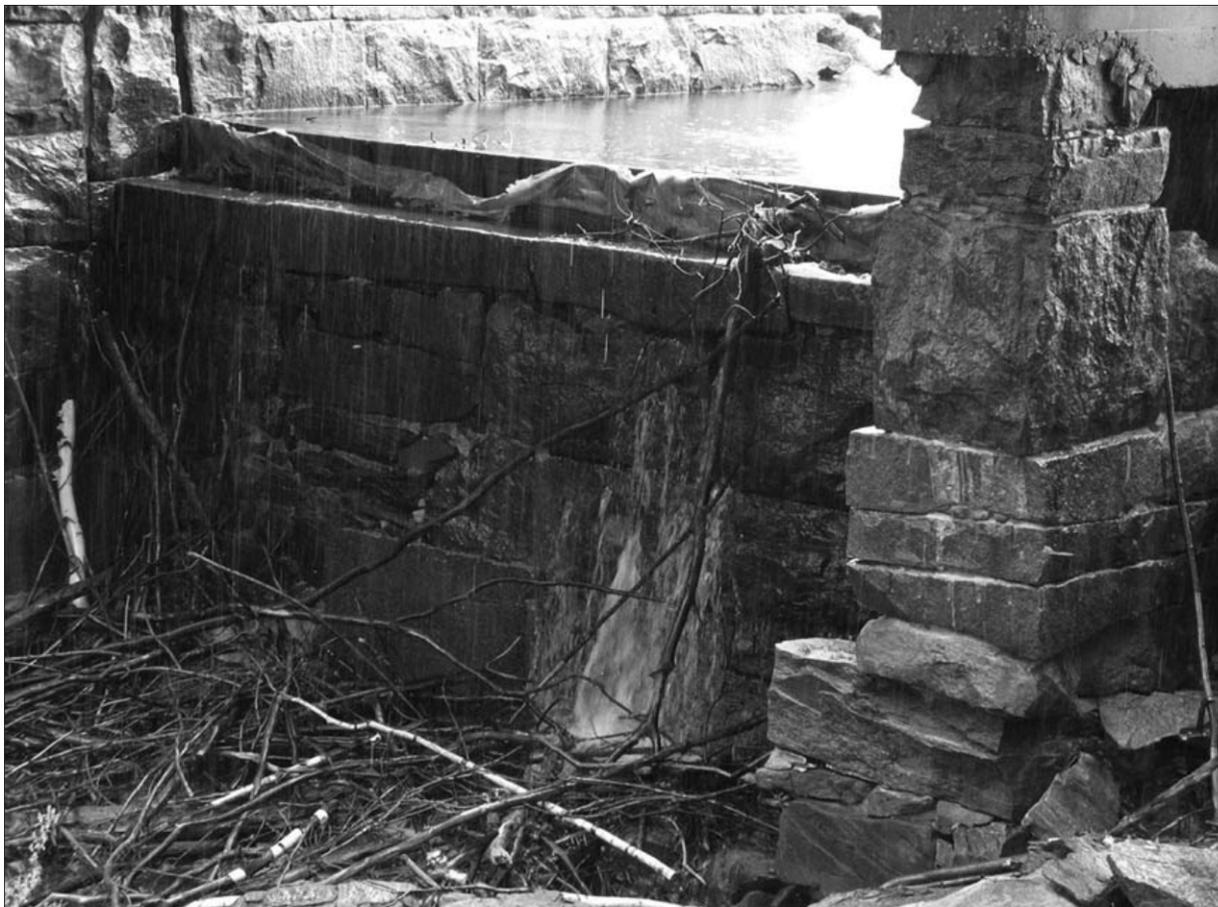
Figure 2. View of the deteriorated and leaking conditions at the spillway prior to rehabilitation.

- The deteriorated masonry and leakage conditions at the spillway (see Figure 2) and the downstream masonry wall; and,
- The erodibility of the "emergency spillway" over the main embankment section of the dam.

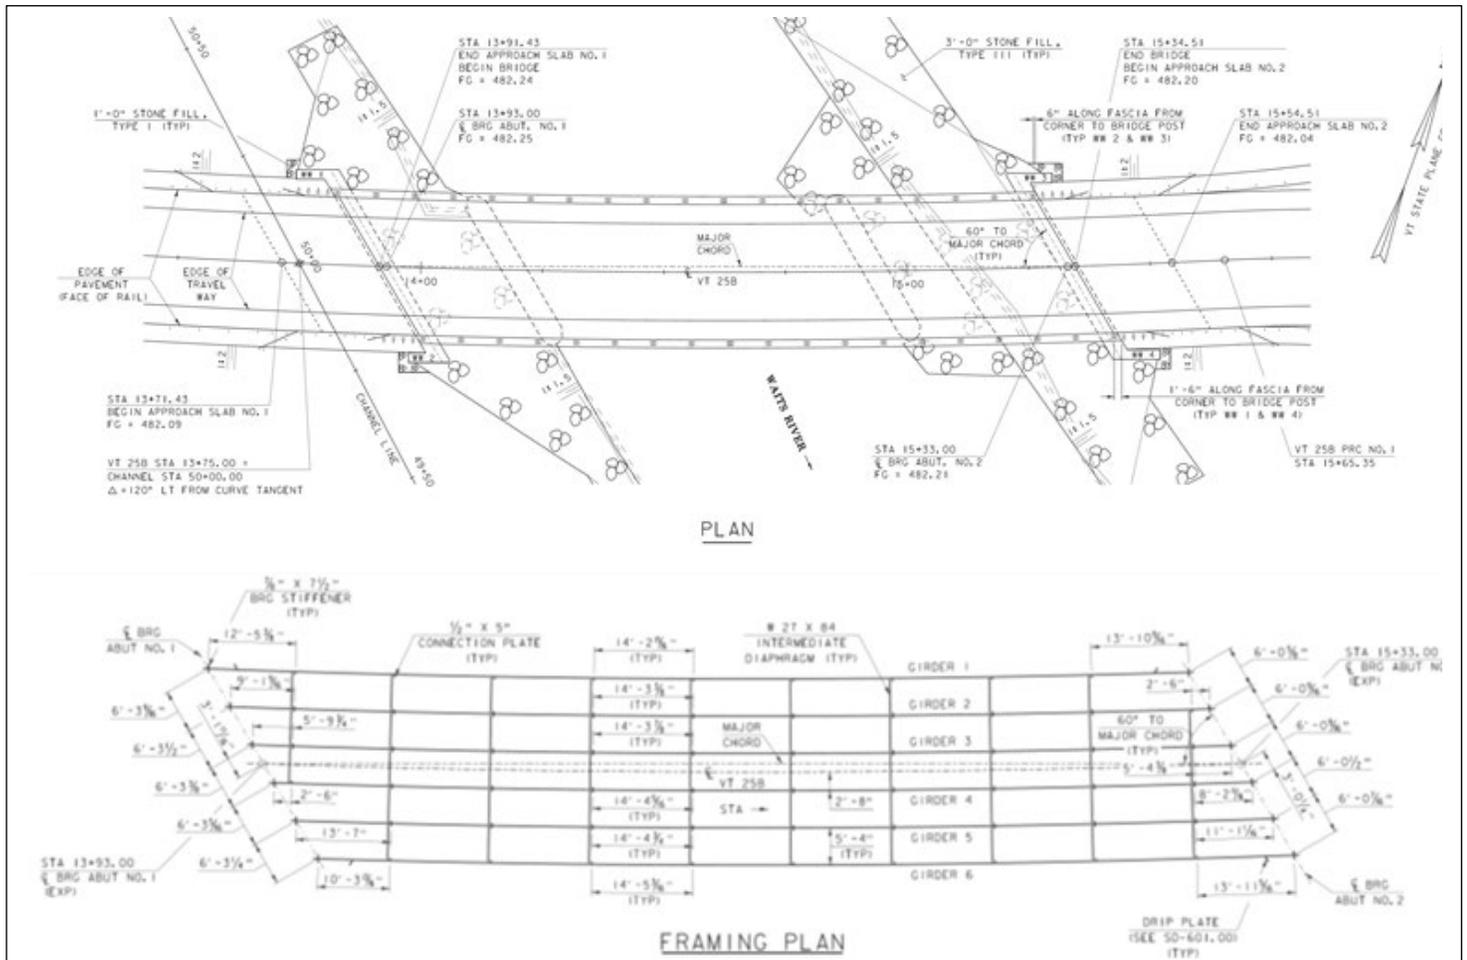
Figure 4. Plan Views of Bradford Bridge (VTrans - Used by Permission)

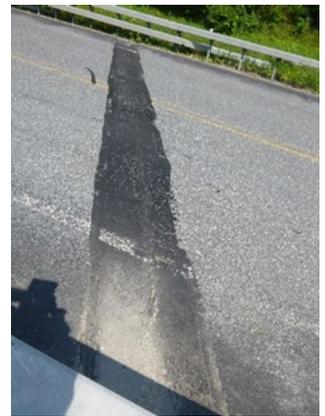
Figure 8. Deteriorating Asphalt Plug Joint at Skewed Bradford Bridge

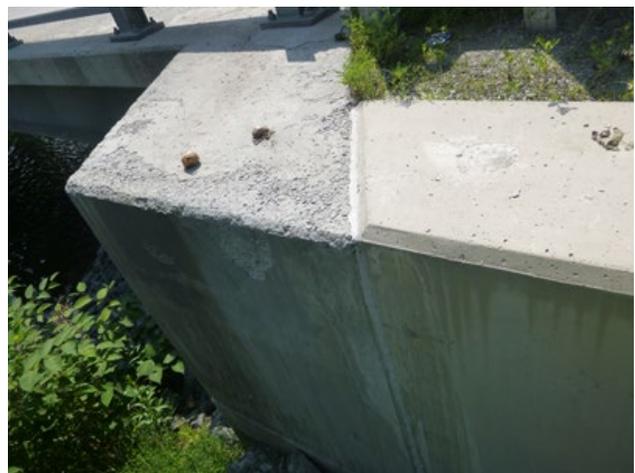
Figure 9. Scaling at Top of Abutment at Bradford Bridge (2021)

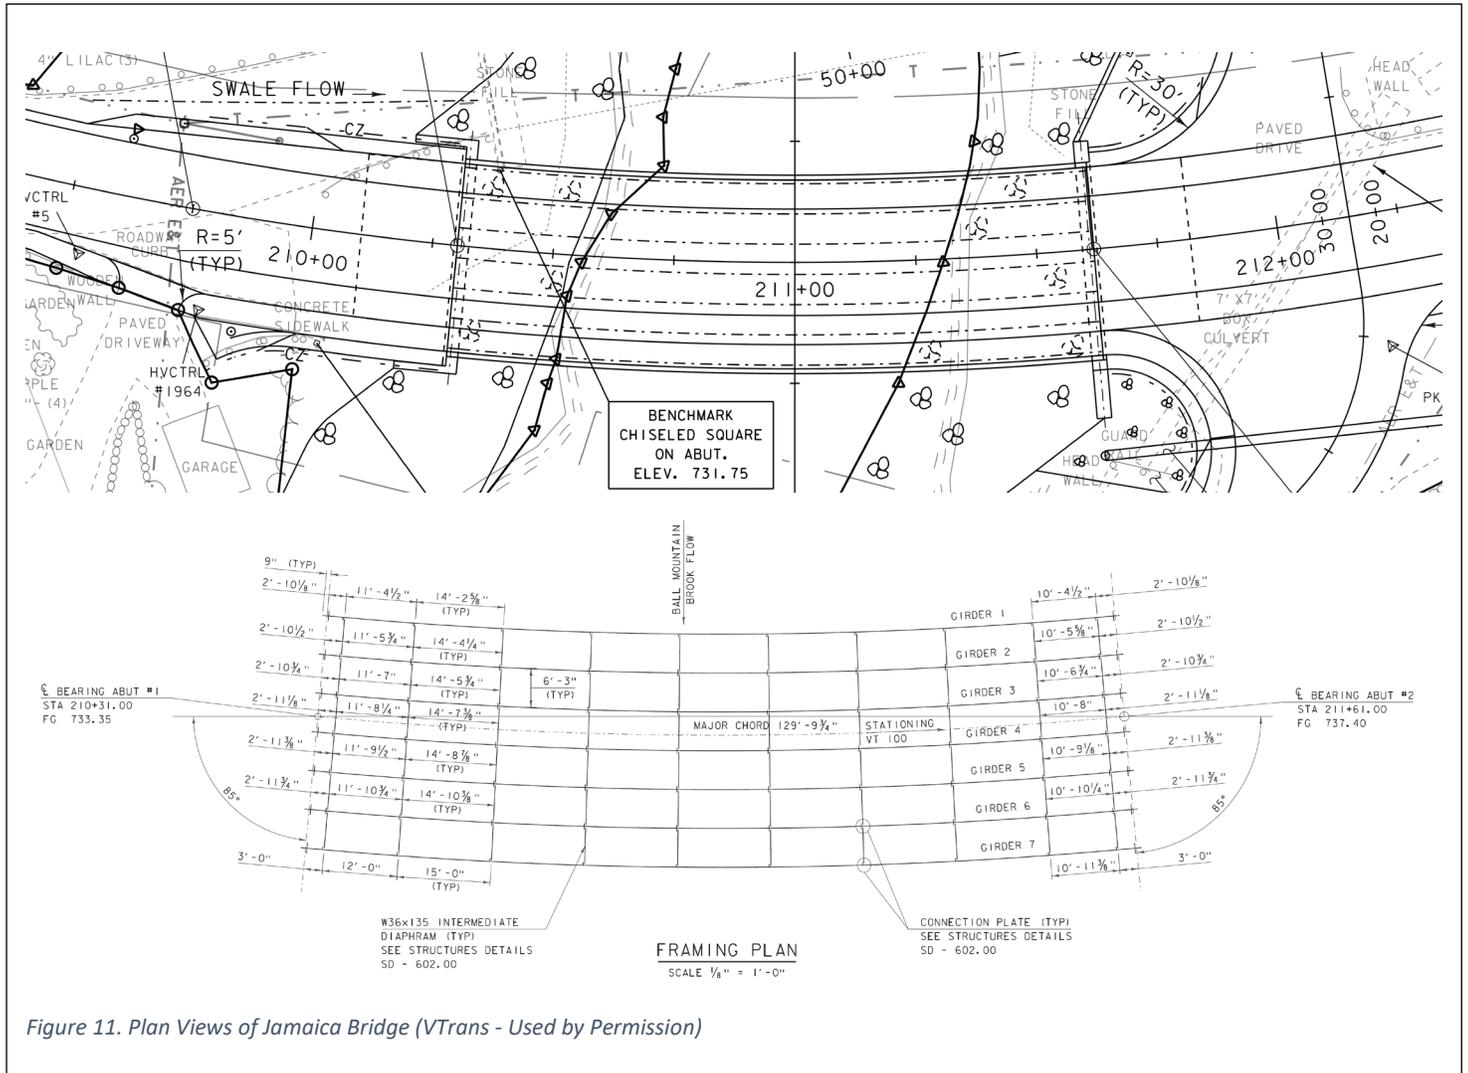
Figure 11. Plan Views of Jamaica Bridge (VTrans - Used by Permission)

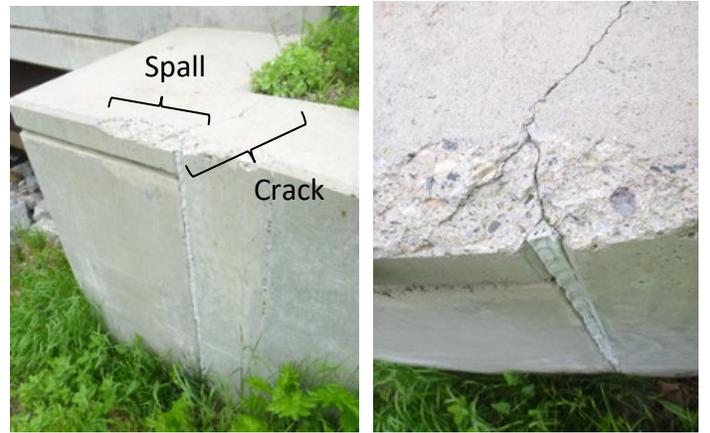
a) Integral Connection

b) Dowelled Connection at Jamaica Bridge

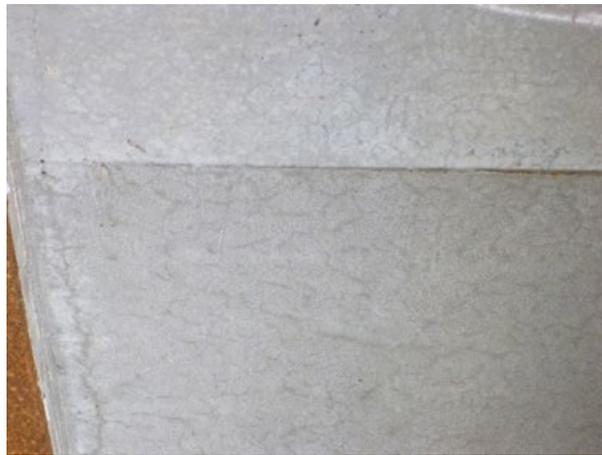
Figure 13. Underside of Deck at Jamaica Bridge

the dry conditions. It was noted that the cracks in the underside of the deck were far less noticeable in the dry conditions.

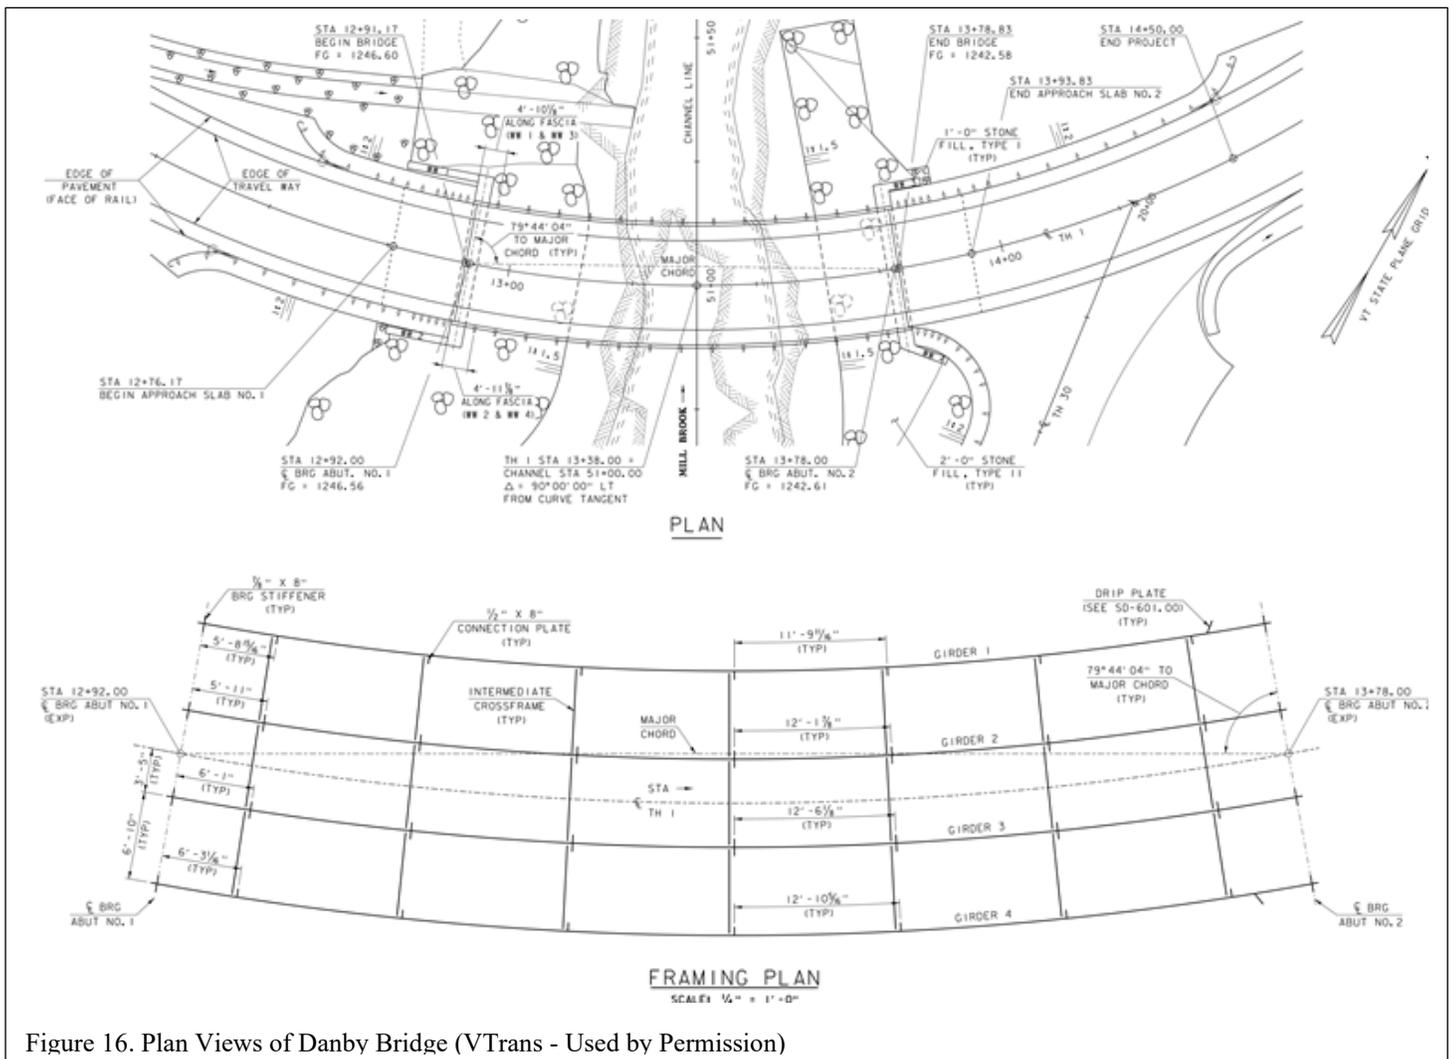
Figure 16. Plan Views of Danby Bridge (VTrans - Used by Permission)

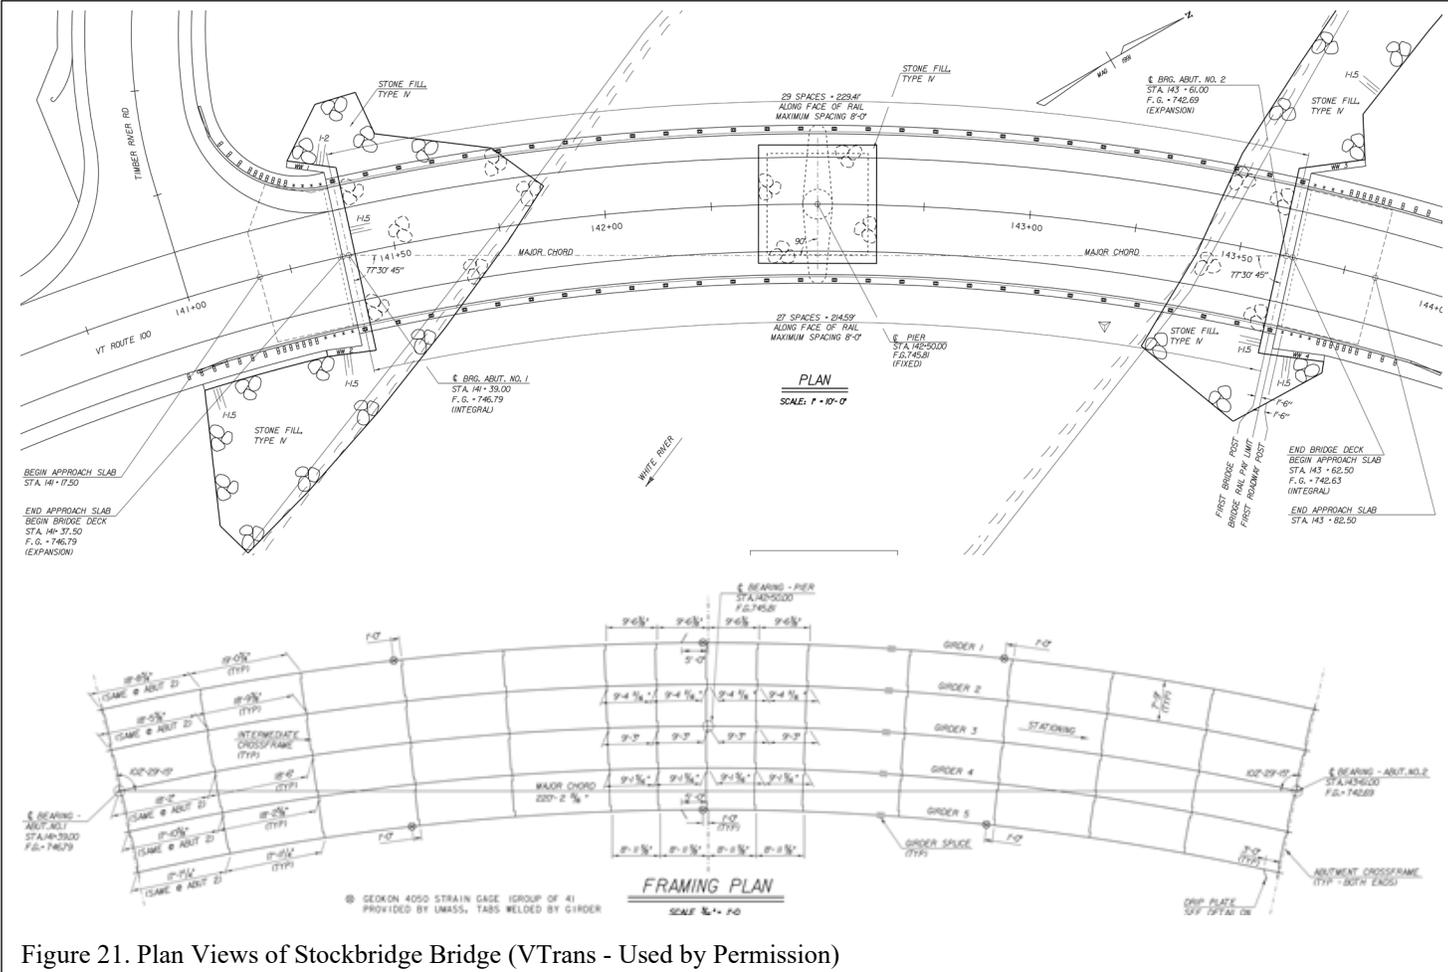
Figure 21. Plan Views of Stockbridge Bridge (VTrans - Used by Permission)

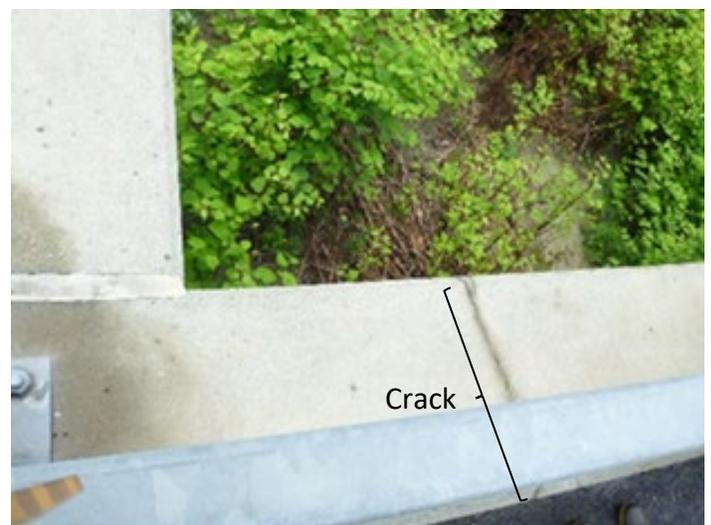
Figure 23. Barrier Crack at Stockbridge Bridge

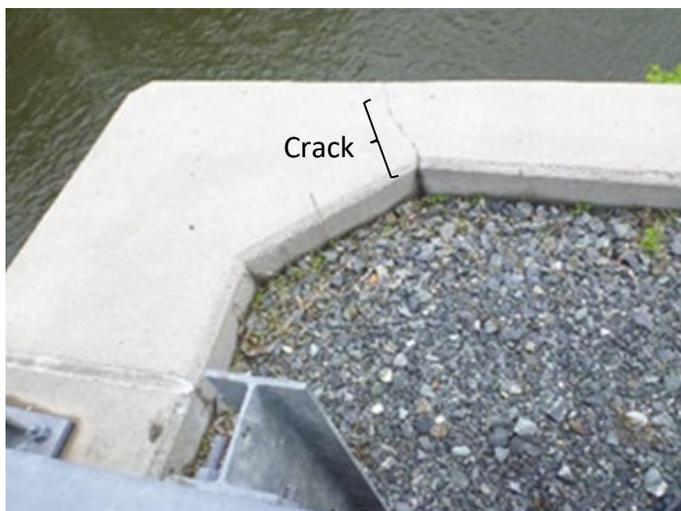
Figure 25. Abutment to Wingwall Connection Crack at Stockbridge Bridge
