A Geotechnical Analysis of the Behavior of the Vaiont Slide

In determining the safety of proposed reservoir slopes, engineers and geologists must have a thorough understanding of the causes of the Vaiont Slide.

A.J. HENDRON, JR., & F.D. PATTON

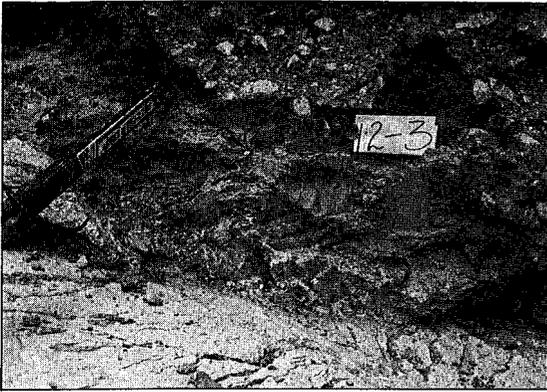
FIGURE 10. A clay layer 5 to 20 cm thick along the failure surface at location 12-3, near the east side of the slide.

Where the surface of sliding is overlain by slide debris, the clays were generally found preserved (for example, see Figures 10, 11 and 12). However, where the failure plane has been exposed, the clays are rapidly eroded by rainfall and by debris flows from the large catchment surfaces (see Figures 13 and 14). Small folds and faulted monoclinial (cascade) structures, which are present in many areas of the slide but are not visible at a

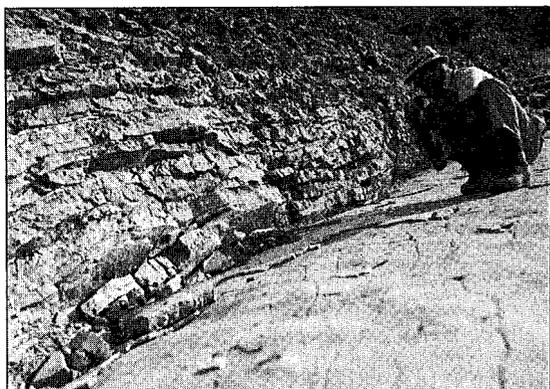
FIGURE 11. A view of the failure surface below the headscarp at location 18-9, about at the western third point of the slide.

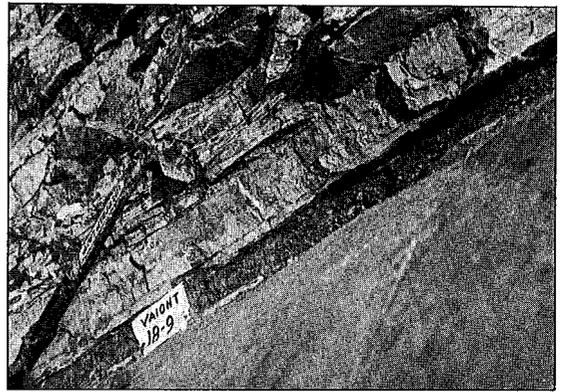
FIGURE 12. Clay interbed 5 cm thick along the failure surface at location 18-9. Other thin clay interbeds up to 0.5 cm thick lie in the rock mass.

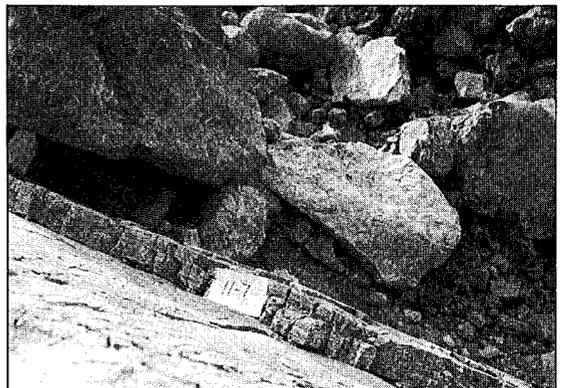
FIGURE 13. Slide debris overlies the failure surface where a clay layer 4 to 6 cm thick has been eroded from beneath the debris at location 11-7, the lower portion of the fourth gully from the west side of the slide.

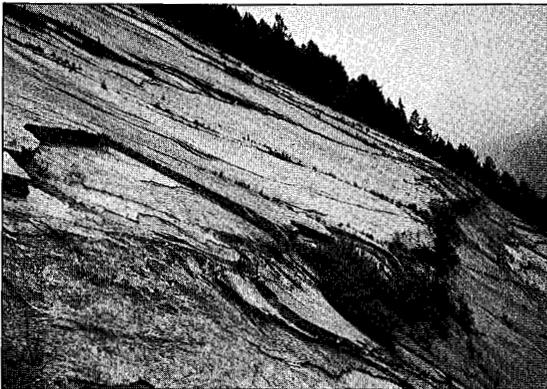
FIGURE 15. A monocline located in the middle of the western rock face. The surface, exposed after the October 1963 slide, is associated with a clay interbed 0.2 to 1 cm thick.

distance (Figure 15), have served to protect and preserve small portions of the clay interbeds that are strategically continuous with large adjacent areas of the 1963 sliding surface (for example, see Figure 16).

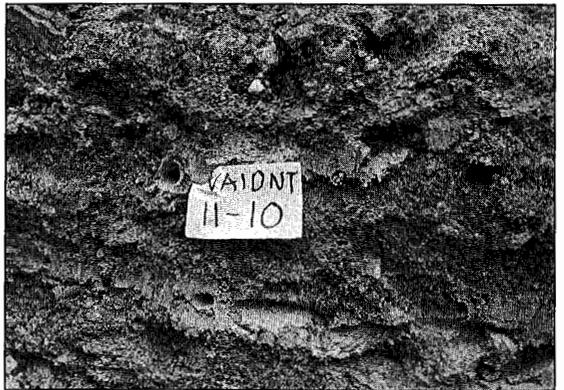
FIGURE 17. Five clay layers 1 to 2 cm thick within the lower 1.5 m of slide debris at location 11-10, the fourth gully from the west side of the slide. The failure surface appears in the lower left corner.

debris exposed along the base of the rock outcrops on the west side of the slide consists of an uncemented angular gravel and sand-sized breccia with frequent layers of clay and breccia with a clay matrix (for example, see Figure 17). The clay layers in this breccia fre-

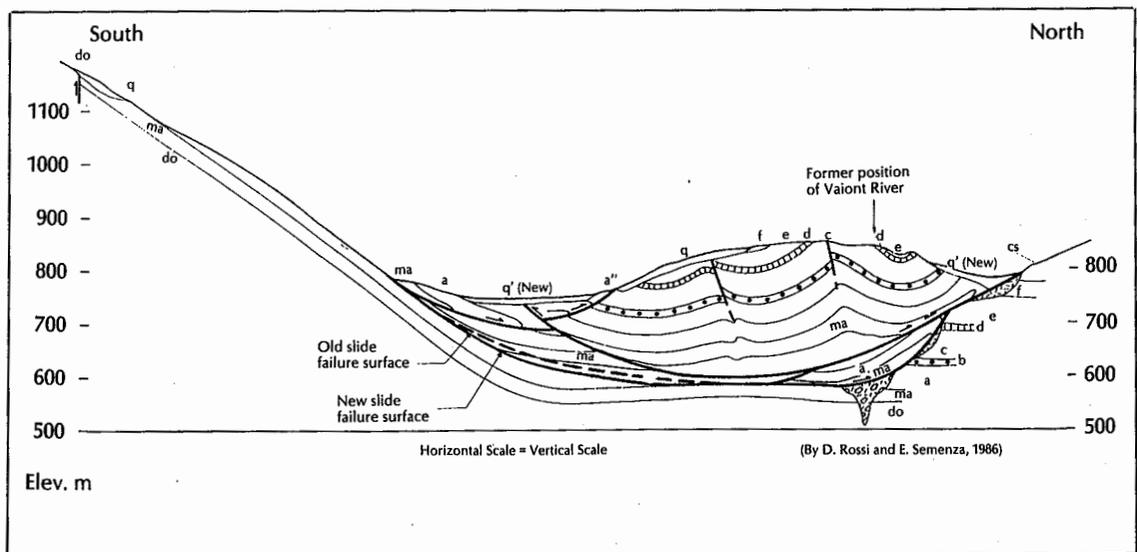
FIGURE 23. Geologic Section 5 after October 9, 1963.

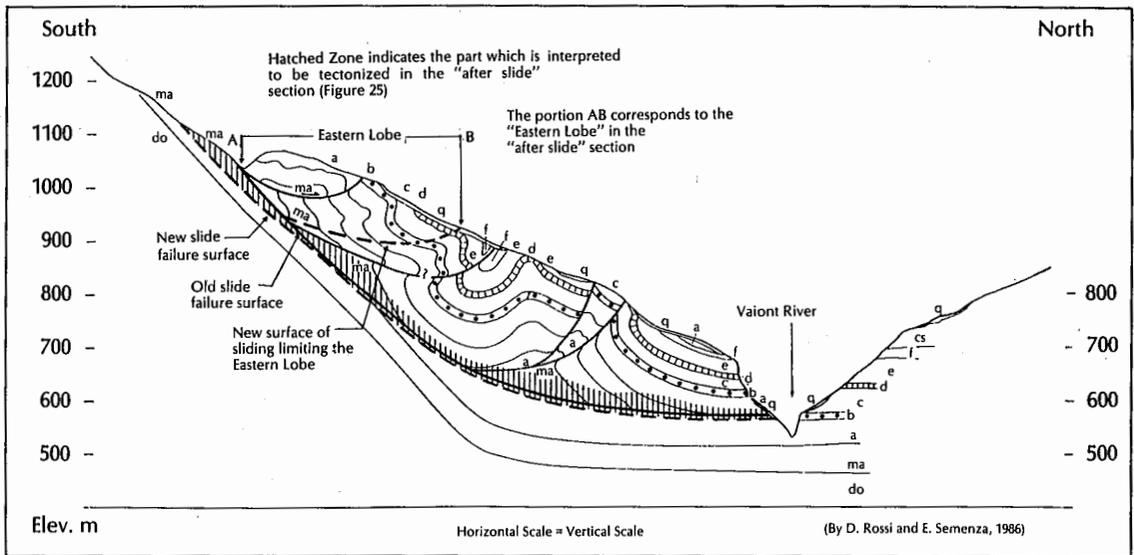
FIGURE 24. Geologic Section 10A before October 9, 1963.

upper part of the slide the Eastern Lobe in Figures 24 and 25, and show it in the area A-B before the slide. Post-slide surface depositional features suggest that the Eastern Lobe did not start its movement until after the main slide mass had completed most of its movement. The two slide movements appear to be essentially independent and the Eastern Lobe appears to have followed the movement of the main slide and formed the slide material shown in the area A-B on Figure 25. Rossi and

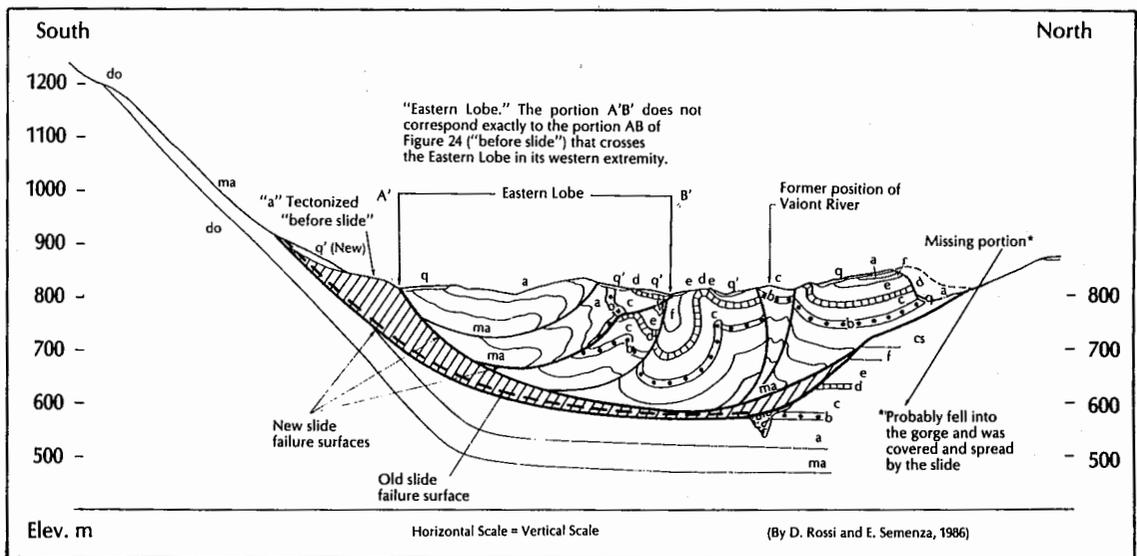
FIGURE 25. Geologic Section 10A after October 9, 1963.

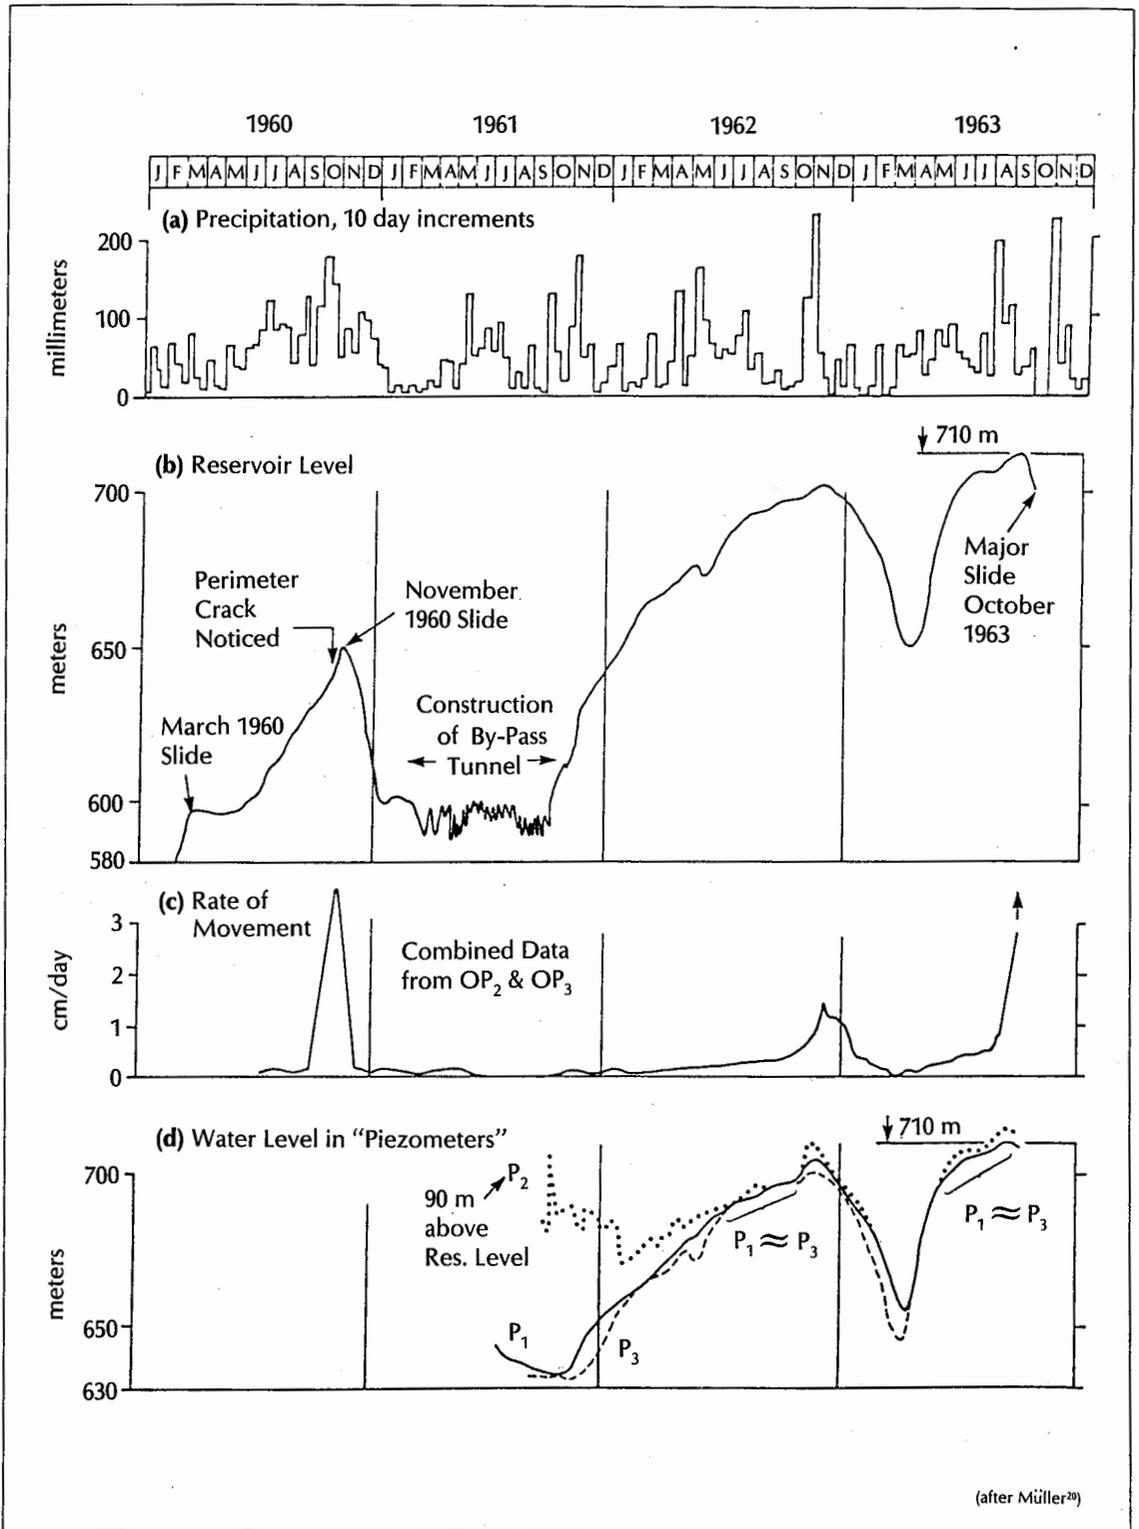
FIGURE 36. A comparison of the water levels, slide movements and precipitation from 1960 to 1963.

The second filling of the reservoir began in October 1961, and near the end of January 1962 the reservoir elevation was again at 650 m. As Figure 36 indicates, the rate of movement corresponding to the second filling to el. 650 m was negligible and the velocity was less than 0.1 cm/day. This behavior was in sharp contrast to the 3.5 cm/day velocity observed when the reservoir was just below el. 650 m during the first filling. Even as the reservoir approached el. 700 m at the beginning of November 1962, the velocity was only about 0.2 to 0.3 cm/day. The rate of movement increased abruptly to about 1.2 cm/day at the end of November 1962, although the reservoir remained nearly constant at the 700 m elevation. This increased movement followed a period of record precipitation for the four-year period shown on Figure 36. The reservoir was lowered to 650 m by the end of March

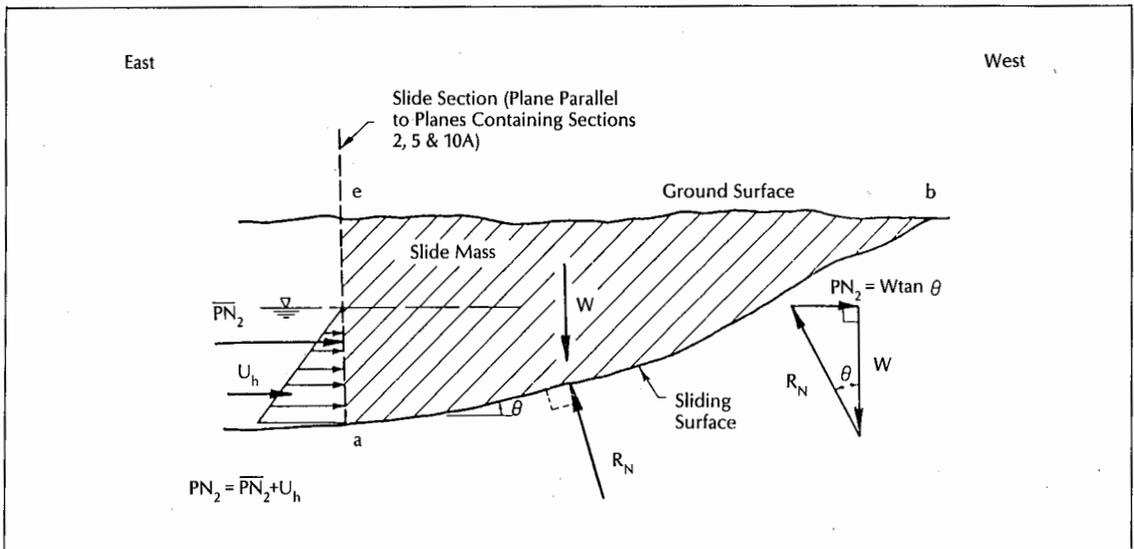
FIGURE 41. Representation of the normal forces on a slide cross section developed by the upstream dip of the sliding surface.
