The Restoration & Treatment of Burlington's Groundwater Supply

Meeting and safeguarding a town's water needs posed challenges due to contamination and restrictions on the available land resources.

PAUL C. MILLETT

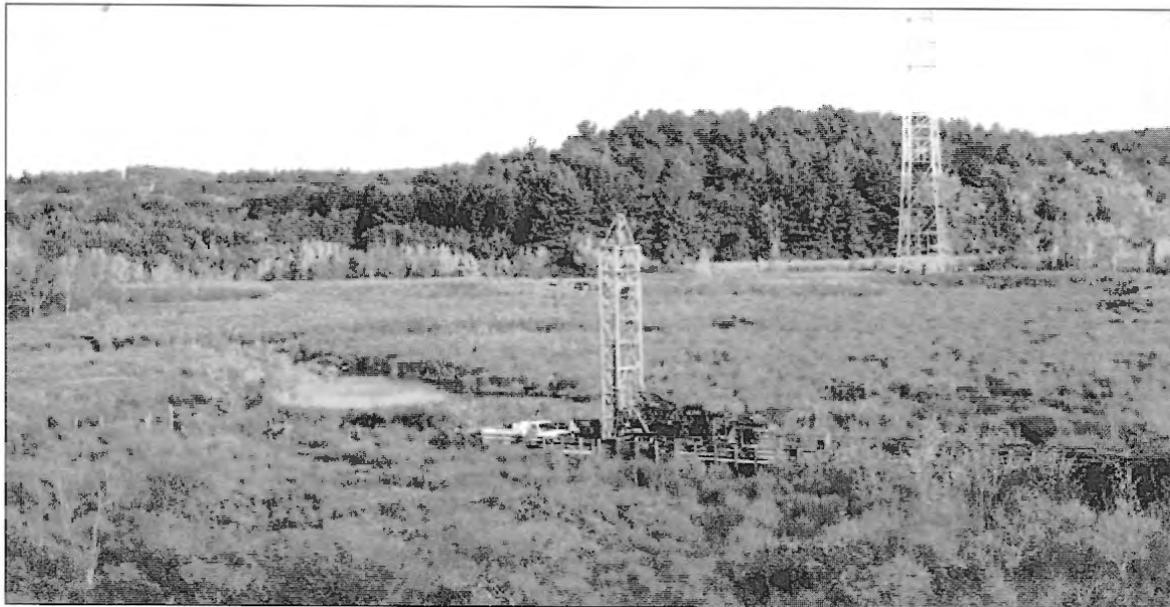
FIGURE 3. Well No. 10 construction.

In May 1997, work commenced on Well 10 construction (see Figure 3). The 46-ton drill rig was assembled in pieces on top of a load distribution frame consisting of four I-beams welded in a rectangular frame to spread the load and to avoid overstressing the capacity of the helical piles. With this arrangement, the deflection of the deck never exceeded 0.5 inch.

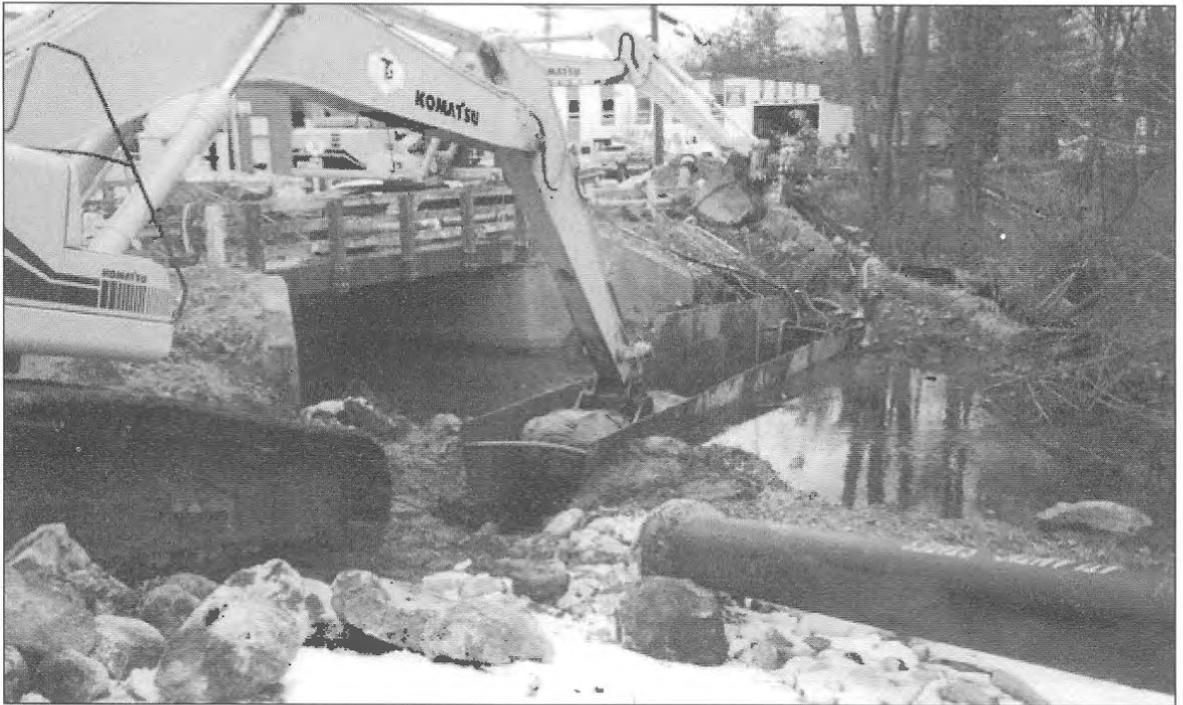
FIGURE 4. A view of the construction at one of the stream crossings for the new water mains.

Approximately 10,000 feet of new cement-lined, ductile iron water main were installed to convey well water from Wells 1 and 2 (3,500 feet to the plant) and Wells 10 and 11 (6,500 feet to the plant). Four stream crossings were required and were constructed in the wetlands and in accordance with the Conservation Commission's conditions (see Figure 4). Air relief valves were located at selected high points along the pipe route to vent air from the mains during filling operations. The water flow rate from each well was controlled by throttling butterfly valves at each well station. This work was completed in approximately six months.

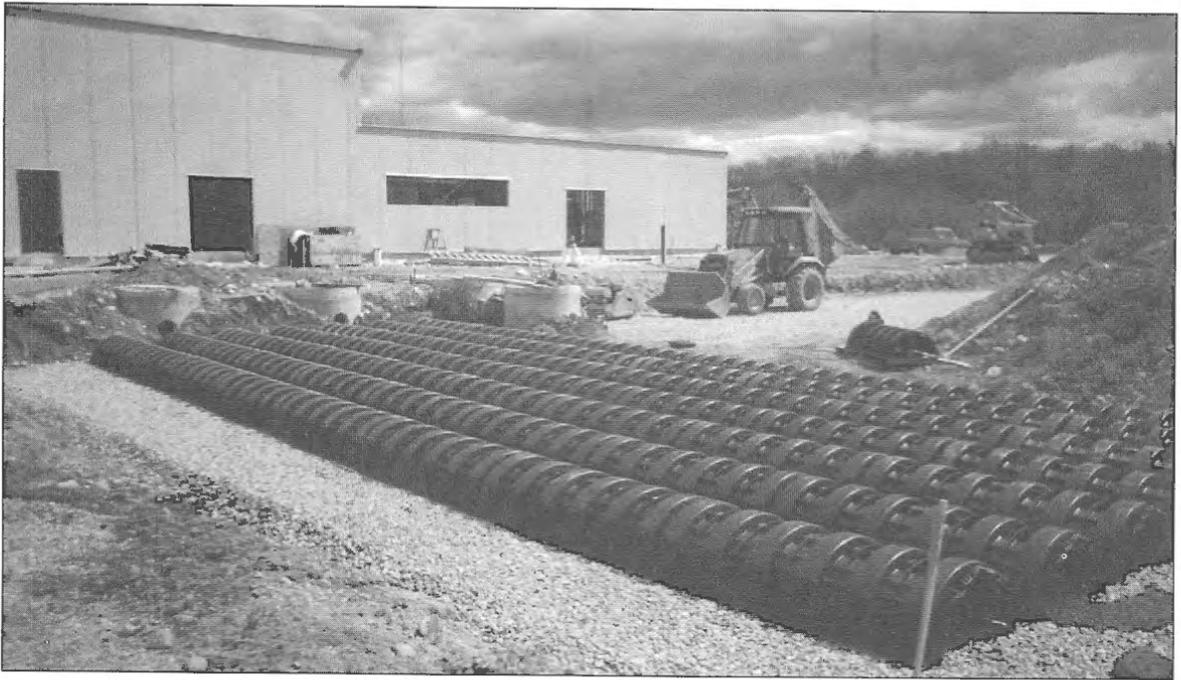
FIGURE 6. Storm water infiltration piping outside the treatment plant.

The treatment process removes iron, manganese and VOCs from the groundwater (see Figure 5). Stormwater from the site is carefully directed through collection piping to a series of infiltrating pipes into the ground and the adjacent wetlands (see Figure 6).

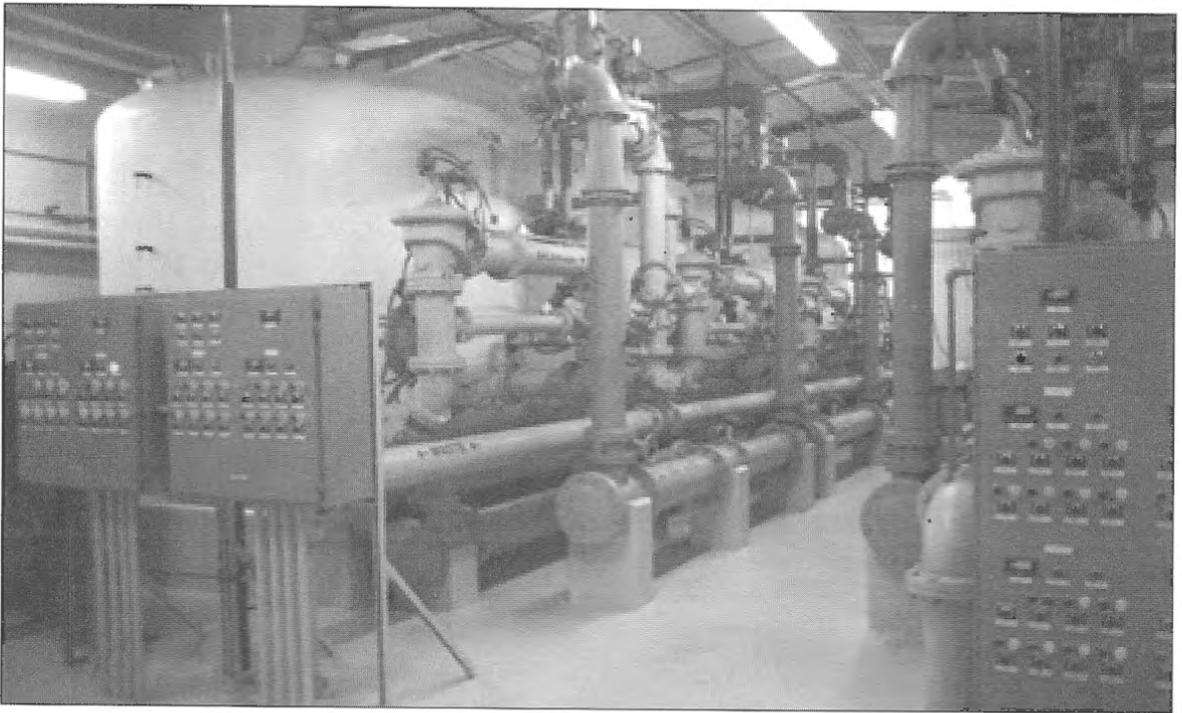
FIGURE 7. Greensand filters and piping.

- Filtration of the well water through eight vertical pressure filters to remove iron

and manganese. Each filter is 12 feet in diameter, and 12.5 feet tall. The filter media consists of 24 inches of green sand (zeolite) and 21 inches of anthracite (see Figure 7). The filters are routinely backwashed using a vigorous air/water mix.

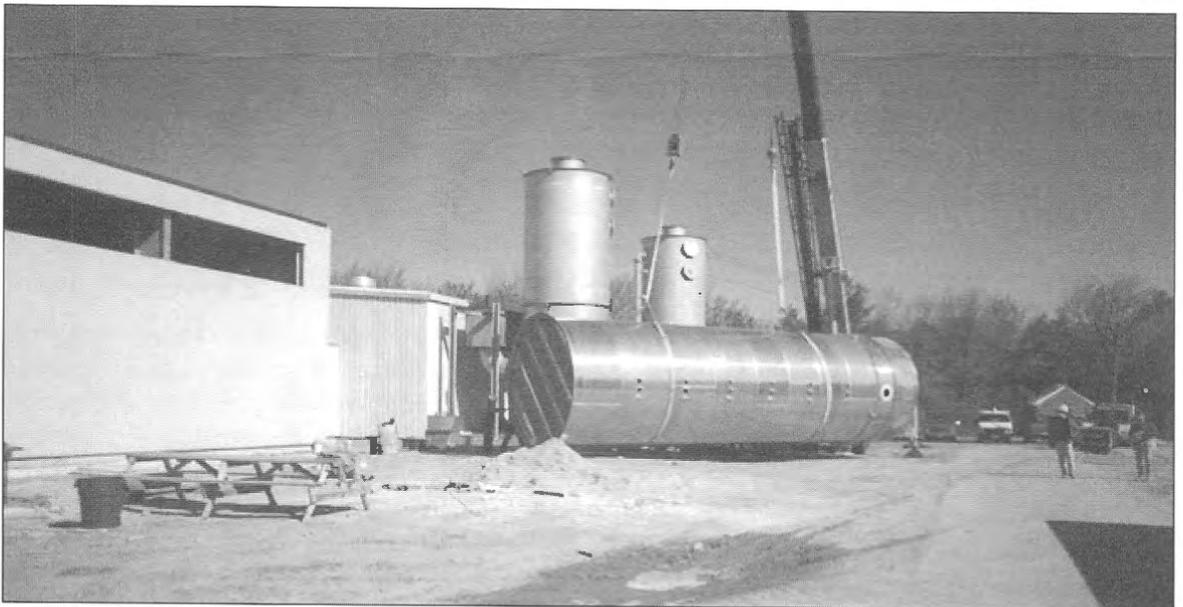
FIGURE 8. Aeration towers.

- Air stripping to remove VOCs. Two new towers approximately 11.5 feet in diameter and 41 feet tall are used in conjunction with the two existing towers to provide a two-step air stripping process (see Figure 8).
- Chemical treatment to enhance the filtration process, using potassium as an oxidant and sodium hypochlorite as an oxidant/disinfectant.
- Further treatment for disinfection with sodium hypochlorite and ammonia, corrosion control with potassium hydroxide and fluoridation before pumping into the distribution system.
- Reserve exterior space of approximately 800 square feet and provisions for adding granular activated carbon filters if required in the future to polish the plant effluent.

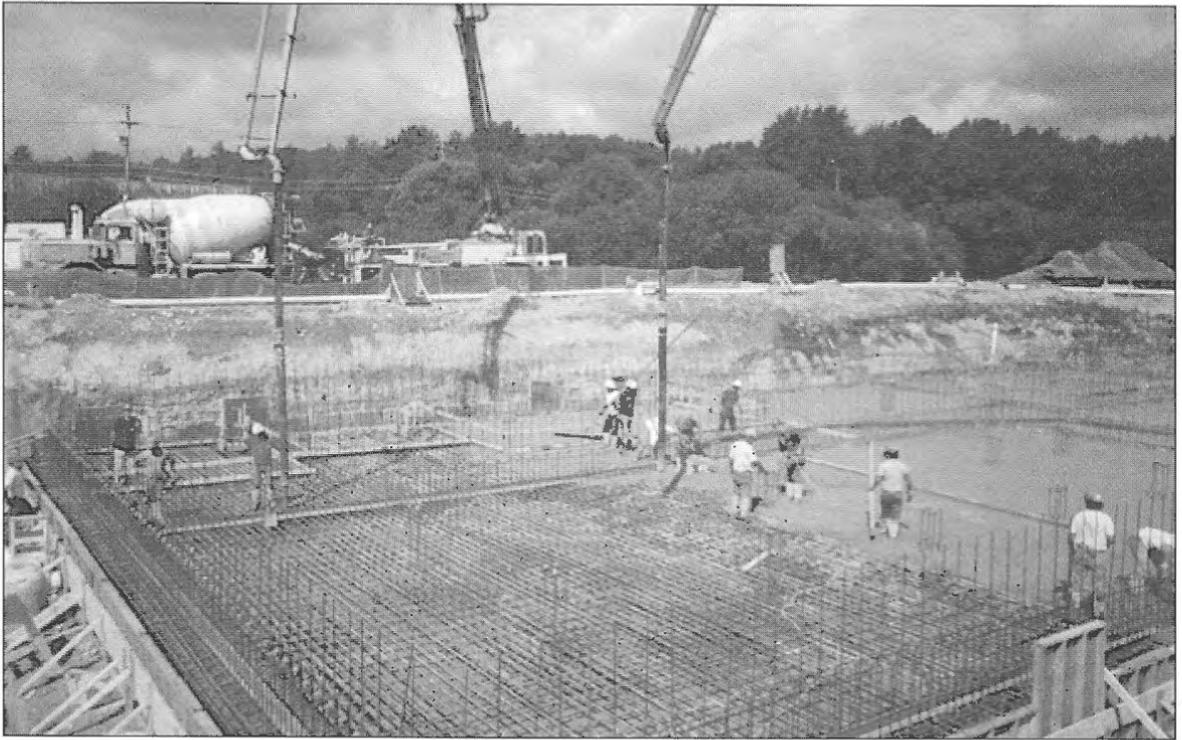
FIGURE 9. Base mat concrete placement for the treatment plant.

plant measured approximately 140 by 70 feet and required 1320 cubic yards of 4,000 pounds per square inch (psi) concrete in a 3-foot thick mat (see Figure 9). The contractor requested a monolithic pour that was approved after a thorough review of the concrete subcontractors plans for concrete delivery, pumping, quality control and field operations for placement, vibration and curing. On August 28, 1997, concrete placement commenced at 6:00 in the morning and was completed at 2:00 in the afternoon. After finishing, the entire top of the mat was covered in wet burlap that was kept saturated for three days to prevent premature curing and cracking.
