The Restoration of Covered Bridges

While engineering techniques have gotten more sophisticated and complicated over time, it is beneficial to revisit tried and true techniques in order to preserve valuable artifacts of our engineering heritage.

PHILLIP C. PIERCE

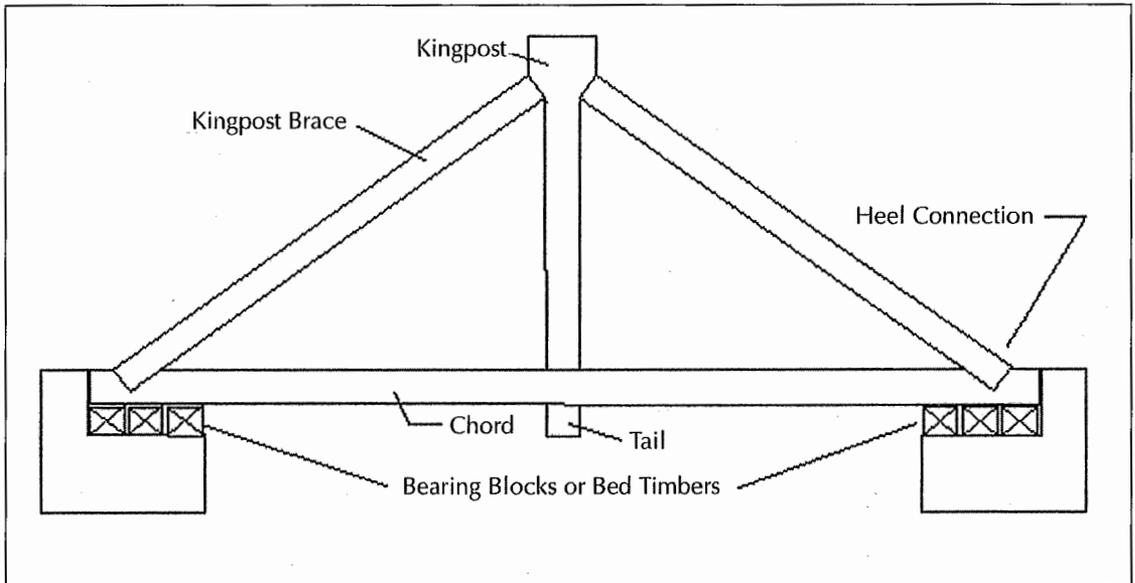
FIGURE 1. Diagram of a kingpost truss.

The kingpost truss is not very common in the extant United States covered bridge

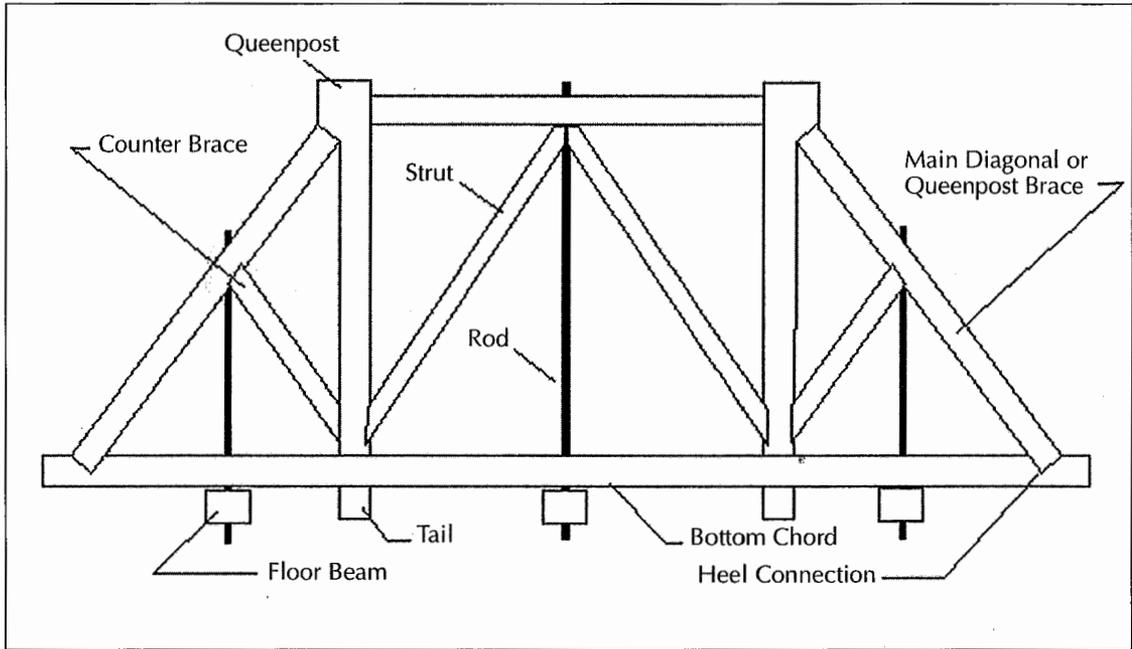
FIGURE 2. Diagram of a queenpost truss.

Queenpost. The next range in span lengths commonly includes trusses developed from a simple modification of the kingpost. The queenpost truss is, conceptually, simply a stretched out version of the kingpost truss, accomplished by adding a central panel with extra horizontal top and bottom chords (see Figure 2). Classic examples of queenpost trusses do not have any diagonal web members in the central rectangular panel. Therefore, the very simplest queenpost "trusses" are not true trusses at all, but rather frames. The vertical members are termed queenposts. These trusses are considered to have three panels.

There are approximately 101 bridges supported by queenpost trusses, or a little over 10 percent of all the surviving covered bridges in

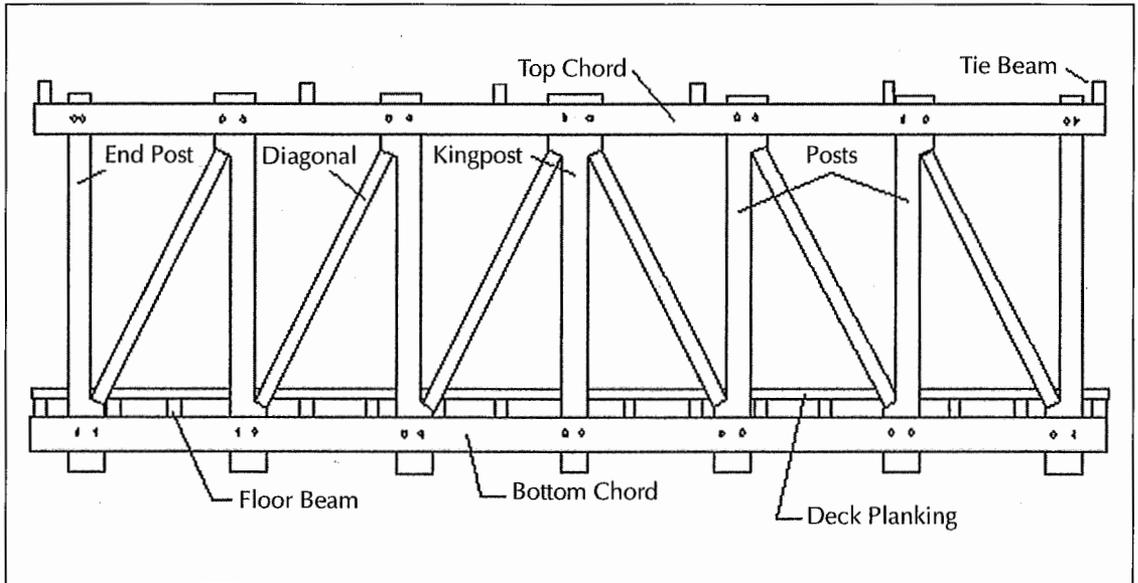
FIGURE 3. Diagram of a multiple kingpost truss.

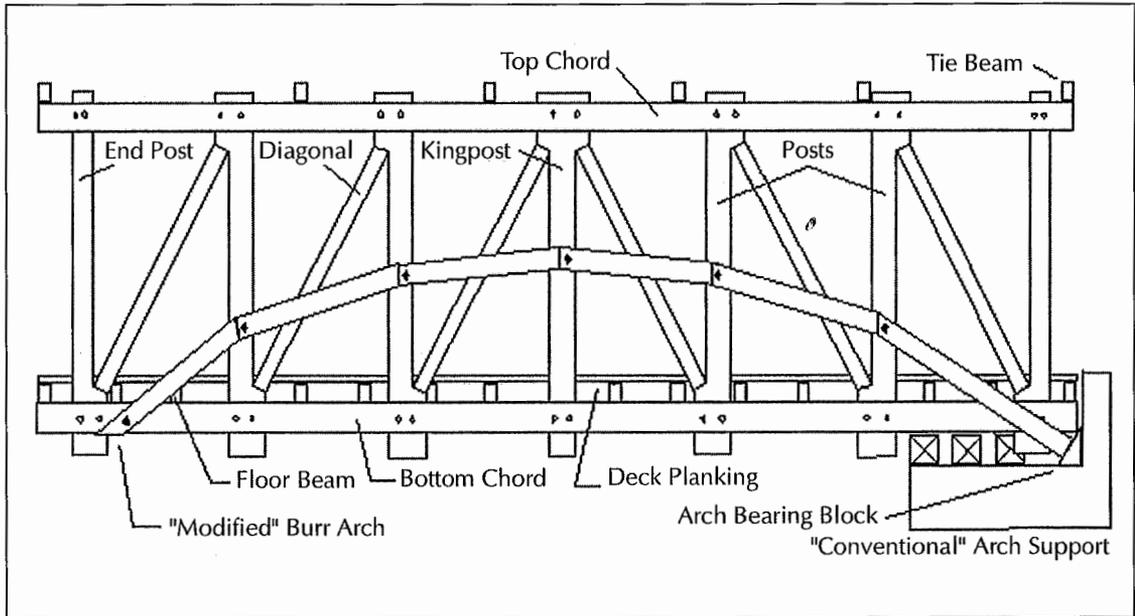
FIGURE 4. Diagram of "conventional" and "modified" Burr arches.

The arch part of most Burr arches is in pairs, which sandwich a single multiple kingpost truss between them. The most common

connection uses a single bolt to join the arches to one another through each of the vertical members of the truss. Load sharing between the truss and the arch components is largely dependent on the relative stiffnesses of those bolts. The floor beams carry the live loads to the truss bottom chords and the roof loads bear on their top chords. In order for these vertical loads to be distributed into the arch, the bolts must resist significant vertical shear forces. The initial, traditional Burr arches used arch components sawn from large, single timbers that were lap-spliced to one another at the verticals. Later, the use of continuous, but laminated (multiple-layer) timber arches became popular with some builders.

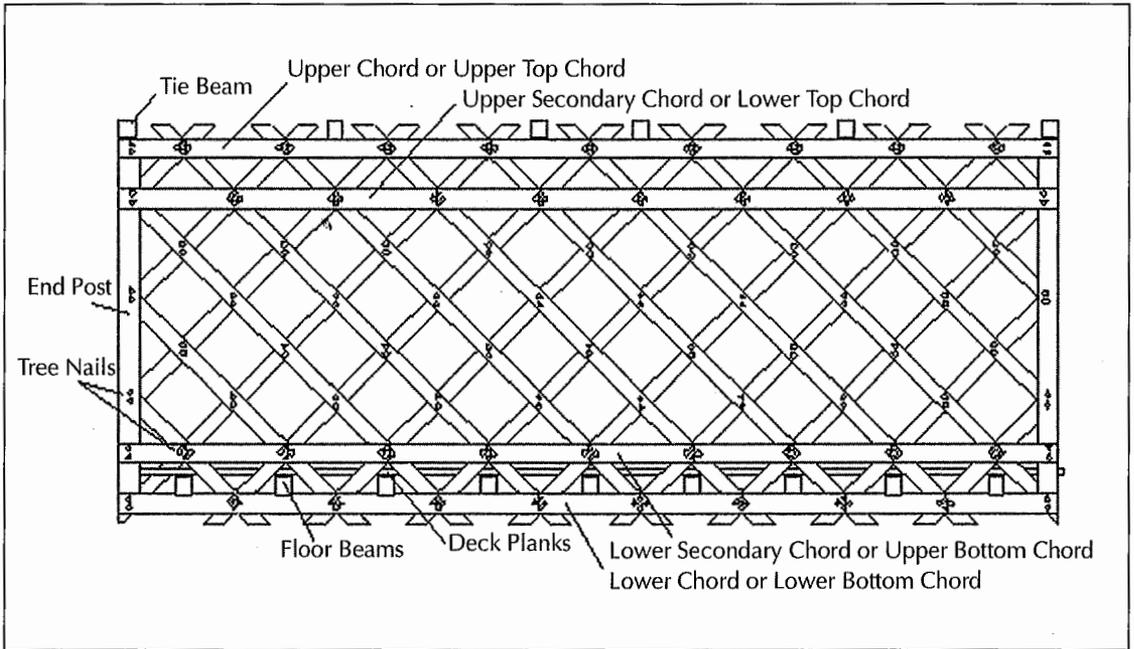
FIGURE 5. Diagram of a Town lattice truss.

Town's lattice configuration relies on an assemblage of relatively short and light planks that were available and easy to handle. He connected the overlapping intersection of members with round timber dowels or pegs, termed "treenails" — pronounced "trunnels" (and so spelled hereafter). The plank intersections in the web may have from one to three trunnels. Where chord members intersect with web or lattice members the overlapping zone may contain as many as four trunnels. The

dowels are often 1.5 to 2 inches (38 to 51 mm) in diameter. The parallel and closely spaced web members are joined to chords along both the top and bottom of the trusses. Two levels of chords are commonly used as the bottom chords. The top chords may have one or two levels of members. The lower-most bottom chord provides the seat for the transverse floor beams.

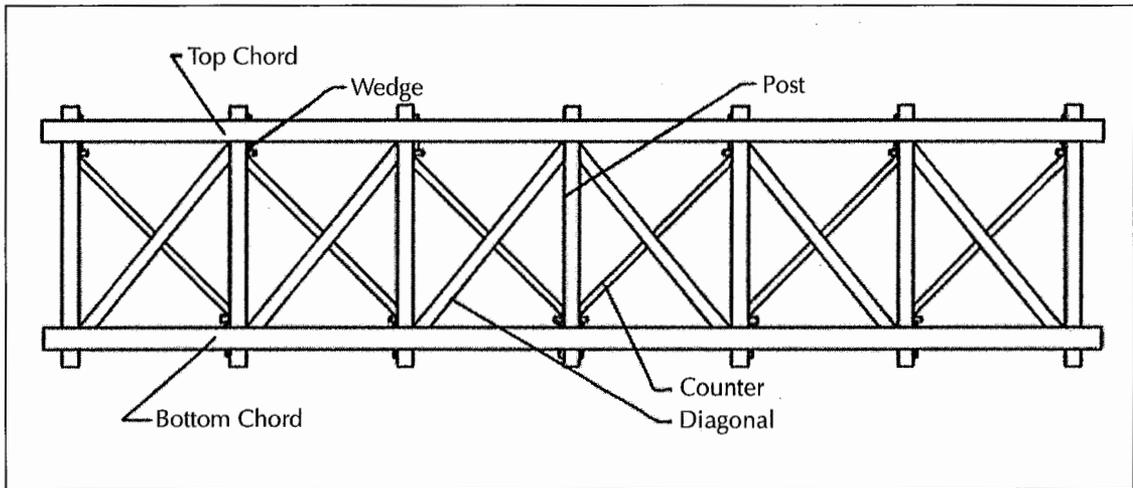
FIGURE 6. Diagram of a Long truss.

Long Truss. Colonel Stephen H. Long first patented a truss configuration in 1830. His focus was on a parallel chord truss, made with heavy timbers and with crossed diagonals in each panel (see Figure 6). A special feature of his bridge included the use of timber wedges at the intersections of the chords, posts and diagonals. The wedges were purported to allow builders and maintainers to adjust the shape of the panels, and provided the opportunity to adjust the initial camber.

Today, some have further proposed that the wedges allowed builders to induce forced loads in the diagonals in a way that would be described as "post-tensioning." While the concept seems logical when viewing a simple two-panel truss or kingpost configuration, the logic breaks down when considering longer structures with multiple panels. There is no universally accepted evidence that these prestressing forces can be predictably induced.

However, the wedges do offer an important increase in the strength of the connection between the horizontal component of the load in the diagonal and the chord. The transfer of load without wedges flows from end bearing on the diagonal to cross grain bearing in the post and then from cross grain bearing at the shoulder of the post back to end grain bearing at the shoulder of the chord. The introduction of the wedge distributes the bearing load from the chord over a much larger area of the post via the wedge in direct cross grain bearing.

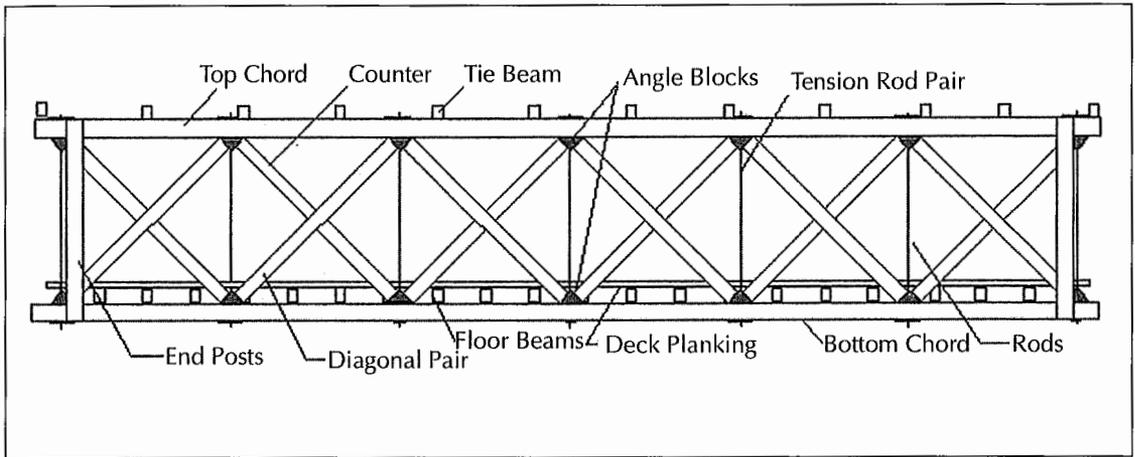
FIGURE 7. Diagram of a Howe Truss.

covered bridges by being the first to use metal components as primary members within an otherwise timber truss. He used timber parallel chords, with timber diagonal braces and counter braces in the panels, but he used round iron rods for the vertical tension members. The threaded rod ends allowed easy adjustment of the structure to keep it tight both during and after erection. Many modifications were made over the years to Howe's original design, in order to address various desired details, but his truss was quickly adopted to withstand the heavy loads on railroads. The popularity of the Howe Truss continues today. It is often selected when constructing new covered bridges. Howe's modification was a major reason for the short life and reduced popularity of Stephen Long's truss — which was essentially the same, but without the iron rod verticals. Howe is also credited with the first published analytical review of his structures, employing the same methods and procedures that Squire Whipple used.

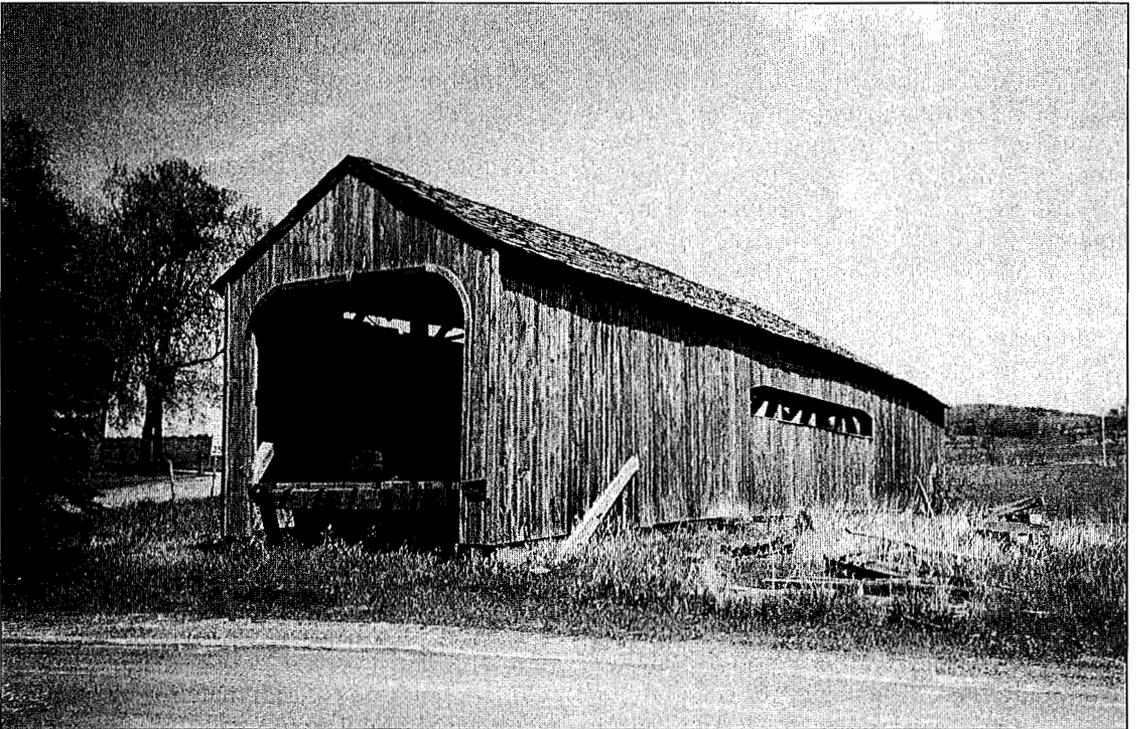
FIGURE 8. A photo of how the Brown's River Bridge sat for thirteen years off its original site.

The bridge sat idle in the field overlooking its foundations, awaiting additional funding to finish the project (see Figure 8). A long effort chasing grants culminated in funding via the Intermodal Surface Transportation Efficiency Act of 1991 and supplemental funding in 1999 from the Transportation Equity Act for the 21st Century.

Bridge Condition at the Start of the Project. Unfortunately, the repairs started in 1987 were not completed and the bridge sat on cribbing for thirteen years (see Figure 8). During that time, the cribbing suffered some differential settlement that racked the bridge. At the start of work, two-thirds of the top chord of the south truss had been attacked by powder post beetles (it cannot be determined if this damage was present before the 1980s). The wood shingle roof installed in the 1980s was leaking. The ends of the bottom chords had been replaced and large bolster beams were positioned beneath the chords. There was no direct splice of the chords and the connection of the bolsters was judged to be inadequate to restore the integrity of the bottom chords without additional work. Several damaged, broken or missing components of the bracing had not yet been addressed.

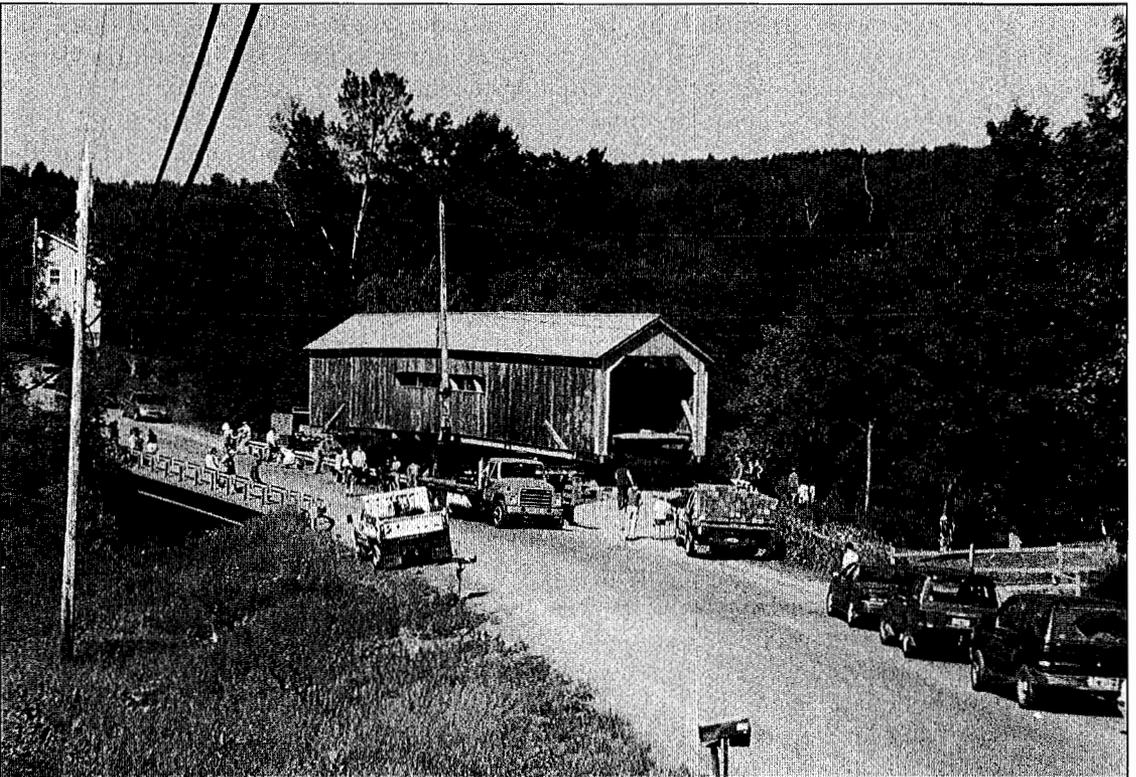
FIGURE 9. Moving the Brown's River Bridge to its new location.

With sufficient funds available, a contract was let for the final repair of the bridge and its abutments and for resiting the structure to its river crossing (see Figure 9). Bridge repair work commenced in early 2001 and it was relocated on July 20, 2001, via heavy moving steerable dolleys towed by large wrecker trucks. Back at its original site, adjacent to a modern bridge that supports vehicular traffic, the covered bridge now serves only pedestrian traffic.

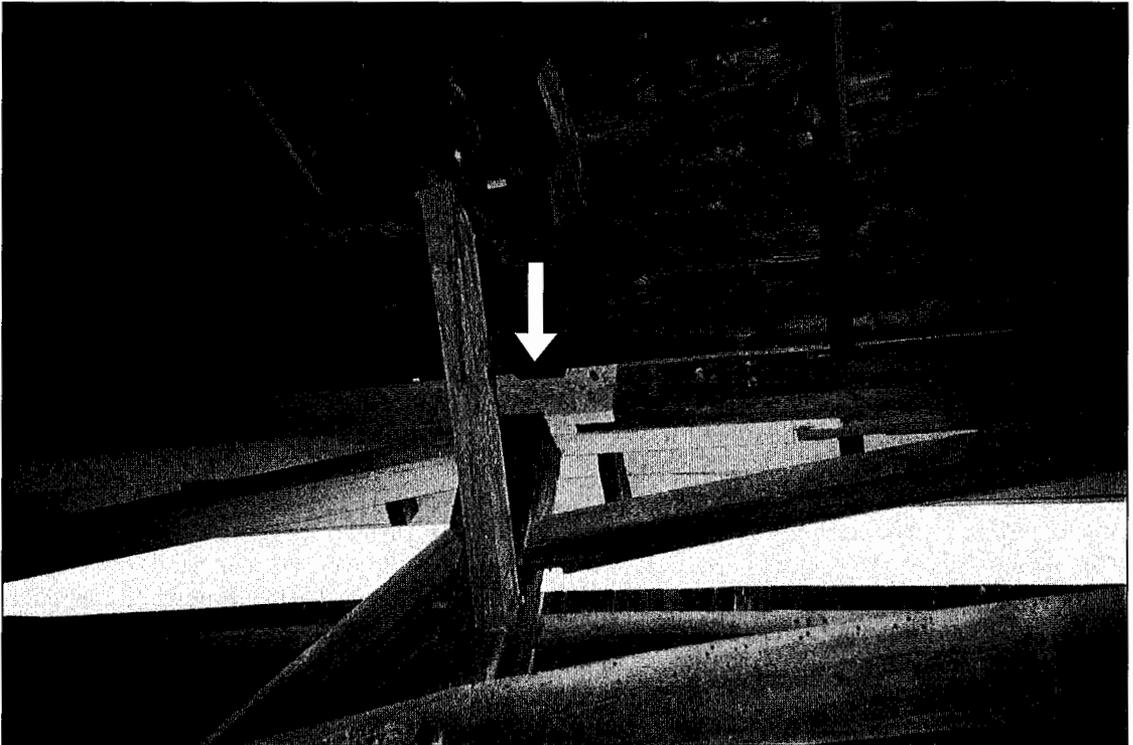
FIGURE 10. Replacement top chords for the Brown's River Bridge.

Timber Repairs. One of the important issues related to this work was the need to replace truss components while attempting minimal removals. The top chord of the east truss was originally built in three pieces with a special joinery connection (see Figure 10). The chords were positioned down onto tenons from the ends of the posts. The replacement of the chord therefore required the temporary support of the rafters and tie beams to raise them out of the way.

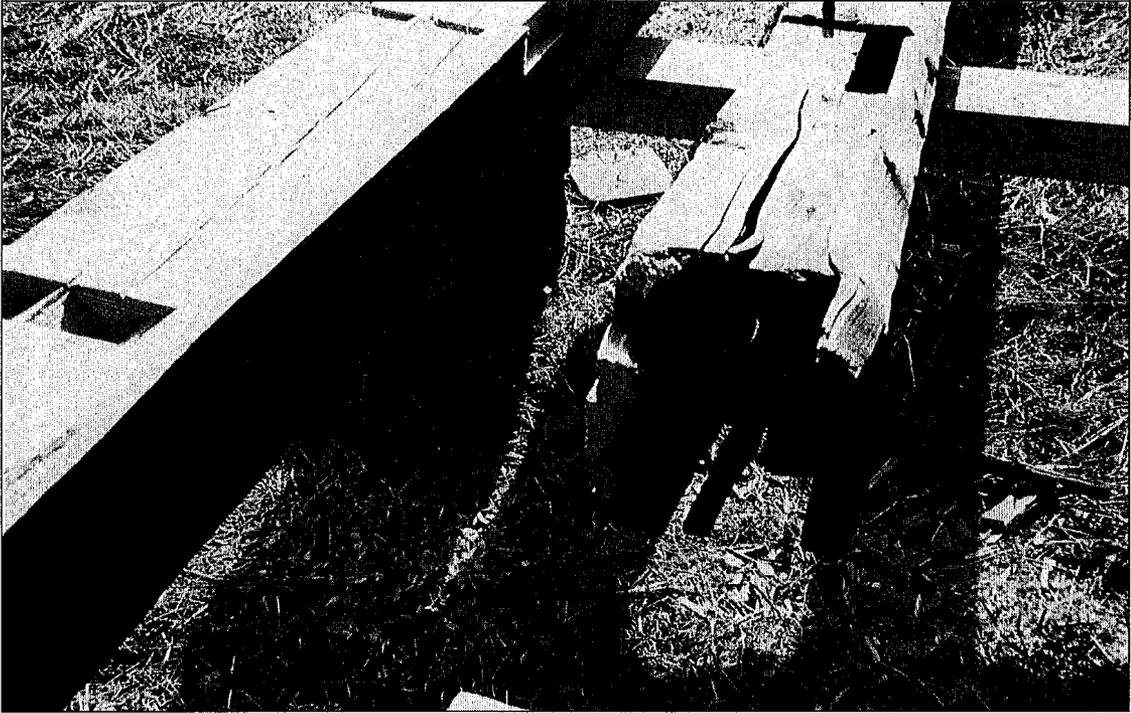
FIGURE 11. Hidden rot inside the top of an old post on the Brown's River Bridge.

While replacing the top chord, a section of substantial rot was found in the top of one post (see Figure 11). No external evidence of such deterioration was visible. Yet, the post either had to be partially or completely replaced. The decision was made to completely replace the post. A couple of other posts were also replaced to better address previous partial repairs that were judged to be insufficiently connected.

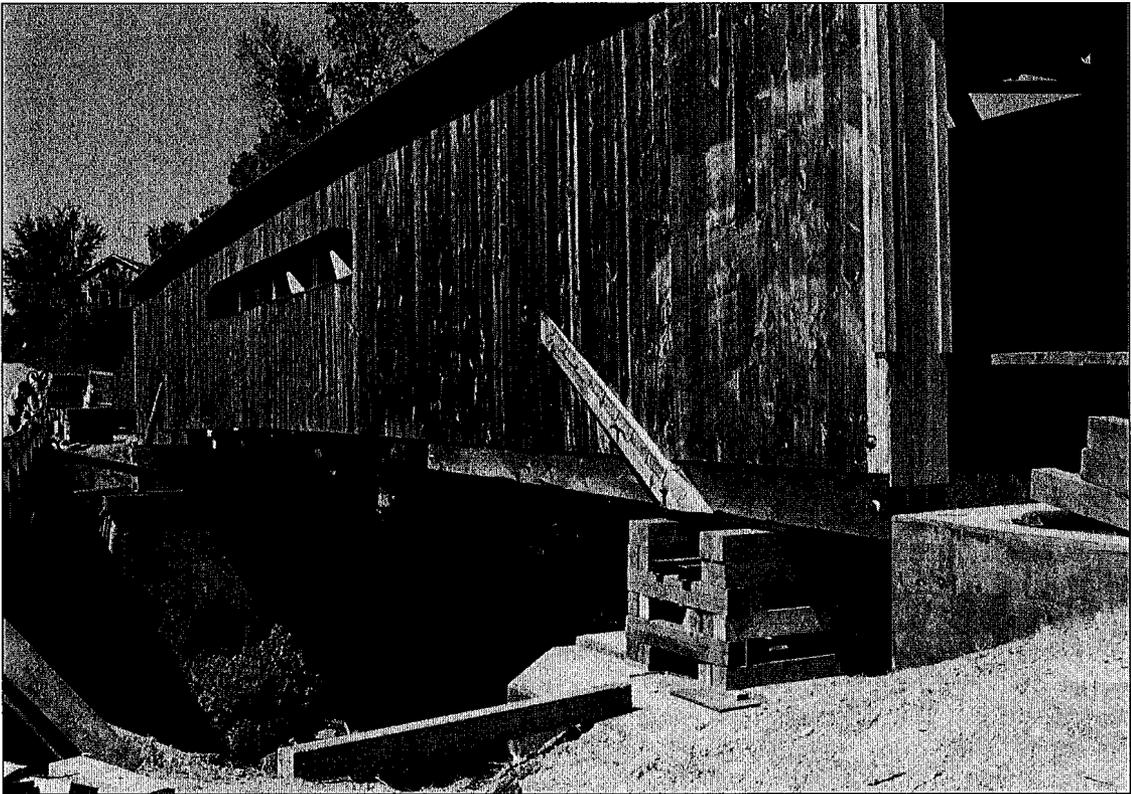
FIGURE 12. The Brown's River Bridge was moved but not down off its temporary cribs.

Modified Burr Arch Details. In Figure 12 it can be seen that the arch elements have been cut off at the bottom of the bolster beams. In a classic Burr Arch, the arch elements project down past the bottom of the chords to bear against the abutment. In so doing, they can true arch behavior to augment the truss

this bridge to pass the bottom chord. Hence the gradual appearance of the arch in Figure 12. Some bridges are built so that the arch components are interrupted at the bottom chord with a splice in order to ensure that the arch remains in the same plane as the bottom chord.

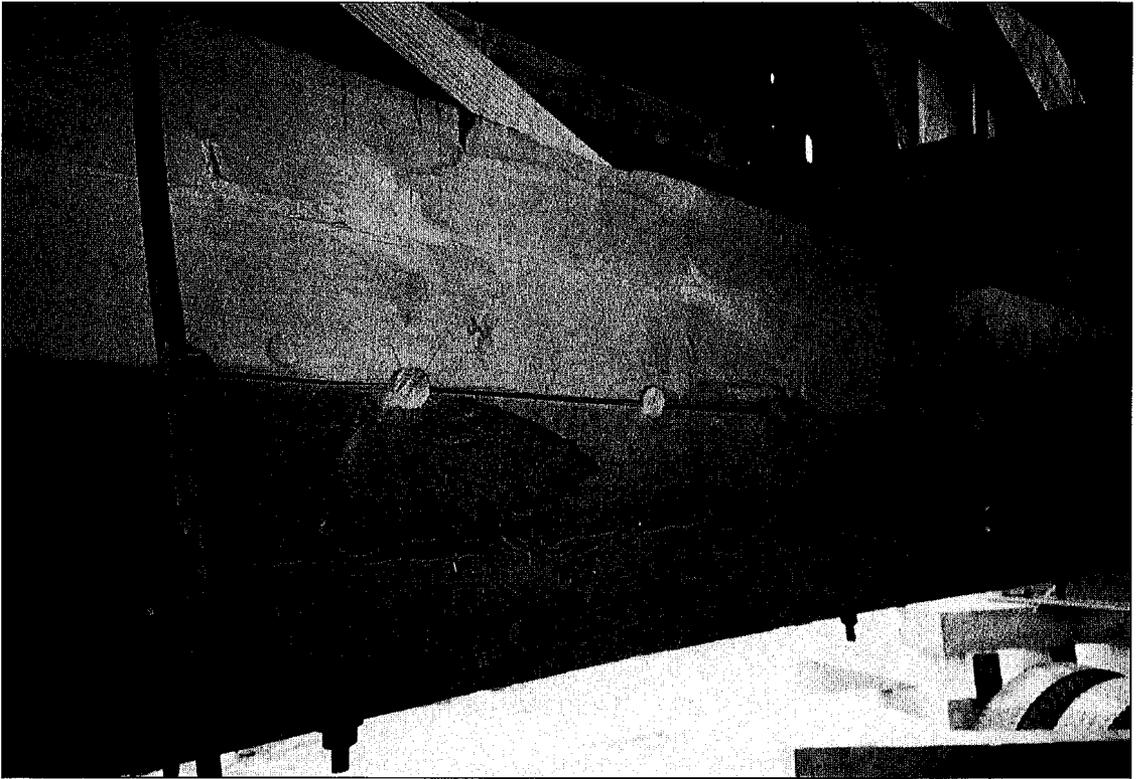
FIGURE 13. A view of shear dowel reinforcement on the Brown's River Bridge.

Accordingly, a plan was devised to install a series of timber shear blocks at the interface of the bottom of the chord to the top of the bolster. In combination with the bolts, the additional shear blocks would provide an acceptable capacity. The plans called for rectangular 4-inch (100-mm) high by 8-inch (200-mm) wide hardwood blocks to be inserted into new pockets cut into the interface from the side. The contractor had considerable experience with use of round wooden dowels to accomplish the same effect and believed the round dowels would serve better in this instance. Following extensive conversations and additional analytical evaluations, round dowels were used (see Figure 13).

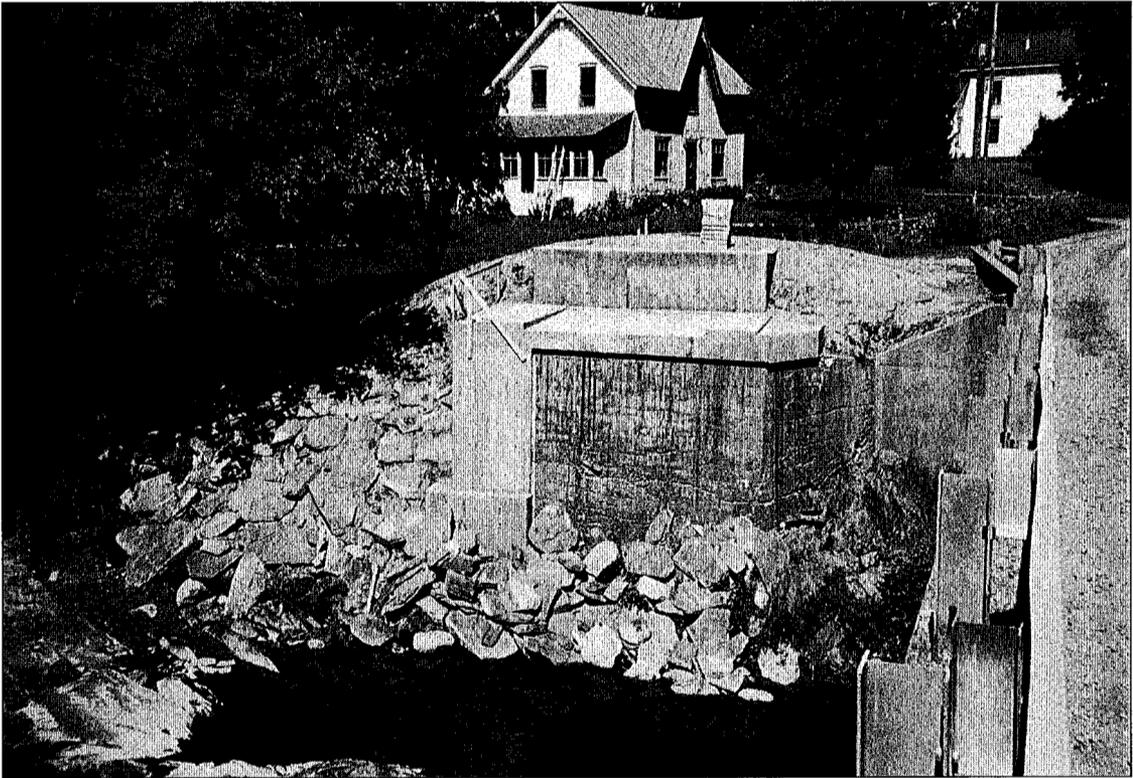
FIGURE 14. A view of the reconstructed east abutment for the Brown's River Bridge.

Foundation Considerations. The original stone abutments had been faced with concrete (a common practice). While the quality of concrete facing was not great, the bulk of it seemed sound and stable. There was no evidence of deep-seated foundation failures; hence it was quickly decided to retain the bulk of the abutments. New caps were required due to a change in the floor configuration. (The trusses originally extended beyond the floor; therefore, the concrete backwalls had jogs at each corner.) The north corner of the east abutment also had separated from the main stem concrete and needed to be replaced. The connecting wing wall was dry laid stone that had shifted and was on the verge of collapse. A roadway drainage pipe

discharged at a point at the beginning of the stone wall and was contributing to its demise. A review of the roadway drainage situation indicated that a cross culvert could be installed in the roadway uphill of the covered bridge abutment. Doing so would permit removing a major portion of the stone wing-wall and regrading in order to fill in the ditch in front of the wall. The corner of the abutment was removed and recast on new concrete stepped footings to connect to the rest of the abutment stem concrete.

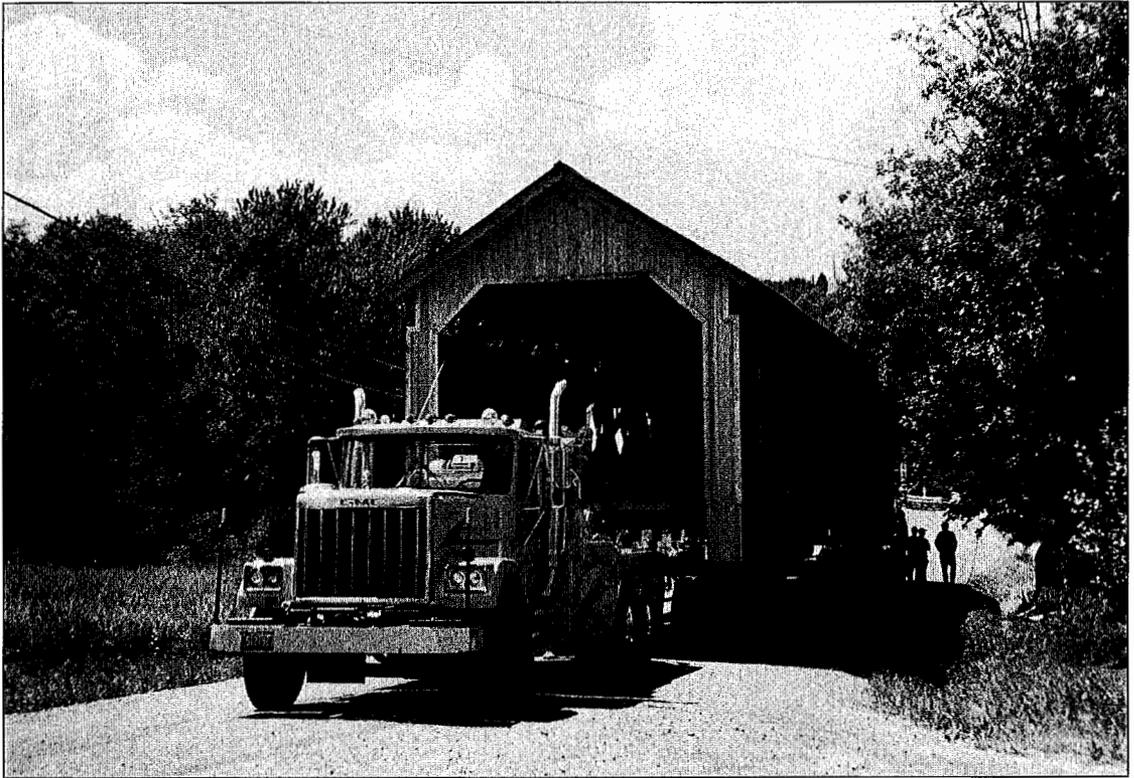
FIGURE 15. The Brown's River Covered Bridge underway on dollies.

Relocating the Bridge. Without question, the relocation of the bridge garnered the most attention. The general contractor decided to hire the services of a company that specialized in moving structures. A pair of steerable dollies was located at each end of the bridge. The power to move the bridge was provided by winches from large wreckers. The roadway is quite steep leading down to the bridge site and the process involved parking a tractor uphill of the bridge and releasing the cables to the limit of the cable spool, then moving the wrecker to start the process again. The far end of the bridge was hooked to a separate wrecker that provided the steering guidance. It was able to hold the bridge in position with its brakes while the rear wrecker was relocated

(see Figure 15). Upon reaching the low point in the profile, the far wrecker took over and pulled it into place.

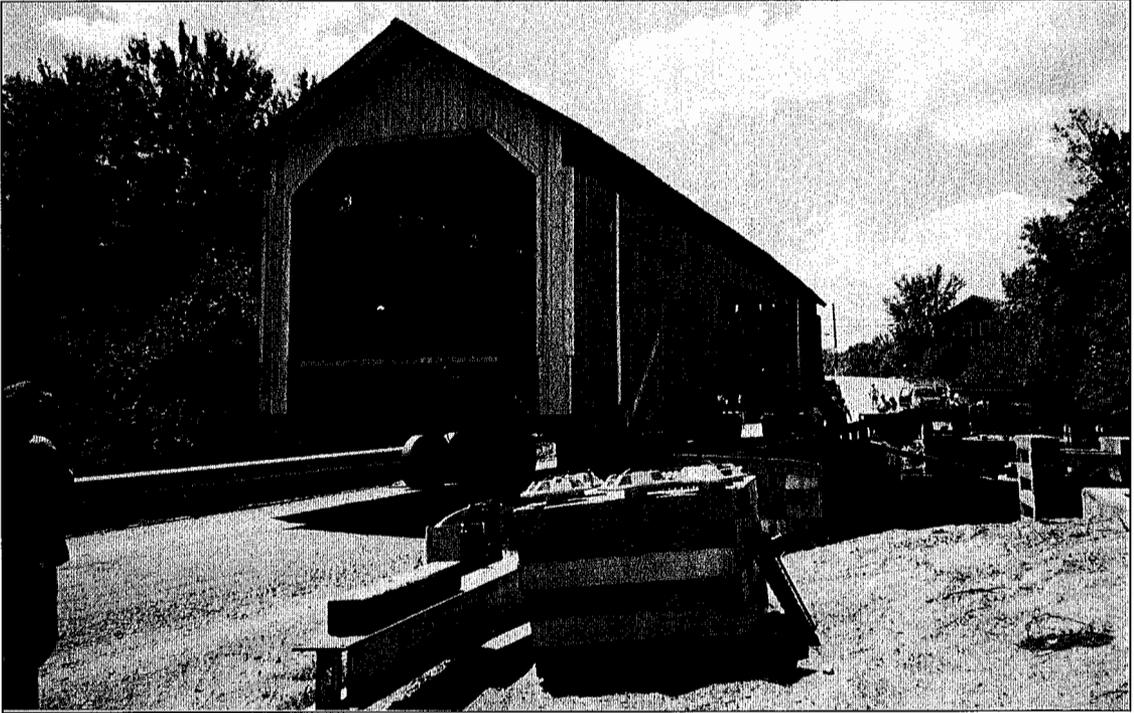
FIGURE 16. Atop the bypass bridge and ready to be slid sideways.

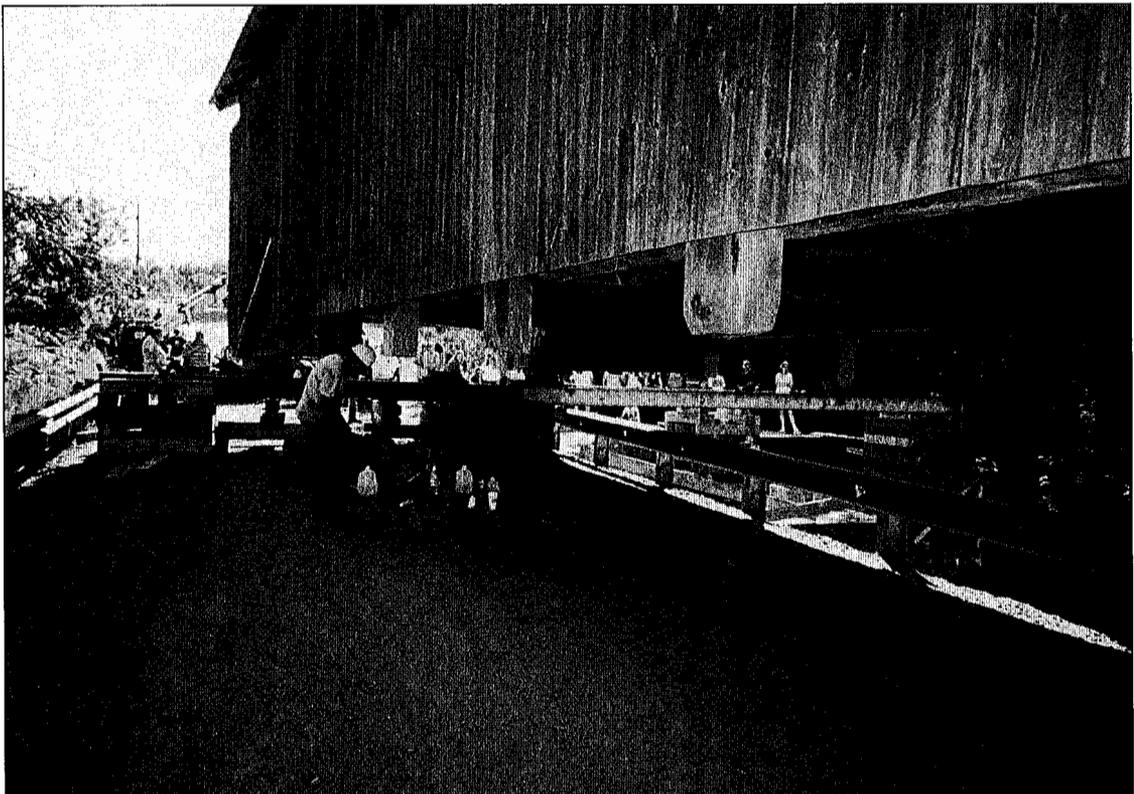
FIGURE 17. The Brown's River Covered Bridge moving sideways.

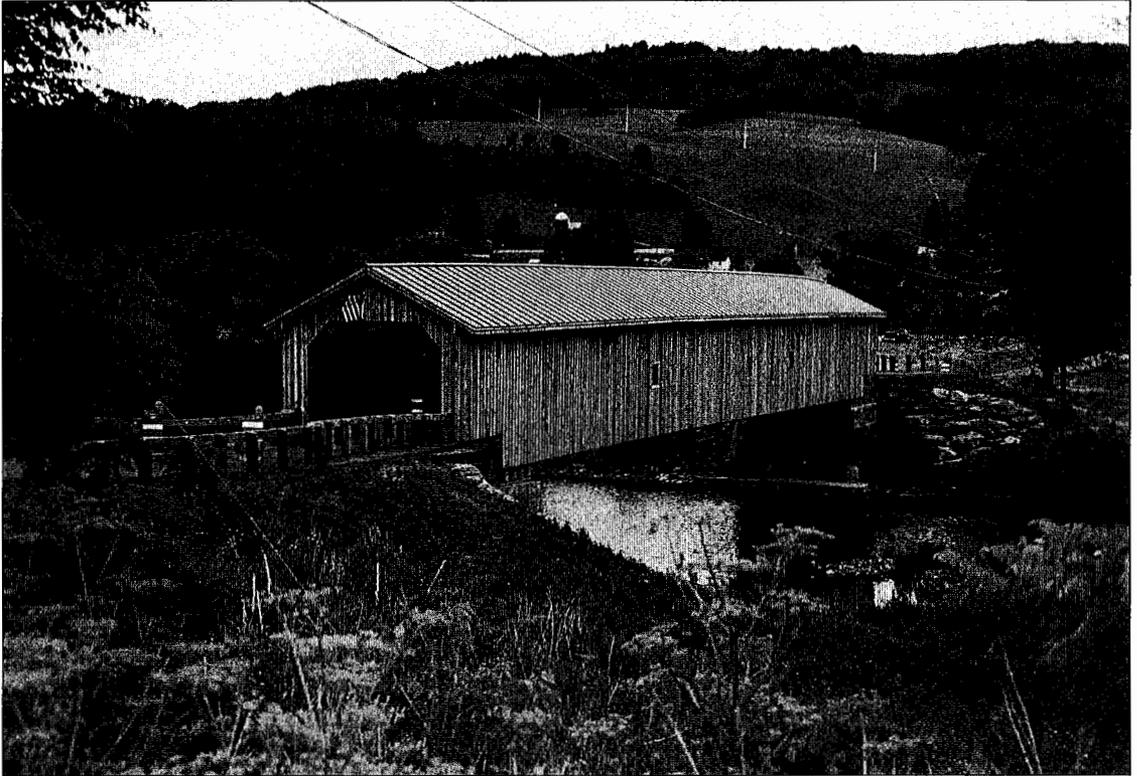
FIGURE 18. A view of the Hamden Covered Bridge.

The Hamden Covered Bridge, built in 1859, spans the West Branch of the Delaware River near the hamlet of Hamden in Delaware County, New York (see Figure 18). The county, as owner, undertook a major rehabilitation of the bridge in 2000. The bridge is supported by truss configurations patented in 1830 by, and named for, Colonel Stephen H. Long.

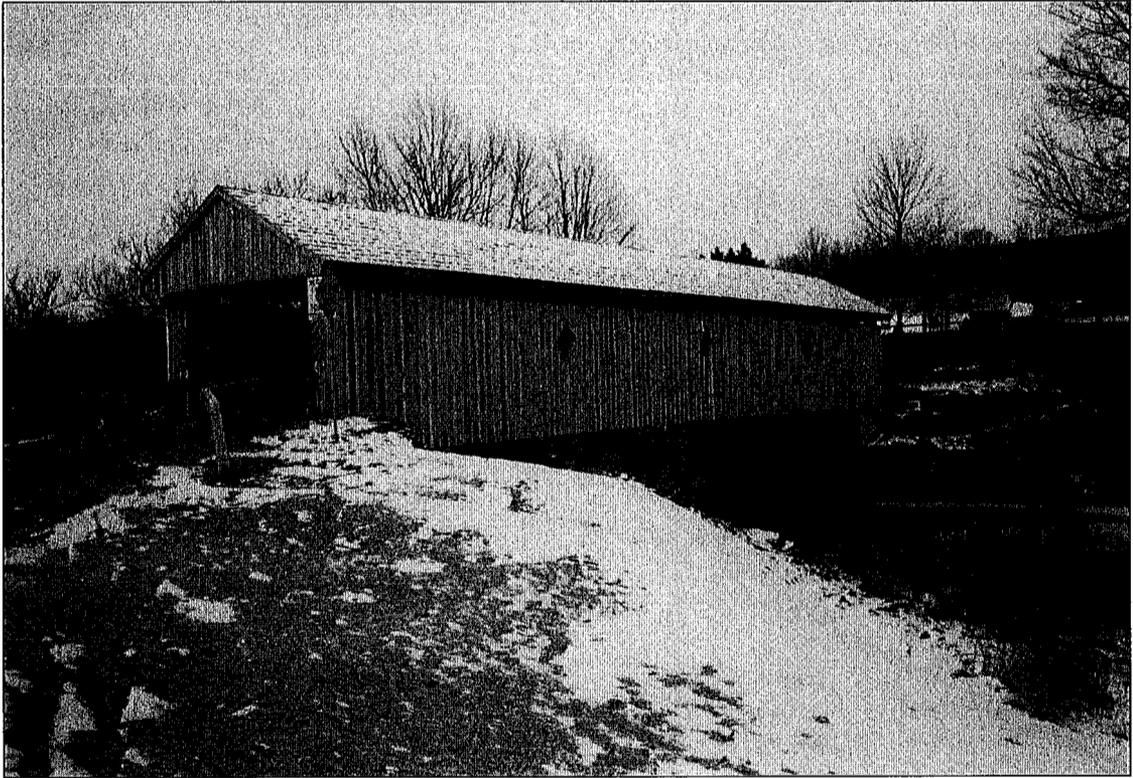
FIGURE 19. A view of Fitch's Covered Bridge.

Several problems requiring solutions were encountered in this bridge rehabilitation, including:

- Hidden deterioration (a common problem with lattice trusses);
- Figuring out how to restore the trusses to their original configuration;

- Dealing with the vertical camber of the tusses (how to deal with existing sagged structures);
- Insufficient bracing;
- A weak floor system; and,
- Devising a way to retain the existing foundations.
