# Foundation Considerations for the Expansion & Renovation of the Hynes Auditorium

*Site and structural conditions as well as building code requirements often result in overwhelming design problems. One unique, but replicable, approach overcame these problems.*

EDMUND G. JOHNSON &  
DAVID A. SCHOENWOLF

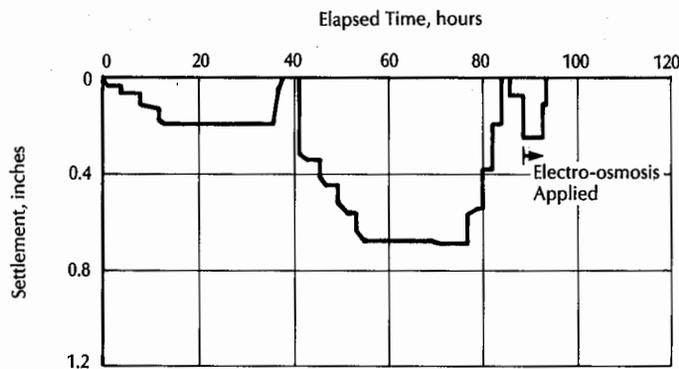
the existing pile foundations could carry the increased loading with an adequate factor of safety and that deflections would be tolerable.

With reference to the data plots, the deflection curve closely follows the theoretical elastic compression slope for a friction pile, indicating
