# Suspension Bridges of New England

*New design innovations have made the suspension bridge a rare bird. Before they all disappear from the landscape, it might be best to review and honor those that still exist.*

DAVID LATTANZI & DEREK BARNES

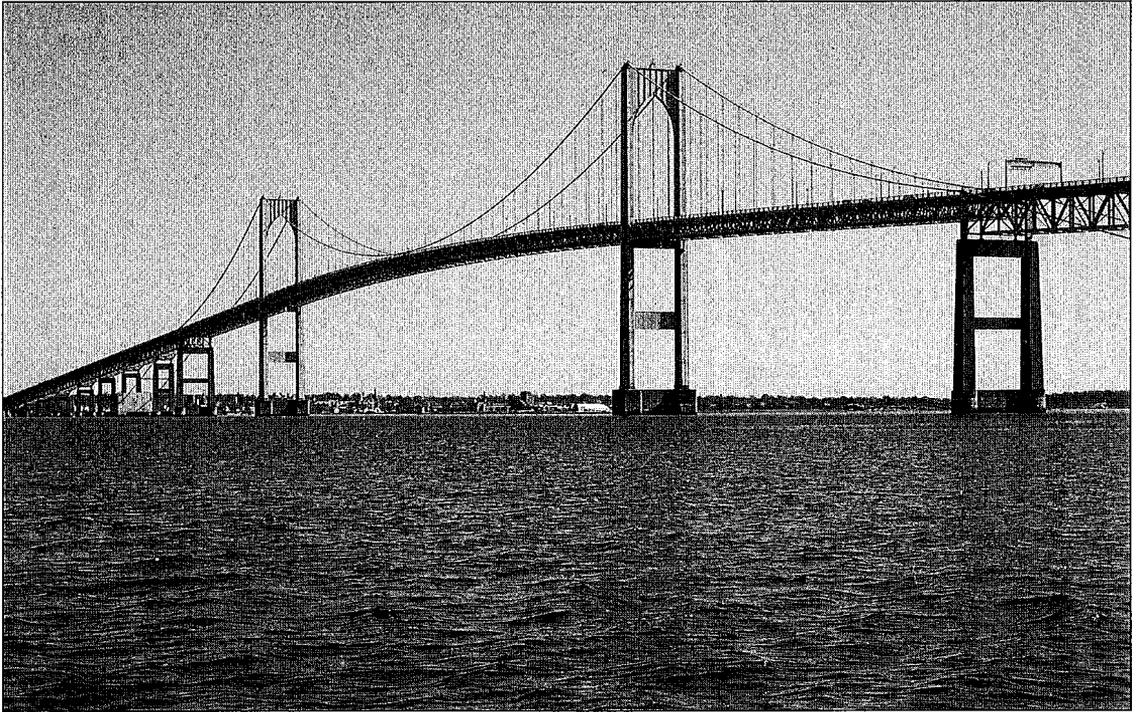
### **Claiborne Pell Bridge, Rhode Island.**

The Claiborne Pell Suspension Bridge is located in Newport, Rhode Island. It stretches a total of 11,248 feet, carrying State Route 138 across the Narragansett Bay and linking Jamestown to Newport.<sup>1</sup> It is the longest sus-

The over two-mile bridge consists of a 1,600-foot suspended span, 688-foot approach spans, eleven deck truss spans totaling 3,450 feet, fifteen girder spans totaling 2,524 feet, 300 feet of multi-girder spans and 2,000 feet of prestressed concrete beams. The bridge roadway carries four lanes of traffic with a total width of 48 feet over the Narragansett Bay at 225 feet above the water line. The maximum grade of roadway is 4.8 percent. The maximum gross weight for vehicles is 40 tons (80 tons with a permit). Its towers rise 400 feet above mean high water. The deck is stiffened by a lateral truss running longitudinally along the bridge that protects against failure due to lateral wind forces.<sup>4</sup>

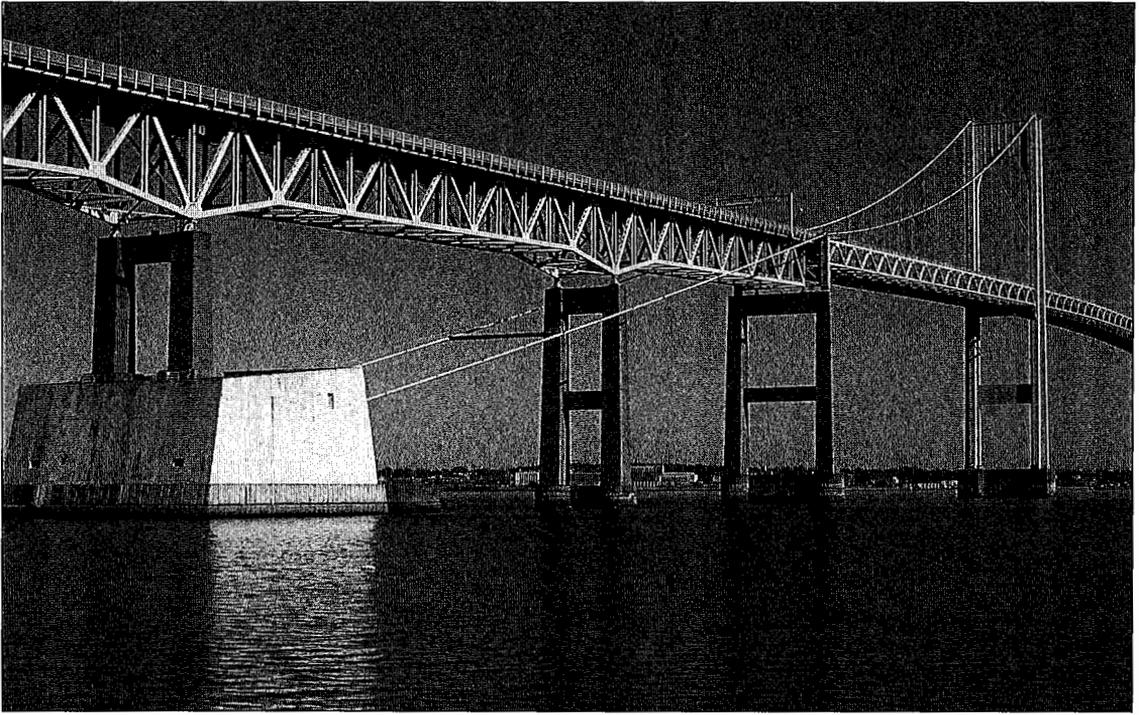
### Approach spans of the Claiborne Pell Bridge.

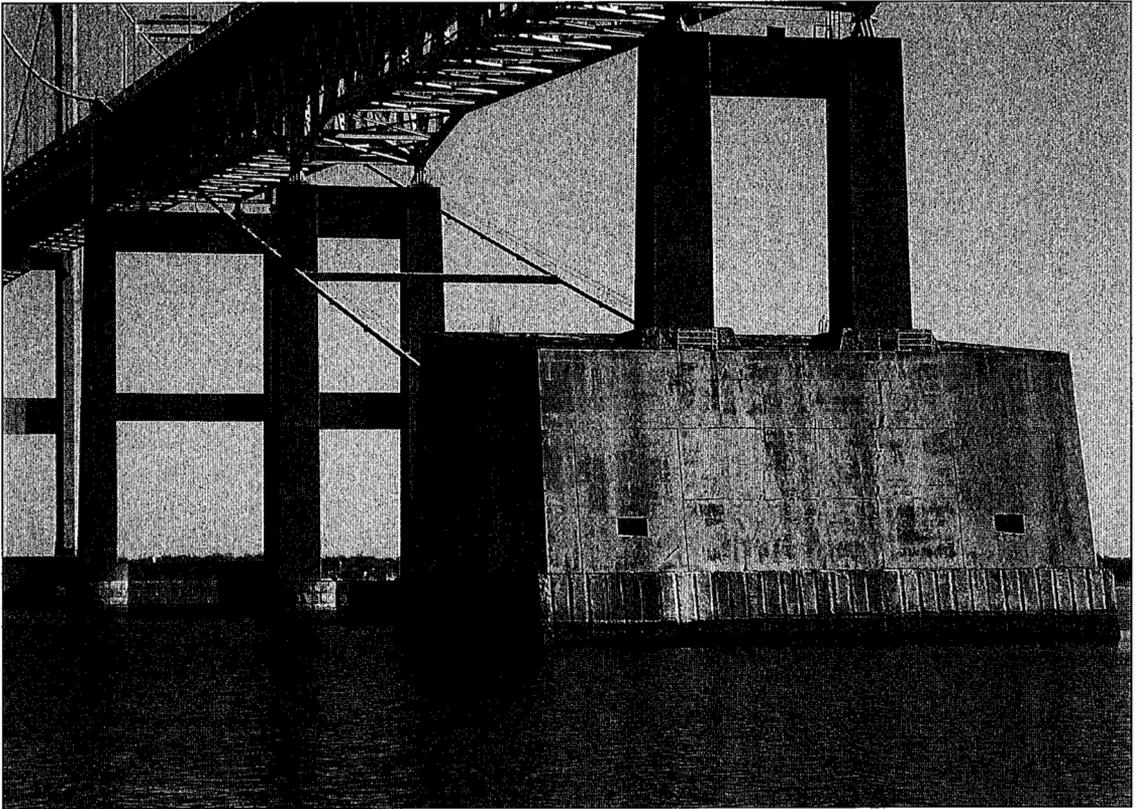
### Claiborne Pell Bridge abutments.

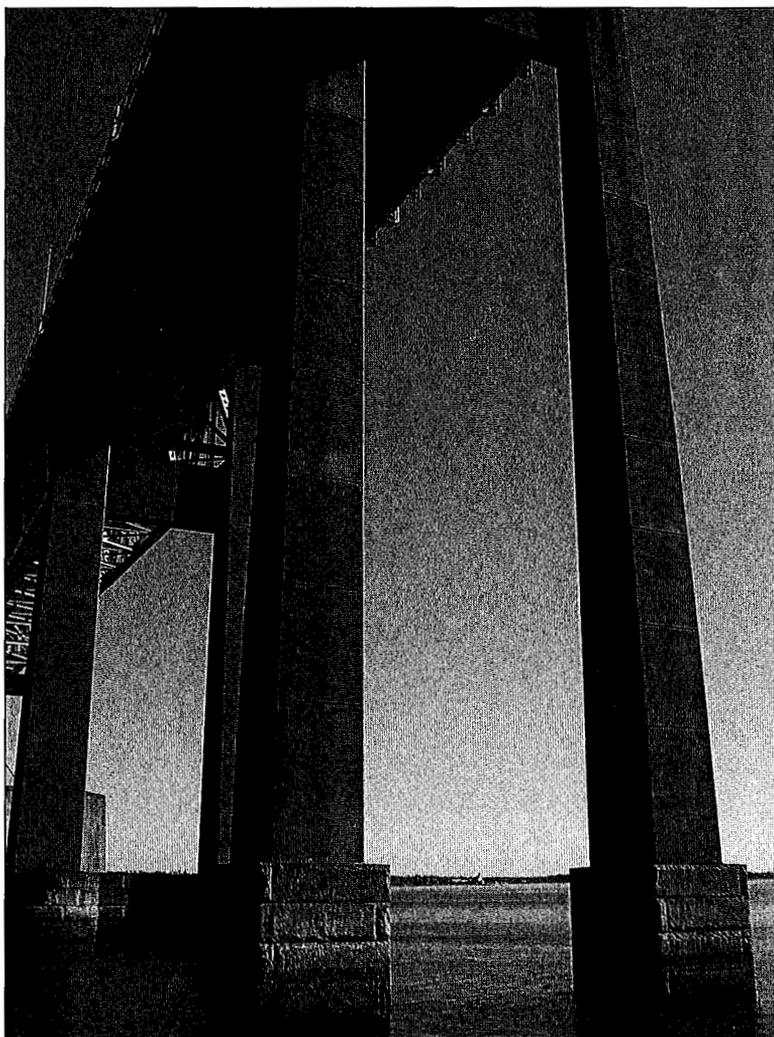
**Claiborne Pell Bridge piers.**

It took an estimated of 90,000 cubic yards of concrete to pour the piers and anchorages. This amount was the largest ever structural concrete placement under water. The tremie method was used, which resulted in reduced pressure exerted on the sides of the pier walls. The steel reinforcing used in the concrete weighed 4,000 tons. The piers were finally completed by 1967.

The bridge's strength and reliability were tested in February 1981. A tanker carrying 50,000 barrels of oil collided with one of the main piers of the bridge. The pier suffered only a smear of grey paint. No structural damage was found whatsoever. The tanker was not so lucky — its bow was impacted ten feet. Even though the bridge sustained the blow

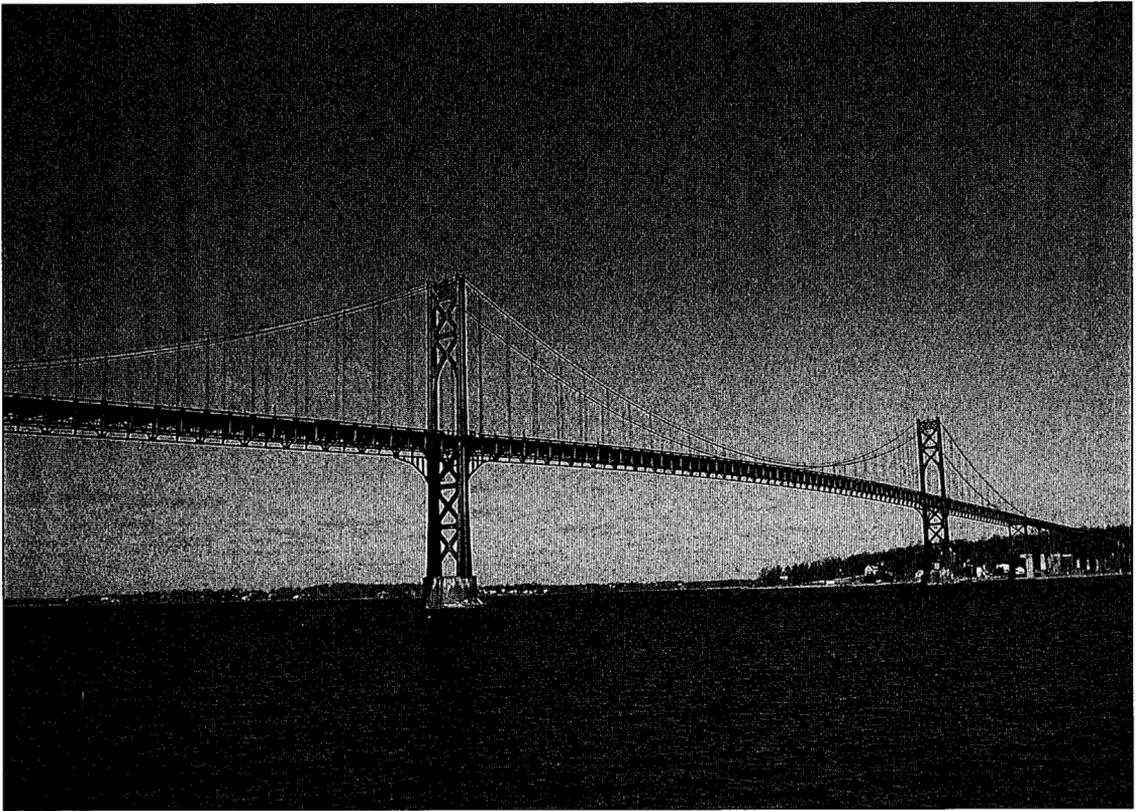
### Mount Hope Bridge, Rhode Island.

The bridge is 6,130 feet long and consists of a 1,200-foot suspension span. The total water span is 3,000 feet. Each 150-foot girder span contains four steel girders. The bridge's roadway carries two lanes of traffic with a total width of 27 feet over 135 feet above the water. The maximum grade of roadway is 3.8 percent. The maximum gross vehicular weight is 42 tons. Its steel towers rise to 285 feet above mean high water. The deck is stiffened laterally by a deep truss running longitudinally along the bridge that protects against failure due to wind forces.

The two main suspension cables each have an 11-inch diameter. Each cable contains 2,450 wires. The total length of wire if laid out end to end is 2,620 miles long. The total loading capacity of the cables is 5,600 tons. The use of cable bents with straight backstays at the ends of the side spans were a major innovation, and resulted in an economic benefit.<sup>8</sup>

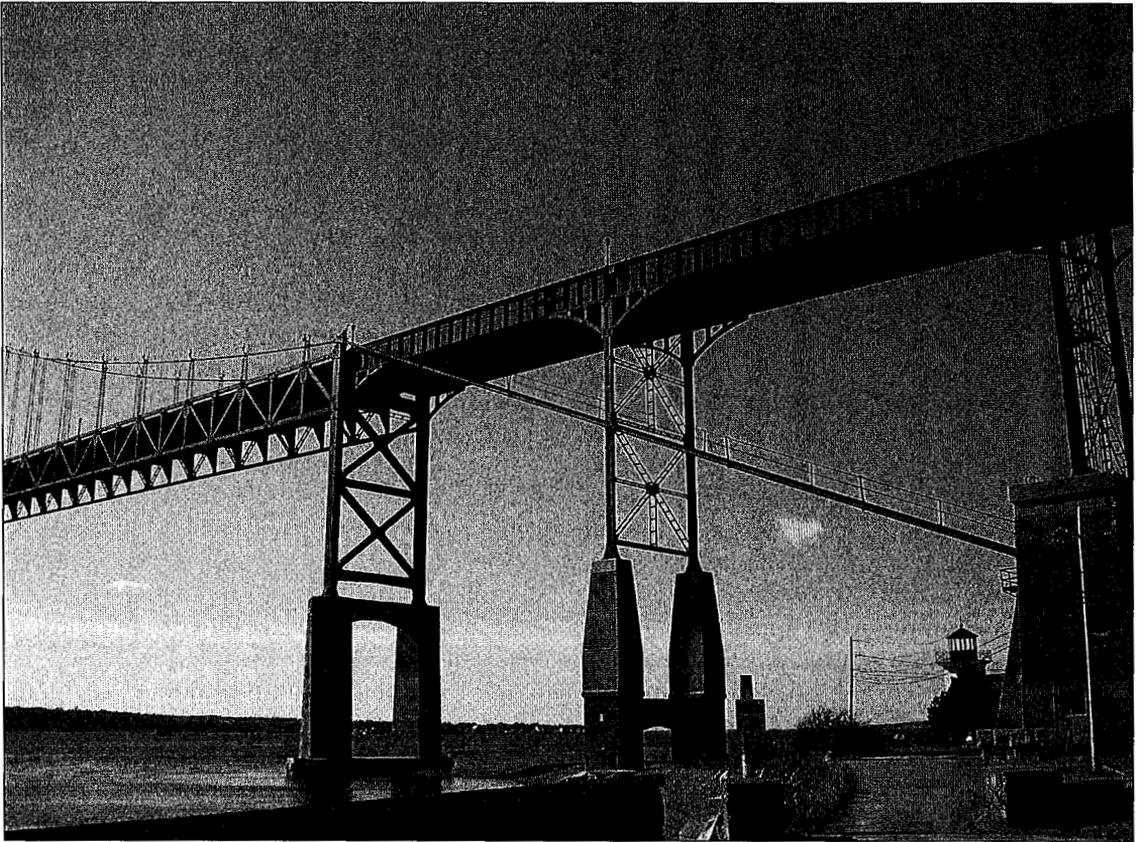
### Mount Hope Bridge abutments and approach spans.

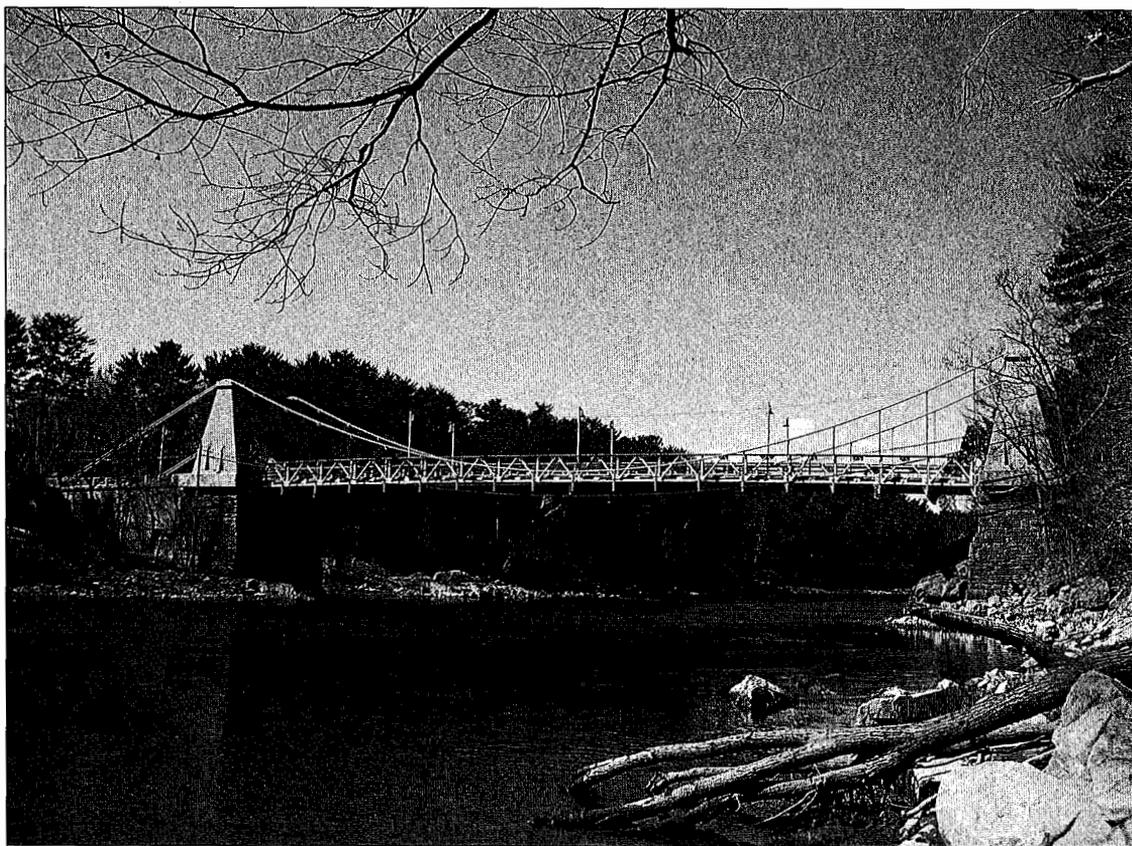
### Merrimack River Chain Bridge, Massachusetts.

The structure now consists of a deck truss-gravity anchored suspension bridge that measures 384 feet between cable anchors (which also includes the 70-foot retained earth approaches). The suspension span is 244 feet (not including the approaches). Instead of wood, the deck truss was constructed with a 7.25-foot-high single-intersecting steel pony stiffening truss hinged at the pier ends and at the center. The roadway width is 24 feet with a 4-foot-wide timber sidewalk.

The problem of those corroding wrought iron chains was solved by using four 3.5-inch-diameter cables containing bundled steel wires. There are two cables on each side that are supported by castings and rollers situated at the top of two hollow reinforced concrete towers. The main cable ends are linked to groups of 1-inch by 5-foot steel eye bars in massive concrete

anchorage. The towers stand about 34 feet above the roadway surface and are supported on the original granite piers. The granite block piers are founded on rock, but are interestingly not bonded with mortar. Instead, wooden dowels were placed in some of the larger blocks to give the blocks strength.

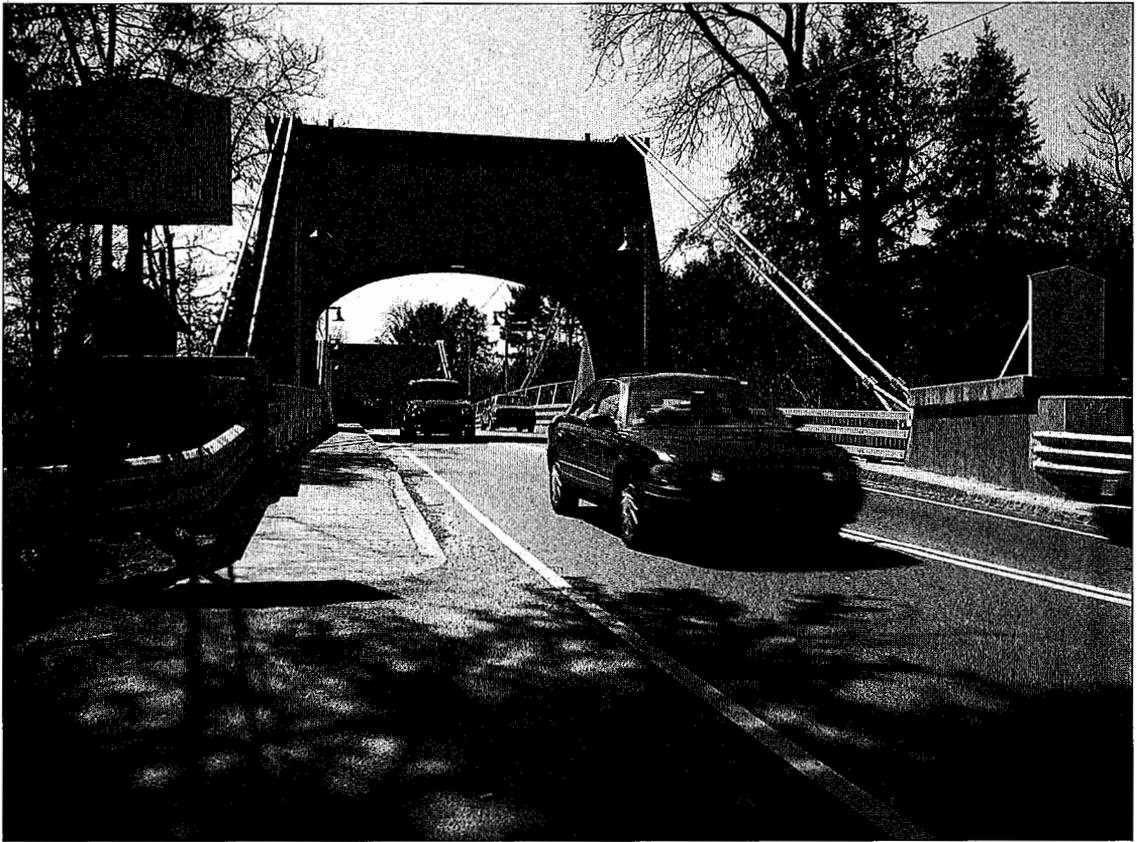
**Merrimack River Chain Bridge roadway.**

The orthotropic deck system was installed for two reasons: it is a very lightweight deck system; and it adds protection to the floor beams from roadway surface constituents. This deck system consists of a steel deck plate longitudinally stiffened by trapezoidal-shaped steel ribs. It acts as a composite by using an extension plate to connect the existing floor beams with the steel ribs. By connecting the floor beams, added torsional stiffness to the deck system is achieved. Also, a special 0.375-inch-thick polymer concrete wearing surface was placed on top of the orthotropic steel plate deck.

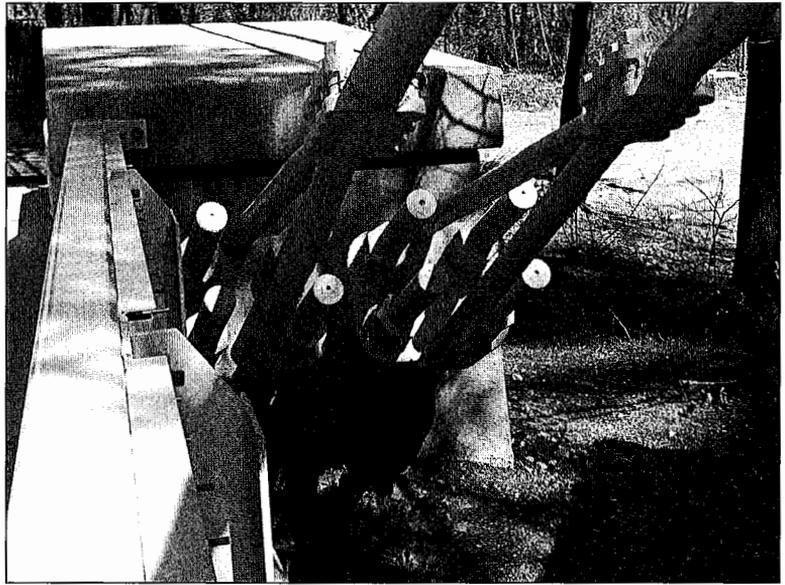
**Merrimack River Chain Bridge cables.**

The suspender cables consist of 2.75-inch steel spaced approximately every 12.33 feet along the deck. They connect from the four main suspension cables and attach to the built-up steel riveted truss floor beams using saddle plate connections. The shorter suspender cables are actually steel rods connected to the floor beams, and the longer cables wrap around a circular plate connecting to the saddle plate.

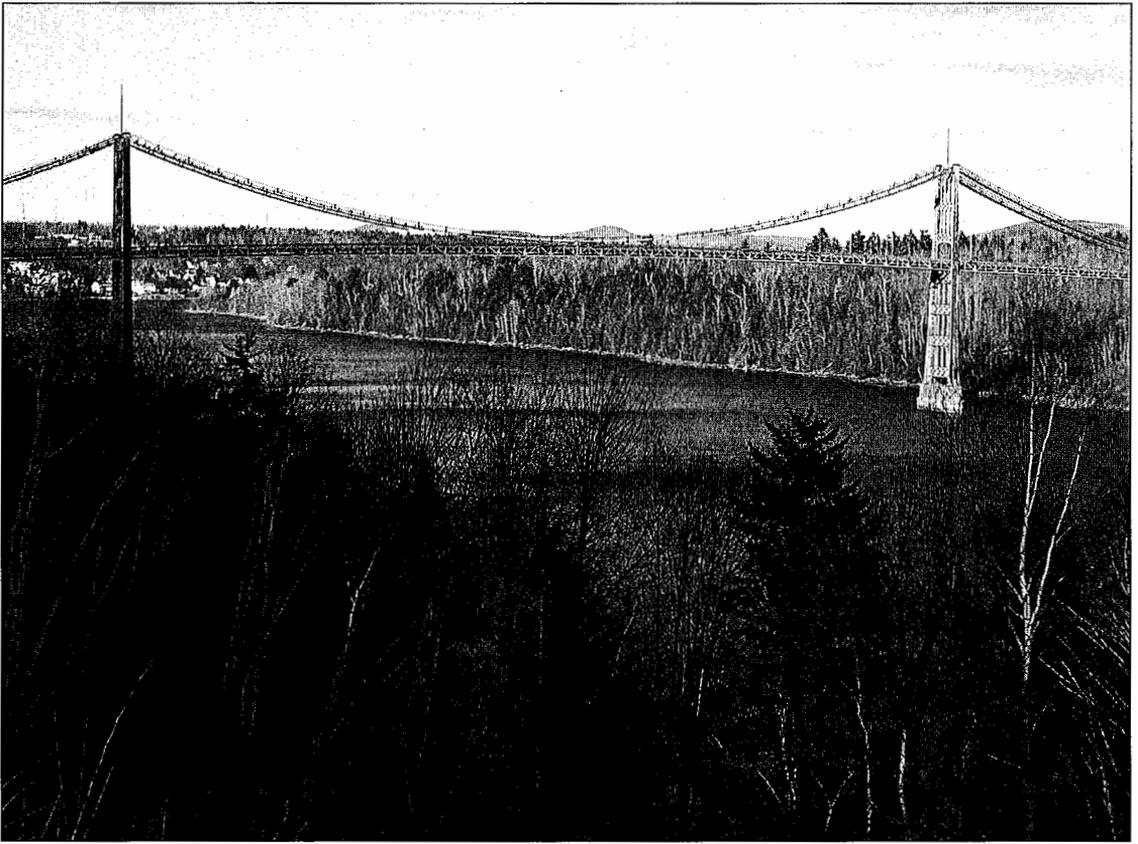
**Waldo-Hancock Bridge, Maine.**

The Waldo-Hancock Bridge is a gravity-anchored suspension bridge with concrete abutments. Like Steinman's other suspension bridges, it has steel pylons and piers supporting the spans. The main span is 800 feet long, and the overall length including approaches is 2,040 feet. The towers reach a maximum height of 236 feet. The deck has deep stiffening trusses, although wind vibrations are still perceptible while crossing the bridge. The bridge has one lane in each direction, which has had a substantial impact on traffic patterns along the Atlantic coast route. Economic concerns led to a helical design of the cable strand system. Helical strands are capable of spanning longer distances and carrying added strength. However, splicing broken helical wires is next to impossible, and would eventually force the replacement of the span.<sup>15</sup>

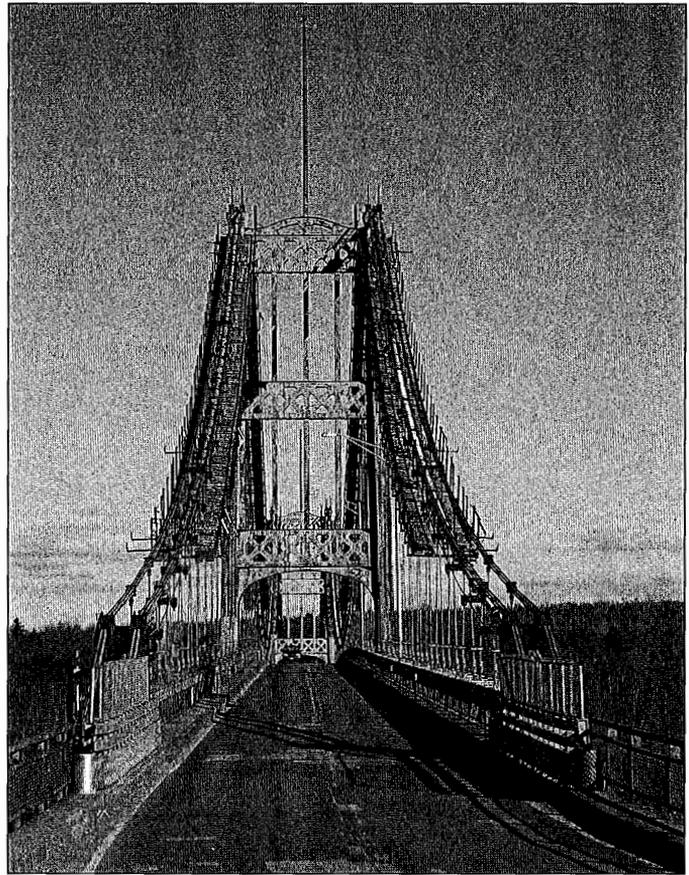
**Waldo-Hancock Bridge roadway.**

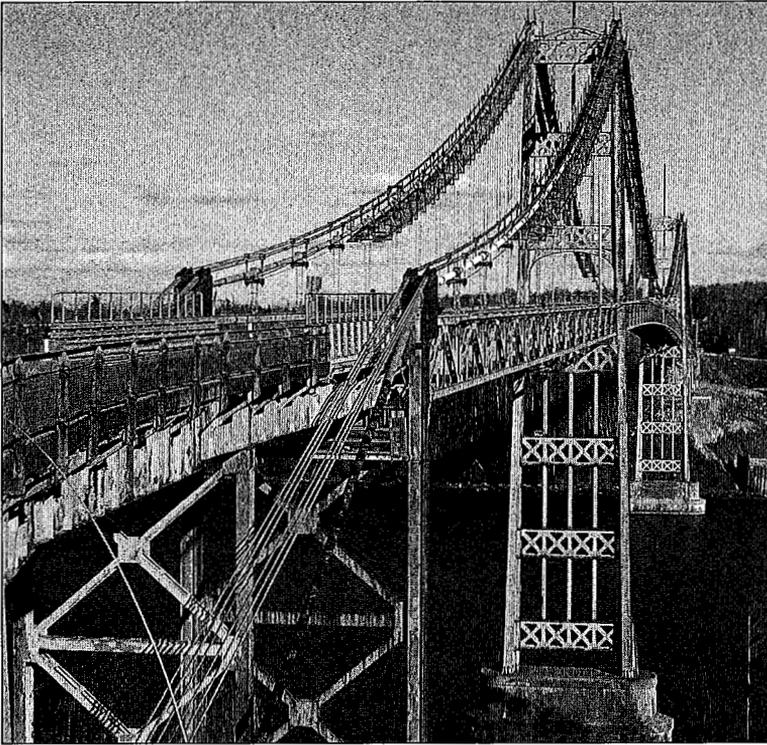
**Waldo-Hancock Bridge primary and secondary cable systems.**

These problems led to emergency rehabilitation work, and an expedited replacement timetable.<sup>17</sup> Additional work was done in order to support the sagging spans. A highly complex and innovative load transfer procedure was performed in 2003 in order to reduce the load on the corroded cables. At an overall cost of \$2.5 million, new abutments and a new cable system were linked to the entire structure via steel plates, which were welded to the original system. The new system now sup-

ports 50 percent of the dead load, and allowed the Maine Department of Transportation (DOT) to increase the load rating to 40 tons. Furthermore, the immediate need for a new bridge has increased the cost to build it, which is now estimated to be roughly \$75 million.<sup>16</sup>

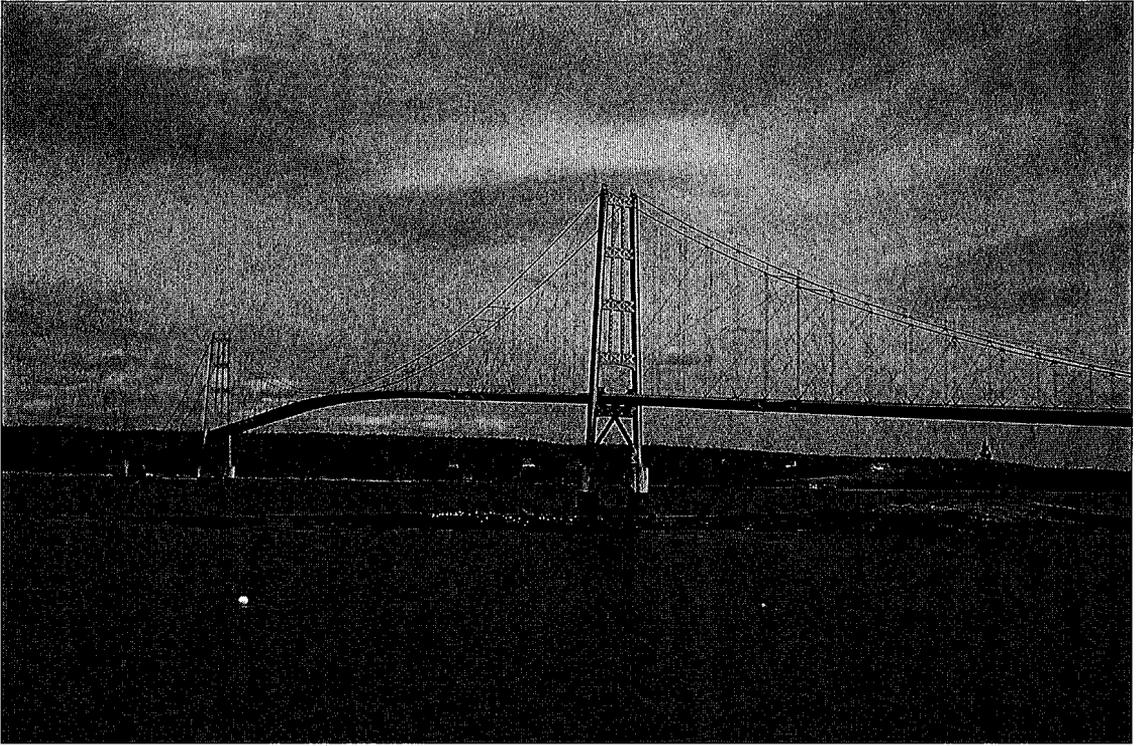
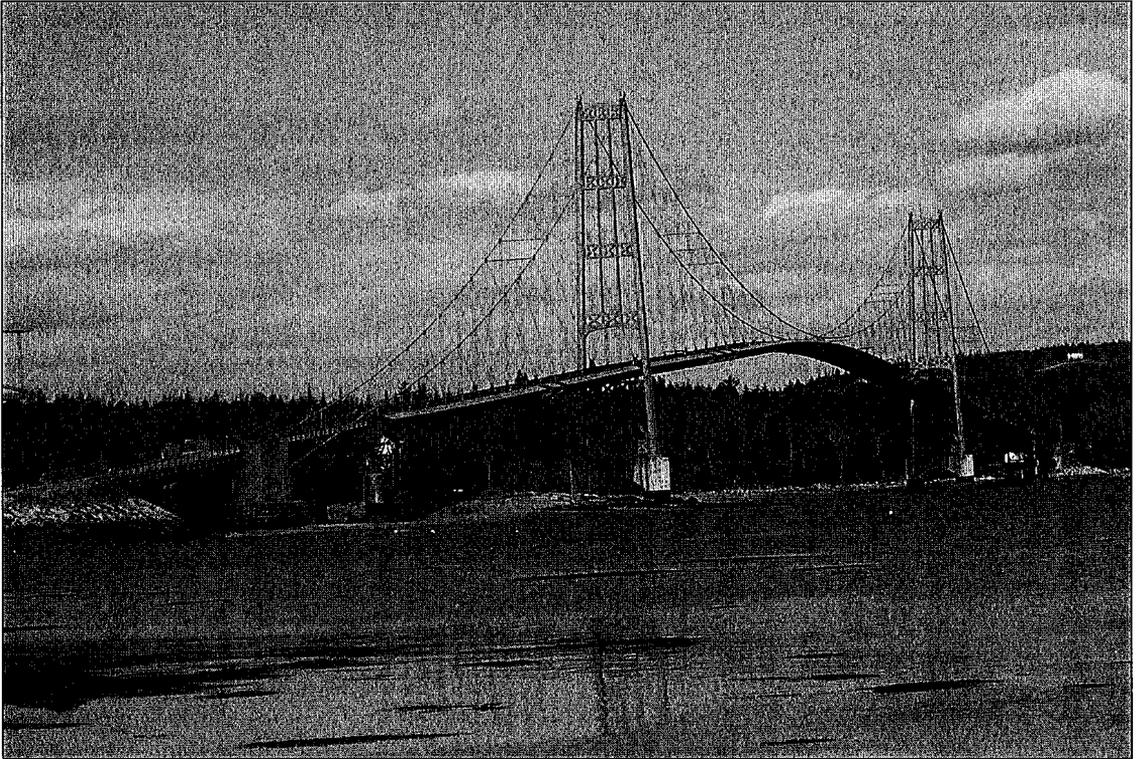
**Deer Isle Bridge, Maine, from the west.**

**Deer Isle Bridge from the east.**

The Deer Isle Bridge is a gravity-anchored suspension bridge with a main span of 1,081 feet. It has steel pylons and piers and it reaches a maximum height of 210 feet. The cable system is unwrapped (meaning that there is no protective casing system and the cables themselves are exposed). Each individual cable was coated to protect against corrosion. The cables run into concrete abutments at the ends without any end casings. The bridge has a thin plate girder deck, one of several that were designed during this period. This method of deck construction led to elegant, slender designs, but also made the bridge susceptible to failure from lateral wind loads. The Tacoma Narrows Bridge is the most famous example of this type of deck design. The pitch of the Deer Isle Bridge is dramatic and it borders on parabolic when seen in elevation. The bridge has one lane in each direction.

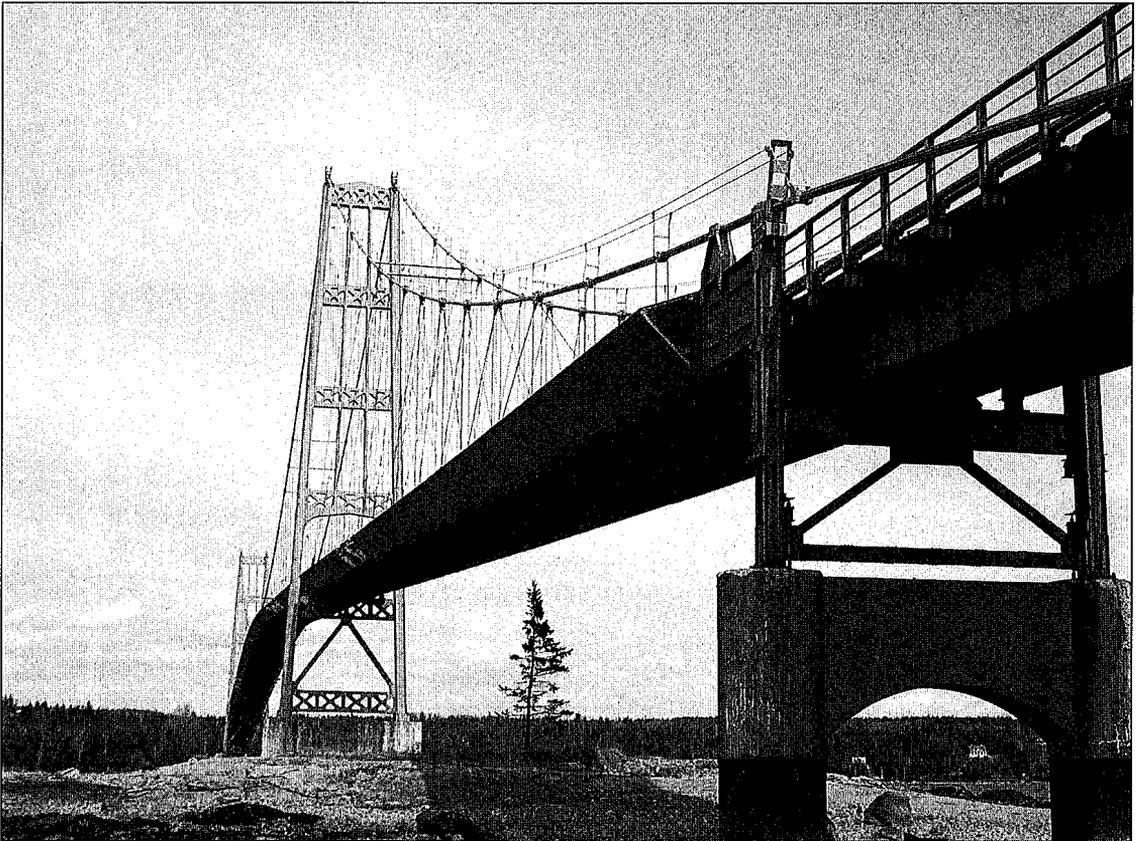
### Deer Isle Bridge orthotropic deck retrofit.

cable corrosion. The inspection also found moderate to heavy local corrosion in the steel superstructure, which is to be expected considering the saltwater environment of the bridge. Currently, the main issue with the bridge is substantial cracking in the deck. While there is no major spalling of the concrete yet, the deck is delaminating and it needs substantial repair. Work is scheduled to begin in 2005.<sup>15</sup>

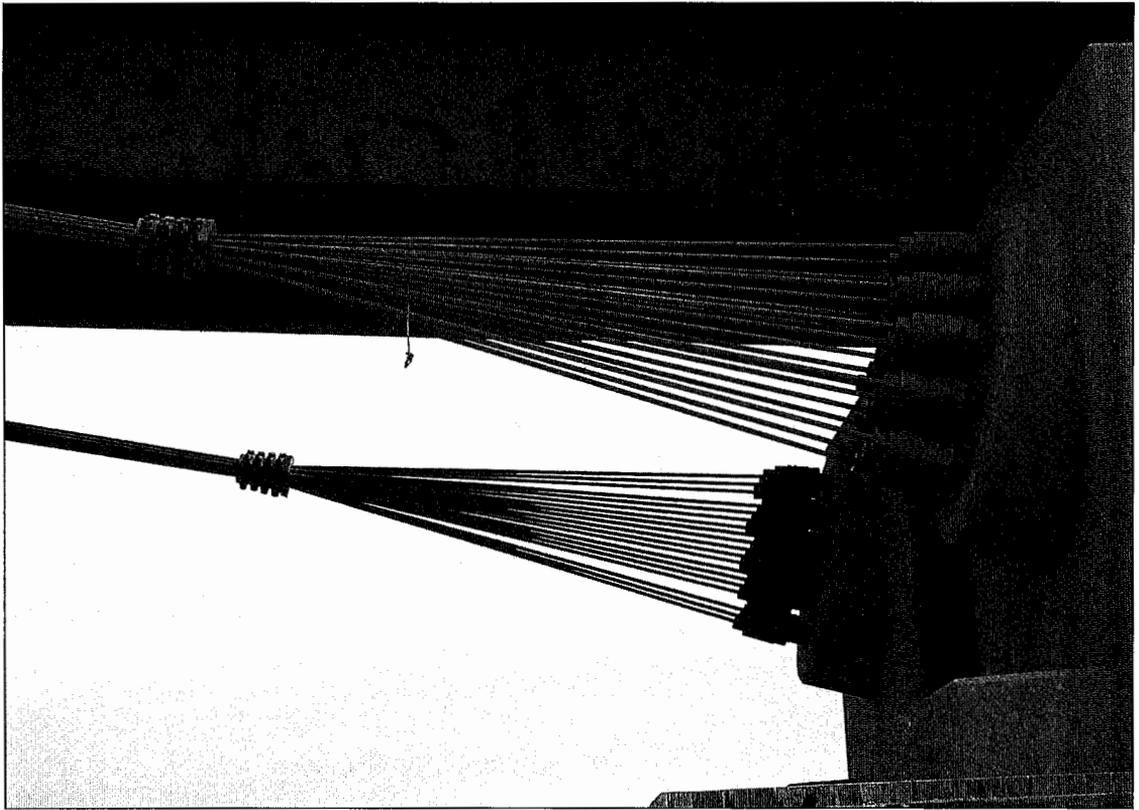
### Deer Isle Bridge cables.

loadings of up to 10 inches even in even moderate wind conditions. These reports led the designer/contractor to retrofit the bridge with diagonal cable stays in order to prevent major vibrations. After the Tacoma Narrows disaster, the Deer Isle Bridge was heavily monitored. A minimum spacing of 500 feet between heavy trucks was ordered, as well as load ratings and closings in high winds. Several major wind studies were undertaken during the 1980s, with the end result being a retrofit of aerodynamic fairings to the plate girder deck in order to counteract wind forces. The bridge is now constantly monitored via wind testing mechanisms attached to the deck that were installed in 1981. These mechanisms send real-time data to research and monitoring facilities in Virginia for further analysis. Despite the retrofit, many locals still comment on uncomfortably high vibration levels during high winds, although designers claim a safety factor of 2.5 for the current bridge.<sup>19</sup>

Aside from the vibration problems, a recent rehabilitation study found the bridge to be in good condition considering its age. The unwrapped cables were very thoroughly inspected and they were rated to be in “good” condition. The lack of corrosion is most likely due to fact that the unwrapped strand system did not have the same issues that plagued the Waldo-Hancock Bridge further south where the wrapping trapped water and accelerated
