An Innovative Rehabilitation Project at the Cobble Mountain Dam Outlet Works

An innovative plugging system provided cost savings and reduced risk on a rehabilitation project for a diversion tunnel high-pressure outlet works facility for a city water supply system.

NEILL J. HAMPTON & JAMES CONSTANTINO

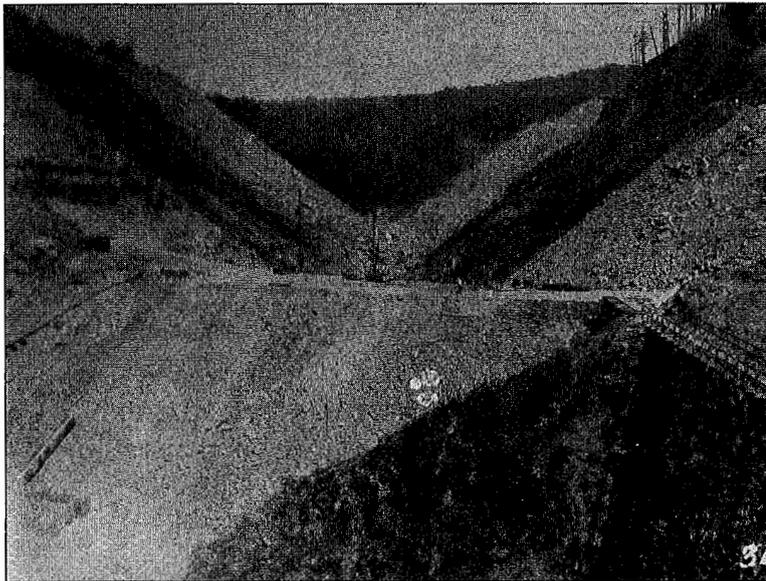
FIGURE 2. Cobble Mountain Dam at about half completion in 1929.

The earthen dam is 240 feet high, retains 22.5 billion gallons of water and is one of only a handful of dams constructed using the hydraulic fill method in the United States (see Figures 1 & 2). The Little River system has the capability of delivering 100 million gallons per day (mgd) of finished water to Springfield and its outer lying communities, serving a total population of approximately 250,000. Raw water is conveyed to the West Parish Filters Water Treatment Plant from Cobble Mountain Reservoir and the raw water conveyance system is comprised of the following key facilities:

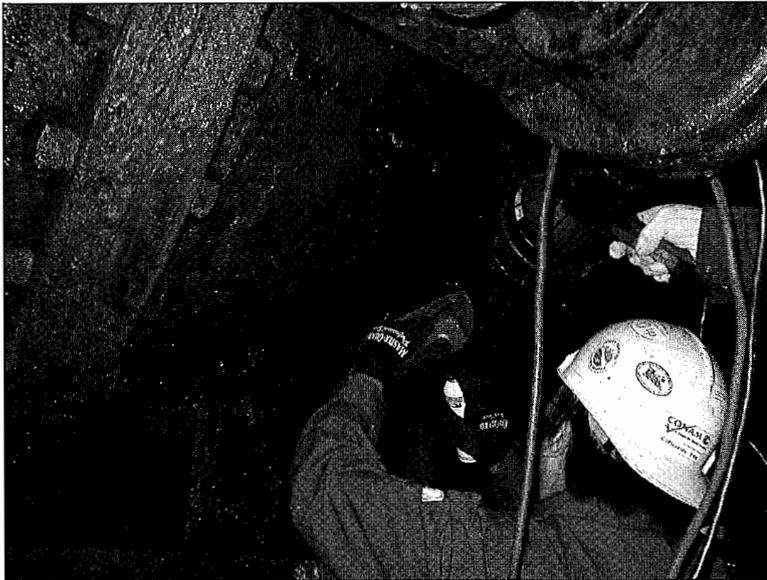
from the reservoir for disassembly of the auxiliary components in the dry. The engineering consultant and a sub-consultant conducted wet magnetic particle and ultrasonic thickness testing on a 2-inch grid across both halves of the valve body (see Figure 20). Based on the results of this survey, it was determined that the valve body castings were fit for service, and would likely exceed the design life of eighty years.

FIGURE 20. Wet magnetic particle inspection of the steel rotary valve body castings.

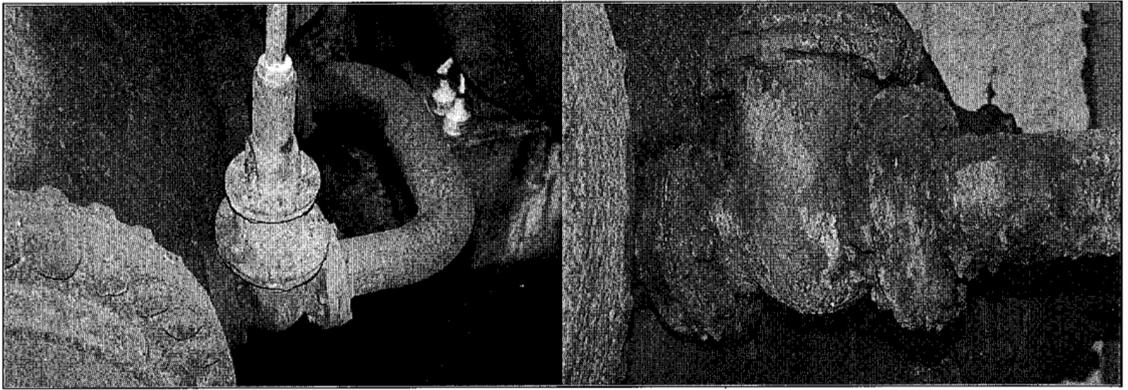
The existing auxiliary bypass valves had severe corrosion and material loss requiring complete replacement (see Figure 21). The challenge was the location of the valve, which was always under system pressure and prevented removal of the valve in the dry because the upstream piping was under full reservoir pressure and could not be isolated. The bypass valves were 5 inches in diameter and had British Standard (BS) flanges installed on double-ended studs with British Standard Whitworth (BSW) threads. Ultrasonic thickness testing indicated a bypass pipe wall thickness of less than 0.125 inch. The pipe wall had deteriorated to a point where replacement was the only option.

FIGURE 21. Rotary valve 5-inch auxiliary bypass valves showing extensive corrosion.

The bypass piping would be replaced with TIG-welded Type 304L stainless steel pipe. The 5-inch bypass valves would be replaced by 4-inch CF-8 stainless steel gate valves. The existing BS flanges were thinner than modern ANSI flanges, so the existing flange studs would be

replaced with custom-designed 304 stainless steel double-ended studs having 55-degree BSW on one end, and 60-degree unified coarse threads on the other. The 4-inch diameter blow-off valves, originally installed on flange bosses located at the bottom of the rotary valves were removed in the early 1990s and replaced with blind flanges (see Figure 22). These valves are essential for flushing rust, silt and rock fragments that are deposited in the main valve body after operation. These valves would have to be replaced.

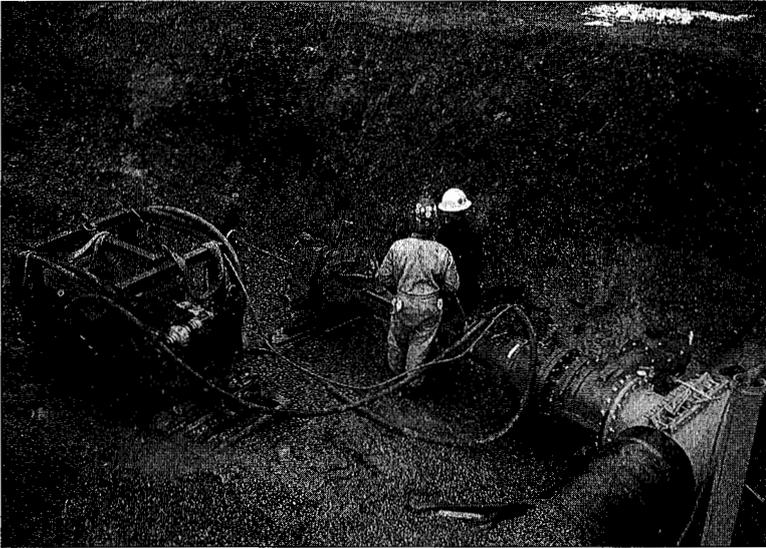
FIGURE 24. A typical wet-tap installation.

to the pipeline, and remove a coupon from the pipe wall (see Figure 24).

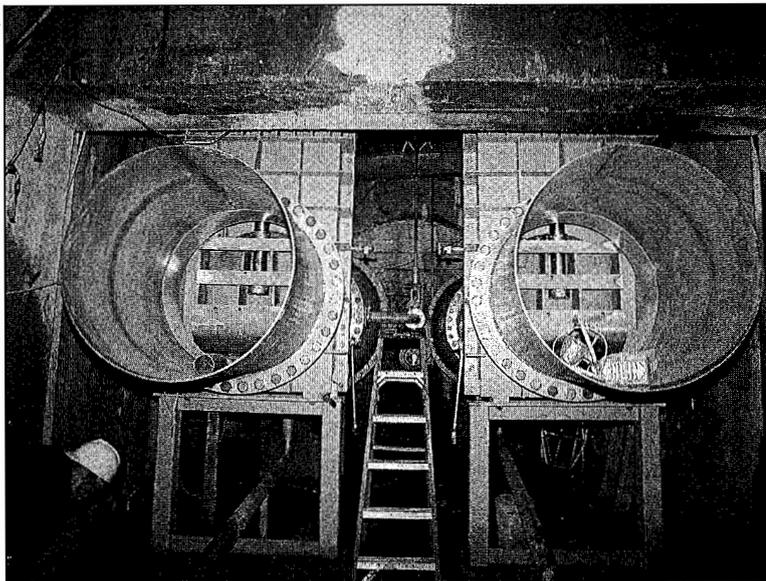
FIGURE 55. Jet-flow gates and discharge piping (view upstream).

The test was a complete success and was well documented. The maximum flow from both jet-flow gates was recorded at approximately 600 mgd, and the 11.5-foot diameter diversion tunnel was flowing full at the discharge portal, under pressure, at this flow rate (see Figure 56). The maximum airflow in the shaft with both gates fully open was 210,000

cubic feet per minute. The differential pressure between chambers was beyond measure, when both gates were opened simultaneously, and the gate chamber access door closed. The door was opened to allow sufficient air to flow down the access stairwell to relieve the vacuum. There was no vibration from the jet-flow gates during the test and noise levels were below OSHA limits at all times, even when the door was opened. The rotary valves created some periodic, loud cavitation that was clearly audible when the jet-flow gates were fully open, but it was not a cause of concern.
