Construction of Underground Facilities for the Narragansett Bay Combined Sewer Overflow Program, Phase I

An ambitious project overcame a rocky start and used innovative practices to meet significant construction challenges.

JOHN KAPLIN & GEOFFREY HUGHES

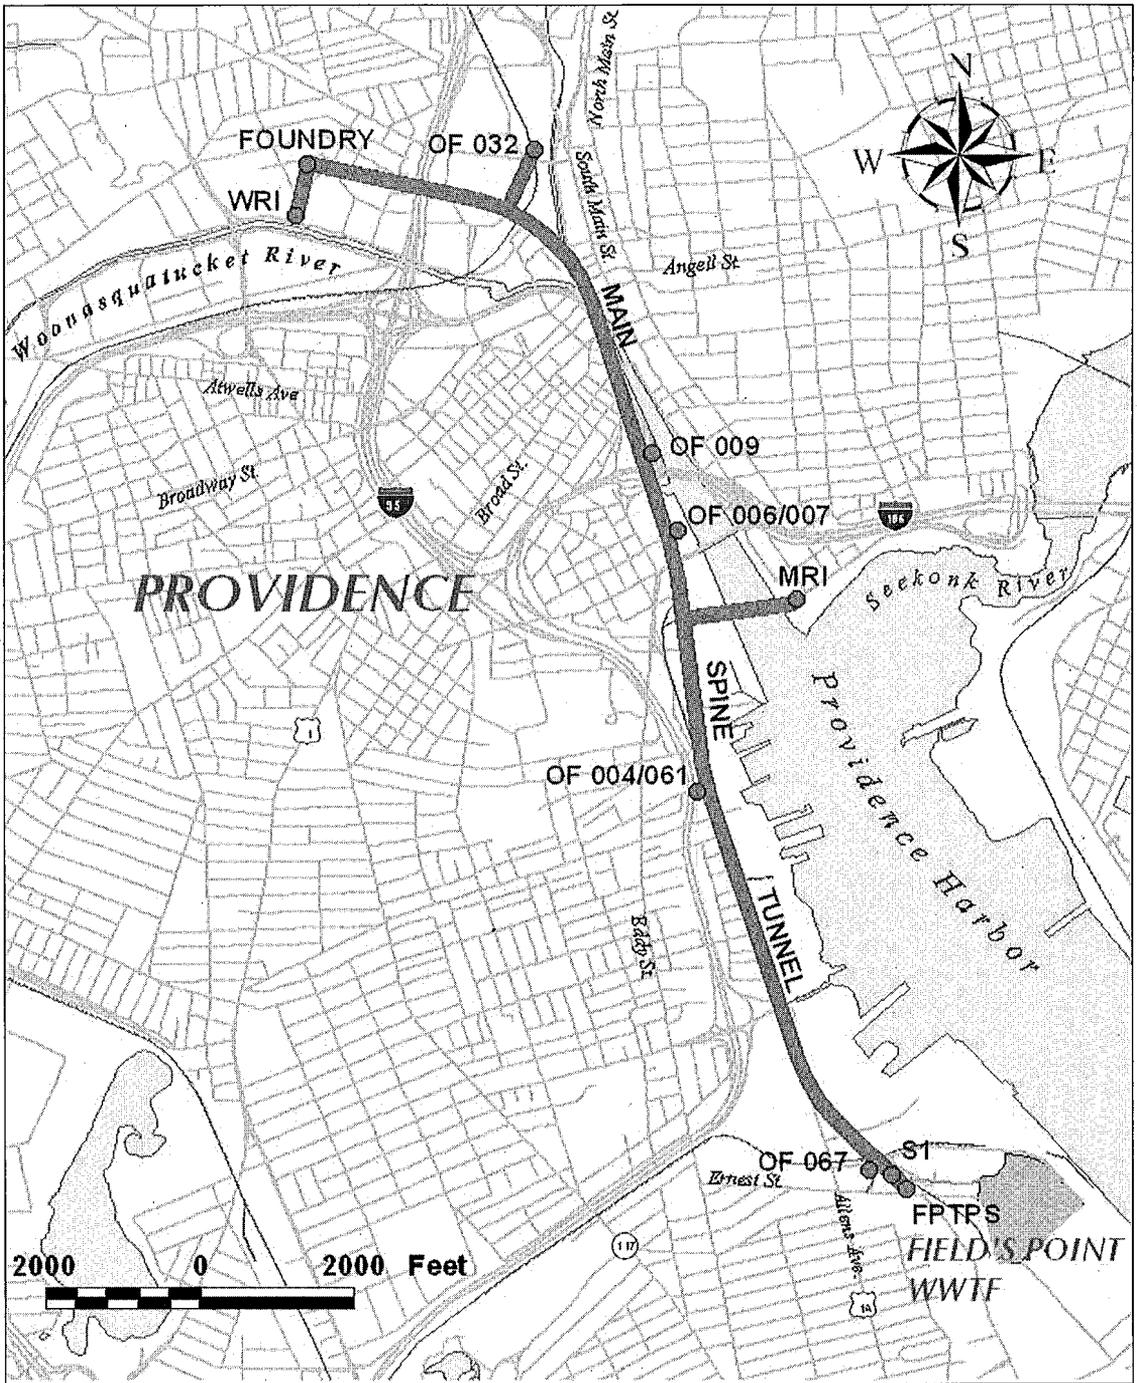
FIGURE 1. Project layout – MST alignment and shaft locations.

As summarized in Figure 1, the Phase I system intercepts existing sewers at nine diversion/relief structures and transfers flow underground via seven gate and screening structures and 5- to 9-foot-diameter drop shafts. At the bottom of these shafts, 8.75- to 15.75-foot-diameter de-aeration chambers in turn connect to 8-foot-diameter adits. The adits total 4,057 feet in length and carry flows to the 16,284-foot-long, 26-foot-diameter, 230-foot-deep main spine tunnel (MST). At the north end of the project area, the 26-foot-diameter foundry shaft provides ventilation/access, while in the south the S1 screening shaft sits adjacent to the new 50 million gallons per day (mgd) Fields Point Tunnel Pump Station (FPTPS). The pumps are housed in a 300-foot-deep cavern, with dimensions 117 by 61 by 68 feet. This cavern is connected to the surface by an 11-foot access shaft and a 32-foot

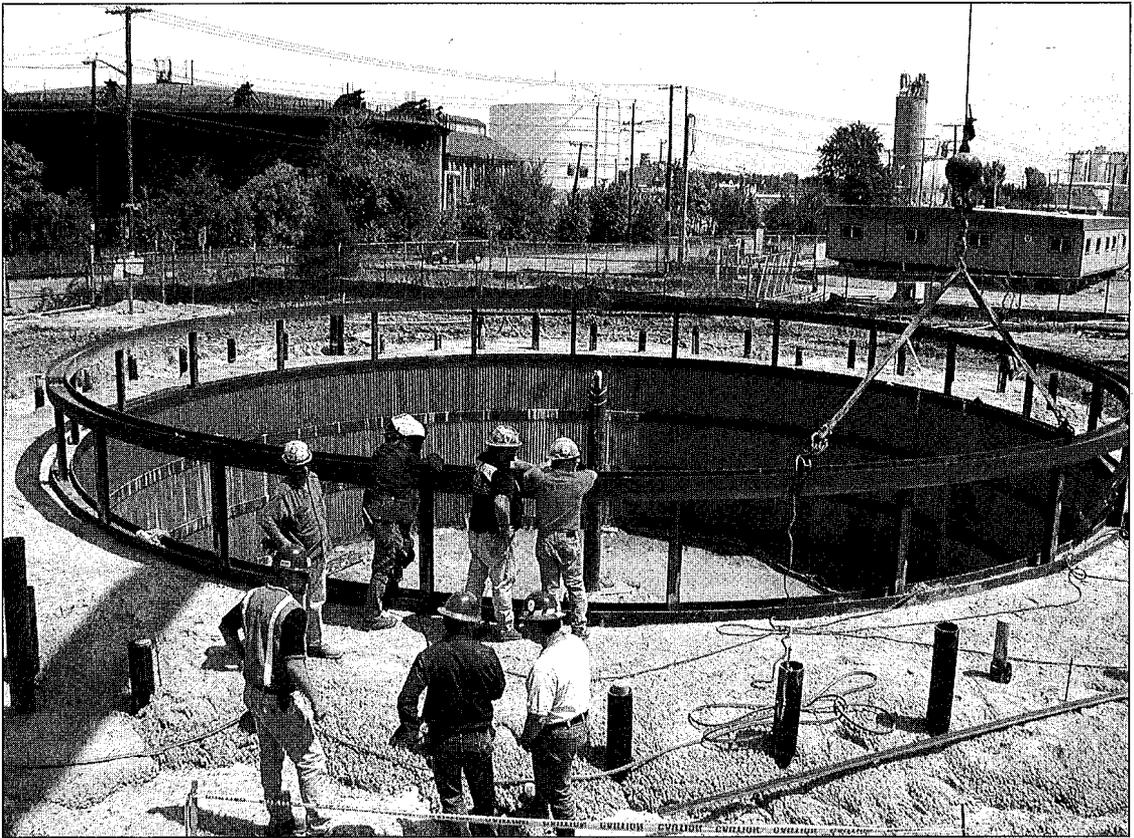
FIGURE 2. S-1 shaft collar construction in June 2002, with the freezepipe casings in the foreground prior to being plumbed and operated.

A 14-foot-deep collar (see Figure 2) at the S-1 shaft was constructed in May 2002, the subcontractor installed the freeze system and the freeze was initiated in late June 2002. The bottom of the collar was situated just above the groundwater table.

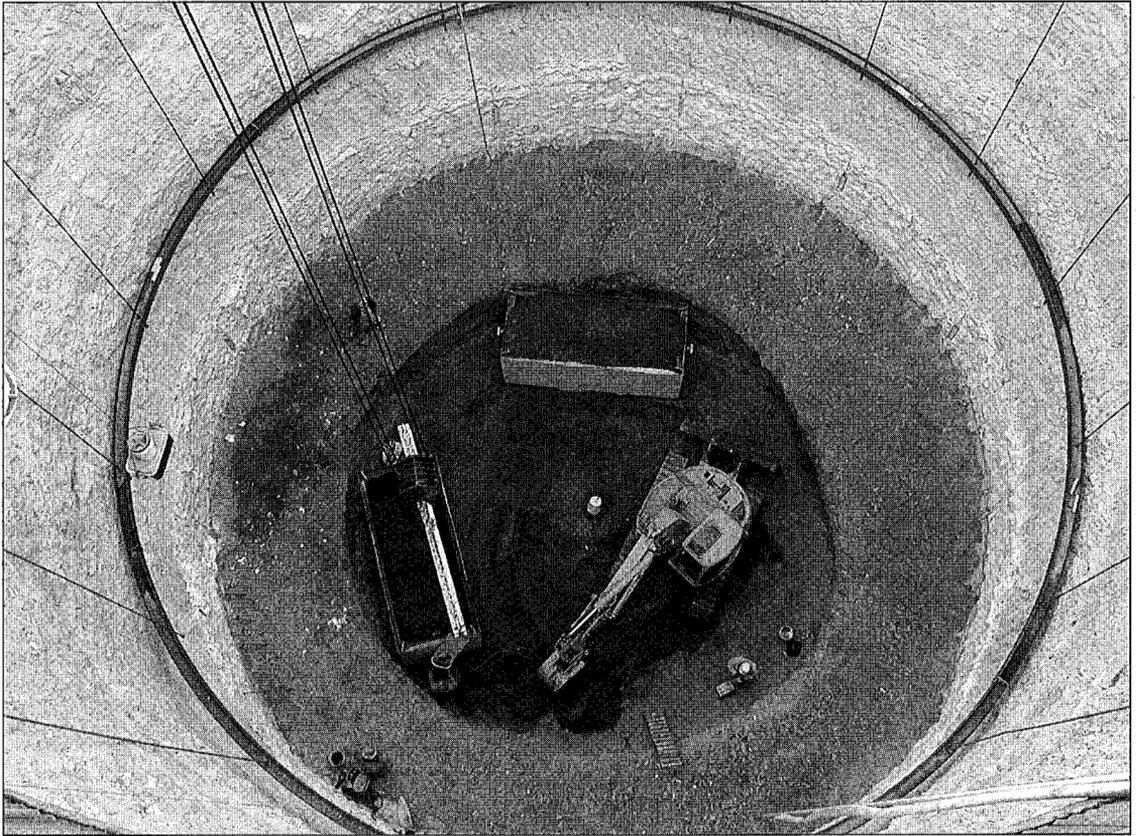
FIGURE 3. With depth, the width of the outer rim of frozen soil increased while the inner core of unfrozen soil decreased, slowing production.

Due to the extended freeze period, the freezeway grew considerably thicker than planned, which resulted in slower than expected excavation rates since the frozen material had to be chipped with a hoe ram (see Figure 3). Upon reaching the top of rock,

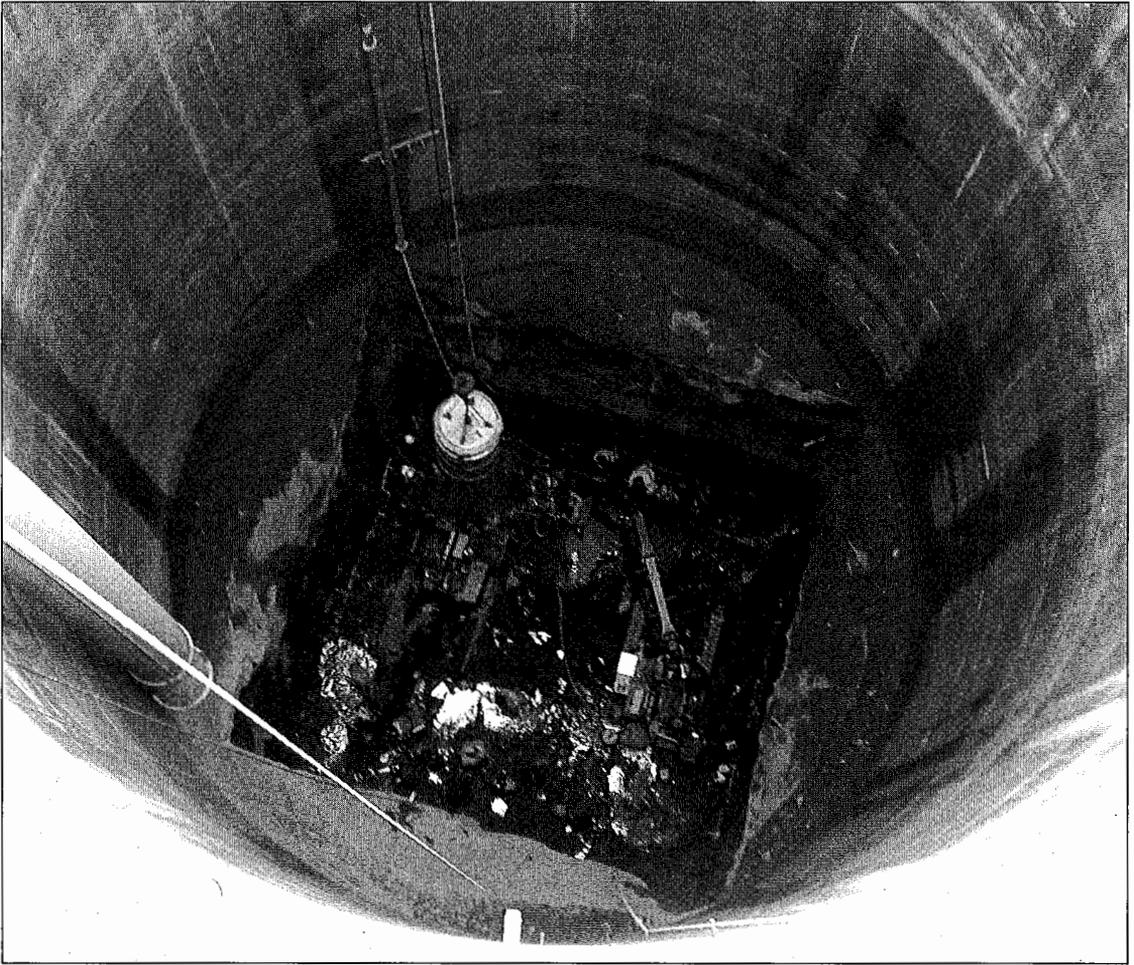
FIGURE 4. Sinking the S-1 shaft into rock below the concrete lining through soil.

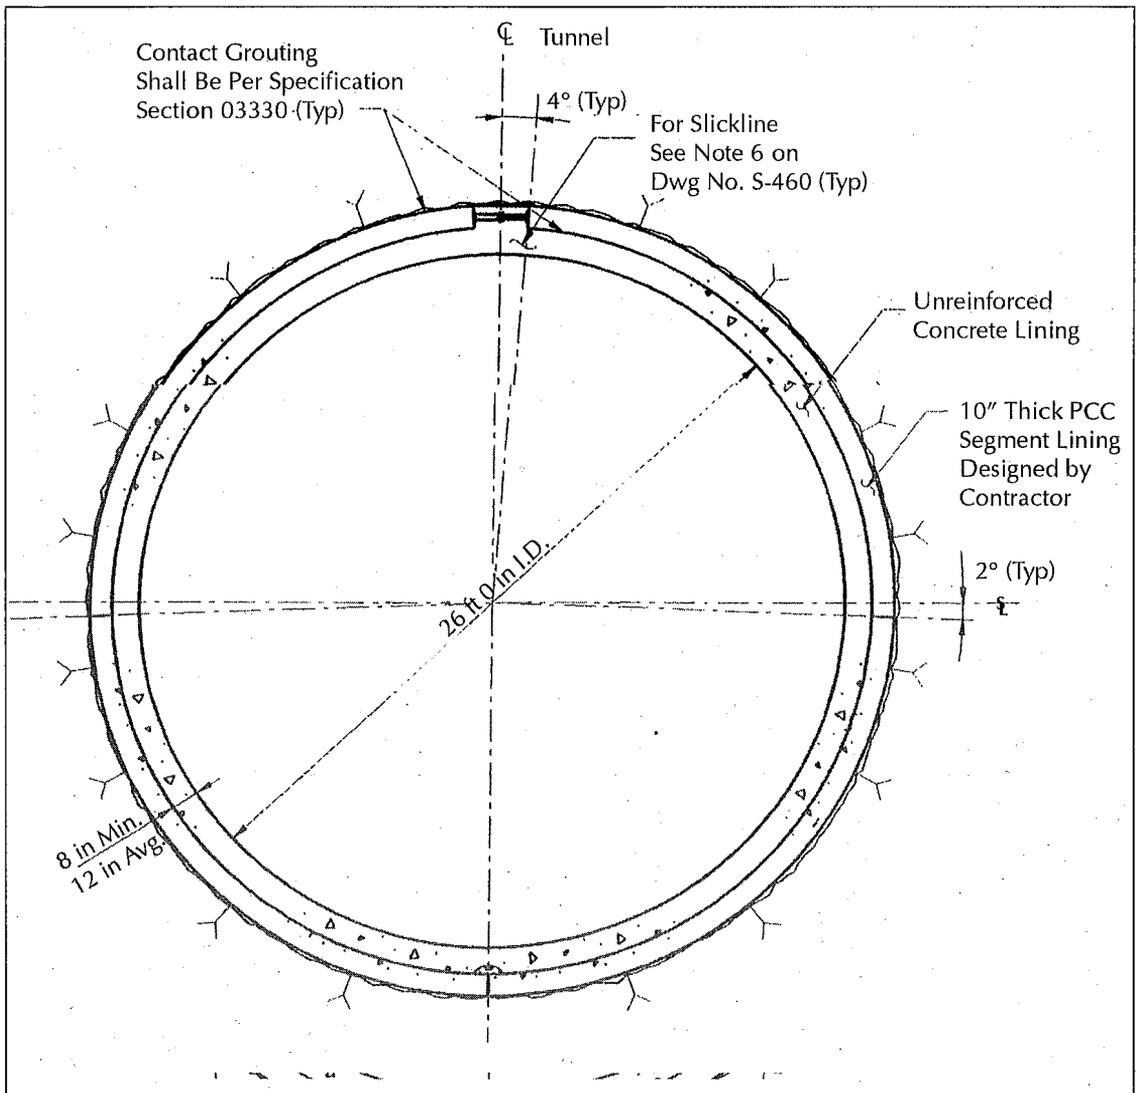
FIGURE 5. The composite MST lining system.

On previous projects the contractor had successfully employed a two-pass excavation and lining system whereby expanded precast segments temporarily support the rock during tunnel mining and a permanent liner is placed thereafter. Shortly after the award of the contract, the contractor proposed that in lieu of the 18-inch CIP contract lining that would be placed within the contractor's 10-inch precast initial support for a total concrete thickness of 28 inches, a 22-inch-thick composite liner consisting of 10-inch-thick precast segments and 12-inch-thick CIP should be considered (see Figure 5). Ultimately, this value engineering cost proposal was accepted and the contract price reduced. The savings were realized predominantly from a reduction of nearly 28,000 cubic yards of concrete and a similar reduction in handling mined rock.

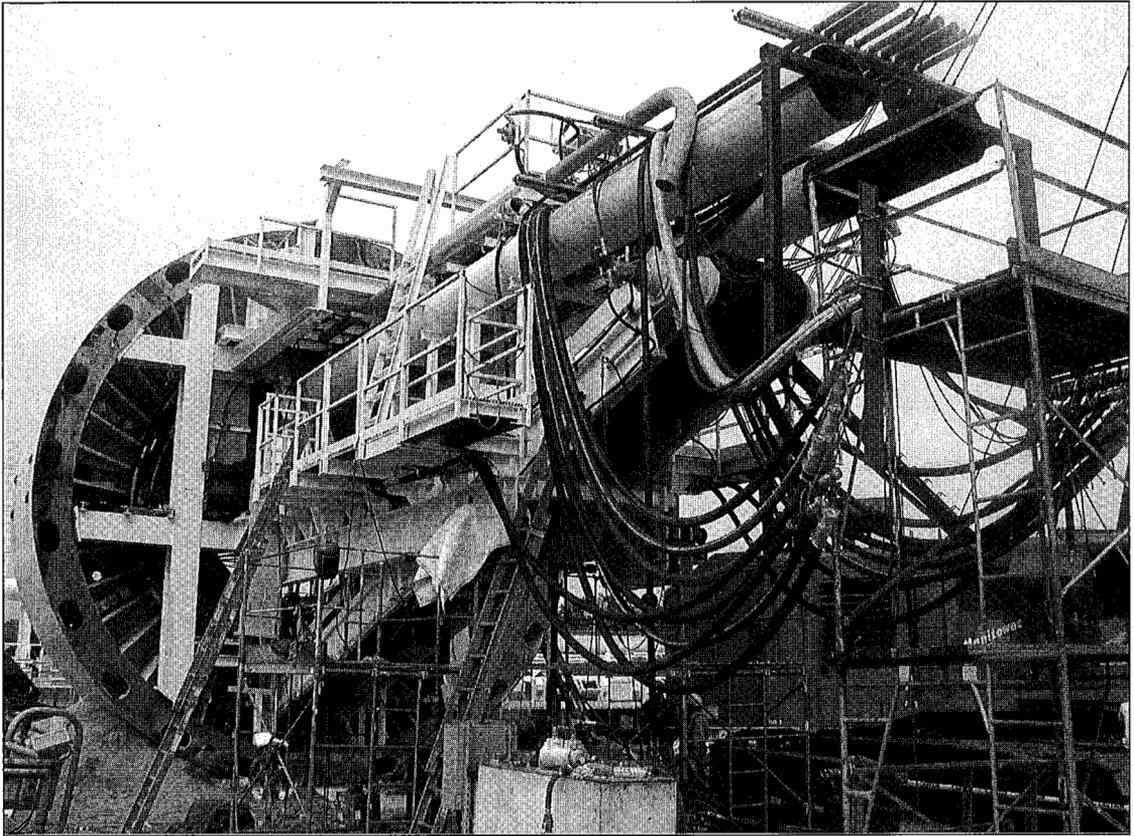
FIGURE 6. The TBM nearly fully assembled at the surface prior to disassembly and installation in the tunnel.

The cutterhead was 30 feet in diameter and was dressed with sixty-five 17-inch-diameter back-loading cutters. The machine employed twenty jacks to propel and steer off precast segments with a total available thrust of 6.3 million pounds. The cutterhead rotated at 3 to 5 revolutions per minute (rpm) and was driven by twenty hydraulic motors rated at a total of 2,465 horsepower.

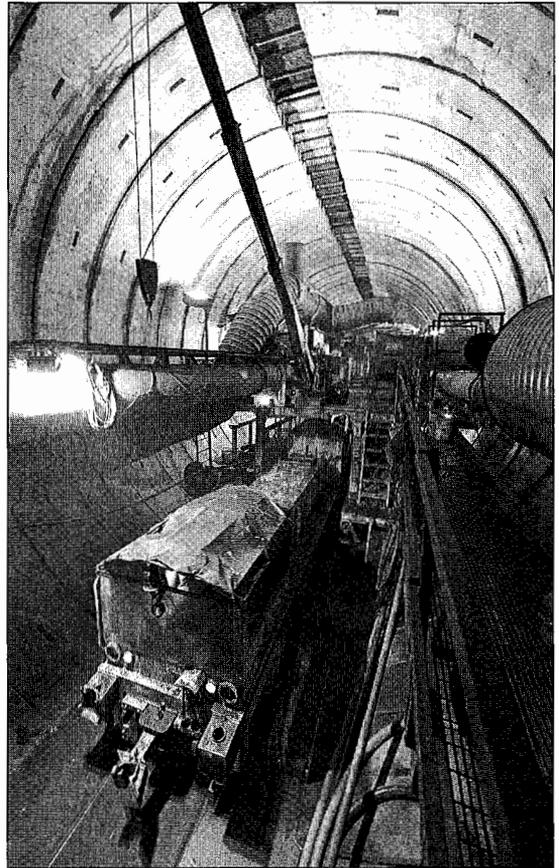
FIGURE 7. A view of the locomotive at the rear of the trailing gear. Note the ventilation intake on the left side and exhaust from the TBM face into the tunnel hard line at right.

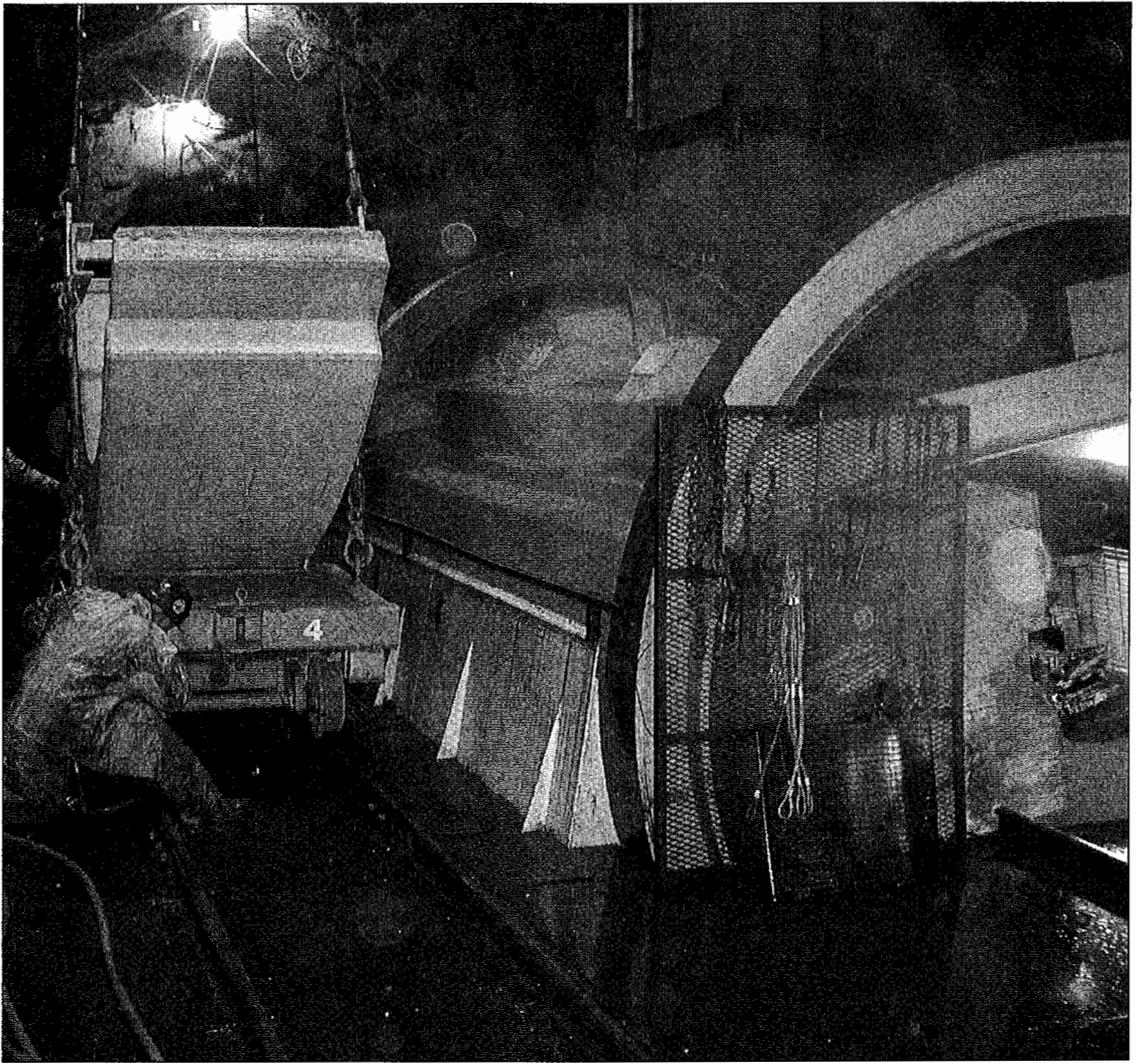
FIGURE 8. The bottom of the S-1 shaft was a busy place during TBM mining. Segment cars were lowered by crane to the track as seen at the left, while muck cars spilled their load onto a rollover dump that fed a vertical conveyor on the right.

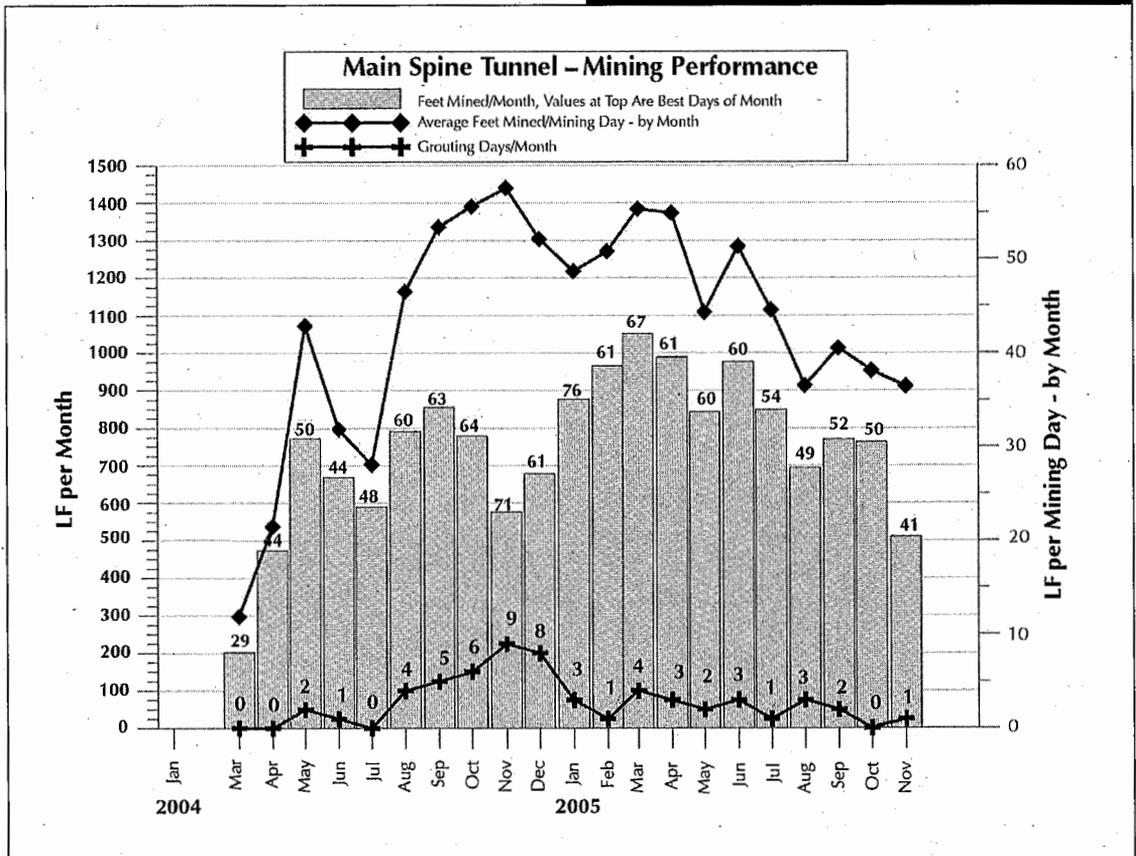
FIGURE 9. TBM advance rates.

Figure 9; the mining crew at hole-through are shown in Figure 10. Figure 9 also shows the impact of pre-excavation grouting on mining production.

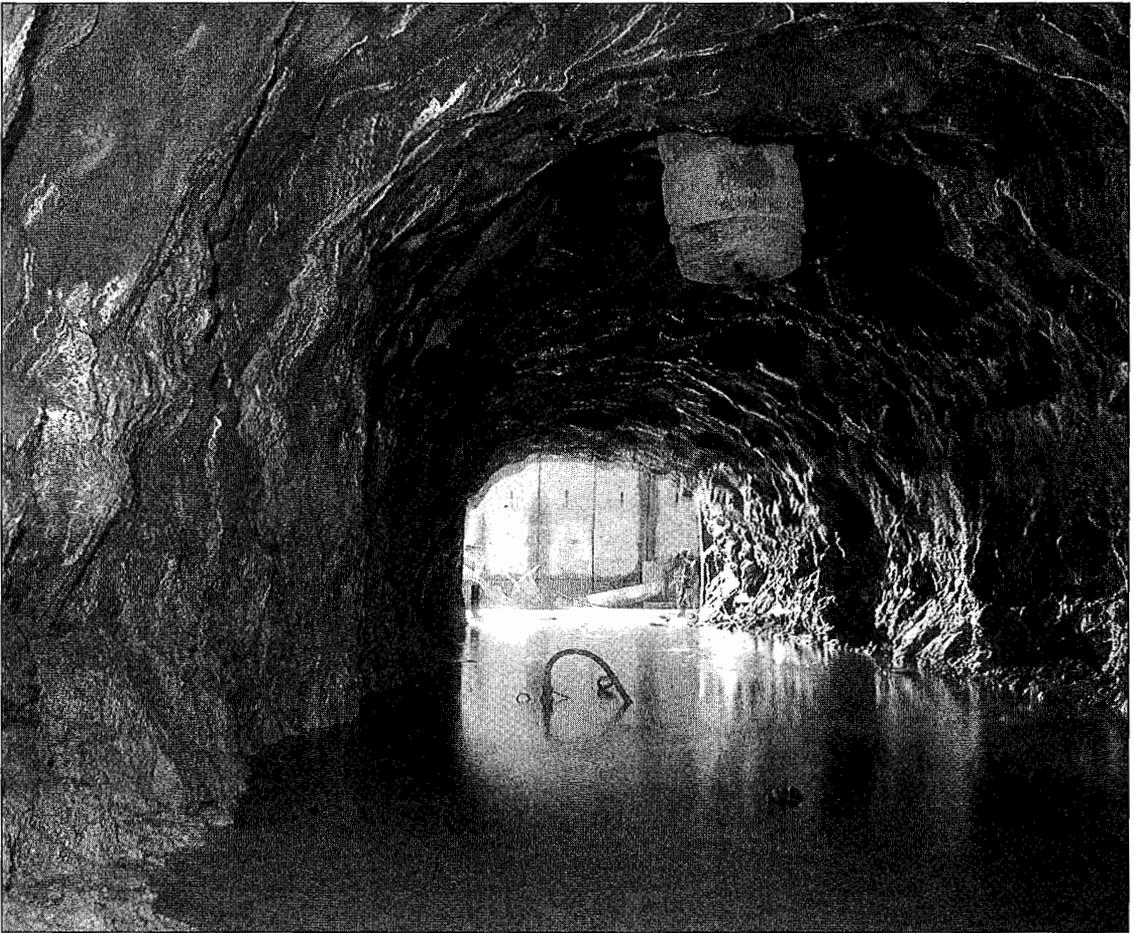
FIGURE 11. Intersection of the adit de-aeration chamber and the vent shaft in the 004/061 adit, with the MST visible in the background.

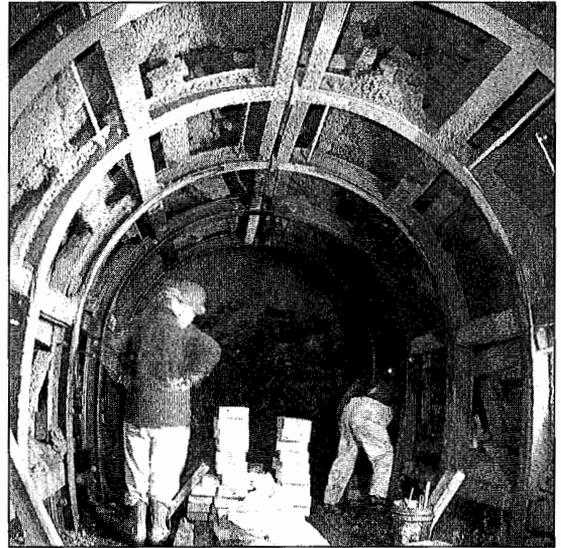
FIGURE 12. The installation of ribs and lagging in the WRI adit.

The 067 adit was driven concurrently with the excavation of the starter tunnel since the adit portal was within 50 feet of the S-1 shaft. The adit at the far north end, the WRI adit (see Figure 12), was driven from the base of the foundry shaft since it too was within 50 feet of that shaft.

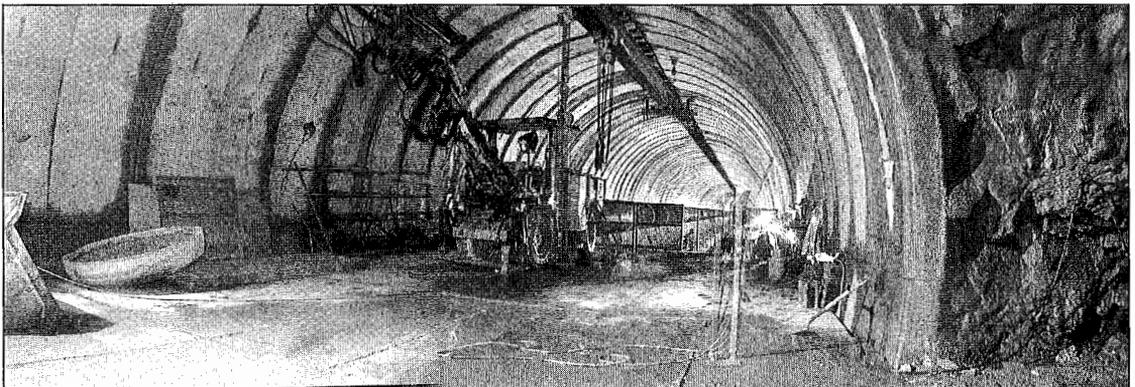
FIGURE 13. Typical work deck installation, with the adit portal visible at right.

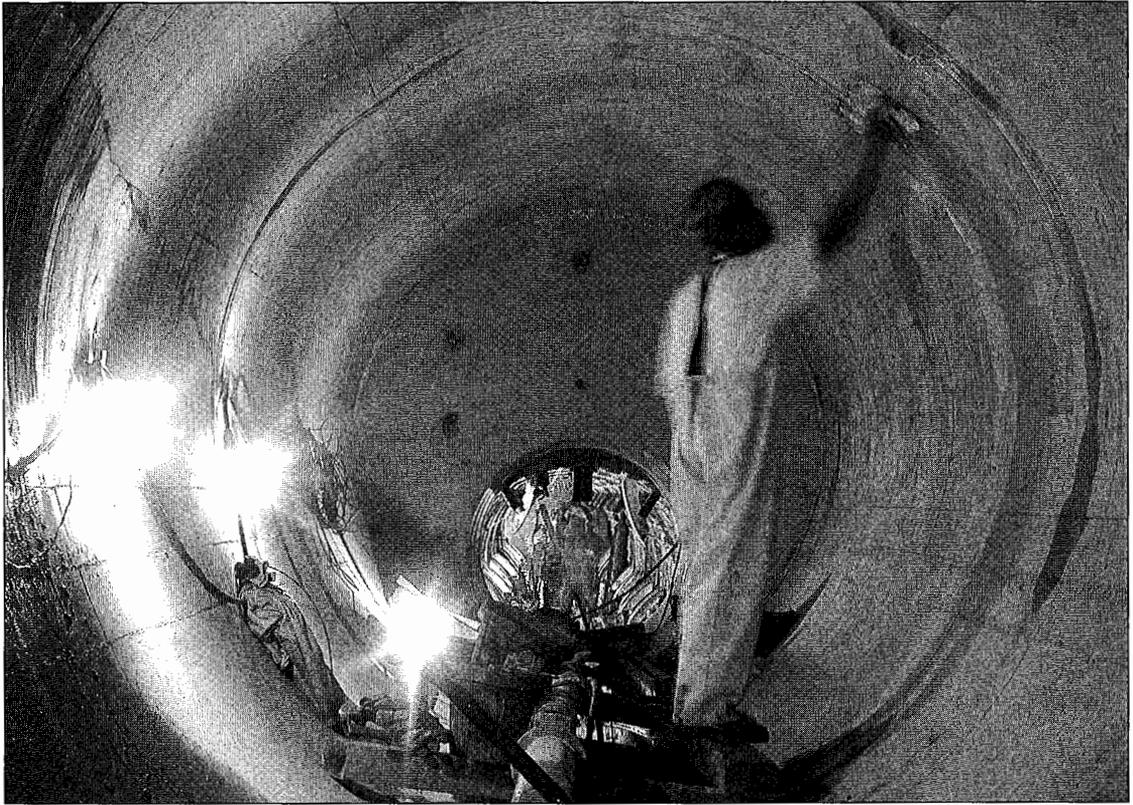
FIGURE 14. Concrete work in a de-aeration chamber, looking out toward the MST. Adit forms are partially visible in the background.

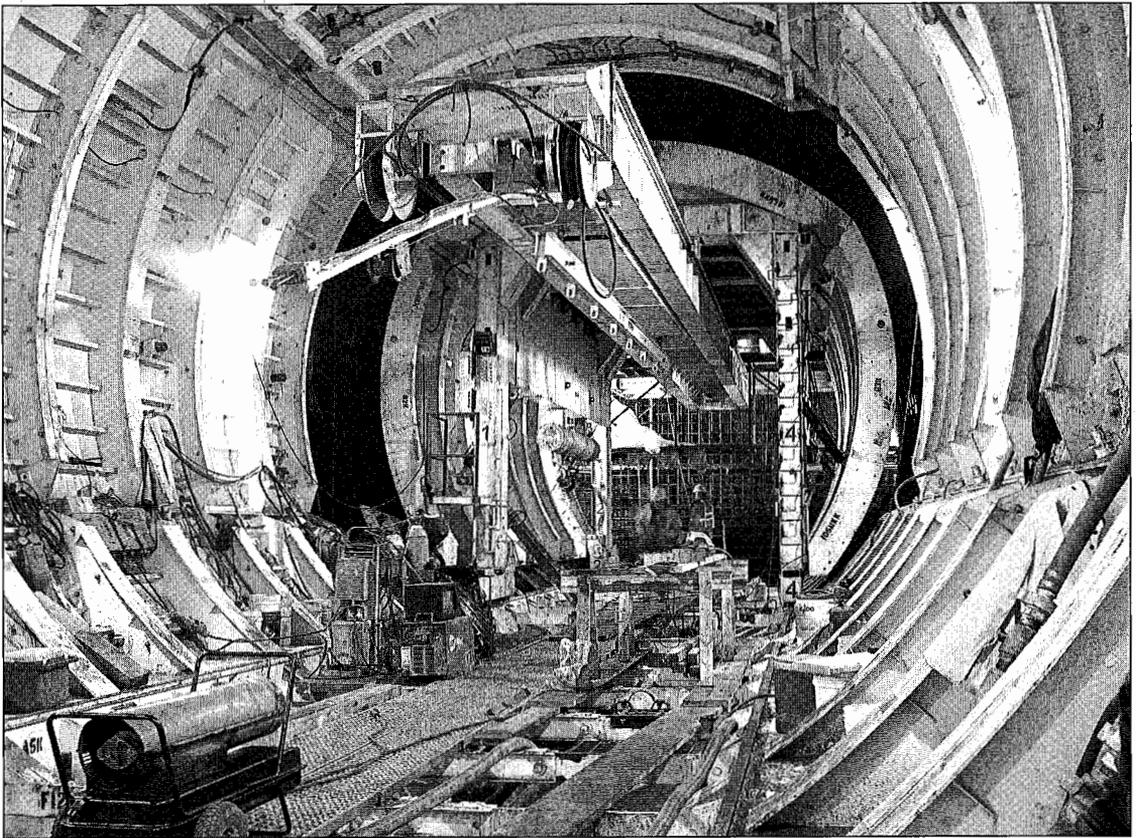
FIGURE 15. Forms and form carrier assembled in the MST just downstream from the foundry shaft.

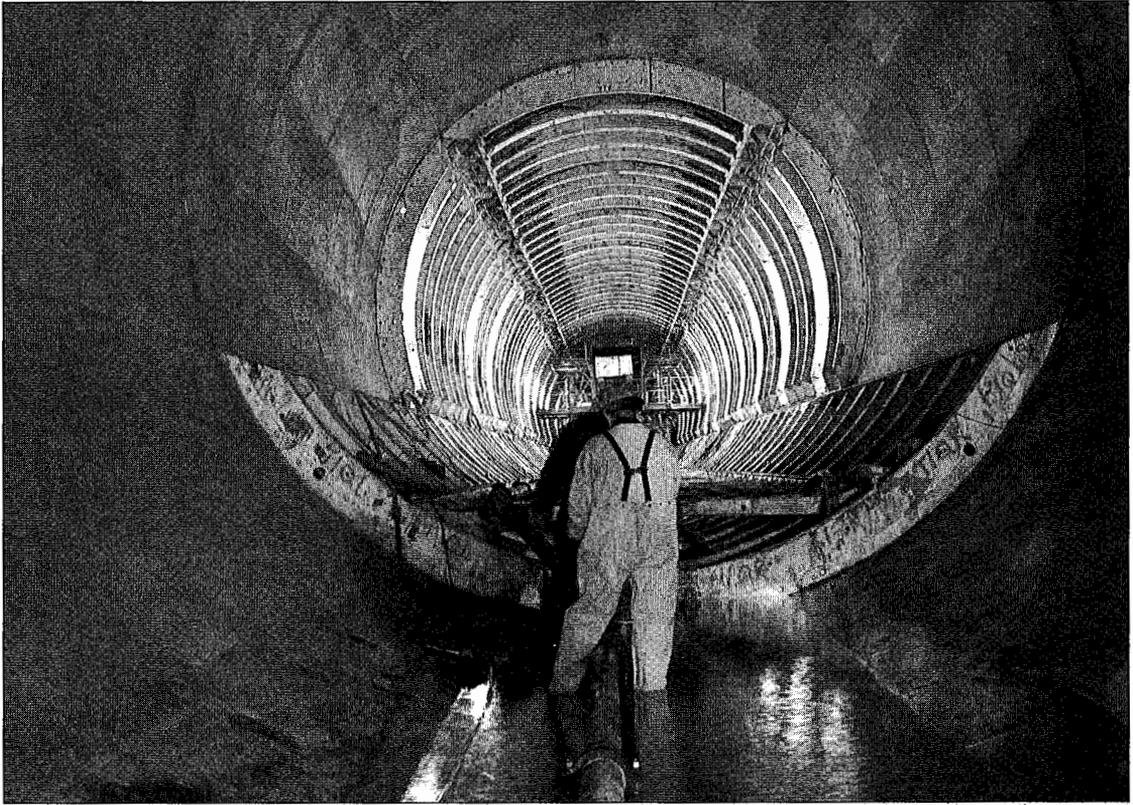
FIGURE 16. Looking downstream at the finished concrete lining and the forms in the MST.

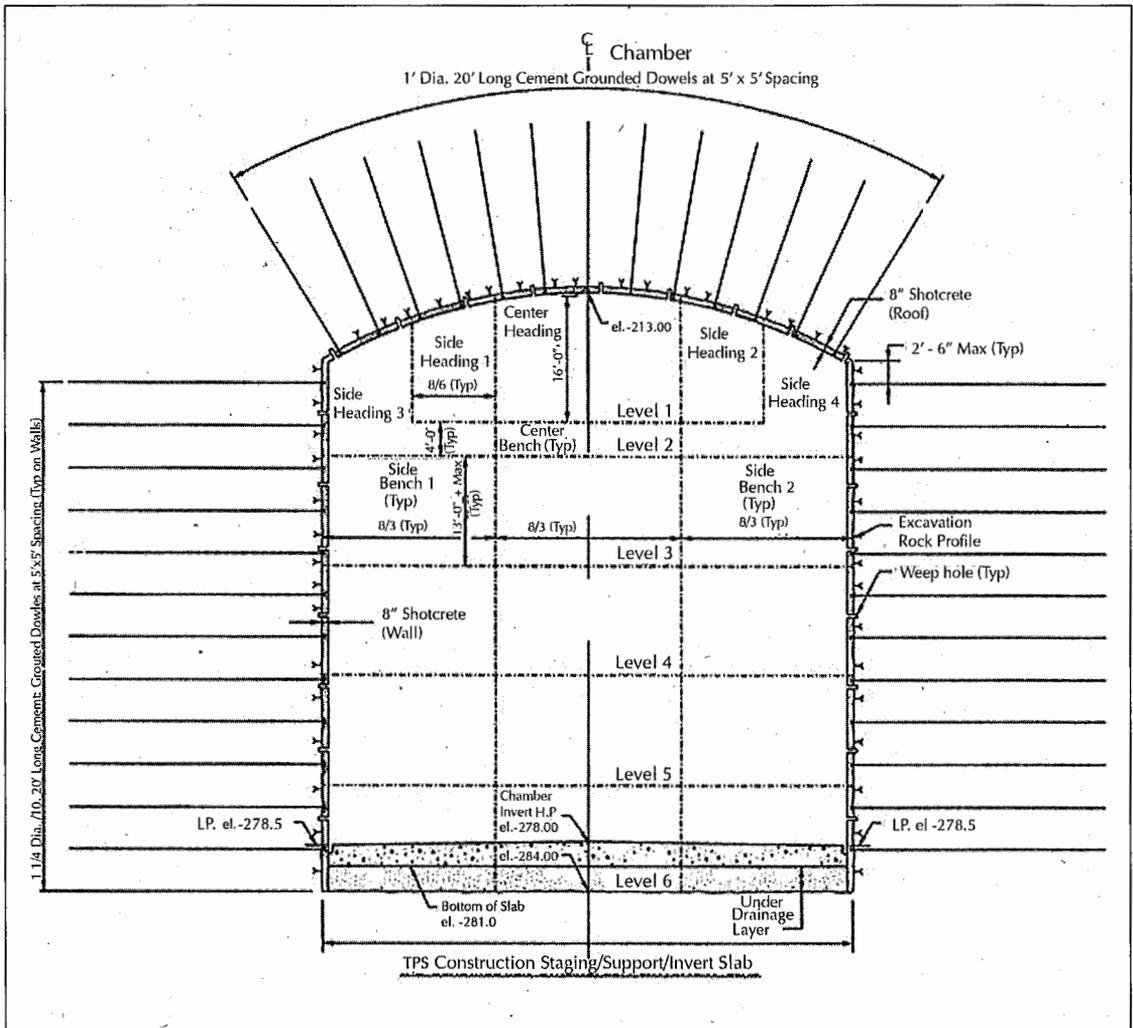
FIGURE 17. The FPTPS design — lining and excavation sequence.

Shortly after notice to proceed in early 2002, the contractor communicated to the NBC its lack of comfort in building the FPTPS cavern as designed with regard to rock stability and support (see Figure 17). The contractor requested additional exploration of rock conditions, further modeling and analyses, and the involvement of a third-party rock mechanics expert to review the design.

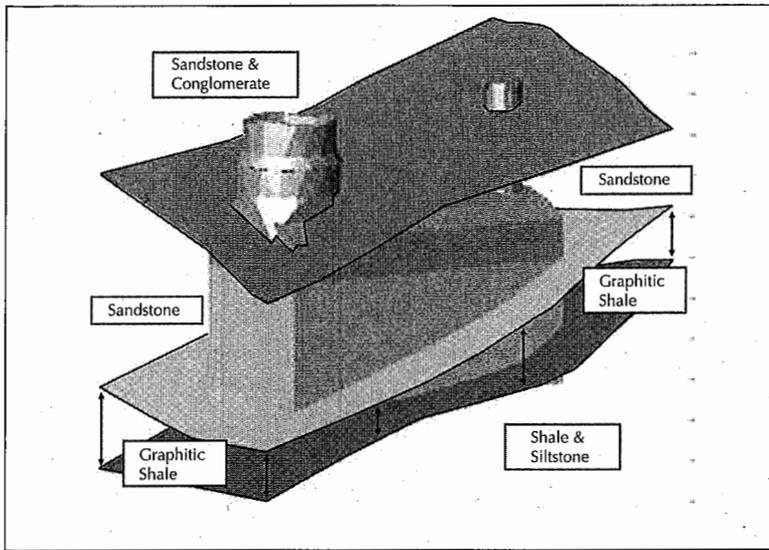
FIGURE 18. A three-dimensional view of the pump cavern with general geologic rock units predicted by site investigation.

The bedrock geology of the cavern consisted of sloping layers, from top down, of conglomerate, sandstone, graphitic shale and shale (see Figure 18). Actual conditions encountered were reasonably close to those that were predicted. The sharply dipping contact between the conglomerate and sandstone at the utility shaft/cavern intersection proved

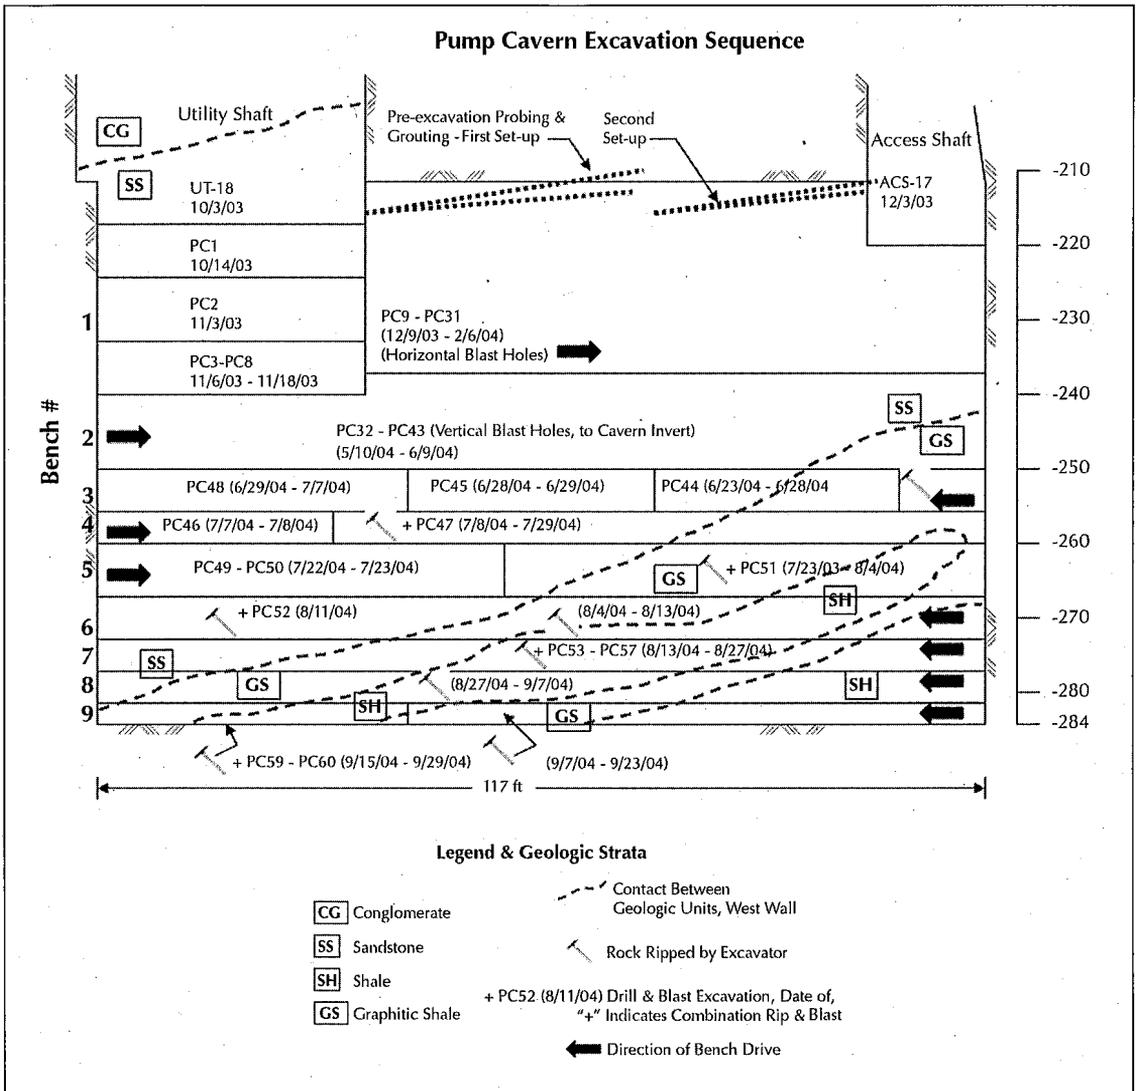
FIGURE 19. The FPTPS cavern excavation sequence.

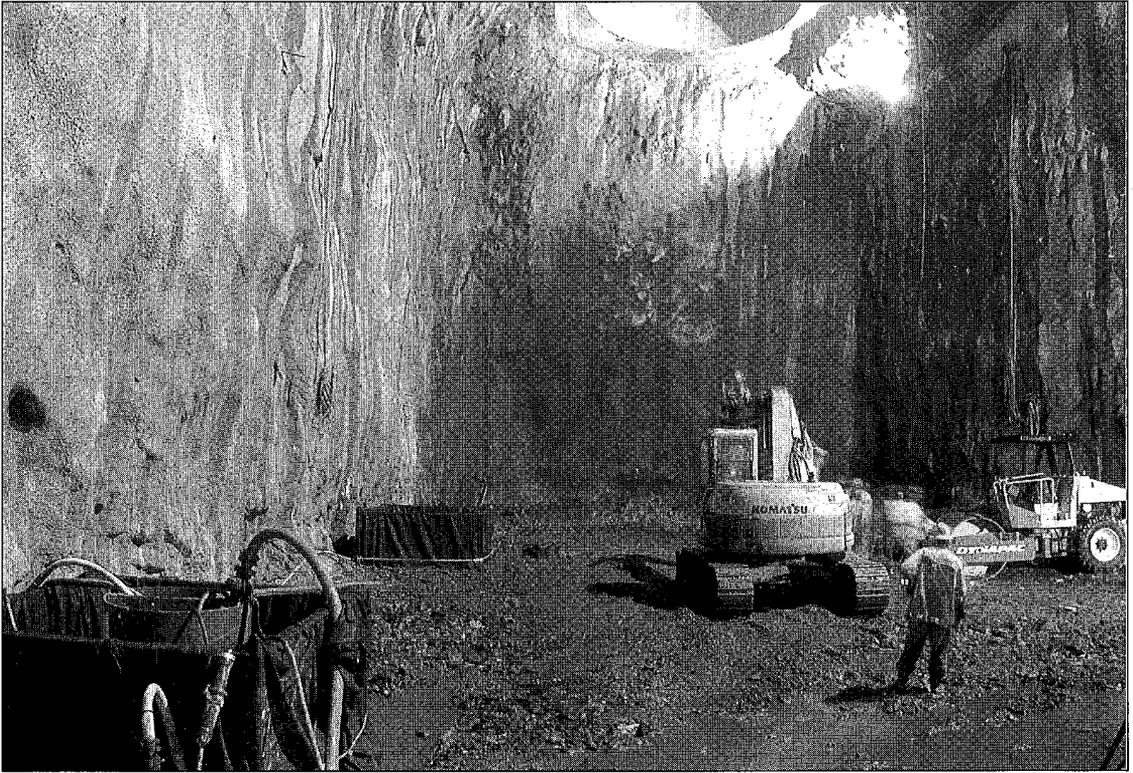
FIGURE 20. The pump cavern viewed from the portal of suction tunnel, fully excavated to invert, with the utility shaft visible in the upper background.

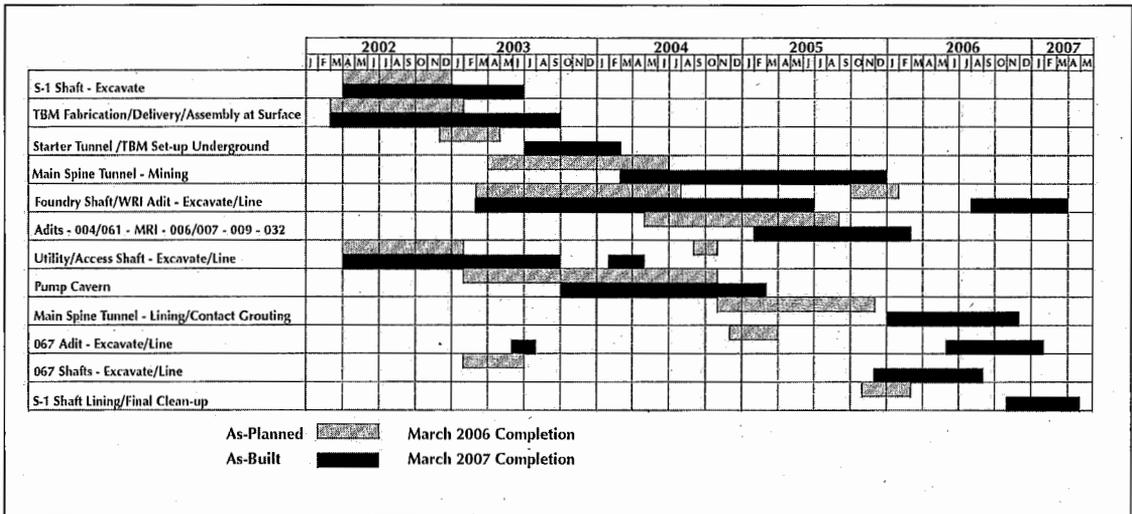
FIGURE 21. Project schedule summary.

The schedule in Figure 21 shows that, in essence, a year was lost prior to the start of MST mining. Of this year, eight months had been lost on the S-1 shaft freeze and excavation. A concurrent and continuing delay associated with TBM delivery, fabrication and set-up in the starter tunnel caused a further four-month slippage. As a recovery measure, the contractor modified its work plan so that the six adits were mined concurrent to MST mining. The complication to daily operations was well managed by the contractor and greatly mitigated earlier delays. From the start of MST mining until project completion, there was no further erosion of the schedule.
