CIVIL ENGINEERING PRACTICE

JOURNAL OF THE BOSTON SOCIETY OF CIVIL ENGINEERS SECTION/ASCE

Repairing the Storrow Drive Tunnel

Interim Repairs of the Storrow Drive Tunnel

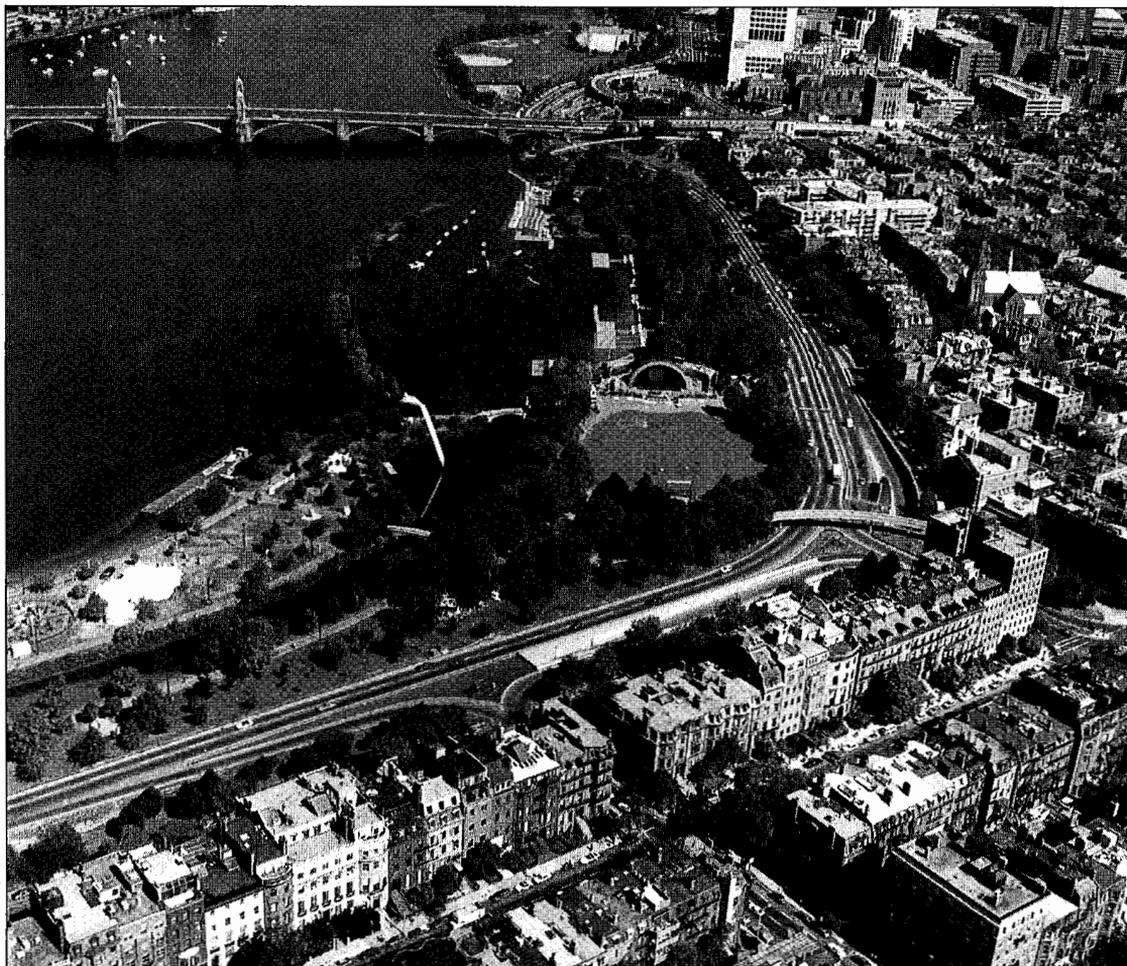
FIGURE 1. Storrow Drive interchange aerial view looking north.

restricted parkway interchange system that actually incorporates two tunnels: the main tunnel carrying underground eastbound through traffic on Storrow Drive; and a much smaller tunnel — the Berkeley Street Underpass — that carries underground traffic entering Storrow Drive eastbound from an on-ramp originating at the end of Berkeley Street (see Figure 1).

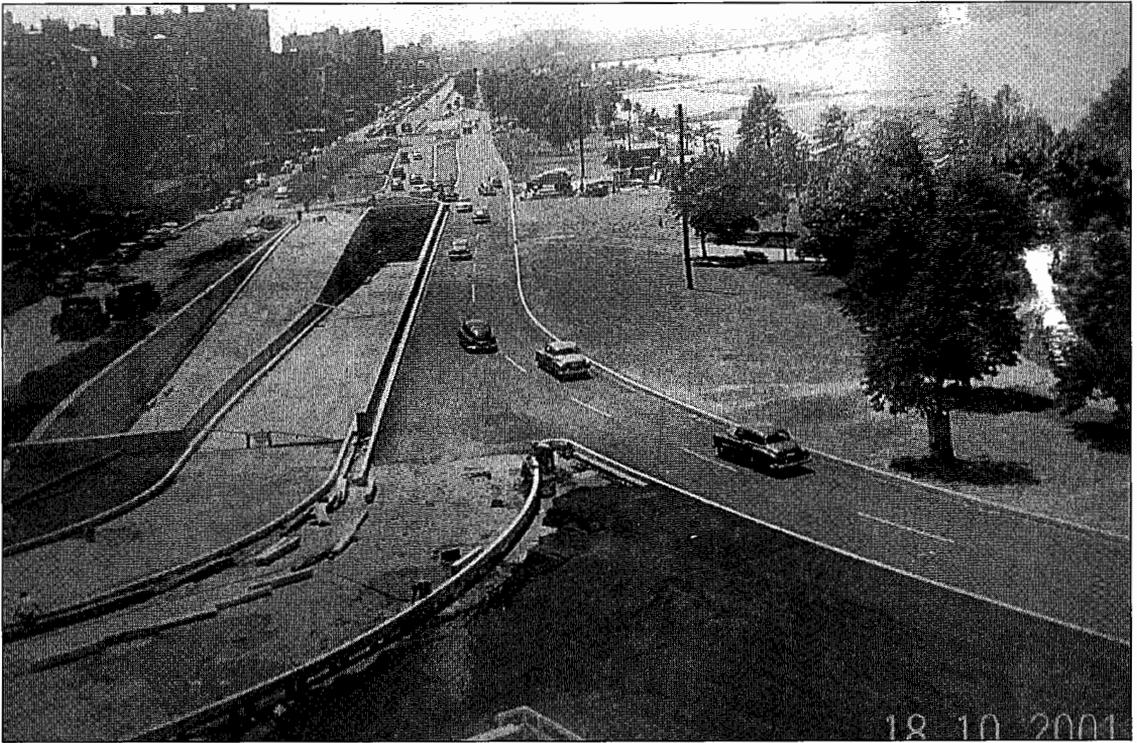
FIGURE 2. Storrow Drive interchange near completion, early 1950s.

exit to Dartmouth Street, which is now blocked by concrete barriers. However, the original configuration had no westbound exit to Otter/Arlington Street as it exists today. Instead, there was a westbound entrance from Otter/Arlington Street, and the only westbound exit was to Clarendon Street via a short collector distributor road between Berkeley Street and Clarendon Street. This collector distributor, running parallel to the parkway mainline, also served as the westbound entrance ramp from Berkeley Street (see Figure 2).

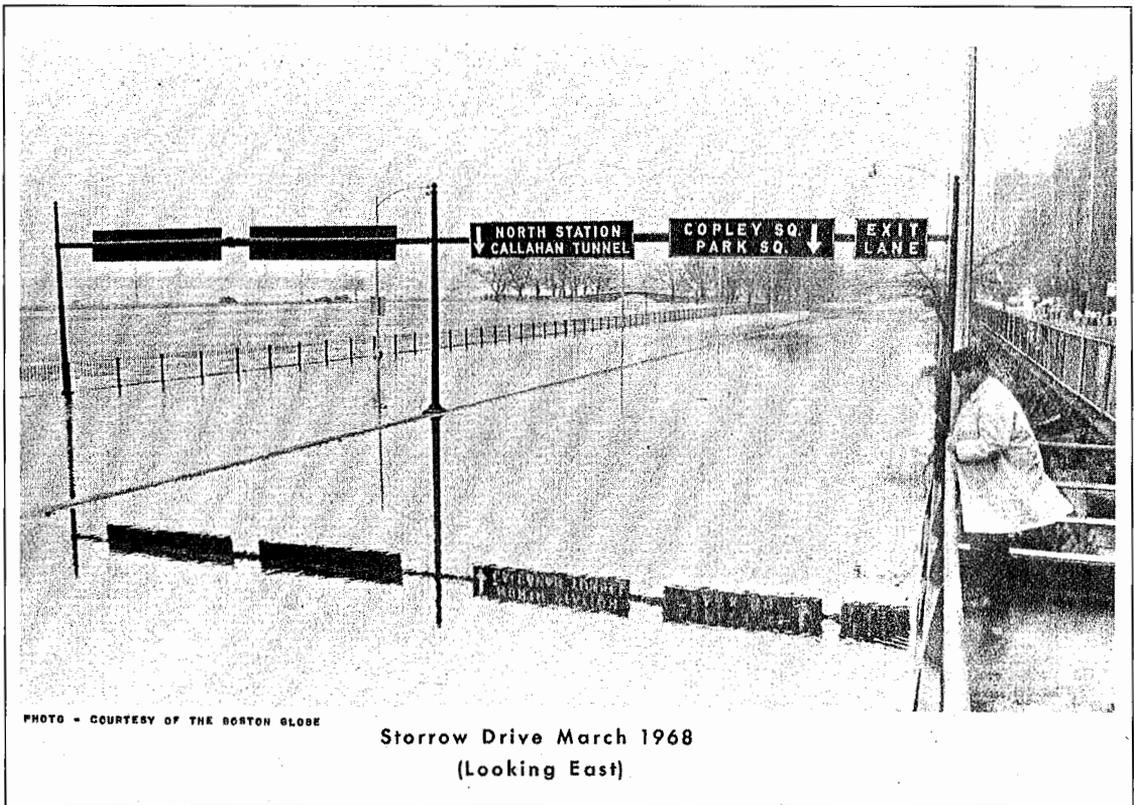
FIGURE 3. Flooded parkway near the tunnel in March 1968.

February 1954, many months before Hurricane Carol hit. Did engineers perhaps observe actual signs of float-out in the tunnels during the hurricane-related flooding? Again, probably not, since an interesting archival photograph from the aftermath of a smaller 1968 hurricane seems to show the main tunnel completely submerged by a Charles River Basin that had overflowed its banks, and a totally submerged tunnel would indicate no risk of float-out (see Figure 3).

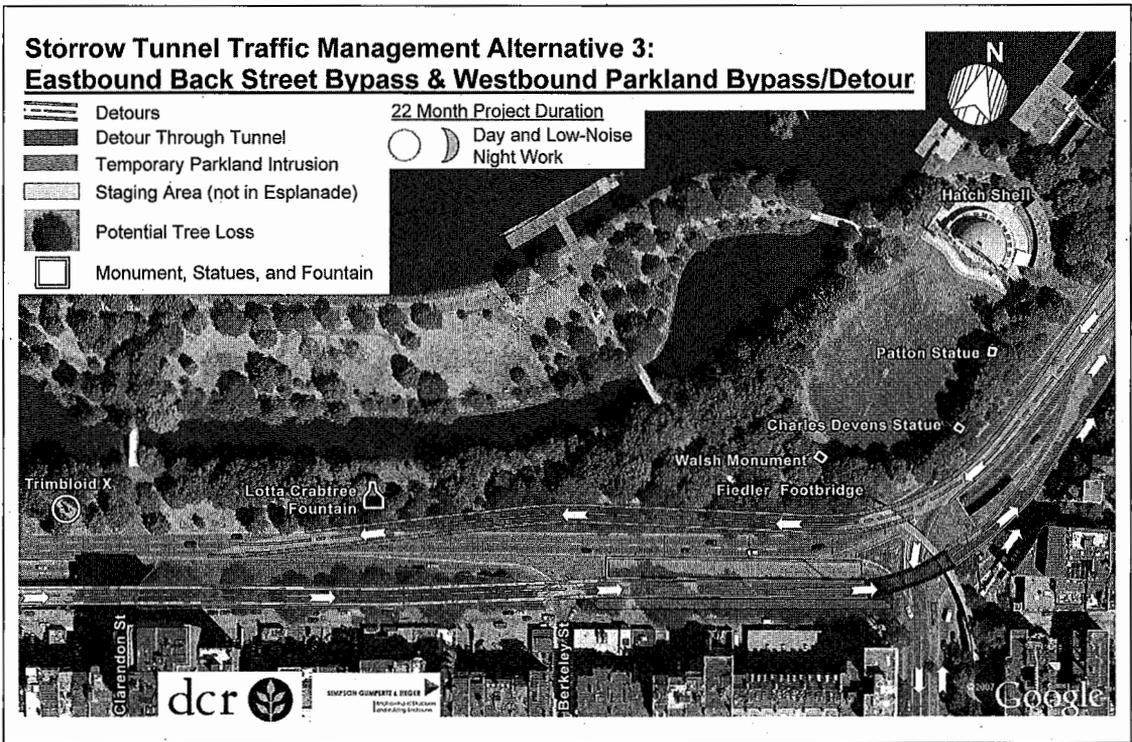
FIGURE 4. Proposed detour road option within the Esplanade.

In 1992, inspections and engineering studies of the Storrow Drive Tunnel revealed significant structural deterioration and other problems related to deficiencies in the original design and construction of the tunnel. In 1993, to address the most immediate safety concerns, emergency repairs were performed at four expansion joints in the tunnel's concrete roof. Also, a sagging section of the tunnel roof that is supported by the longest-spanning steel beams was permanently shored with new steel columns. In 2001, the DCR, then still known as the MDC, awarded a design contract to an engineering consulting firm to re-evaluate the structure's condition, to assess options for rehabilitating the tunnel and to perform preliminary and final design of the selected rehabilitation option. A report with preliminary recommendations was completed in 2002. The 2002 report included preliminary traffic management plans, which, for some rehabilitation options, included temporarily routing eastbound and westbound traffic onto temporary roads in the Esplanade parkland adjacent to the tunnel that is currently covered with grass and trees. Up to eighty trees between Arlington Street and Clarendon Street would have to be removed to implement this traffic management scheme (see Figure 4).

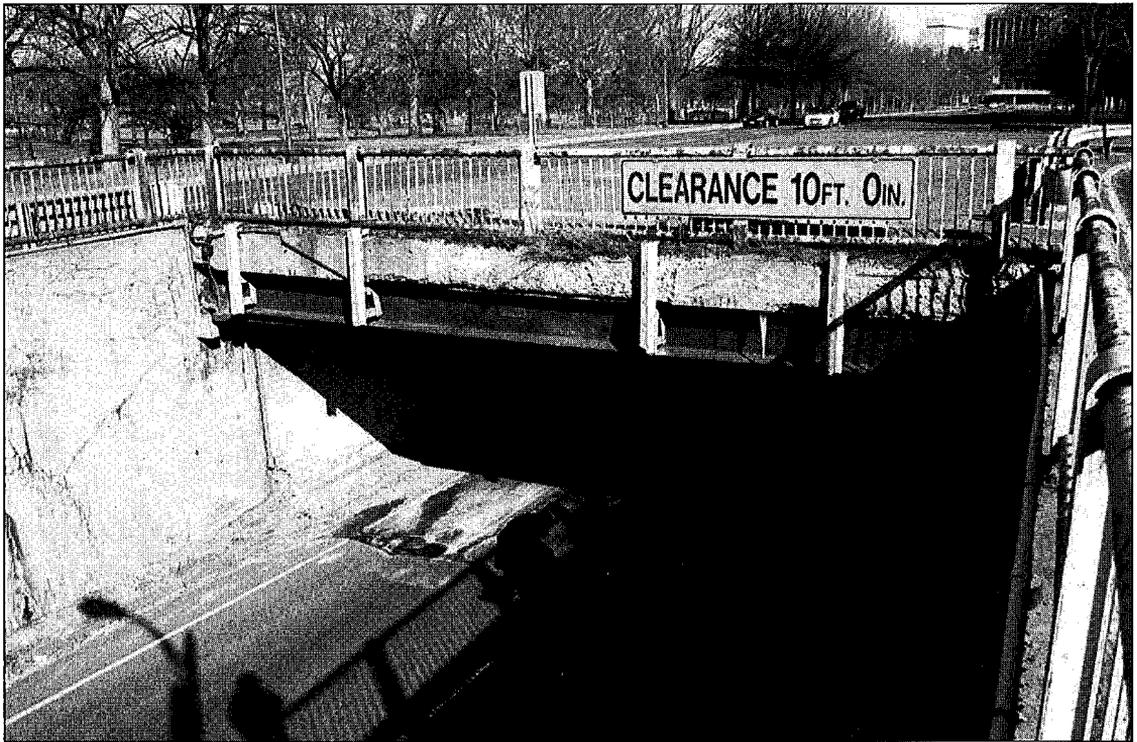
FIGURE 5. West Portal before repairs.

- Removal of deteriorated concrete and construction of an up-turned concrete beam over the west portal (the impact-damaged steel roof beam was left in place) (see Figures 5 and 6);
- Installation of hanger supports to prevent reinforcing bars falling at a location where long lengths of bars had been exposed in 1993 but the concrete repair was never completed;
- Installation of structural retrofits (steel plates and angles) at approximately twenty fatigue-prone connections in the

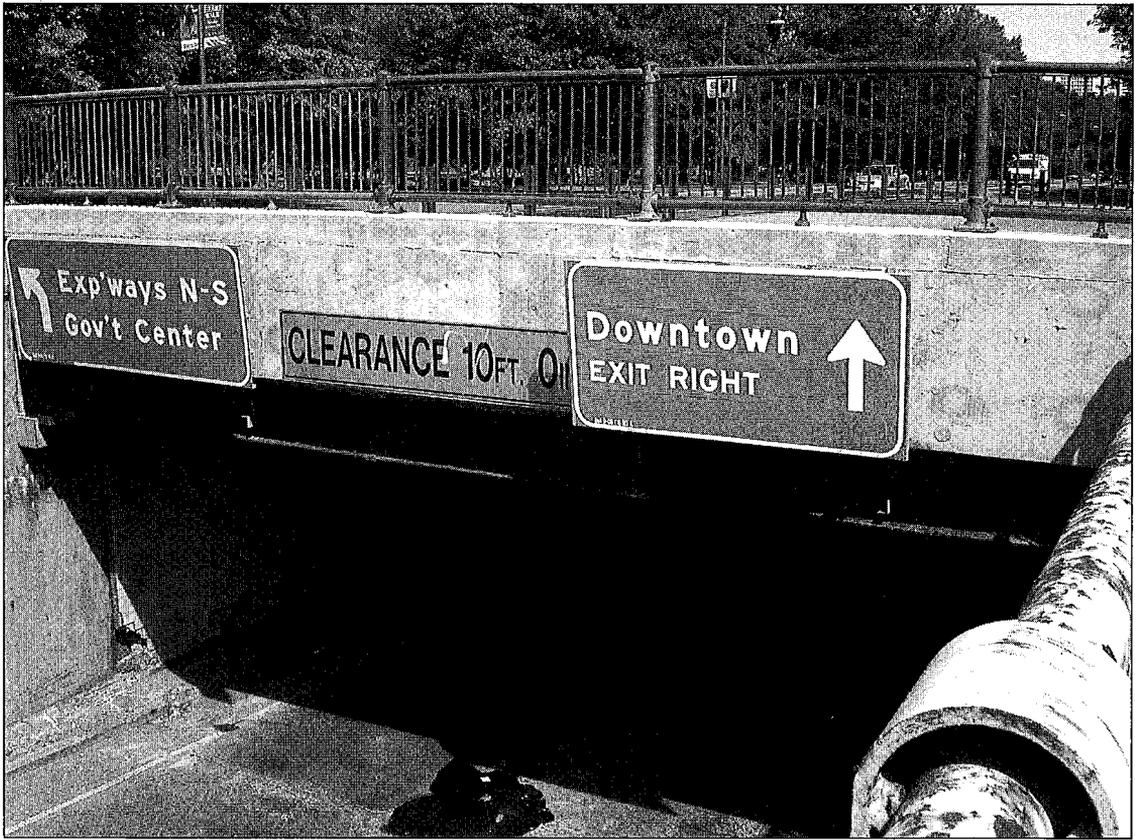
FIGURE 6. West Portal after repairs.

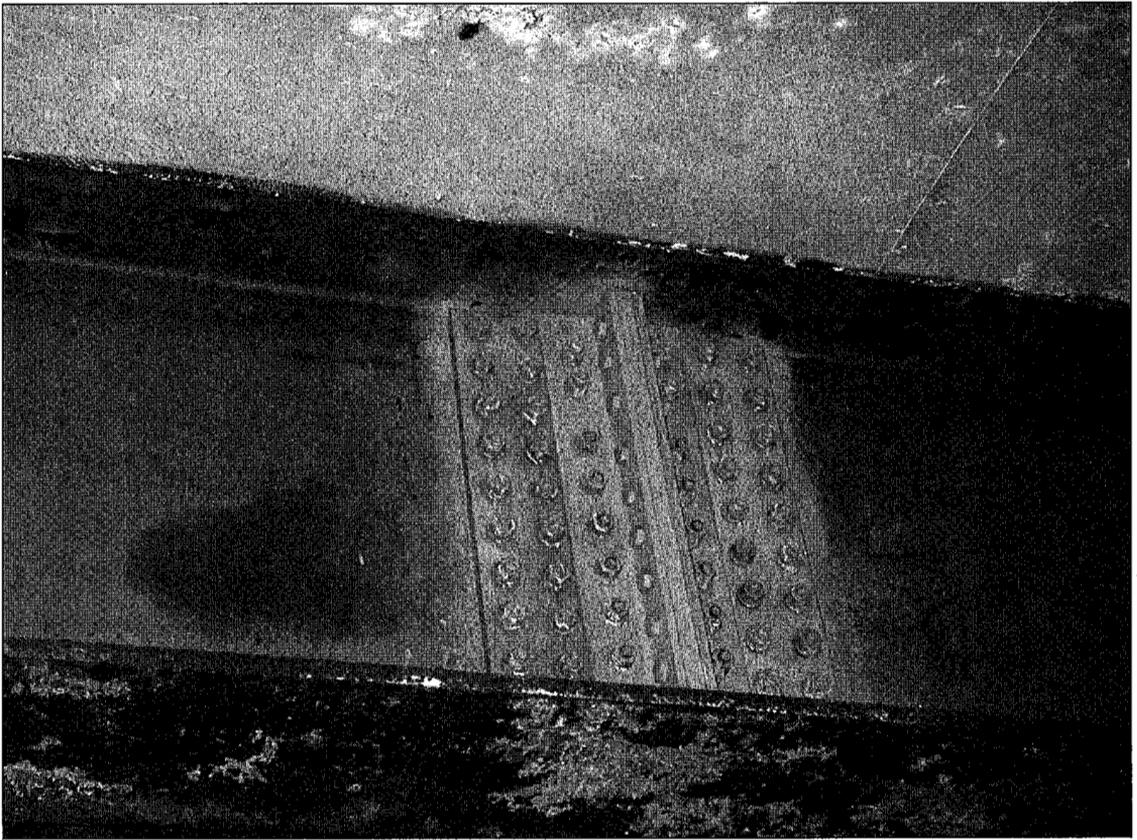
FIGURE 7. Bolted steel retrofit of a fatigue-prone diaphragm connection.

steel beam roof framing system (see Figure 7);

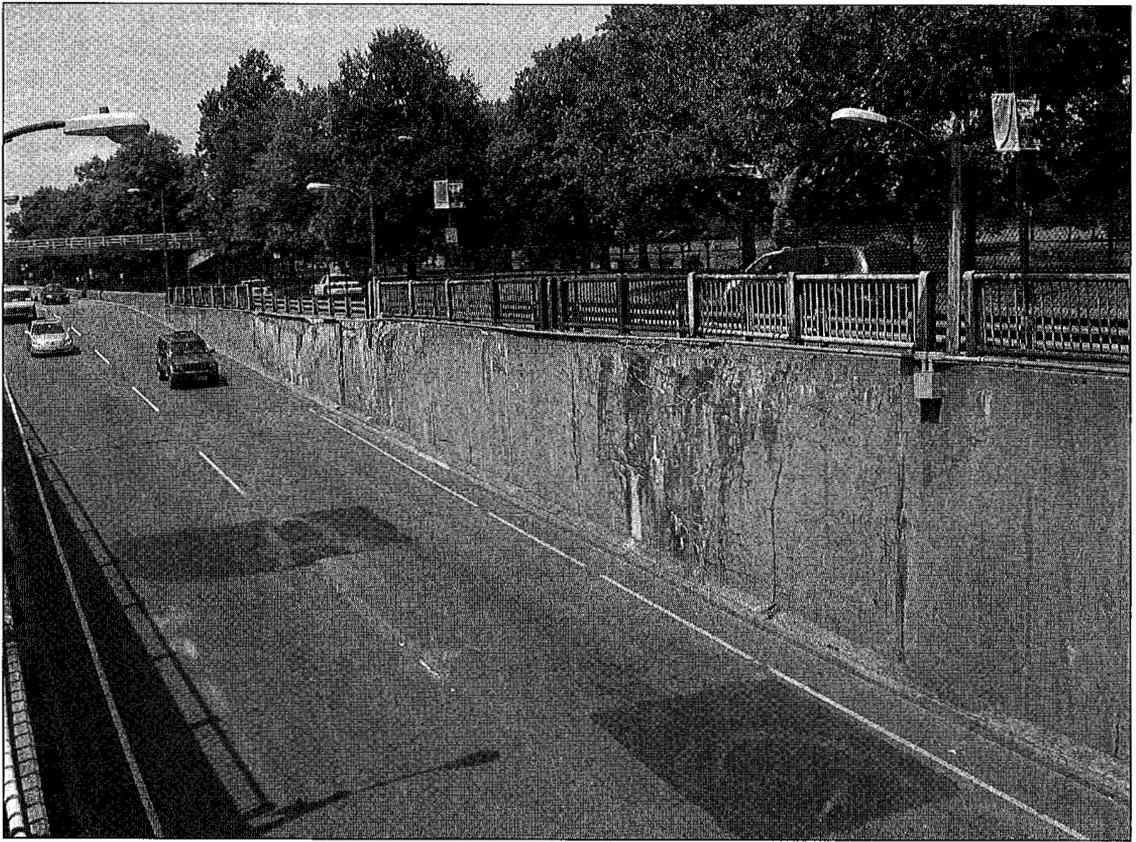
FIGURE 8. Northwest boat section wall and railings before repairs.

- The thick reinforced concrete roof slabs of the eastern portion of main tunnel require restoration at all expansion joints because they are severely deteriorated, with disintegrating concrete and large lengths of reinforcing bar hanging free of embedment in concrete. The loss of reinforcing at these locations reduces the strength of the slabs in this section of the tunnel. Also, the conditions at these joints pose a threat to traffic below from falling concrete and reinforcing steel.
- The walls of the open boat sections require restoration because they have extensive cracking with some leakage and unsightly efflorescence. Four wall panels have extensive disintegration of concrete surfaces (see Figure 8).
- The pumps that remove drainage water

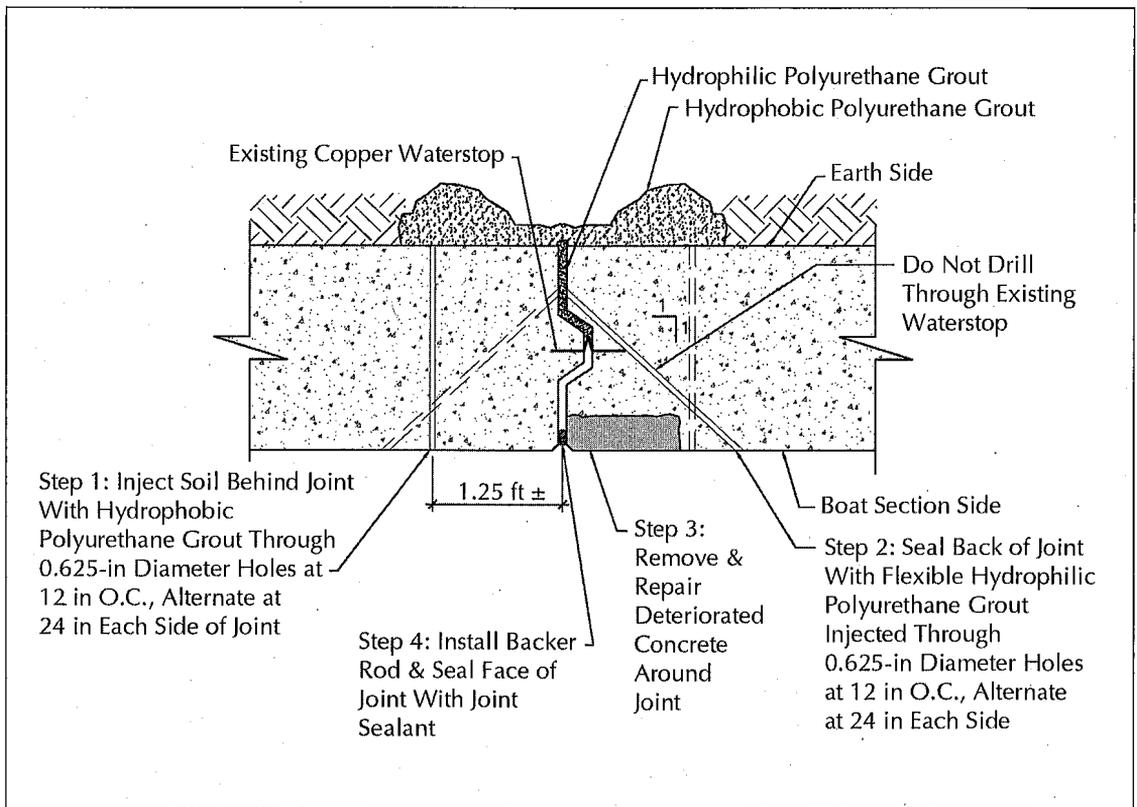
FIGURE 9. Polyurethane waterproofing detail at wall joints.

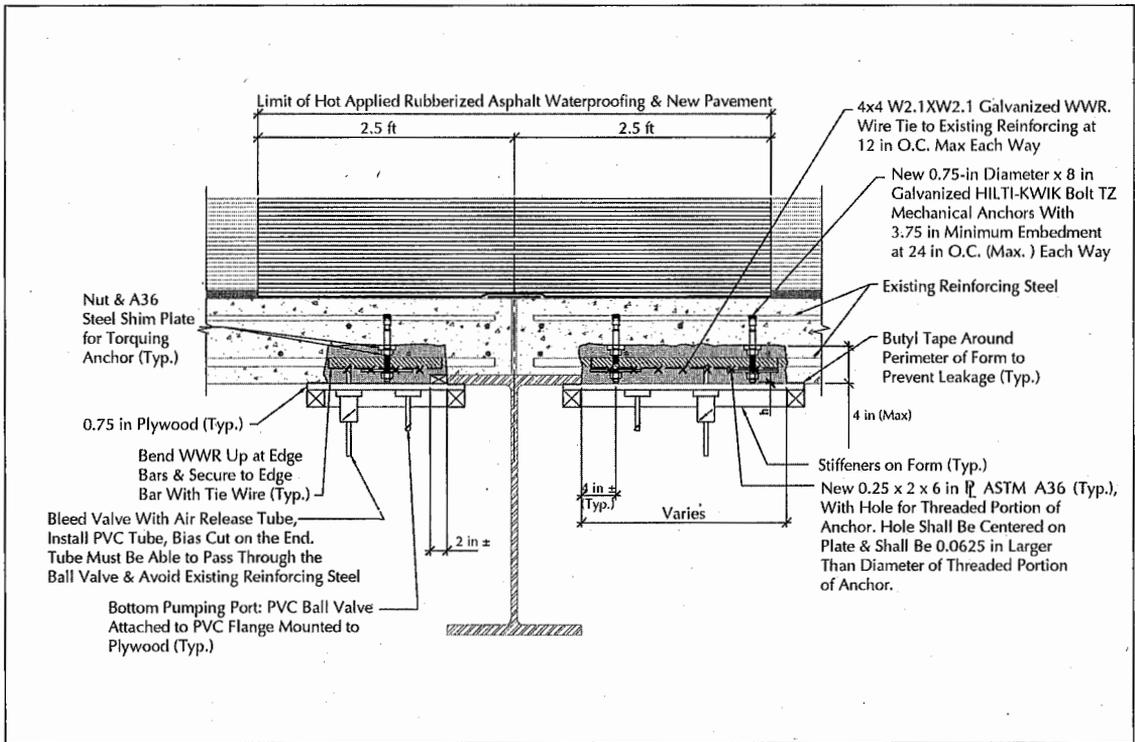
FIGURE 10. Partial depth repair detail at the concrete roof slab.

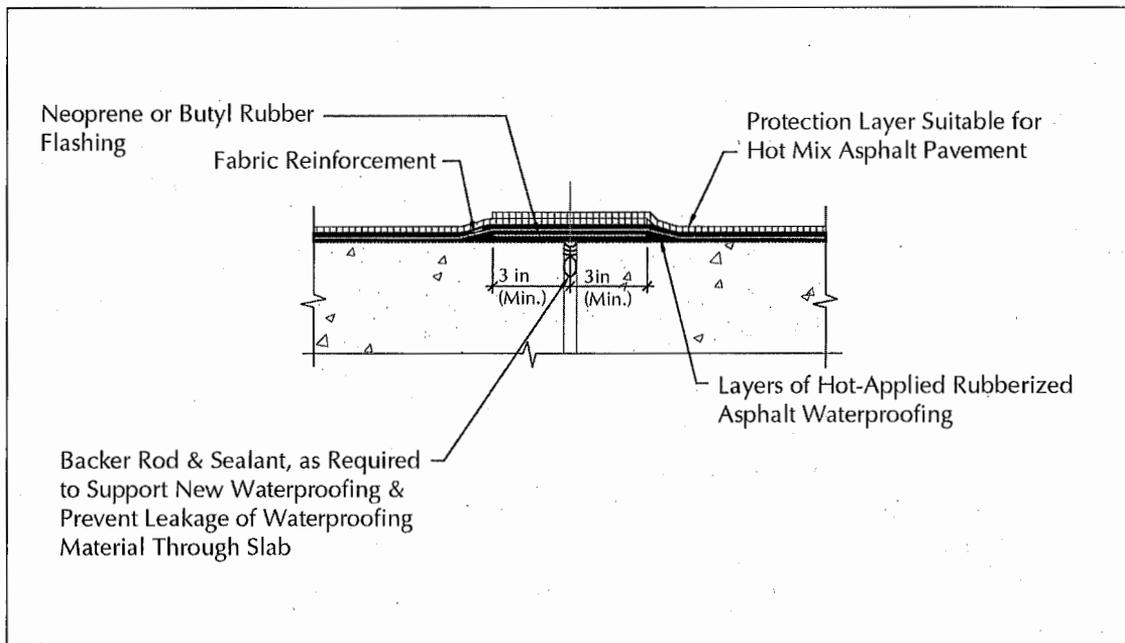
FIGURE 11. Waterproofing detail at the roof slab expansion joints.

Topside Waterproofing at Roof Joints. The designers selected a roof joint waterproofing system that could be installed during the short work windows available during nighttime lane closures of Storrow Drive westbound. A more elaborate, redundant and durable joint-

sealing system was considered, but was not selected due to the short-term nature of the repair and the practical limit on installation time. The selected system was a hot-applied rubberized asphalt waterproofing system that incorporated a flexible flashing to accommodate expansion joint movement and fabric reinforcement to provide added strength and durability at both construction joints and expansion joints (see Figure 11). This system could be effectively installed during the time available to excavate and patch the areas over the joints during the overnight lane closures. It was also tolerant of the expected surface imperfections in the top of the concrete roof slabs.

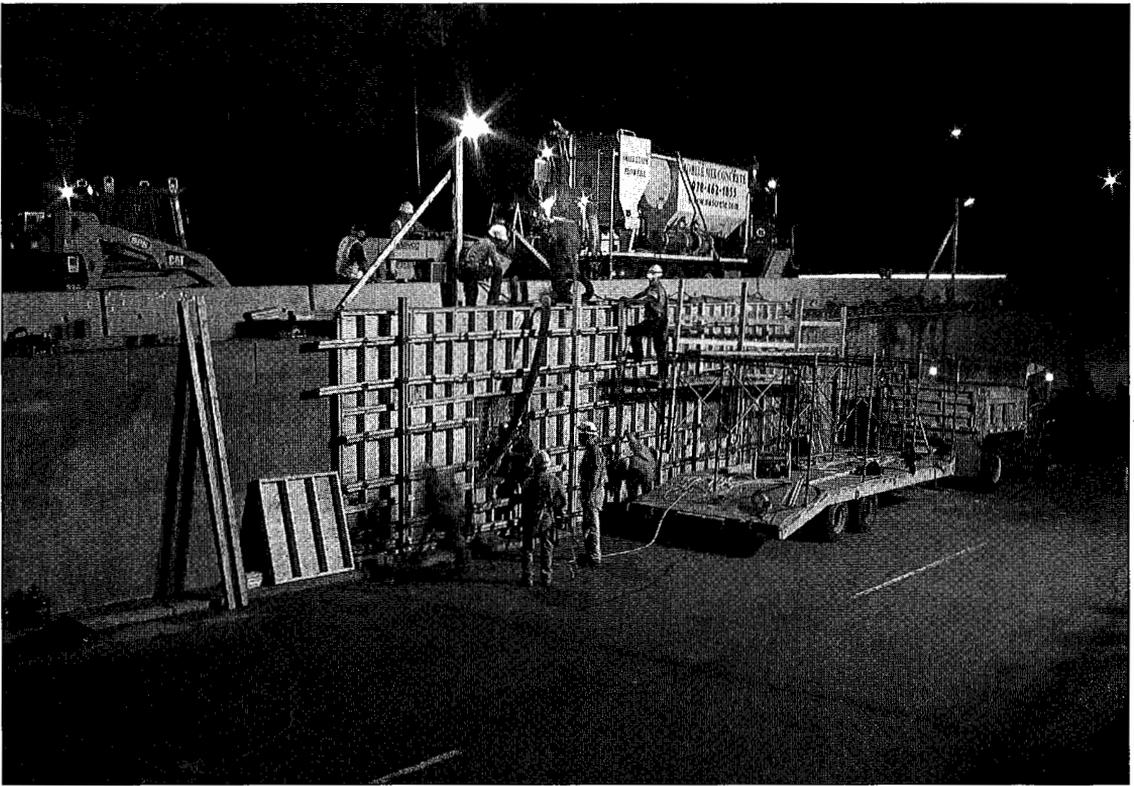
FIGURE 12. Wall repair concrete placement using the mobile mixer.

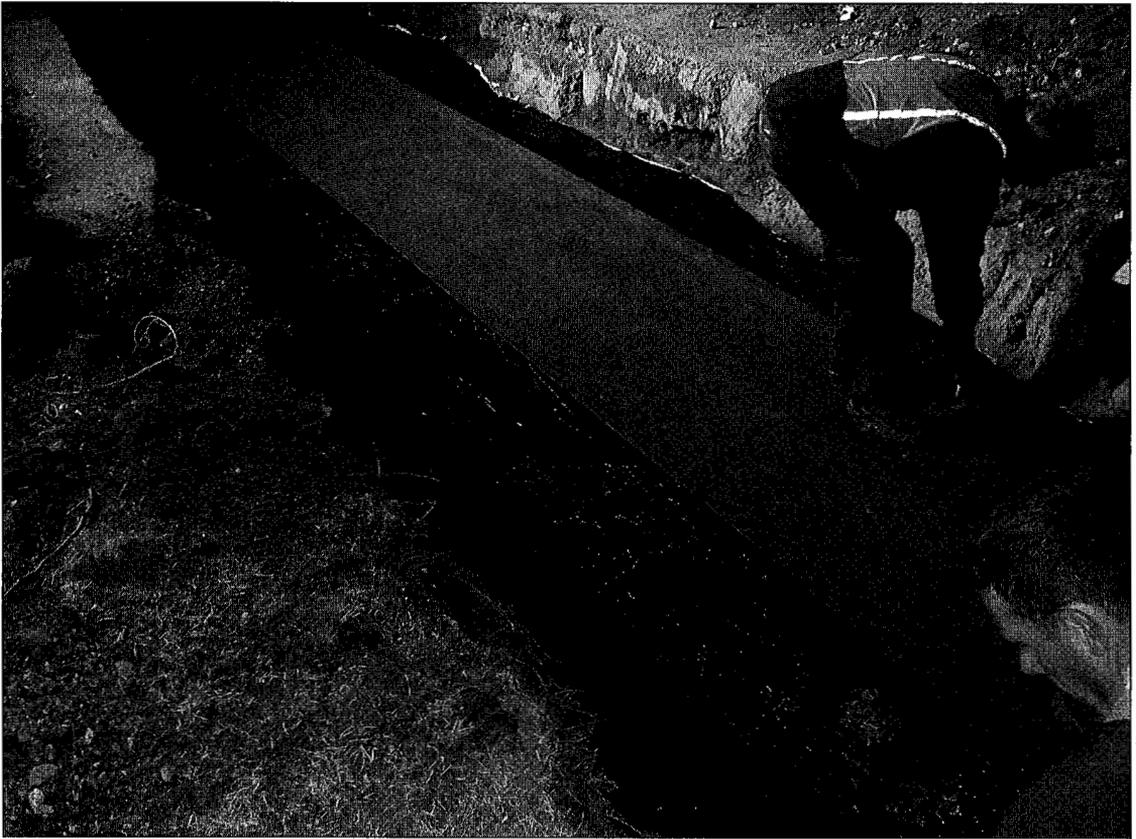
FIGURE 13. Waterproofing and protection board at a roof slab expansion joint.

Topside Roof Joint Waterproofing. In 2007, the DCR had their on-call maintenance repair contractor perform a trial installation of the hot-applied rubberized asphalt waterproofing system over the west-most expansion joint in the roof of the main tunnel. This joint was not one that had shown excessive leakage or deterioration to the roof slab or steel beam below it (although some of these problems were evident), but it was located entirely within the median of the interchange, which

made it ideal for a trial application since traffic control was not an issue (see Figure 13). The trial used one of the three similar systems that were specified for this work in the interim-repairs contract, and it was generally successful. The concrete roof at this joint, over Beam 10 (the tenth from the west portal), was in fair to good condition and was easily prepared to receive the waterproofing system by complete removal of the old asphalt and membrane-waterproofing system, followed by cleaning and flame-drying of the exposed concrete surface. The original joint-filler/forming material was still in place at this joint, and it was providing unexpectedly good resistance to leakage through the joint, at least during the warm weather that was prevalent during the trial installation. The only significant problem that occurred during this installation was at the southerly end of the joint, where a fairly large tree had grown in the soil over the south wall of the tunnel.

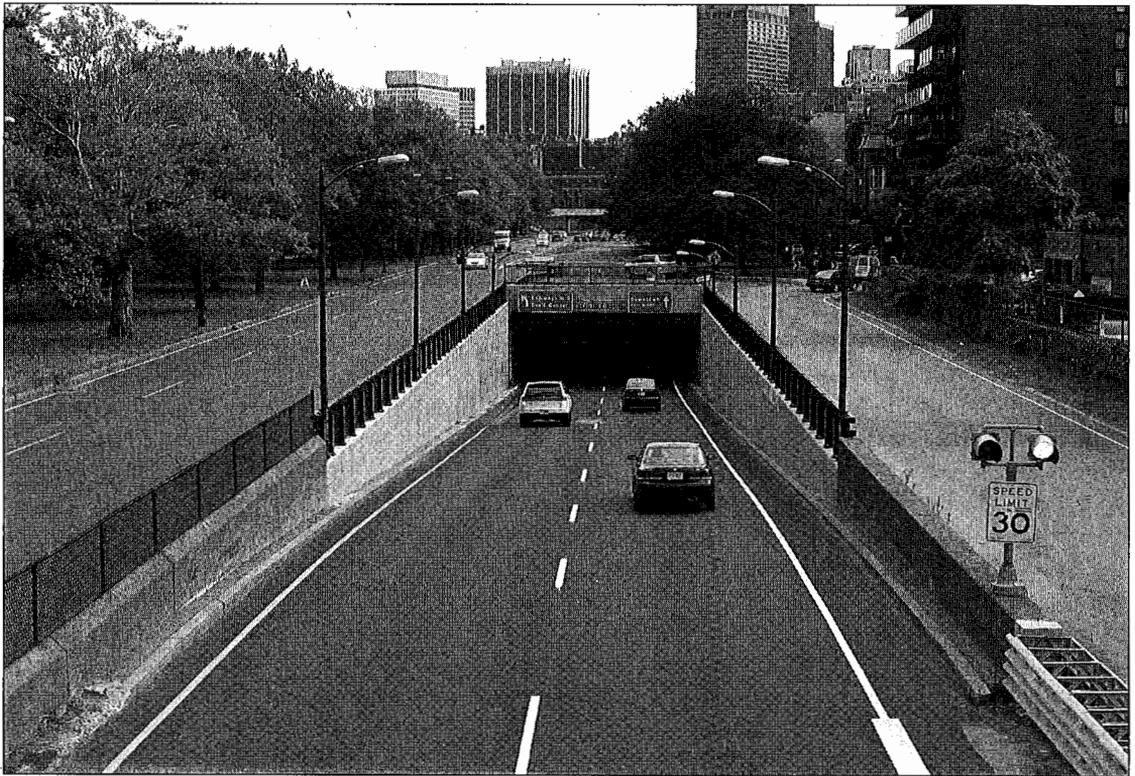
A view of the finished project, with the repaired boat section walls and new railings at the west approach.

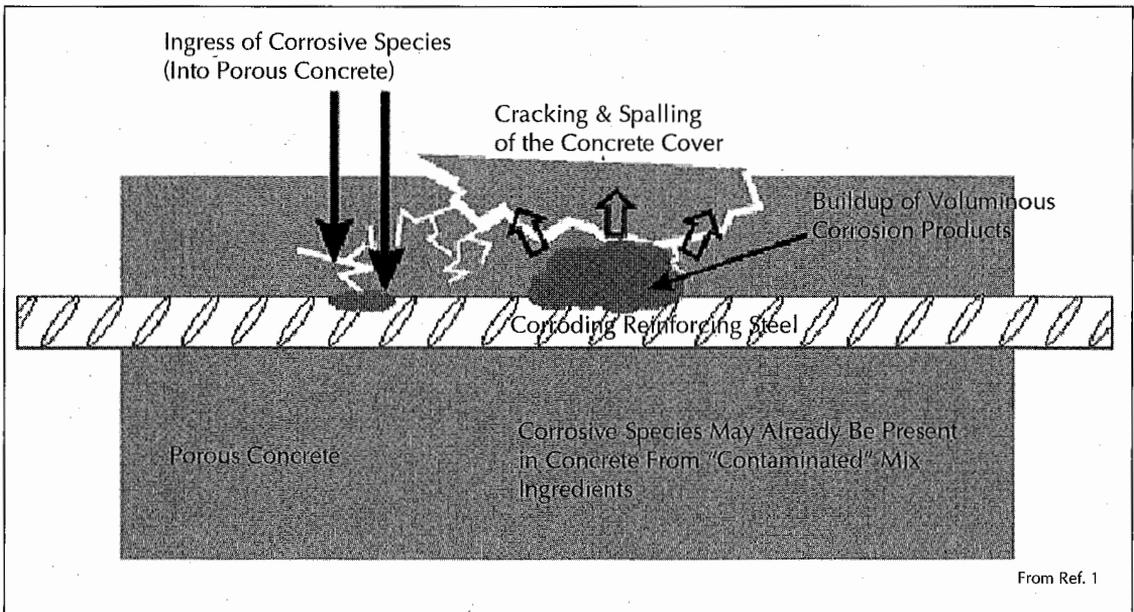
FIGURE 1. Corrosion damage in reinforced concrete.

Corrosion of reinforcement results in the formation of rust that has two to four times the volume of the original steel. The increas-

ing volume of rust causes concrete tensile stresses that may be the main cause for internal microcracking, external longitudinal cracking and eventually spalling (see Figure 1). Corrosion also produces holes in the surface of the reinforcing steel, reducing strength capacity due to the reduced cross-sectional area. All these factors may lead to serviceability failure and/or loss of structural integrity.

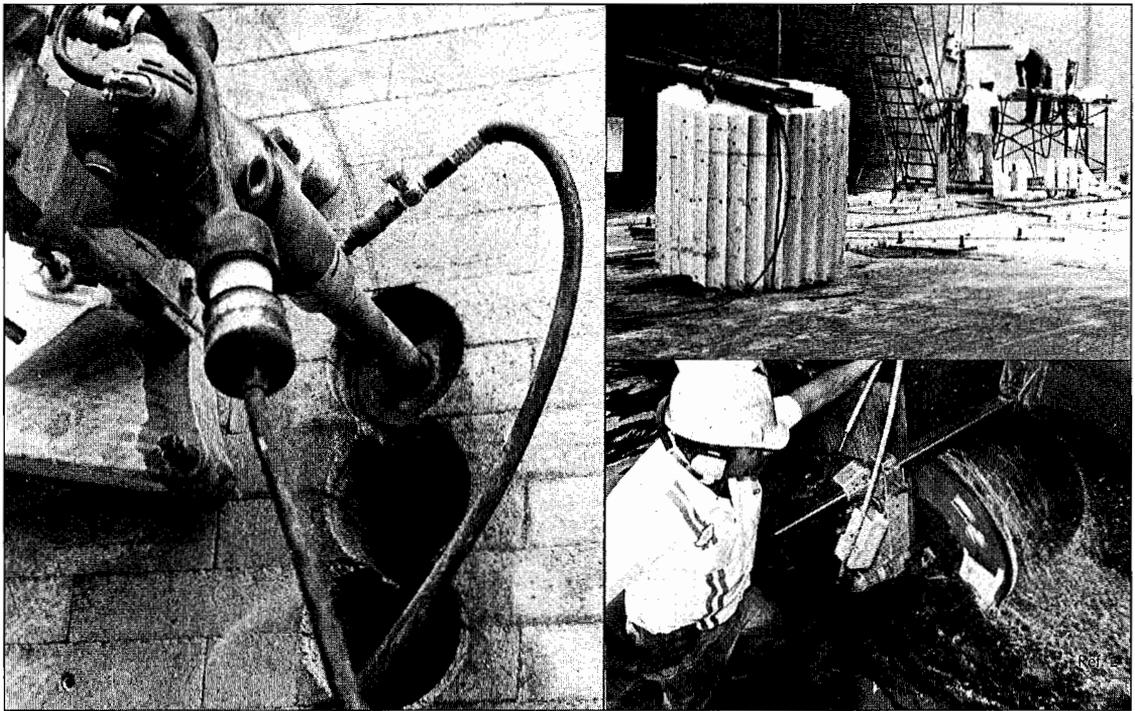
FIGURE 2. Side-by-side or stitch coring (left); extracting one large core (top right); and in standing water (bottom right). (From Ref. 2.)

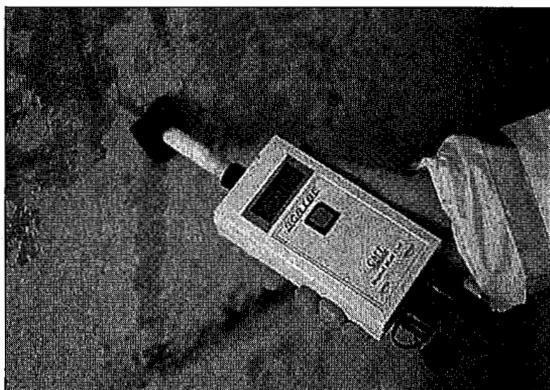
FIGURE 3. Half-cell potential testing equipment. (Courtesy of Hammond Concrete Testing, Ref. 3.)

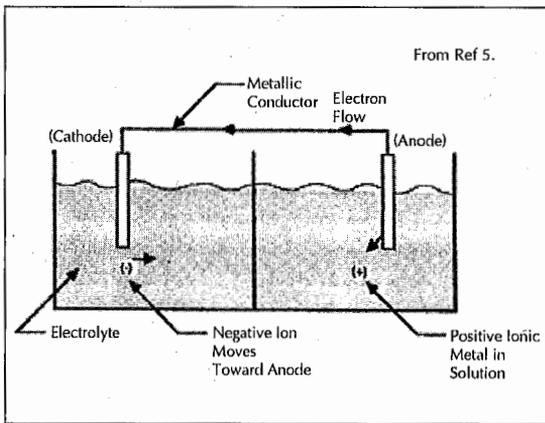
FIGURE 4. A basic corrosion cell.

electromotive force. The anode emits electrons and the cathode receives them, with corrosion forming in the anode. With both metals connected, an electrical flow can be observed, creating a corrosion cell (see Figure 4).⁵

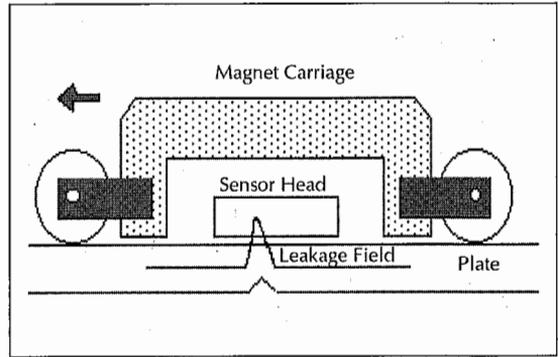
FIGURE 5. Magnetic flux leakage.

MFL measures changes in the path of magnetic force lines, or flux, near a ferromagnetic

material with defects. In the presence of a magnetic field, ferromagnetic materials align their electric dipoles with the external field. A high intensity magnetic field has more aligned dipoles. The applied magnetic field needs to be strong enough to overcome noise, as well as the distance between the magnetic source and the ferromagnetic field. When the flux detects corrosion or fractured steel, it leaks out instead of traveling to the south pole of the magnet. The reduction in cross-sectional area of the material causes the leakage. MFL equipment use "Hall Effect" sensors, which react to and develop a voltage difference between the parallel faces of crystal sensors to detect the leakage.

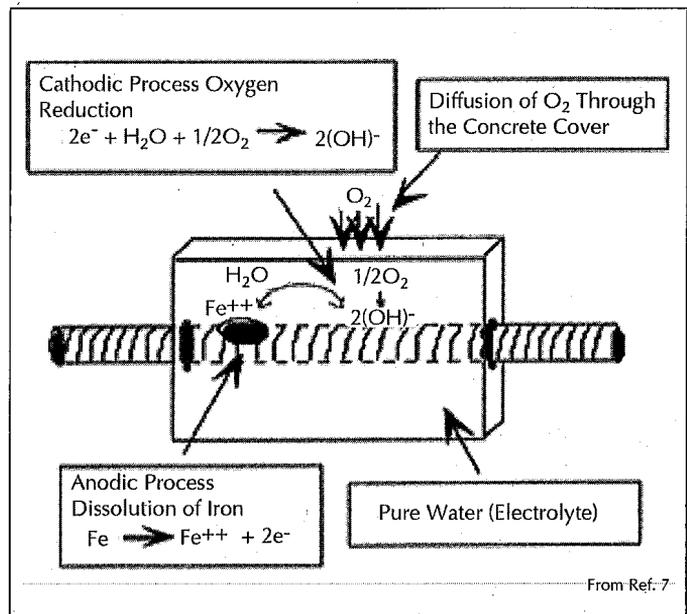
FIGURE 6. Corrosion inhibitors in concrete.
