# CIVIL ENGINEERING PRACTICE

JOURNAL OF THE BOSTON SOCIETY OF CIVIL ENGINEERS SECTION/ASCE

SPRING/SUMMER 1993

VOLUME 8, NUMBER 1

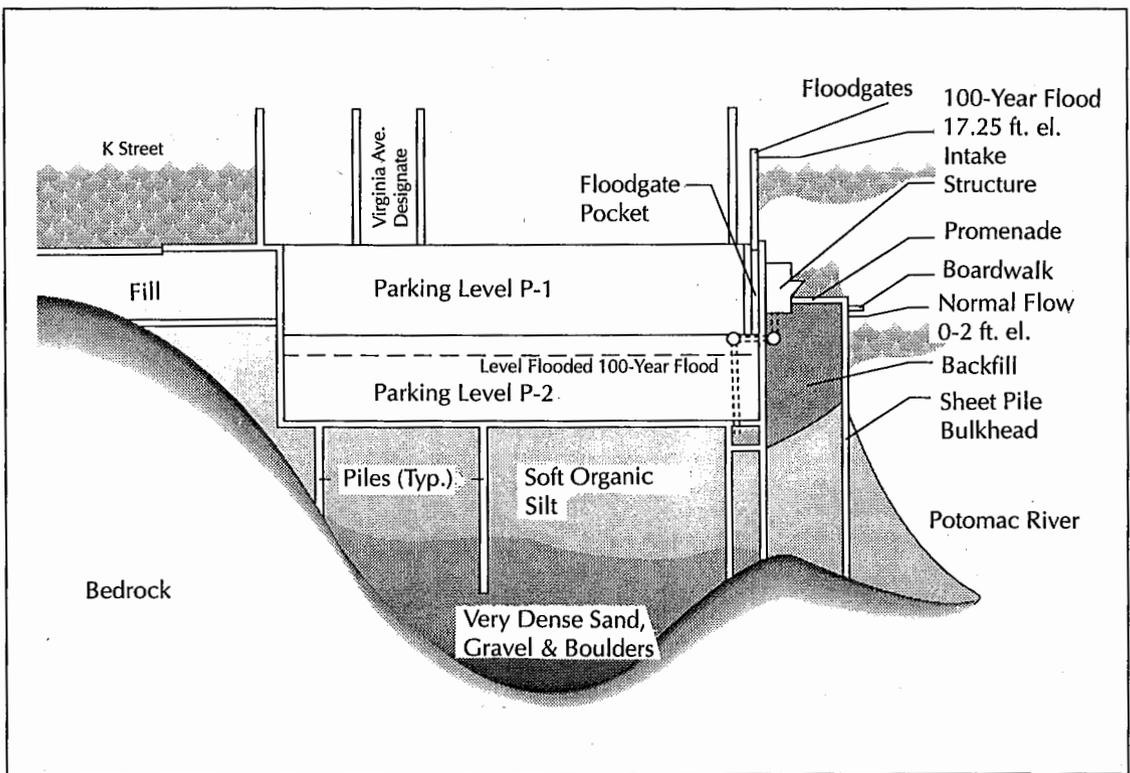
**FIGURE 2. Cross section of the development's flood protection system.**

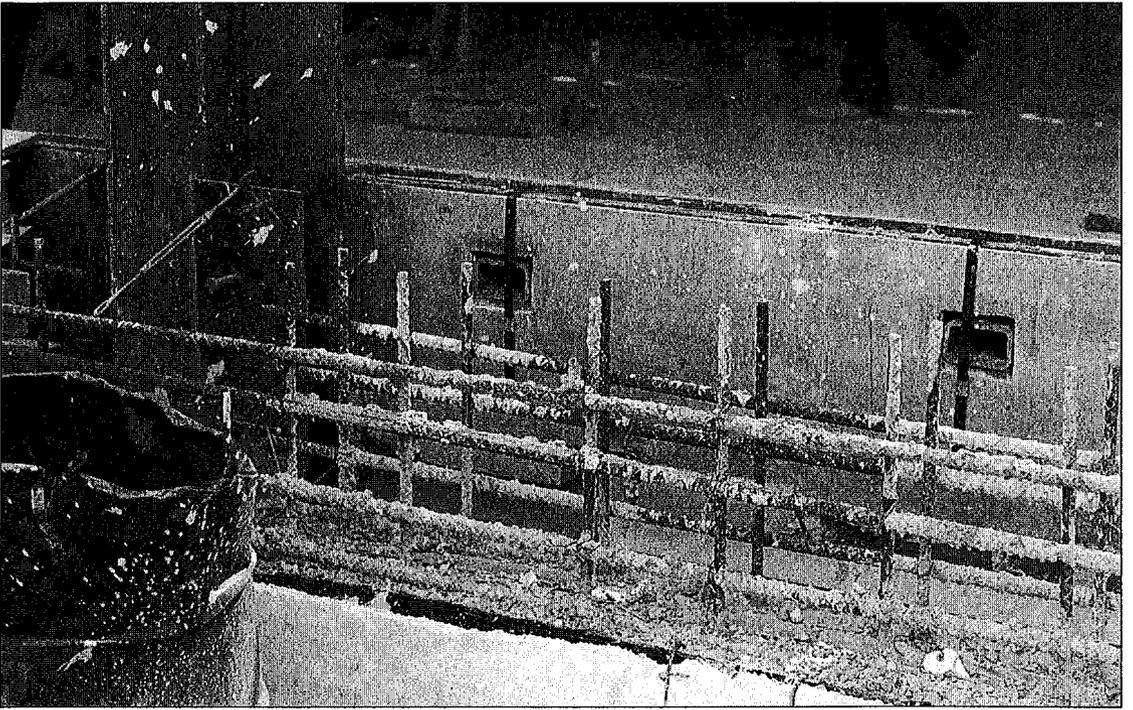
**FIGURE 3.** A view of the steel seal locking device for the floodgate.

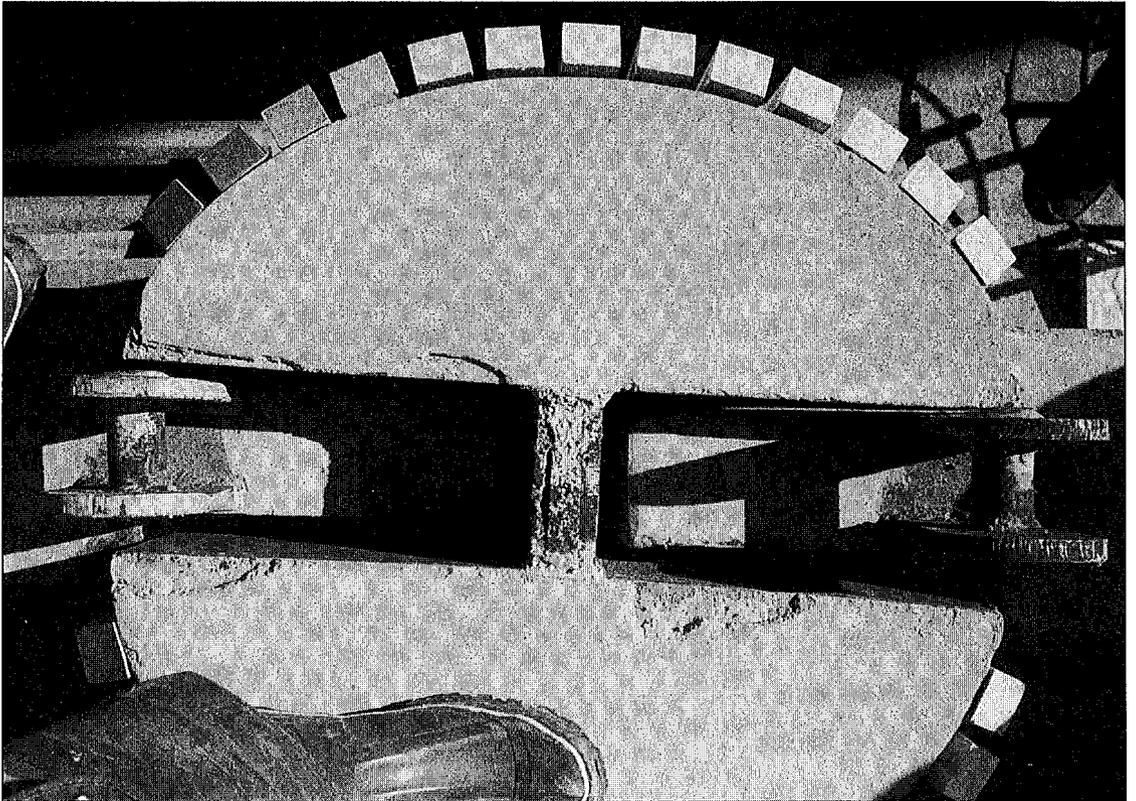
**FIGURE 4.** A view of the floodgate pylon with the gate in locked position.

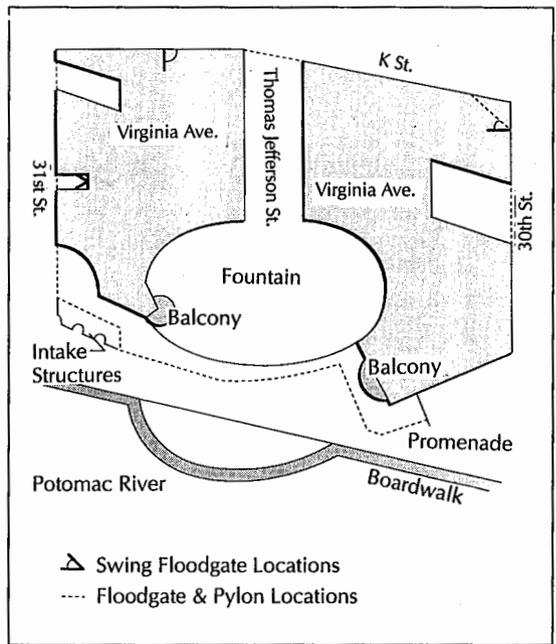
**FIGURE 5. Location of building walls and floodgates.**

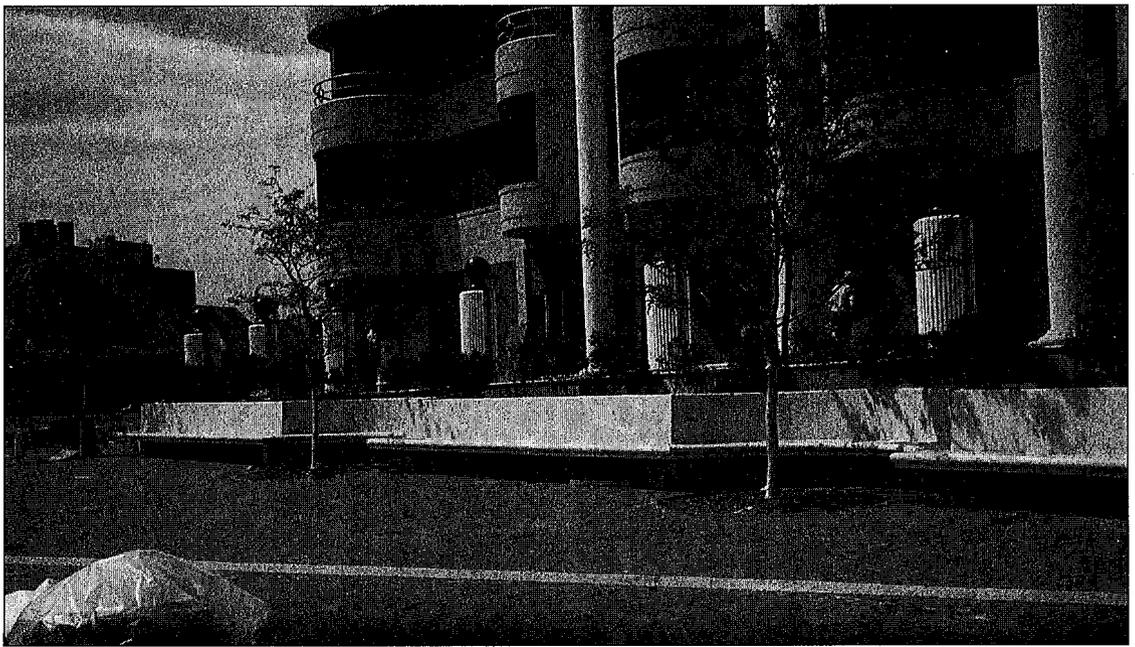
**FIGURE 6. A view of the intake structures.**

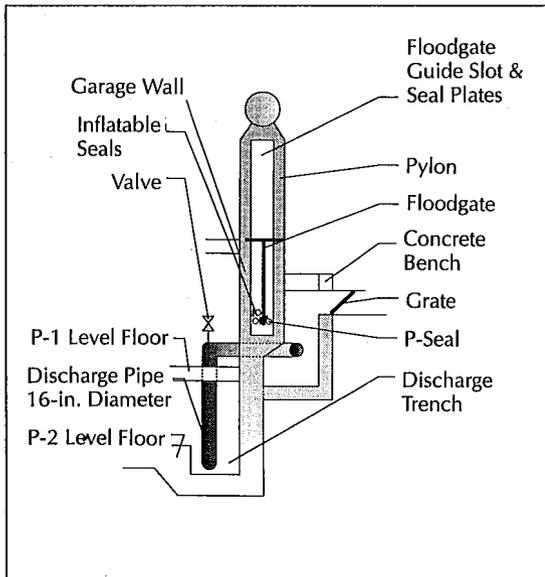
**FIGURE 7. Intake structure detail.**

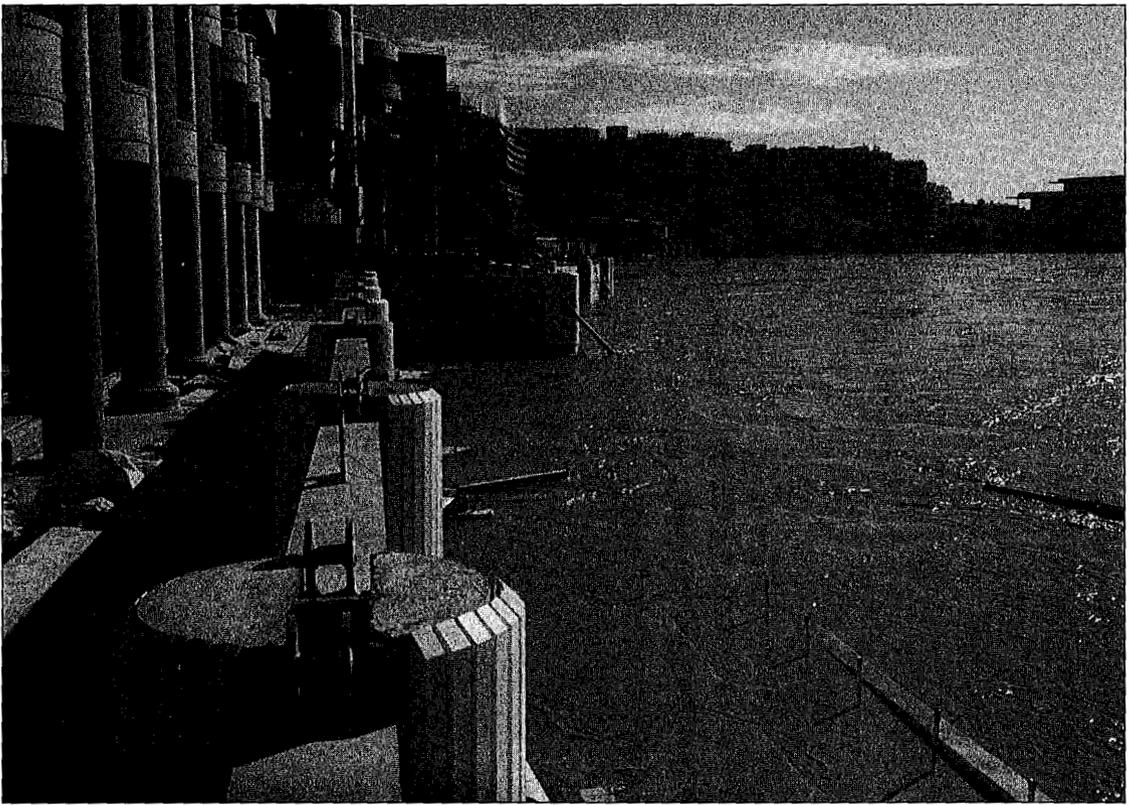
**FIGURE 8.** A view of the floodgates in operation.

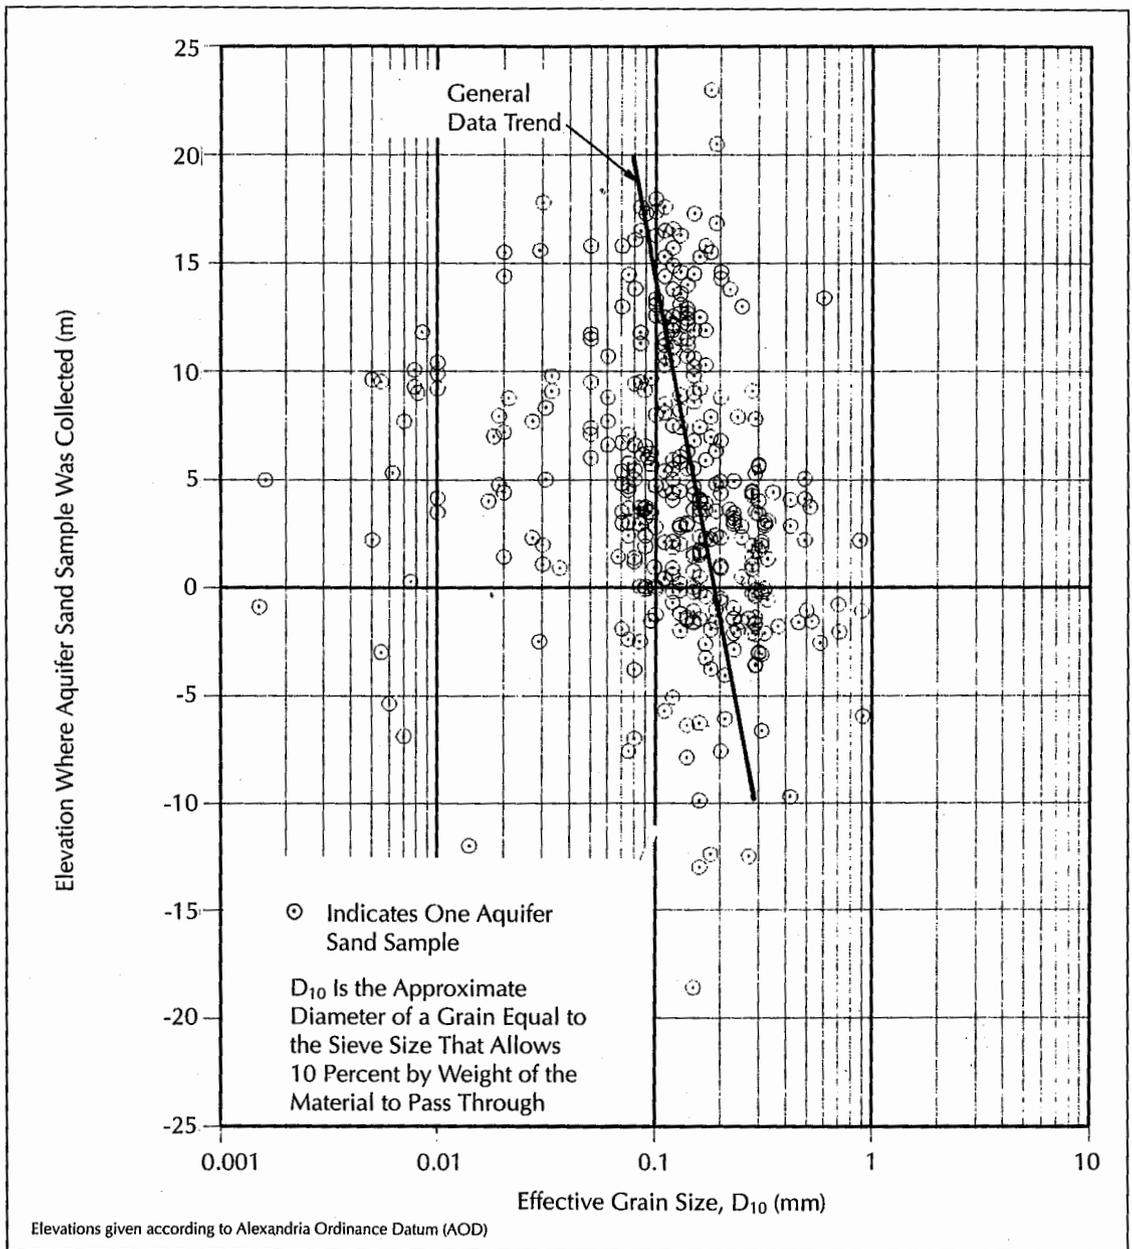
**FIGURE 5. Effective grain size,  $D_{10}$ , versus elevation.**

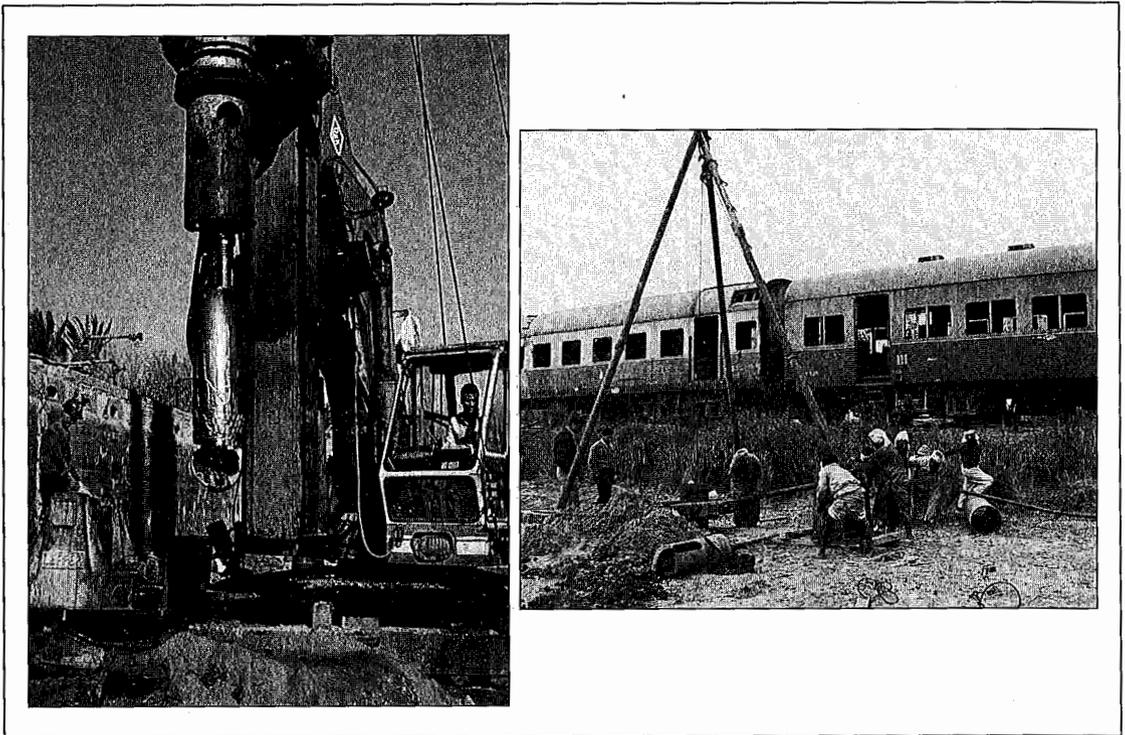
**FIGURE 6. Typical well drilling methods used for construction dewatering deep well installation.**

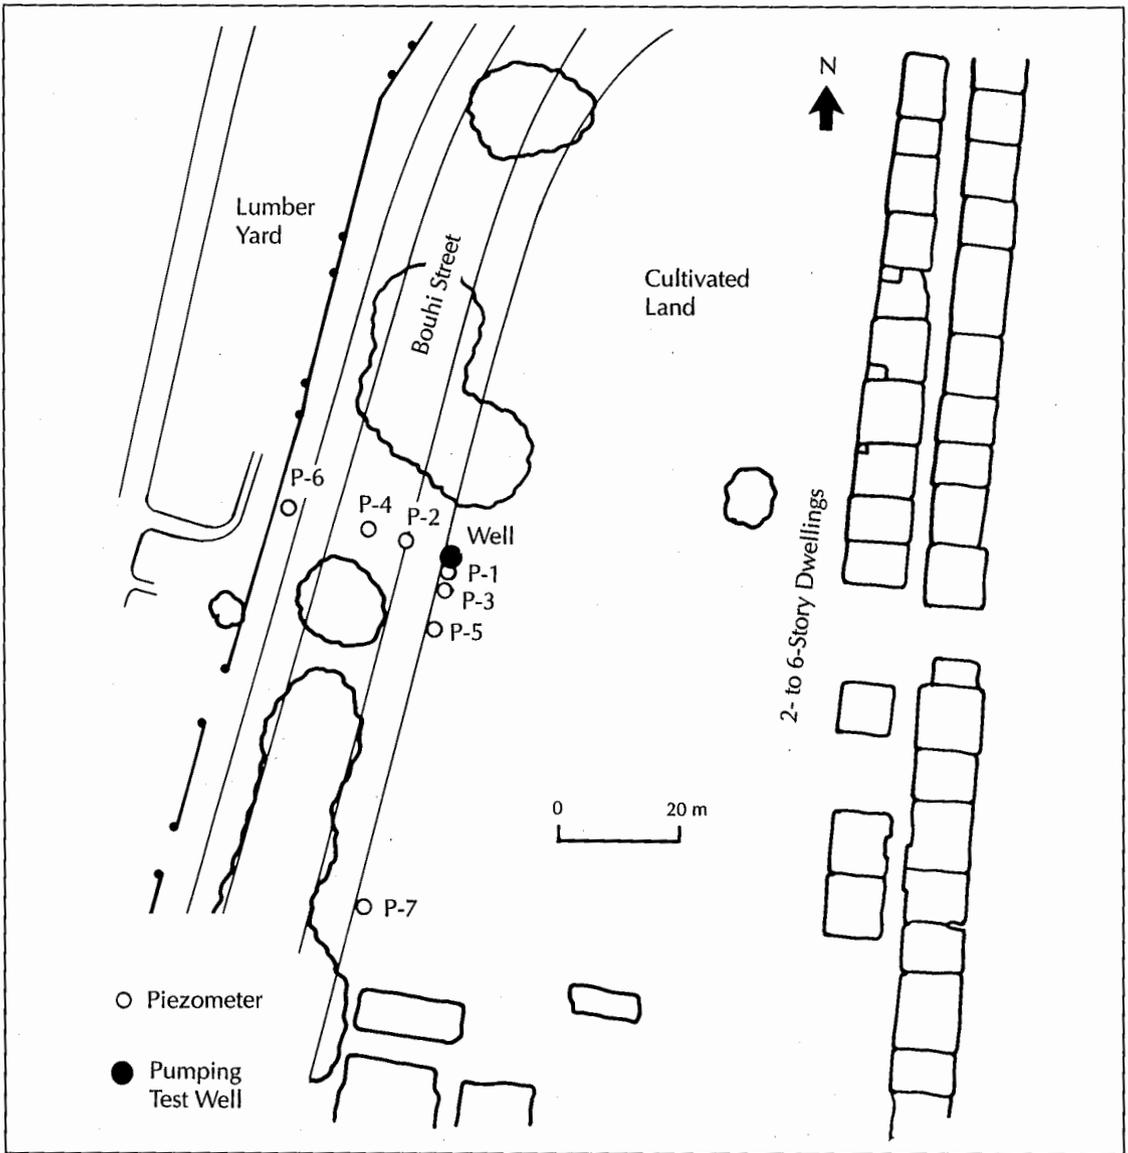
**FIGURE 7. Embaba site pumping test set-up.**

One partially penetrating deep well and seven piezometers were installed in 1984 at the Embaba site, as shown in Figure 7. The well, in-

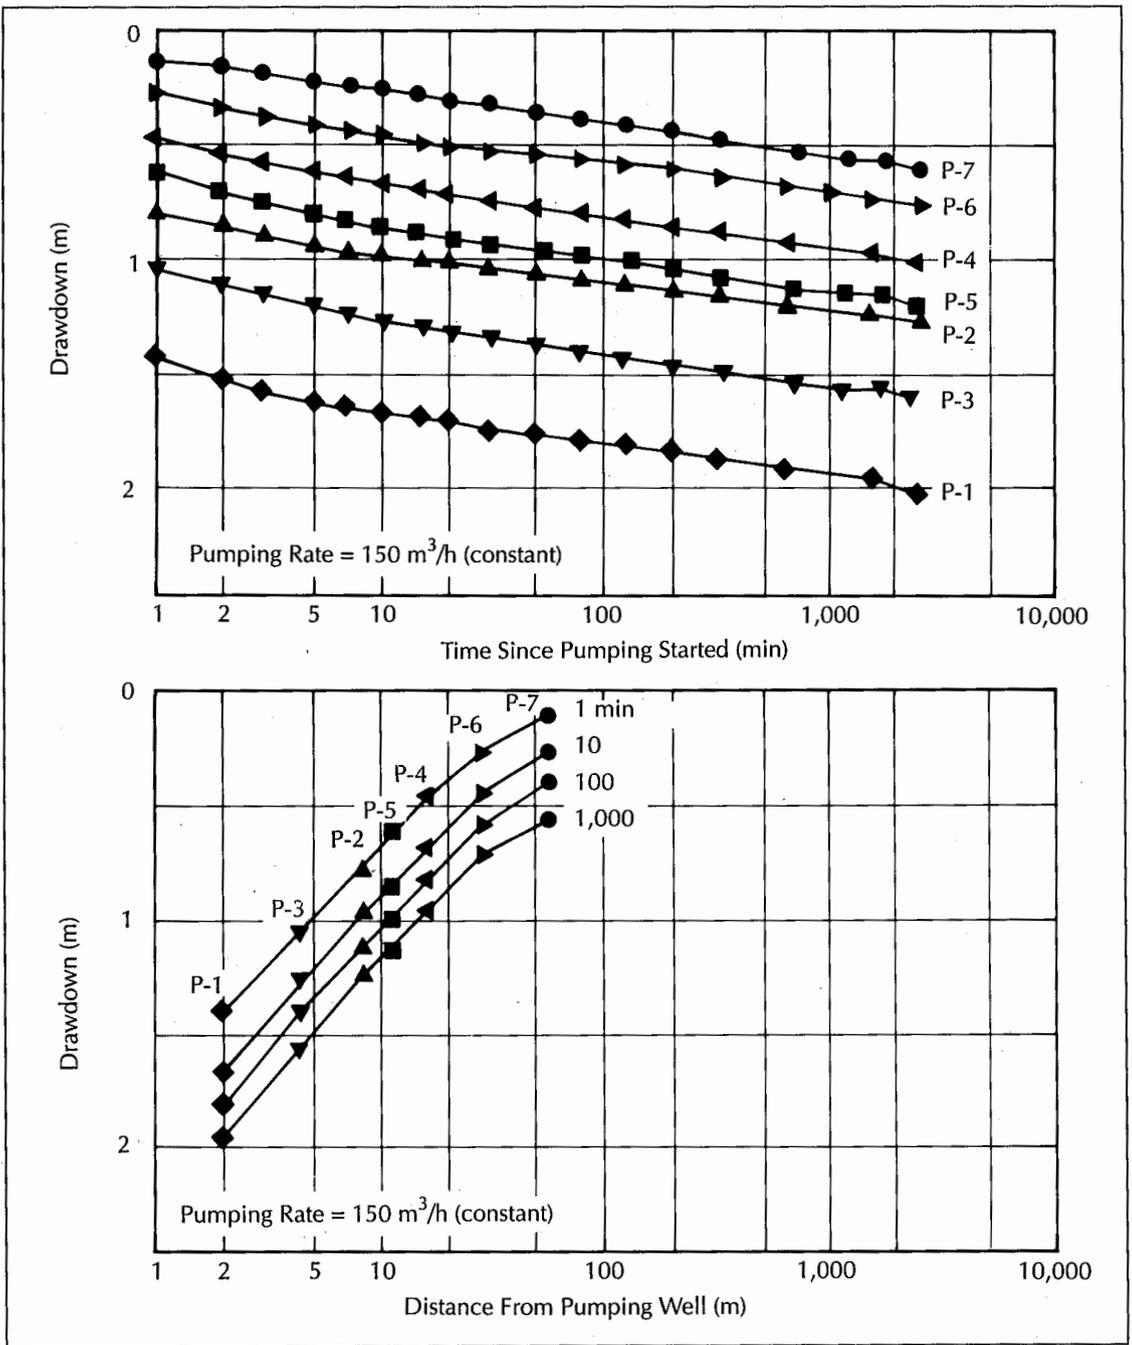
**FIGURE 8. Pumping test results from the Embaba site.**

A step-drawdown test was conducted at an initial pumping rate of 49 cubic meters per hour ( $\text{m}^3/\text{h}$ ) for one hour, followed by recovery for one hour. The sequence was repeated at two

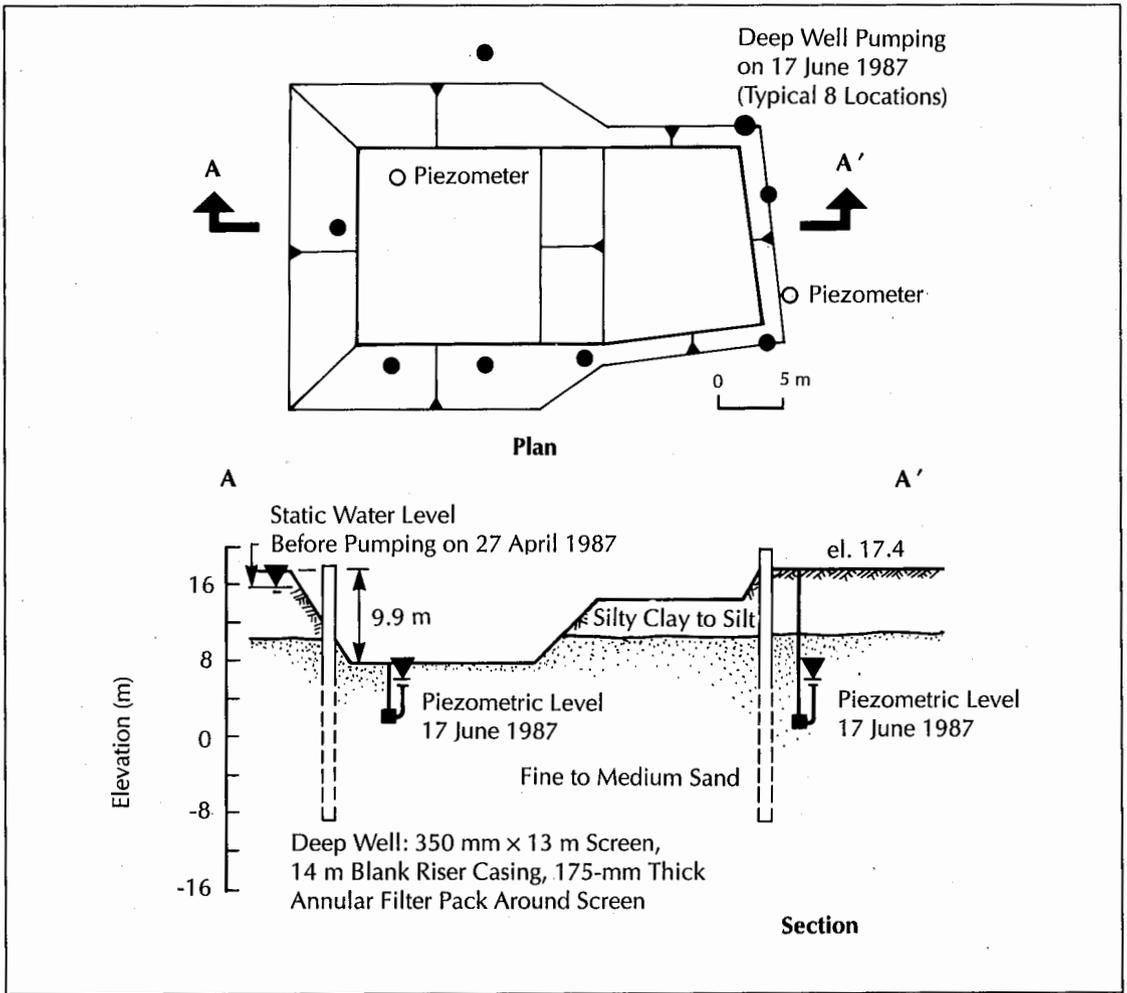
FIGURE 9. The deep well system layout for the Embaba site.

The general layout for the deep well system used at the Embaba site is shown in Figure 9. Stratigraphic conditions at the site include a silty clay to silt confining stratum that is approximately seven meters thick. Below seven meters, a fine to medium sand aquifer unit was encountered. The aquifer is estimated

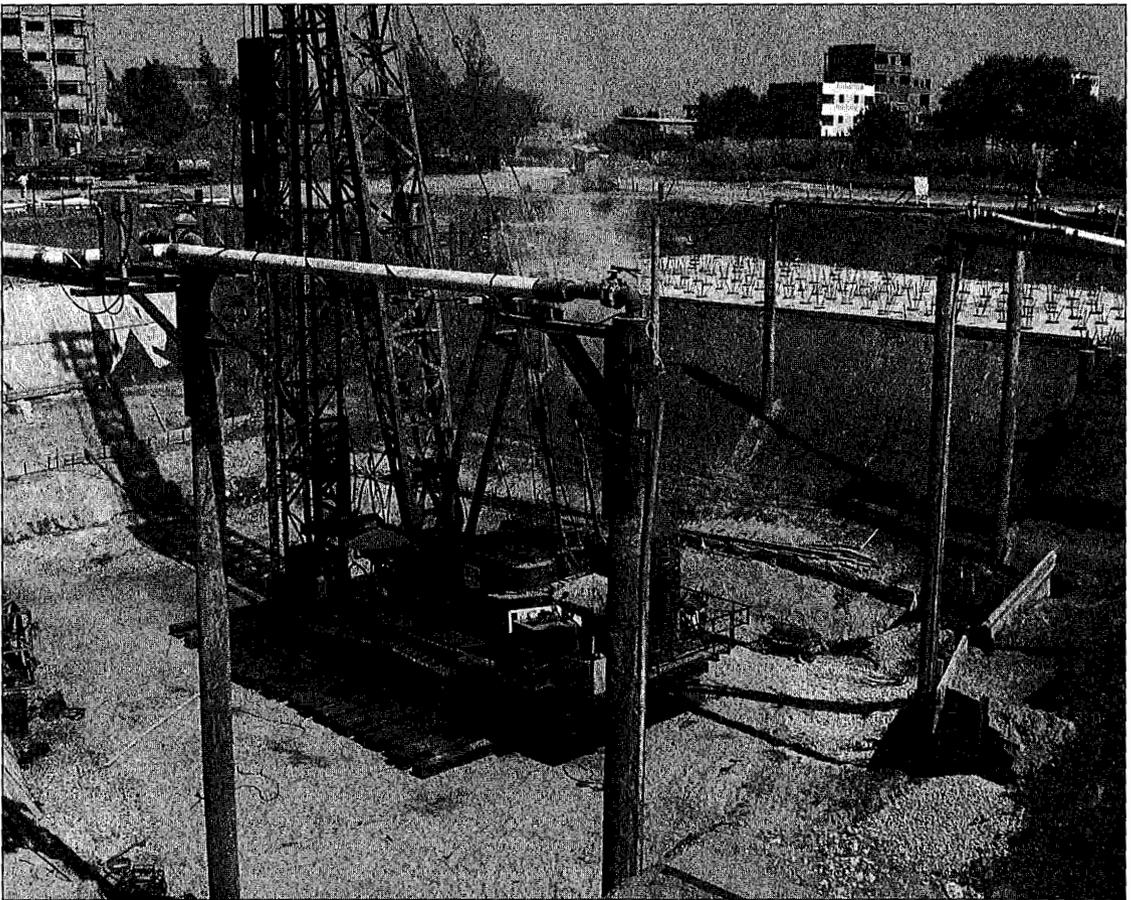
**FIGURE 10. Dewatered excavation for a West Bank Pumping Station (the Boulac site).**

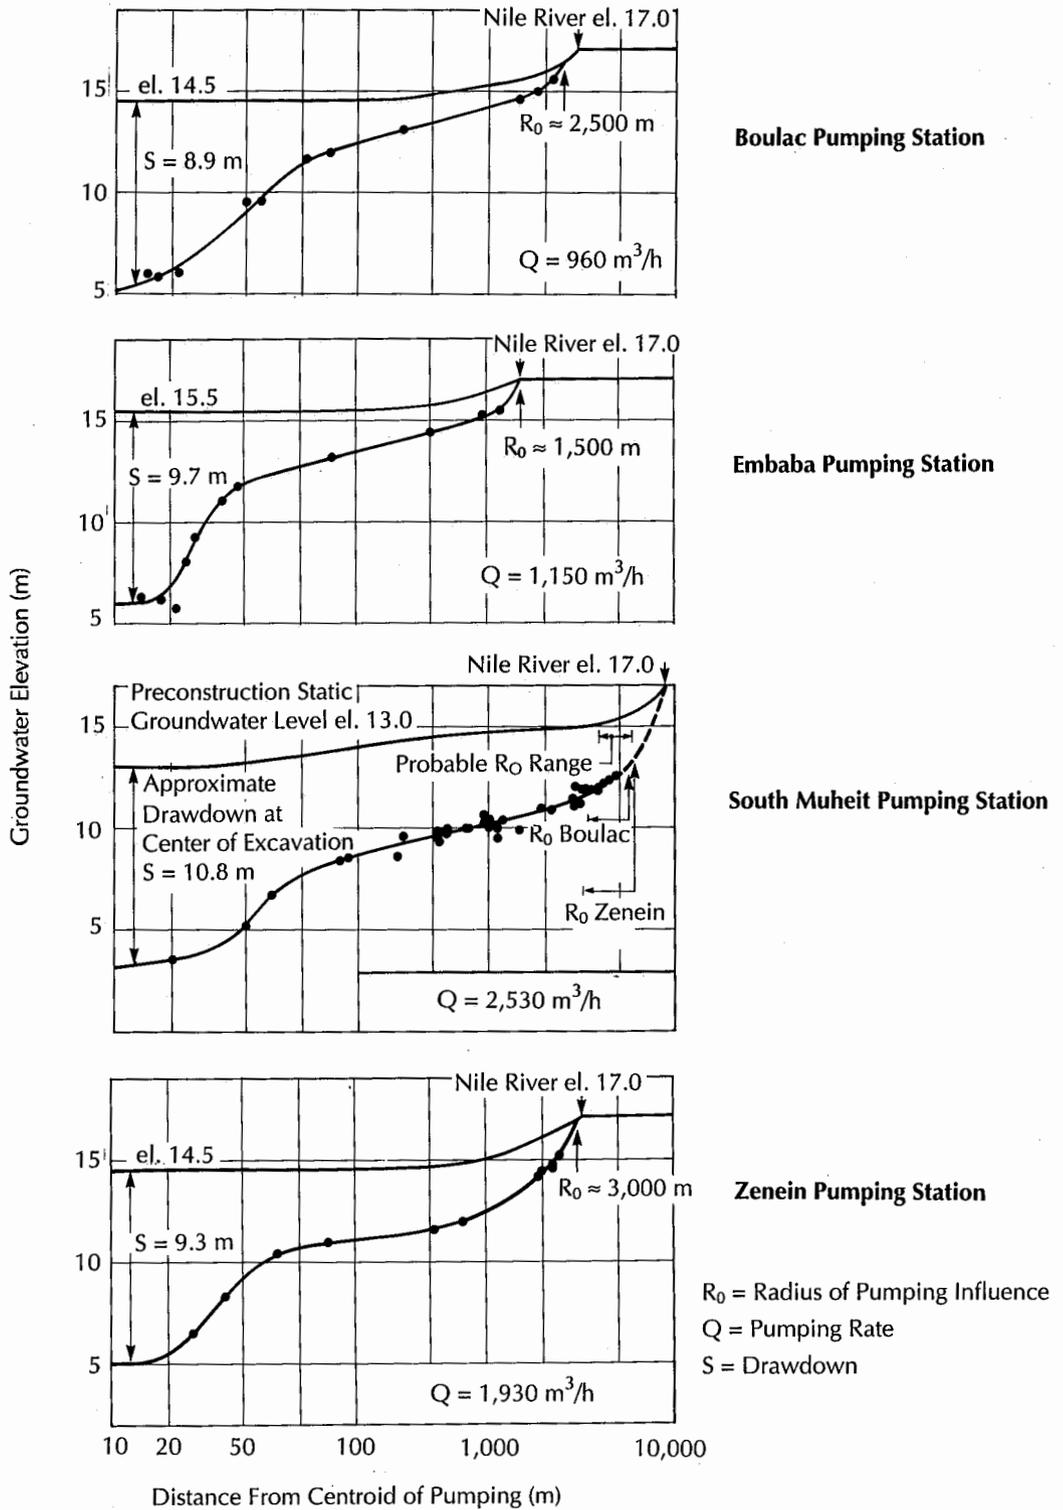
**FIGURE 11. Deep well system drawdown versus log distance for each site.**

Of particular interest in comparing pumping test results to dewatering system results are the drawdown versus log distance curves obtained for each deep well system. A plot of drawdown versus distance from the centroid of pumping is shown in Figure 11 for each of the four sites. A bend (distortion) in all of the curves is noted at a distance of approximately 50 to 100 meters from the centroid of pumping, corre-

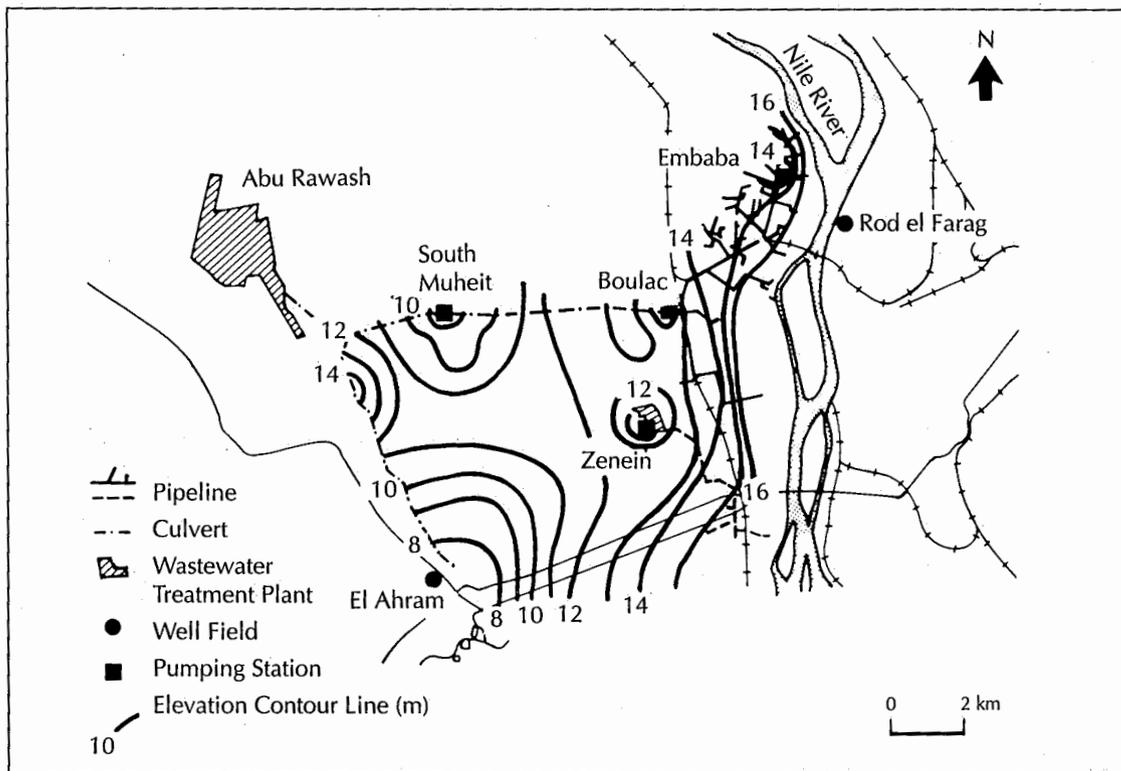
FIGURE 12. Piezometric level contour map during construction dewatering in July 1987.

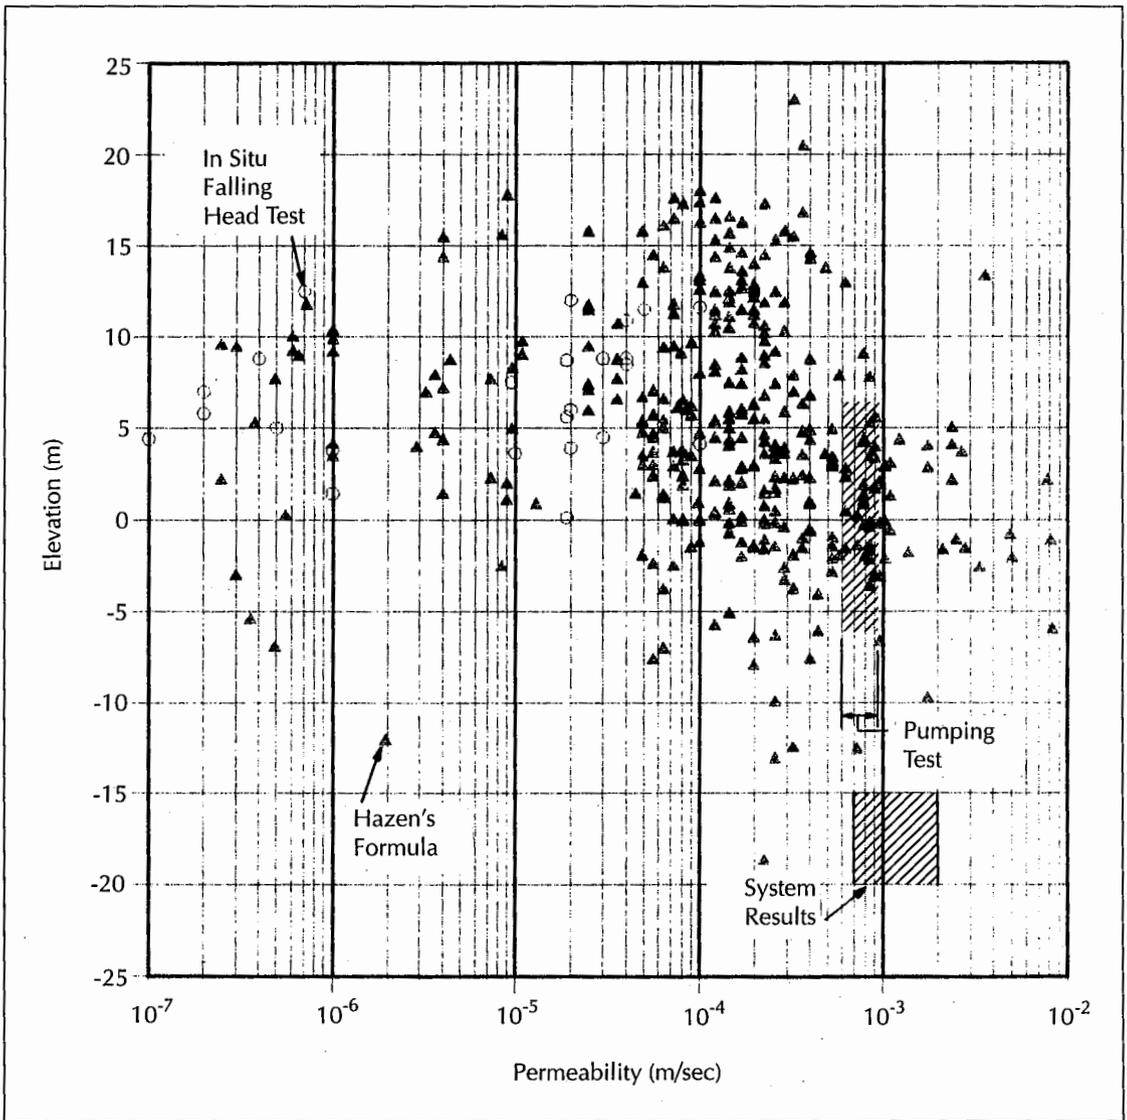
**FIGURE 13. Summary of permeability data.**

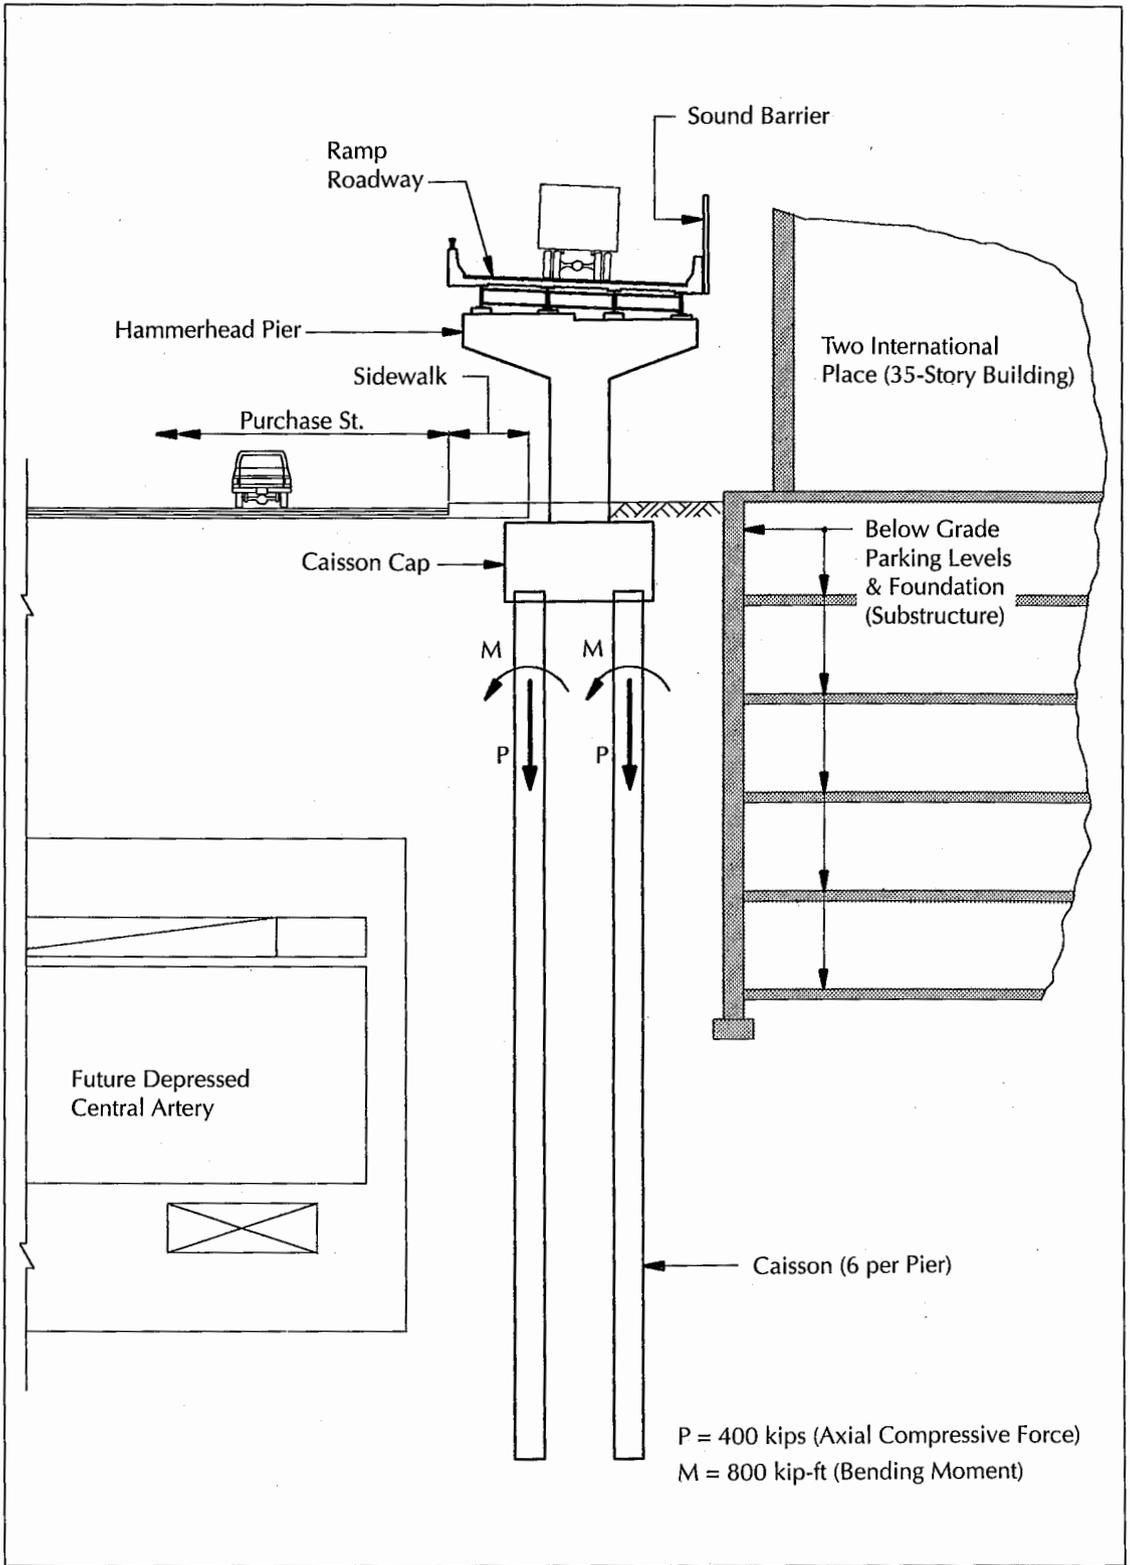
**FIGURE 3. Typical cross section of the reinforced concrete pier.**

- The first was the *current condition* with soil present around the pile cap and the caissons (see Figure 3).
- The second was the *future condition*, when the excavation for the depressed Central Artery will have eliminated the soil that is the only means of lateral support around the caisson cap and caissons (see Figure 4).

For the first condition, a computer model was developed in order to simulate the lateral earth support. This computer model made use of spring supports around the caissons and the pile cap.

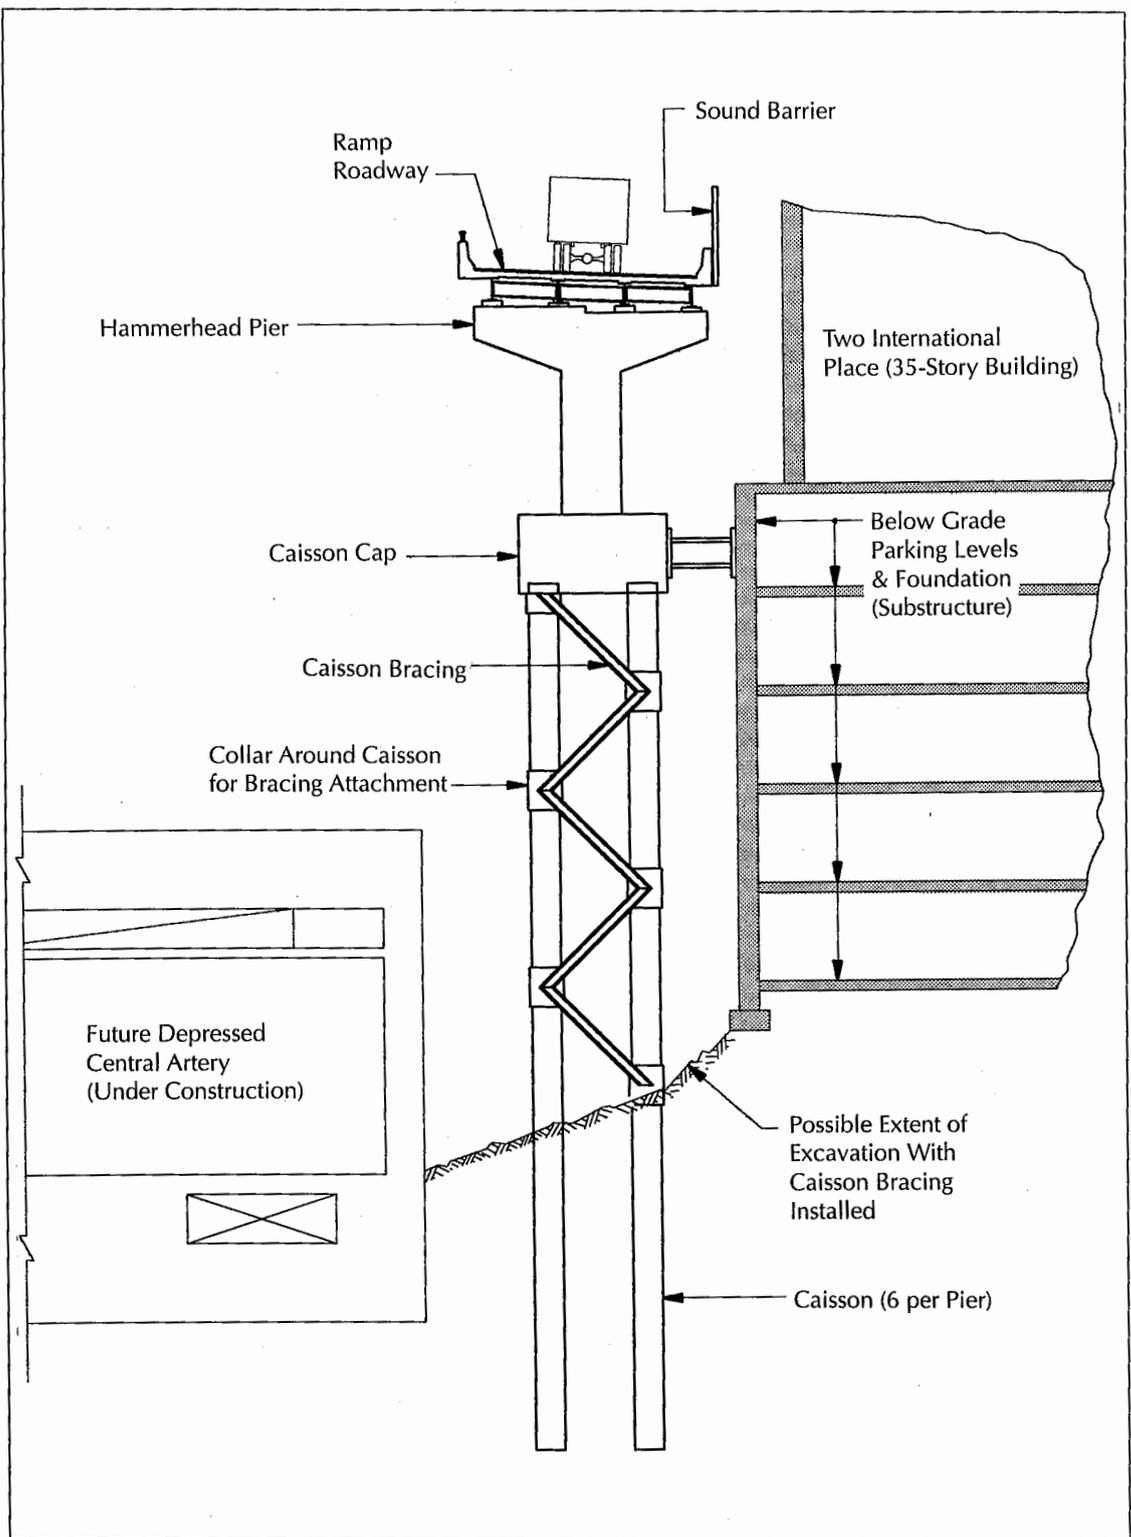
**FIGURE 4. Cross section of the reinforced concrete pier during the construction of depressed Central Artery.**

For the second condition, a bracing system was schematically designed in order to brace the caissons and the caisson cap. The bracing system will be installed in the future in a step-by-step sequence during the excavation of the depressed Central Artery (see Figure 4).

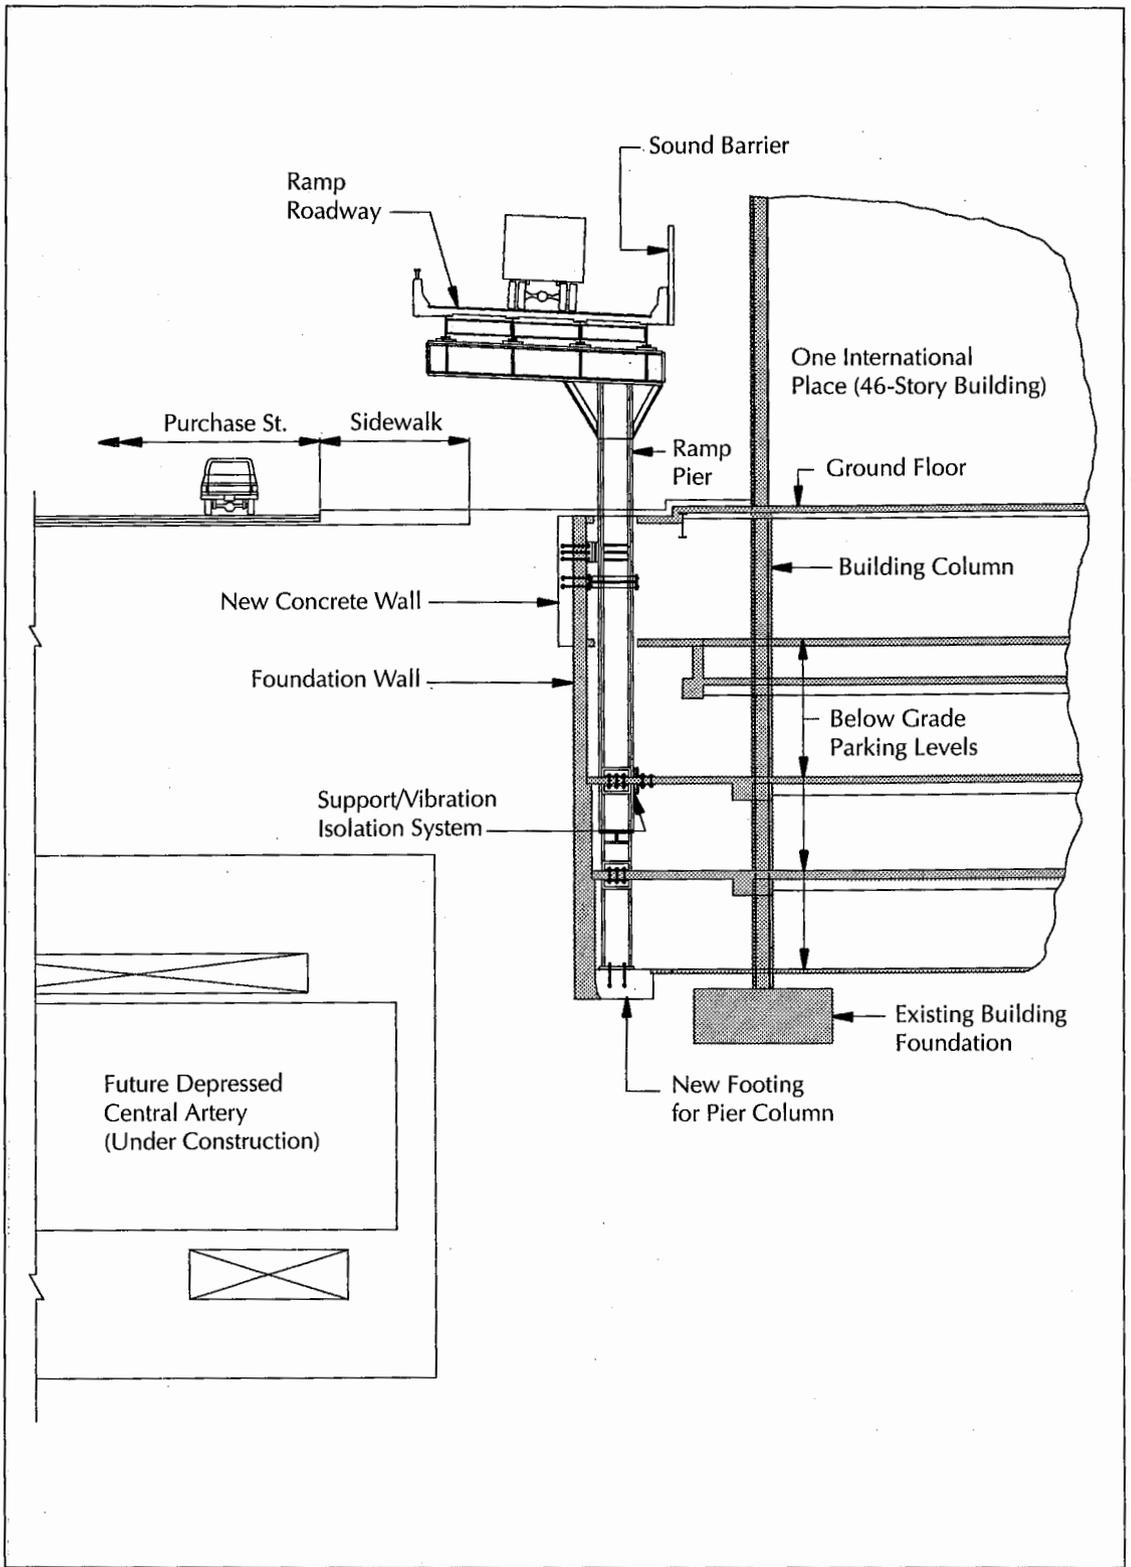
**FIGURE 5. Typical cross section of the structural steel pier.**

Based on the those considerations, a structural steel system was clearly advantageous. Four of the five steel piers consisted of a single box column supporting a cantilevered box girder (see Figure 5). The fifth pier required two columns. Each of the box columns is supported on a new spread footing bearing on a glacial till subgrade below the lowest level of the existing building. The new spread footings are of a type similar to those used for the existing One International Place building but were designed to function independently from the existing building foundations.
