# CIVIL ENGINEERING PRACTICE

JOURNAL OF THE BOSTON SOCIETY OF CIVIL ENGINEERS SECTION/ASCE

SPRING/SUMMER 1993

VOLUME 8, NUMBER 1

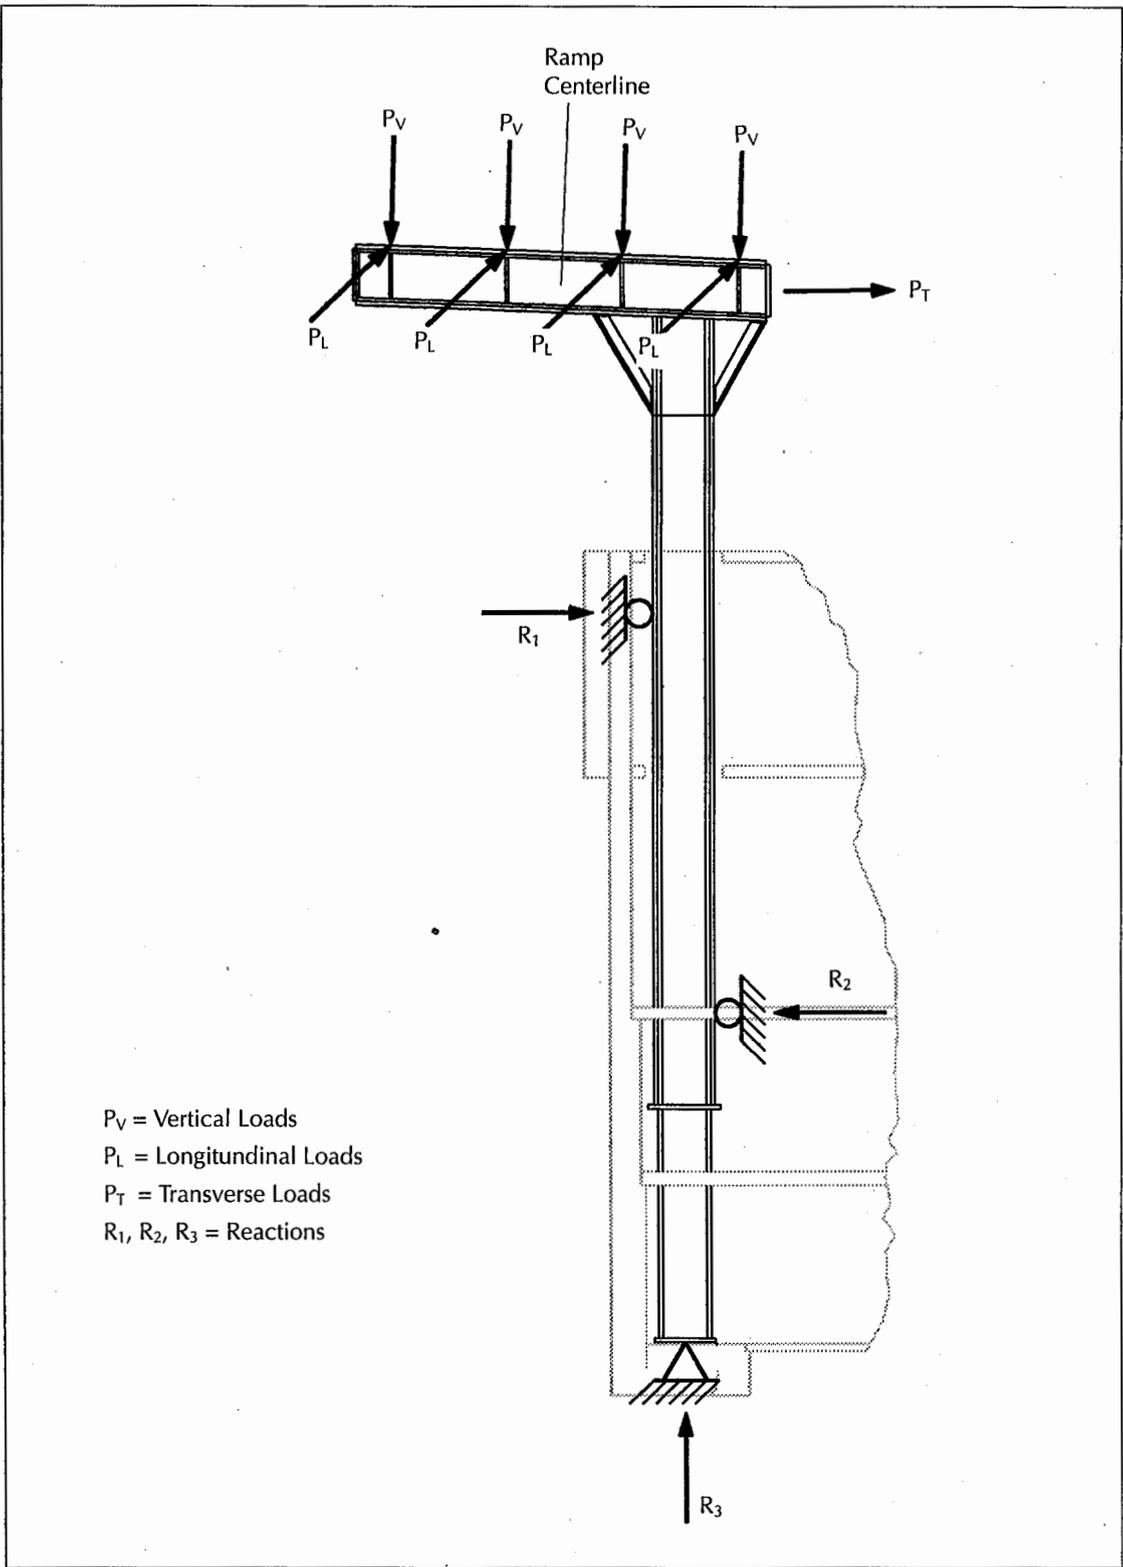
**FIGURE 6. Model of the support system for the single column steel piers.**

and supporting columns. The moments in the columns were resisted by the garage floors and the foundation wall of the One International Place building acting as a couple (see Figure 6). The design loads creating these bending moments consisted of:

The vertical loads and bending moments on the box column were resisted by the reactions —  $R_1$ ,  $R_2$  and  $R_3$  — shown in Figure 6. The existing building's foundation wall was reinforced in order to develop reaction  $R_1$ , while the reaction  $R_2$  was resisted by the existing garage slabs.

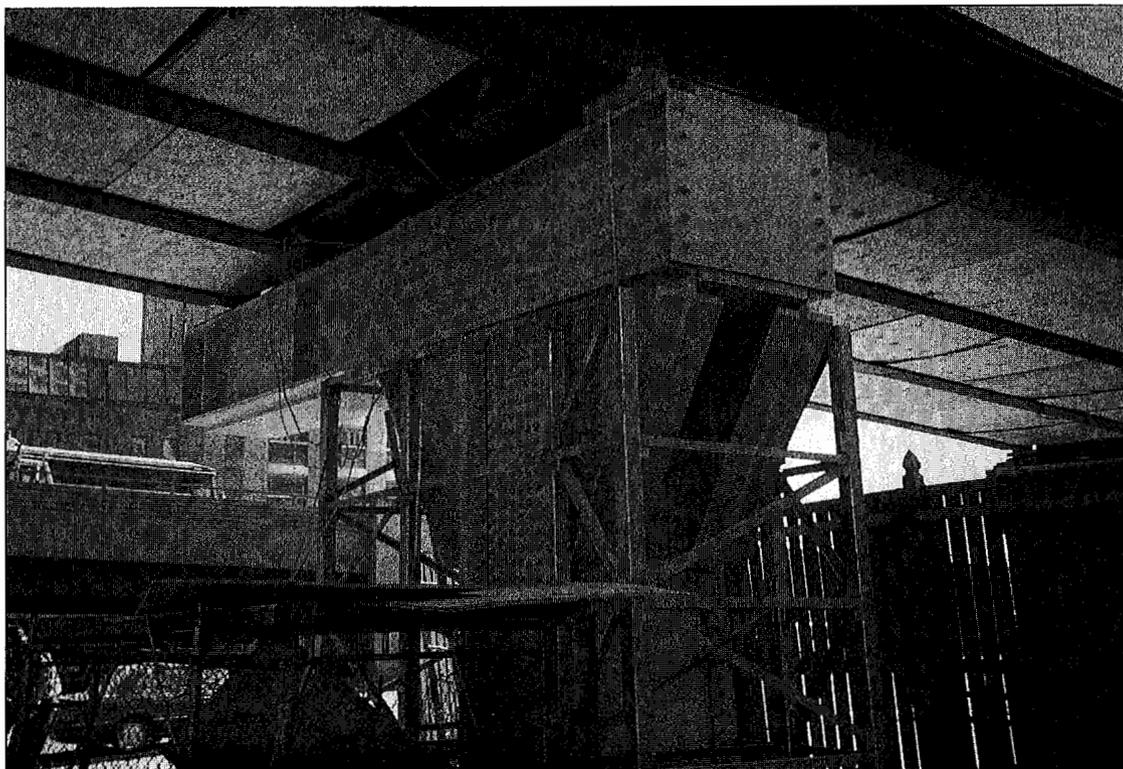
**FIGURE 7. A view of a steel pier during construction.**

All cantilevered box girders and box columns consisted of two W36 beams with 2.5-inch thick top and bottom cover plates. Many internal stiffeners were used in the box girders in order to increase the rigidity of the section against torsional warping. No field welding was permitted by the Massachusetts Highway Department (MHD) Standard Specifications since fracture-critical steel was used for all five of the steel piers. All field connections were therefore bolted connections that had been pre-assembled in the shop in order to ensure the proper fitting of all elements in the field (see Figure 7).

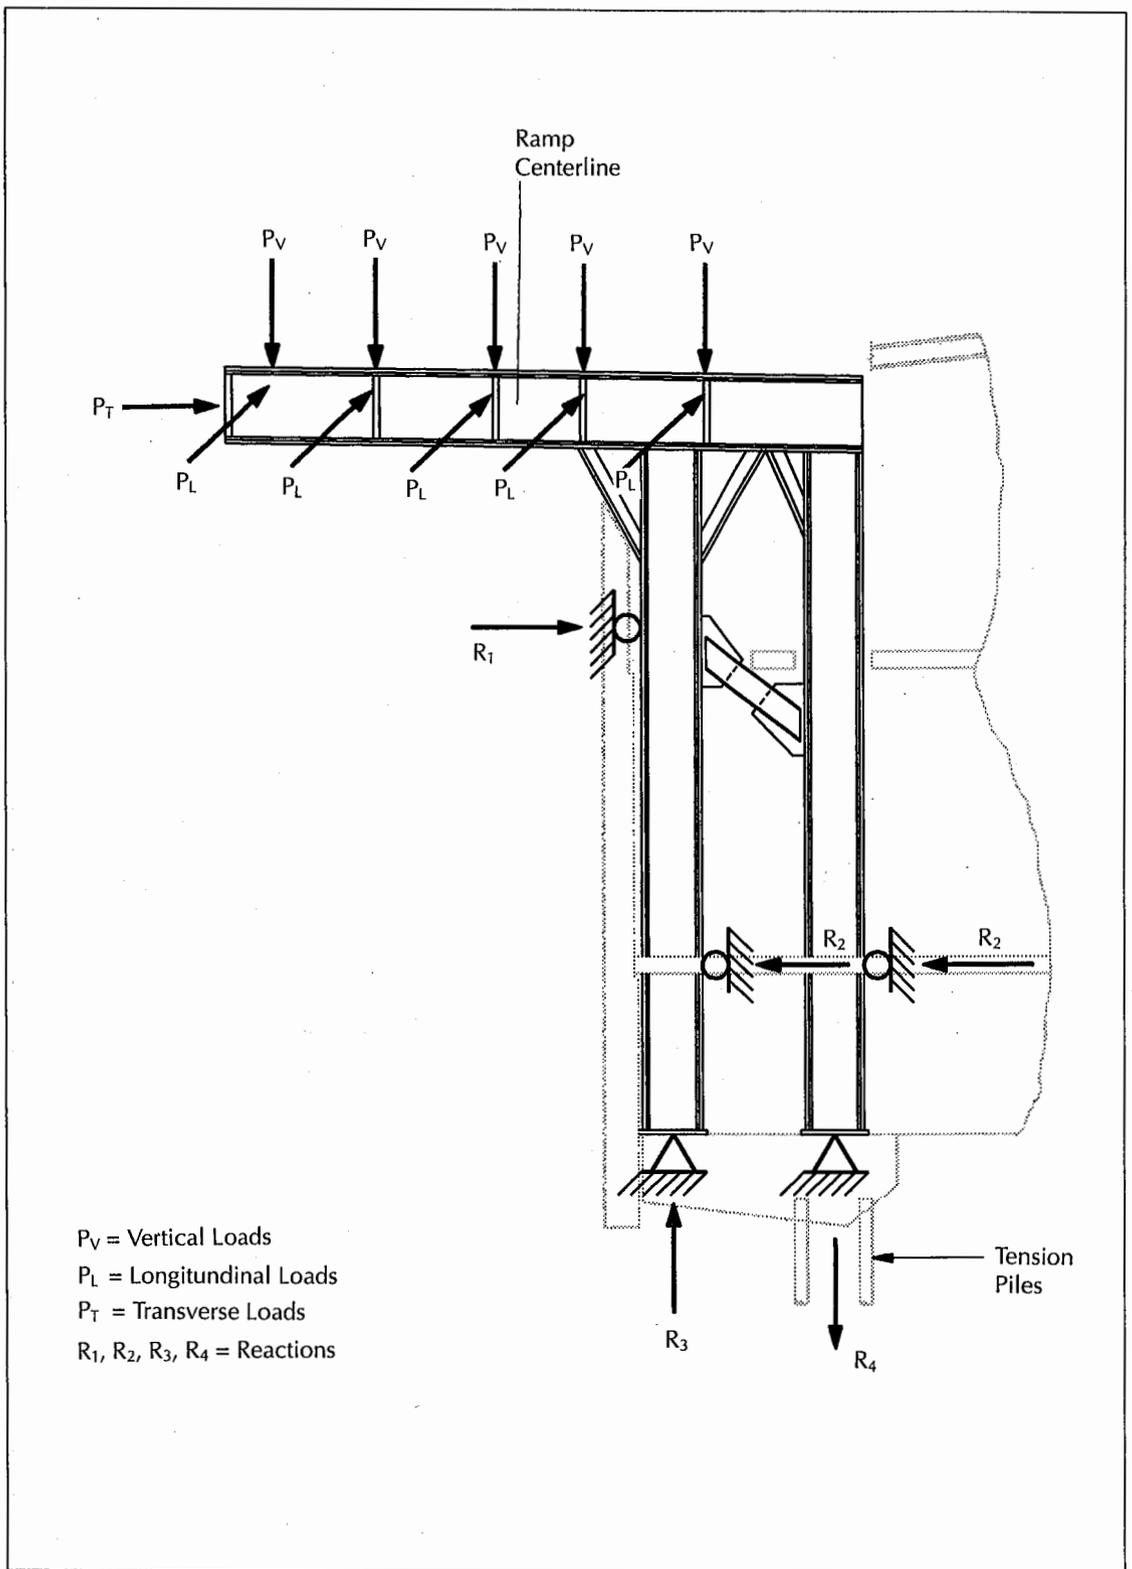
FIGURE 9. Model of the support for the double column steel piers.

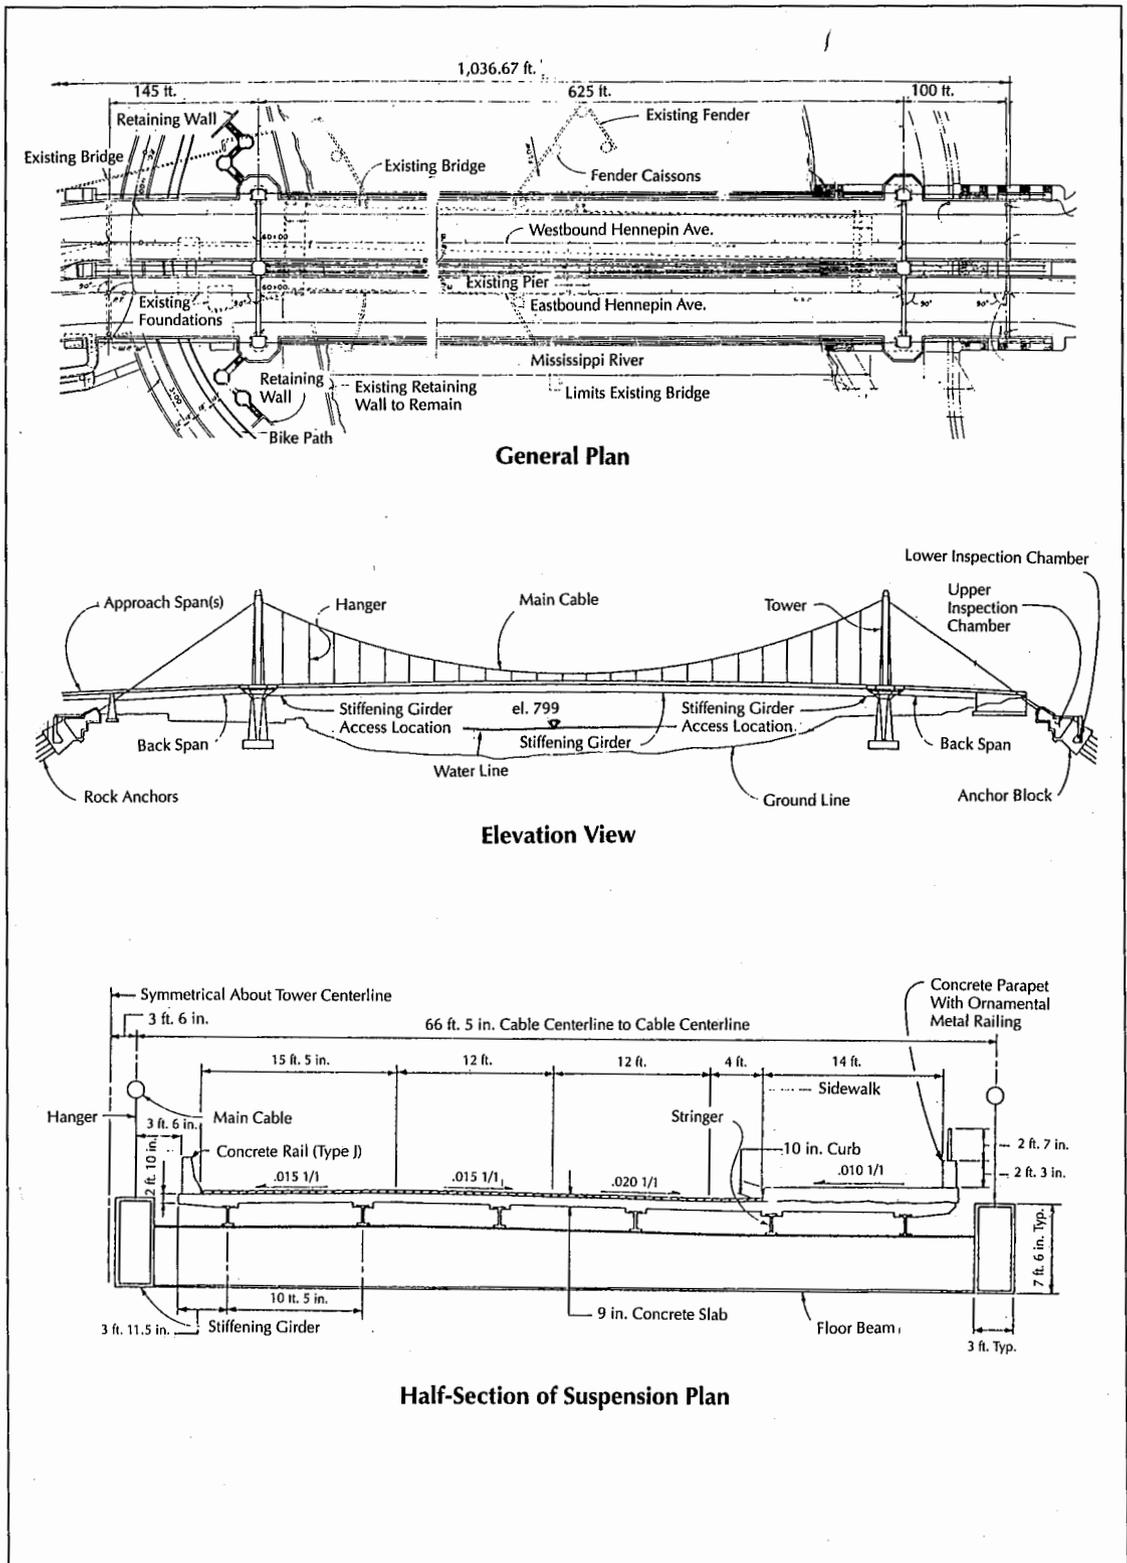
FIGURE 1. Hennepin Bridge plan/elevation.

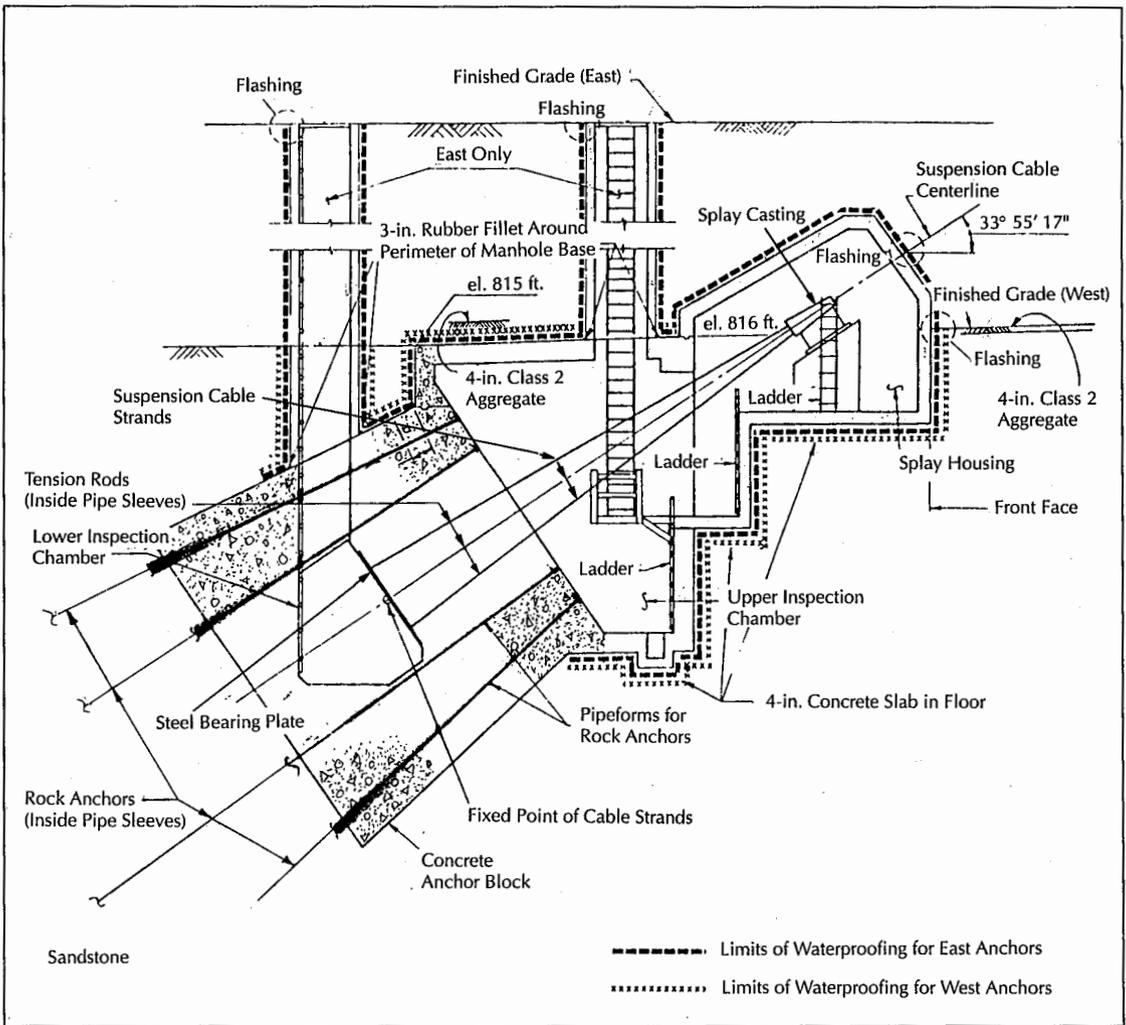
**FIGURE 2. Typical section through the anchor.**

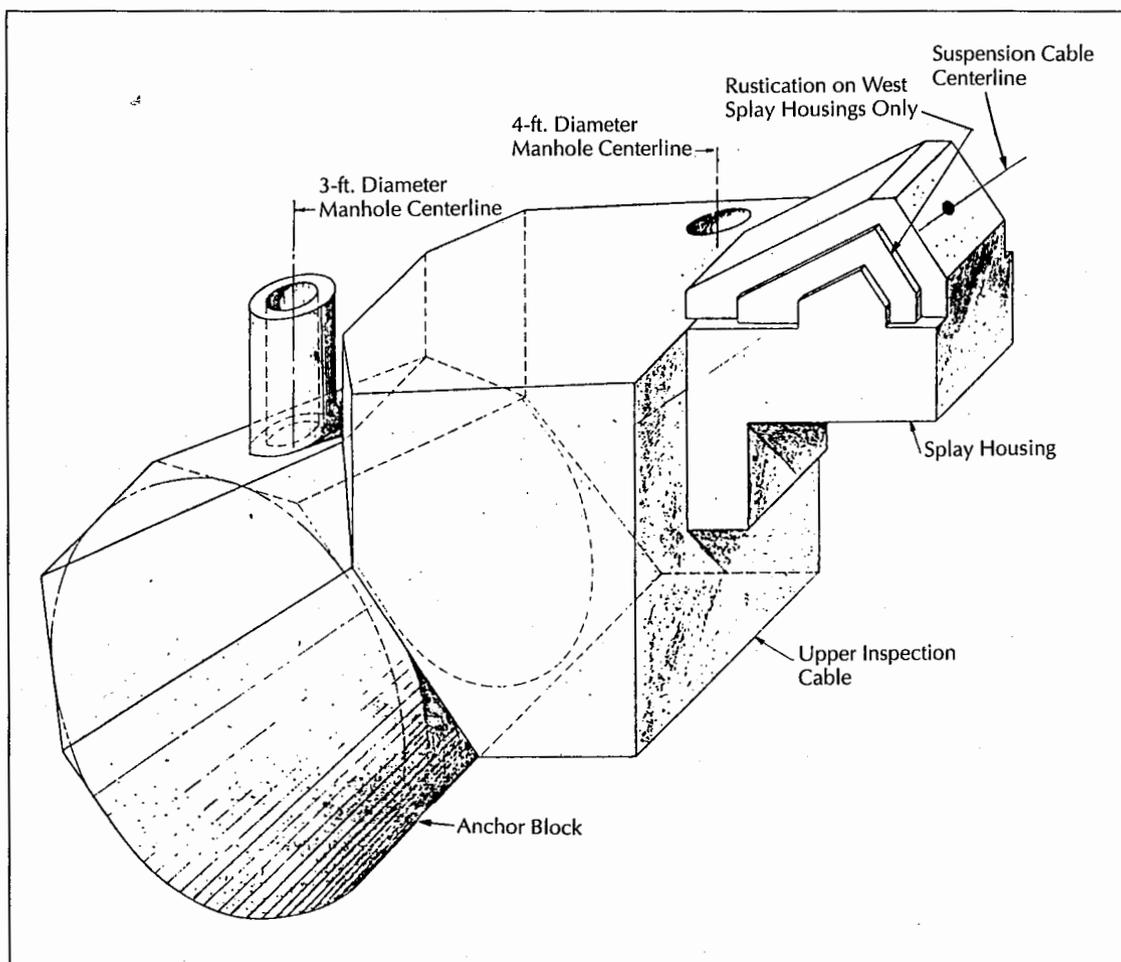
**FIGURE 3. Anchorage isometric.**

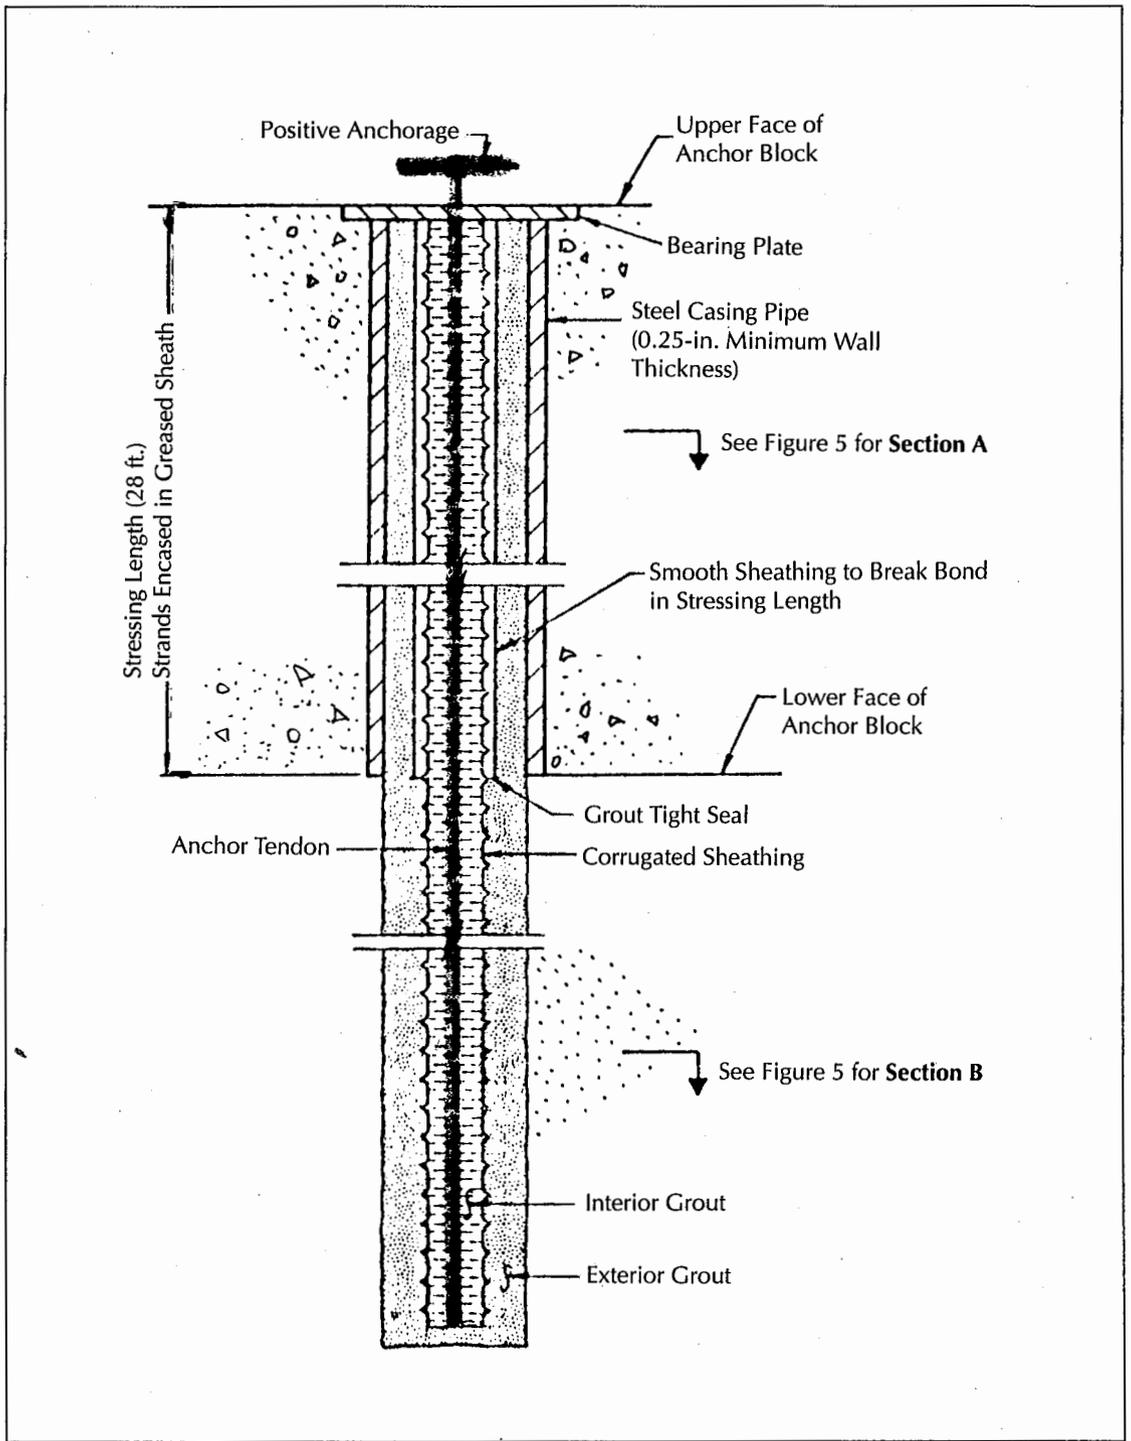
**FIGURE 4. Rock anchor detail.**

The design rock anchor load was approximately 700 kips, with total anchor lengths ranging from 80 to 105 feet. Each tendon consisted of nineteen 0.6-inch diameter seven-wire strands inside a corrugated polypropylene sheath. The tendon was grouted along its full length, including the stressing length (inside and outside of the sheath) in one step so there would be no cold joints that would possibly lead to a breach of the dual corrosion protection system. The unbonded (stressing) length consisted of grease-injected strands encased in plastic jackets.

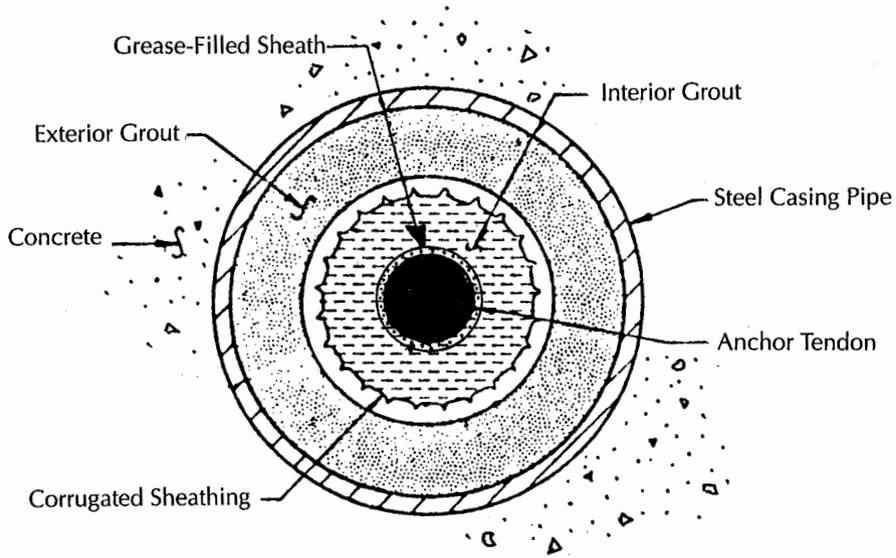
Section A (Stressing Length) from Figure 4

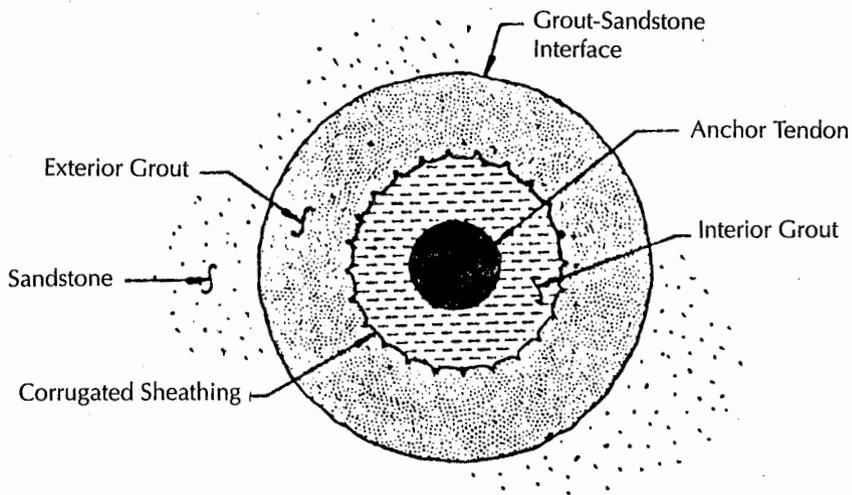
Section B (Bond Length) from Figure 4

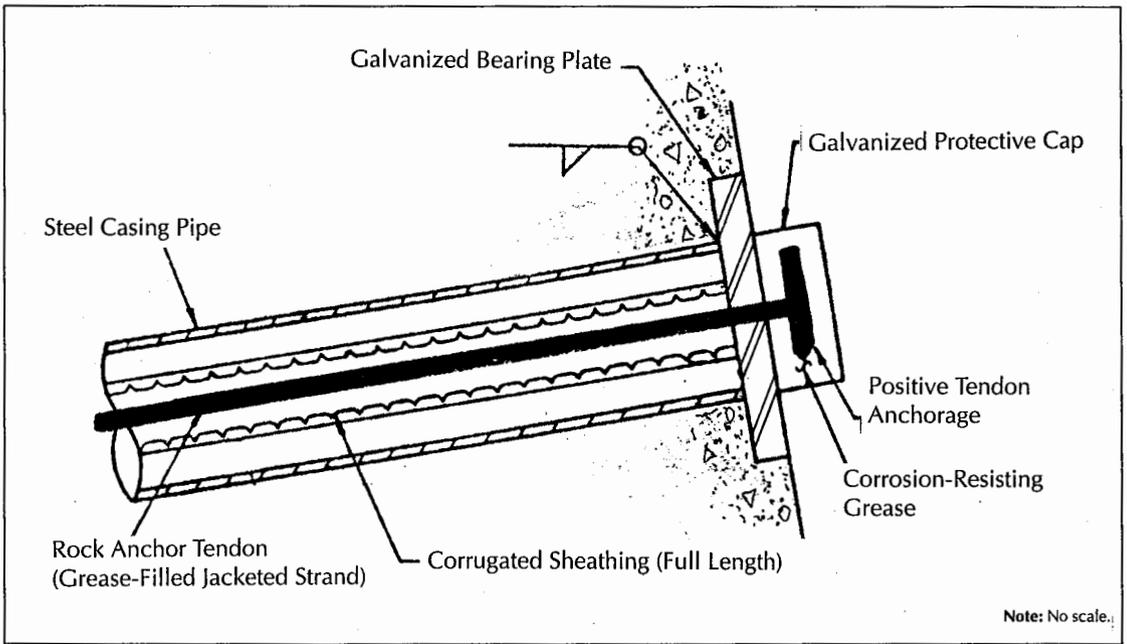
FIGURE 6. Rock anchor head detail.

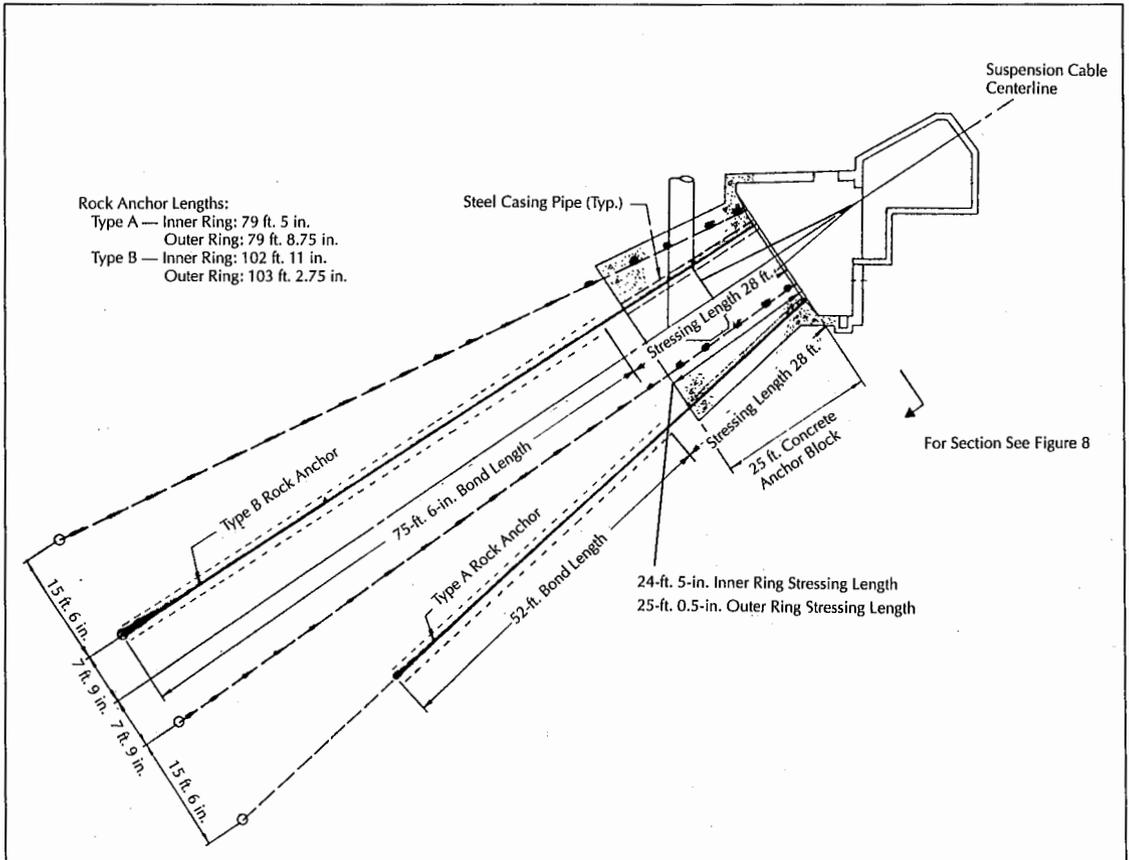
FIGURE 7. Rock anchor layout.

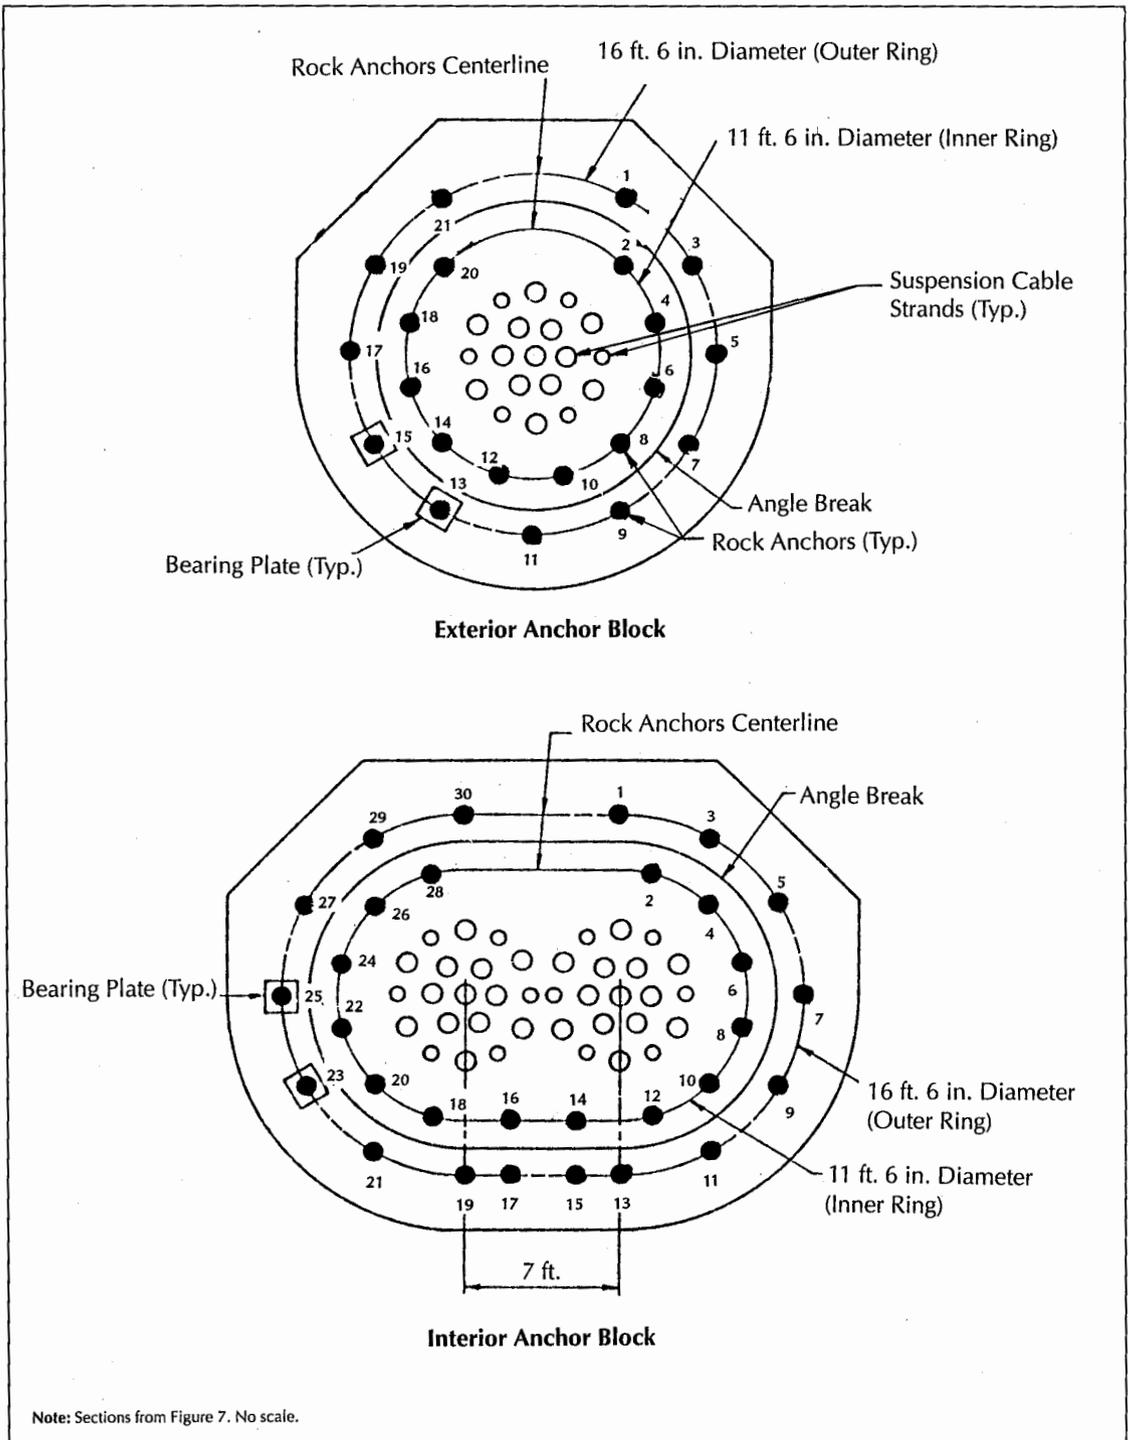
**FIGURE 8. Section of interior and exterior anchor blocks.**

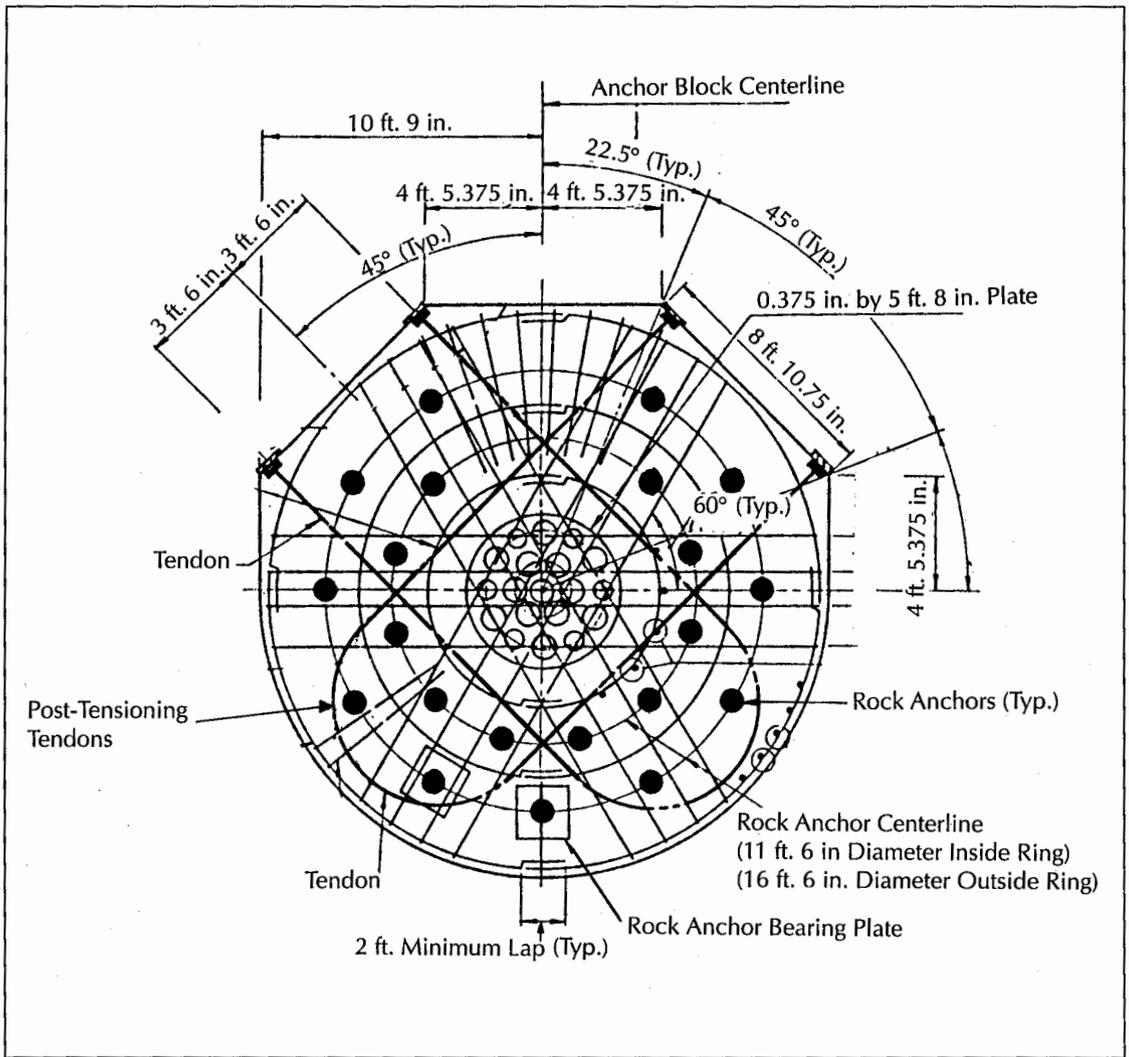
FIGURE 9. Top face of an exterior anchor block.

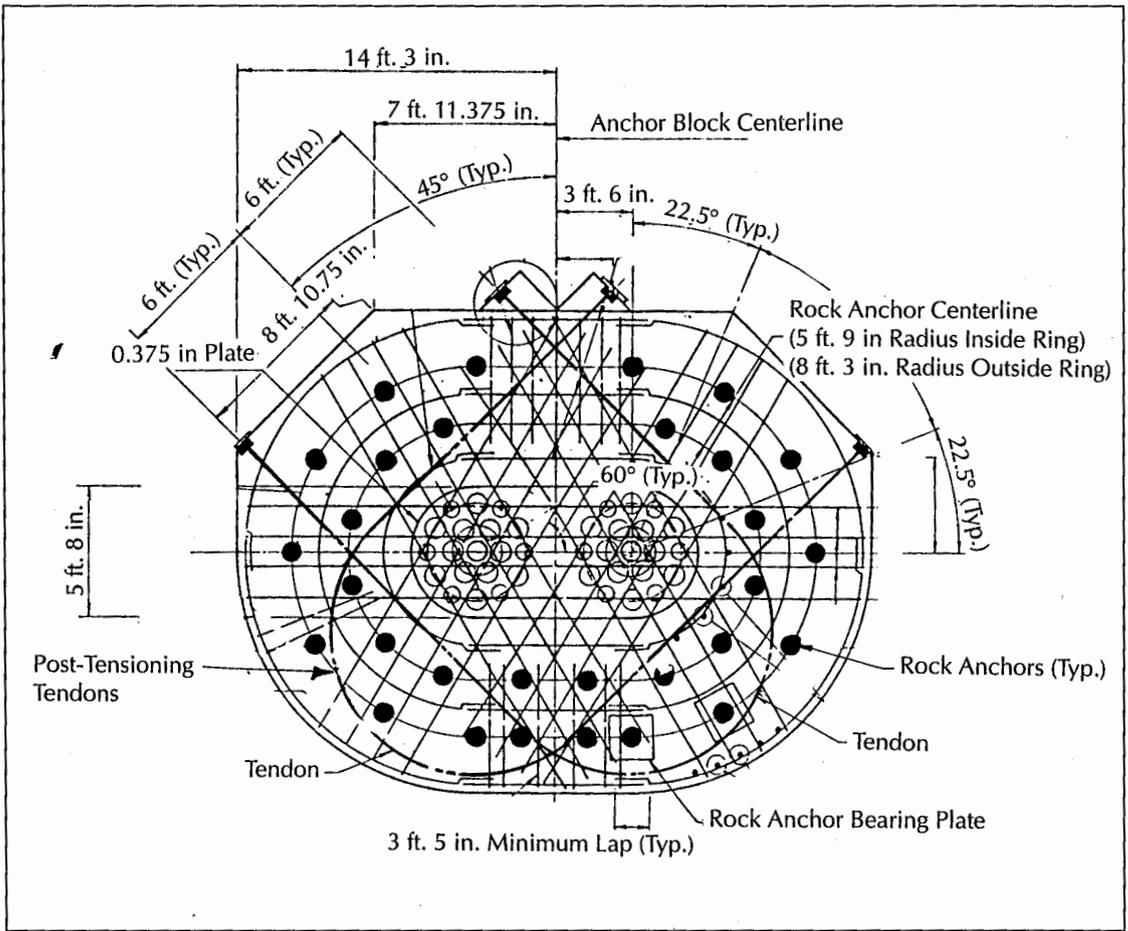
FIGURE 10. Top face of an interior anchor block.

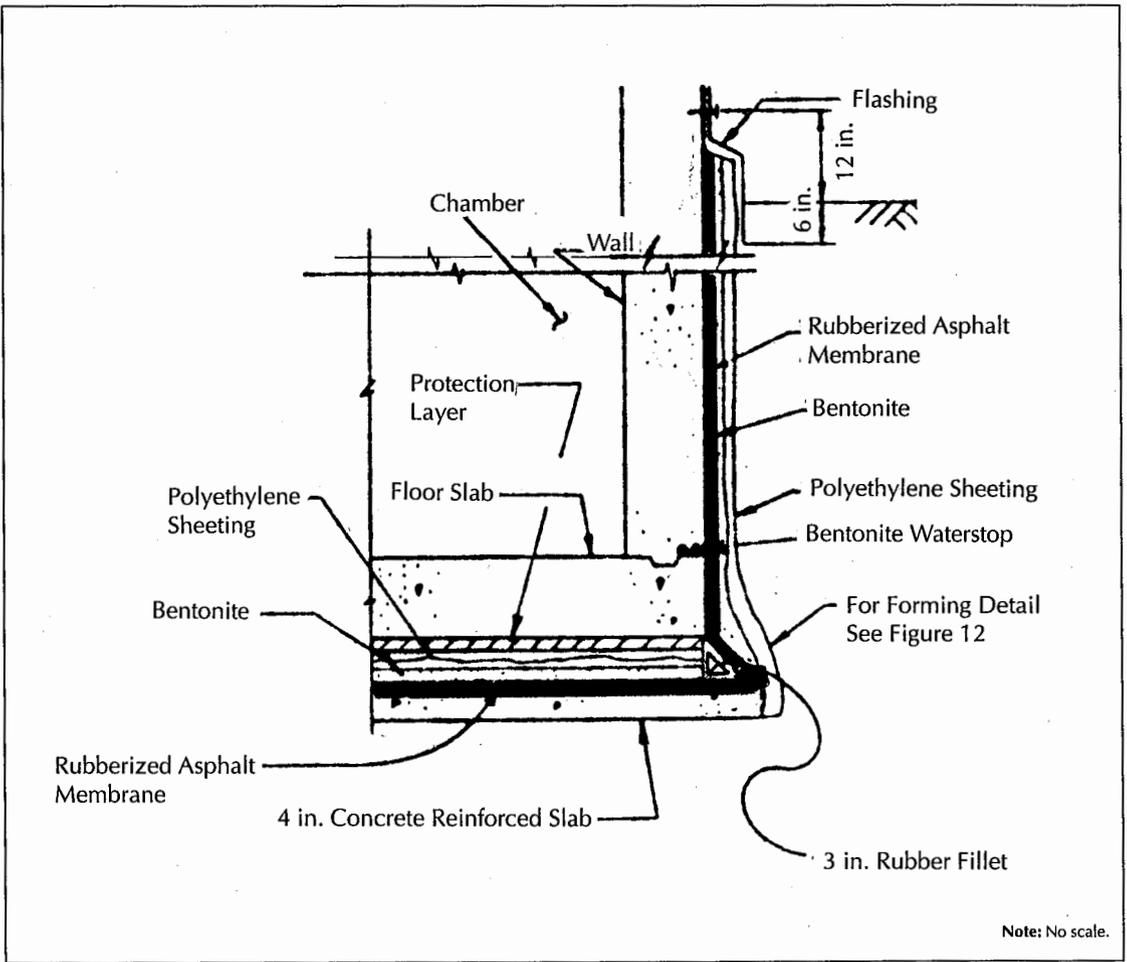
**FIGURE 11. A corner detail for the anchor chamber waterproofing system.**

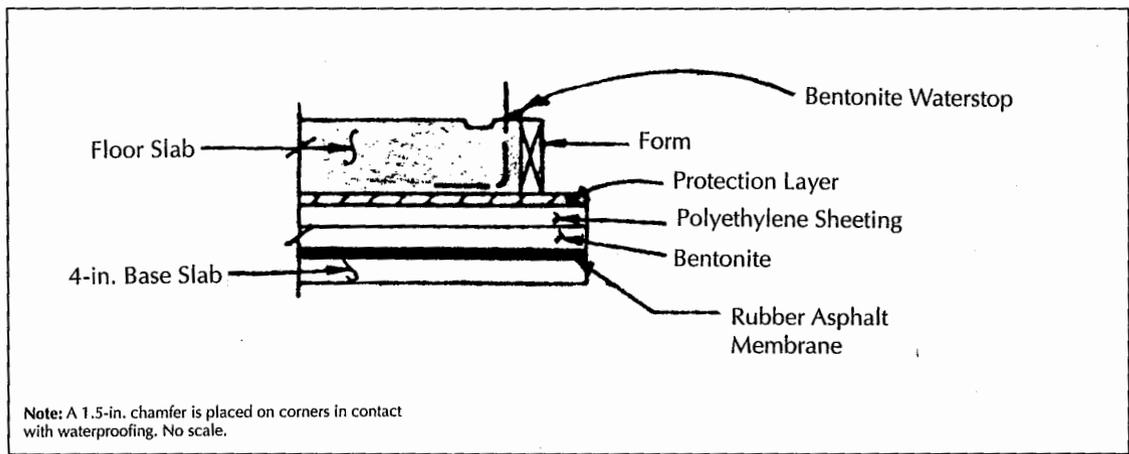
**FIGURE 12. Waterproofing floor slab forming detail.**

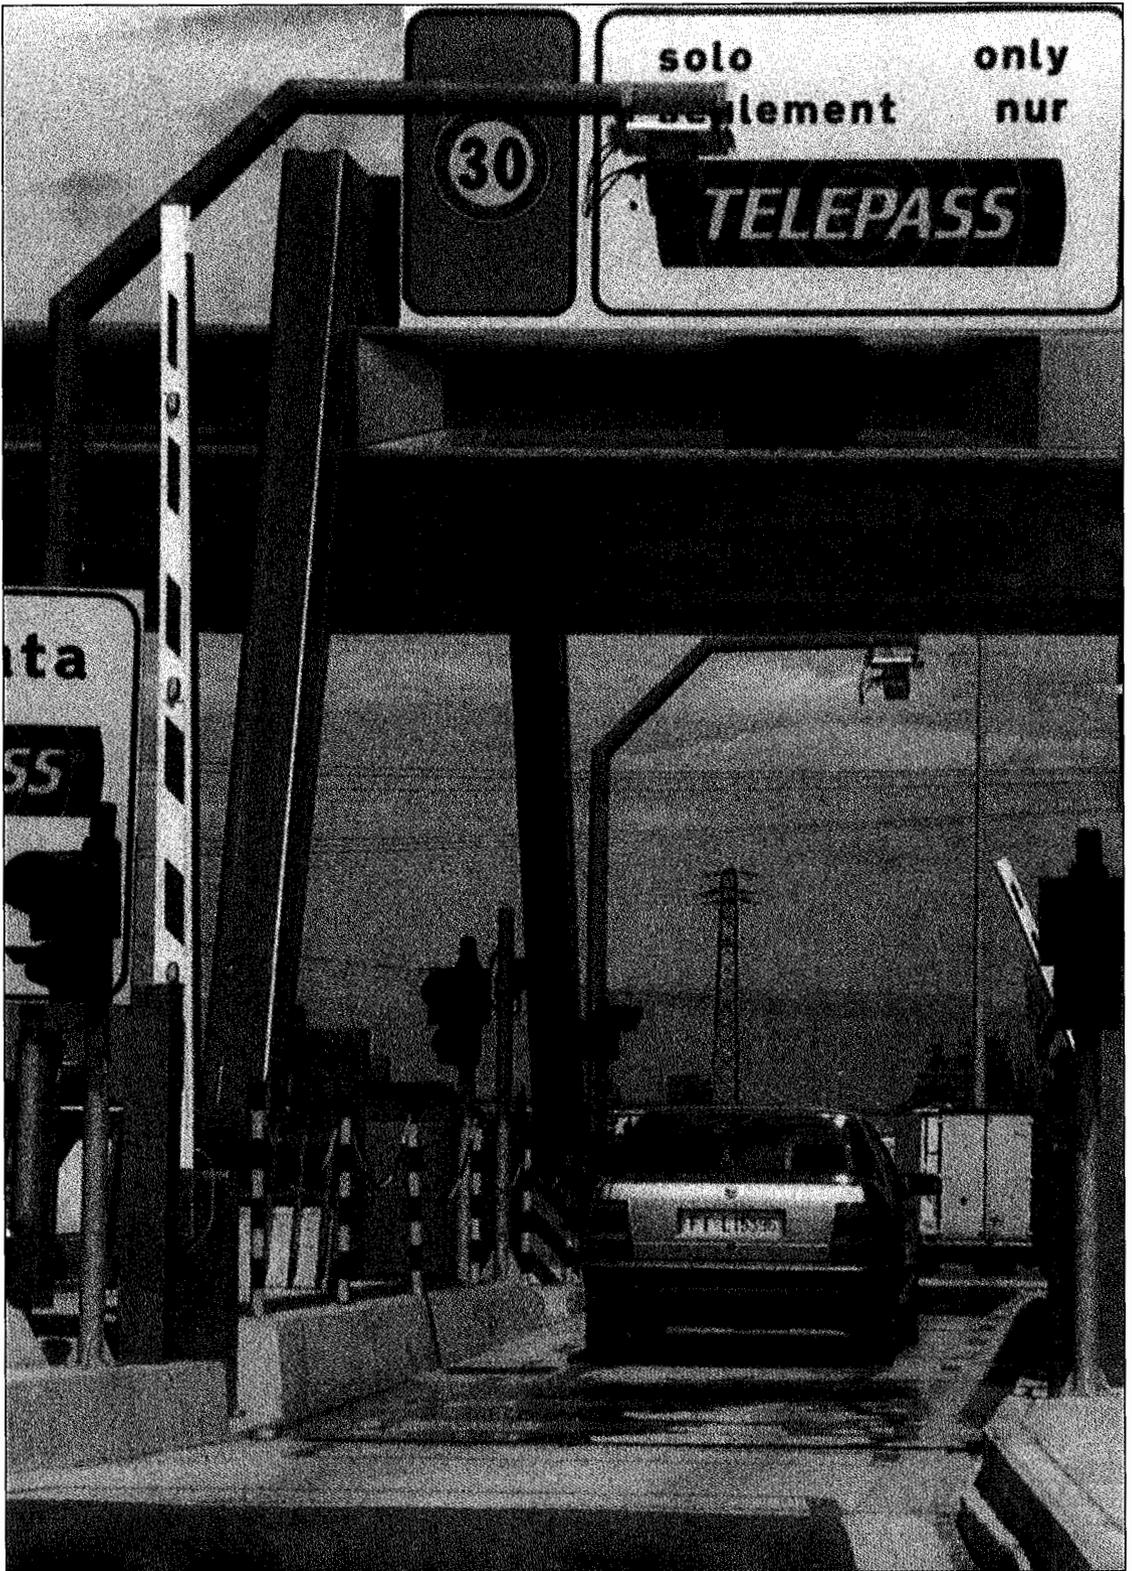
FIGURE 3. A view of a Telepass toll collection lane.

*Telepass.* The Telepass, a plastic "smart" card, contains a microchip and is used in non-stop electronic toll collection. The Telepass payment system is similar in set-up to the current account ViaCard. Telepass users may pass through designated Telepass toll gates at up to 30 km/hour (see Figure 3). Speed is limited at that rate for safety purposes only; the system can function with vehicles passing by at speeds up to 130 km/hour. Vehicles are also requested to maintain a safe distance of 20 meters from each other in the lane.

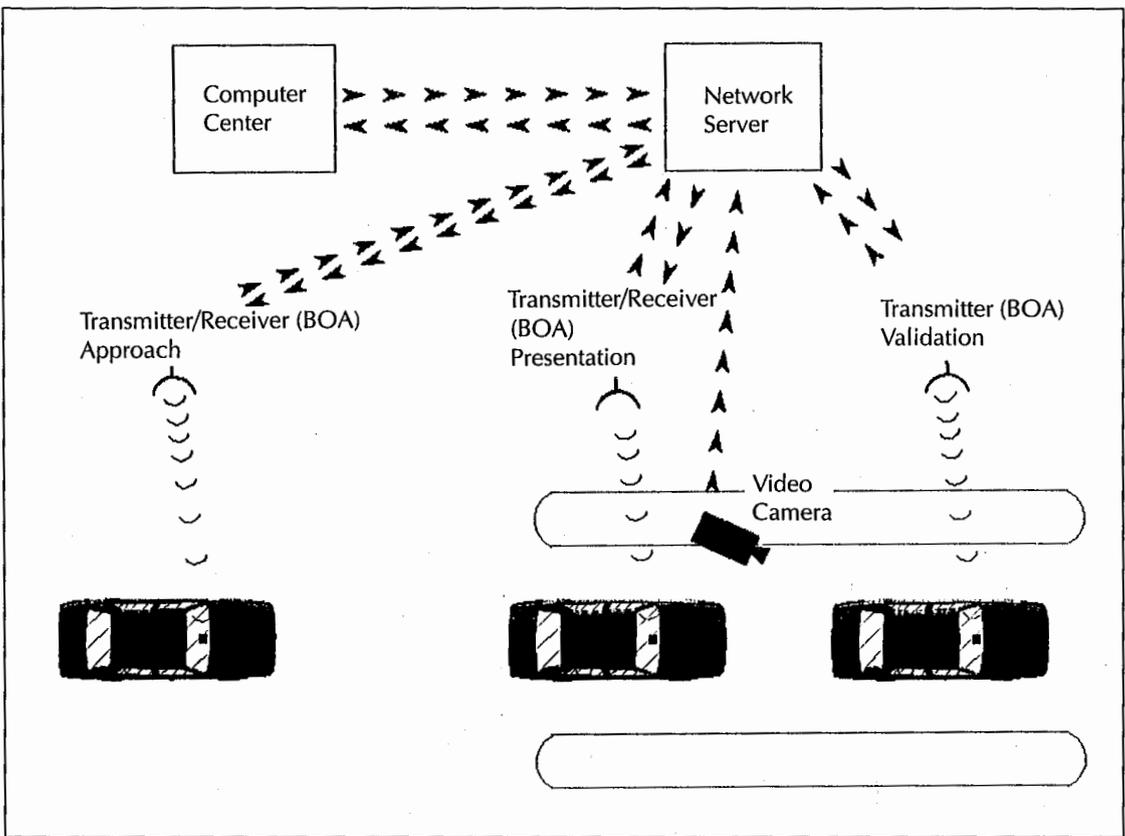
**FIGURE 4. A schematic of the Telepass telecommunications system.**

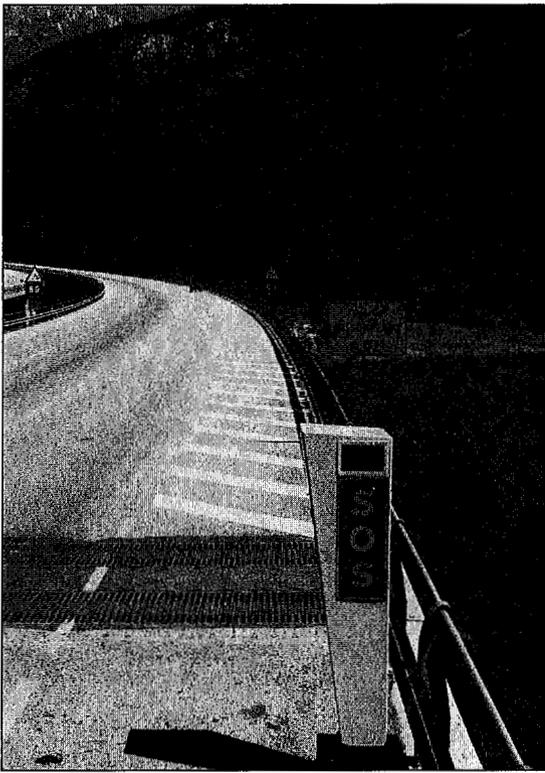
**FIGURE 7.** An SOS callbox.

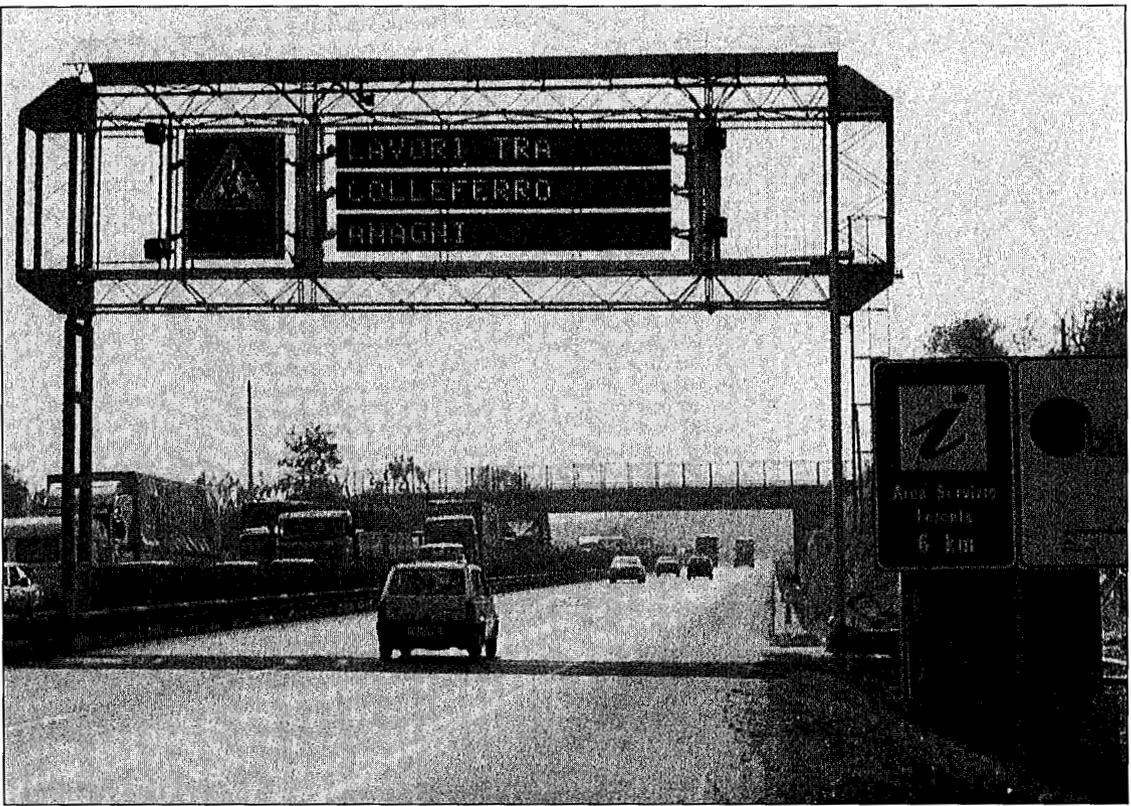
**FIGURE 8.** A variable message sign indicating that maintenance work is being carried out along a stretch of roadway.
