# CIVIL ENGINEERING PRACTICE

JOURNAL OF THE BOSTON SOCIETY OF CIVIL ENGINEERS SECTION/ASCE

SPRING/SUMMER 1993

VOLUME 8, NUMBER 1

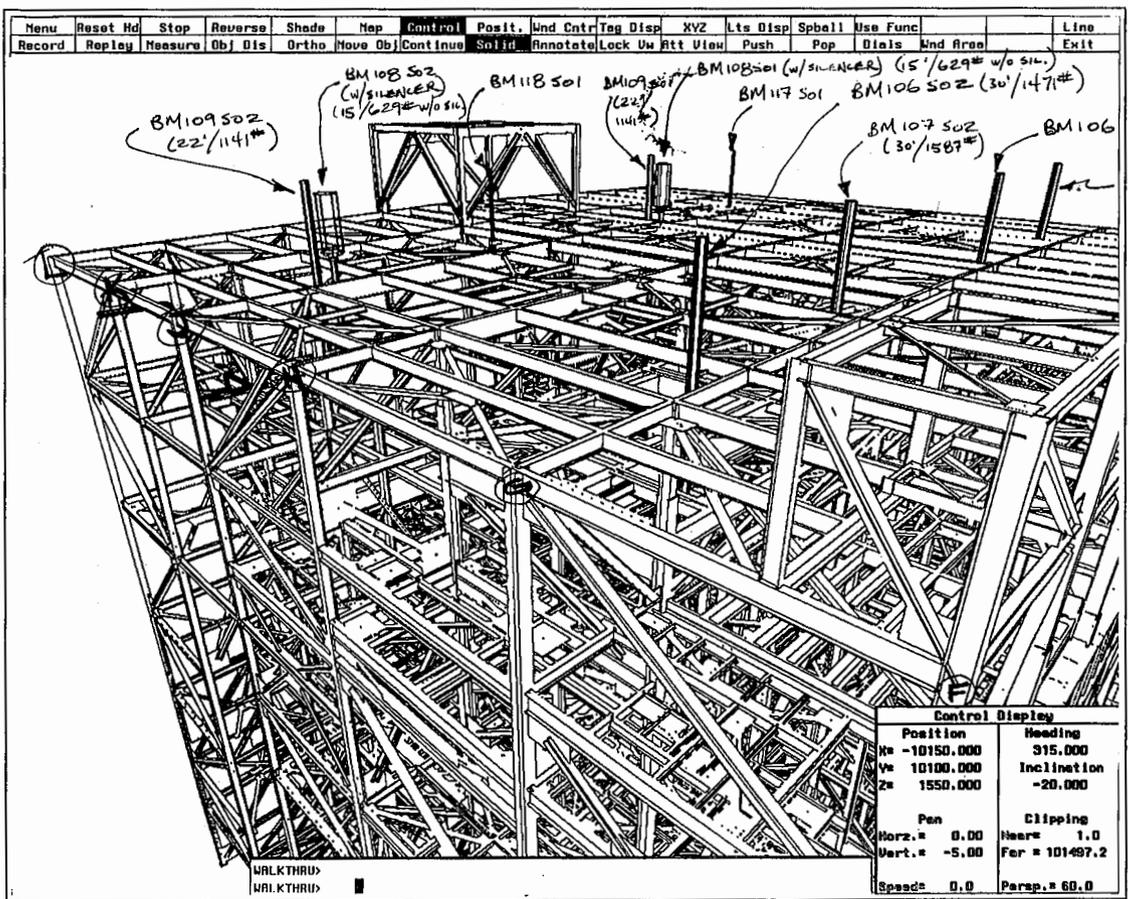
**FIGURE 2. Boiler roof penetrations to structural steel (with field notations).**

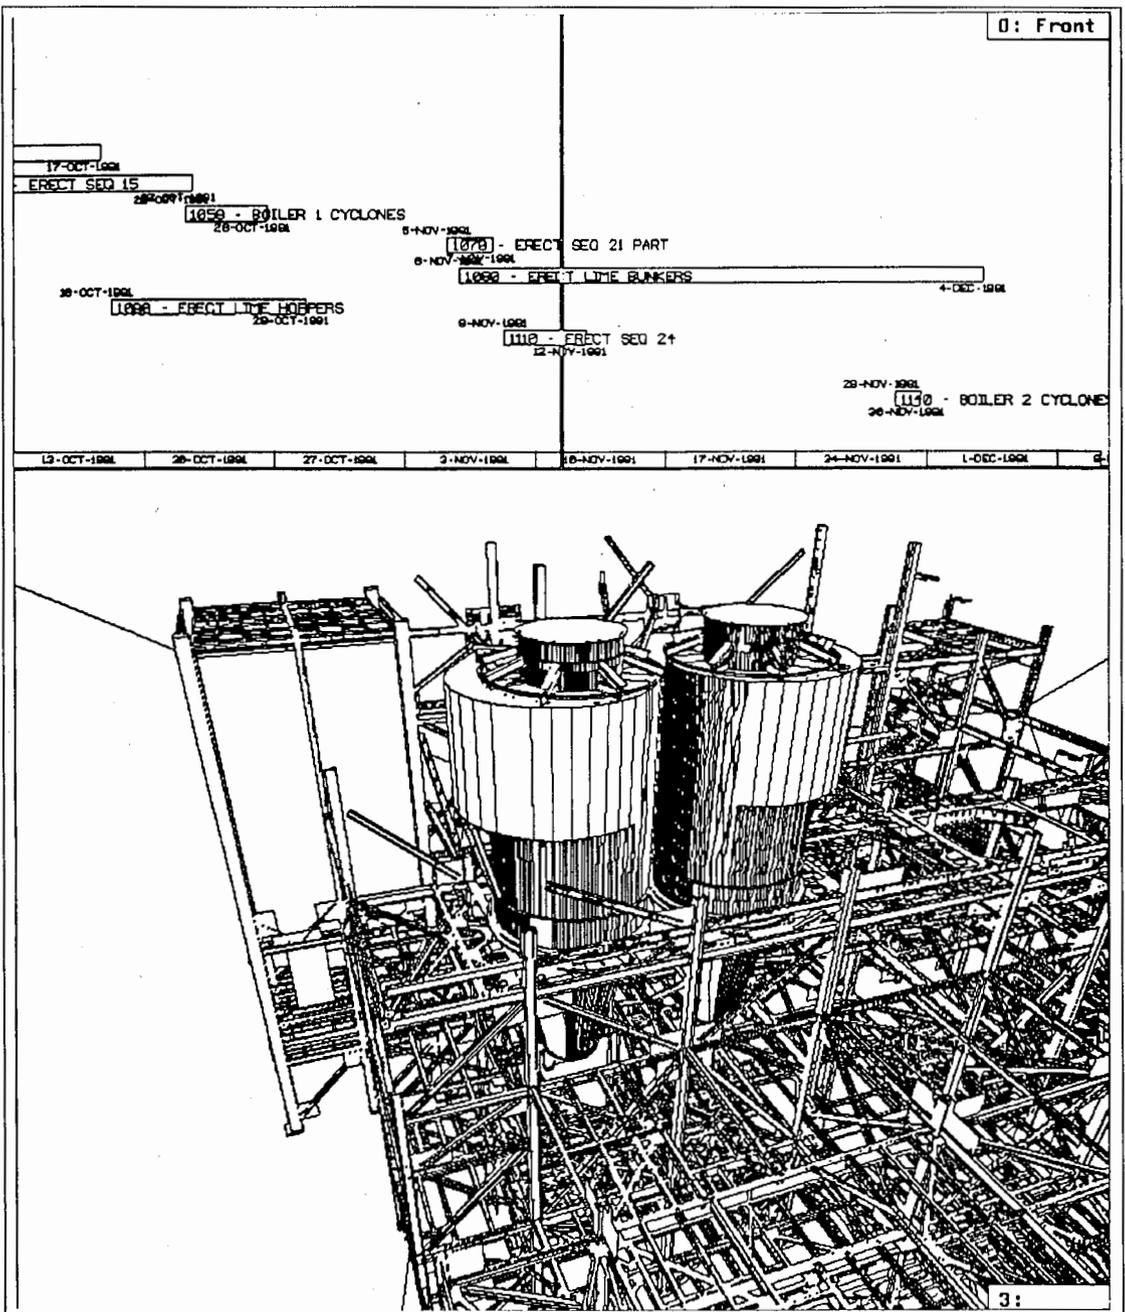
FIGURE 3. Screen image showing the boiler and structural steel schedule simulation.

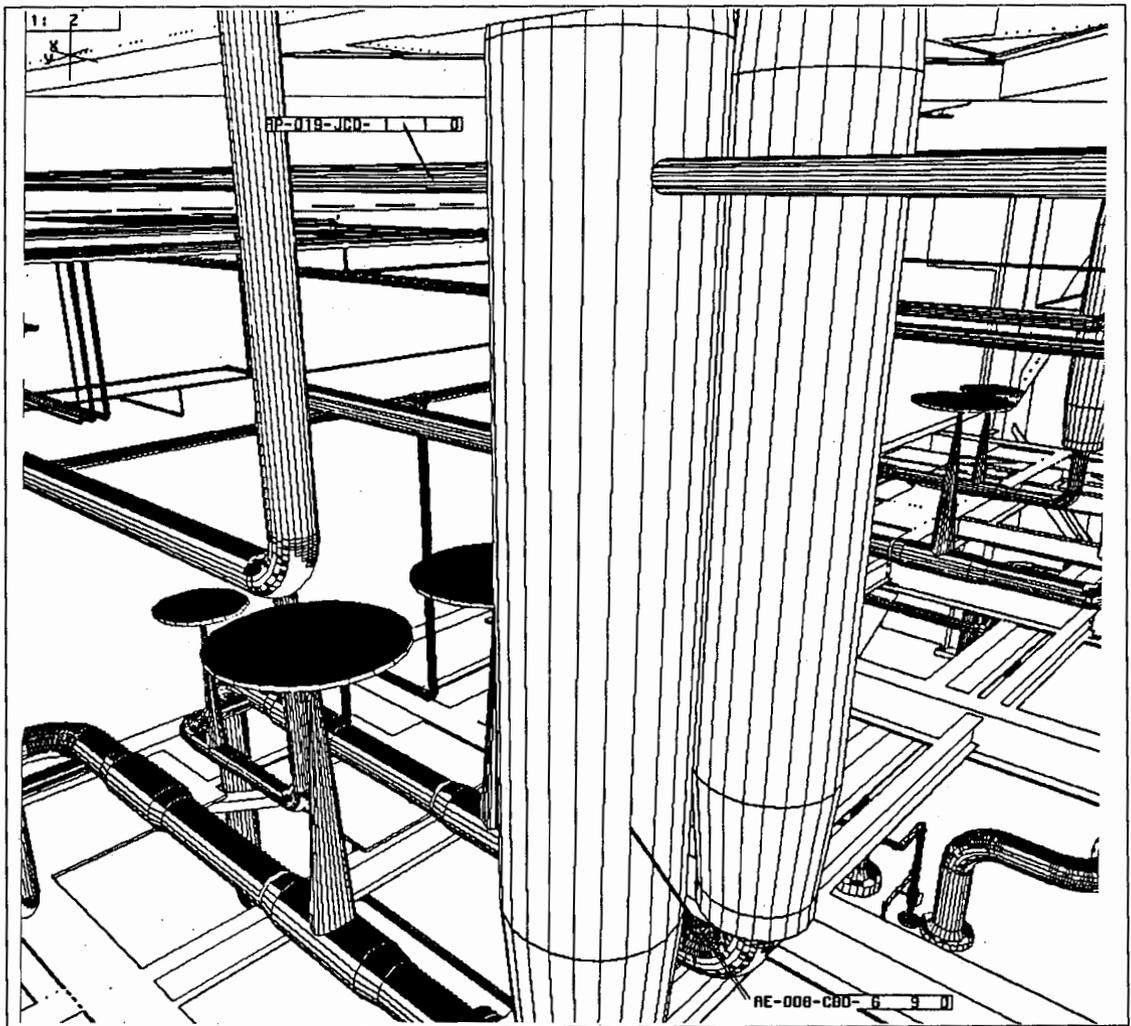
**FIGURE 5. Pipe to pipe interference.**

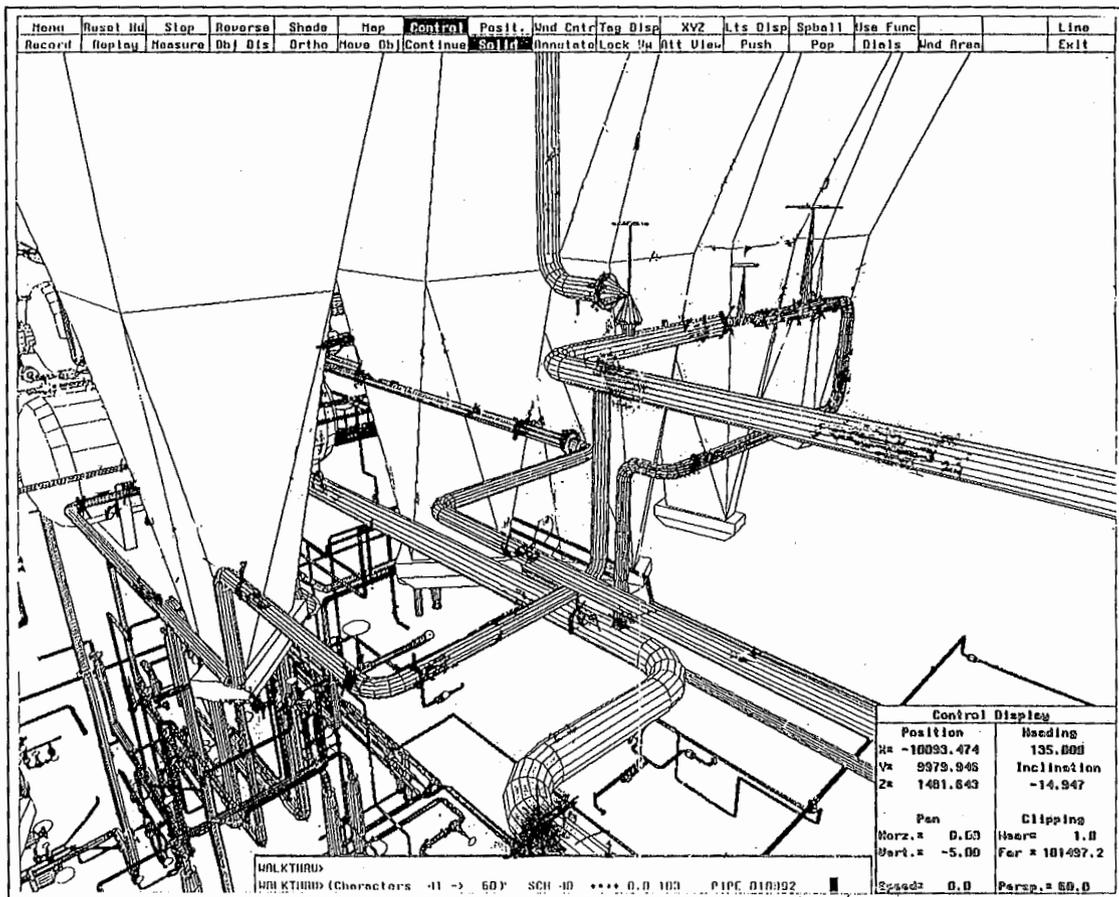
FIGURE 6. A screen dump showing pipe located near the coal bunkers.

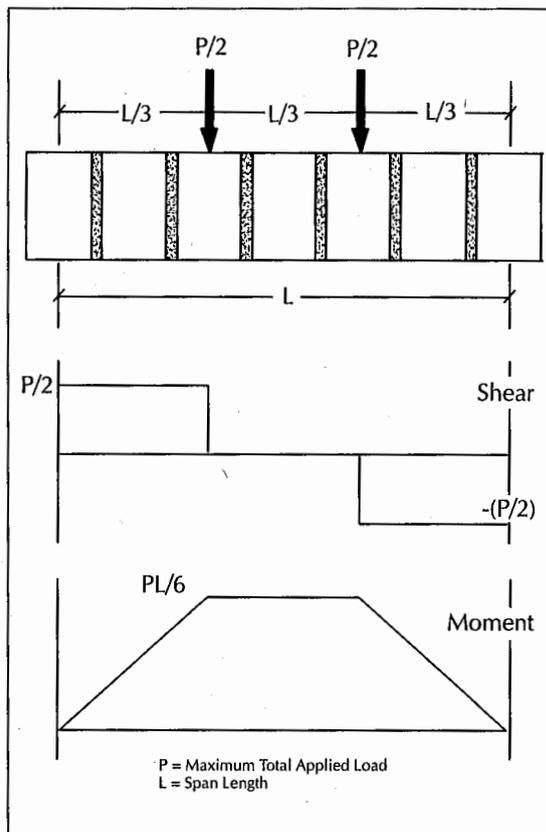
**FIGURE 12. Shear and bending moment diagrams of third point loading.**
