Seismic Strengthening of Existing Buildings

The methods of earthquake damage mitigation — including strengthening buildings and reducing earthquake forces — show a high degree of variation from building to building.

NICHOLAS F. FORELL

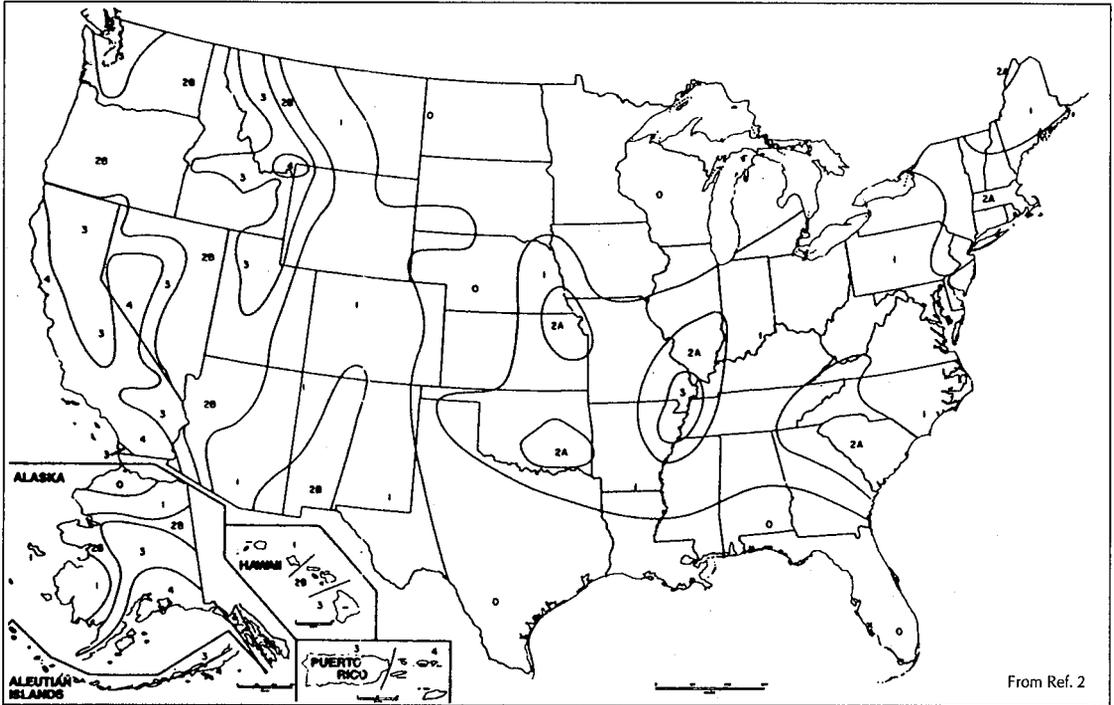
FIGURE 1. A UBC seismic zonation map of the United States.

Seismic zonation is an ongoing effort. Currently used zonation maps are included in the UBC (see Figure 1) and NEHRP (see Figure 2). The NEHRP zonation maps are currently un-

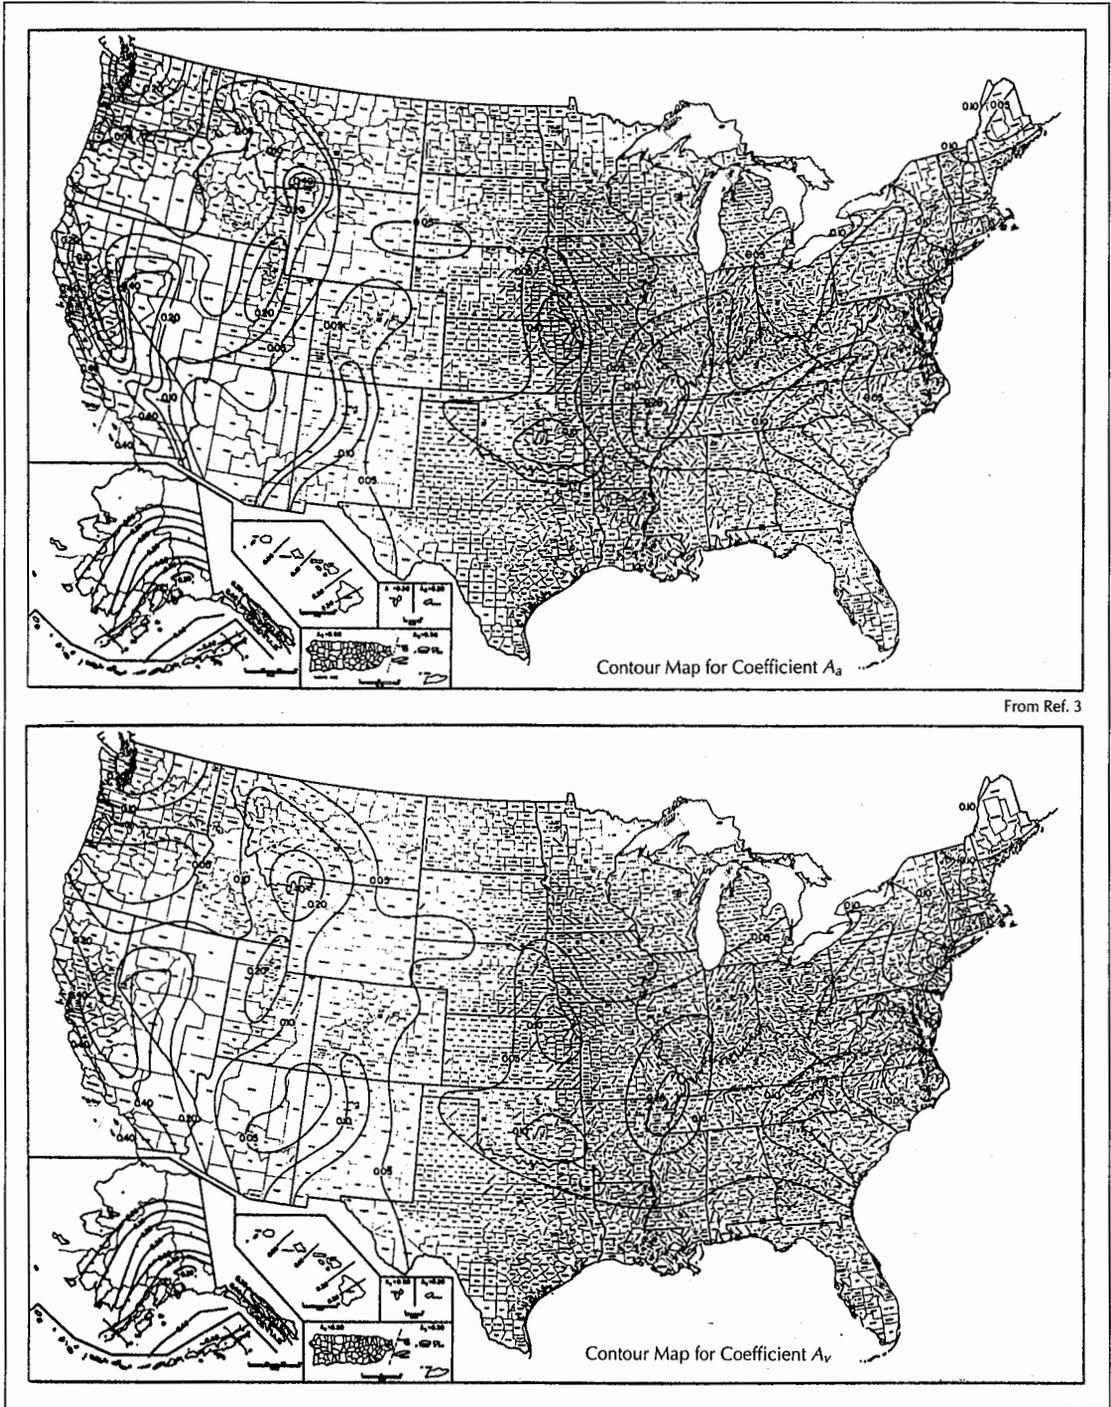
FIGURE 2. NEHRP seismic zonation maps of the United States.

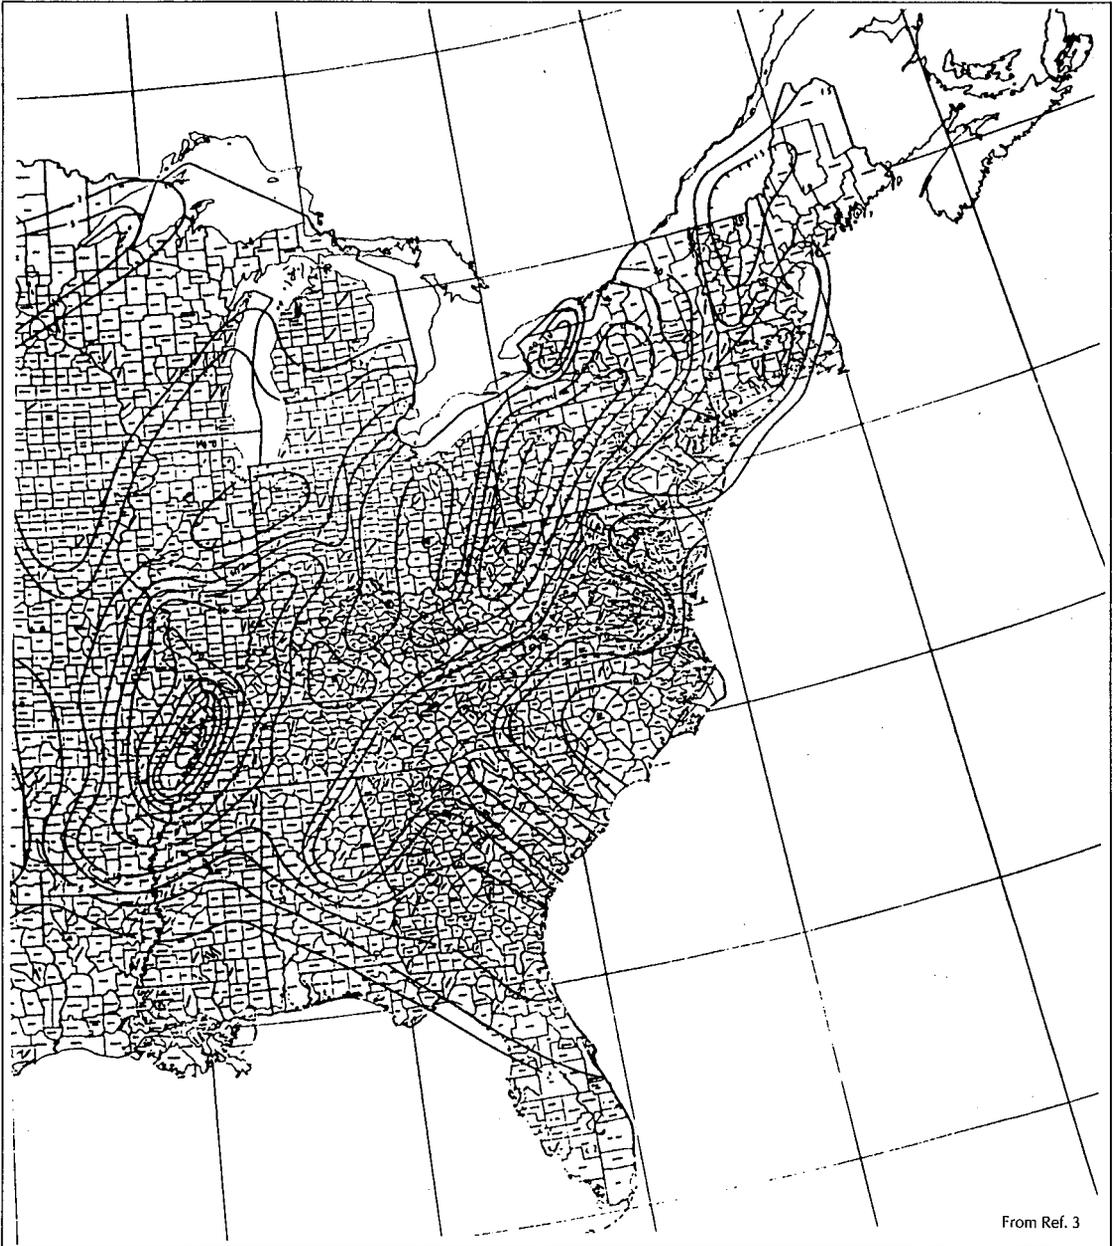
FIGURE 3. Proposed new NEHRP seismic zonation map of the eastern United States.

der revision (see Figure 3). Earthquake-resistant design is based on an assumption of the seismicity and seismic risk of a specific region. Estimates based on recorded earthquakes carry

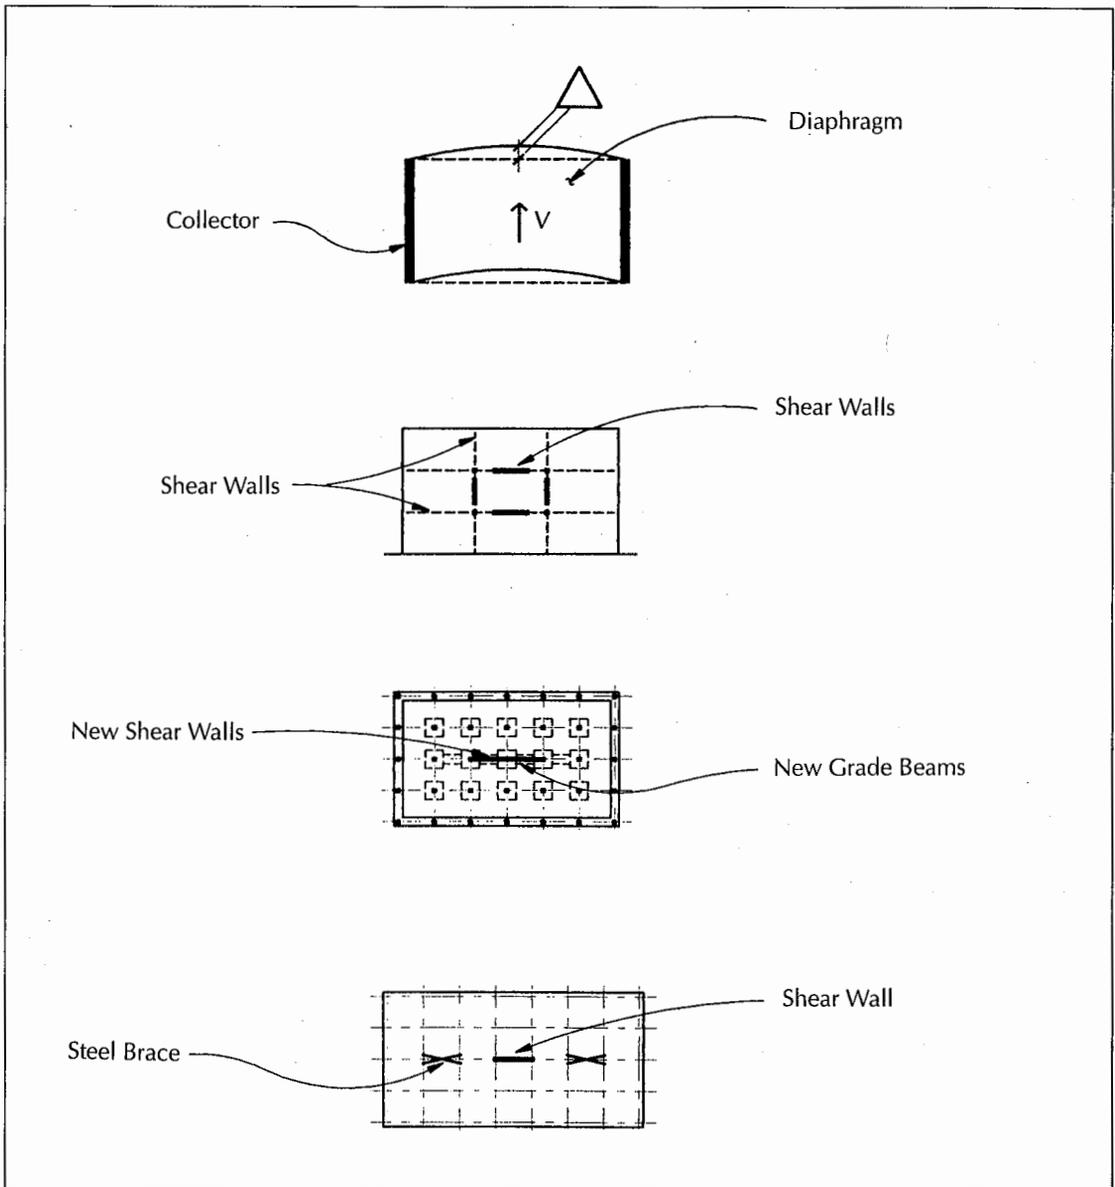
FIGURE 5. The application of different seismic upgrading systems on existing buildings.

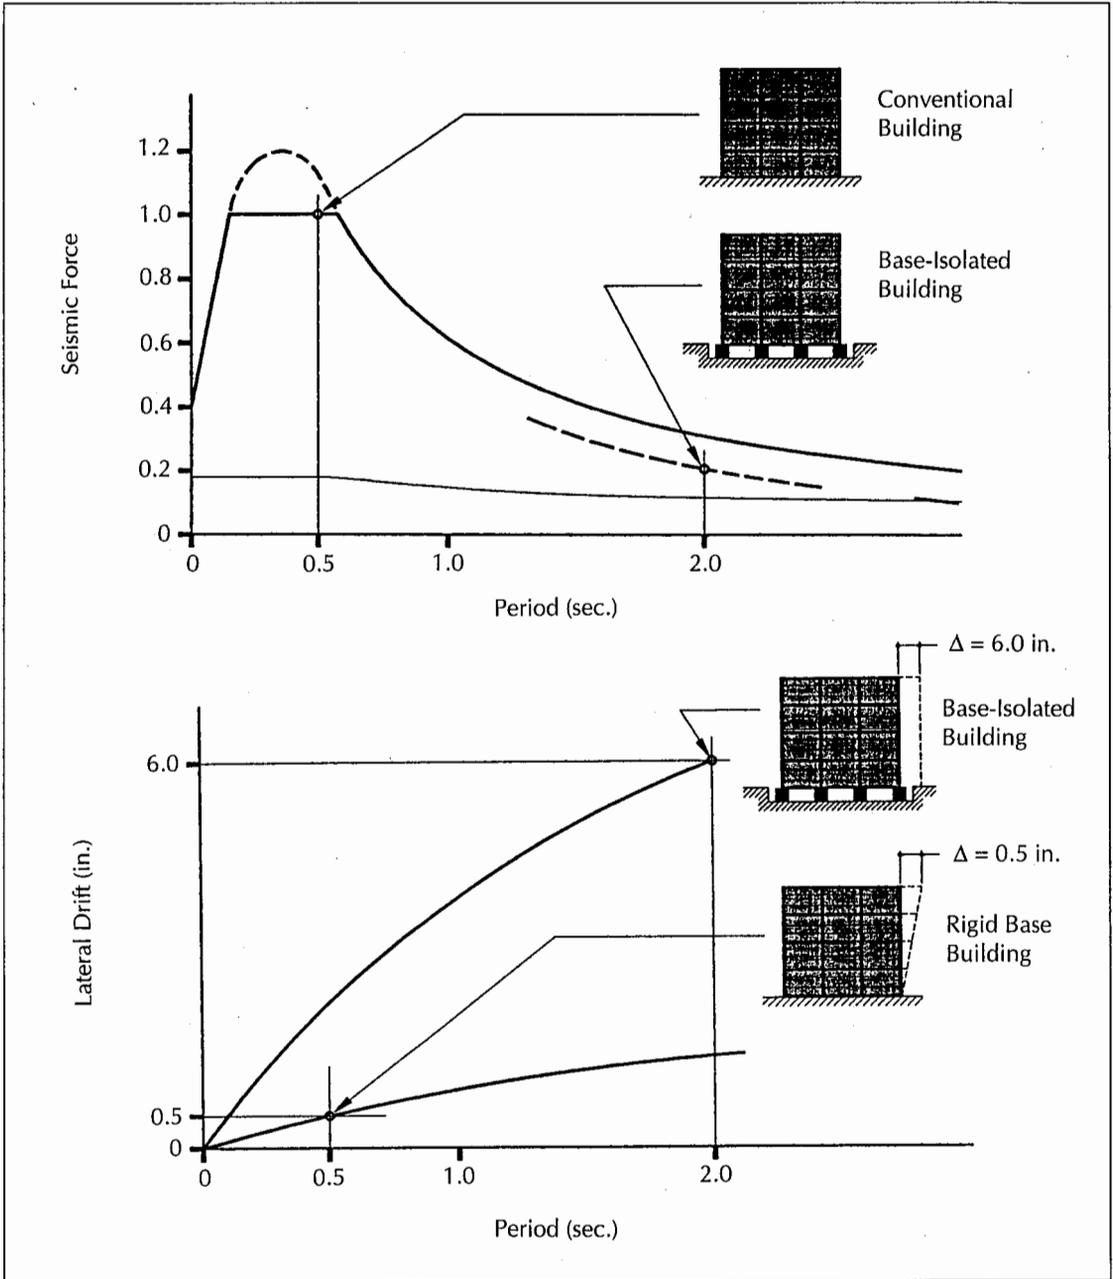
FIGURE 6. Base isolation response.

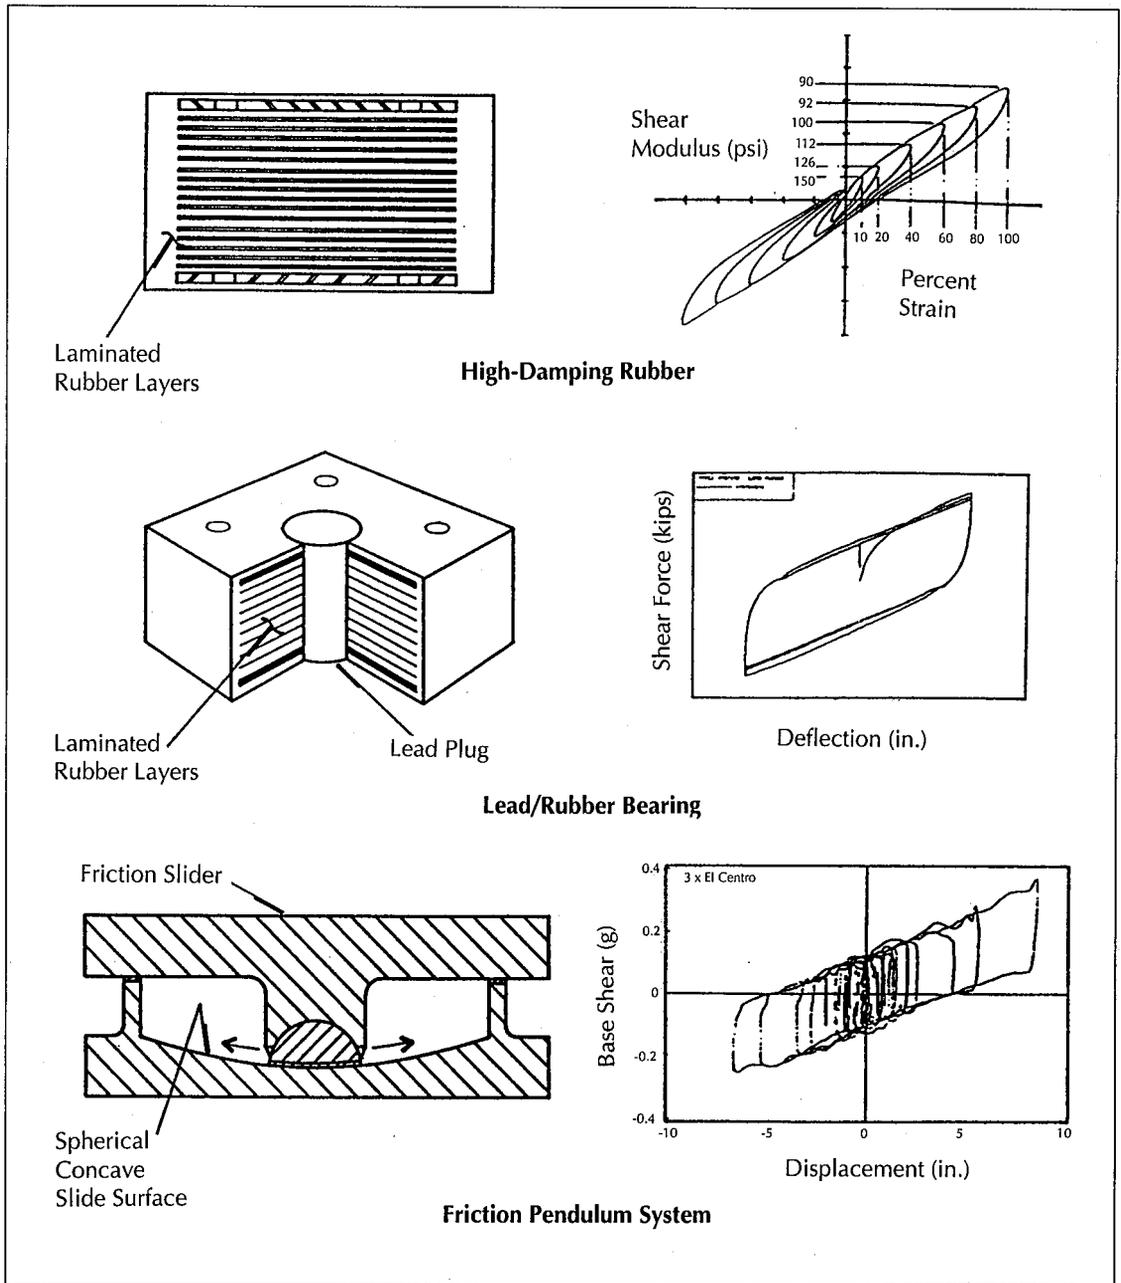
FIGURE 7. Isolation systems and hysteresis curves.

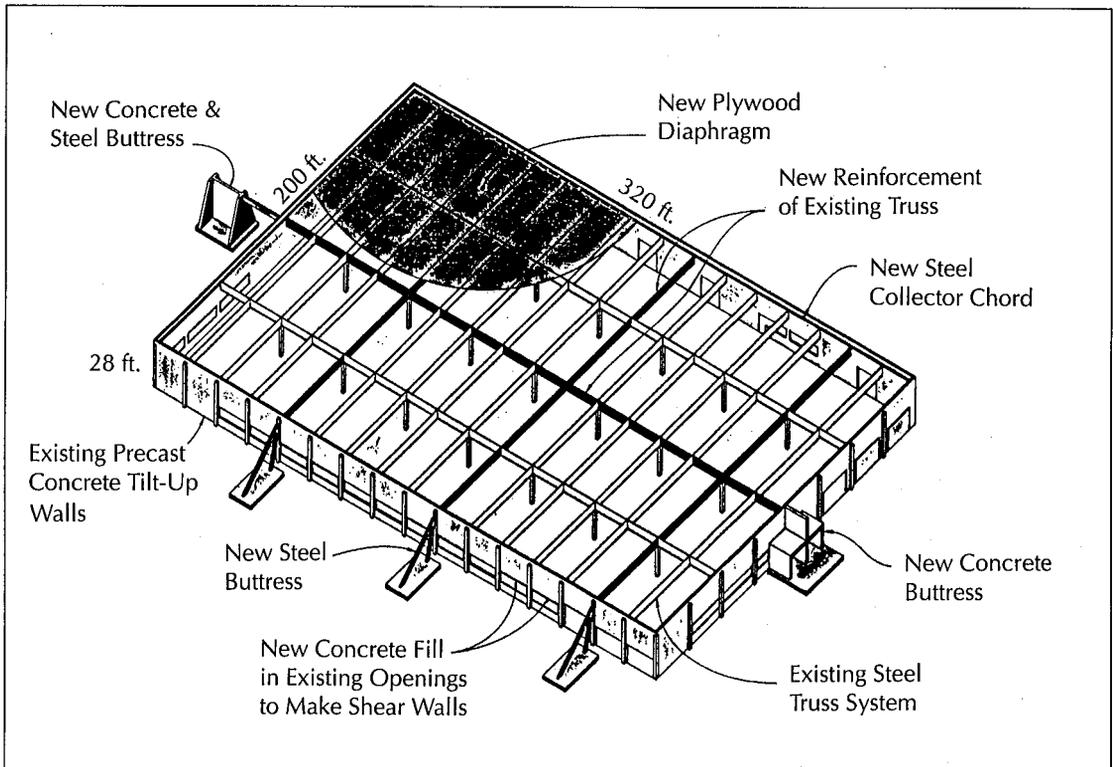
FIGURE 9. Schematic view of the seismic bracing for IBM Building 001.

retrofit concept was developed in accordance with the priorities established in Stage II (see Figures 9 and 10).

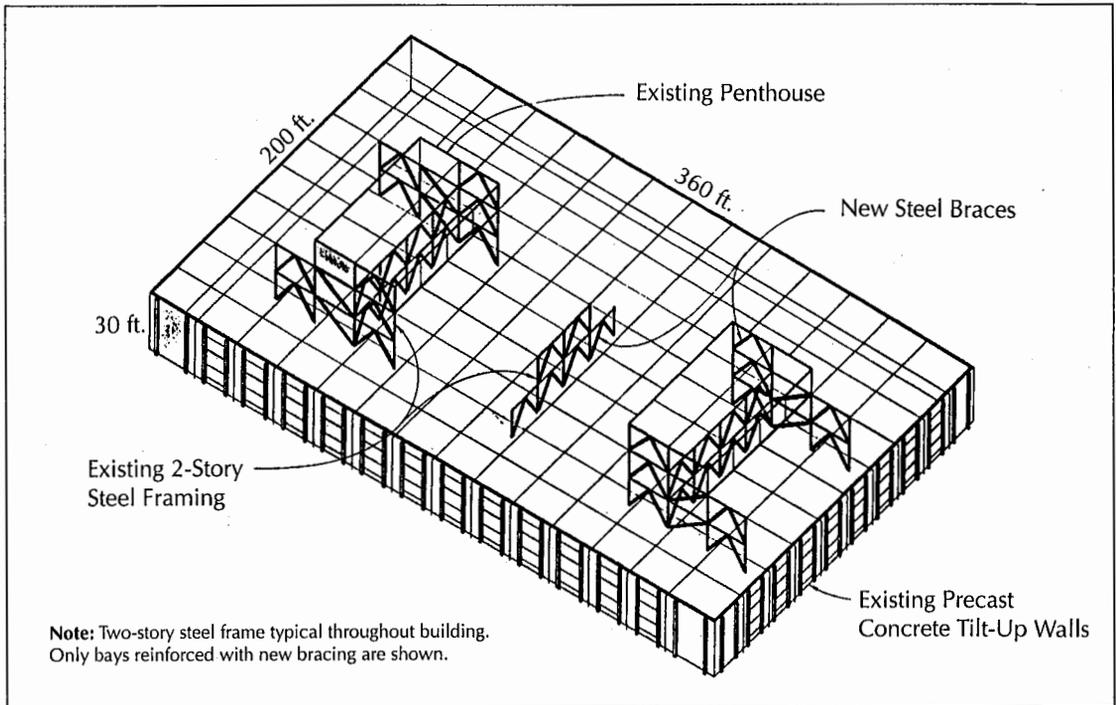
FIGURE 10. Schematic view of the seismic bracing for IBM Building 014.

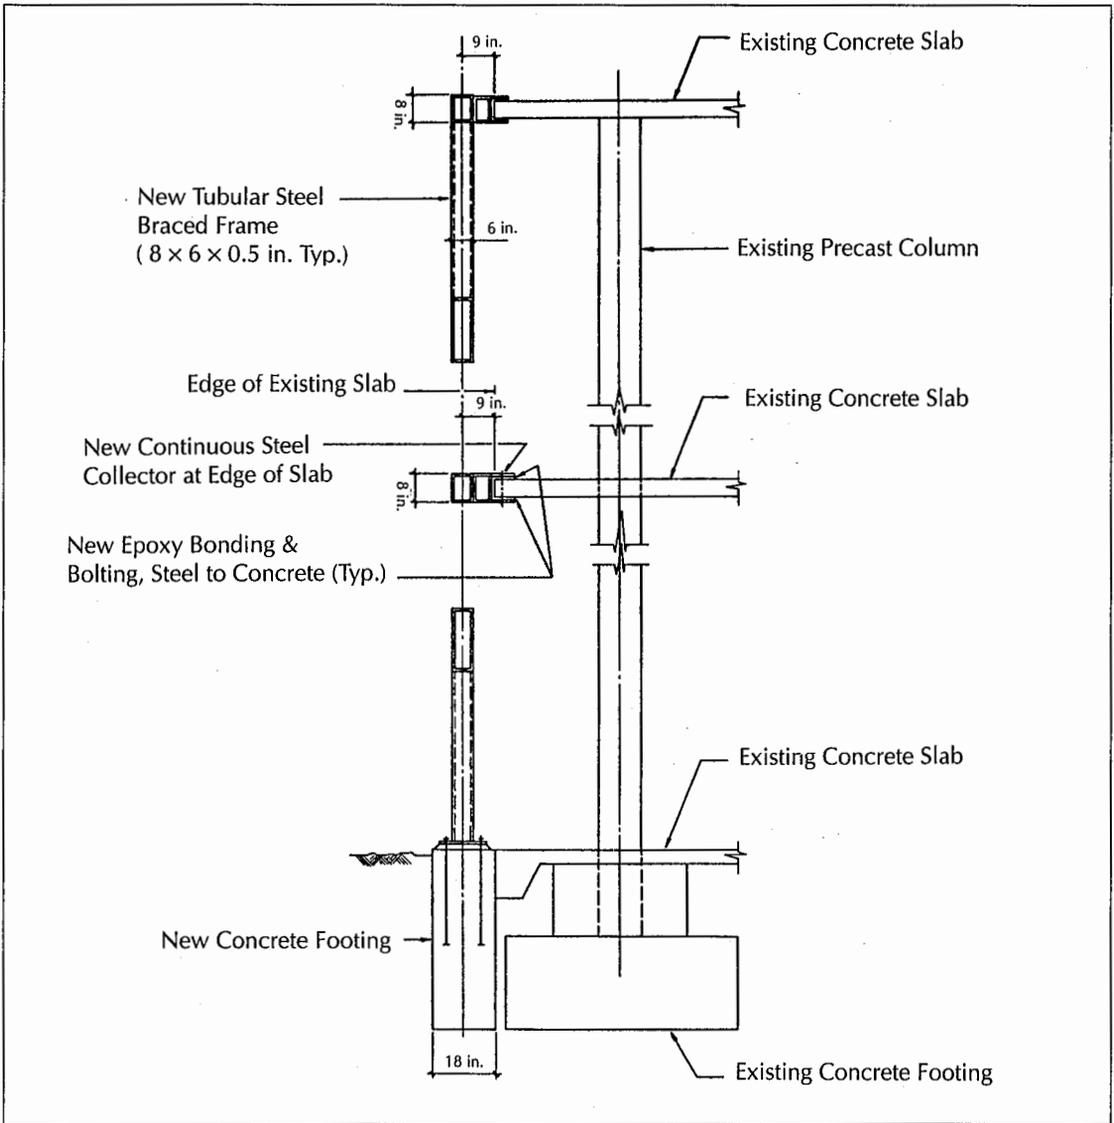
FIGURE 12. A section of the brace frame for USGS Building 2.

Building 2 is a post-tensioned concrete lift slab structure. The major seismic strengthening elements are exposed tubular vertical trusses constructed with new foundations at the face of the building (see Figure 12). These trusses are connected to the existing concrete slabs that cantilever beyond the face of the building. Some new interior concrete shear walls were provided in sections closed off from the rest of

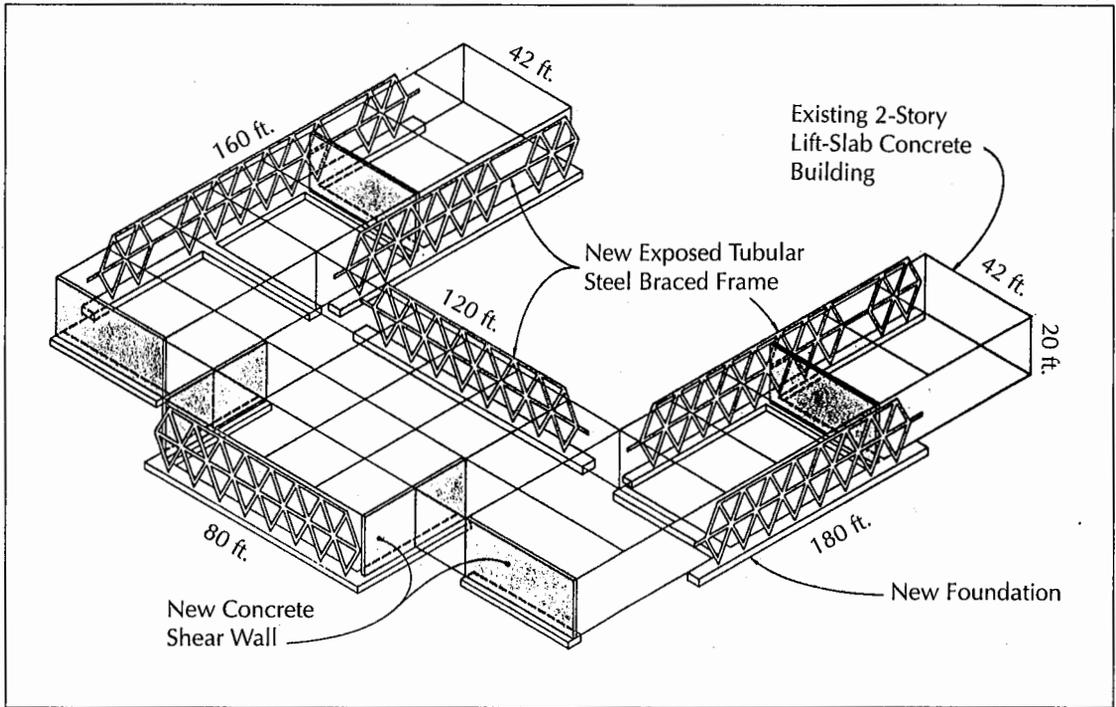
FIGURE 13. A schematic view of the seismic bracing for USGS Building 2.

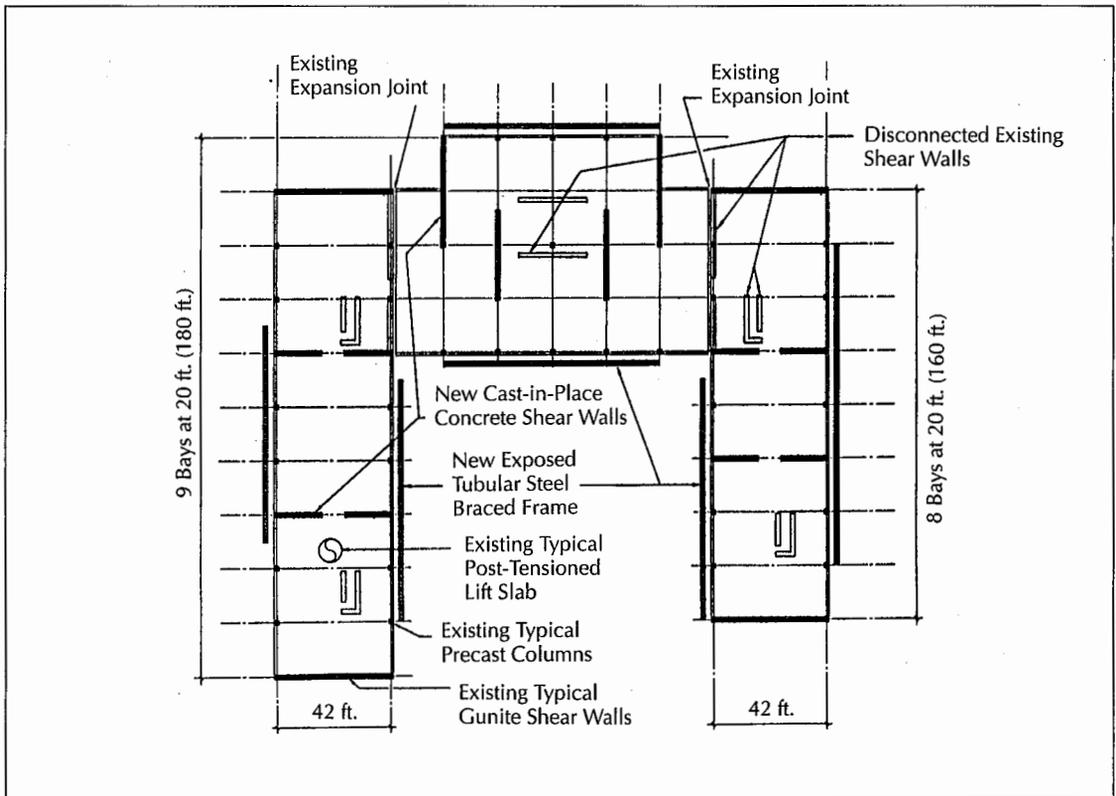
FIGURE 14. The seismic strengthening system for USGS Building 2.

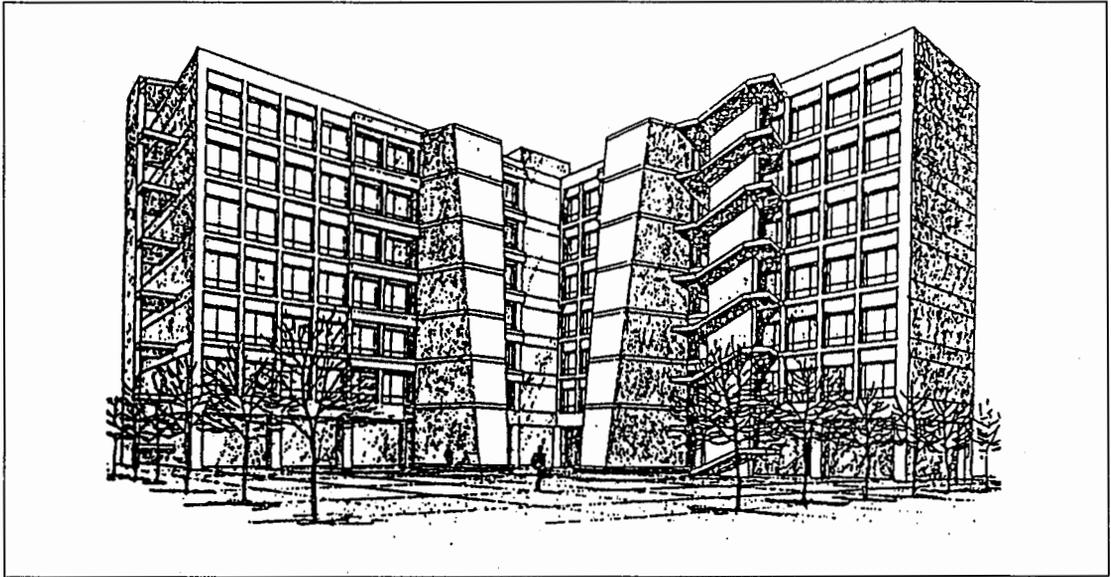
FIGURE 15. LLNL Building 111.

towers located to minimize the stresses in the long diaphragms (see Figure 15). The towers rise from a seven-foot thick reinforced concrete

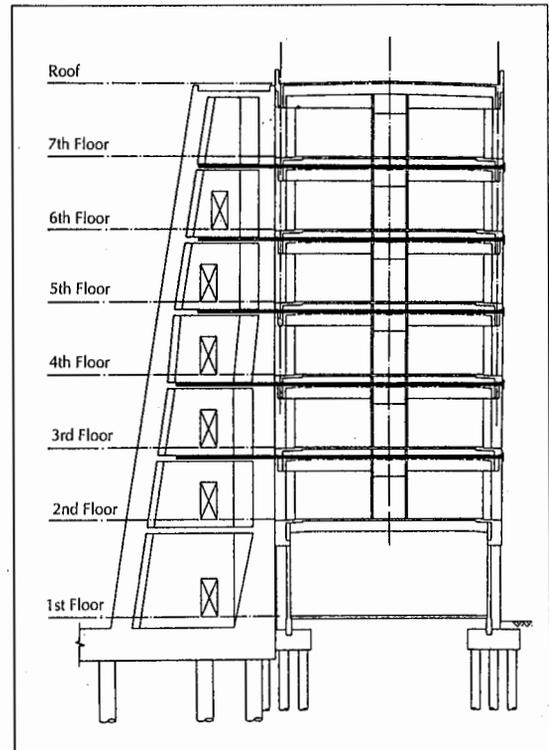
FIGURE 16. Section of LLNL Building 111.

foundation mat, which is supported on 38 three-foot diameter drilled reinforced concrete piers extending from 50 to 70 feet below the mat (see Figures 16 and 17).

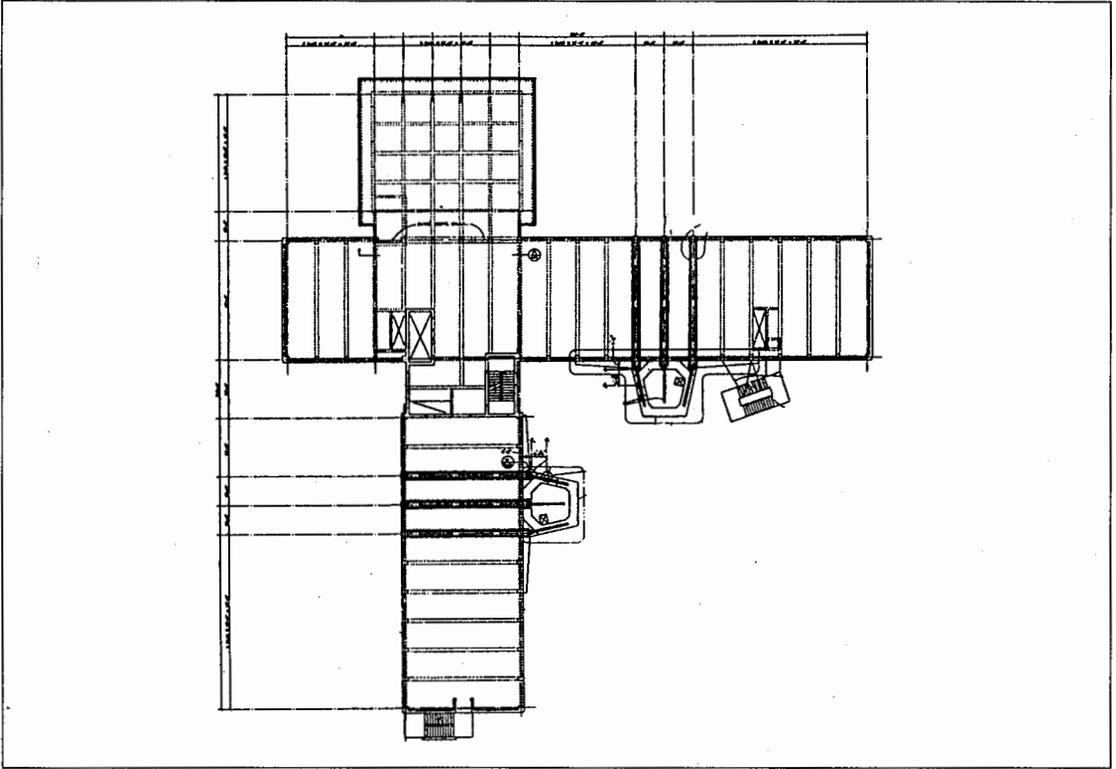
FIGURE 17. Plan view of LLNL Building 111.

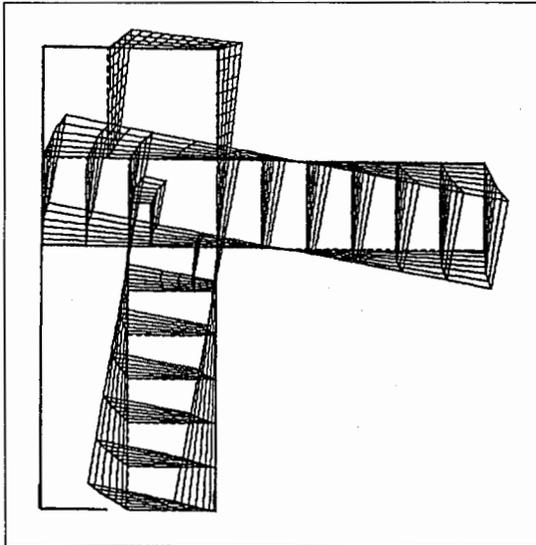
FIGURE 18. Three-dimensional model of LLNL Building 111.

- A three-dimensional finite element program for modeling frames, shells and asolid elements was used. Foundation springs simulated the vertical and horizontal stiffness of the piers for this structural analysis program (SAP).
- A SAP computer model was also used to assess the effect of vertical accelerations on the structure.
- Lastly, a three-dimensional flexible diaphragm SAP model was developed to assess the effect of the flexibility of the diaphragms on the effectiveness of the newly added towers.

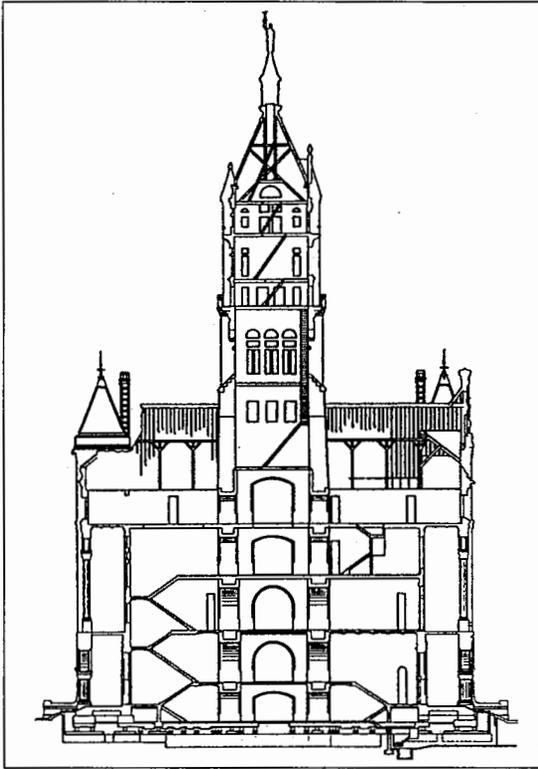
The building was constructed of unreinforced masonry and sandstone masonry walls with thicknesses of up to 24 inches for interior walls and 36 inches for exterior walls. Foundations are a combination of sandstone plinth and concrete footings. The first and fourth floors are framed with timber beams and planked with either wood floors or concrete topping. The second and third floors are framed with steel beams supporting shallow brick arches, which are covered with stone fill and a concrete topping. Anchorage between floors and walls is minimal. The roof framing is a steeply pitched timber system.

FIGURE 20. Section view of the City and County Building, Salt Lake City.

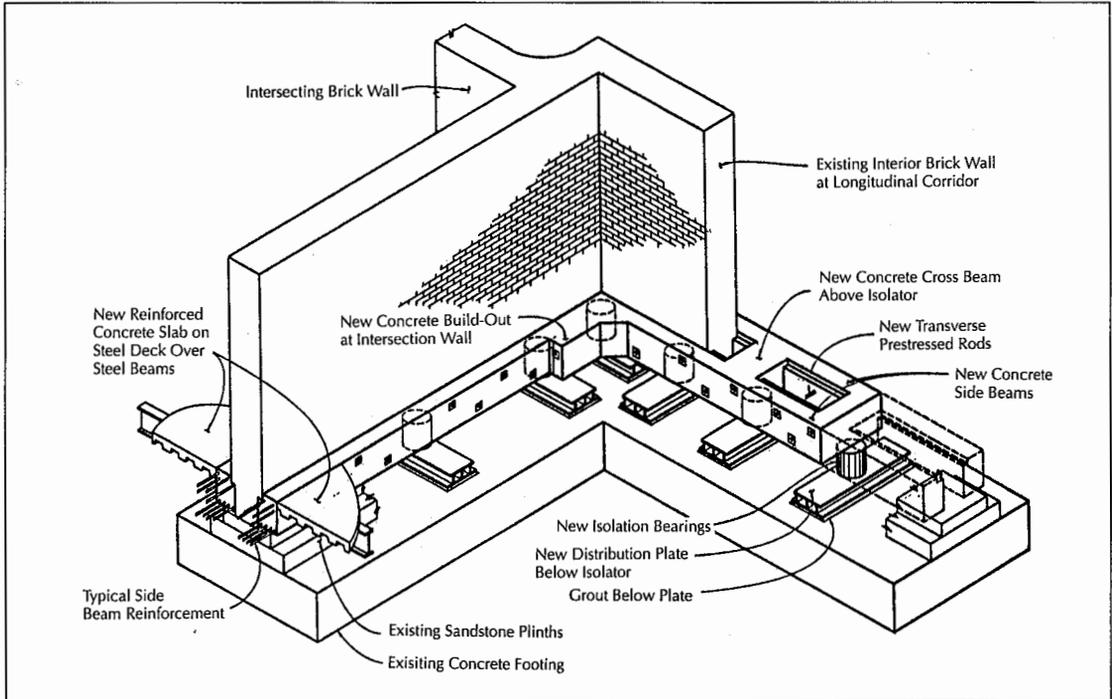
Once the concrete side beams were installed, portions of the masonry walls and plinth under the cross beams were removed, permitting the installation of the base isolators (see Figure 21). Four hundred and forty-seven isolation bearings were placed under the building. The isolators were preloaded to minimize axial shortening of the bearings. After installation, the

FIGURE 21. An isometric cutaway at an interior wall intersection (Salt Lake City).

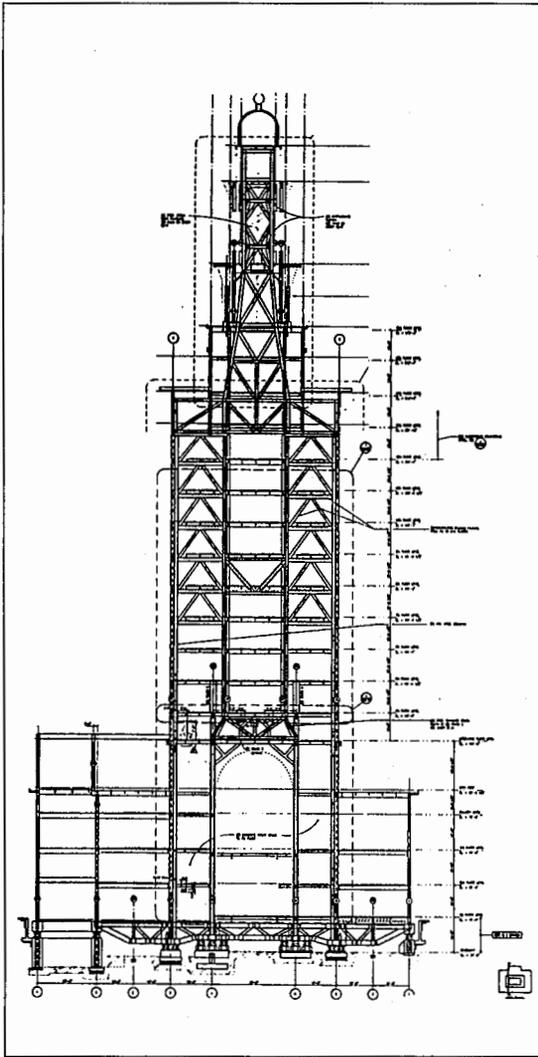
FIGURE 23. Section view of the Oakland City Hall.

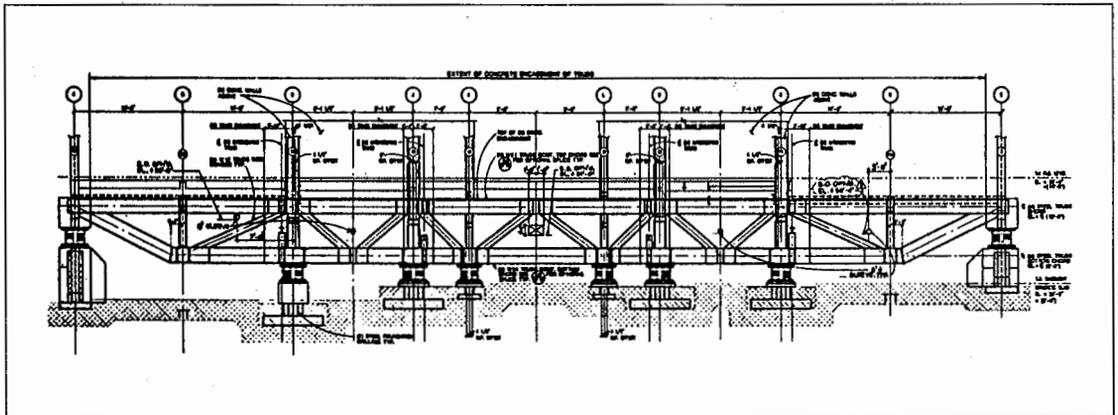
FIGURE 24. Truss section at the Oakland City Hall.

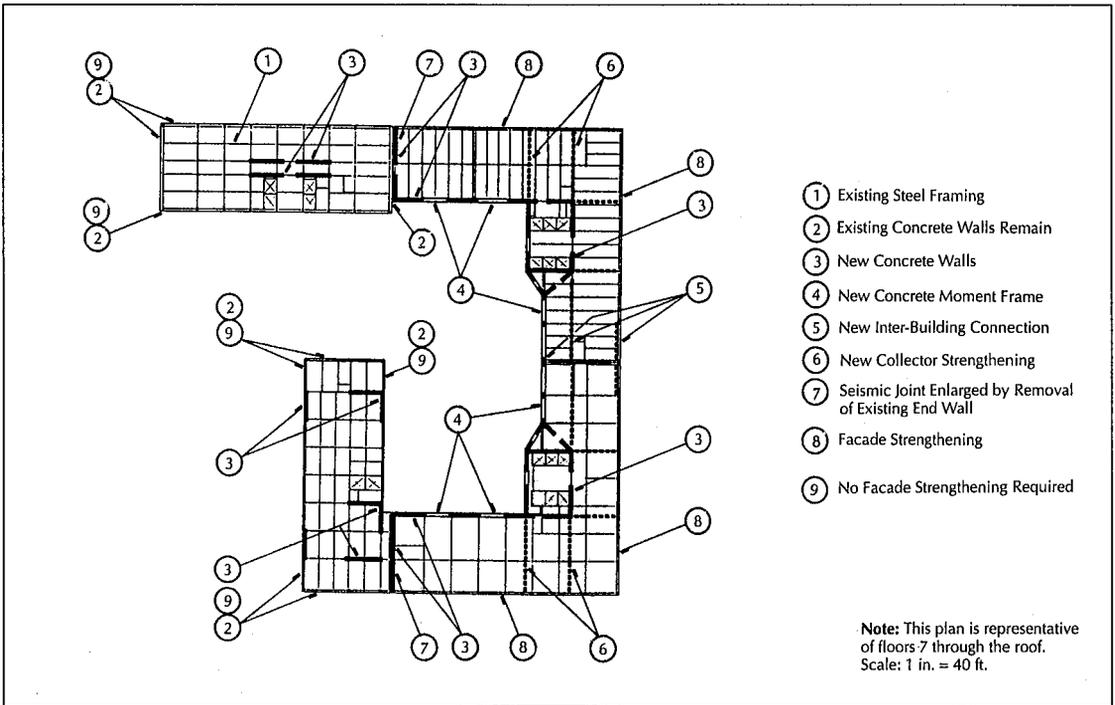
FIGURE 26. Upper level framing plan for the PG&E Market Street complex.

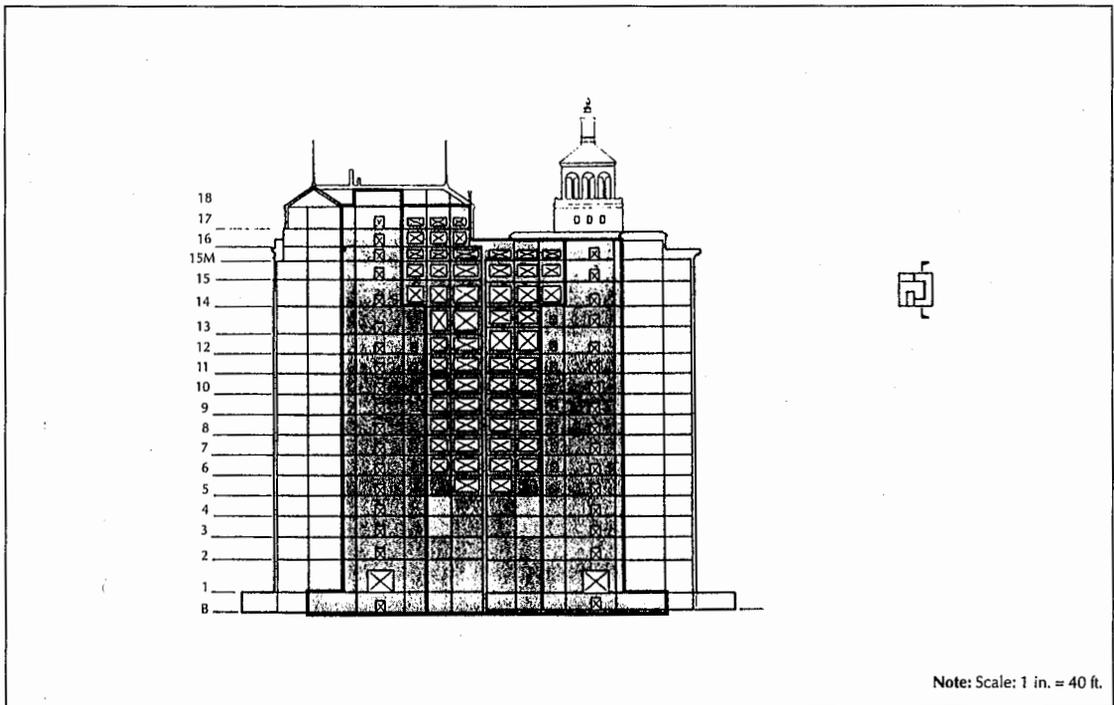
FIGURE 28. South court wall elevation of the PG&E Market Street complex.

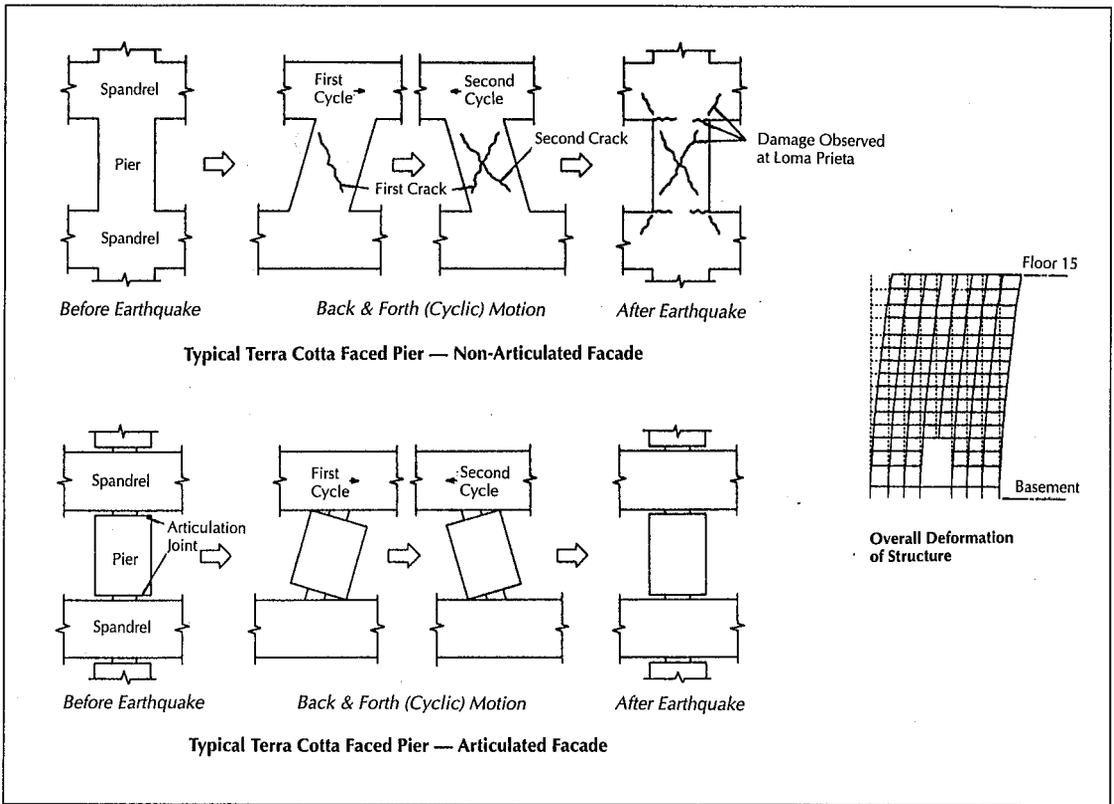
FIGURE 29. Seismic response of the facade for the PG&E Market Street complex.

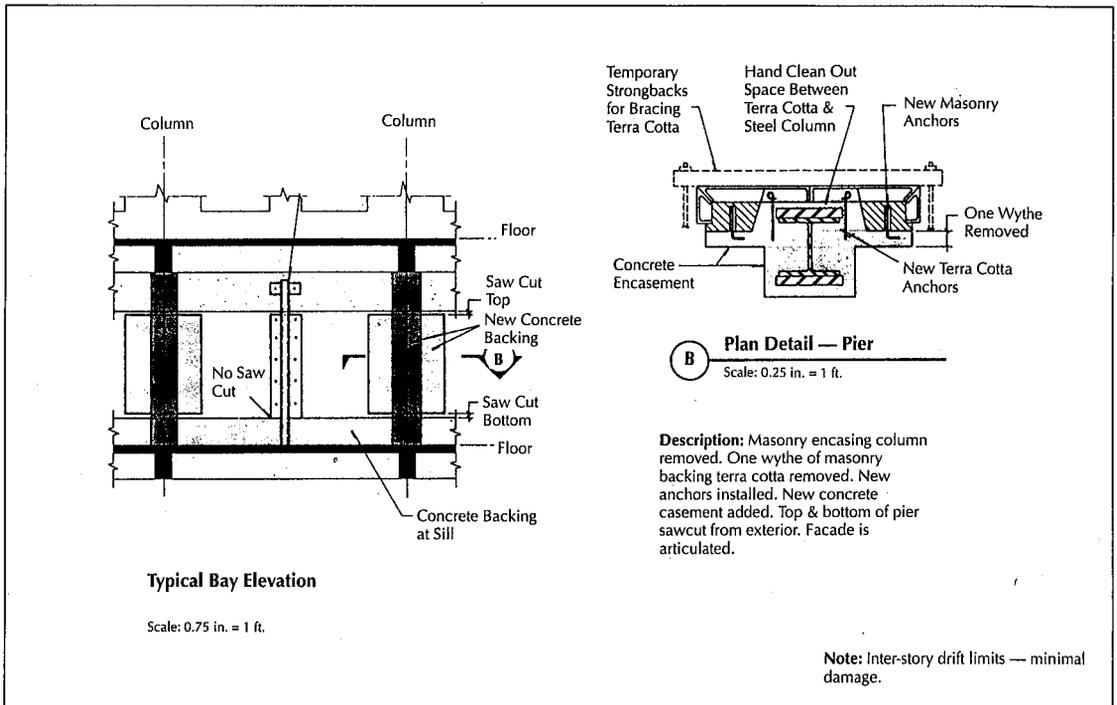
FIGURE 30. Articulated facade details for the PG&E Market Street complex.

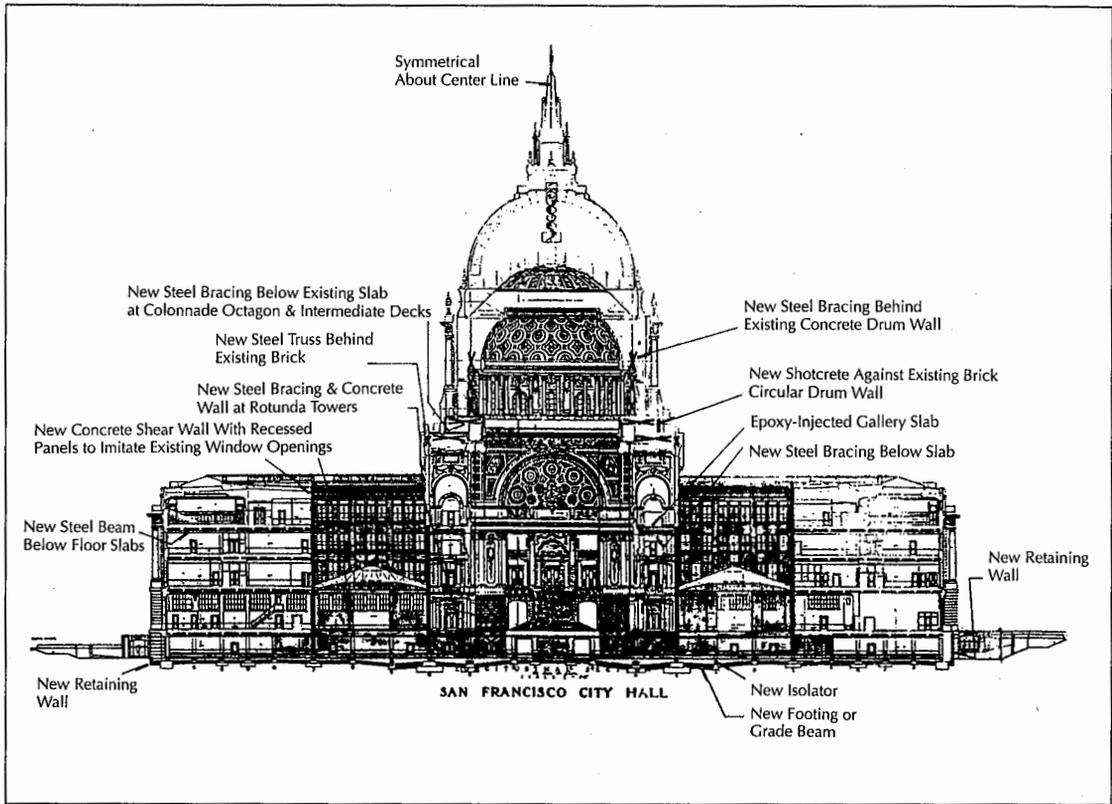
FIGURE 33. Longitudinal building section of San Francisco City Hall showing the base-isolation scheme.

The seismic strengthening will involve repairs to damaged unreinforced masonry and hollow clay tile walls and the construction of supplementary load resisting systems to stiffen and strengthen the building to withstand severe earthquakes without collapse. The supplementary systems should have a minimal impact on the building's historic aspects. Both fixed-base and base-isolation solutions were studied. Base isolation was chosen because it offered the following advantages:
