JOURNAL OF THE
**BOSTON SOCIETY OF CIVIL
ENGINEERS**

**NORWEGIAN EXPERIENCE WITH STEEL PILE
FOUNDATIONS TO ROCK***

BY DR. LAURITS BJERRUM†

(Presented at a meeting of the Structural Section, B.S.C.E., held on March 13, 1957.)

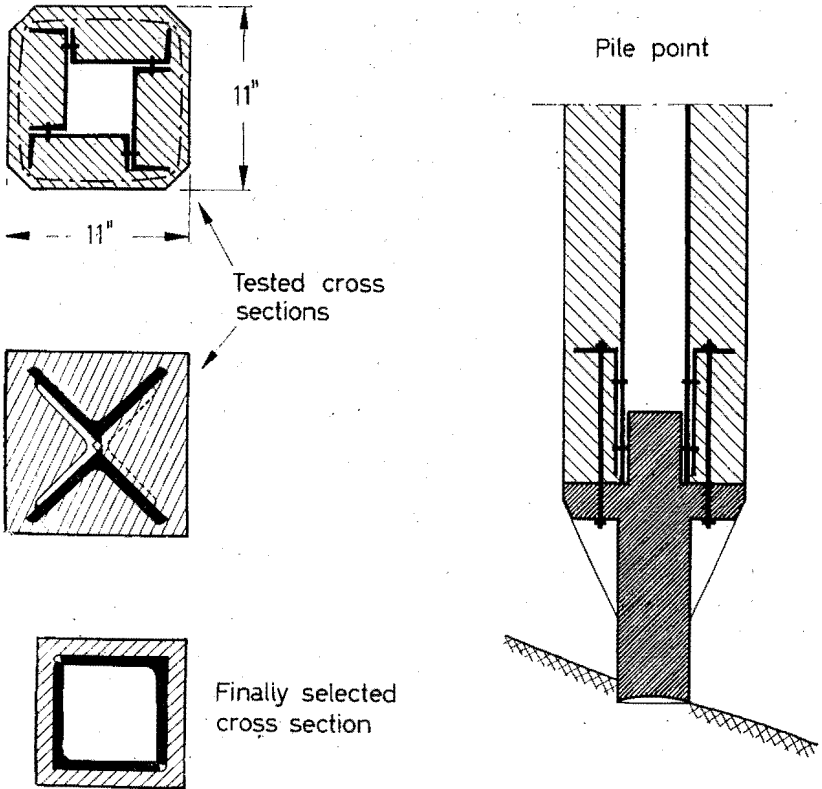
FIG. 1.—CROSS SECTIONS OF STEEL PILES AND PILE POINT USED FOR FOLKETEATERET OSLO 1931. (FOLKESTAD 1934).

The cross sections of the steel piles which were used for the first buildings in Oslo are shown in Fig. 1. The final design was a pile made by welding two angles together to form a box section which was covered by a layer of mortar in order to prevent corrosion. Since it proved difficult to keep the mortar intact during the driving of the piles, the use of unprotected piles was suggested. In this connection the building authority of Oslo made an investigation of the corrosion of some old steel piles, and they came to the conclusion that unprotected piles could be used in clay if the clay showed a basic reaction, expressed by the criterion that the pH be higher than 7.

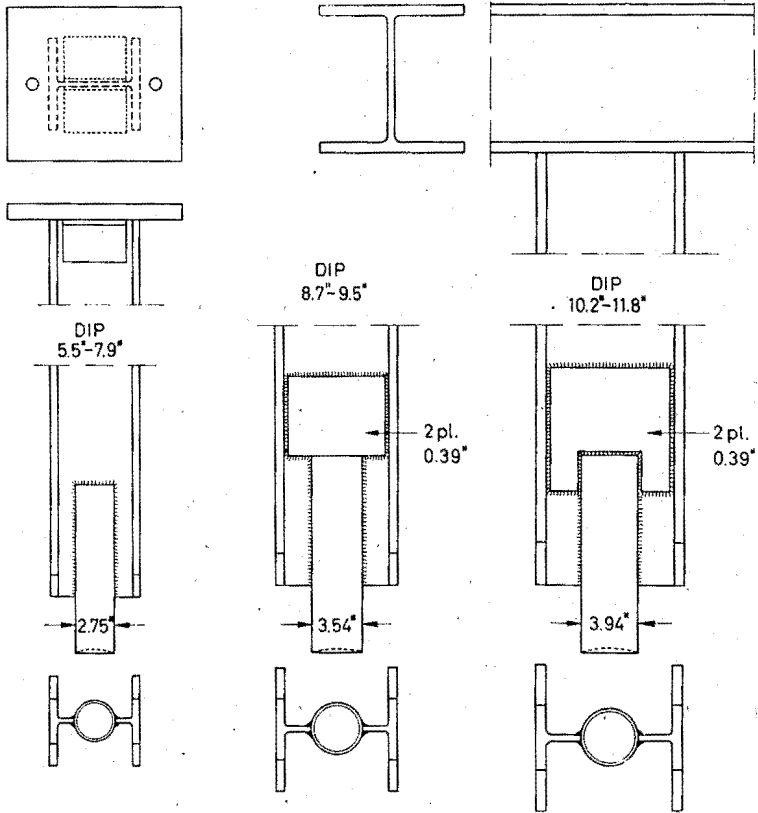
FIG. 2.—H-SECTION STEEL PILES WITH POINTS AND CAPS AS REQUIRED BY THE BUILDING AUTHORITY OF OSLO.

DIP is the notation of a wide-flanged H-beam in the Deutsche Industrie-Normen (DIN 1025).

Since then only unprotected steel piles have been used, and the H-sections have found an extensive application. Fig. 2 shows the most commonly used sizes and gives the specification of pile caps as required by the authorities of Oslo.

driven in Norway and Sweden since 1931. The first points used for the box piles were made of cast iron. For the H-piles the points are made of tempered steel bars of 3 or 4 inches diameter. A slice is cut into the web of the H-section and the bar is welded to the sec-

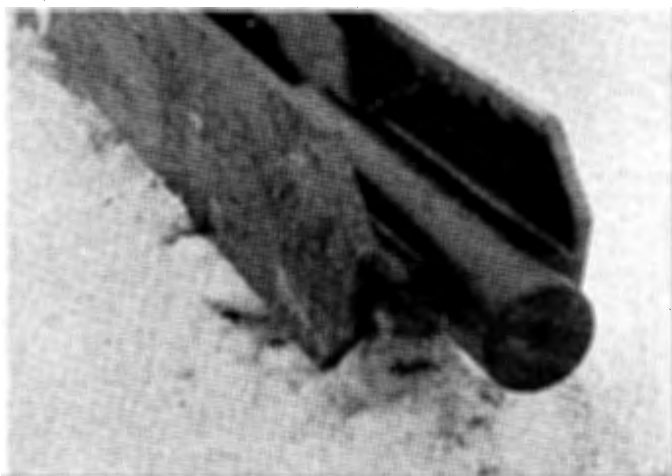
FIG. 4.—PHOTOGRAPH OF PILE POINT FOR H-SECTION.

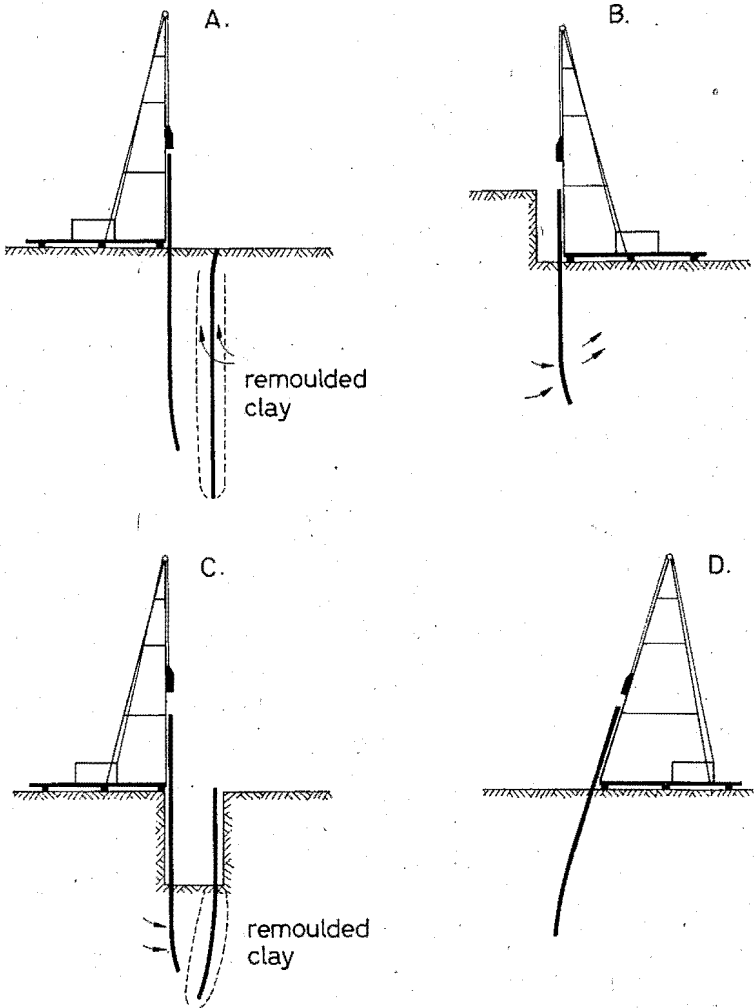
FIG. 5.—FACTORS WHICH CAUSE MISALIGNMENTS OF PILES DRIVEN INTO SOFT CLAY.

- A. The pile will have a tendency to bend in the direction of newly driven neighbouring piles around which the shear strength of the clay is previously reduced.
- B. Along the walls of an excavation the displacement will mainly take place in direction of the excavation and the pile will tend to bend away from the wall.
- C. In trenches and shafts the displaced clay will primarily be squeezed up in the bottom of the excavation and the piles will consequently have a tendency of a curvature against the centerline of the excavation.
- D. Due to their weight batter piles will tend to bend in a downwards direction.

stitute has studied the driving of slender piles and determined those factors which may contribute to misalignments of the piles. Some of these factors are illustrated in Fig. 5.

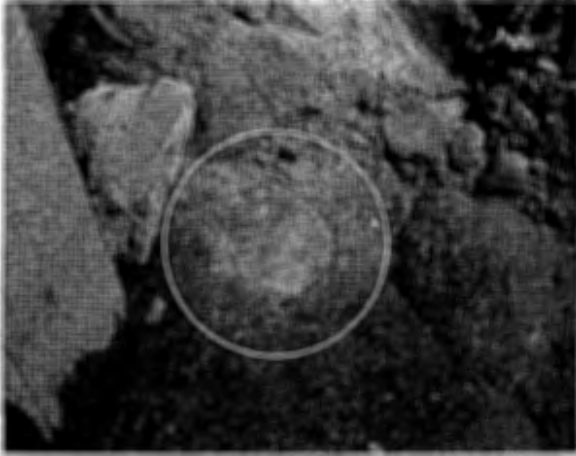
FIG. 7.—PHOTOGRAPH OF THE ROCK BELOW POINT NO. 1 IN FIG. 6. The circle indicates the depression caused by the pile point.

Fig. 7 shows a photograph of the rock below pile No. 1, after the excavation. It illustrates how the point has chiseled a depression in the rock with a concave circular form which gives a direct impression of a satisfactory bearing of the pile. Fig. 8 shows pile No. 1 after the excavation and it can be seen that the point is intact in spite of the

fact that the pile was subjected to 800 blows and that the rock was extremely hard.

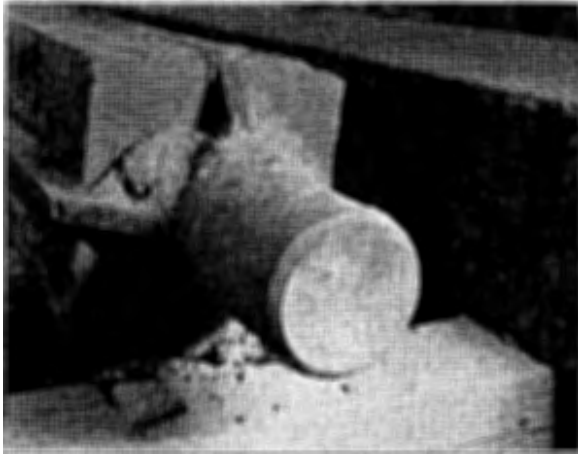
FIG. 8.—PHOTOGRAPH OF THE POINT OF PILE NO. 1 IN FIG. 6 AFTER EXCAVATION.

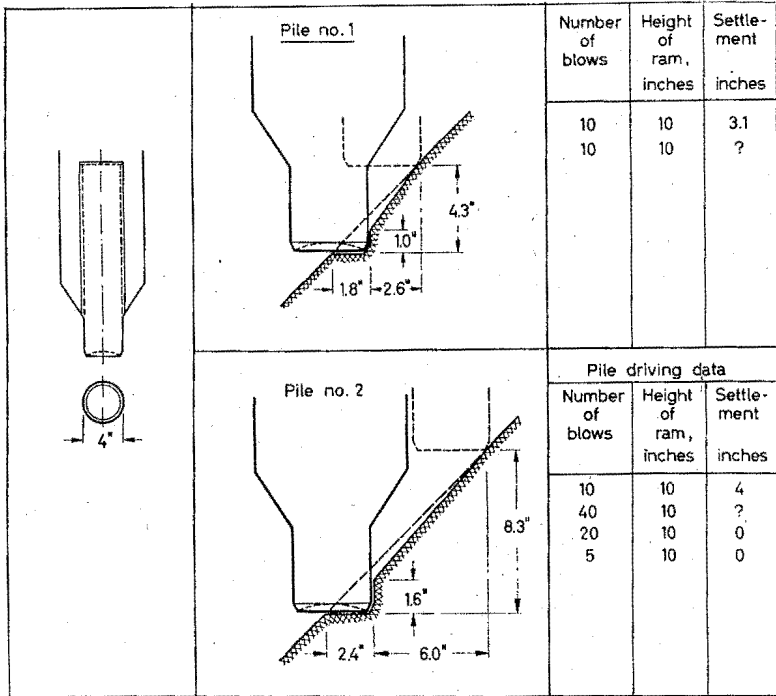
FIG. 9.—TEST DRIVING OF PILES TO HARD ROCK WITH 45° INCLINATION (PETTERSON 1941).

in Fig. 9. In this case the rock was a very hard granite with a smooth surface.

As can be seen from the figure the piles did not bite into the rock immediately after contact. They slid along the surface 4-8 inches before they stopped. With our present experiences this sliding is explained by the relatively large drops of the ram which were used. It

was possible, however, for both piles to establish a toe for the points. In the author's opinion the pile driving was stopped too early. With a sufficient number of blows it would have been possible to continue the chiseling procedure until the total area came into contact with the rock. It is, thus, interesting that pile No. 2, which had the best contact with rock, also is the pile which received the greatest number of blows.

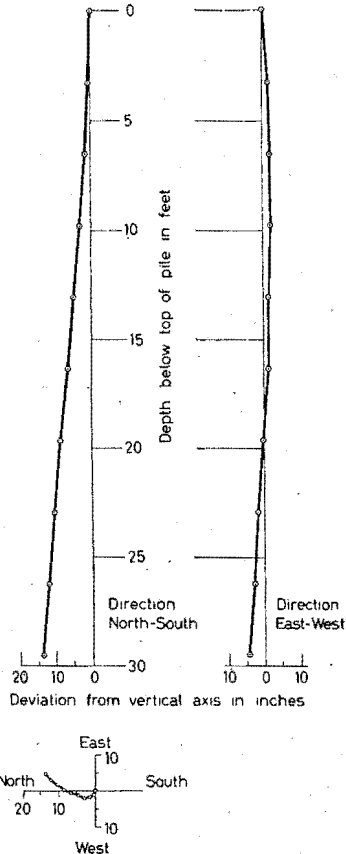
FIG. 10.—RESULT OF MEASUREMENT OF THE CURVATURE OF A STEEL PILE.

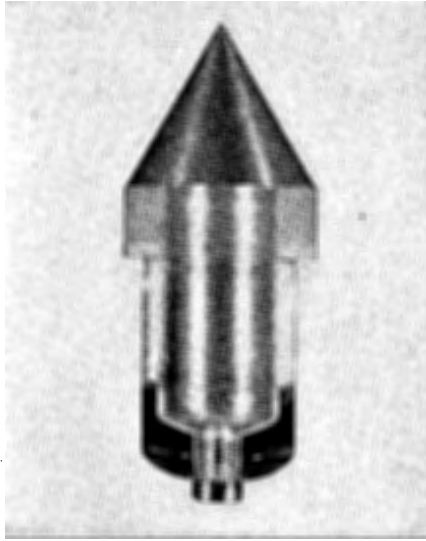
FIG. 11.—PHOTOGRAPH OF THE CORROSION POINT FOR IN SITU MEASUREMENTS OF CONDUCTIVITY AND DEPOLARIZATION OF SOIL.

In order to obtain reliable measurements of the factors controlling corrosion, Dr. I. Th. Rosenqvist at the Norwegian Geotechnical Institute has constructed a sounding device with which the depolarization and the resistivity are measured directly "in situ". The corrosion penetration-device consists of a $1\frac{1}{4}$ " steel tube supplied with a magnesium point insulated from the tube as shown in Fig. 11. The sounding device is driven into the clay and at various depths two types of measurements are made.

The next step is to measure the galvanic current passing from the tube to the magnesium point when they are short circuited. This current indicates how fast the negative electrons are removed from the

surface of the steel tube, and it will, therefore, give an expression for the cathodic depolarization of the clay. If the measured current of the short circuited system is multiplied by its electric resistivity, the "electromotive force" is obtained. Preferably this is expressed by the degree of depolarization, obtained by dividing it by the maximum value, for instance measured in salt water saturated with oxygen.

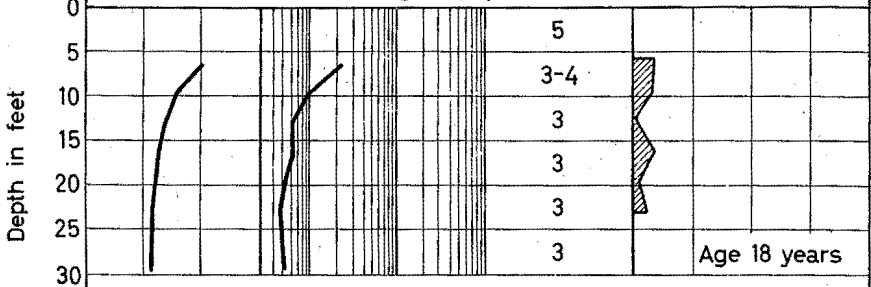
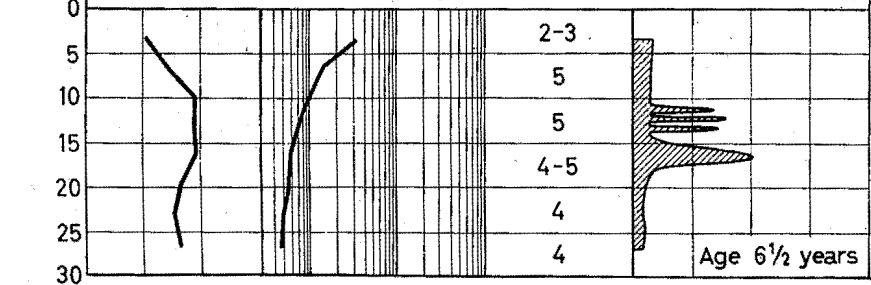
FIG. 12.—EXAMPLES ON RESULTS OF IN SITU MEASUREMENTS WITH THE CORROSION POINT AT THREE DIFFERENT SITES, WHERE ACTUAL CORROSION WAS OBSERVED ON STEEL PILES.

Fig. 12 shows three examples of measurements of the corrosivity from three different sites in Norway. In each profile the measured

The example from Hafslund in Sarpborg is a silty clay with an intermediate degree of depolarization and a relatively high resistivity. According to the values obtained by the corrosion test the clay is classified as having a low corrosivity. This is confirmed by observations from a pulled steel pile which was driven 17 years before the inspection. The steel pile showed an attack smaller than 3/1000 of

The next example is a typical Oslo clay of marine origin. Due to the salt content the resistivity is as low as 50 OhmCm. The

depolarization is, however, low to intermediate with a marked increase in the upper crust. In spite of the low resistivity the clay shows an intermediate corrosivity and this was also confirmed from an 18-year-old steel pile which was pulled for inspection. The corrosion varied from 1/100 to 2/100 of an inch, this means 1/2000 of an inch per year.

The third example in Fig. 12, Persgangen, is also a clay from Oslo with the typical low resistivity of the marine clays. In this case, however, the depolarization was as high as 77 per cent. The conditions are very unfavorable in this profile and a 6½-year-old steel pile which was pulled, showed serious corrosion up to 1/10 of an inch. This corresponds to an average corrosion of more than 1/100 of an inch per year.

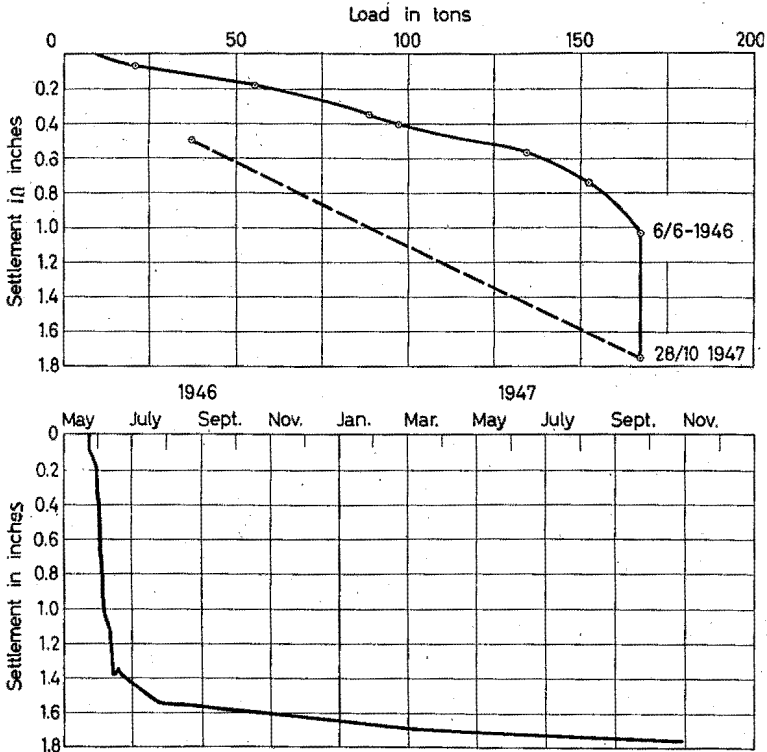
FIG. 14.—RESULTS OF 17 MONTHS LOADING OF A 87 FEET LONG CONCRETE PILE IN OSLO. THE PILE, WHICH WAS SUPPLIED WITH A 4" DIAMETER OSLO-POINT, WAS DRIVEN APRIL 23-24, 1946.

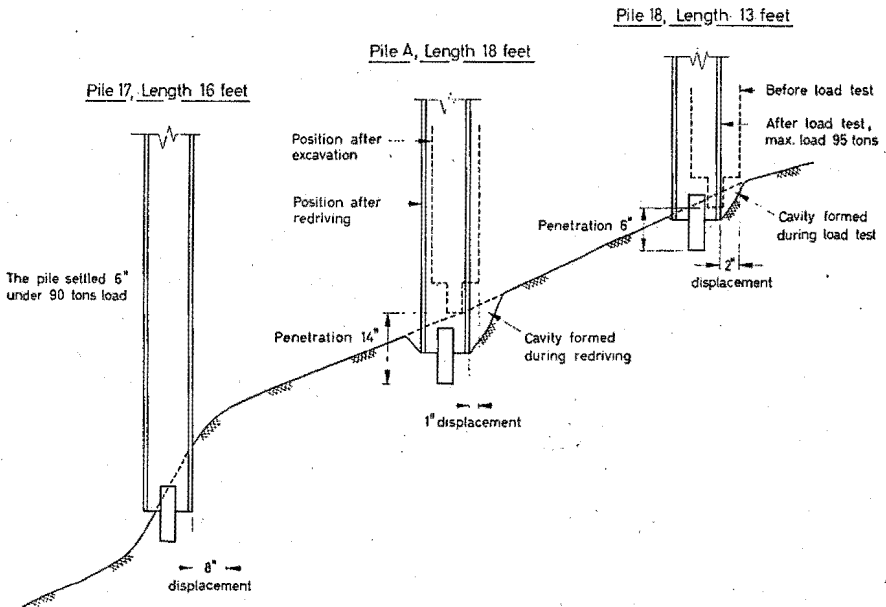
FIG. 15.—STEEL PILES IN SLEMMESTAD EXCAVATED AFTER THE DRIVING (BERNTSEN 1955).

which had a length of only 15 to 20 feet. The result of the inspection of the piles is shown in Fig. 15. It proved that even if the points had slid on the rock surface, they finally obtained a hold in the rock and a bearing was established after 2-4 inches of penetration into the rock. During the loading test of pile number 18, the point of the pile penetrated 6 inches further into the rock, squeezing the rock so that a crater was formed around the point.

Pile number 17 was test loaded after the excavation in order to observe what happened with the piles during a loading test. At 40 tons load the pile started to settle and the point was directly observed to penetrate into the rock. As the point came deeper below the rock surface, a greater load was required to bring the point to failure, and after 6 inches settlement the bearing capacity had increased from 40 tons to 90 tons. The explanation of the small failure loads of the

piles was, thus, that the bearing capacity of the alum shale was exceeded. The 30-40 tons failure loads of the piles correspond to a unit pressure at the rock of 4000-7000 lb/in². This value represents, thus, the bearing capacity for a circular point at a depth of one to two inches. At a depth of 6-8 inches, the bearing capacity increased to double the value.

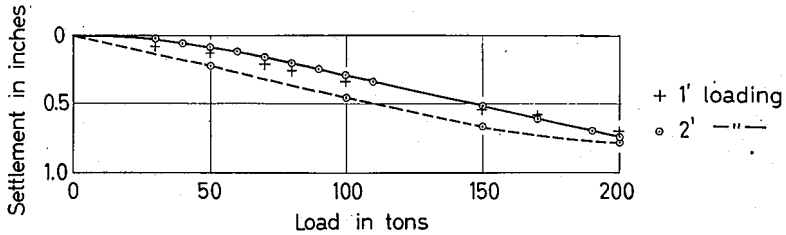
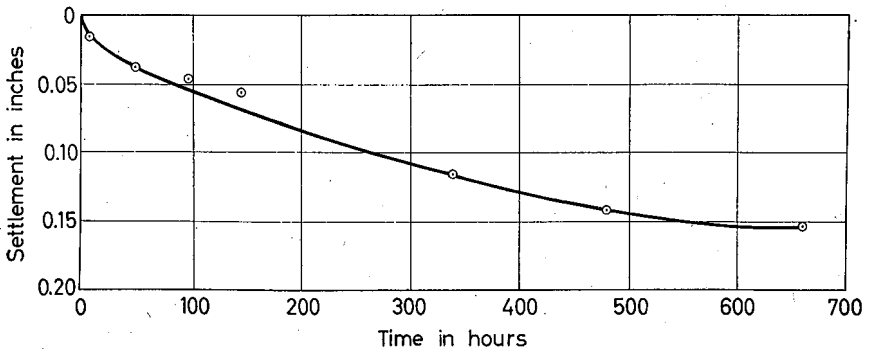
FIG. 16.—LOADING TEST ON A 85 FOOT LONG STEEL PILE TO ROCK AT THE BRIDGE AT FREDRIKSTAD.

Pile number 25 was loaded with 200 tons—which is two times the design load—for a period of a month. The results of the settlement observations are shown at Fig. 16, and, as seen from the figure, the immediate settlement under the 200 tons loading was approxi-

mately $\frac{3}{4}$ inches and the additional settlement during the one month loading amounted to only 0.2 inches. The permanent set of the pile after removing the load was negligible. The total maximum settlement after one month's loading is approximately equal to the elastic compression of the pile, which must be considered as a very satisfactory result.

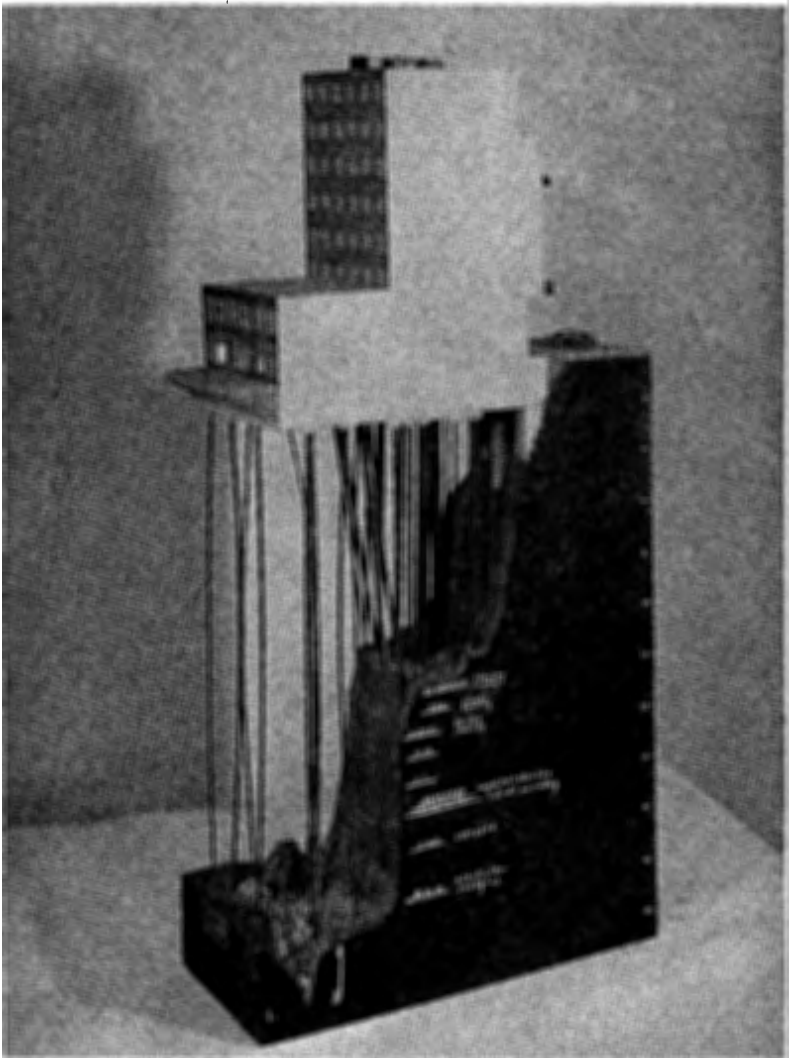
FIG. 17.—MODEL OF PILE FOUNDATION OF FRIDTJOF NANSENS PLASS NUMBER 8.
