# The Performance of Highway Bridges in the Northridge, California, Earthquake

*Bridge seismic retrofit programs exhibited a high degree of success. However, additional requirements for retrofit programs and initial design are needed.*

NATIONAL CENTER FOR EARTHQUAKE  
ENGINEERING RESEARCH

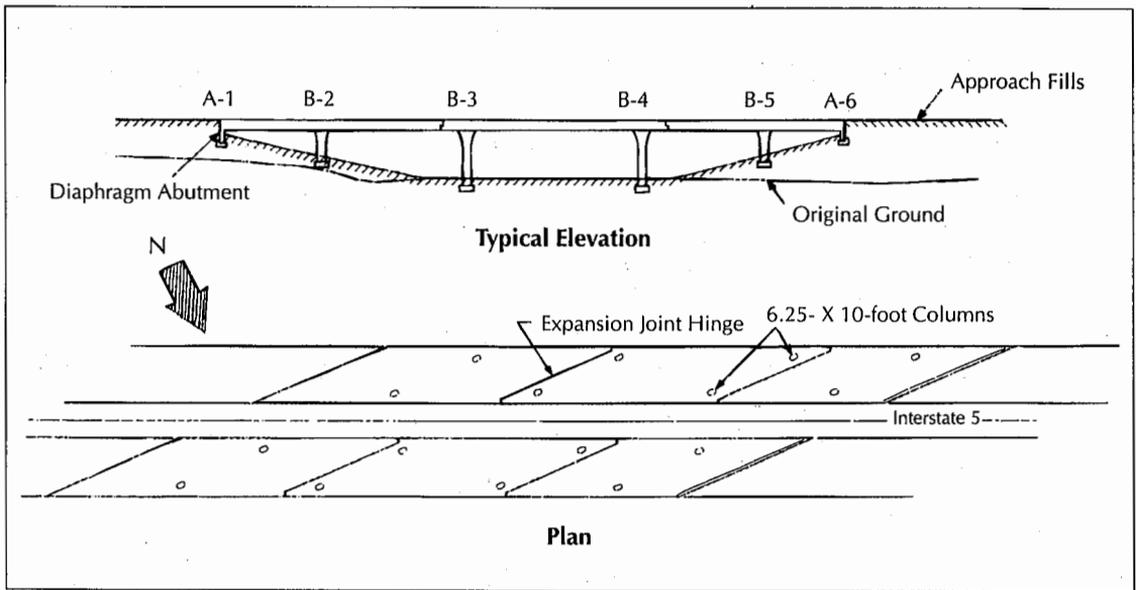
**FIGURE 4. General plan and elevation for the Gavin Canyon crossing.**

The two outside frames are composed of cast-in-place reinforced concrete box girder construction. Each frame is supported on a monolithic end diaphragm abutment and a single two-column bent. The center frame is a cast-in-place prestressed concrete box girder supported on two bents, each with two columns. The abutments, expansion joints and bents are all oriented at a relatively large skew that is approximately 67 degrees to normal. The bridges are separated by a 42-foot wide median. A schematic of the bridges is shown in Figure 4.

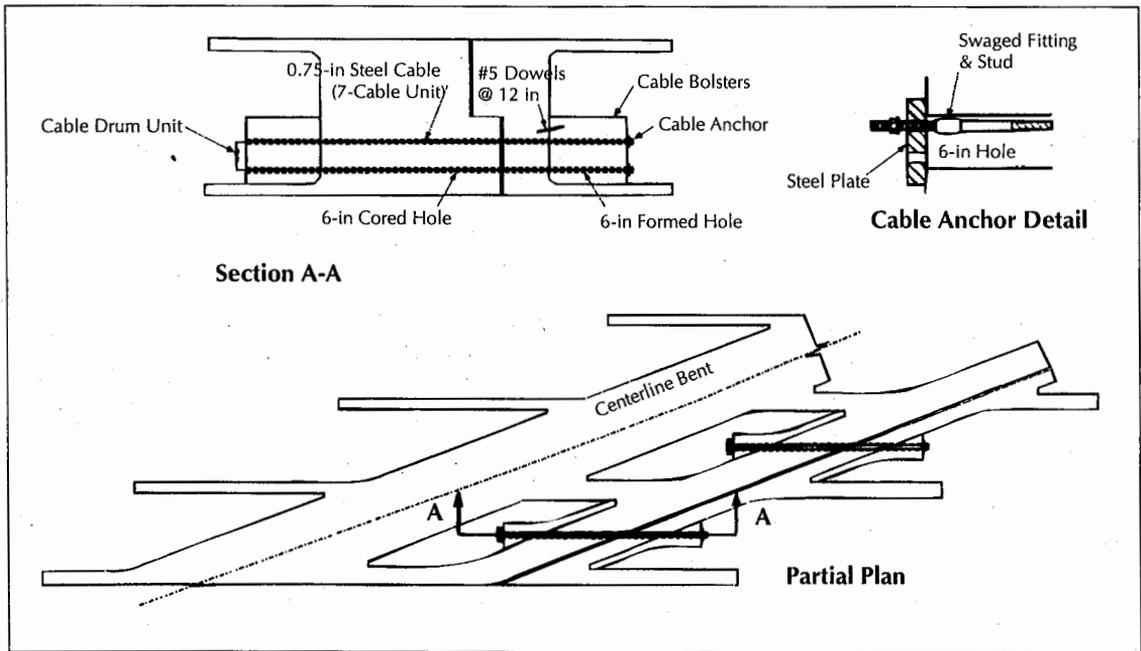
**FIGURE 5. Hinge restrainer details for the Gavin Canyon Undercrossing.**

Expansion joint hinge restrainers were not present during the 1971 earthquake. They were installed after the earthquake. The restrainers are unusual by modern standards because they are oriented along the centerline of the bridge rather than normal to the expansion joints. Restrainer details are shown in Figure 5.

The movement of the superstructure caused restrainer cables to be pulled at an angle to their principal axis as evidenced by spalling at the edges of cored holes through which the restrainers passed. In some cases, restrainer cables snapped as the expansion joints separated. In other cases, they pulled through the expansion joint diaphragm. Some cables remained intact, helping support the partially unseated spans and preventing the unseating of the span at one of the hinges.

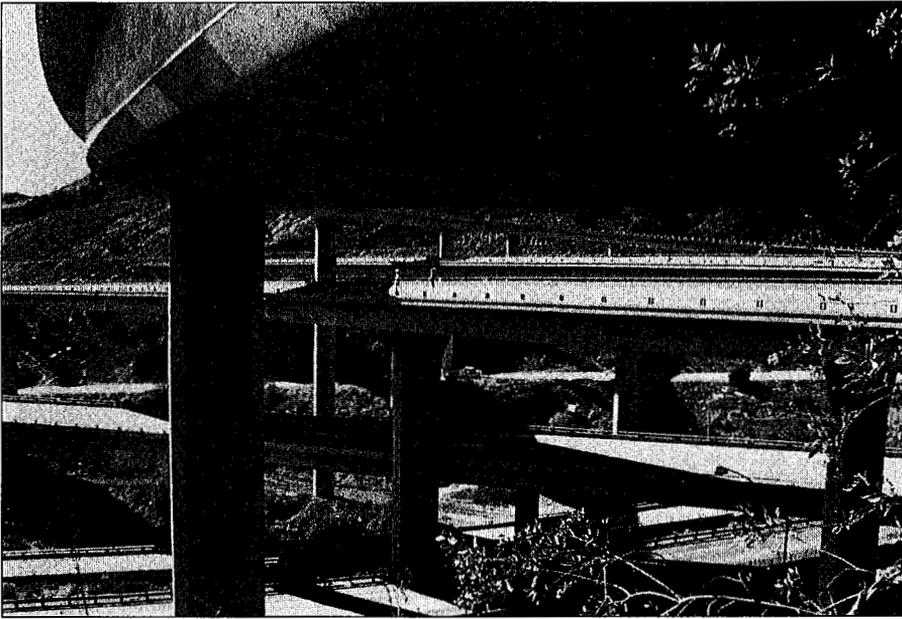
**FIGURE 8.** A view from abutment 10 of the south connector looking southwest at the SR14/I-5 interchange.

The SR14/I-5 interchange is located on steeply dipping, well consolidated sandstone of the Towsley formation. Alluvium is present locally. Structures are founded in the sandstone with abutment fills present at approaches. A general view of this interchange immediately following the earthquake of January 17 is shown in Figure 8. A simplified plan view of this interchange is given in Figure 9. In this view, the four viaducts that allow the interchange of traffic between I-5 and SR14 are shown. A fifth structure, which carries southbound truck traffic from SR14 to I-5, is not shown. It suffered only minor shear key damage.

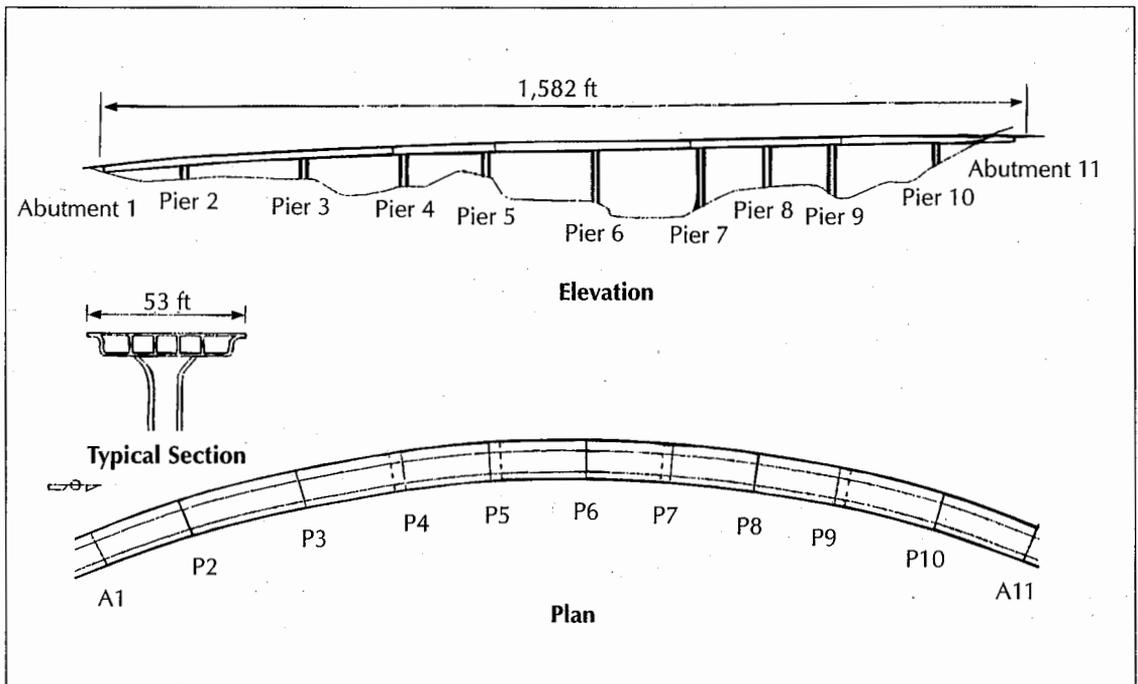
**FIGURE 10. General plan and elevation for the SR14/I-5 separation and overhead (south-bound).**

width of 53 feet. There is no skew but the structure is curved to a radius of 2,200 feet. The bridge is constructed in five segments with four intermediate hinges. See Figure 10 for details of the span geometry.

1 to the hinge of span 3 when this earlier earthquake occurred. (These spans subsequently collapsed in the Northridge earthquake of 1994.) Concrete from the hinge of span 9 to abutment 11 had been completely placed but the spans had not been prestressed. The remainder of the superstructure had not been constructed. Most of the damage to the superstructure was the result of falsework settlement.<sup>9</sup>

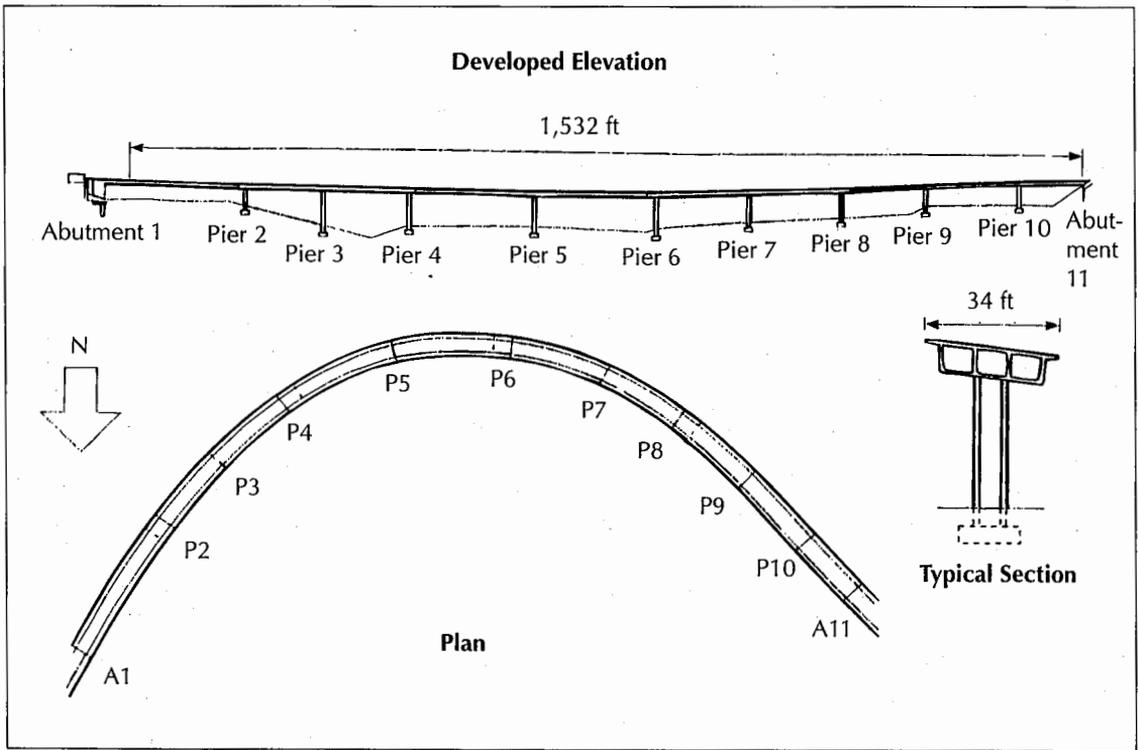
FIGURE 14. General plan and elevation for the SR14/I-5 north connector.

The north connector in the SR14/I-5 interchange is a 10-span, continuous, cast-in-place, three-cell, concrete box girder bridge. It has seat type abutments and single column bents supported on both spread footings and piled footings. The total length is 1,532 feet, with an overall width of 34 feet. The bridge is constructed in five segments with four intermediate hinges. See Figure 14 for details of the span geometry.

This bridge was under construction at the time of the 1971 San Fernando earthquake. Approximately 80 percent of the superstructure from abutment 1 to hinge 4 in span 8 was complete. During this earlier earthquake, the deck profile altered a total of 0.4 feet in a reasonably uniform change from abutment 1 to the hinge at pier 8. The hinges experienced the following minor damage: crushed expansion material, slight spalling, separated waterstops and failed equalizing bolts. Pier 2 exhibited signs of move-

ment at the ground level having an embankment separation of two inches around the column. A crack was also noted on the superstructure soffit near pier 3.<sup>9</sup>
