# Evaluation of the Canoe Creek Bridge Abutments

*Effective repair of bridges experiencing structural distress requires a well-planned evaluation of the bridge based on site characteristics.*

BOHDAN I. CZMOLA

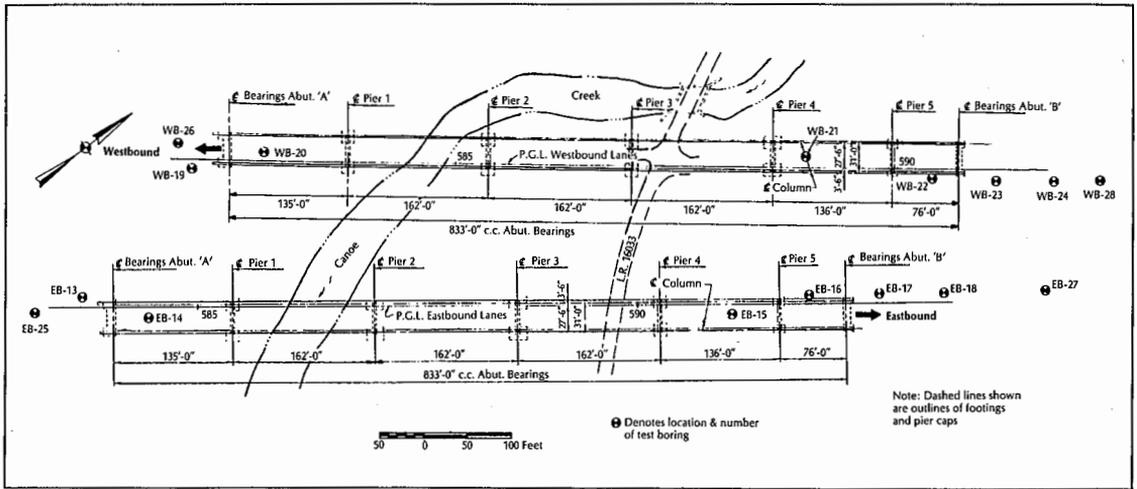
**FIGURE 1. Plan drawing of the original Canoe Creek Bridge design.**

The subsurface drilling program was conducted in two phases. A total of 16 boreholes were drilled at the locations shown in Figure 1. Twelve borings were drilled during the first phase — six borings along the eastbound highway and six borings along the westbound

highway. These Phase I borings were drilled to obtain geotechnical data to aid in determining the causes of the structural distress experienced by the dual bridges. Two borings were drilled at the west ends and four borings at the east ends of both the eastbound (Borings EB-13 through EB-18) and westbound (Borings WB-19 through WB-24) highways. Borehole depths ranged from 38 to 108 feet.

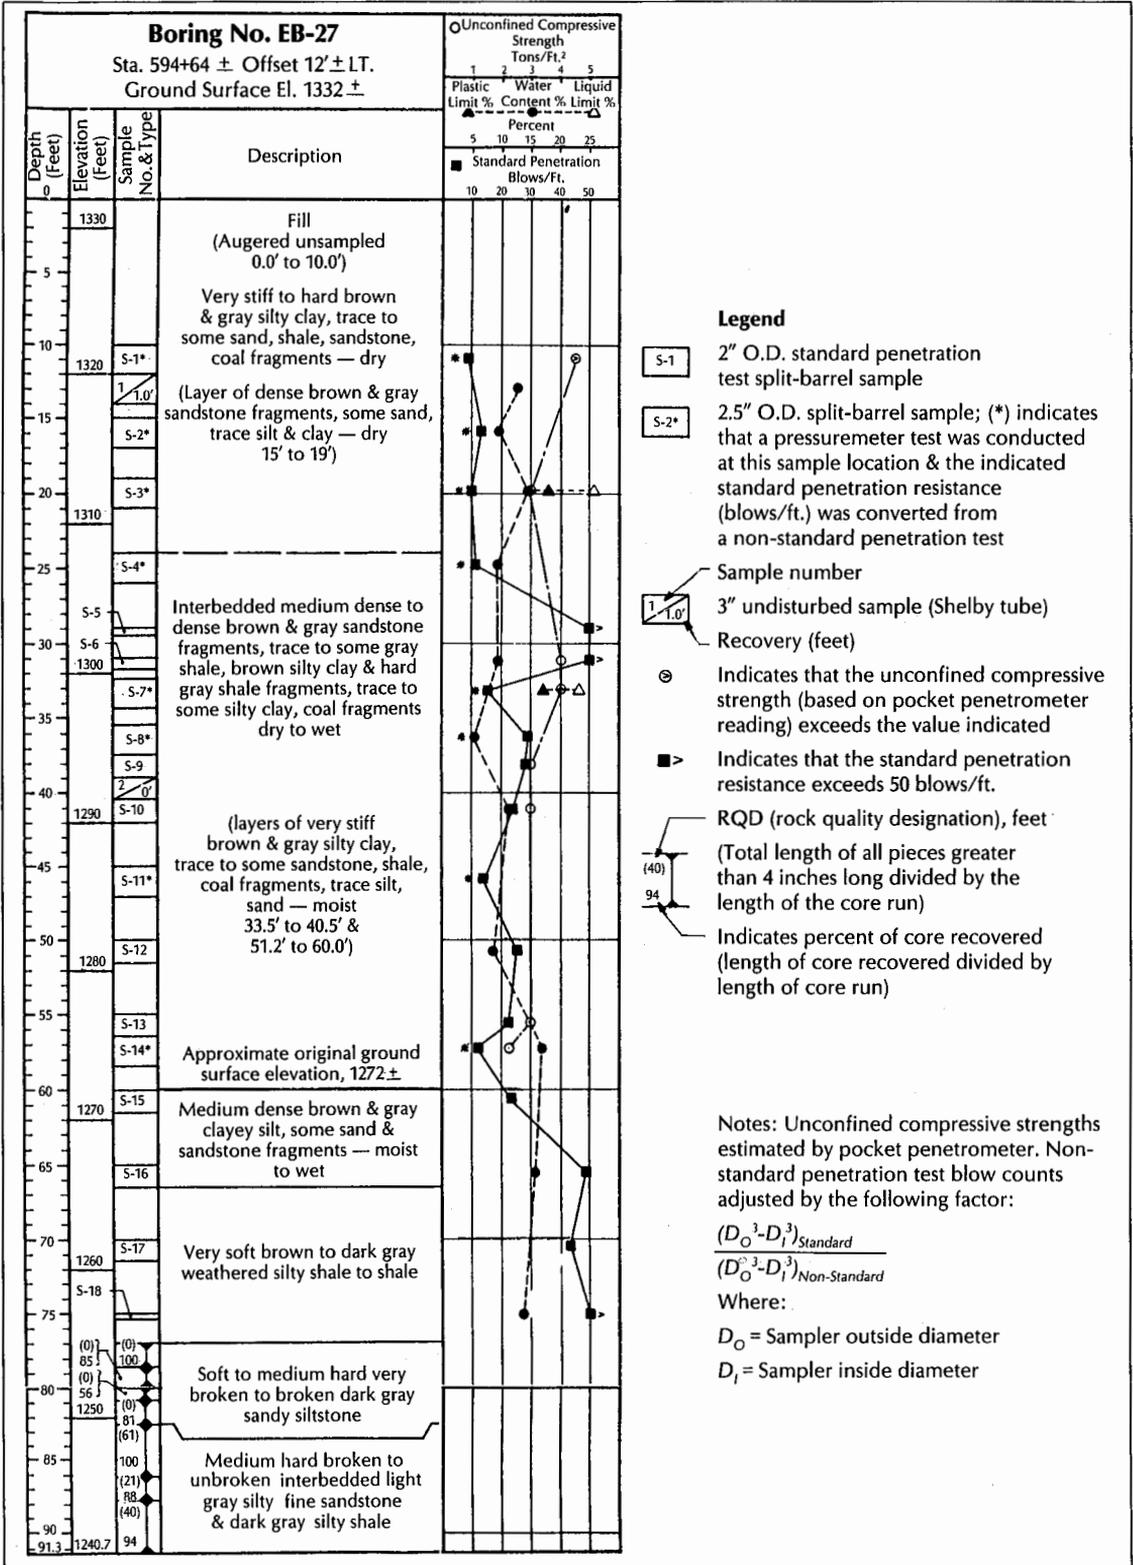
FIGURE 15. A typical boring log from the Canoe Creek Bridge evaluation.

*in situ* soils. Whenever the recovered SPT samples were cohesive, pocket penetrometer readings were performed on them to estimate their unconfined strengths. Pressuremeter testing was conducted in three of the four boreholes drilled for investigation of the abutment foundation conditions. Rock quality designation (RQD) values were determined for all of the rock cores that were recovered. RQD values ranged from 0 to 75 percent and averaged 25 percent, indicating that the surface of the rock strata was relatively weathered. Results of the SPT and pocket penetrometer testing, as well as RQD values, were summarized on the boring logs, an example of which is shown in Figure 15.

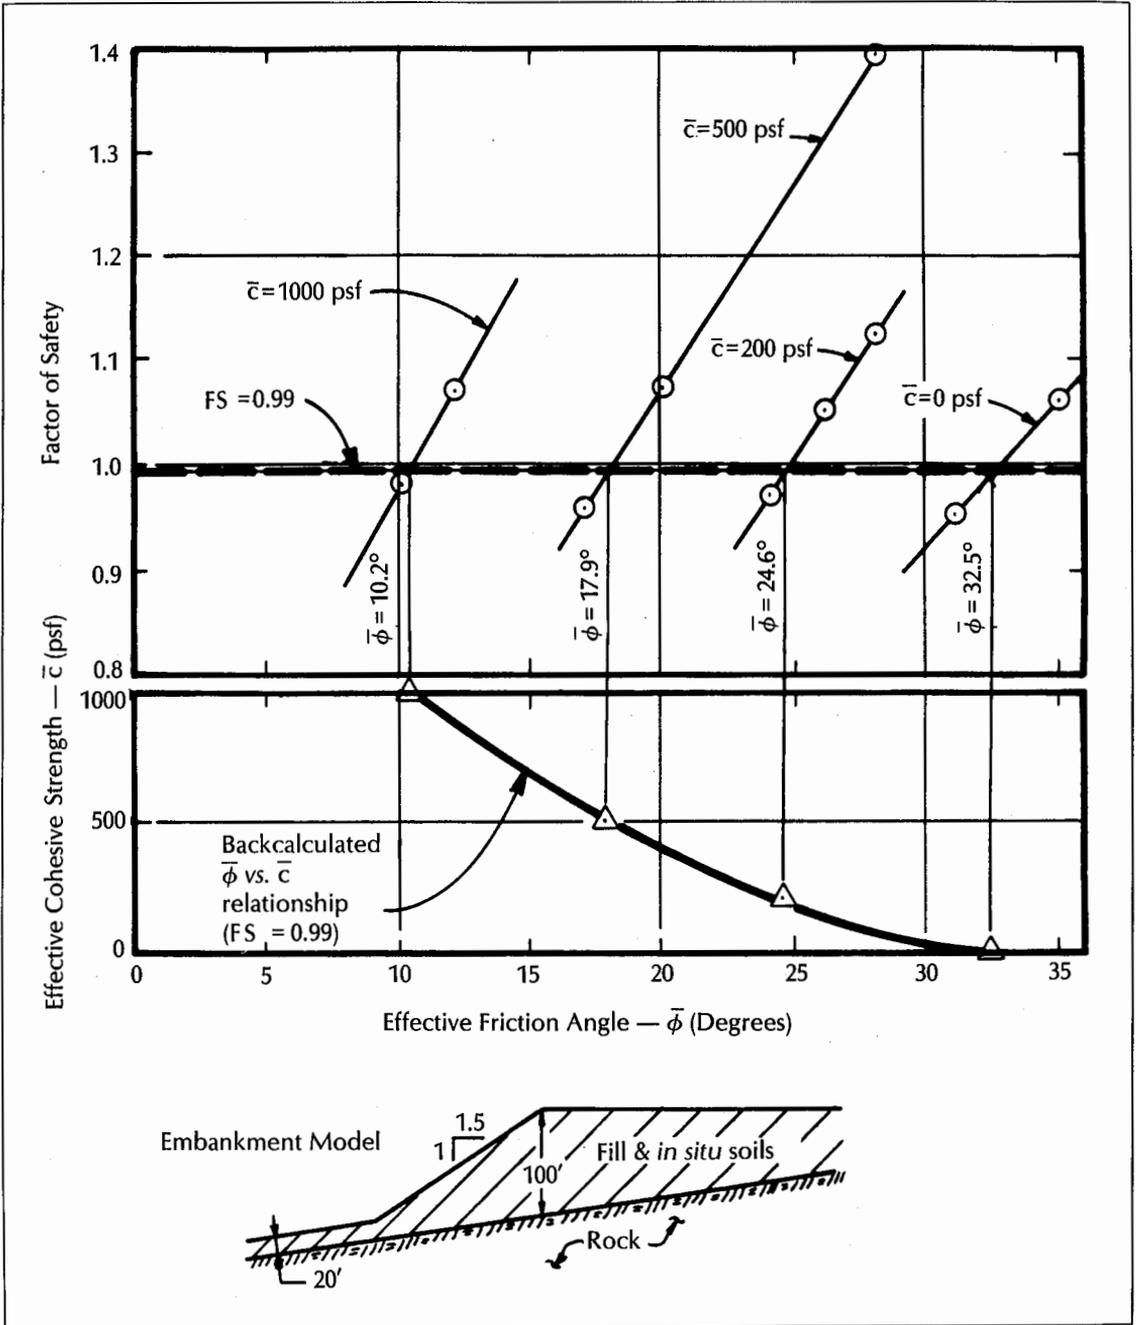
**FIGURE 16. Stability analysis for the bridges.**

The results of the stability analyses were plotted on an effective friction angle versus factor of safety graph, as shown in the top portion of Figure 16. Individual values of effective friction angles that would yield a factor of safety of 0.99 for each of the four effective cohesive strengths were obtained by linear interpolation as shown in Figure 16. The interpolation procedure yielded the combination of effective cohesive strengths and friction angles as shown in Table 2, each of which resulted in a factor of safety of 0.99 for the model embankment.

These four sets of calculated strength values were plotted and a curve was drawn through the data points as shown in the lower graph of Figure 16. This curve represented all the possible combinations of effective cohesive strength and friction angle that would produce a factor of safety of 0.99 for the model embankment configuration. Since the factor of safety of the four highway abutment embankments was previously estimated to be approximately 0.99, it was, therefore, postulated that the actual overall average strength parameters for the embankments would fall very near or on this curve.

An effective angle of internal friction of 25 degrees and an effective cohesive strength of 200 psf were selected as being representative

of field conditions. Based on these strength parameters, factors of safety were obtained for regraded embankment configurations as shown in Table 3. Because of the vital significance of Highway I-80 as a transportation corridor, PennDOT deemed it prudent to select the 2.5:1 slope.

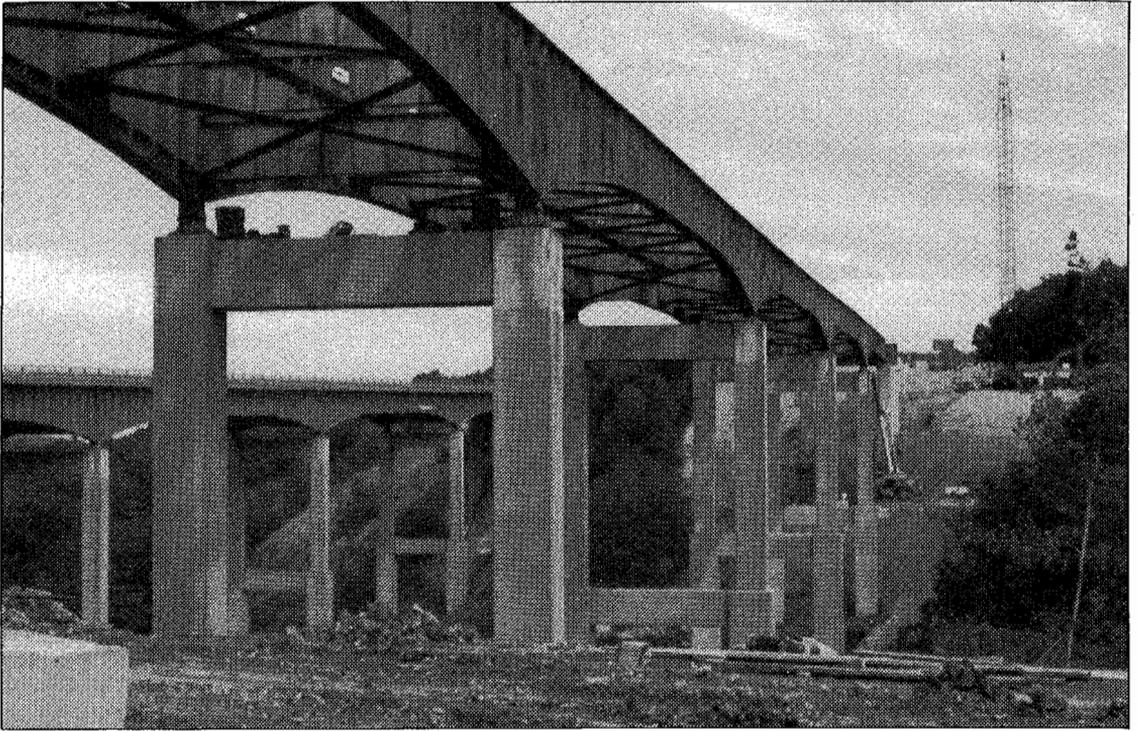
**FIGURE 18.** A view of the eastbound bridge after deck removal.

Figures 18 through 23 depict recent construction activities. A monitoring program measuring settlement of the eastbound bridge abutments has been implemented. To date, the east and west abutments have settled 0.36 and 0.24 inches, respectively. The abutment foundations are performing well, and it appears that total settlements will be within the 2-inch design criteria.

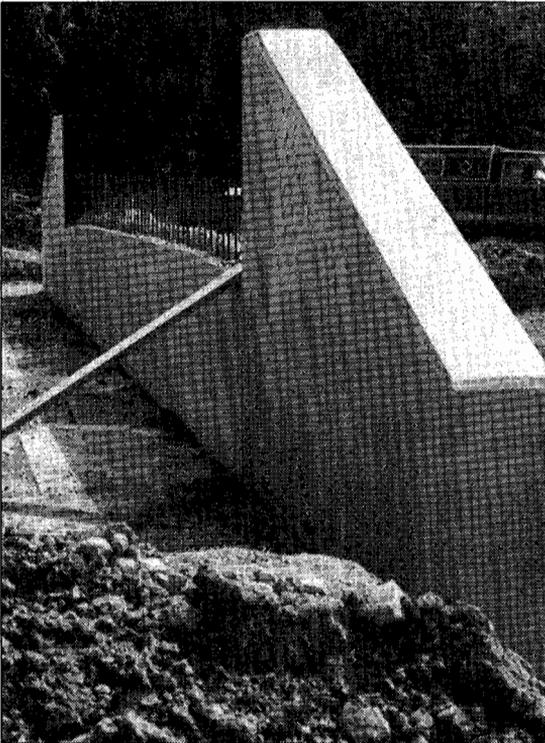
**FIGURE 19.** Newly constructed eastbound highway east end abutment and wing walls.

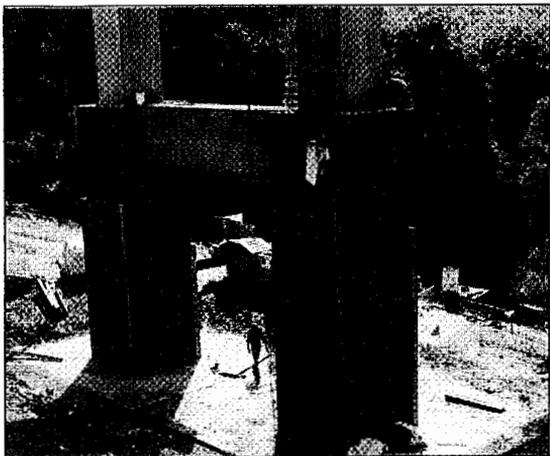
**FIGURE 20.** A view of the reconstructed Pier 5.

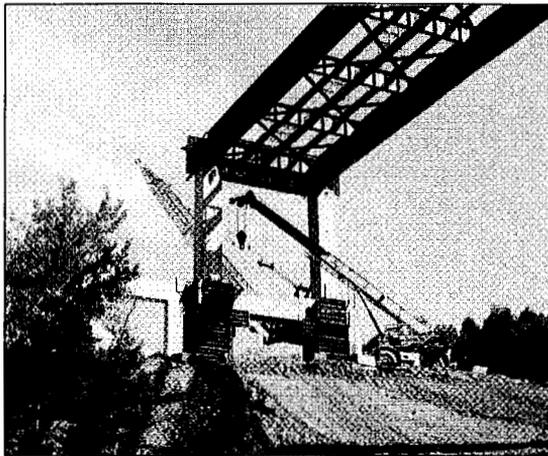
**FIGURE 21.** Reconstructed Pier 5.

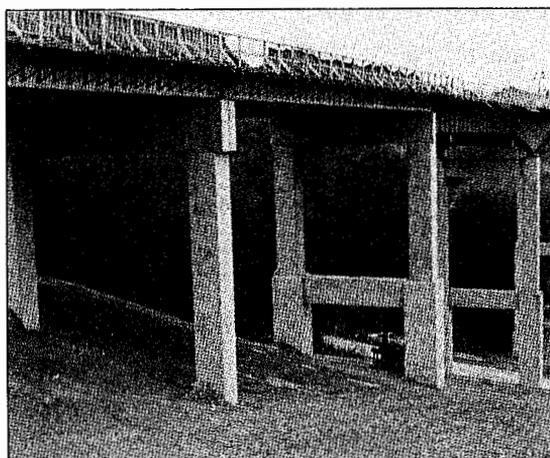
**FIGURE 22.** Recently added Pier 6, reconstructed Pier 5 and original Pier 4 (shown left to right). Note the new, simply supported prestressed concrete box beams and regraded slope.

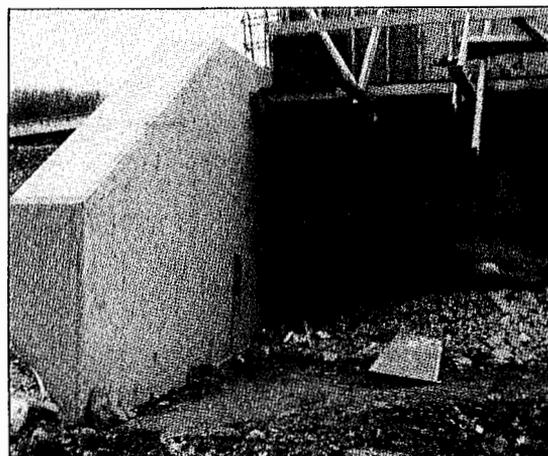
**FIGURE 23.** Newly constructed eastbound highway east end abutment and new box beams.
