Reducing Seismic Risk in Massachusetts

A program that evaluates the seismic risk of existing buildings is instrumental in developing structural modifications that will reduce seismic risk.

STEVEN P. MCELLIGOTT, JAMES R. GAGNON
& CHRISTOPHER H. CONLEY

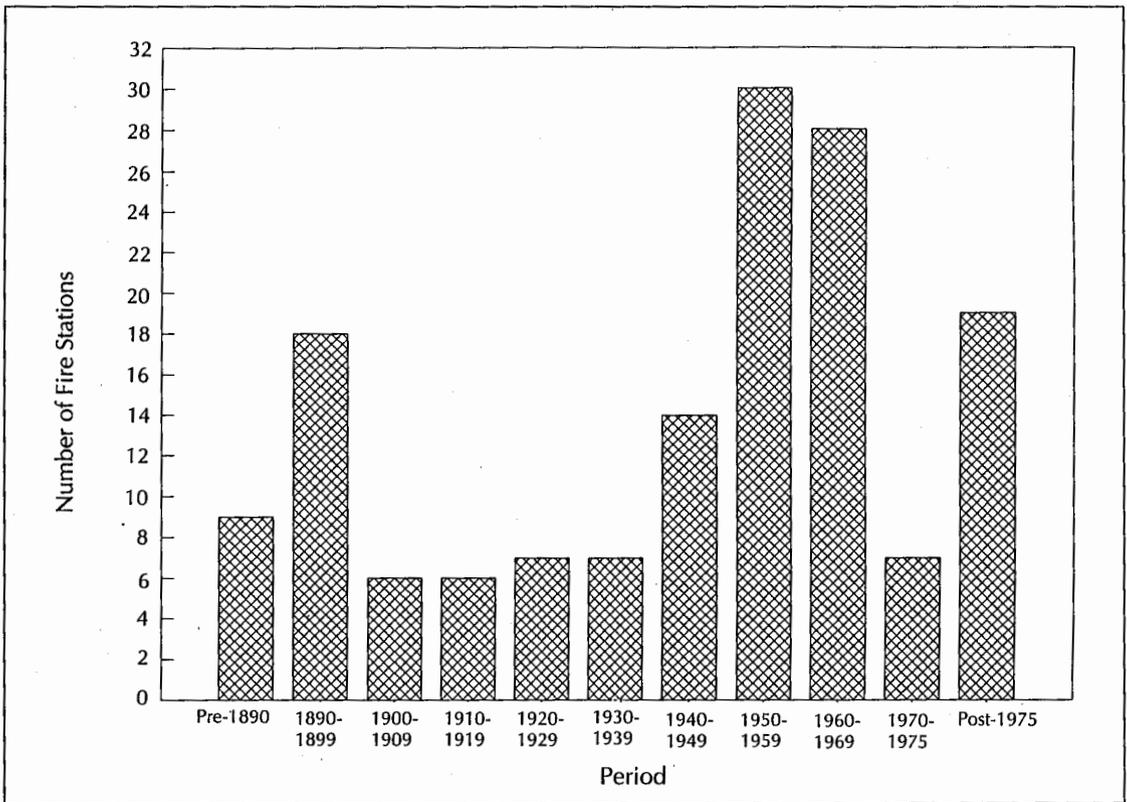
FIGURE 7. Distribution of construction dates among fire stations in Middlesex County.

Figure 7 presents a histogram showing the number of fire stations built within certain decades. The advanced age of the stock of fire stations can be clearly seen since a significant number were built prior to the turn of the century. It is interesting to note that only 17 of the fire stations were built after the inclusion of seismic provisions in the Massachusetts building code. Most of the fire stations were built in

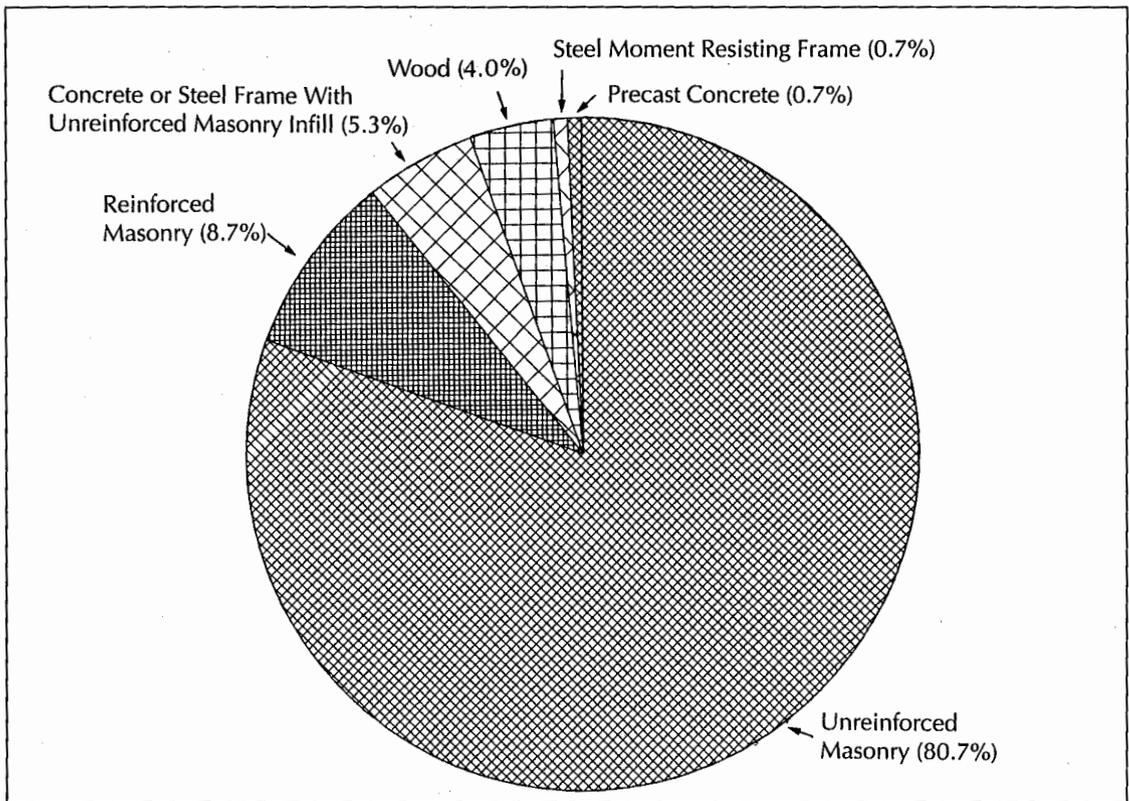
FIGURE 8. Distribution of construction types for fire stations in Middlesex County.

the 1950s and 1960s, before the inclusion of seismic provisions in 1975. A breakdown of the construction types found is shown in Figure 8. Unreinforced masonry construction, which has repeatedly demonstrated poor performance in past earthquakes throughout the country, makes up a clear majority of the fire stations.

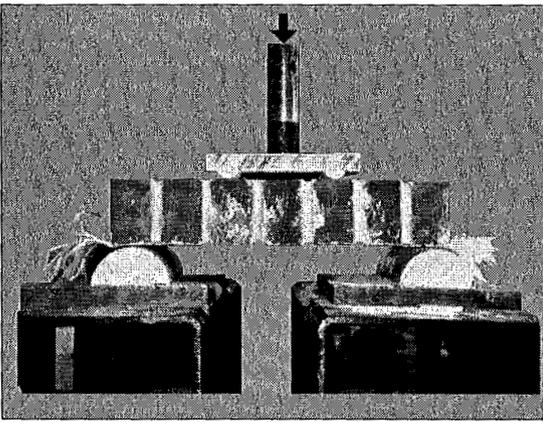
FIGURE 10. Flexural beam test setup.

Flexural beam tests were performed to determine the effect of the reinforcing on the flexural strength of the masonry. The flexural beam test was used because of its versatility and ability to produce data with little effort and cost. This test is, potentially, a simple and economical representation of the behavior of walls subjected to out-of-plane lateral loadings. The flexural beam test was conducted in accordance with ASTM E518-80.⁷ The specimen was placed horizontally across a 15.75-inch span so that the reinforced face would be placed in tension (see Figure 10). A third point load was applied to the specimen manually with a hydraulic actuator until failure.

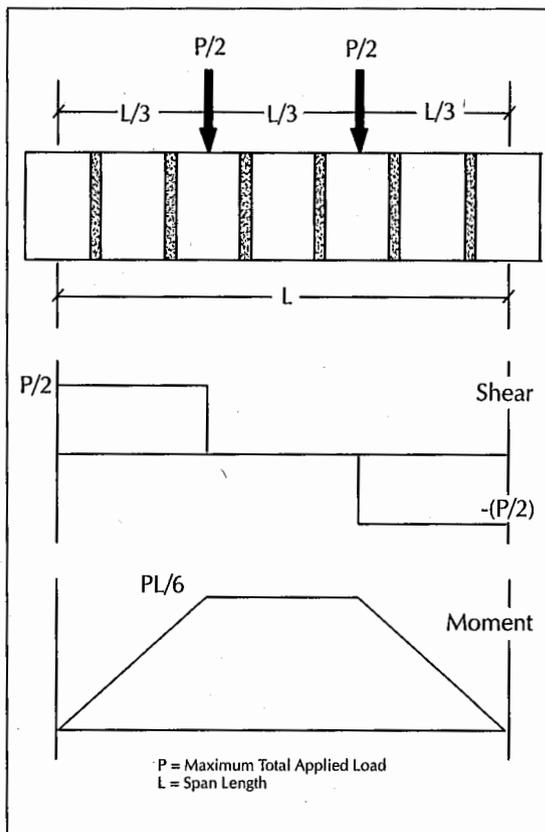
FIGURE 12. Shear and bending moment diagrams of third point loading.

Flexural cracks were observed in the mortar joints of the two-inch-spaced glass fiber reinforced specimens at a load level of approximately 300 lbs, corresponding to 49 psi. These specimens ultimately failed in shear at their first joint before failing in bending at midspan. Even though less reinforcement was present in the 2.67-inch-spaced glass fiber reinforced specimens, their flexural bond strength was approximately the same as that of the two-inch-spaced specimens. Since all glass fiber reinforced specimens failed in shear outside of the middle third of the span, it was concluded that the amount of reinforcing had little effect on the strength of the beam. It was felt that the masonry failed in shear before the true flexural capacity of the specimens was obtained.

As the shear and moment diagrams in Figure 12 indicate, failure within the middle third of the beam would be caused by bending stresses. Outside this region, the beam is exposed to both shear and bending. The applied load could cause a shear failure in the region before the ultimate moment capacity of the beam is reached in the middle section.

To determine if this was the case for the glass fiber reinforced specimens, the shear strength of the masonry was estimated and compared to the actual shear stress in the specimens at failure. In place of actual testing, Brick Institute of America formulas were utilized in estimating the shear strength of the masonry. Based on the compressive strength of the brick of 10,940 psi (obtained from the manufacturer), the compressive strength of the masonry, f'_m , was determined to be 1,727 psi.

The shear strength and corresponding load to cause shear failure were determined to be 27.7 psi and 1,558 lbs, respectively. The experimental results of the glass fiber reinforced specimens indicated applied loads ranging from 1,875 to 1,976 lbs. It is obvious that the shear strength of the specimens was exceeded, thus inducing failure.

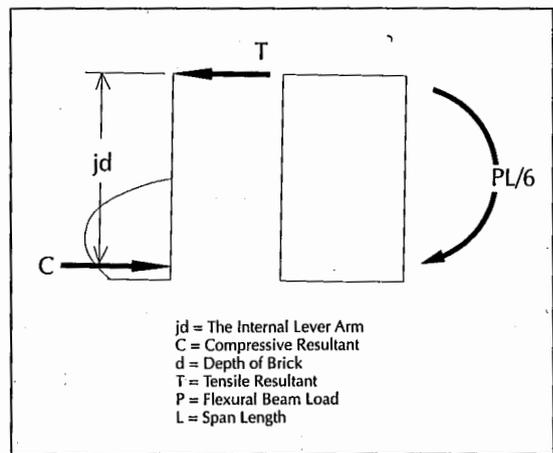
FIGURE 13. Free body diagram of a flexural beam specimen.

A free body diagram illustrating what occurs at failure in the beam specimen due to third point loading is presented in Figure 13. In order to simplify the analysis, the effects of the self-weight of the specimen as well as the weight of the loading attachment were neglected. Also, the mortar was assumed to have no tensile strength, a commonly made assumption in the analysis of masonry structures.

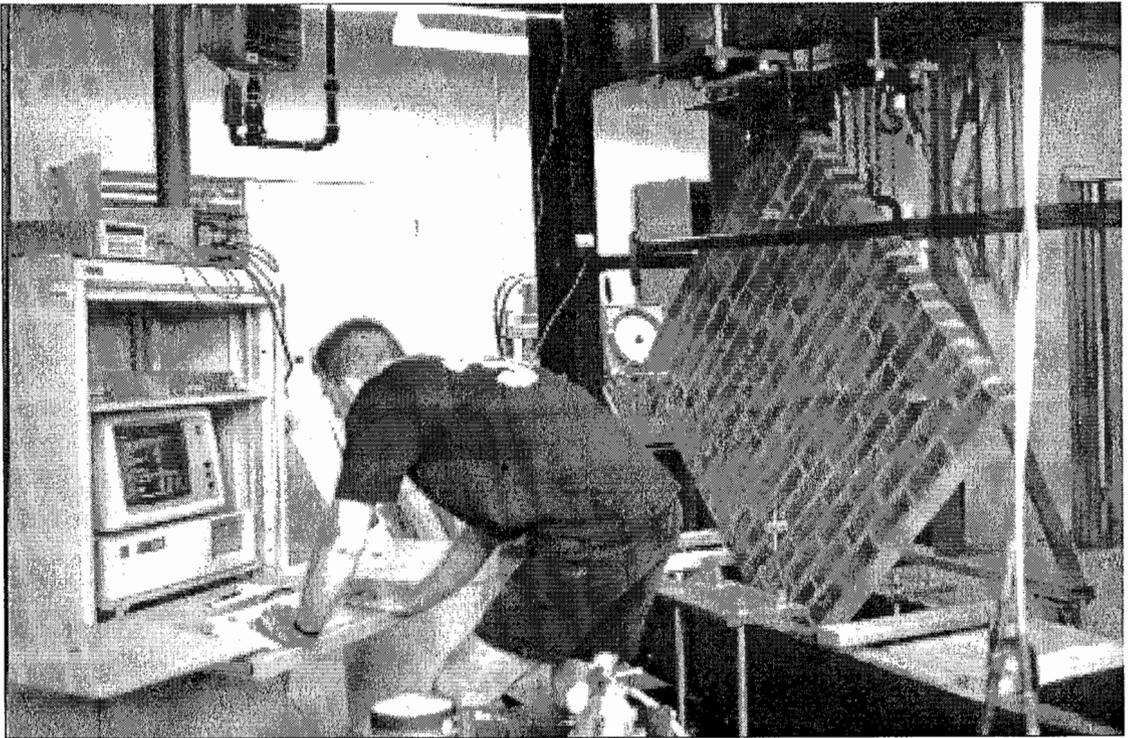
FIGURE 14. Diagonal tension test setup.

The flexural beam tests addressed walls subjected to out-of-plane loading. Diagonal tension tests were also conducted to investigate the resistance of walls to in-plane loading. It is a deficiency in a combination of this diagonal tensile strength and shear along horizontal bed joints that leads to the failure of a wall exposed to an in-plane lateral loading.

These tests, shown in Figure 14, were conducted in accordance with specifications set forth in ASTM E519, where a four-foot square panel is loaded to failure along one of its diagonals.⁹ Tests were performed on four test panels — two unreinforced, one reinforced with a two-inch glass fiber mesh (laid up by hand with glass fiber roving) and one reinforced with polyvinylbutyral film. As a result of previous flexural testing, the glass fiber reinforcement was chosen for its strength, while the polyvinylbutyral film was chosen for its ductility.
