# Back Bay Boston, Part II: Groundwater Levels

*Man-made structures that permanently lower groundwater levels can have adverse effects on buildings with water table sensitive foundations.*

HARL P. ALDRICH, JR. &  
JAMES R. LAMBRECHTS

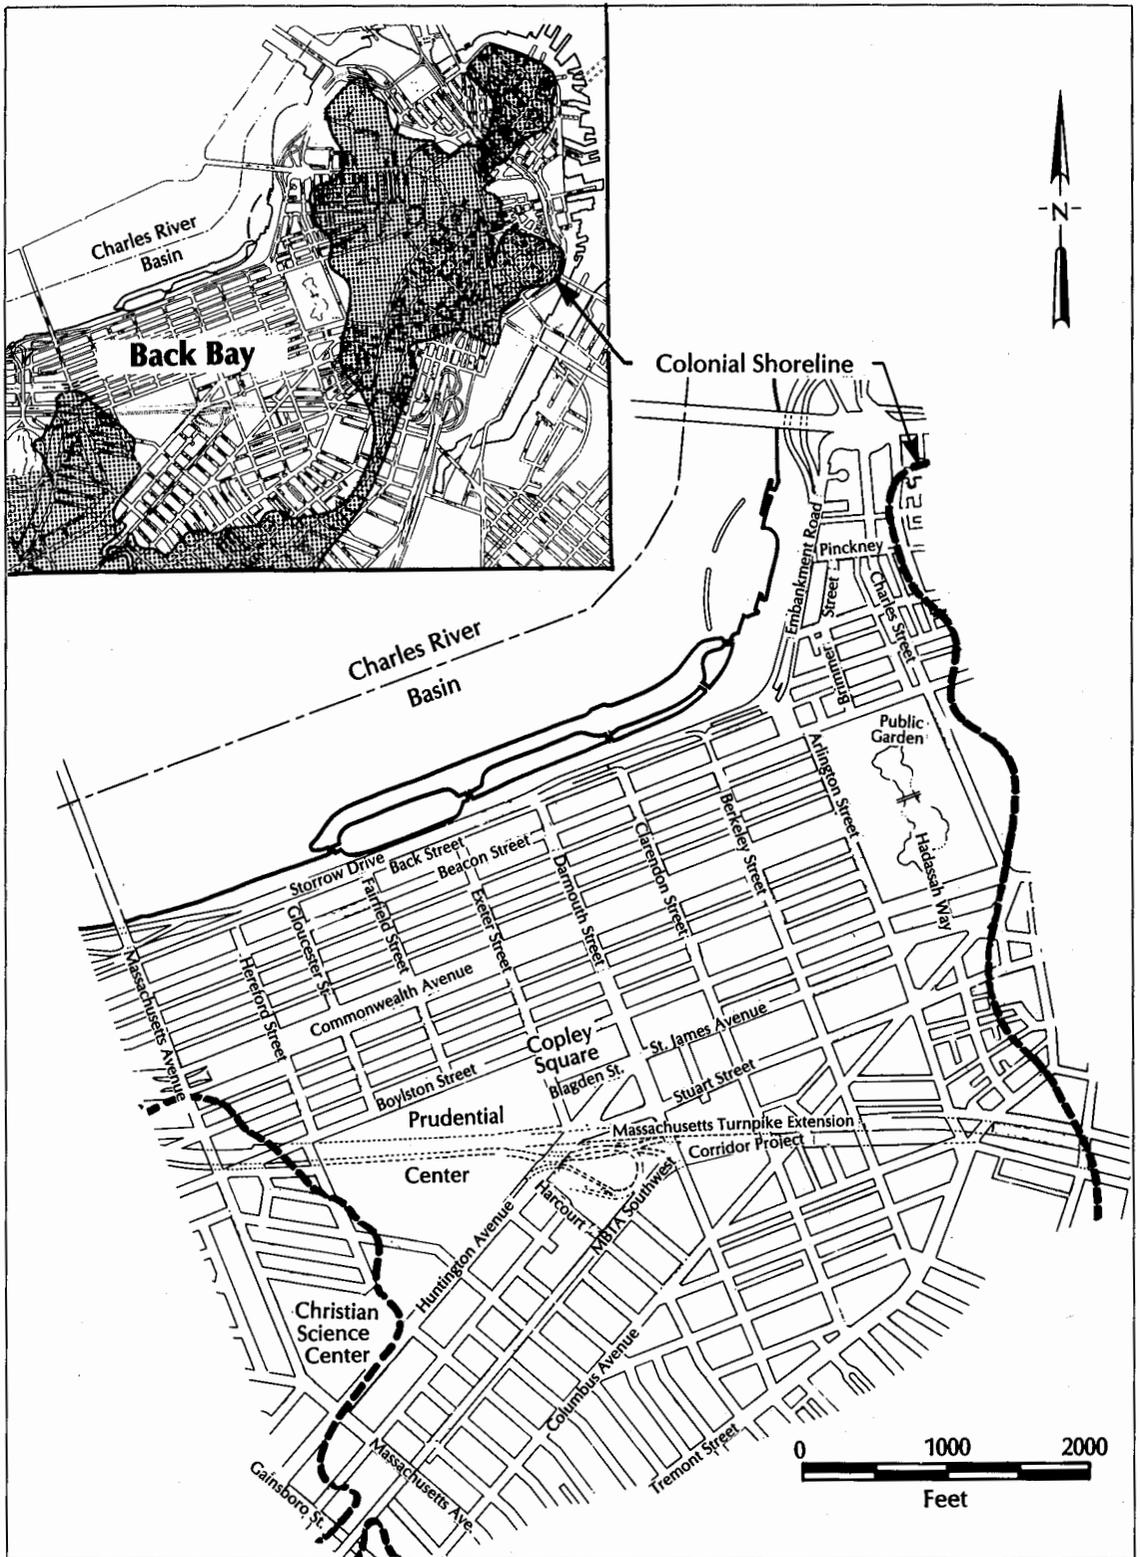
**FIGURE 1. A map of Back Bay Boston showing the location of the colonial coastline.**

During the nineteenth century, a tidal estuary of the Charles River known to Boston residents as the Back Bay (see Figure 1) was filled to create land for an expanding population. Most of the homes, churches and other buildings constructed prior to 1900 were founded on wood piles driven through fill materials and organic soils to bear in the underlying sand and gravel or clay stratum. For the most part, the tops of these piles were

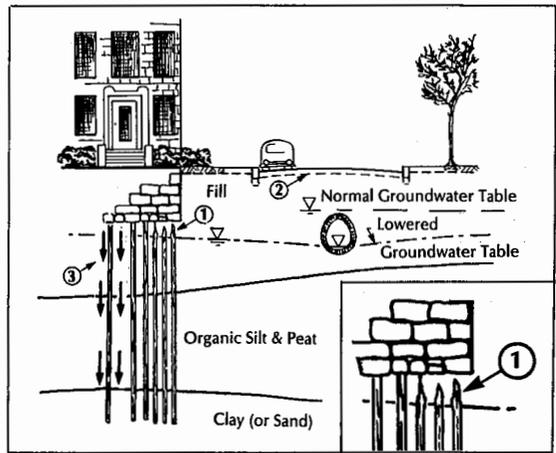
**FIGURE 3. Principal adverse effects of lowered groundwater levels: (1) decay of wood piles when exposed to oxygen; (2) ground subsidence due to compression of organic silt and peat; and (3) negative friction (drag) on piles when the ground settles.**

buildings, streets, underground utilities and other structures, as discussed by Aldrich.<sup>5</sup> Potential problems applicable to the Back Bay are illustrated in Figure 3 and include:

- Deterioration of wood piles
- Ground subsidence
- Negative friction (drag) on piles

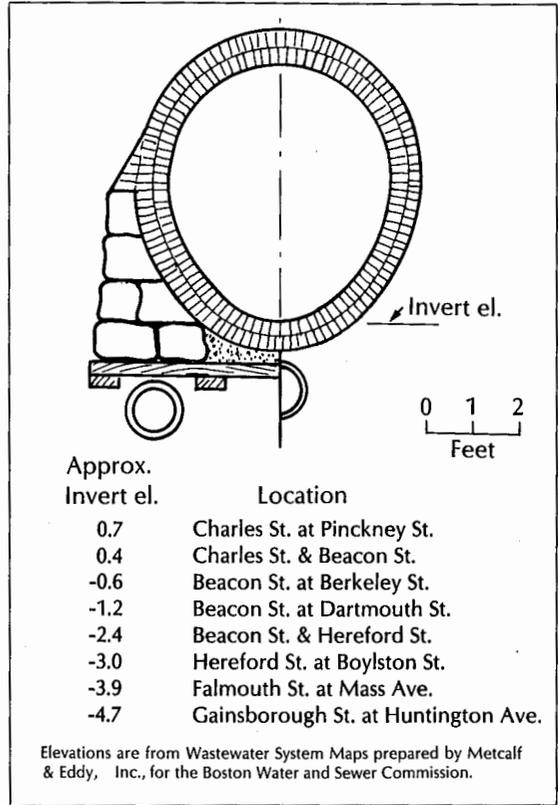
**FIGURE 7. A typical cross section of the West Side Interceptor. Invert elevations at selected locations are noted.**

The intercepting sewers and the main sewer, from the upper reaches to the pumping station at Calf Pasture, varied in size from 3 to 10.5 ft. in diameter. The larger ones were circular and the smaller ones were generally egg-shaped. The West Side Interceptor was egg-shaped, 57 in. wide and 66 in. high (see Figure 7). Sewers were constructed with double or triple rows of mortared brick, and where piles were required, a timber platform was constructed and the sewer was cradled on mortared granite masonry. It is of considerable importance to note that the intercepting sewers were constructed with an underdrain pipe varying from 8 to 12 in. in diameter that was placed below the sewer to
