CIVIL ENGINEERING PRACTICE •

JOURNAL OF THE BOSTON SOCIETY OF CIVIL ENGINEERS SECTION/ASCE

FALL 1986

VOLUME 1, NUMBER 2

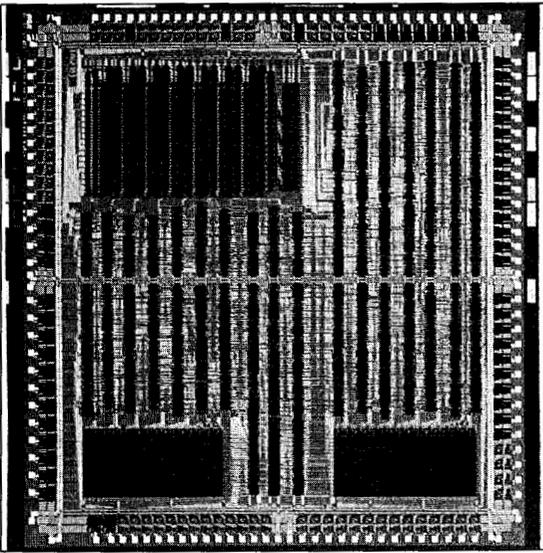
FIGURE 1. A typical integrated circuit.

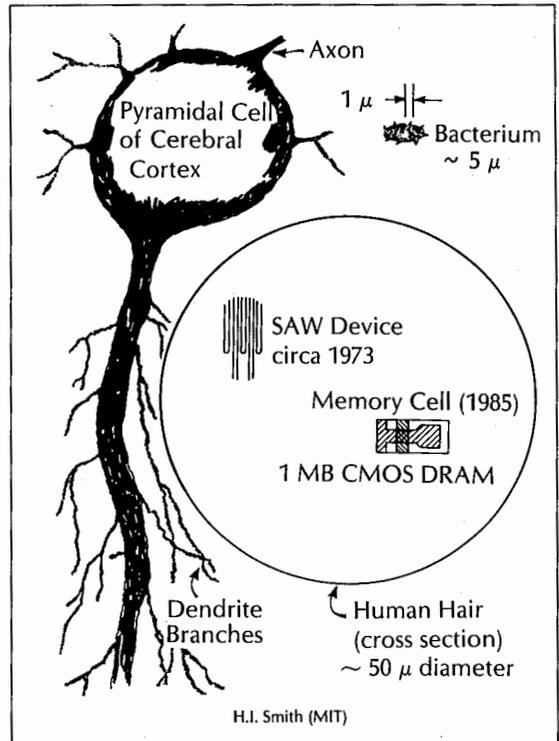
FIGURE 2. Relative size comparisons.

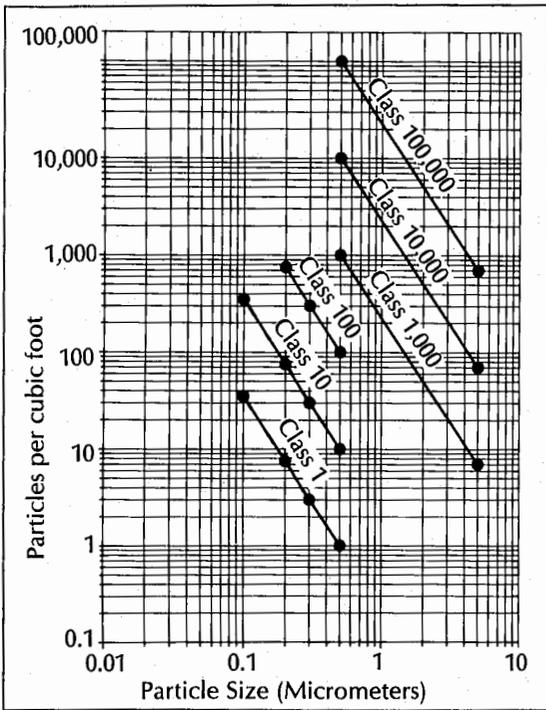
FIGURE 3. Proposed class limits in particles/cubic ft. (from revision to Federal Standard 209B).

that regulates the quality of air is necessary for the production of these submicron components. In fact, the level of air purity is used to define the hierarchy of clean room design classifications. The standards for air cleanliness are outlined in Federal Standard 209B that specifies acceptable limits for airborne particle contamination, temperature and relative humidity ranges, differential pressure requirements and acceptable noise and vibration levels. Clean rooms are classified by their specific particle count definition. With five different classes — Class 10,000, Class 1000, Class 100, Class 10 and Class 1, the number of airborne particles 0.5 microns or larger in each cubic foot of air must not exceed the room class number. Particle count, particle size and sampling rate are the three classification parameters. Once the sampling rate has been fixed, the counts and the size constitute the clean room class (see Figure 3).

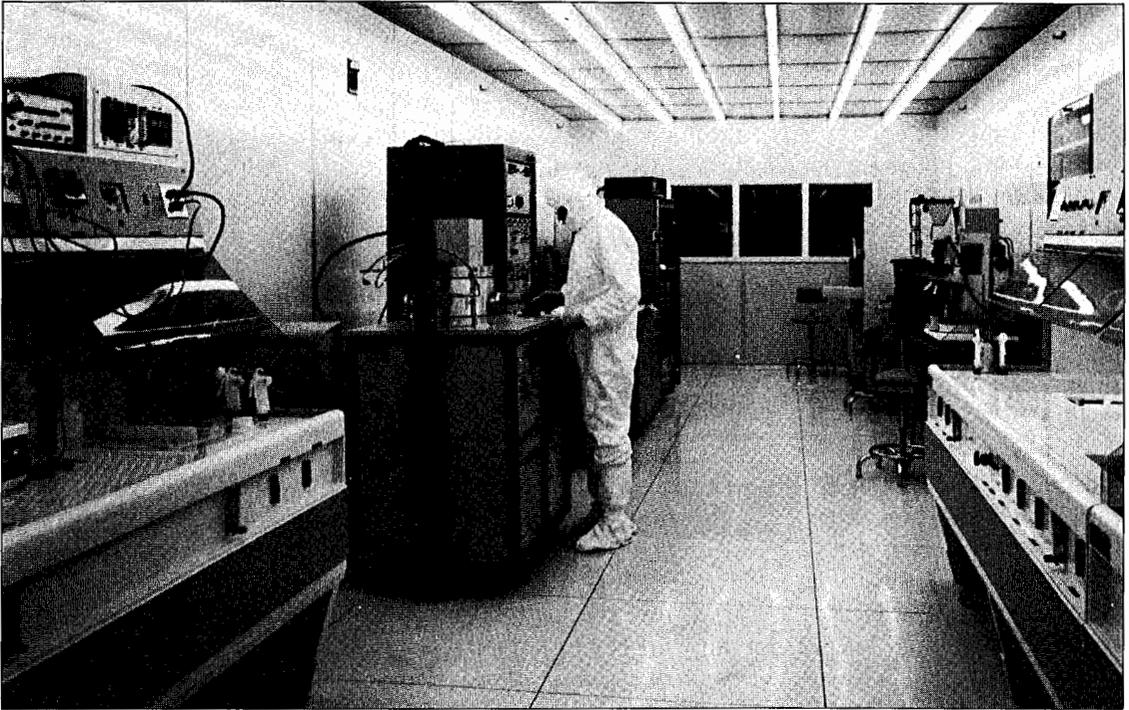
FIGURE 4. A typical clean room.

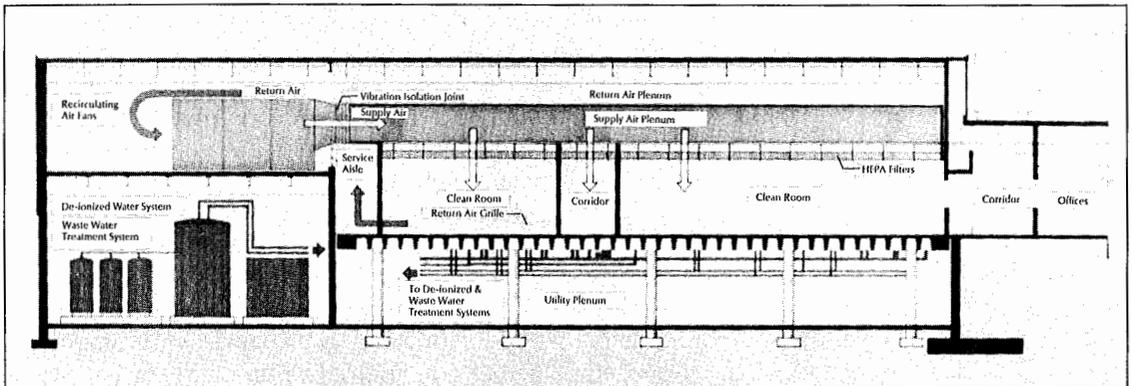
FIGURE 5. A building section from a typical microelectronics facility.

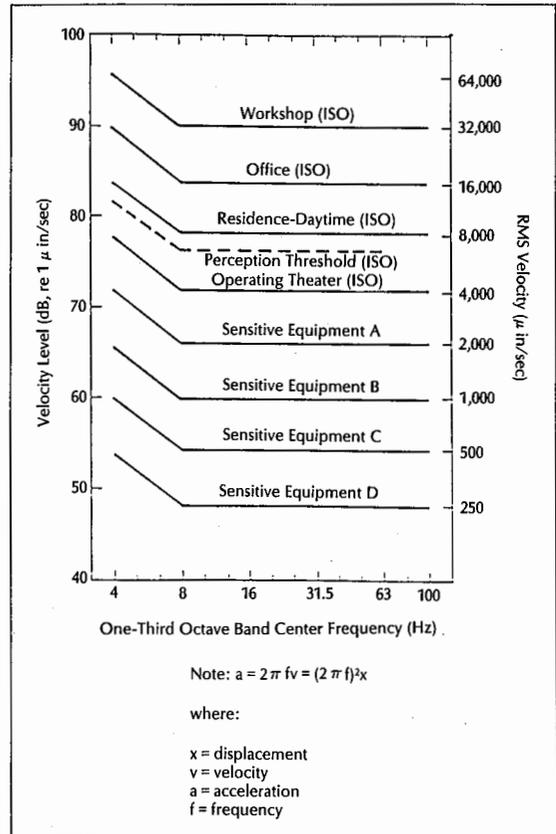
FIGURE 6. Vibration criteria for sensitive equipment in buildings (courtesy of BBN Laboratories, Cambridge, MA).

A completely vibration-free environment is an unrealistic design objective for any sophisticated advanced technology facility. Generally, facility vibration criteria are projected from research compiled by manufacturers and specialty vibration consultants with regard to the manufacturing process' anticipated sensitivity to vibration. These criteria consist of various limits of vertical velocity amplitude *vs.* frequency (see Figure 6).

- A. Optical balances, bench microscopes
- B. Aligners, steppers, etc., for 5 micron or larger line widths
- C. Aligners, steppers, etc., for 1 micron or larger line widths
- D. E-Beam and other 1 micron or sub-micron equipment; scanning electron microscopes

The common criterion for the submicron microelectronics facilities of today is the Sensitive Equipment D line. It is interesting to note that the working magnification level for

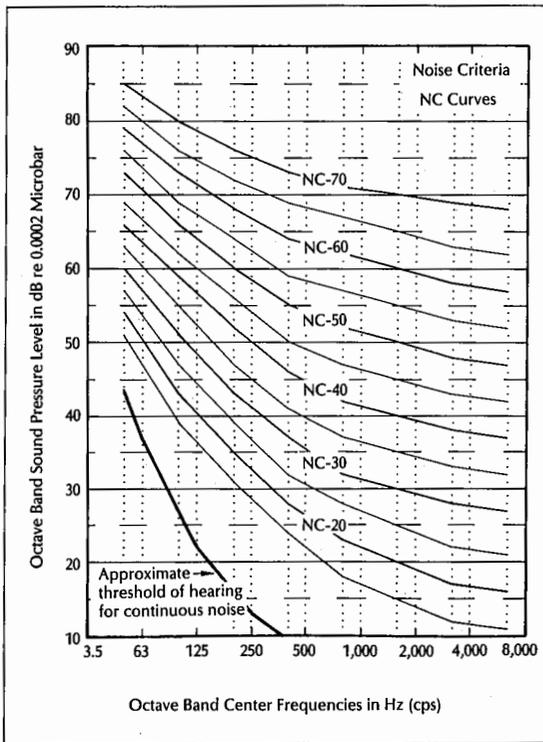
FIGURE 7. The criteria for mechanical system noise (courtesy of BBN Laboratories, Cambridge, MA).

Figure 7 shows the Noise Criteria (NC) Curves that indicate sound levels in dB vs. frequencies. The NC-55 noise criteria curve is the generally acceptable clean room area design limit for noise within these spaces. Figure 8 identifies several problem areas that are associated with vibration and noise. A well planned facility will have design components that mitigate the typical issues shown.

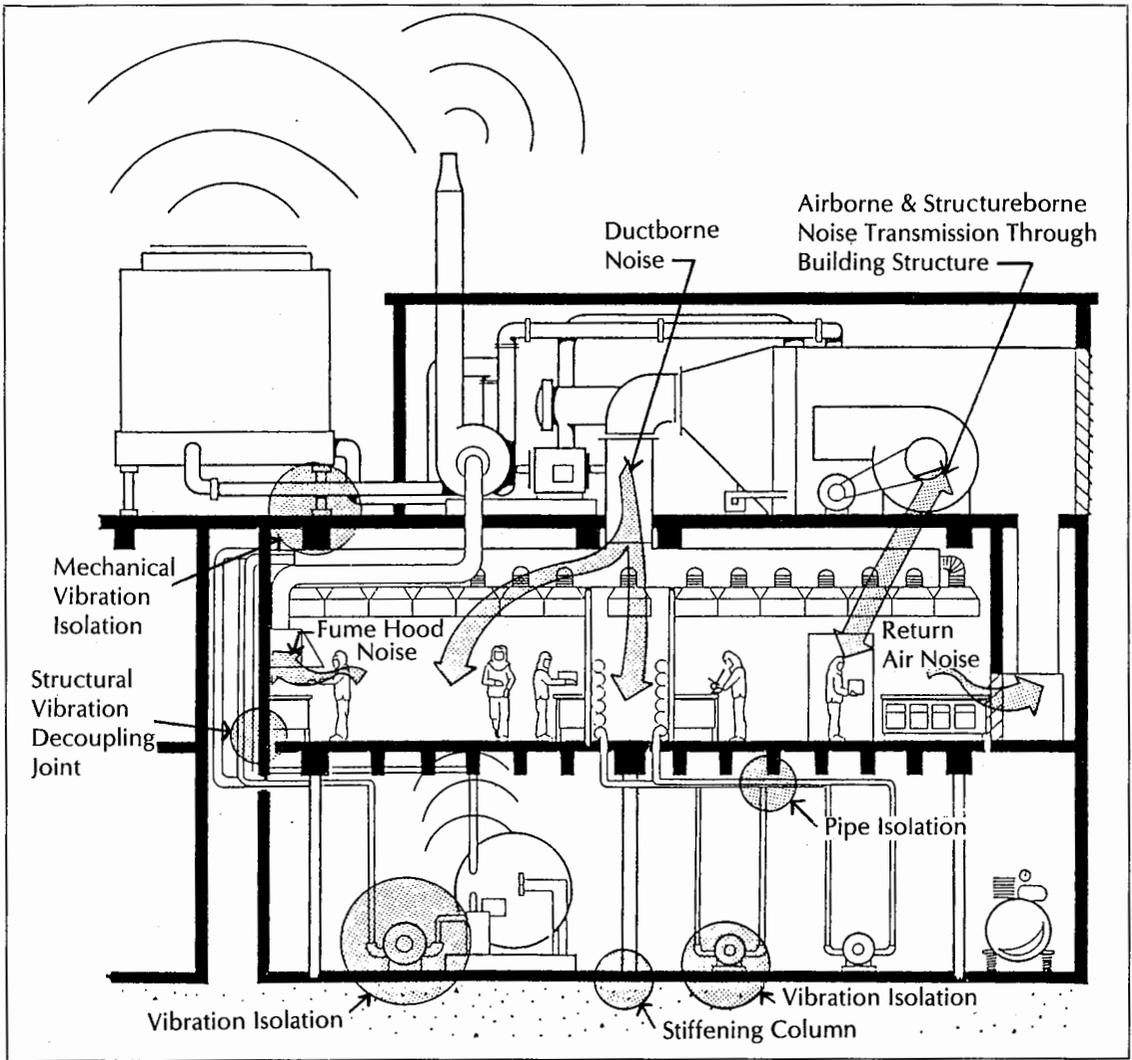
FIGURE 8. Vibration/noise problem areas within a microelectronics facility.

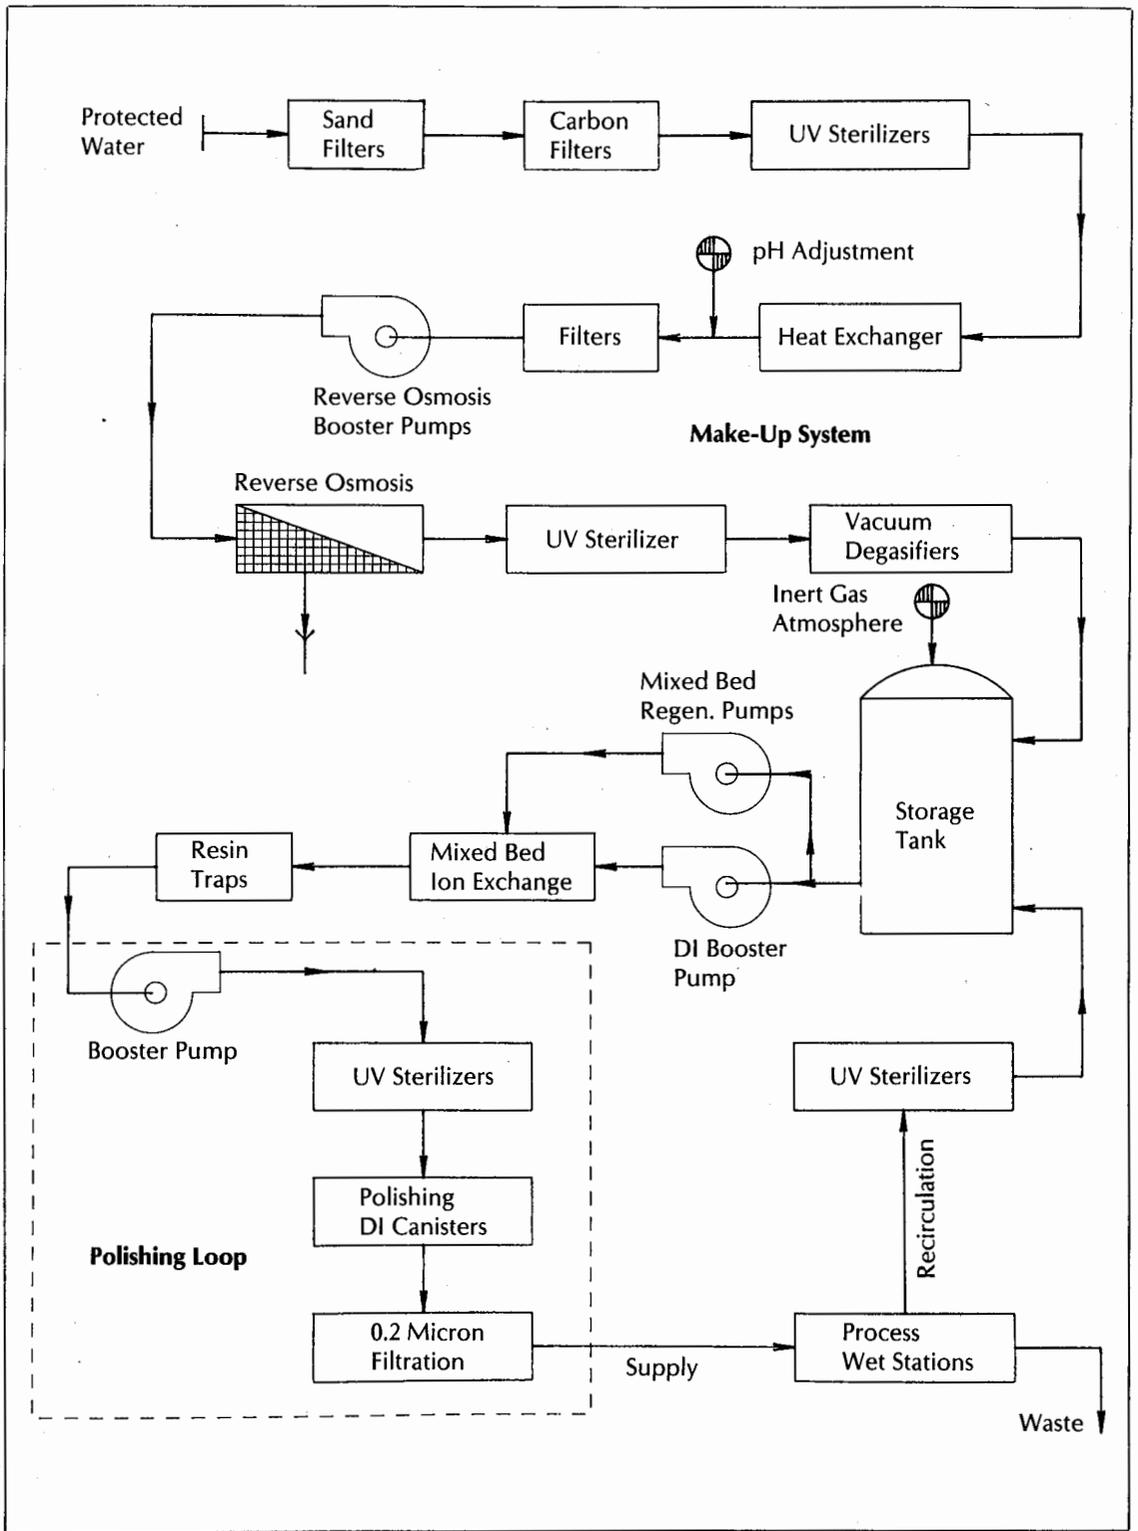
FIGURE 9. A schematic of a typical microelectronics facility high purity water treatment system.

A critical element in the integrated circuit manufacturing process is the ultrapure rinse water used to wash the product at various stages of development. Water for micro-electronics use may be purified by distillation, ion exchange, reverse osmosis, ultrafiltration, electrodialysis or a combination of these methods (see Figure 9).

The pretreatment portion of the purification system treats the raw make-up water so that it is suitable to enter the final purification system. Included in this process is the filtration of suspended solids, removal of organics, pH adjustment to minimize scaling, UV sterilization and chemical treatment to prevent the fouling of the reverse osmosis membranes, pre-heating to 70° and reverse-osmosis. Pretreatment removes the majority of the dissolved salts, organics and bacteria. At this point, the treated water should have a resistivity of 1 to 10 megohms and be free of organics and bacteria.

Storage/distribution consists of one or a series of storage reservoirs used to handle peak flow conditions. The stored water is constantly pumped through the polishing loop and returned to the distribution pumps. Final purification consists of ion-exchange and resin traps, prior to final filtration in the polishing

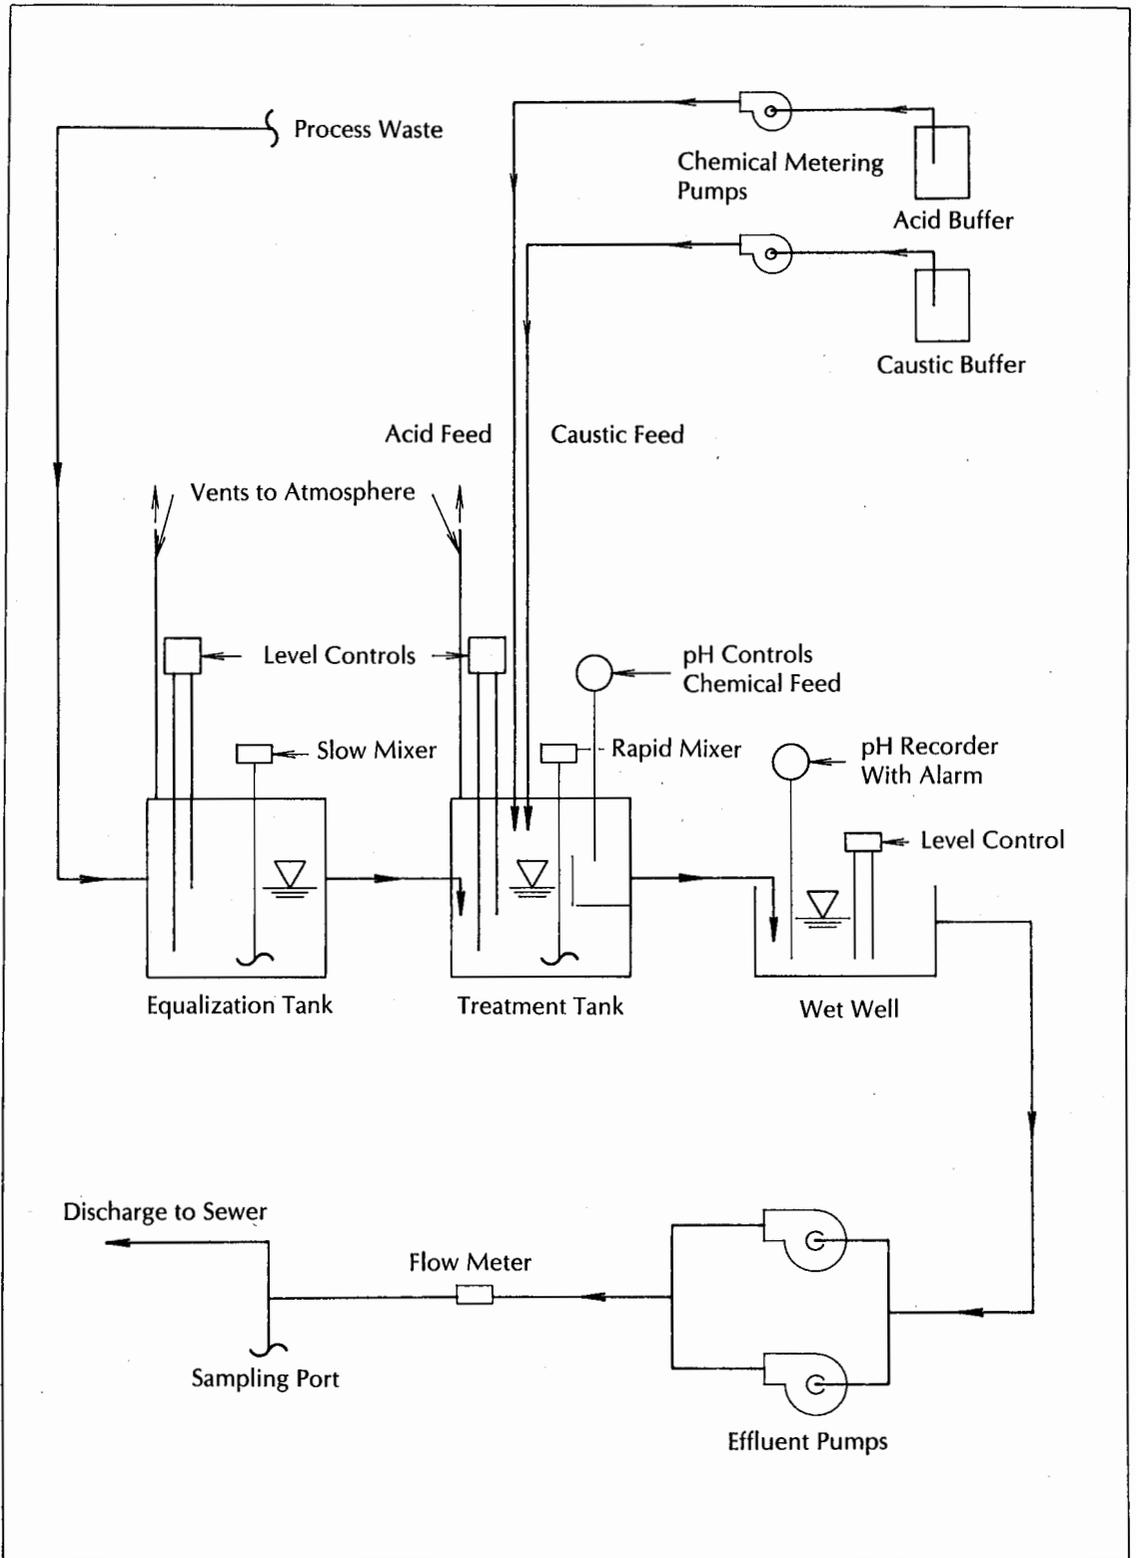
FIGURE 10. A schematic of a typical microelectronics facility waste water treatment system.

Most waste water from the integrated circuit manufacturing process requires only neutralization prior to being discharged to local sewage systems. This process equalizes the strength of strong acids and bases in an equalization tank that overflows by gravity into a treatment tank. Caustic (sodium hydroxide) and acid (sulfuric) solutions are pumped into the treatment tank under the control of a pH probe via metering pumps.

This process is automatic and continuous (see Figure 10).

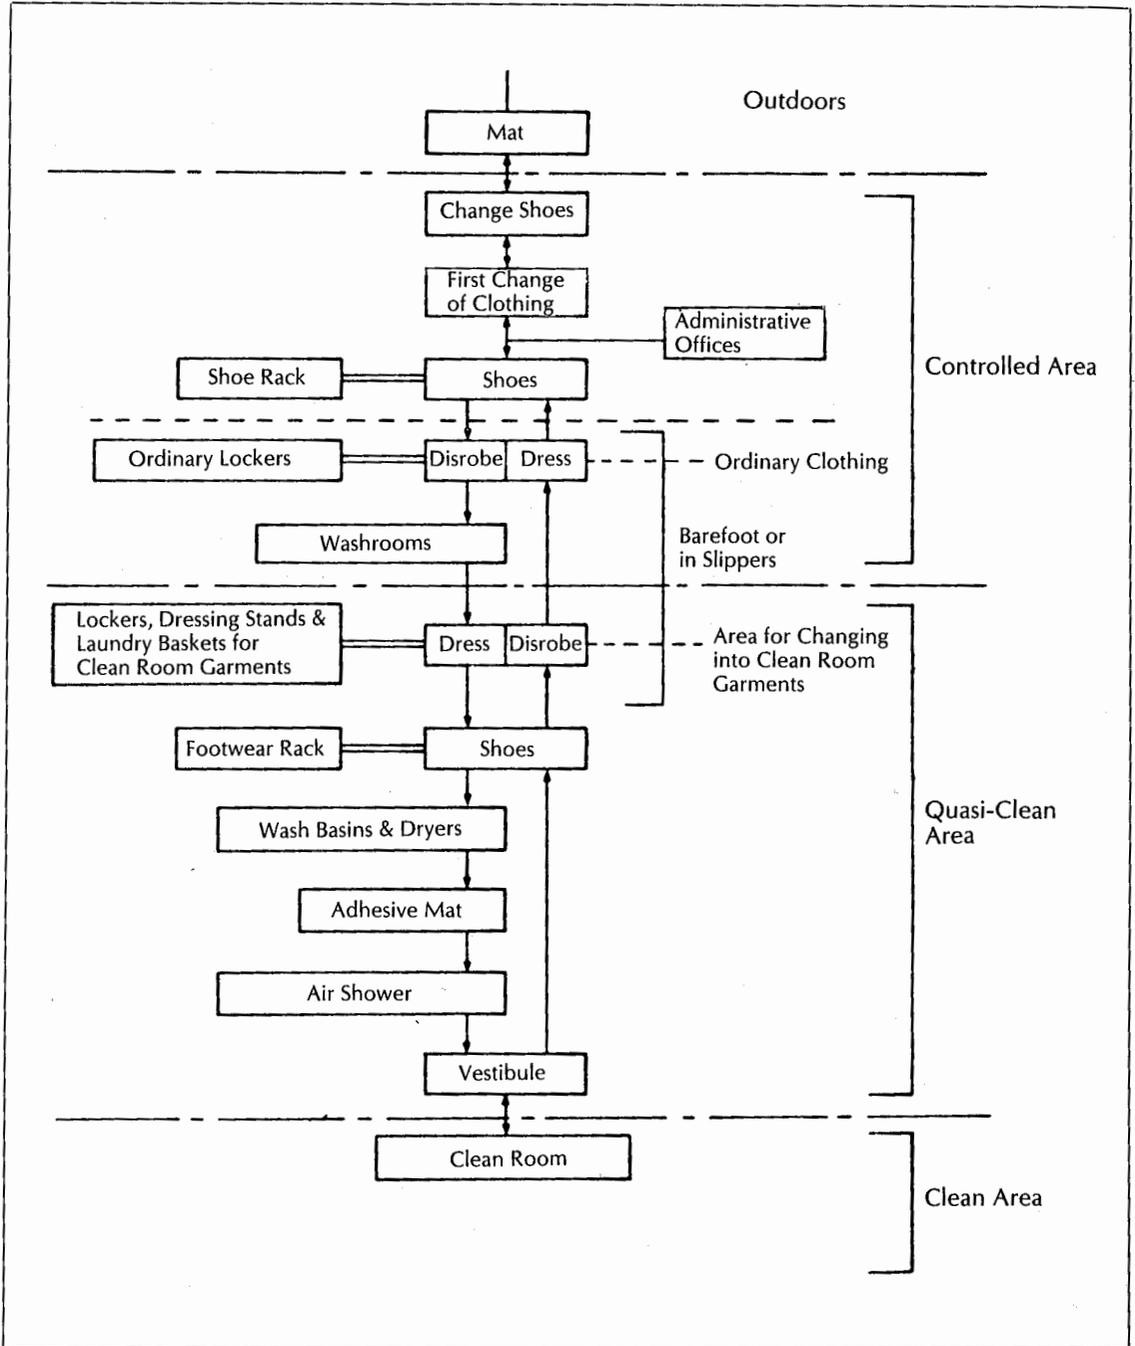
FIGURE 11. A clean room entry diagram.

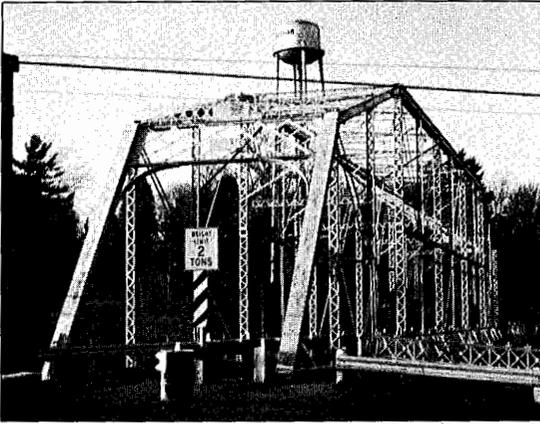
FIGURE 1. The Stuyvesant Falls Bridge viewed from the south.

The Stuyvesant Falls Bridge is a single span, steel, two-truss structure erected in 1899 by the Berlin Iron Bridge Company of East Berlin, Connecticut. Columbia County shoulders the maintenance responsibility for the bridge and has performed routine maintenance of sand blasting and painting over the years. The only heavy maintenance on the structure was performed in 1939, when the original wood deck was dismantled and the present open-grid steel deck was installed.

The two steel trusses, measuring 34 feet (10.4 m) top to bottom chord and 19.4 feet (5.9 m) C_L to C_L , carry a 17-foot (5.2 m) wide

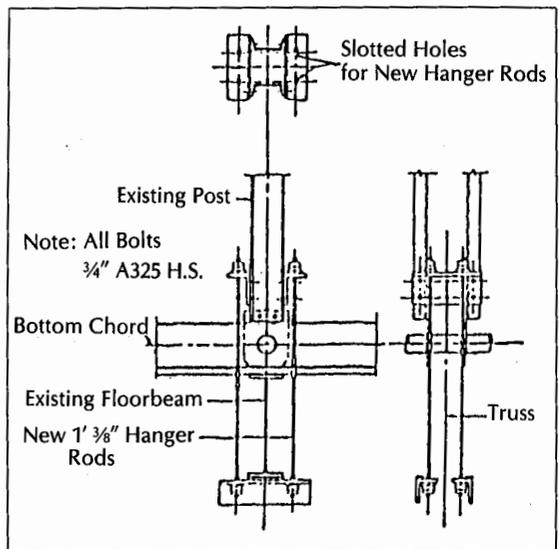
FIGURE 7. Floorbeam hangers.

The next repair in line was the strengthening of the floorbeams. Without removing the grating (which was in fair condition) and stringers, a platform was erected under each floorbeam (see Figure 7). Four angles were bolted onto the webs of the beam as close to the flanges as possible. The corroded stringers

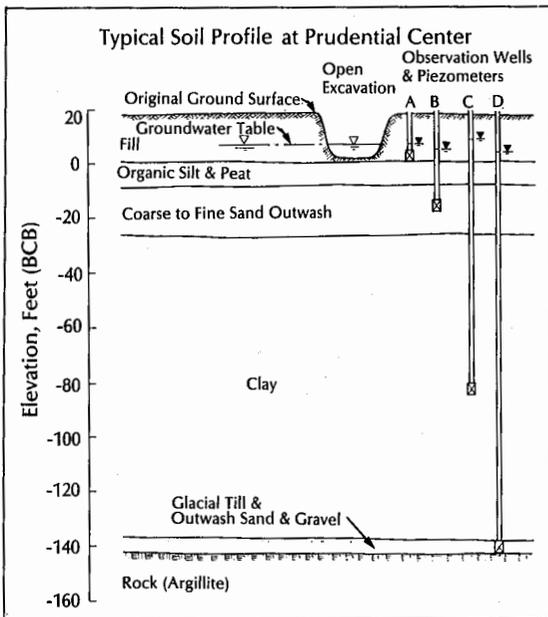
FIGURE 2. A typical soil profile, with groundwater table. Well A shows the static water level.

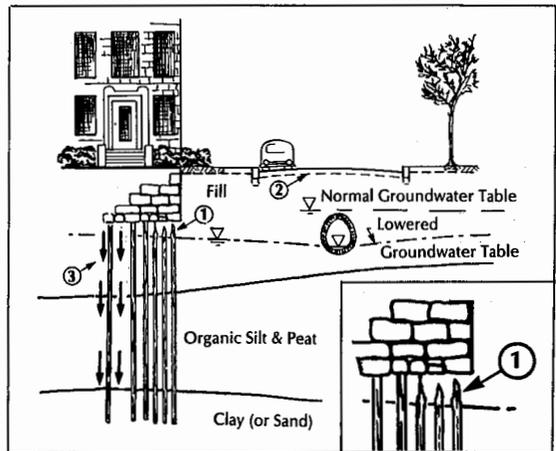
FIGURE 3. Principal adverse effects of lowered groundwater levels: (1) decay of wood piles when exposed to oxygen; (2) ground subsidence due to compression of organic silt and peat; and (3) negative friction (drag) on piles when the ground settles.

buildings, streets, underground utilities and other structures, as discussed by Aldrich.⁵ Potential problems applicable to the Back Bay are illustrated in Figure 3 and include:

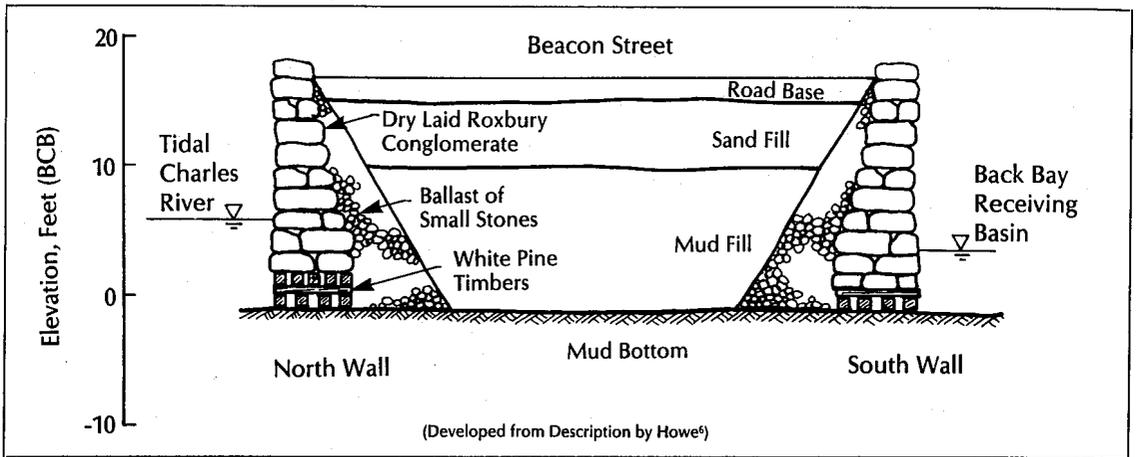
FIGURE 5. A typical cross section of the Mill Dam.

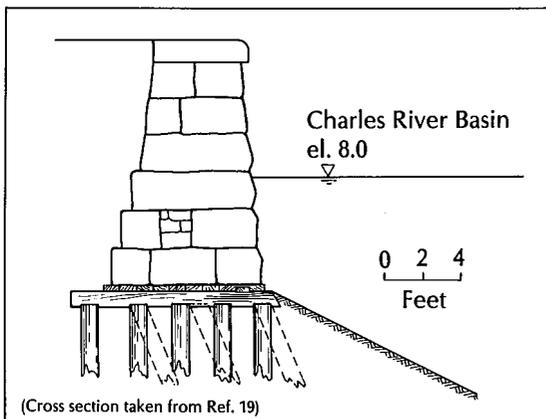
FIGURE 6. The sea wall along Back Street.

Concurrent with the filling, a sea wall was constructed along the Charles River to create Back Street that parallels Beacon Street on the water side. The top of this wall is clearly visible from Storrow Drive. A similar wall was constructed in about 1865 behind homes on the water side of Brimmer Street on Beacon Hill. Both walls were composed of dry-laid granite placed on a timber platform and supported on wood piles (see Figure 6). It is probable the walls were ballasted with stone or gravel, similar to the Mill Dam walls.

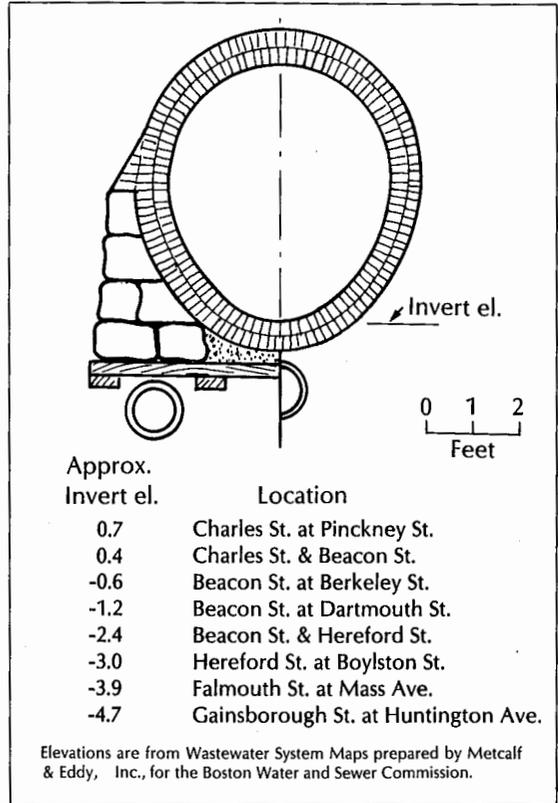
FIGURE 7. A typical cross section of the West Side Interceptor. Invert elevations at selected locations are noted.

The intercepting sewers and the main sewer, from the upper reaches to the pumping station at Calf Pasture, varied in size from 3 to 10.5 ft. in diameter. The larger ones were circular and the smaller ones were generally egg-shaped. The West Side Interceptor was egg-shaped, 57 in. wide and 66 in. high (see Figure 7). Sewers were constructed with double or triple rows of mortared brick, and where piles were required, a timber platform was constructed and the sewer was cradled on mortared granite masonry. It is of considerable importance to note that the intercepting sewers were constructed with an underdrain pipe varying from 8 to 12 in. in diameter that was placed below the sewer to

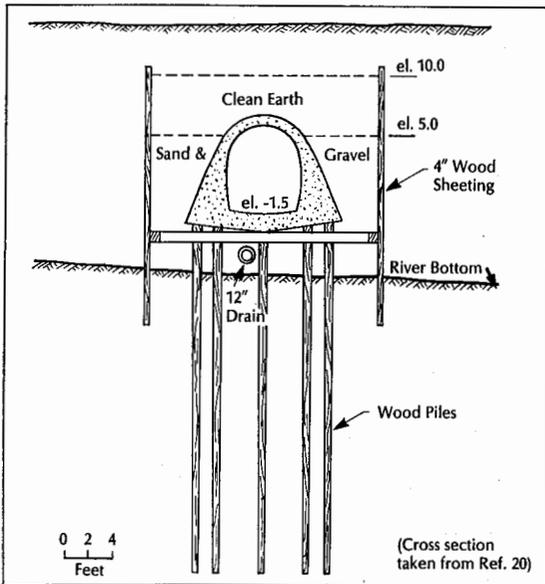
FIGURE 8. A typical cross section of the Boston Marginal Conduit.

The marginal conduit was constructed in a 100-ft. wide earth fill embankment placed immediately north of Back Street, beyond the old dry rubble retaining wall. Presently, the conduit lies beneath Storrow Drive. Over most of its length, it is a reinforced concrete horseshoe-shaped section 76-in. wide by 92-in. high, supported on wood piles, as shown in Figure 8.

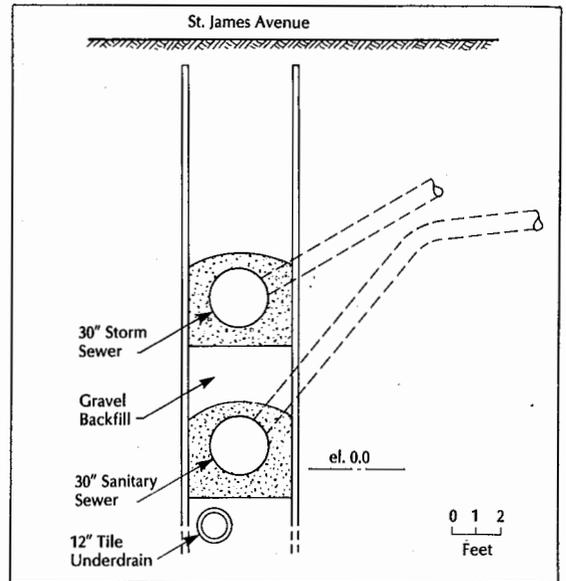
FIGURE 9. A typical cross section of the St. James Avenue sewer.

The present system of low level sewers was constructed throughout Back Bay between 1910 and 1912. Underdrain pipes again were commonly used as shown in Figure 9, which presents a section through the St. James Avenue storm and sanitary sewers. By that time, nearly 75 years ago, there was little

When contours of equal water level were analyzed (see Figure 13), the loss of groundwater was traced to leakage into a 30-in. diameter sewer on St. James Avenue (see Figure 9). Construction of a partial dam in the sewer on Dartmouth Street, where it joins the Boylston Street sewer in front of the Public Library, caused observation wells to rise immediately, proving without a doubt the source of the lost groundwater.

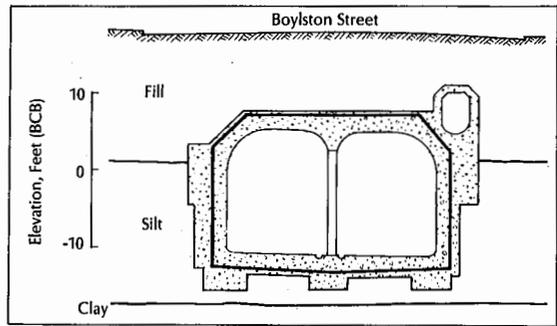
FIGURE 10. A cross section of the Boylston Street Subway at Sta. 58+00 between Berkeley and Clarendon Streets (Ref. 21).

The Boylston Street subway crosses Back Bay from Massachusetts Avenue to Charles Street. Within this area, the bottom of the subway varies from approximately el. +3.0 at Massachusetts Avenue, to el. -19.0 between Arlington Street and Hadassah Way (its lowest point) to el. -10.0 at Charles Street. Table 2 presents elevation and soil condition data for the subway. A cross-section through the structure between Berkeley and Clarendon Streets is shown in Figure 10.

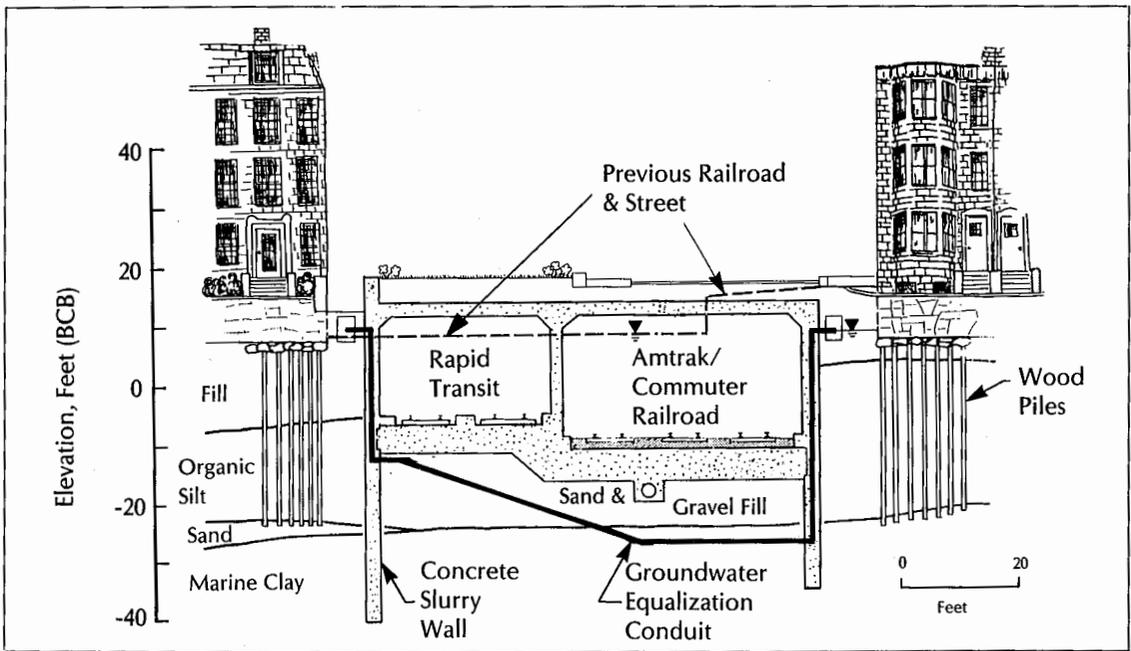
FIGURE 11. A cross section of the Southwest Corridor Project tunnel, taken at Follen Street.

Reinforced concrete slurry walls were used for lateral support of the sides for about 2,100 ft. of the tunnel excavation (see Figure 11). The concrete walls were 3-ft. thick and penetrated 8 to 15 ft. into the clay stratum. They were used as the tunnel's permanent outside walls. Although water leakage did occur through some of the vertical joints between wall panels, there was no appreciable lowering of groundwater levels in adjacent areas.

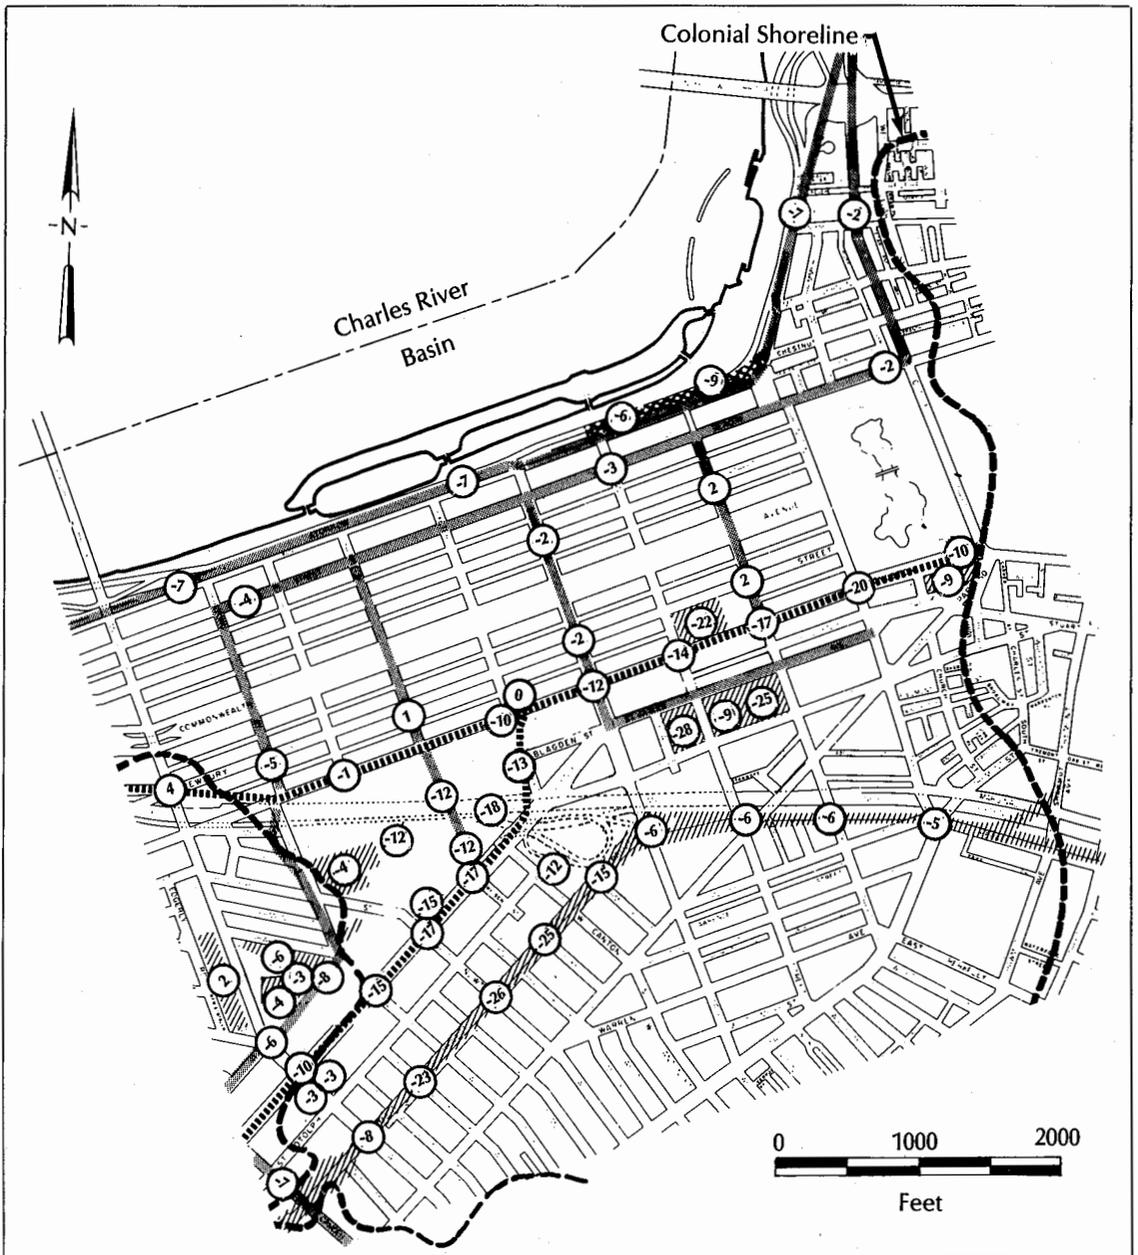
FIGURE 12. The locations and elevations of major deep excavations in Back Bay.

and construction records. The locations of major deep excavations for both buildings and sewer and transportation projects, and the approximate elevations of the bottoms of these excavations are shown in Figure 12 on page 50.

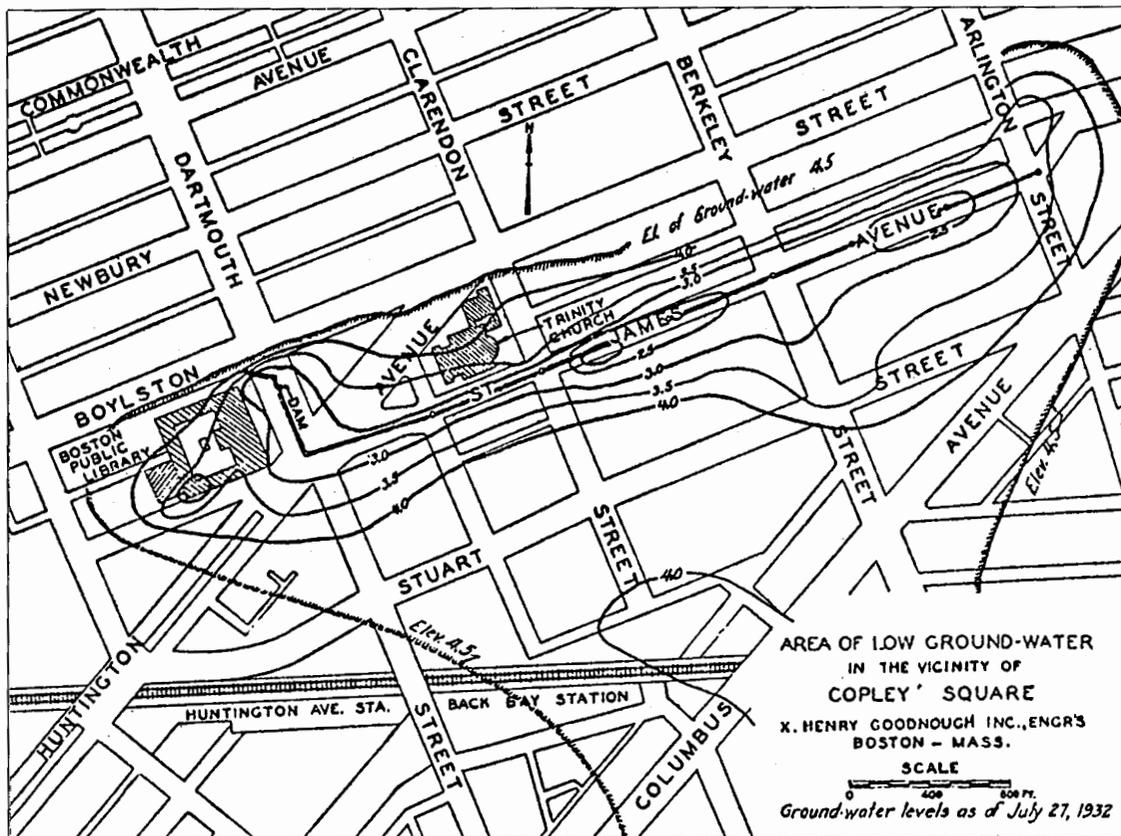
FIGURE 13. Water level contours along St. James Avenue in 1932.¹⁶

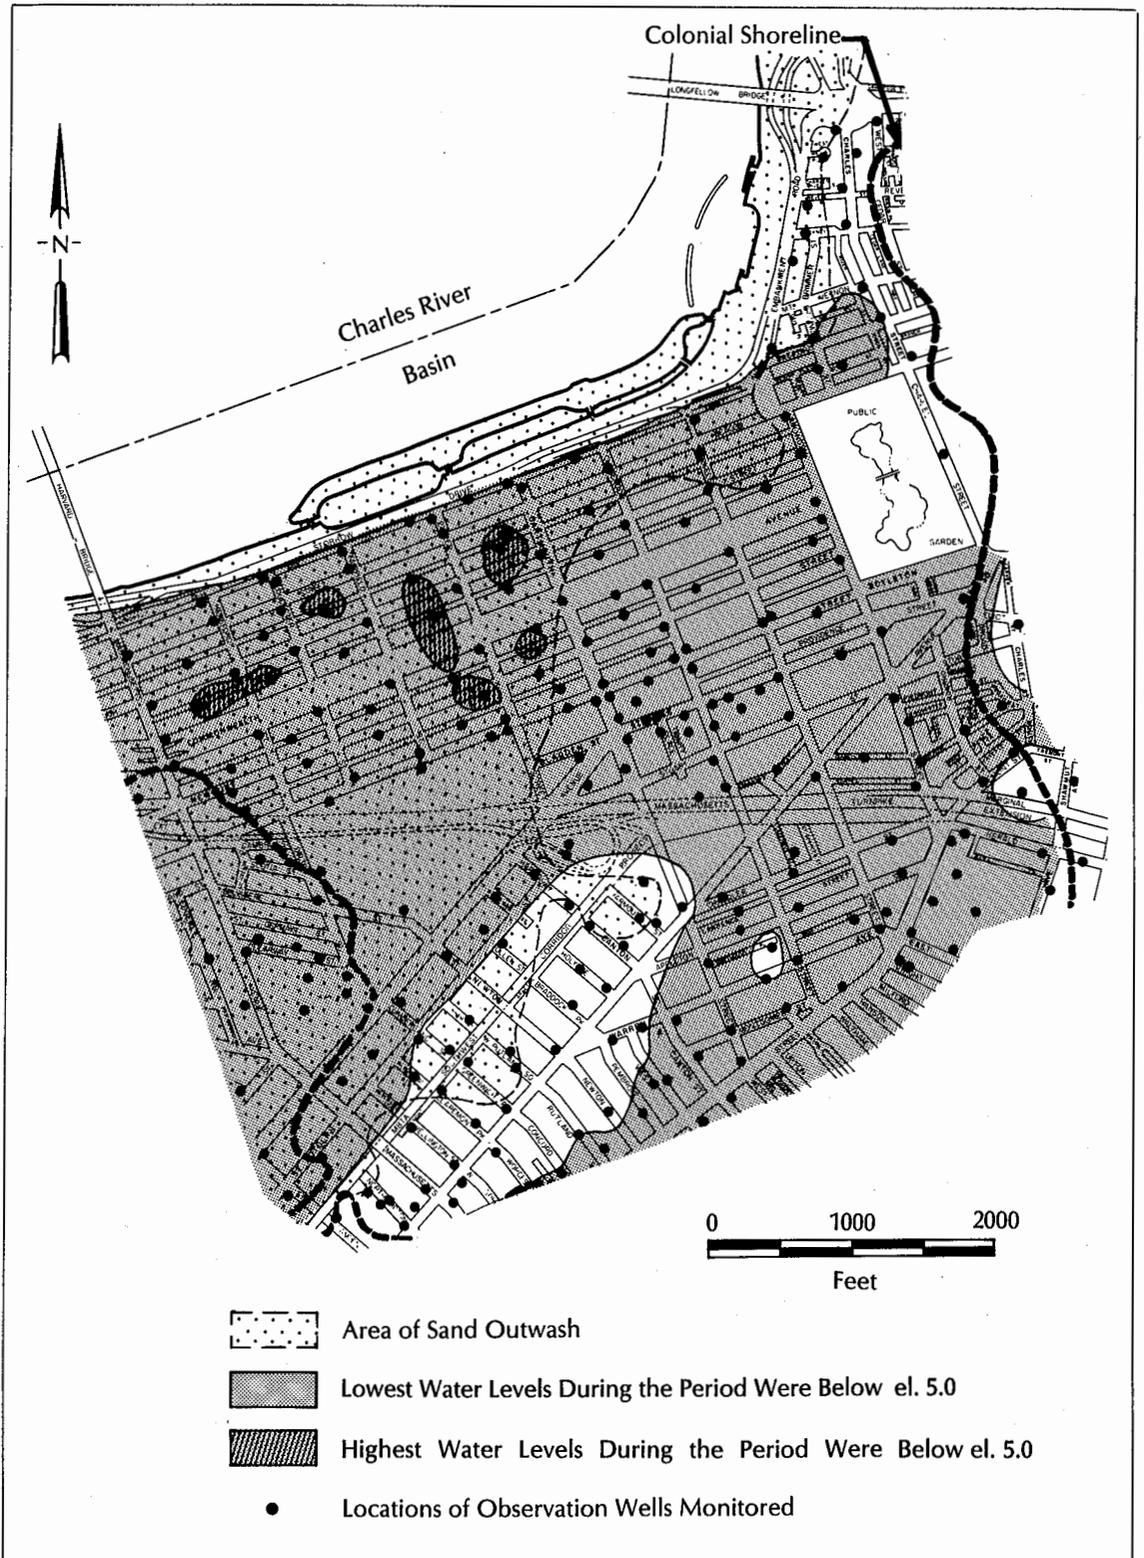
FIGURE 14. Areas of Back Bay having groundwater levels below el. 5.0 during 1936-1940.

levels recorded during the program are not available, since they were destroyed in a fire at Boston City Hall. Figure 14, on page 56, prepared from contour plans by Cotton and Delaney, shows areas in Back Bay having water levels below el. 5.0 during that 4-year period.⁴

It would appear, by comparison of Figure 15 with Figure 14, that water levels throughout Back Bay were higher in the 1960s than in the 1930s. Note, however, that Figure 15 was based on two isolated readings while the 1930s data represent extreme lows from numerous readings over a four-year period. Furthermore, the 1960s readings were taken during a wet period; precipitation in 1967 was 6 in. above normal and 5 in. of rain fell on March 17-18, 1968. On the other hand, looking at the high water level readings, two of the seven wells that were never above el. 5.0 in the 1930s, were above that level in the 1960s. No significant construction dewatering during the 1967-68 period has been reported. Groundwater levels were again below el. 5.0 in the John Hancock area and along Tremont Street in the South End.

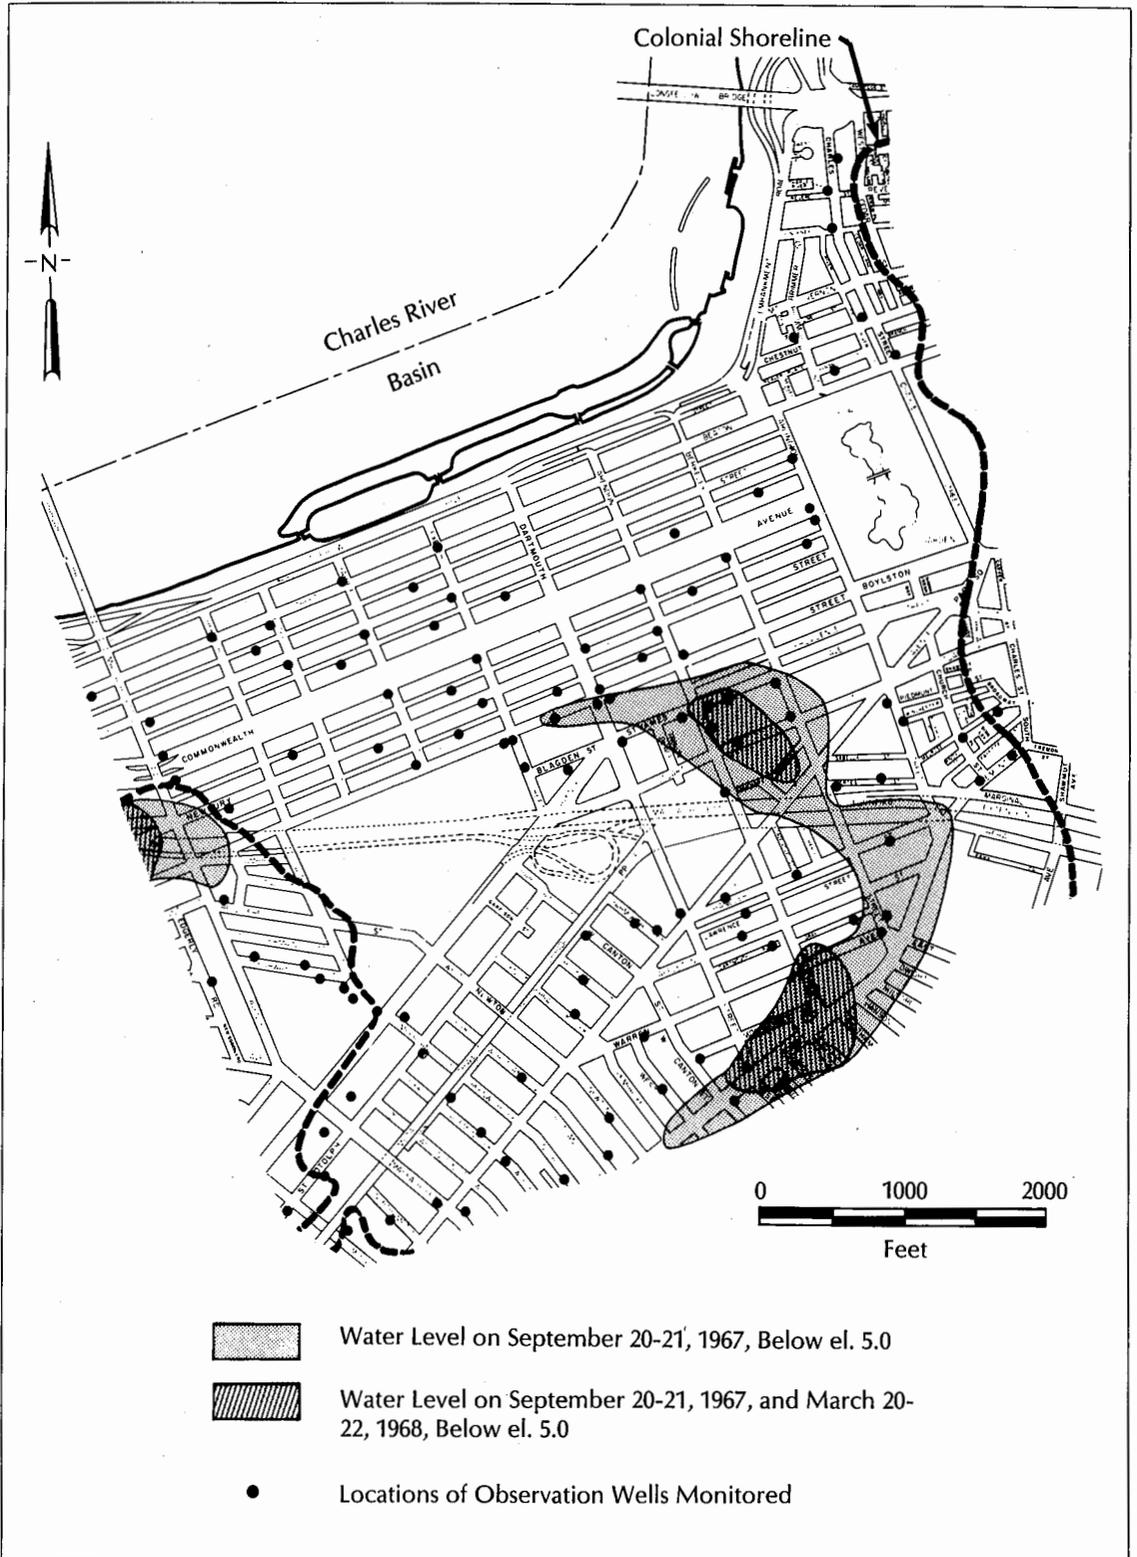
FIGURE 15. Areas of Back Bay having groundwater levels below el. 5.0 during 1967-1968.

Belt expressway on groundwater levels. The USGS used observation wells extant from the WPA survey completed in 1940. Less than half of the original wells were found to be usable. Results of the USGS study were published in 1975 as *Hydrogeologic Investigation Atlas HA-513*.⁴ Figure 15 has been prepared from the groundwater contours presented therein.

Areas in Back Bay where the September 20-21, 1967, water levels were below el. 5.0 are shown in Figure 15. Areas where both readings, the second on March 20-22, 1968, were below el. 5.0 are also indicated. In addition to the areas shown, low levels were observed in wells around the Christian Science Center; however, those data may not have been available to the USGS.
