CIVIL ENGINEERING PRACTICE •

JOURNAL OF THE BOSTON SOCIETY OF CIVIL ENGINEERS SECTION/ASCE

FALL 1986

VOLUME 1, NUMBER 2

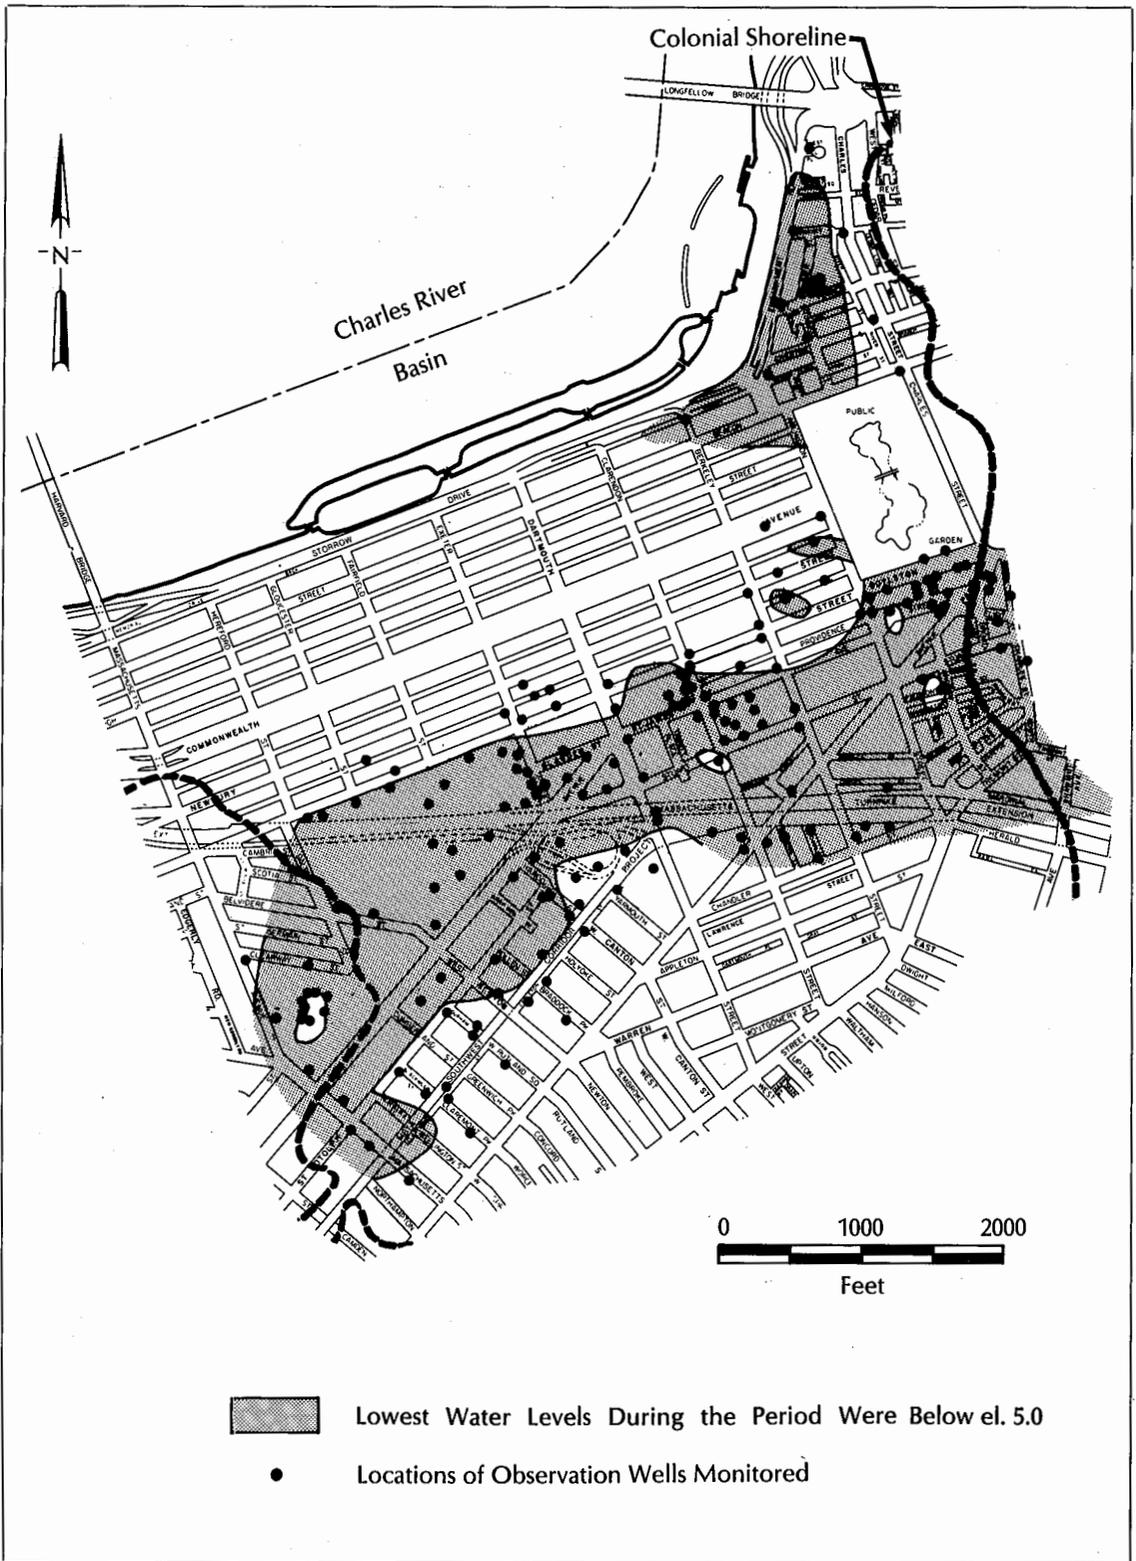
FIGURE 16. Areas of Back Bay having groundwater levels below el. 5.0 during 1970-1985.

Figure 16 shows the location of most of the observation wells monitored at some point during the 15-year period from 1970 to 1985 and the area where the lowest water level observed was below el. 5.0. The monitoring period often lasted less than a year, since the purpose of the monitoring was to monitor the effects of construction and dewatering that caused the temporary lowering of water levels in areas adjacent to sites. Some data in Figure 16 were affected by construction dewatering while the two readings in 1967-68 (see Figure 15) were not affected.

Groundwater levels substantially below el. 5.0 in the area of the Christian Science Center and in the Park Square area south of the Public Garden were due to construction-related dewatering. Observed low groundwater levels around Hadassah Way were due to sump pumping from a basement in that area. Groundwater levels of approximately el. 3.0 were observed within the Prudential Center, probably caused by leakage into the underground parking garage. The effect of these low levels on groundwater in adjacent areas is mitigated by a wall of steel sheetpiling that encloses the Prudential Center site. (Note that the USGS observations shown in Figure 15 did not include the Prudential Center.)

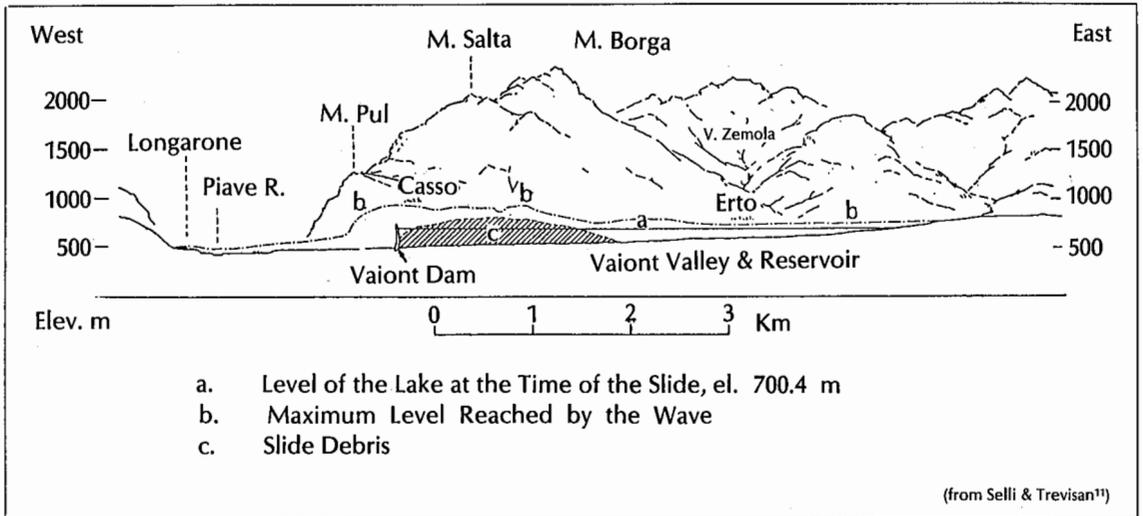
FIGURE 2. Longitudinal profile along the Vaiont Valley, looking north.

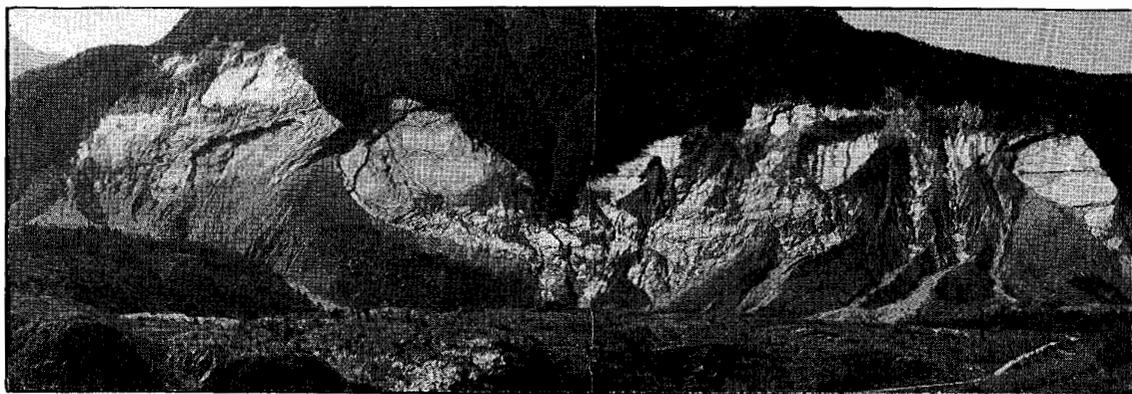
FIGURE 3. Photograph of the Vaiont Slide area, July 1979.

A photograph of the Vaiont Slide as it appeared in July 1979 is given in Figure 3. This photograph shows the M-shaped outline of the slide as seen when facing Mt. Toc from Casso, north of the slide. A plan view of the immediate area of the slide prior to October 9, 1963, is given in Figure 4. The plan view shows the slide in relation to the Vaiont Dam and the maximum proposed reservoir level (el. 722.5 m). Prior to the slide, the principal feature in this area was the central north-south trending dry valley of the Massalezza, a tributary to the Vaiont River. This valley has been referred to as the Massalezza Ditch. On the left side of the Vaiont River, and just downstream from the junction with the Massalezza Ditch, was a prominent bluff at el. 777 m called the Punta del Toc. A prominent bench at about el. 840 to 850 m was present part-way up the western side of the slide. This plain was called the Pian della Pozza, or Pozza, and contained several enclosed depressions similar to those found in karstic or glaciated regions, or in areas with old landslide debris. Along the toe of the slide, the Vaiont River varied in elevation from 500 m near the dam to 560 m at the upstream side of the slide.

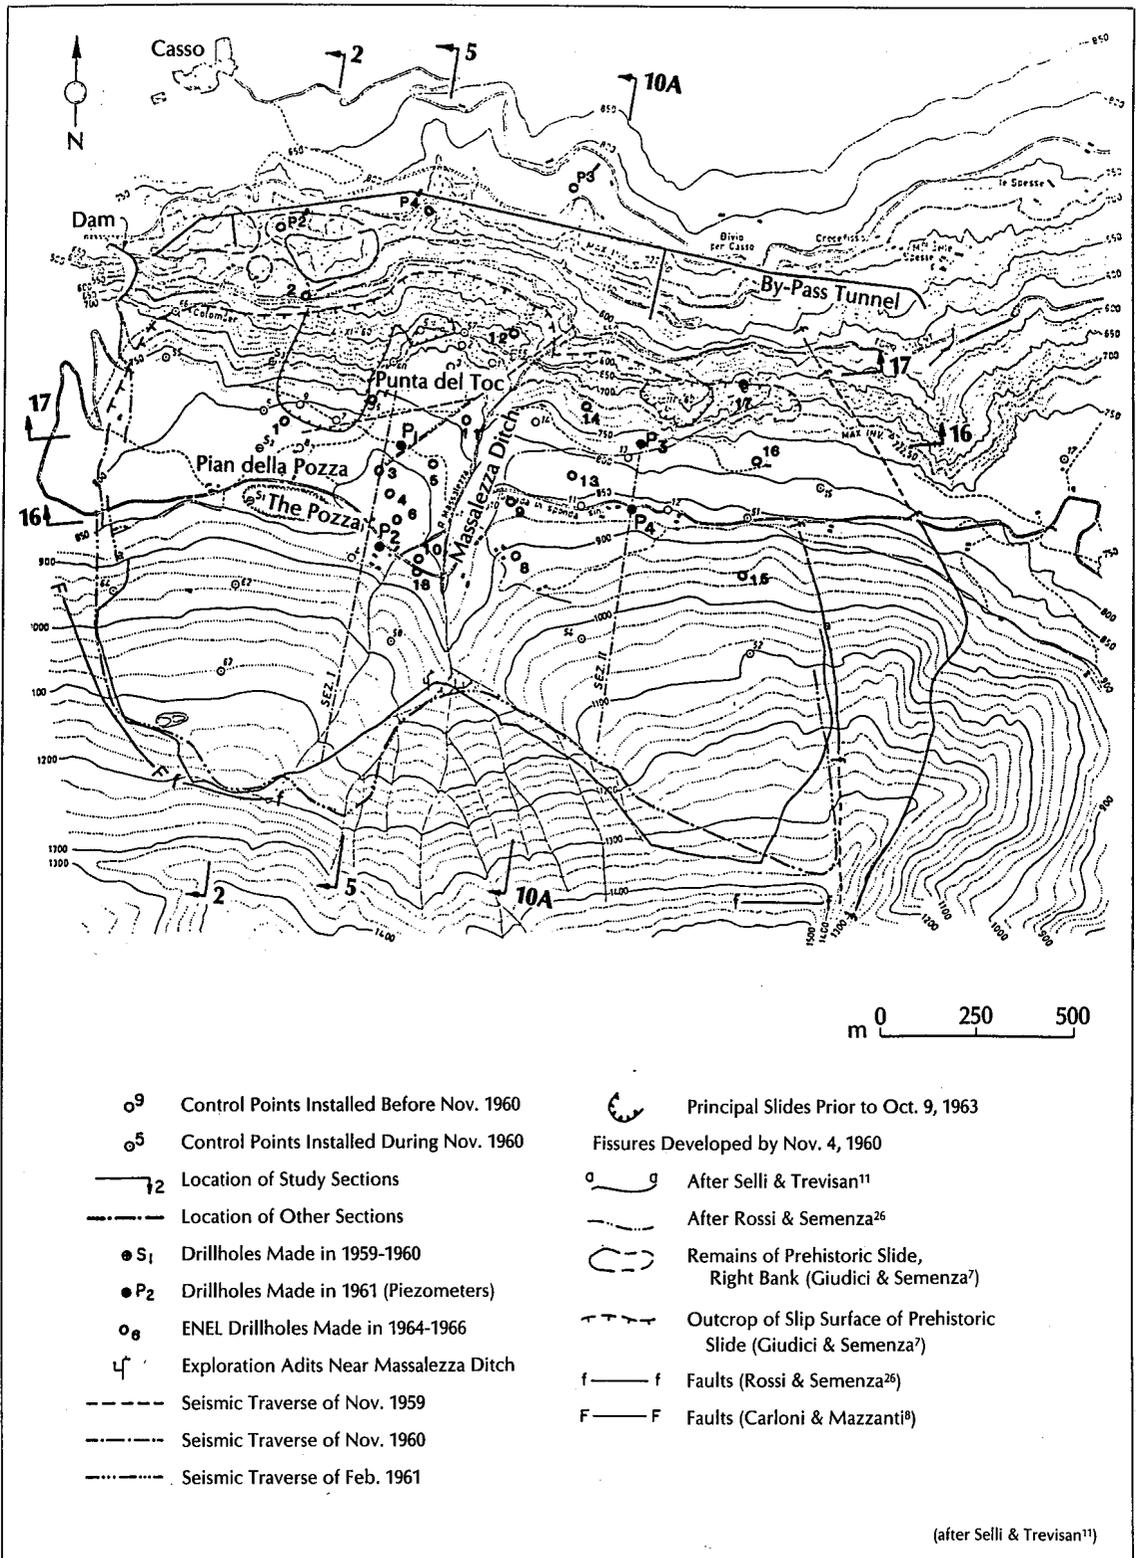
FIGURE 4. Plan view of the valley prior to the slide of October 9, 1963.

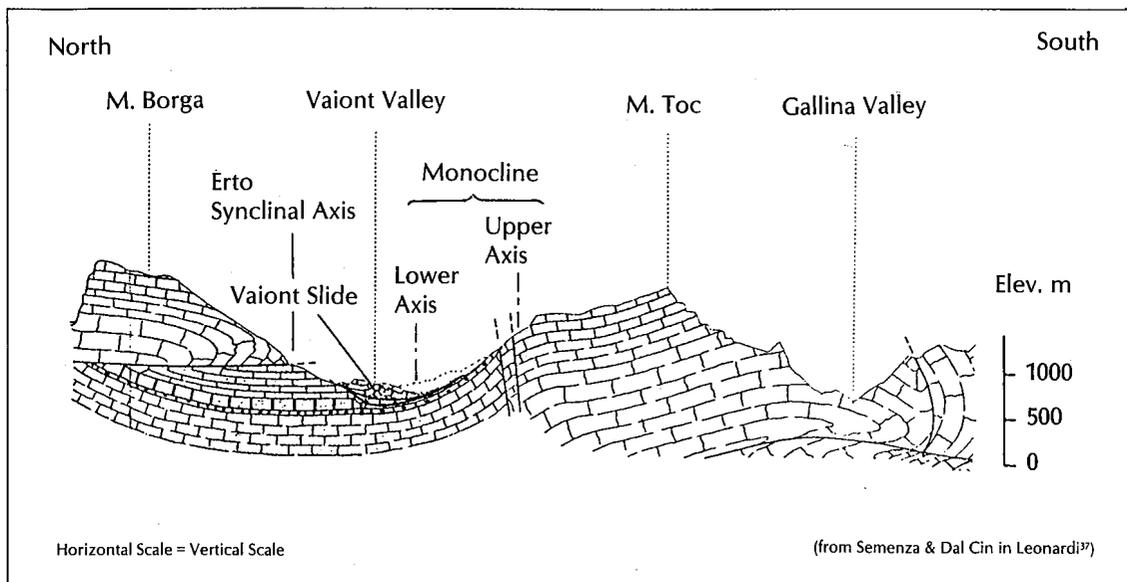
FIGURE 5. Regional north-south geologic section through the Vaiont Slide.

The Vaiont Valley has been eroded along the axis of an east-west trending, asymmetrical syncline plunging upstream to the east. This feature has been called the *Erto syncline*. The syncline is shown extending under Mt. Borga north of the slide on Figure 5. The upstream plunge is shown in Figure 6 on a section made by Broili through the toe of the slide.²

An abrupt monoclinical flexure on the south limb of the Erto syncline forms a distinctive and important aspect of the geology of the slide. The axis of the lower fold of the monocline is aligned subparallel to the Vaiont River, some 400 to 800 m to the north (see Figure 5). Between this axis, which forms the rear of the "seat of the chair," and the river there is a 9° to 20° eastward dip of the beds down the plunge of the syncline. South of this axis, the beds dip to the north towards the Vaiont River at 25° to 45°. These beds form the "back" of the slide. The axis of the upper fold of the monocline corresponds to the top of the head scarp of the western portion of the slide. This upper axis is shown in Figure 5 but does not show up on the sections shown in Figure 7 on page 74, since the sections do not extend far enough south.

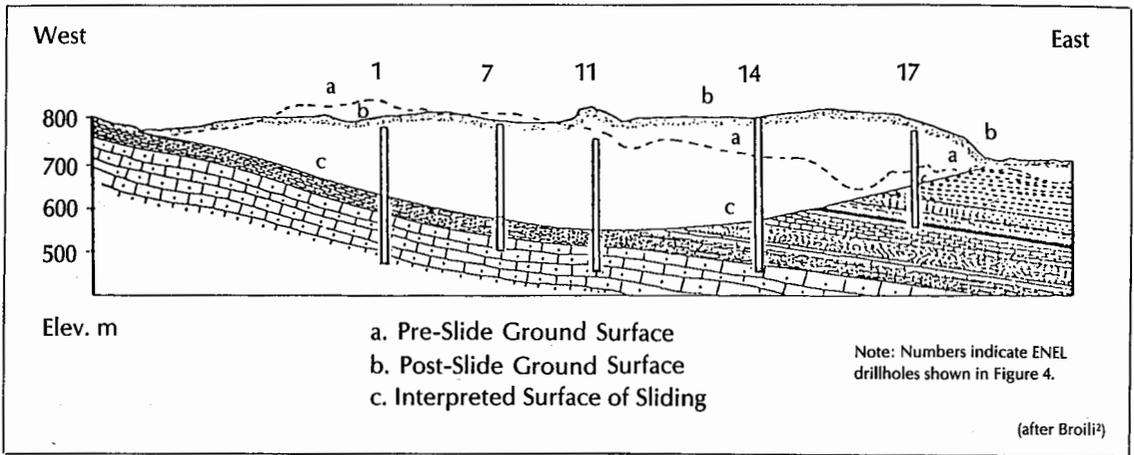
FIGURE 6. East-west geologic section through the toe of the slide.

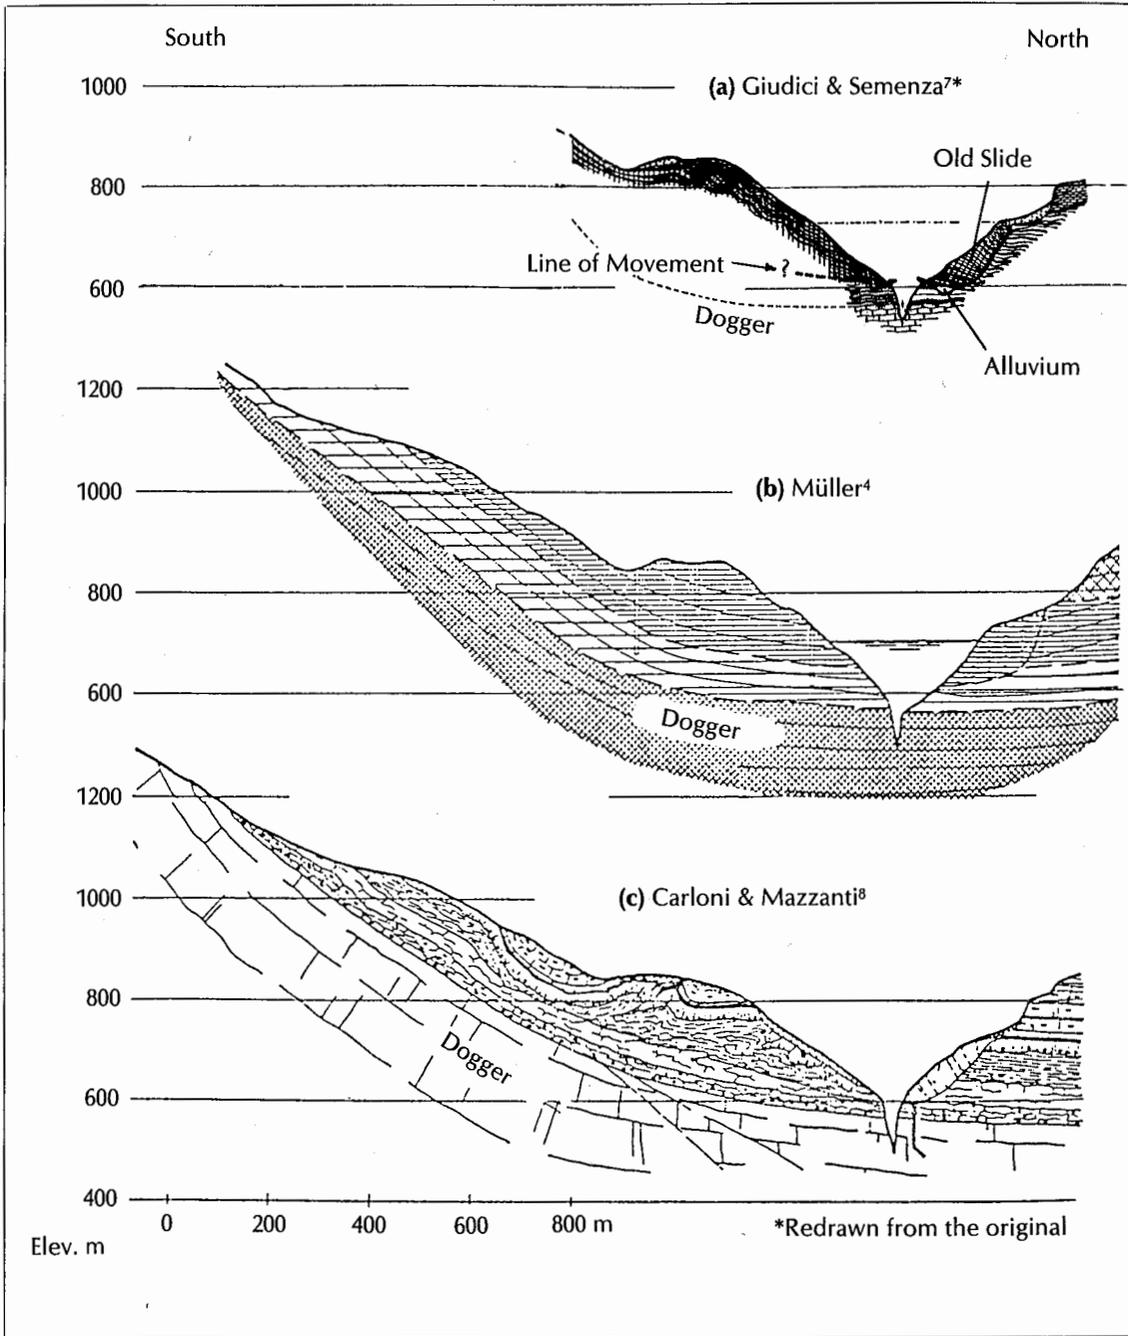
FIGURE 7. Geologic sections of six other investigators.

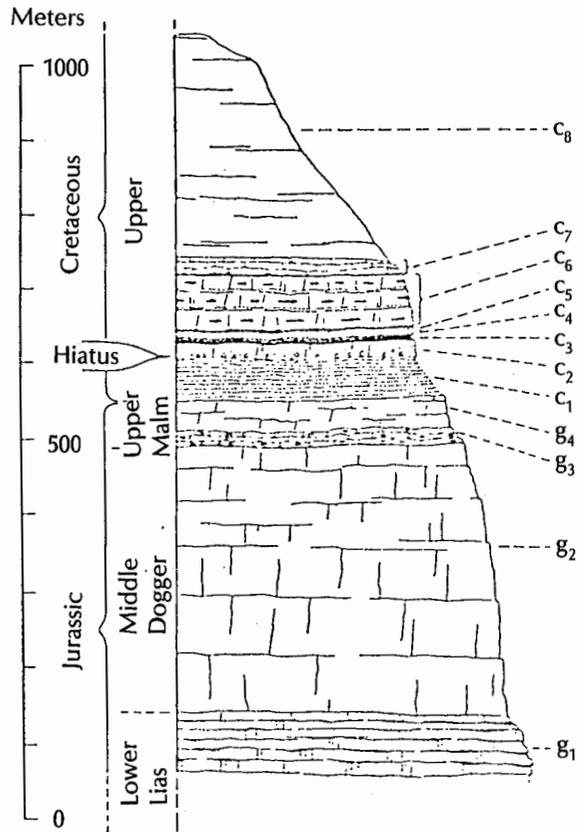
- g₃ Cherty limestone, dark gray color, beds 5-20 cm thick, nodular reddish chert, age *Malm*, total thickness 25-35 m (weak unit?).
- g₂ Oolitic limestones to dolomitic limestones, locally porous dolomite due to solution, beds in upper part 0.5-1 m thick, otherwise approx. 1 m, age *Dogger*, total thickness 350 m.
- g₁ Limestone, gray to bluish well-stratified, beds 5-15 cm thick, partings of bituminous marl, age *Lias*, total thickness 80-100 m.

FIGURE 8. Geologic column of the valley, with a description of the column.

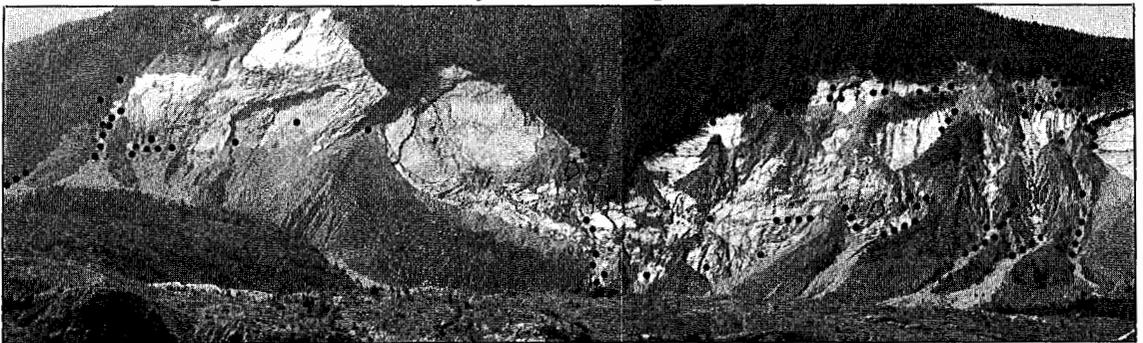
FIGURE 9. Photograph of the Vaiont Slide showing locations of field observations. Clay layers were observed at most locations. An arrow and open circle indicate the location of one of the exploratory adits.

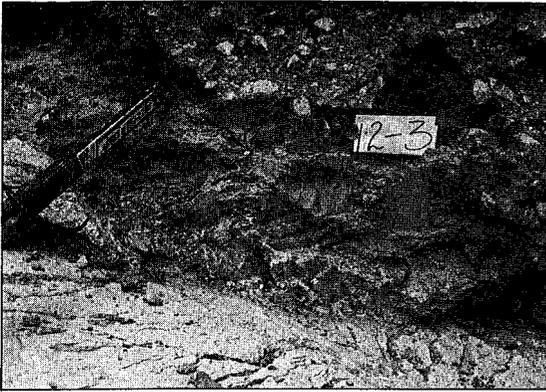
FIGURE 10. A clay layer 5 to 20 cm thick along the failure surface at location 12-3, near the east side of the slide.

Where the surface of sliding is overlain by slide debris, the clays were generally found preserved (for example, see Figures 10, 11 and 12). However, where the failure plane has been exposed, the clays are rapidly eroded by rainfall and by debris flows from the large catchment surfaces (see Figures 13 and 14). Small folds and faulted monoclinial (cascade) structures, which are present in many areas of the slide but are not visible at a

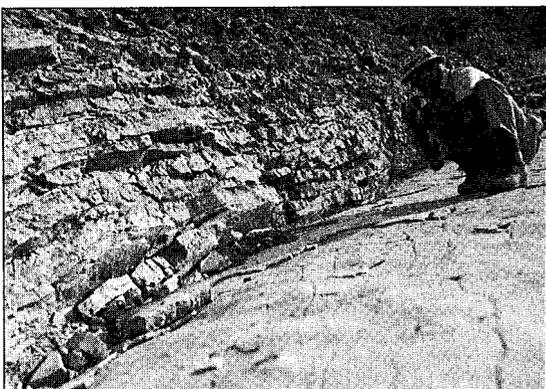
FIGURE 11. A view of the failure surface below the headscarp at location 18-9, about at the western third point of the slide.

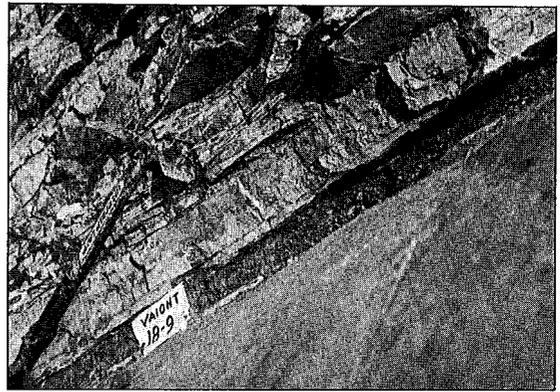
FIGURE 12. Clay interbed 5 cm thick along the failure surface at location 18-9. Other thin clay interbeds up to 0.5 cm thick lie in the rock mass.

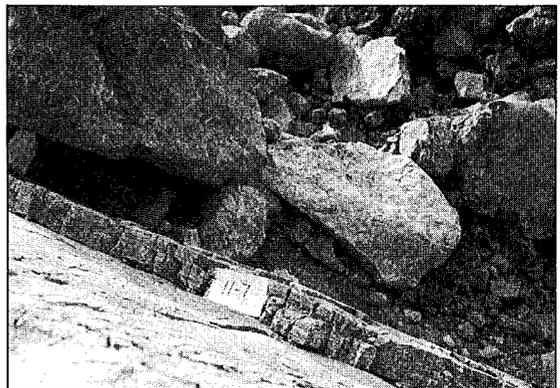
FIGURE 13. Slide debris overlies the failure surface where a clay layer 4 to 6 cm thick has been eroded from beneath the debris at location 11-7, the lower portion of the fourth gully from the west side of the slide.

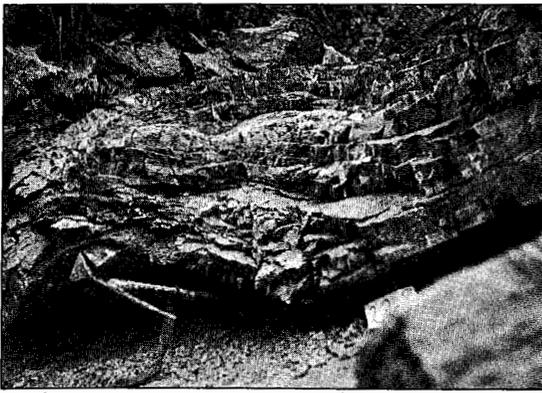
FIGURE 14. A view of a clay interbed 7 to 10 cm thick protected by a small fold and associated with adjacent failure surfaces at location 22-8, the fifth gully from the west side of the slide, one-third the way up the rock face.

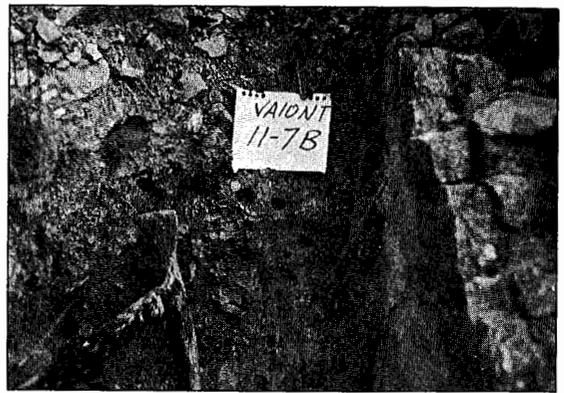
FIGURE 16. A clay layer, at location 11-7B, 10 cm thick lying between bedrock to the right and slide debris to the left. The clay is protected by a cascade structure, but is associated with the nearby failure surface.

distance (Figure 15), have served to protect and preserve small portions of the clay interbeds that are strategically continuous with large adjacent areas of the 1963 sliding surface (for example, see Figure 16).

eroded off of exposed bedding plane surfaces. Figure 16 is an example of a clay layer preserved in such a structure. Because of local increases in shearing resistance, the monoclinical and cascade structures also tend to collect the slide debris overlying them.

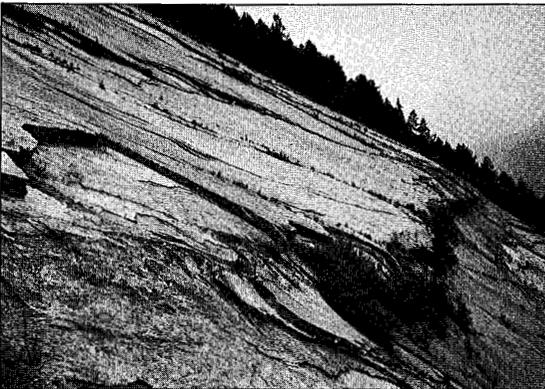
FIGURE 15. A monocline located in the middle of the western rock face. The surface, exposed after the October 1963 slide, is associated with a clay interbed 0.2 to 1 cm thick.

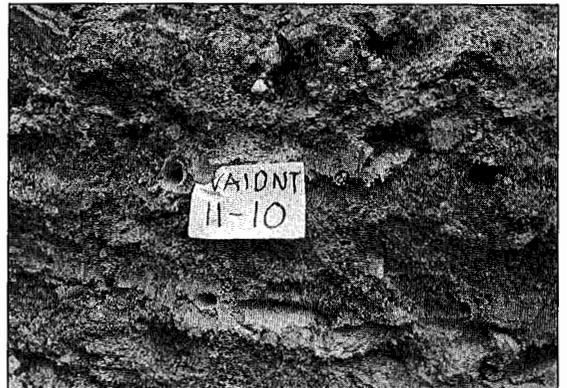
FIGURE 17. Five clay layers 1 to 2 cm thick within the lower 1.5 m of slide debris at location 11-10, the fourth gully from the west side of the slide. The failure surface appears in the lower left corner.

debris exposed along the base of the rock outcrops on the west side of the slide consists of an uncemented angular gravel and sand-sized breccia with frequent layers of clay and breccia with a clay matrix (for example, see Figure 17). The clay layers in this breccia fre-

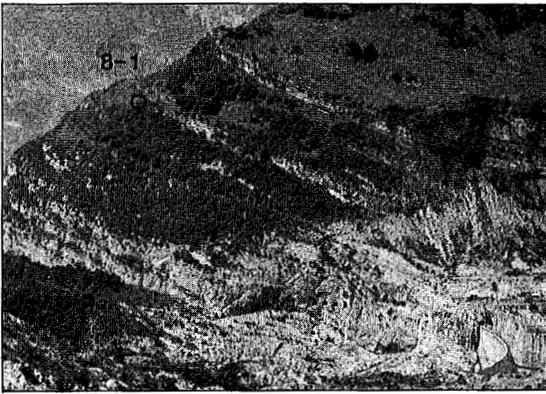
FIGURE 18. Location 8-1 where in-situ clay layers outcrop southwest of Casso in the same stratigraphic horizon as the failure surface. The top of the Vaiont Dam is in the lower right.

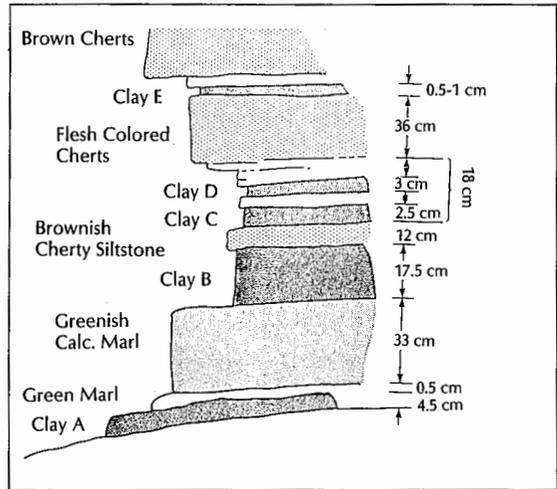
FIGURE 19. A sketch of the outcrop of Malm rocks southwest of Casso. This outcrop lies in the same stratigraphic sequence as those at the base of the Vaiont Slide.

on pages 82-83) to those taken from the failure surface of the slide. A sketch of this outcrop is shown in Figure 19.

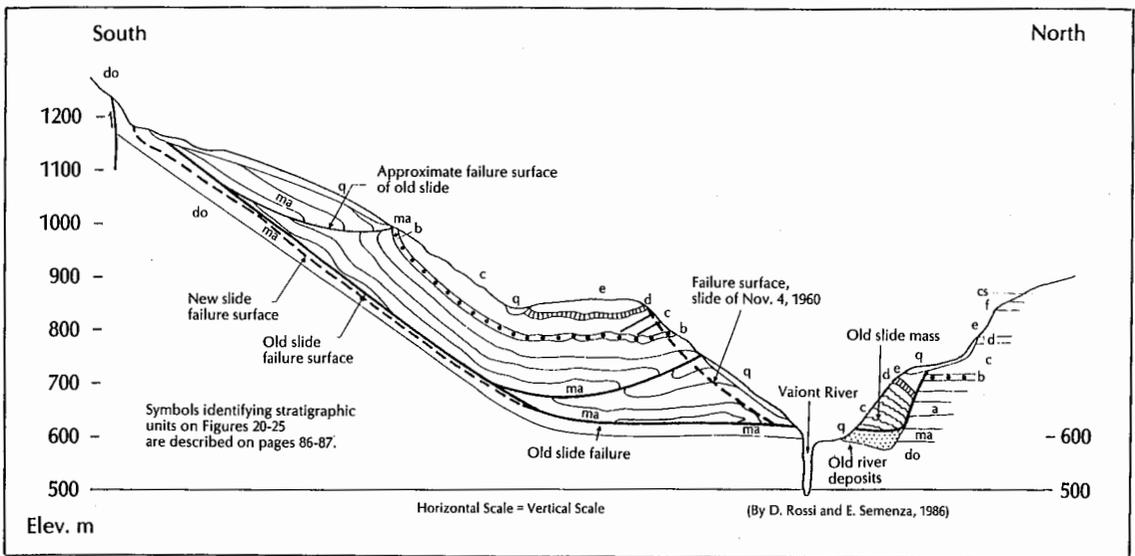
FIGURE 20. Geologic Section 2 before October 9, 1963.

Figure 20 depicts Section 2 before the October 9, 1963, slide. Two different minor variations in the interpreted surface of sliding are shown along the steeply inclined portion of the slide. Figure 20 also indicates a fault at the top of the slide area and some previous sliding within the future slide mass. A portion of the old remnant block of slide material on the right-hand side of the Vaiont Valley is also

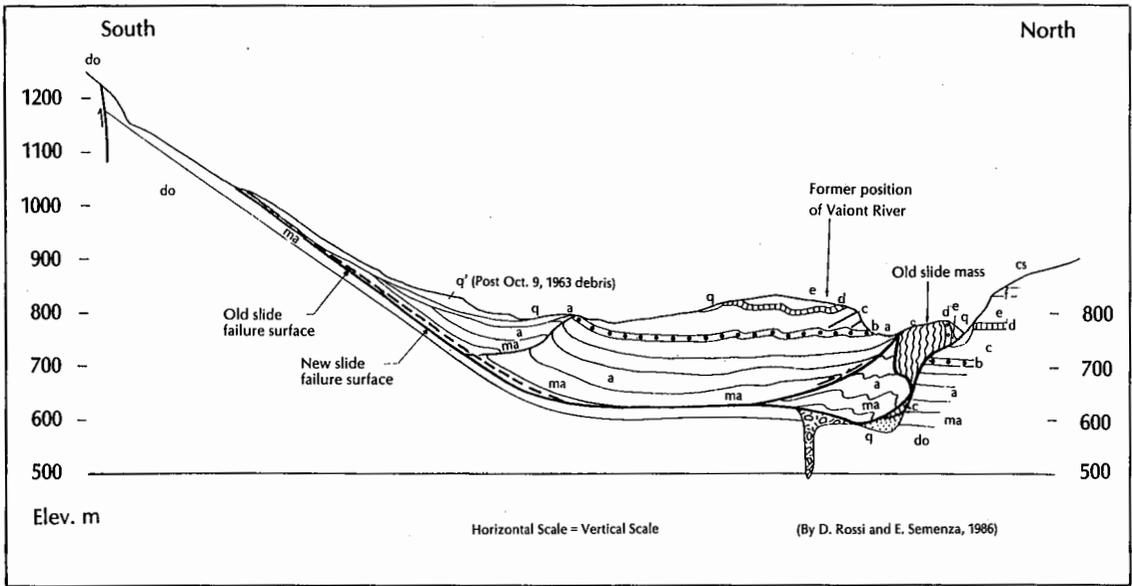
FIGURE 21. Geologic Section 2 after October 9, 1963.

Figure 21 portrays Section 2 after October 9, 1963. It indicates a moderately simple downhill translation of the slide. The figure also depicts a remarkable upward displacement of the old slide material on the right-hand valley wall and some of the post October 9, 1963, debris and alluvial fans covering portions of the surface of the main mass. Figure 21 shows that the failure plane is parallel to the bedding in the upper part of the slide, but cuts across the bedding in the lower part of the back of the slide. The authors agree with the general position and orientation of the slide surface shown for the exposed portions of the failure surface. Whether the surface of sliding cuts across beds at depth or not is a matter of interpretation. Appreciably more drillholes would be required to better define the degree of conformity of the failure surface to the bedding.

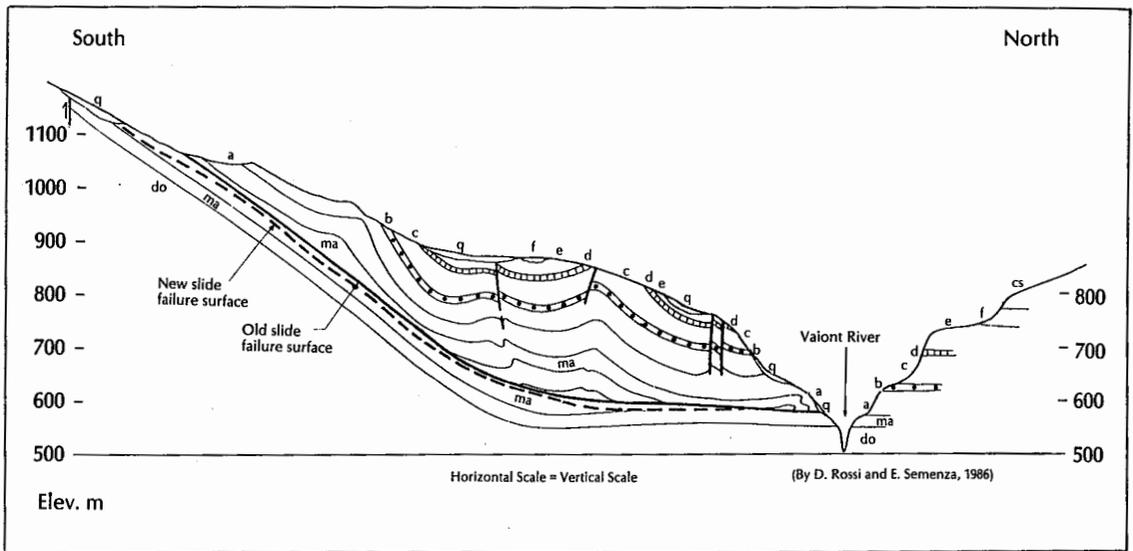
FIGURE 22. Geologic Section 5 before October 9, 1963.

Figure 22 presents Section 5 before October 9, 1963. It illustrates a section with a large stabilizing toe relative to the small volume that acts as a driving force.

portrayed by the two directions of movement noted on the planes of sliding at the toe. A comparison of Figures 22 and 23 reveals only

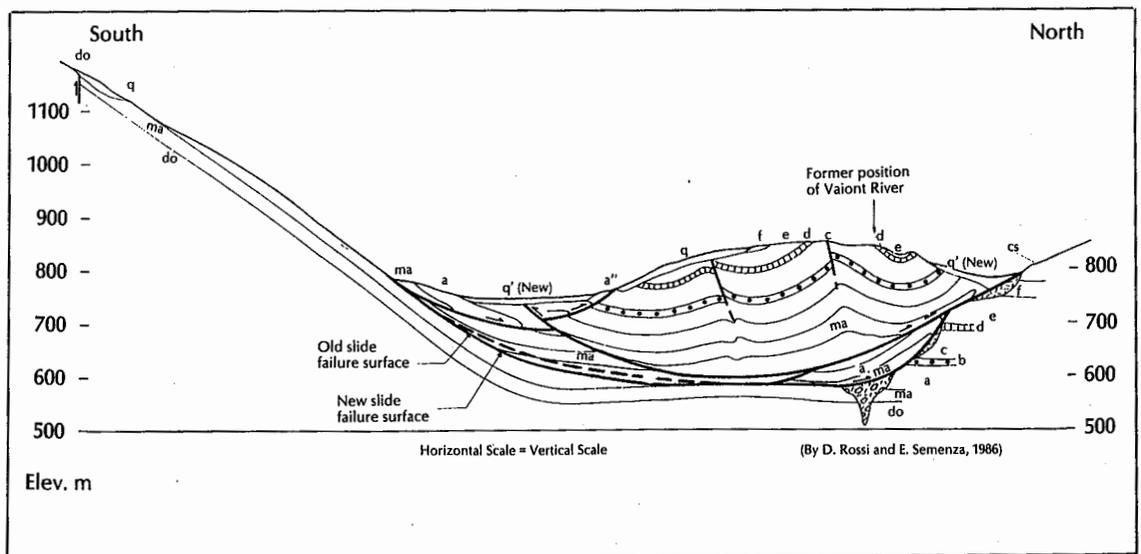
FIGURE 23. Geologic Section 5 after October 9, 1963.

Figure 23 shows Section 5 after October

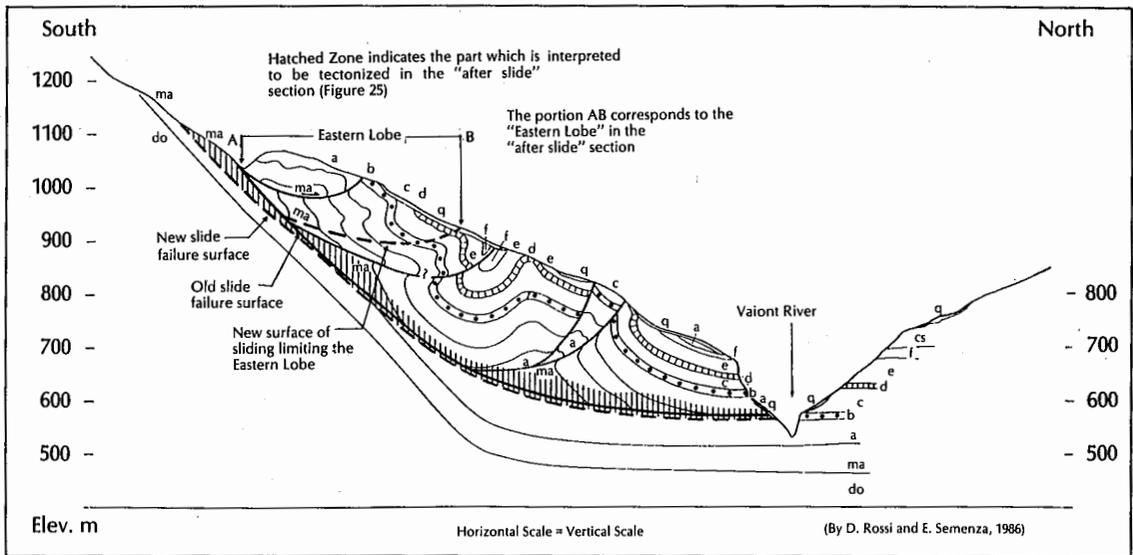
FIGURE 24. Geologic Section 10A before October 9, 1963.

Geologic Section 10A presented in Figure 24 shows the geologic structure of a representative section of the eastern side of the slide taken in the approximate direction of initial movement of the main slide mass. Most sections of this part of the slide presented in previous investigations have been oriented some 10° to 20° counterclockwise in plan view to give more emphasis to the direction of movement of the top of the eastern portion of the slide. Rossi and Semenza called this

Semenza have also speculated on the existence of a "tectonized" zone highlighted by the hatching along the failure surface in Figures 24 and 25. By comparing Figure 24 to Figure 25, it can be seen that there is relatively little surface deformation of the majority of the sliding mass that is not accounted for by a translational and rotational displacement, except for the deposit of the Eastern Lobe. Figure 25 also shows the near-horizontal surface of the slide mass following the 1963

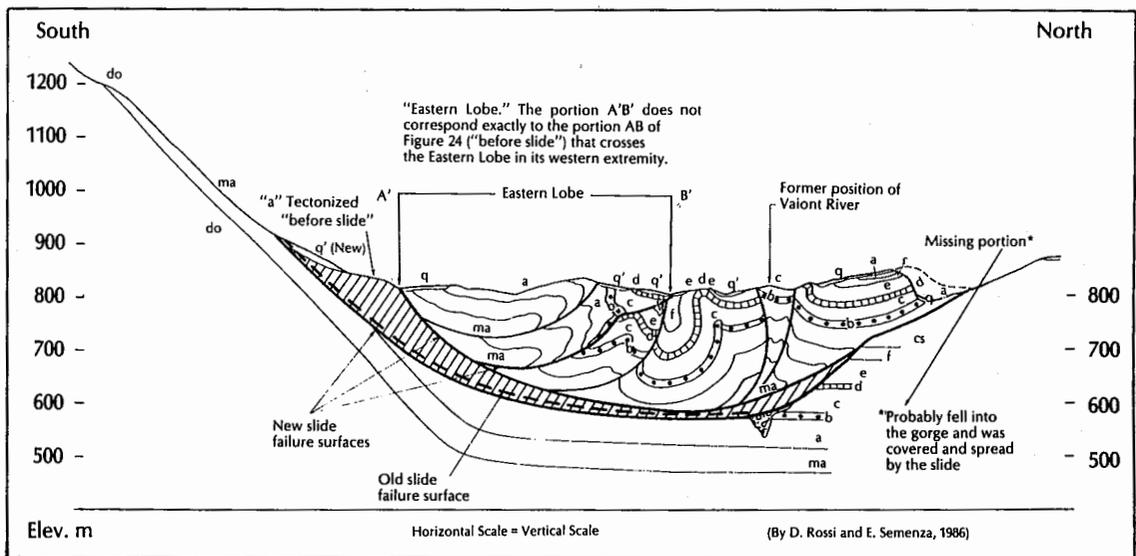
FIGURE 25. Geologic Section 10A after October 9, 1963.

slide, reflecting the very low shear strength along the base of the slide. In Figure 25, Rossi and Semenza note that a portion of the front of the pre-1963 canyon wall is missing. They have suggested that this portion fell into the gorge and was covered and spread by the slide movement. Presumably, part of this missing volume may have been removed by wave action.

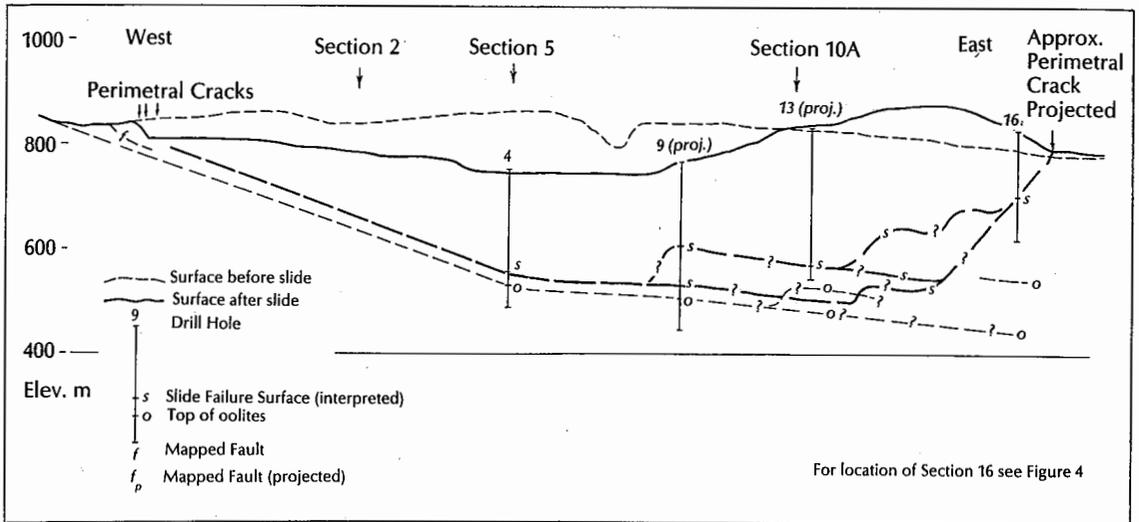
FIGURE 26. Geologic Section 16.

without an examination of an east-west section. Sections 16 and 17, shown in Figures 26 and 27, are east-west sections based on information obtained from drill-holes made after the slide. The dip of the beds along the seat of the slide is steeper (17° and 22°) on the west end near the dam and flatter (9° to 11°) in the central portion of the slide. The bedding steepens again to 30° to 40° just east of the slide (not shown in these sections). An interpretation of the stair-stepped seat of the slide on its eastern side is shown in Figures 26 and 27. The shapes of these steps are not

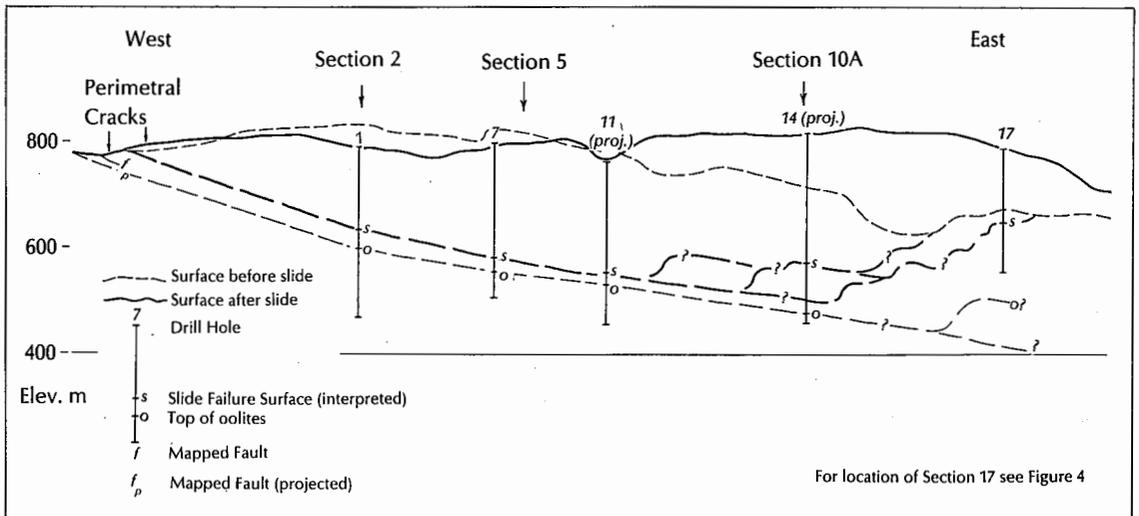
FIGURE 27. Geologic Section 17.

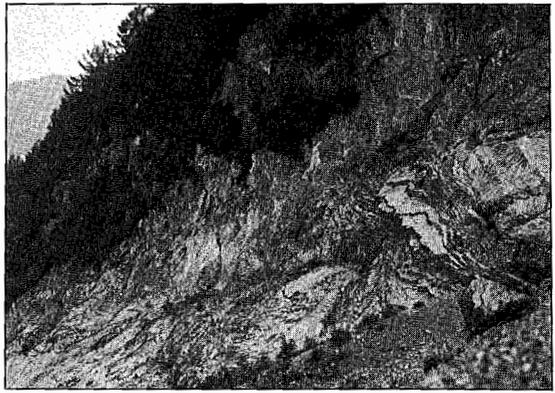
FIGURE 28. The western portion of the headscarp above location 18-6. The old headscarp is visible in the vegetated area above with a steep monoclinical fold changing to a fault at the scarp. Fragments of partly cemented breccia containing solution features remain attached to the cliff above.

The fault and associated dragfold found at the headscarp at the top of the western half of the slide are shown in Figure 28. The beds steepen appreciably close to the headscarp where they turn vertical or are faulted. Figure 28 shows that the recent headscarp is the lower portion of an older scarp whose shape is evident on the vegetated cliffs above. The fault mapped by Rossi and Semenza (shown in Figure 4) formed the eastern boundary of the slide.²⁶

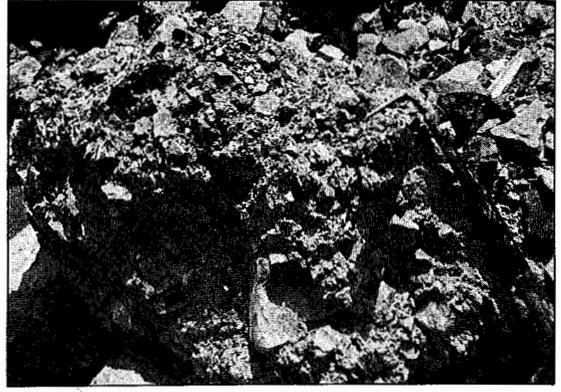
FIGURE 30. A float boulder of partly cemented breccia in alluvium below rock slopes whose source is believed to be breccia at the headscarp similar to that shown in Figure 24.

Roman times. A close-up view of the partly cemented talus material from the old bergschund-like crevasse at the scarp of the slide is shown in Figure 30.

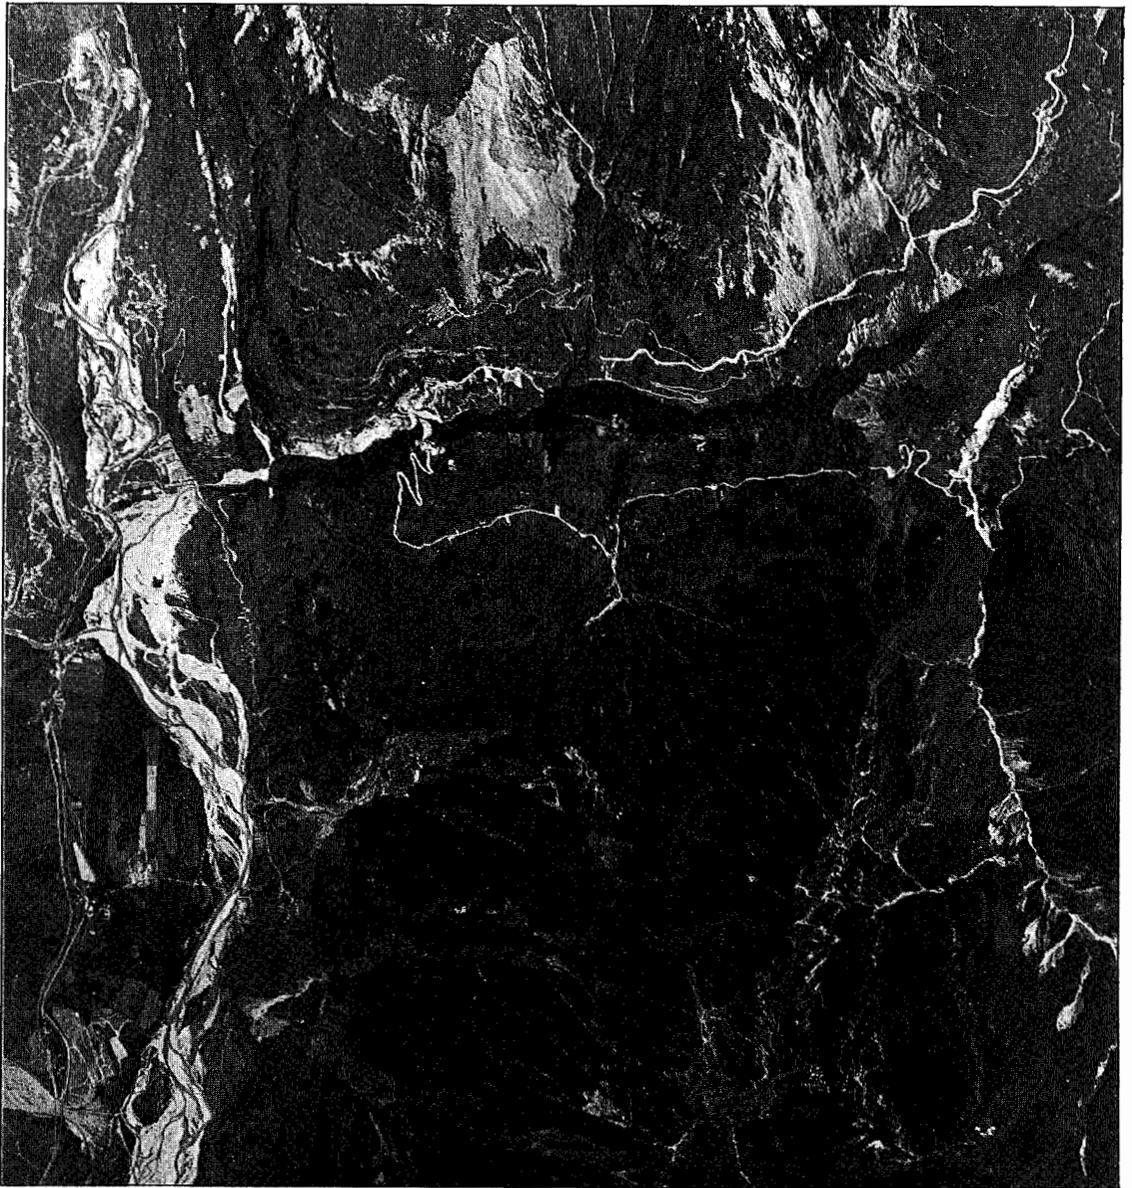
FIGURE 31. Airphoto of the Vaiont Dam and Reservoir area taken in 1960.

In order to answer these questions, airphotos taken in 1960 and another set taken a few days after the slide of October 9, 1963, were examined. One of the 1960 airphotos is presented as Figure 31. Figure 32 shows the geomorphic features delineated from the airphoto in Figure 31. Some of the major topographical features related to the slide have been depicted in Figure 32, including depressions and scarps, streams, gullies and sinkholes. Also outlined are the dam, reservoir, roads and visible traces of trails.

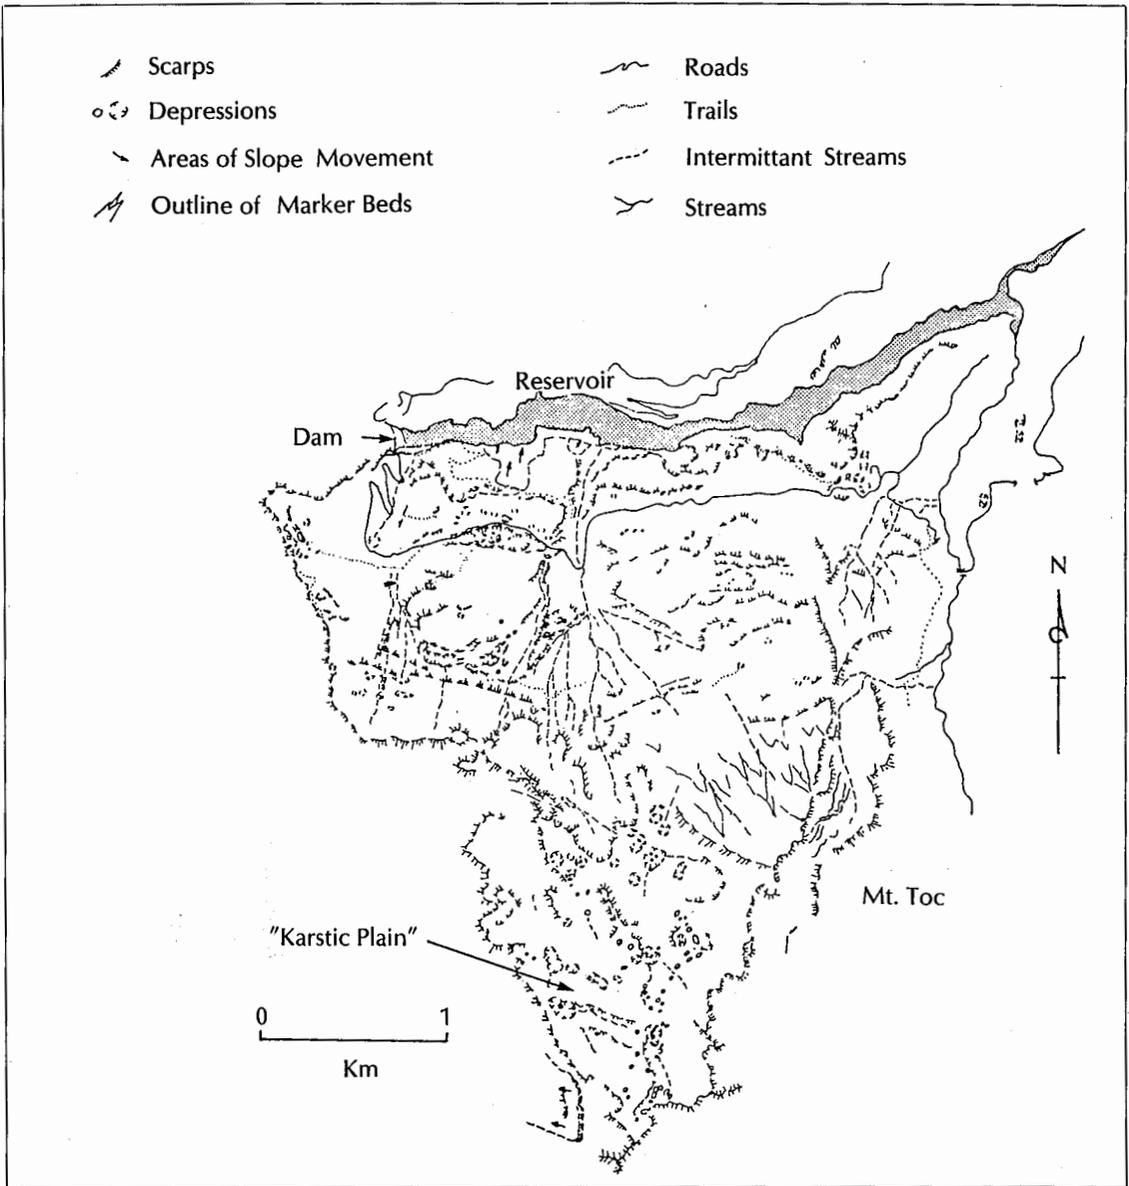
FIGURE 32. Geomorphic features of the Vaiont Slide area delineated from the 1960 airphoto (same scale as Figure 31).

The second geomorphical feature of particular interest, and one of the most surprising aspects of the airphoto study, was the substantial area of pronounced karstic topography in a basin above the slide and to the west of the peak of Mt. Toc. Other small incipient sinkholes are present in the surface of the Dogger beyond the western and southern limits of the slide. These apparent kettles or sinkholes, which sometimes form small elongated doline-like depressions, are mapped in Figure 32.
