CIVIL ENGINEERING PRACTICE •

JOURNAL OF THE BOSTON SOCIETY OF CIVIL ENGINEERS SECTION/ASCE

FALL 1986

VOLUME 1, NUMBER 2

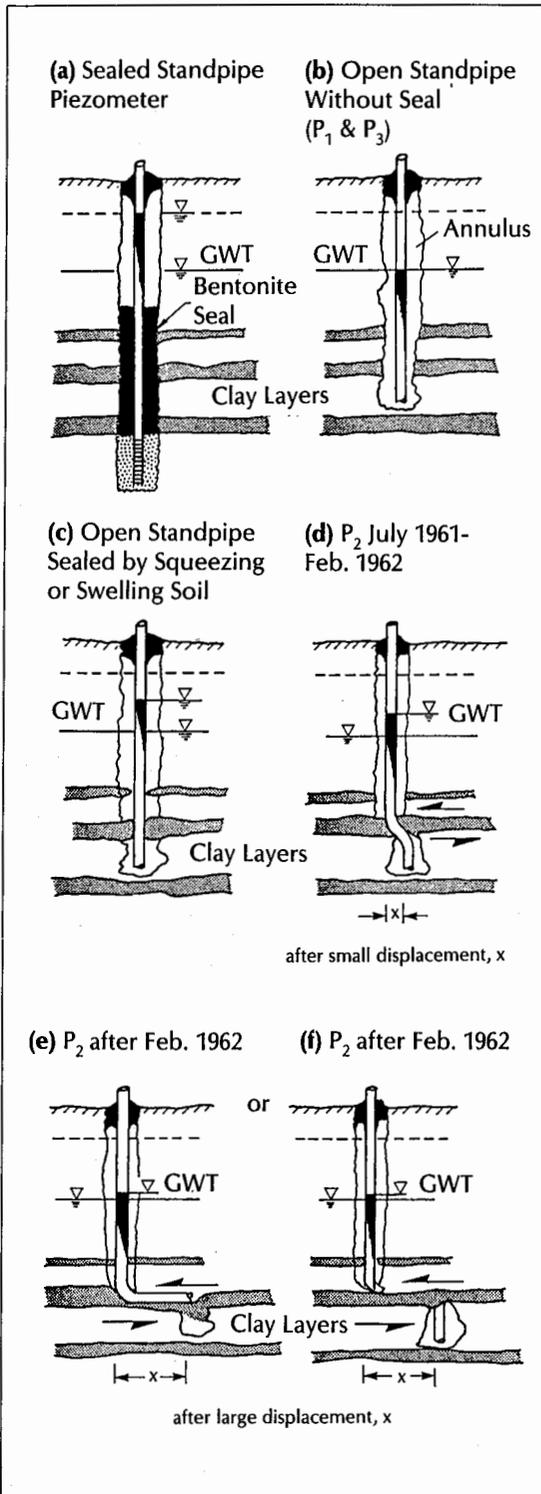
FIGURE 33. Sketches showing a possible explanation for the water levels recorded in P2.

layer squeezing around the pipe), then the water level inside the pipe would reflect average hydraulic pressure conditions in the formations below the seal as shown in Figure 33c. Such a seal could conceivably provide water pressure readings in the vicinity of the base of the slide as precise as if a fully-sealed standpipe piezometer, such as that shown in Figure 33a, had been installed. With continued but small displacements of the slide, the seal around the pipe could be eroded or the pipe could bend or be pulled apart and start to leak as shown in Figures 33e and 33f.

From early November 1961 (when P2 was first read) until late January 1962, the water level in P2 was 25 to 90 m above the reservoir levels. During this period the slide moved 5 to 10 cm. From February to July 1962, piezometer P2 showed levels lower than previously indicated, but still 2 to 10 m higher than piezometers P1 and P3. During this interval the slide had moved from 20 to 25 cm (since P2 was installed). After July 1962, the water levels recorded in P2 were generally within 1 to 2 m of those recorded in P1 and P3. Thus, the total displacement of the slide since P2 was installed was about 30 cm by July 1962. This much displacement was probably sufficient to pull out, rupture or pinch the end of the pipe in the manner suggested in Figures 33e and 33f.

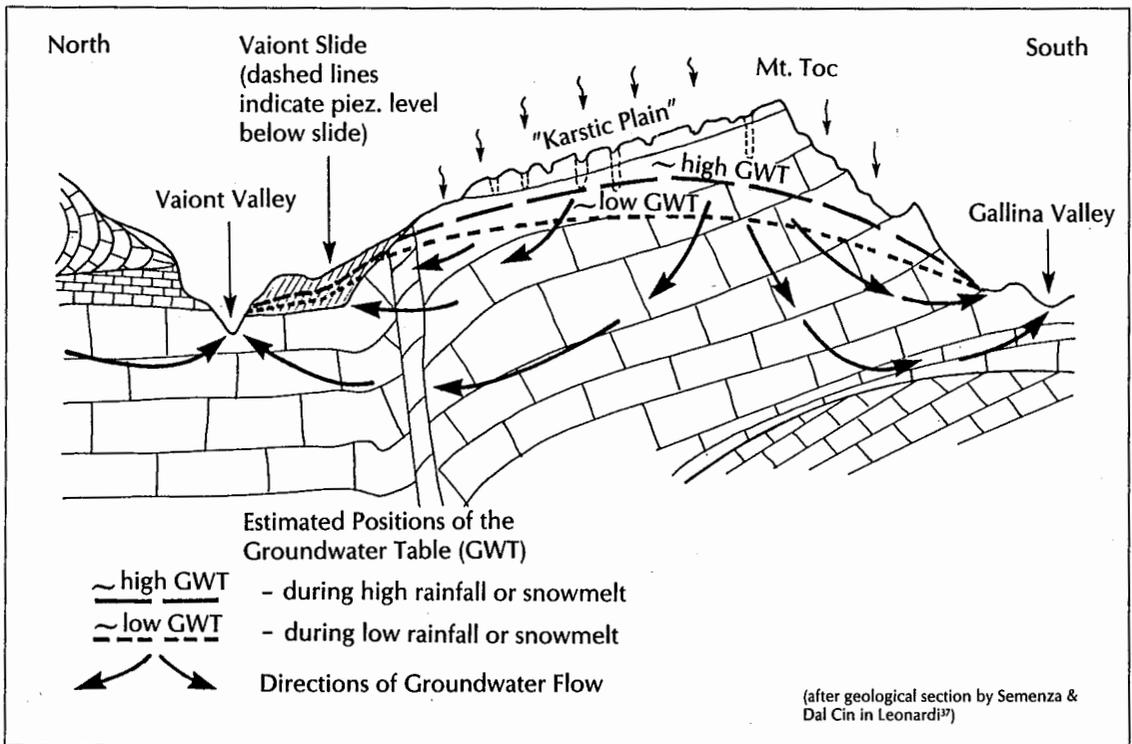
FIGURE 34. A schematic section through the Vaiont Slide showing the estimated regional groundwater flow system.

Figure 34 on page 97 shows the general groundwater flow system that might be expected on a section through Mt. Toc, assuming a relatively homogeneous and isotropic distribution of hydraulic conductivities within the mountain. If on the northern slopes of Mt. Toc there was a tendency for

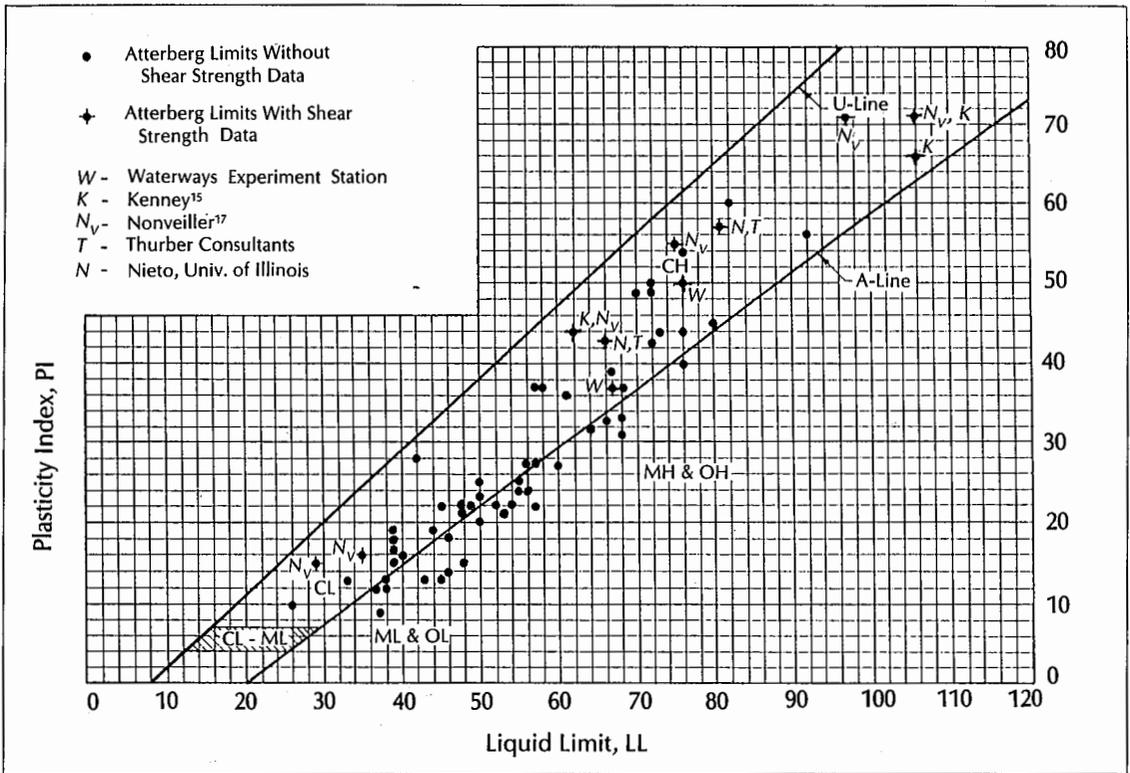
FIGURE 35. Plasticity chart for the clay samples from the slide site.

Results of tests by Kenney and Nonveiller for clay samples from the Vaiont Slide are also shown on Figure 35.^{15,17} The liquid limits (29 to 116) and plasticity indices (15 to 71) of some of these samples exceed those measured in this study, but are consistent with the character of the clays noted in the field observations.

The shear strength along the base of the slide was assumed to be related more to the residual shear strength of the multiple layers of clay found along the basal surface of sliding than to the higher shear strengths of the rock-to-rock contacts. This assumption represents a basic departure from previous stability analyses, such as those performed by Müller, Lo *et al.*, Chowdhury and others.^{4,20,42,6} The bases for this assumption are the authors' field observations, summarized in Table 1, and the results of the laboratory shear strength and Atterberg limit tests, summarized in Tables 2, 3, 4 and 5, and in Figure 35.

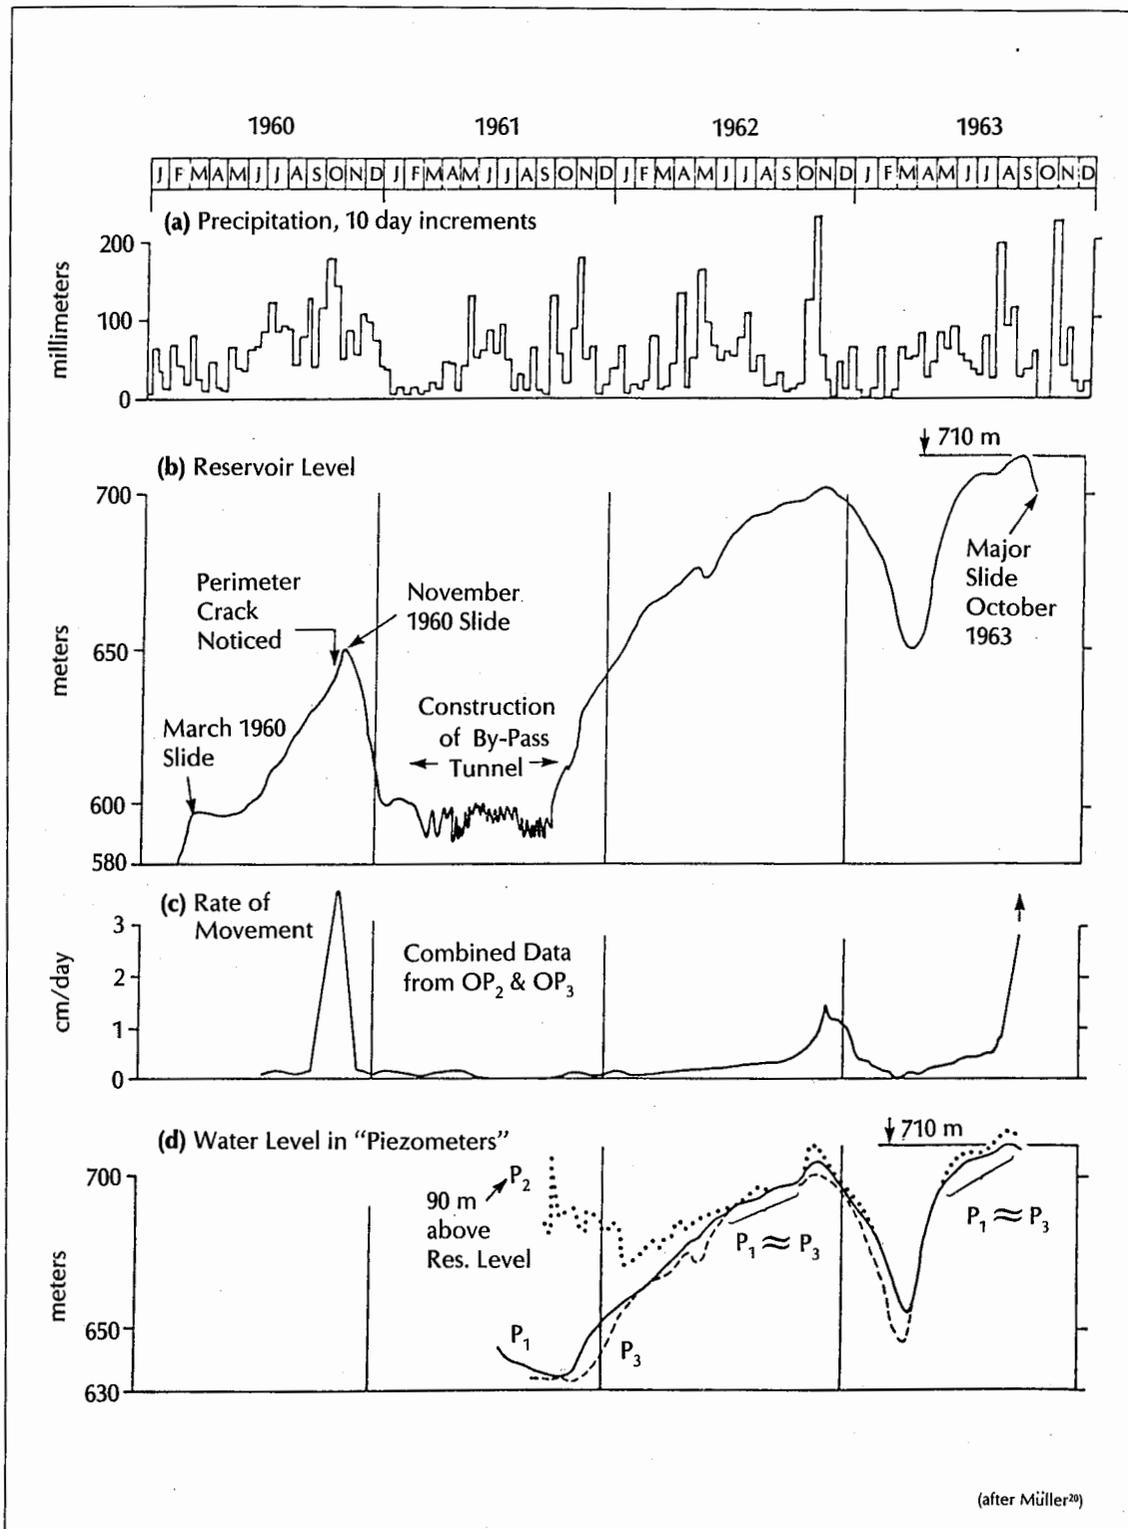
FIGURE 36. A comparison of the water levels, slide movements and precipitation from 1960 to 1963.

essentially outlined the perimeter of the entire slide as it subsequently developed in 1963. This perimeter crack is shown in Figure 4 together with the outline of the October 9, 1963, slide. Figure 36 demonstrates that the development of the perimeter crack coincided with the maximum 10-day precipitation for the year. Also, the onset of significant movement coincided with the start of a period of unusually heavy and prolonged precipitation that followed an exceptionally wet July and August. The slide continued to move after the perimeter crack opened, reaching a maximum rate of 3-4 cm/day at the end of October 1960.

The reservoir was held between el. 585 and 600 m from early January 1961 until early October 1961. During this period, a bypass tunnel was driven into the right bank of the valley opposite the 1963 slide area. This period was one of moderately low precipitation except for one wet 10-day stretch in May 1961. The rate of movement of the slide during this period was negligible. Piezometers P1, P2 and P3 were installed during this period and water level readings commenced as shown on Figure 36.

The second filling of the reservoir began in October 1961, and near the end of January 1962 the reservoir elevation was again at 650 m. As Figure 36 indicates, the rate of movement corresponding to the second filling to el. 650 m was negligible and the velocity was less than 0.1 cm/day. This behavior was in sharp contrast to the 3.5 cm/day velocity observed when the reservoir was just below el. 650 m during the first filling. Even as the reservoir approached el. 700 m at the beginning of November 1962, the velocity was only about 0.2 to 0.3 cm/day. The rate of movement increased abruptly to about 1.2 cm/day at the end of November 1962, although the reservoir remained nearly constant at the 700 m elevation. This increased movement followed a period of record precipitation for the four-year period shown on Figure 36. The reservoir was lowered to 650 m by the end of March

on and above the slide very likely may have been higher than at Erto. Müller summarized the precipitation records in 10-day increments (shown at the top in Figure 36).²⁰

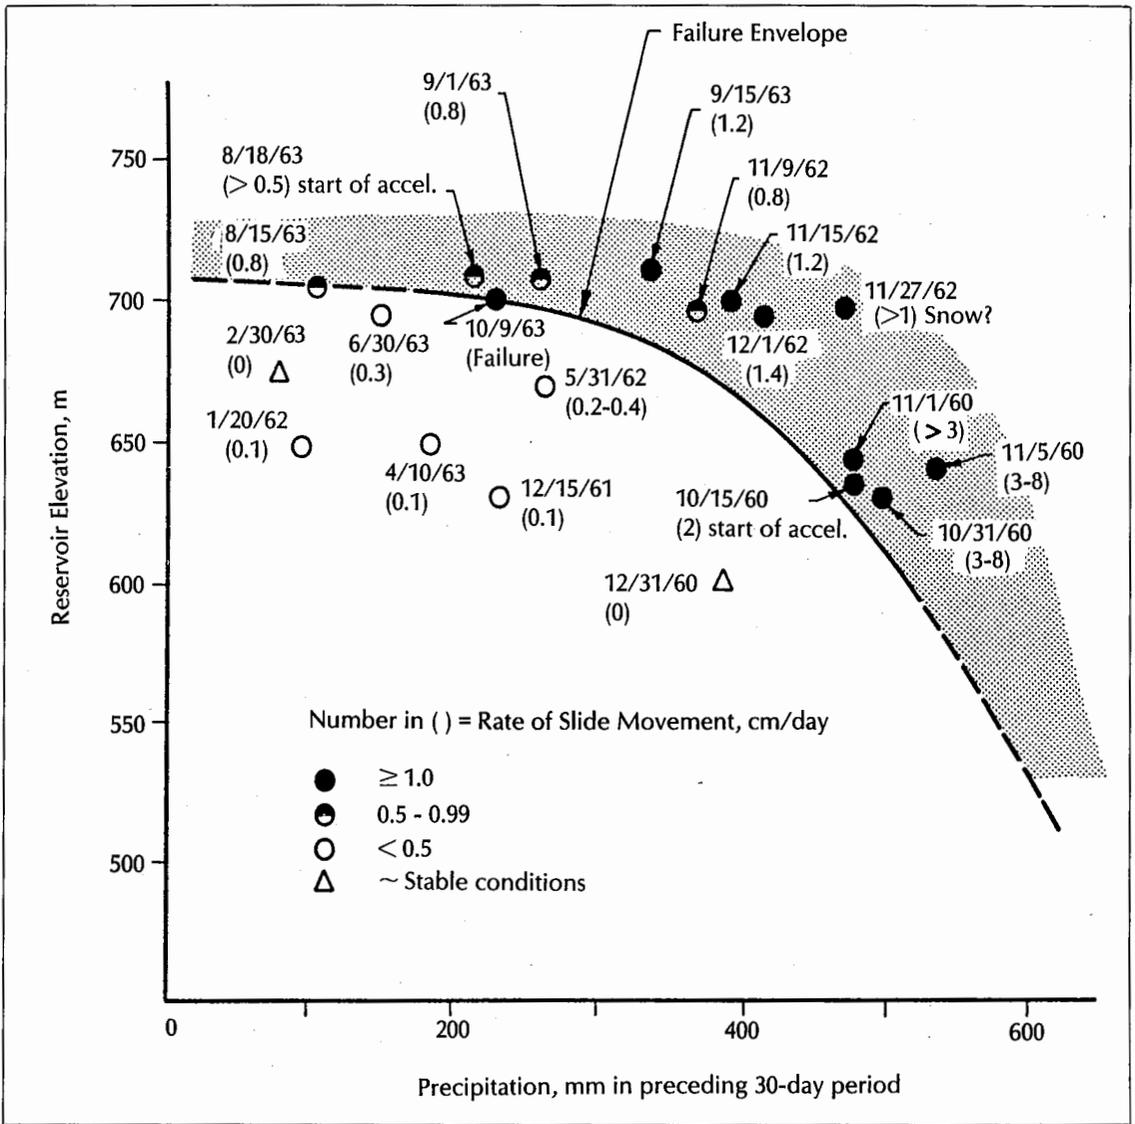
FIGURE 37. The stability of the Vaiont Slide for reservoir elevation vs. 30-day precipitation.

Graphical representation of rainfall and reservoir data is shown in Figure 37 on page 112. The water level in the reservoir is

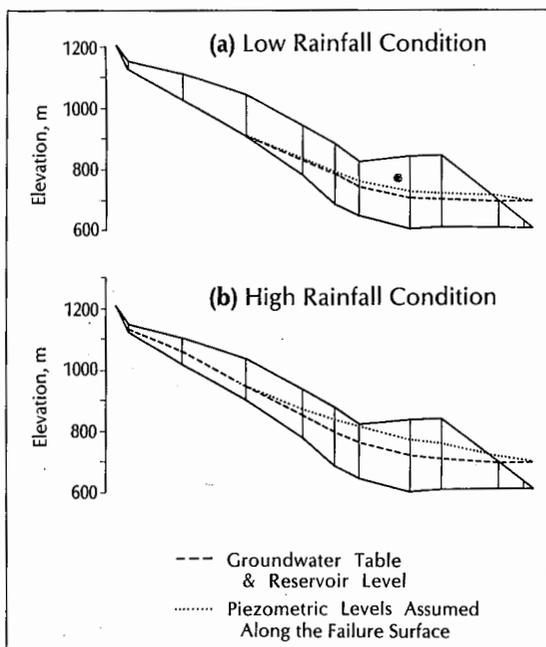
FIGURE 38. Piezometric levels used in stability analyses for Section 2, at a reservoir elevation of 710 m.

report.¹⁸ An example of the actual piezometric levels used is illustrated in Figure 38 for Section 2 with a reservoir level of 710 m.

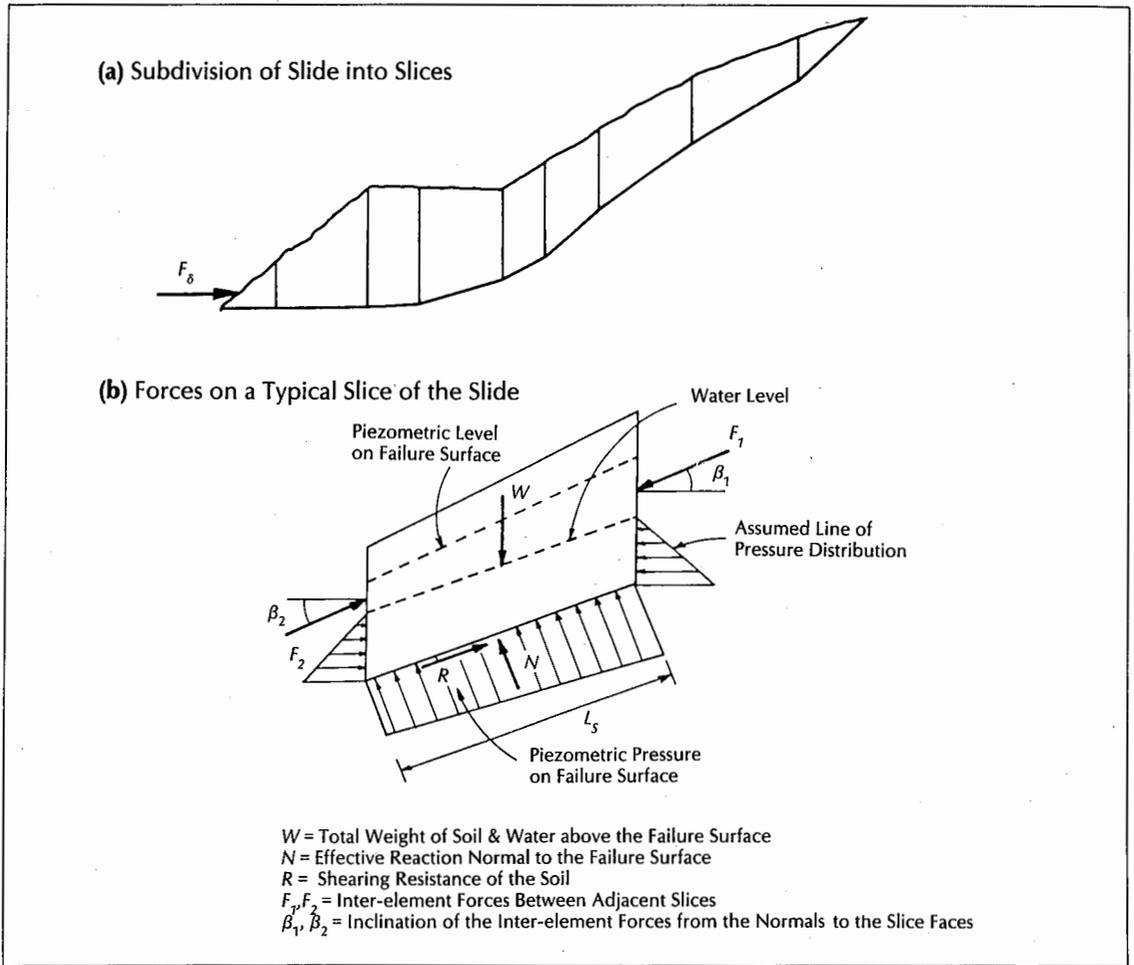
FIGURE 39. Selection of typical slices and forces acting on a typical slice.

shown schematically in Figure 39. Developed at the request of the authors, this method is described by Anderson in Hendron and Patton.^{50,18} The analyses of the three cross sections chosen as representative of the different portions of the slide were carried out by means of a computer program that calculated the factor of safety by considering the surface of sliding as a series of planes. Each cross section was subdivided into slices with vertical boundaries between slices as shown in Figure 39a.

Shear forces between slices were considered in these analyses. The maximum obliquity permitted for the resultant lateral force, F , acting on a vertical plane between slices is defined as β (Figure 39b) and is representative of the shearing resistance across strata of limestone, chert, siltstone and clay. The values of β used in these analyses

was less than 1.0, the force, designated as F_δ (Figure 39a), would be compressive. If the factor of safety was greater than 1.0, then F_δ would be a tensile force.

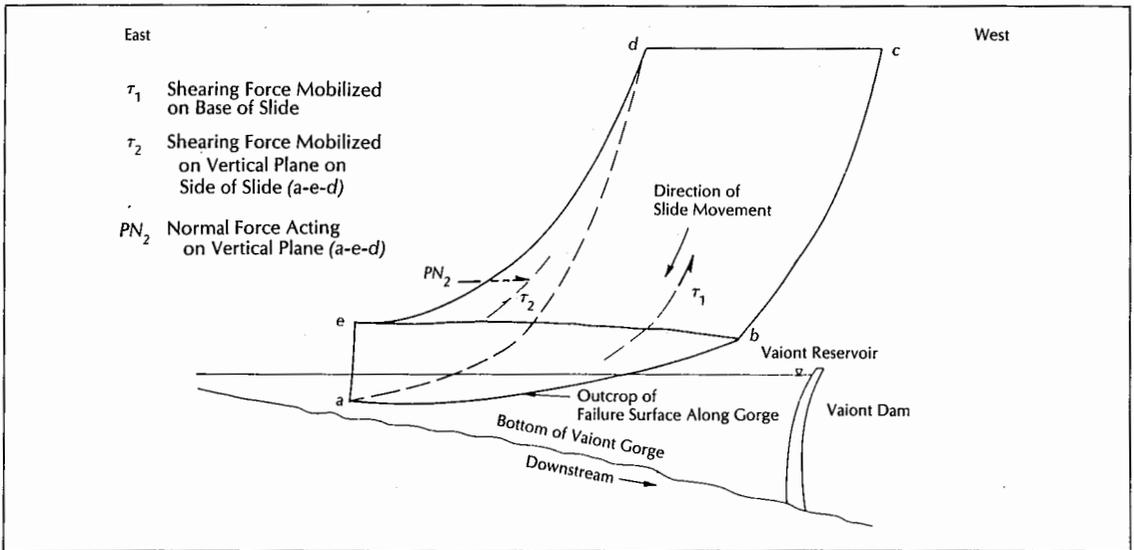
FIGURE 40. A schematic illustration of the three-dimensional nature of the Vaiont Slide mass.

Figure 40 is a schematic diagram that illustrates the three-dimensional nature of the possible failure wedges resulting from the upstream dip of the failure surface at the base of the slide. In this figure, the plane *a-e-d* is taken as a vertical plane in the direction of movement and would be parallel to Sections 2, 5 and 10A. The surface *a-d-c-b* corresponds to the basal bedding plane failure surface, the

direction perpendicular to plane *a-e-d*. The resisting force, τ_v , as shown schematically in Figure 40, is shown below to be significant and necessary for equilibrium of the slide at all times. This requirement would be true even before the filling of the reservoir, assuming the shear strength along the bedding planes was governed by the clays and was in the range of 8° to 12° . The angle of shearing resistance used along the base of the slide *a-b-c-d* was 10° to 12° . The angle of shearing resistance on planes parallel to plane *a-e-d* in Figure 40 was assumed to be $\sim 36^\circ$.

tions identified by Sections 2, 5 and 10A. The triangular wedge *a-e-b* in Figure 41 corresponds to the east-west section shown as *a-e-b* in Figure 40. The surface shown as *b-a* in Figure 41 represents the eastward dipping failure surface as shown in Figure 27. The total horizontal normal force PN_2 required in section *a-e*, Figure 41, to prevent upstream (eastward) movement down the apparent dip of the bedding planes is formulated by:

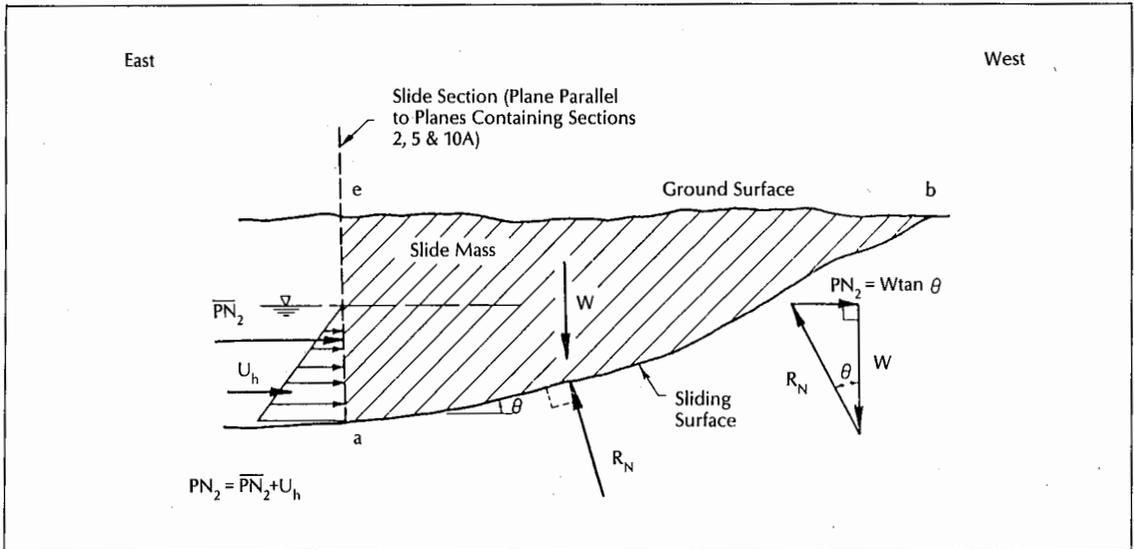
FIGURE 41. Representation of the normal forces on a slide cross section developed by the upstream dip of the sliding surface.

Figure 41 illustrates a cross section taken at right angles to the two-dimensional sec-

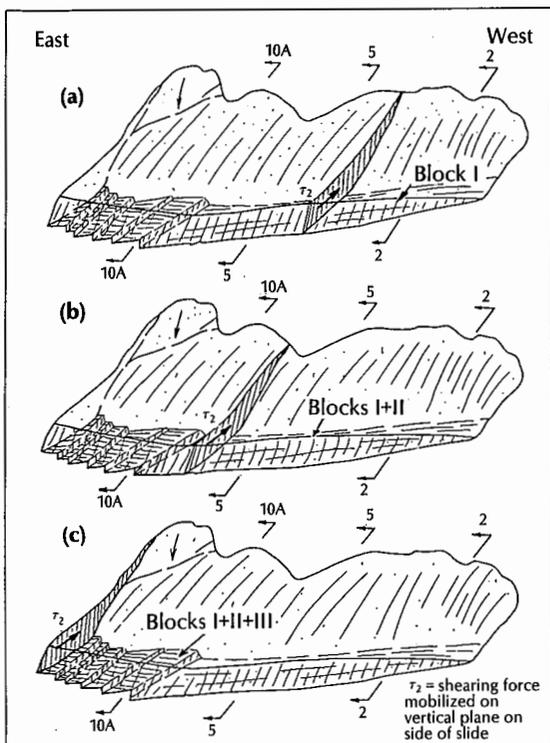
FIGURE 42. A depiction of the three blocks used in the three-dimensional stability analyses.

The schematic diagram in Figure 42 shows the three-dimensional nature of the blocks selected for the calculation of forces acting in the upstream (easterly) direction. These blocks are designated as Block I, Block I + II and Block I + II + III. In Appendix D of Hendron and Patton, the factor of safety of Block I (Figure 42a) is shown to be 1.07 for $\phi = 12^\circ$, $\beta = 40^\circ$, $\phi_R = 36^\circ$ and high rainfall with reservoir elevation at 710 m.¹⁸ The factor of safety of Block I + II is 1.31 (Figure 42b) and the factor of safety of Block I + II + III is 1.00 (Figure 42c). These three-dimensional analyses, which consider the shear forces between sections caused by the upstream dip of the strata, account for the fact that the entire slide came down at one time. This finding was not apparent from the two-dimensional analyses that yielded calculated factors of safety for Sections 2, 5 and 10A that were quite different

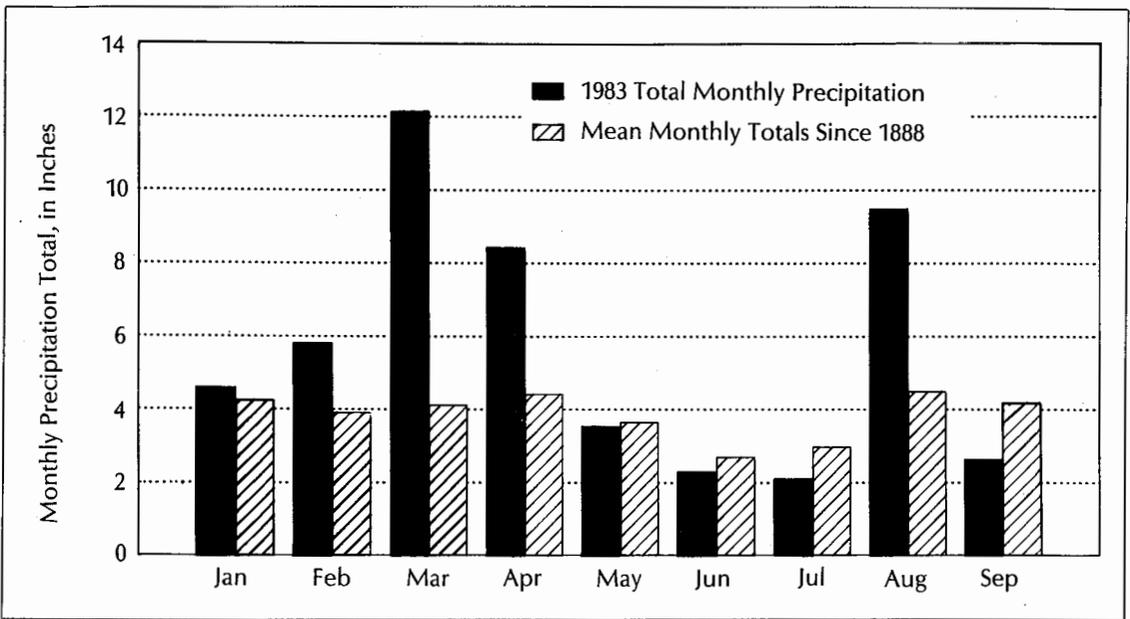
FIGURE 2. Comparison of 1983 monthly precipitation totals with mean monthly totals for the precipitation gage at Plymouth recorded over 95 years.

Sets of streamflow measurements were made August 2, 22 and September 12, 1983. For this basin, base flow was assumed to have been reached at least three days after a precipitation event. A very wet spring contributed to high groundwater levels throughout the summer. Monthly precipitation totals for the period of January to September 1983¹ were compared with mean monthly totals for the same months for the past 95 years² as recorded by a National Oceanic and Atmospheric Administration precipitation gage located four miles southeast of the study area in Plymouth (see Figure 2). Groundwater levels are illustrated in Figure 3, which compares the 1983 monthly groundwater level observations with the average observed monthly levels for the same months since October 1956 at the Plymouth 22 observation well six miles south of the study area.³ This 42-foot deep well is in a water-table aquifer consisting of glacial outwash.

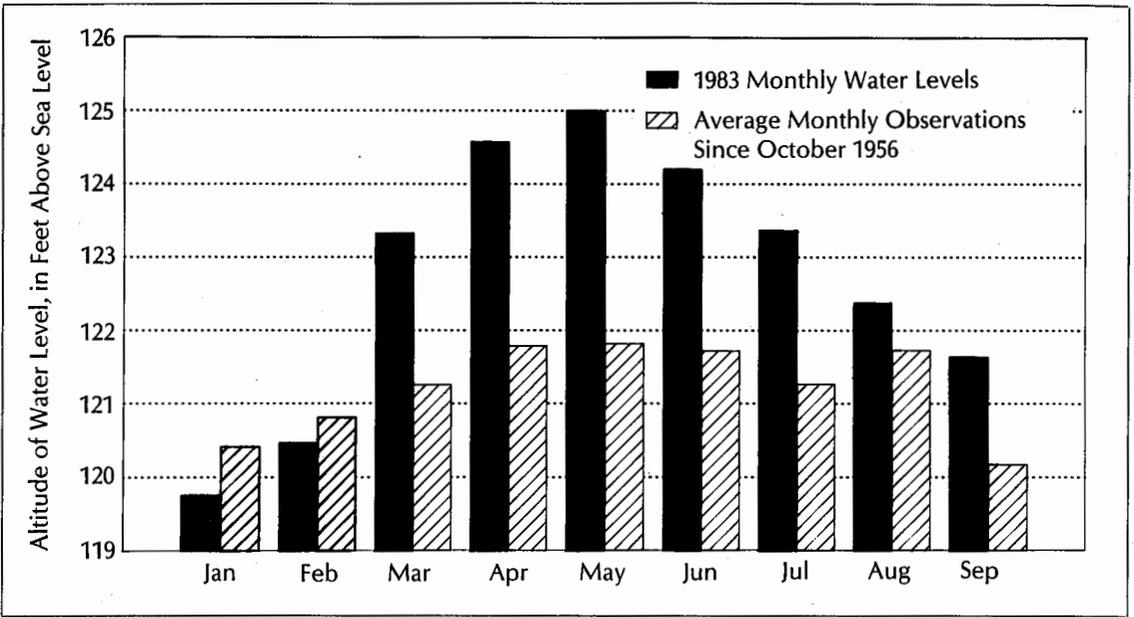
FIGURE 3. Comparison of 1983 monthly groundwater level observations with average monthly groundwater level observations since October 1956 for the Plymouth 22 observation well.

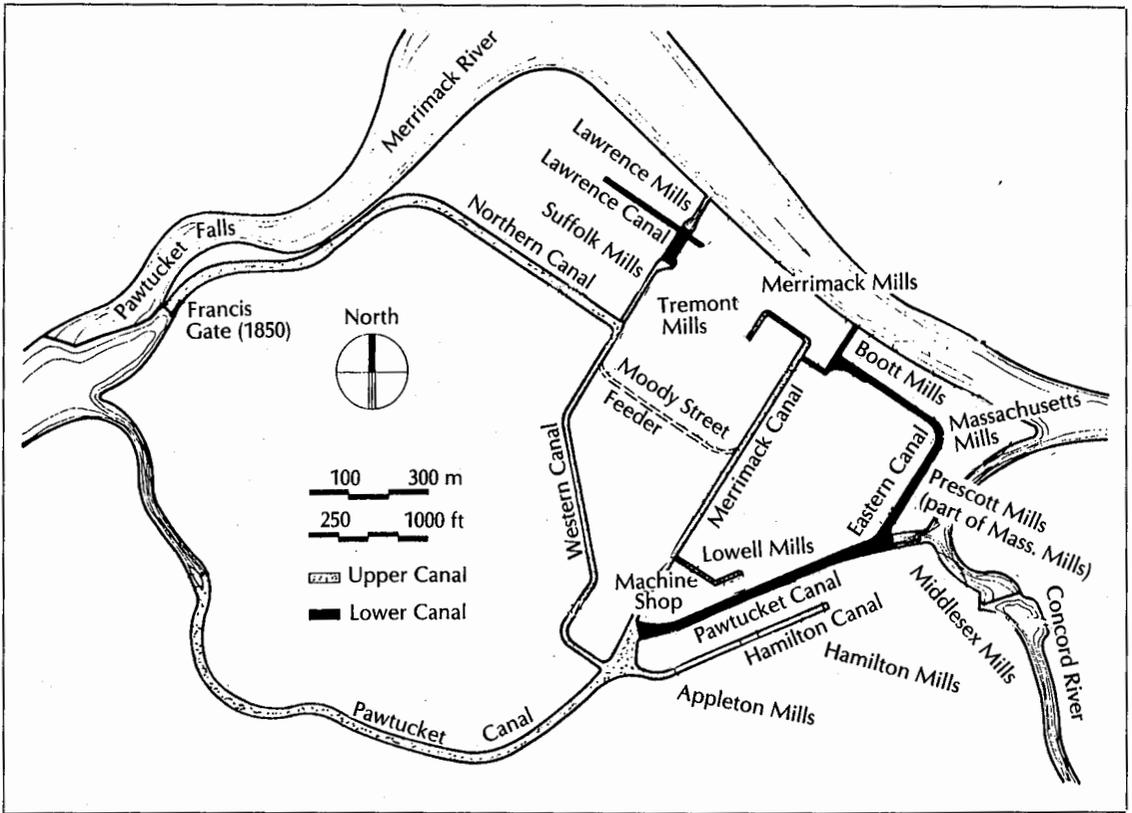
FIGURE 1. The Lowell canal system in 1848.
