Design & Construction of Deep Stone Columns in Marine Clay at Spectacle Island

Stone columns can be an effective ground modification technique. However, their implementation depends to a high degree on specific site characteristics.

ERIC M. KLEIN & RICHARD F. TOBIN

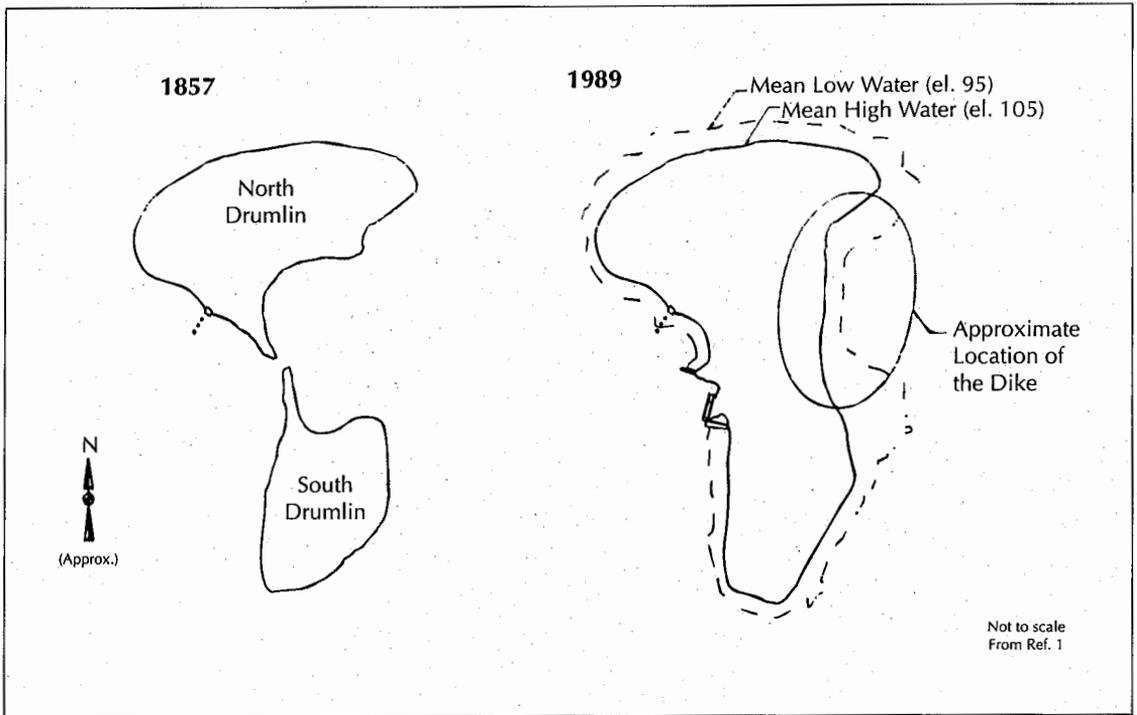
FIGURE 1. Spectacle Island plan.

1930, materials continued to be dumped on the island until 1960. The island has been unused since 1960. The outline of the island as it existed in 1989 is shown in Figure 1, where the extent to which the island was enlarged by offshore dumping of the refuse can be seen. The thickness of the refuse on the island varies up to about 100 feet near the center of the island. The thickness of the refuse is significantly less to the north and south. On the east side of the island, the refuse has been eroded by wave action, creating a bluff as much as 60 feet in height above the harbor. In addition, leachate from the refuse has flowed into the harbor.

A major construction item in the Spectacle Island disposal facility is a dike that has been constructed just off the eastern shore of a portion of the island (see Figures 1 and 2). The purposes of the dike are to:

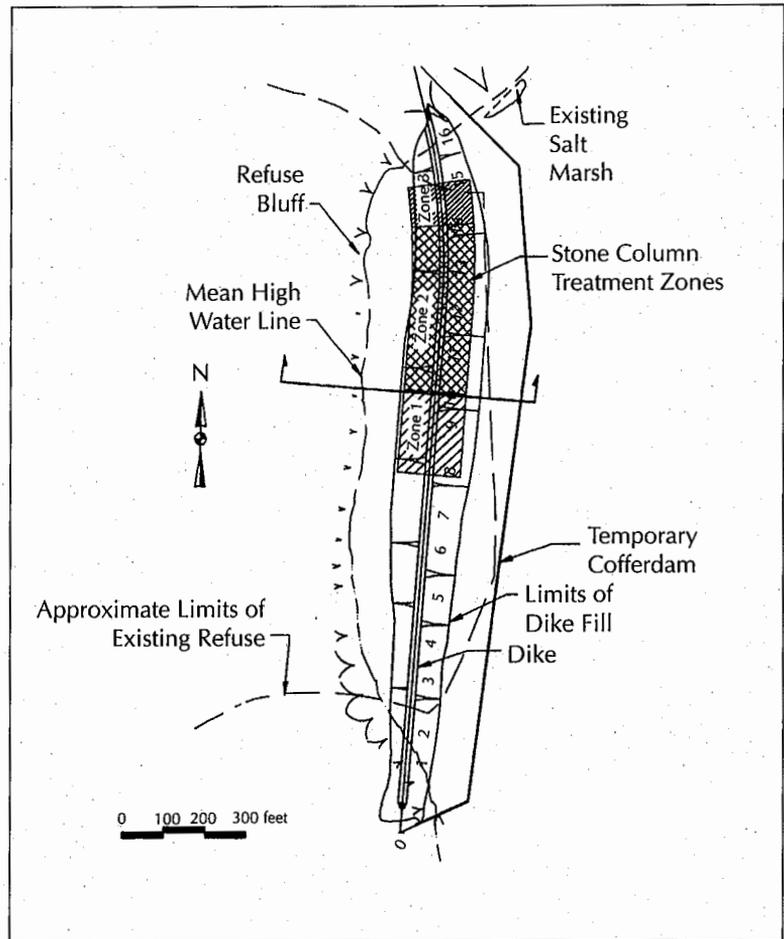
FIGURE 2. Dike plan showing the treatment areas.

A plan showing the cofferdam and dike alignments is shown in Figure 2. A cross section of the proposed dike is shown in Figure 3. The outside slope is 2:1 (H:V), and the backslope is 1.5:1. Proposed grades upslope from the dike are about 3:1. The maximum elevation of the island will be about elevation 270 on the north drumlin.

The final design called for a 150-foot-wide, treated area centered on the dike baseline (extending from dike station 8+00 to station 15+00). This area straddled the clay-filled valley. Three different area ratios were used, depending on the amount of treatment required to achieve the required factor of safety. Figure 2 shows the locations of the different treatment zones. Table 2 summarizes the column spacings in those zones, assuming a column diameter of 3.5 feet and a triangular arrangement of columns.

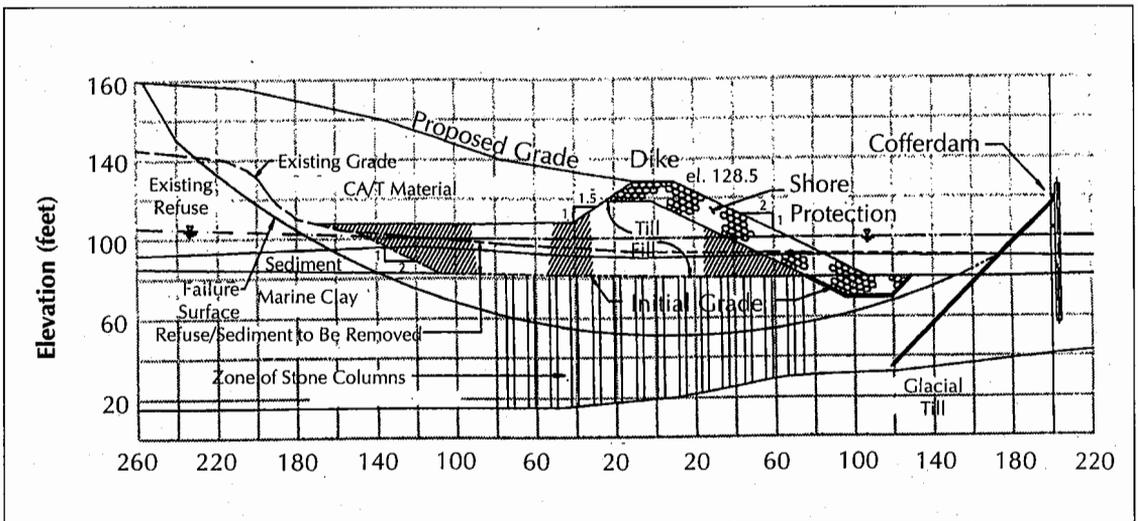
FIGURE 3. Dike cross section.

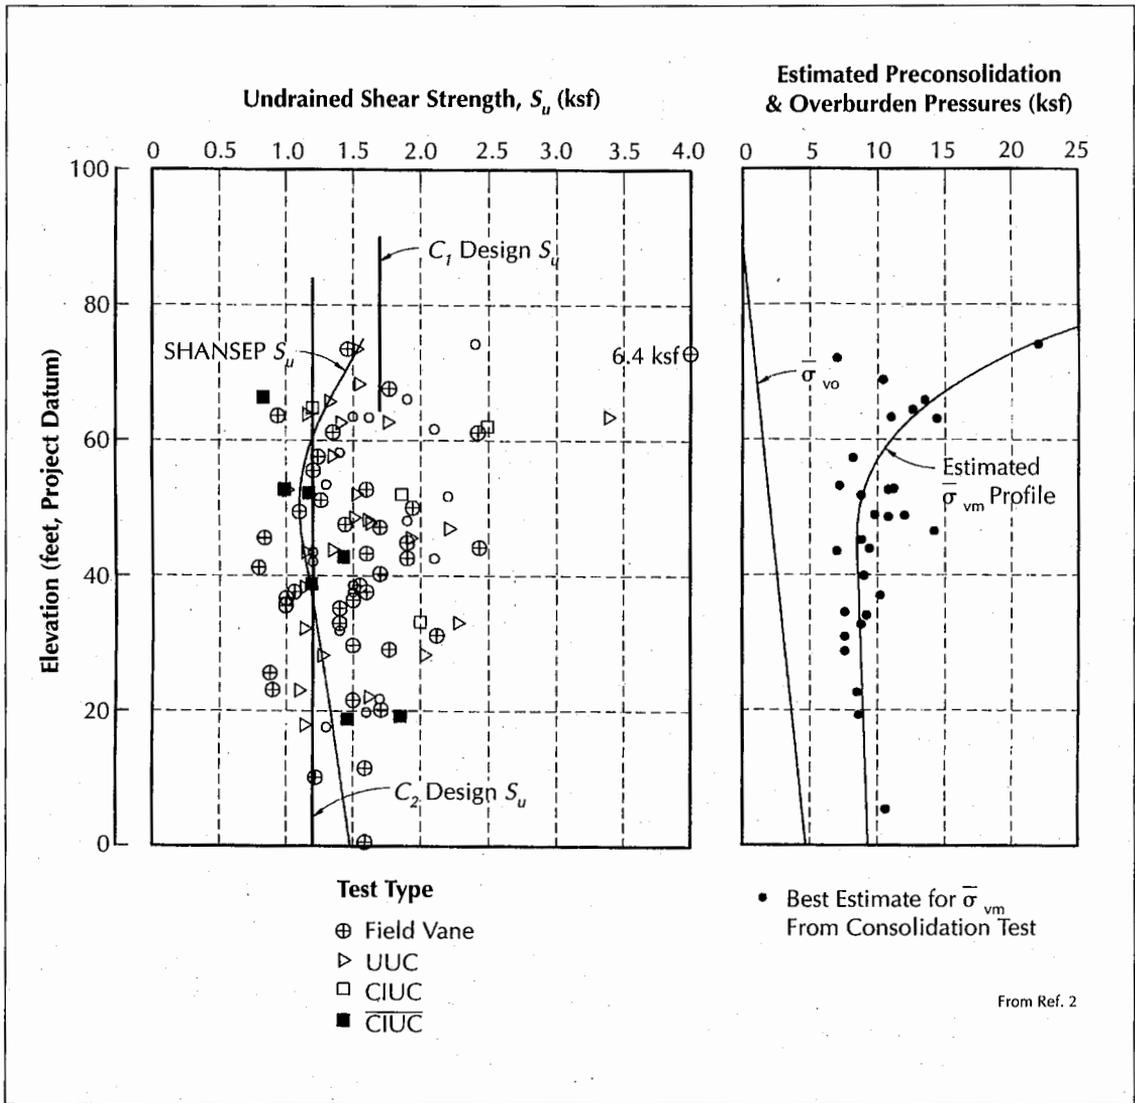
FIGURE 4. Soil property profiles.

The SPT blow counts (N-values) in the clay ranged from zero (weight of rods) to 78 blows/foot, with most values between 4 and 20 blows/foot. Stress history profiles from consolidation test data for the offshore clay are plotted in Figure 4. These profiles indicate that the offshore clay is heavily overconsolidated at higher elevations. The average overconsolidation ratio (OCR) in the vicinity of the dike decreases with depth from greater than 20 to about 2 near the bottom of the deposit.

For comparison of the various strength data for the offshore clay, a plot of undrained shear strength versus elevation (see Figure 4) was made using the SHANSEP approach.³ Based on this approach, the peak undrained shear strength, S_u , of typical clays is related to the effective overburden stress, σ_{vo} , and the OCR as:

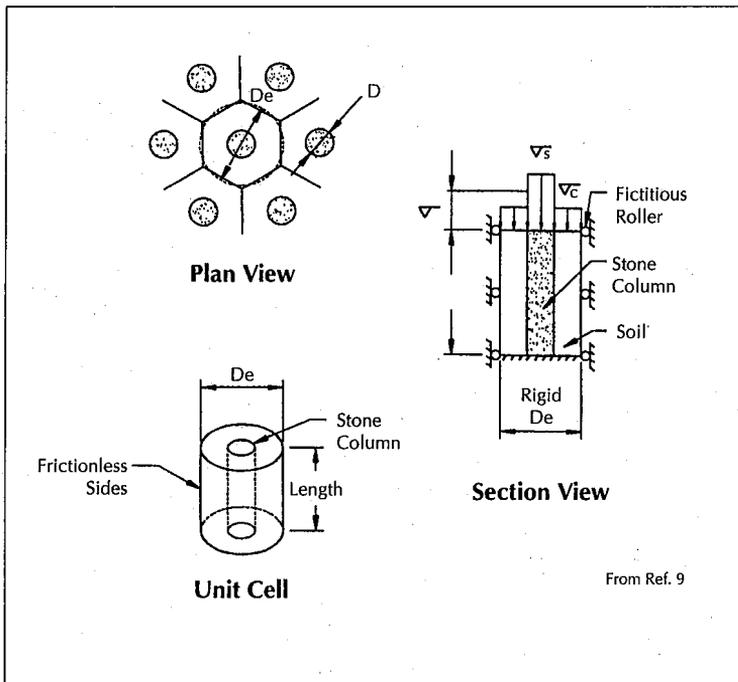
FIGURE 5. Unit cell.

Figure 5 illustrates the unit cell concept and the stress concentration ratio concept. The area ratio, a_s , is defined as the fraction of soil tributary area of the stone column replaced by the stone:

Figure 5 also illustrates another important concept — *stress concentration ratio*. Stress concentration occurs on the stone columns because the columns are stiffer than the surrounding clay and because the overlying embankment will arch loads from the clay onto the columns. This stress concentration effect only applies to loads applied after the stone columns are complete and not to the weight of the stone column. The stress concentration ratio, n , is defined as the ratio of stress applied to the stone column, σ_s , to the stress applied to the clay soil, σ_c :

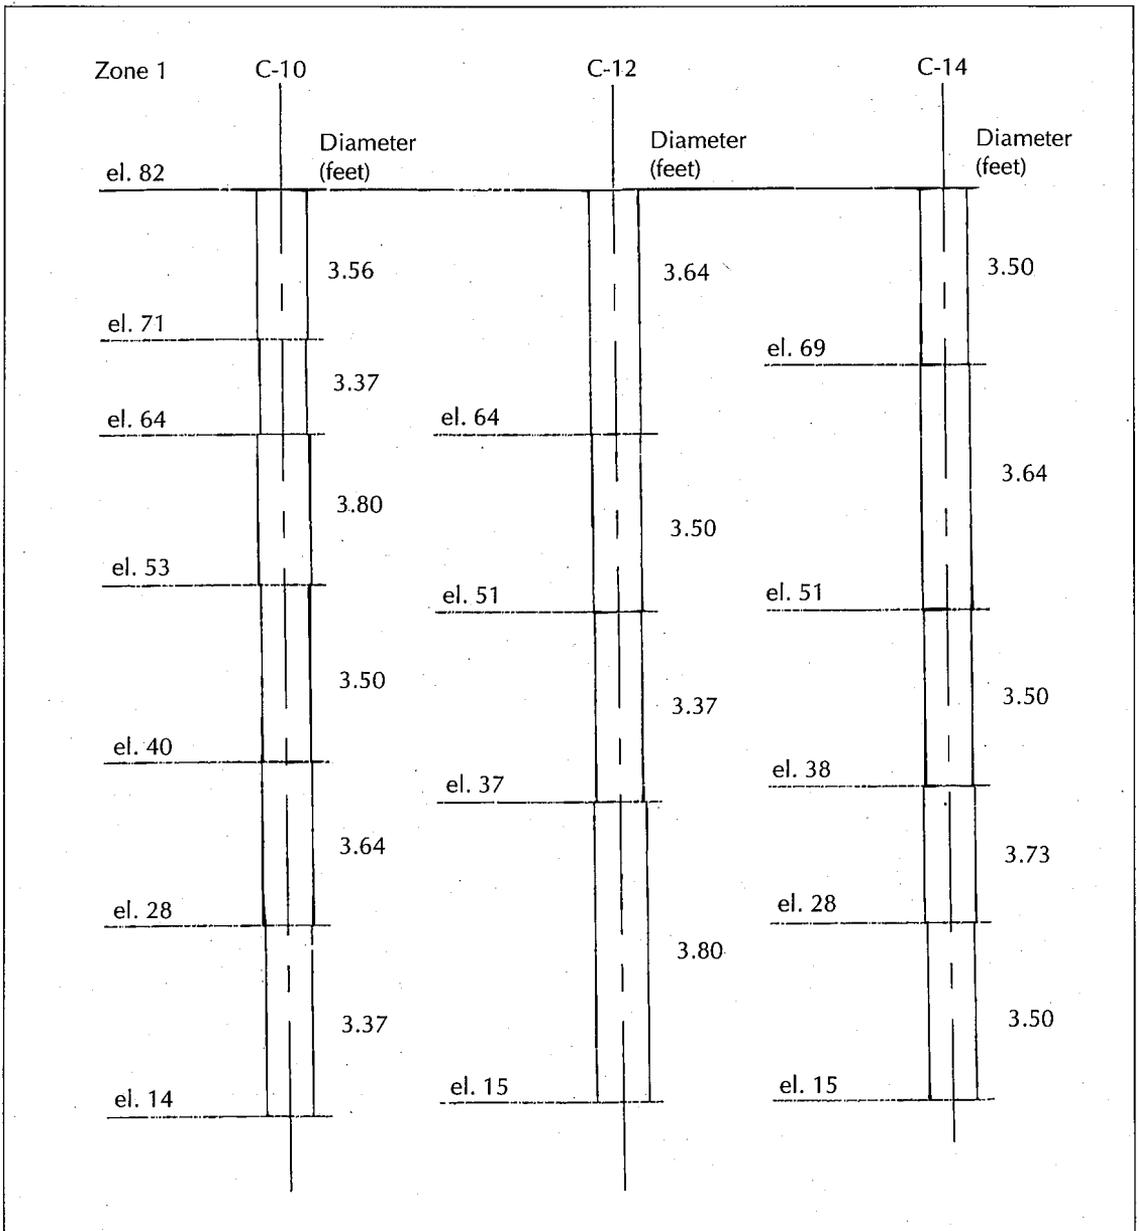
FIGURE 6. Cross section of typical stone columns.

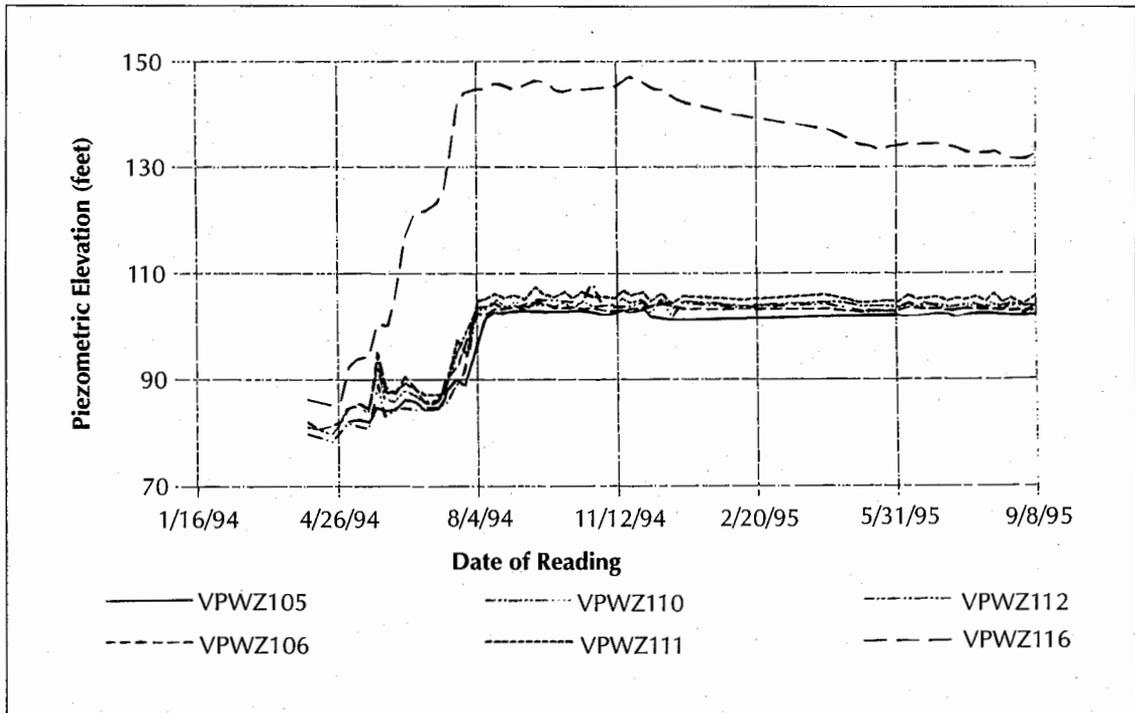
FIGURE 7. Measured piezometric levels in the clay below the dike.

Plots of piezometric level versus time for piezometers installed in the clay below the dike are shown in Figure 7. Measurements of pore

It can be seen on Figure 7 that the piezometric level in the treated zone rose up to slightly above mean sea level (elevation 100) in late-July 1994 when the cofferdam was flooded.

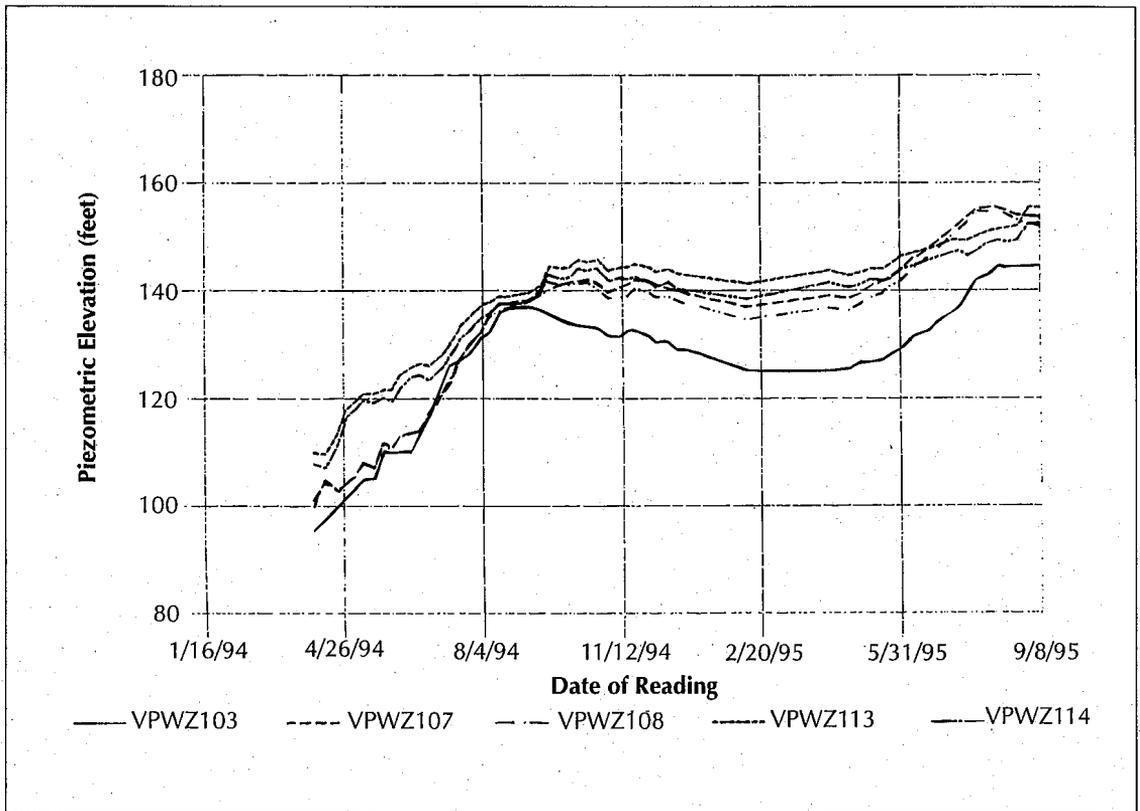
FIGURE 8. Measured piezometric readings behind the dike outside the stone column treated area.

Plots of piezometric level versus time for piezometers installed behind the dike (outside the stone column-treated area) are shown in Figure 8. These instruments are located in areas where CA/T fill was placed behind the dike to

a level at, or slightly above, the dike crest elevation. They show pore pressure increases similar to those measured at MS209. However, the pore pressure increases occurred much more gradually because the rate of fill place-
