Moving an Historic Lighthouse

Using an intricately phased process that required careful planning, this lighthouse structure was moved 450 feet across "soft" terrain and was saved, for the foreseeable future, from the effects of severe coastal erosion.

PETER PARAVALOS &
WAYNE H. KALAYJIAN

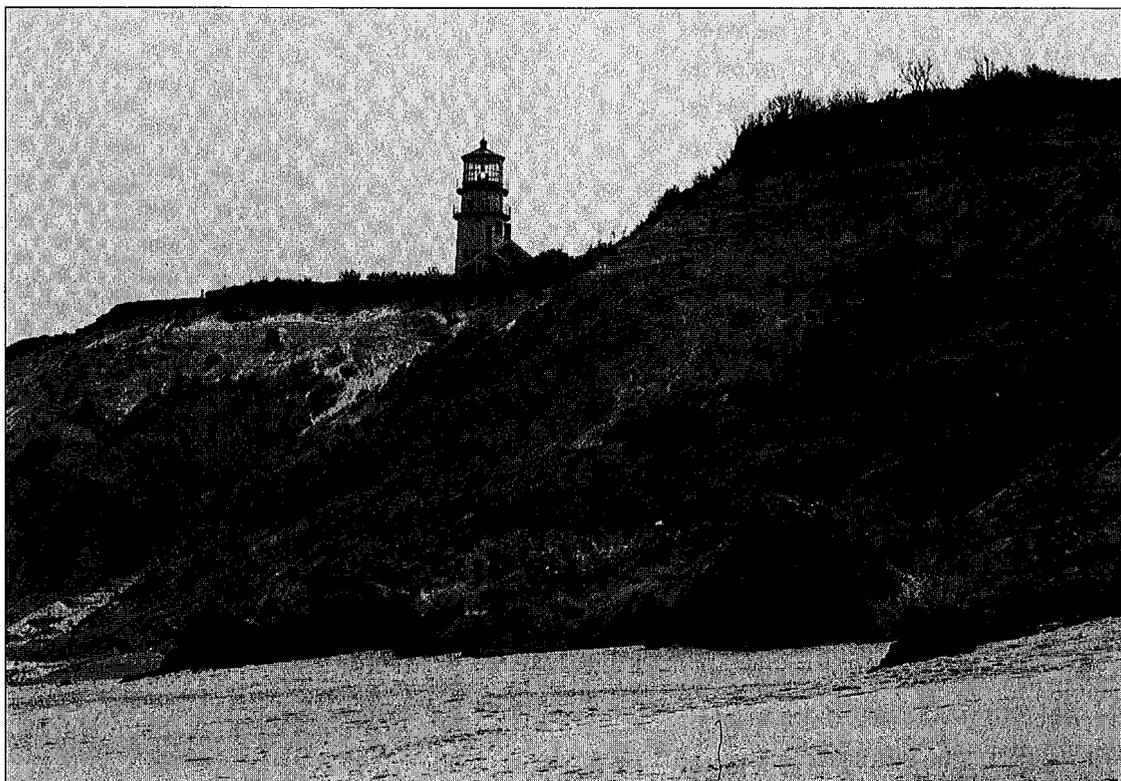
FIGURE 2. A view of the lighthouse from the beach.

Site. The lighthouse sat at the end of Highland Road overlooking the Cape Cod National Seashore (see Figures 1 and 2). It consisted of a tower that was equipped with an unmanned beacon, a one-story equipment room and connector building, as well as a two-story keeper's dwelling (see Figures 3 and 4). The complex was immediately flanked on the north and south by a nine-hole golf course that is maintained by the National Park Service.

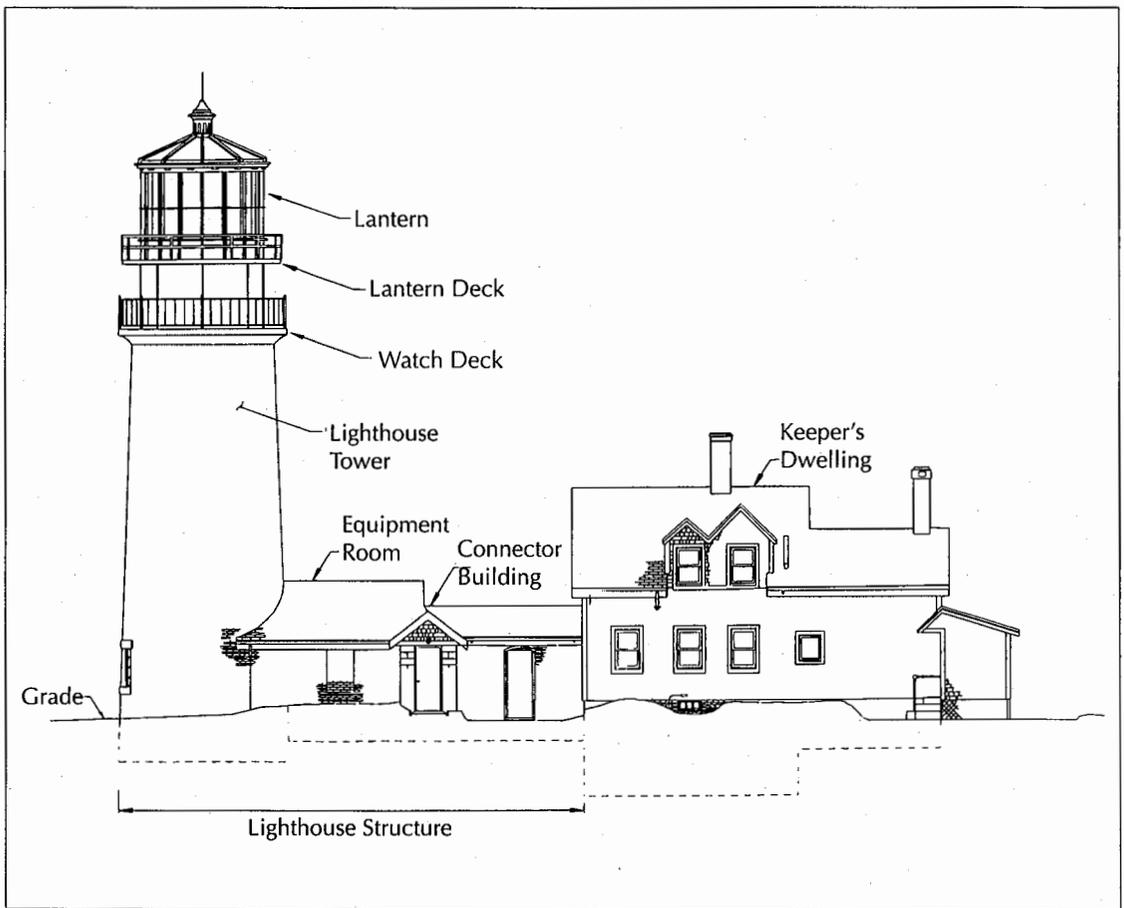
FIGURE 4. The Highland Lighthouse — east elevation.

Lighthouse Tower. The tower contained five levels: the ground slab at grade, the half-deck, weight-deck, watch-deck and lantern-deck. All of these decks were of steel plate construction. A cast-iron spiral staircase was bolted to the interior face of the tower wall and was the sole means of ascent to the lighthouse lantern. The inside diameter of the tower was approximately 11 feet and the top of tower stood at nearly 66 feet above grade (see Figure 4). Tower walls measured 3.5 feet thick and consisted of three brick masonry courses separated by two

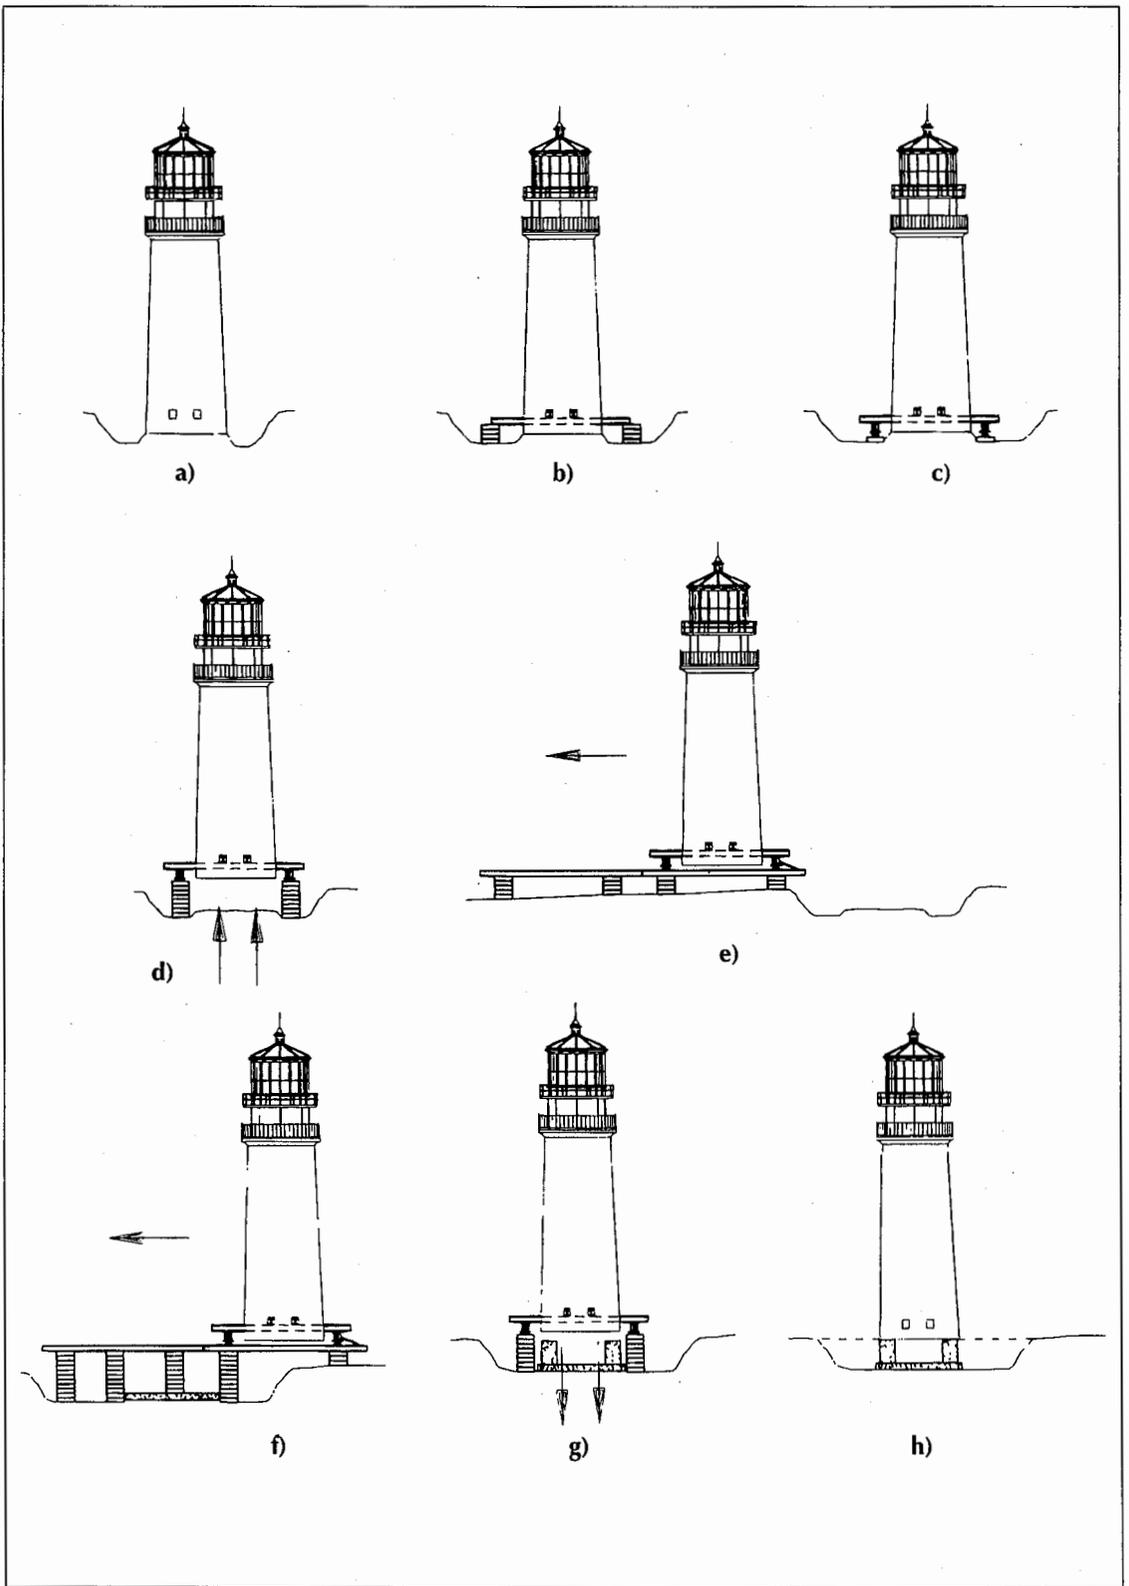
FIGURE 5. The construction sequence for moving the lighthouse structure.

In 1993, the construction contractor and subcontractor mover partnered to orchestrate the 360-foot move of the Southeast Lighthouse on Block Island (located in Rhode Island Sound). The Block Island project had been a "soft" move, where the lighthouse had traveled over unreinforced earth. The construction contractor anticipated that it would use a similar technique at the North Truro site. (In contrast, a rival contractor had unsuccessfully proposed a "hard" move approach for the Highland Light project. This method would have required pouring a concrete travel-way over which the buildings would have rolled.) Figure 5 shows the construction sequence for moving the lighthouse tower.

The second preparatory phase consisted of stabilizing the lighthouse tower and the equipment room/connector building, which would be moved as a monolithic unit. This phase required repointing the mortar in the brick walls, blocking over all windows with timber studs and wrapping the exterior of the tower with corsets consisting of 2- by 4-inch vertical timbers spaced at 3-foot intervals and wrapped together with wire (see Figure 7). Next, a 5-foot deep continuous trench was excavated around the base of the entire structure, thereby exposing the foundation walls (see Figure 5a).

that would lift the lighthouse structure (see Figures 5c and 9).

to eliminate the effects of uneven cribbing and localized ground settlement. All jacks were then switched into unified mode and fourteen of the twenty-six jacks (seven on each side of the tower) began the initial lift. To compensate for the structure's asymmetrical massing, jacks closest to the tower exerted between 3,500 to 4,000 psi. Jacks nearer to the equipment room exerted between 1,200 to 1,500 psi. Once the structure had been raised one full stroke (16 inches), the fourteen extended jacks were temporarily locked into zone mode, and additional cribbing was shimmed under the twelve remaining jacks that had not been used during the initial lift. With new cribbing in place, these twelve jacks then lifted the lighthouse structure another full stroke. This technique was repeated until the building had been lifted 5 feet, at which point workers could access its underside and wrap the masonry base with steel banding in order to maintain its structural integrity (see Figure 5d).

ture would travel on seven rails rather than two (see Figure 12). Each rail consisted of two 40-foot long W14x140 sections connected end-to-end. These girders were detachable, so that as the lighthouse structure crept toward the end of one section, the other could be maneuvered to swing around and re-attach to form a continuous rail system. To provide a smooth and firm rolling surface, a horizontal ¼-inch thick steel plate was welded to the top flange of each beam. The bolted connections between the roll beams were designed to transfer substantial shear stress as the lighthouse structure travelled from one W14 section to the next (see Figure 5e).

A lateral force of 500 psi was exerted by each ram, pushing the building one full stroke (5 feet), at a rate of about 20 feet per hour. After each stroke the rams were reset (which meant that they were disconnected, retracted and rebolted to the roll beams to prepare for the next push). In this fashion, the lighthouse structure was moved to its new location in ninety push strokes (see Figure 5f).

Once the base of the lighthouse had been moved and was directly aligned 8 feet above its new foundation, the crawler dollies, rollers and roll beams were completely dismantled. Then the 450-ton structure was slowly lowered by means of reverse jacking until the required beacon focal elevation was reached. To compensate for the difference in elevation between the old and new sites, additional structure was installed under the base of the lighthouse (see Figure 5g) — a 3.5-foot wide

concrete bearing wall cast as a sandwich between the top of mat footing and bottom of the building. Once the concrete had cured, the lighthouse was plumbed, pressure supplied by the jacks was released and the weight of the structure was slowly redistributed onto the new bearing wall and footing (see Figure 5h). As expected, consolidation of the sandy soil was nearly instantaneous, with minor cracking occurring between the tower and the adjoining equipment room.

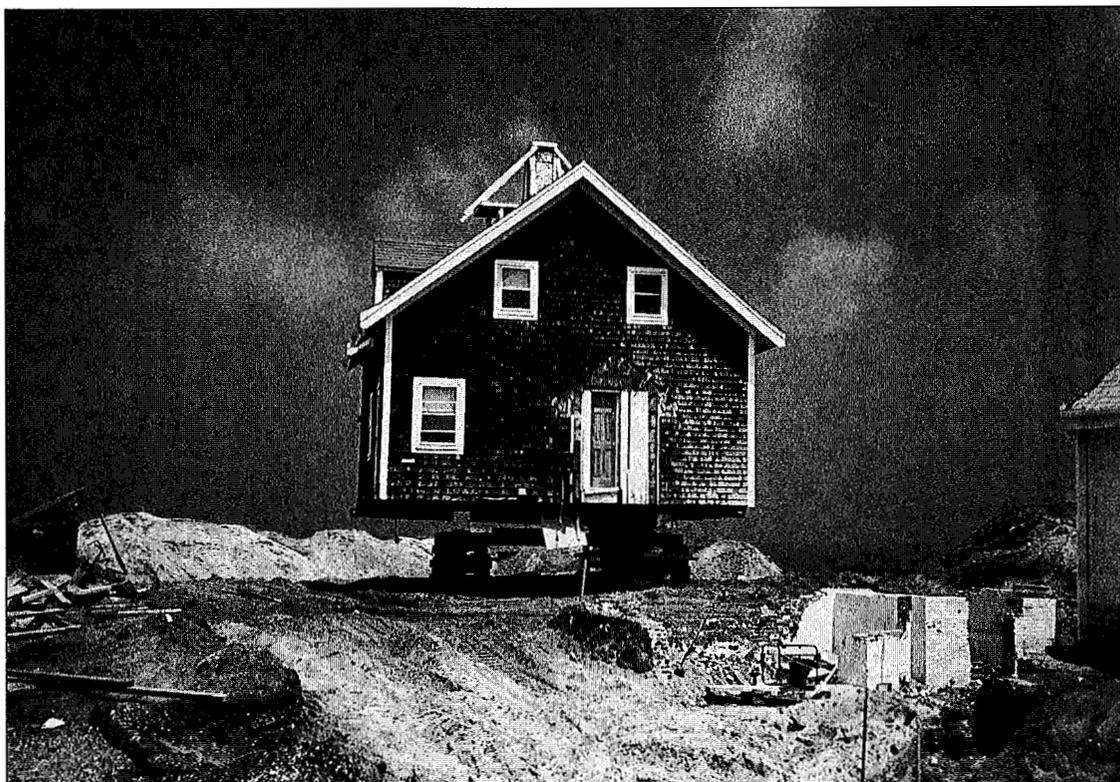
FIGURE 6. A view of the jacked keeper's dwelling.

were then threaded through these holes to support the floor framing system. After that the connection with the adjoining connector building was severed, and the keeper's dwelling was jacked 8 feet vertically in the air and rolled 30 feet to the north (see Figure 6).

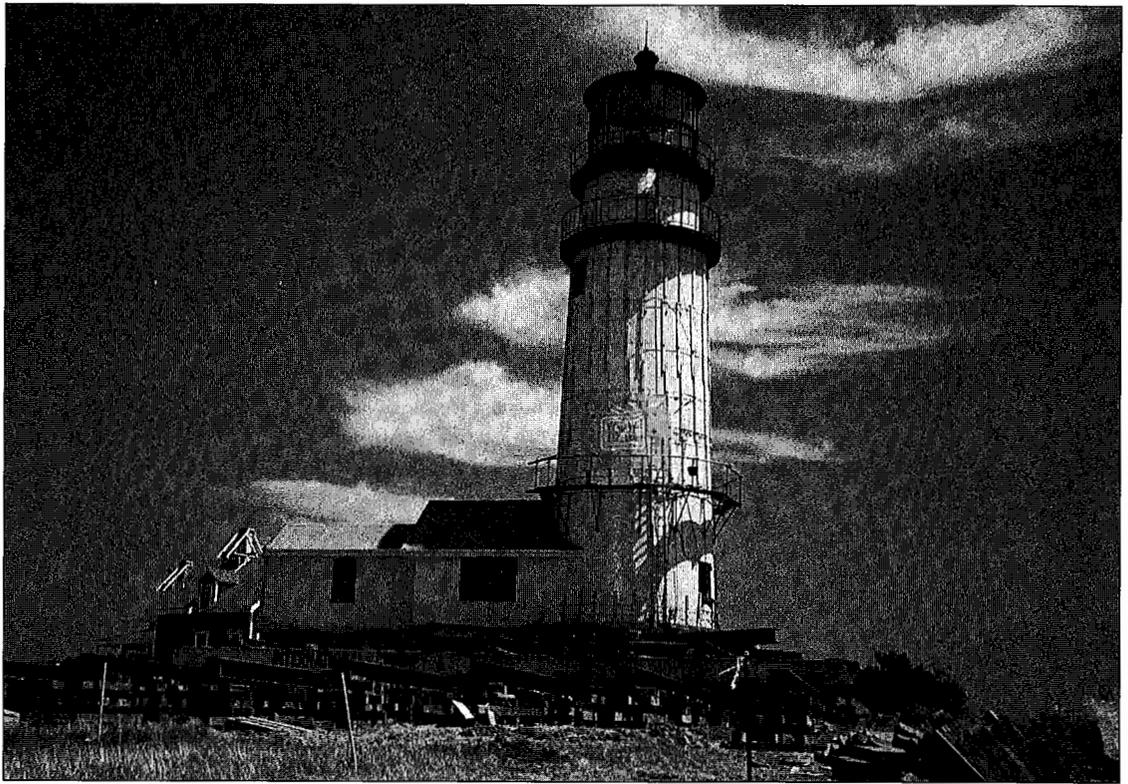
FIGURE 7. A view of the lighthouse tower with corsets.

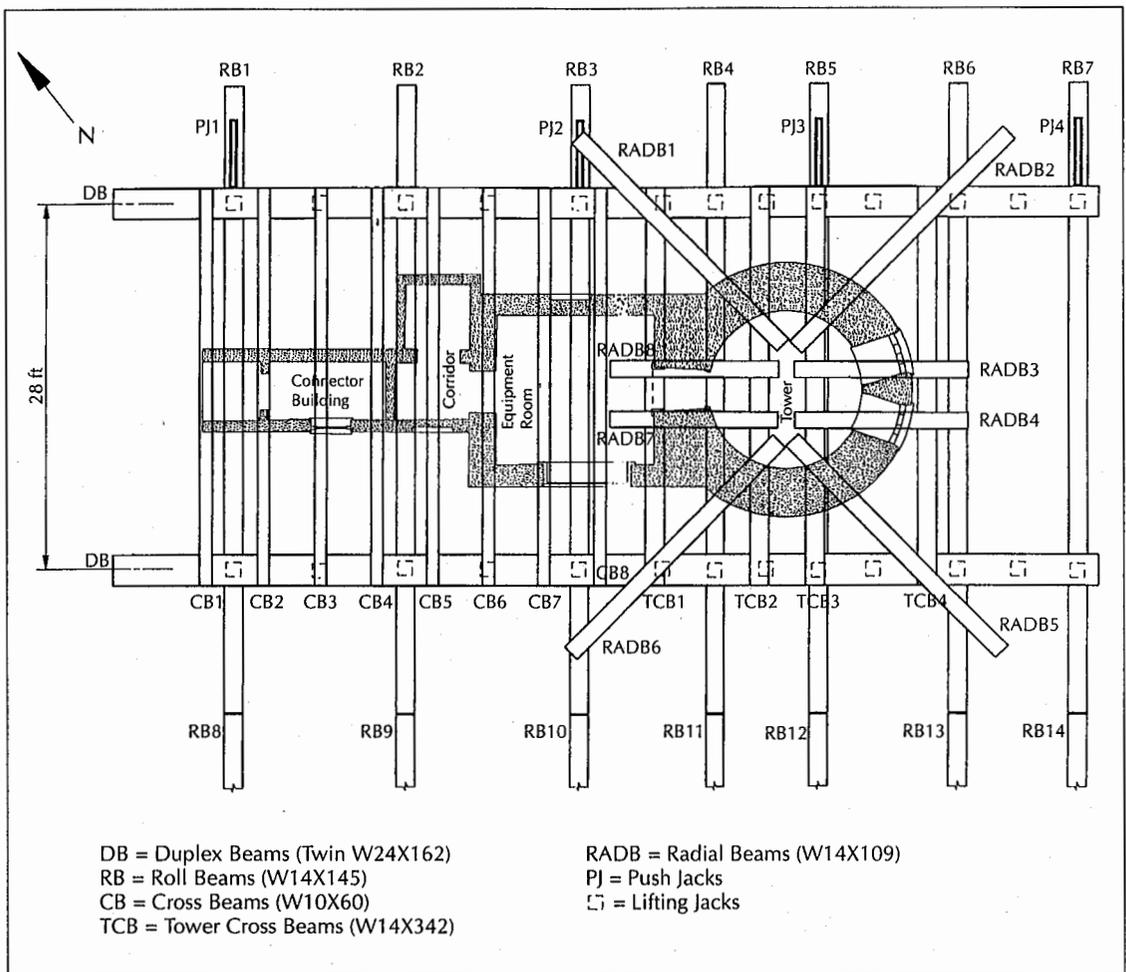
FIGURE 8. A plan view of the temporary steel frame lifting system.

To support the lighthouse structure for the duration of the move, the moving subcontractor developed an intricate temporary steel framing system (see Figure 8). To install this framework, twelve square openings were precisely cut around the circumference of the tower foundation wall using a diamond-impregnated cable-saw. Next, two W14x342 cross beams were threaded through the east and west wall openings in the tower foundation. Each of these beams were supported on two stacks of oak cribbing located 5 feet from the tower face (see Figure 5b). To ensure that lifting pressures would be uniformly distributed onto the flanges of the W14 cross beams throughout the jacking process, oak lintels were installed at the top of each wall opening, and any remaining voids across the opening were grouted solid.

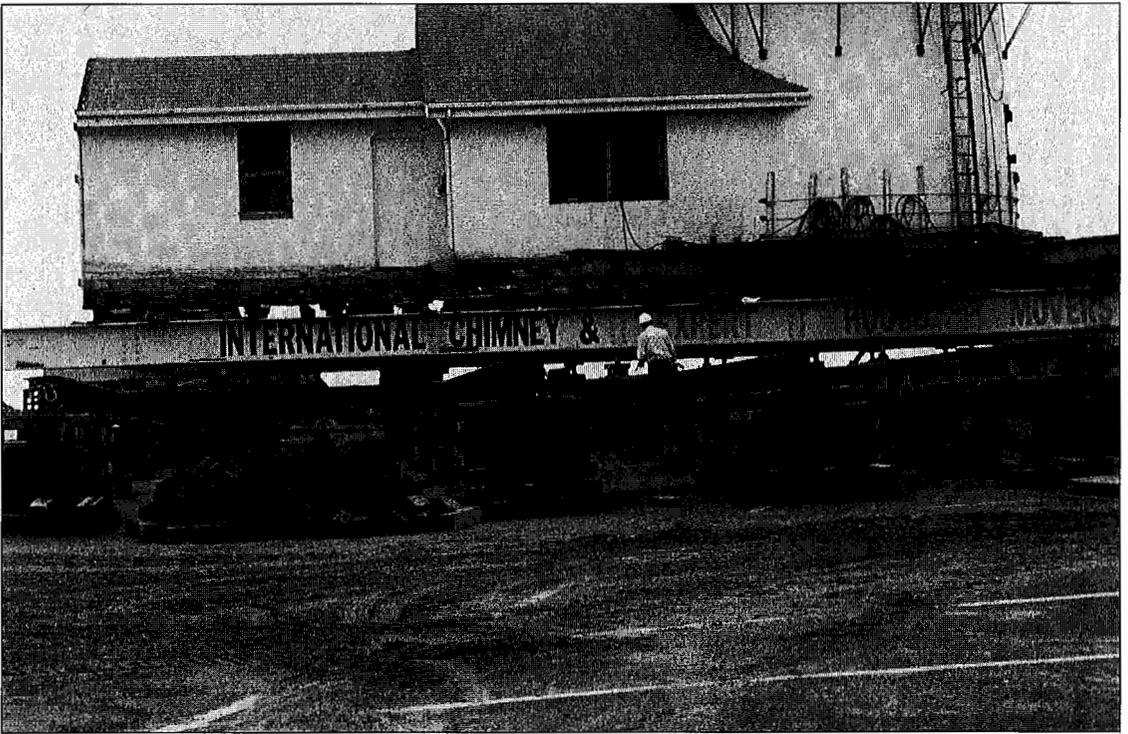
FIGURE 9. A view of the jacks lifting the lighthouse structure.

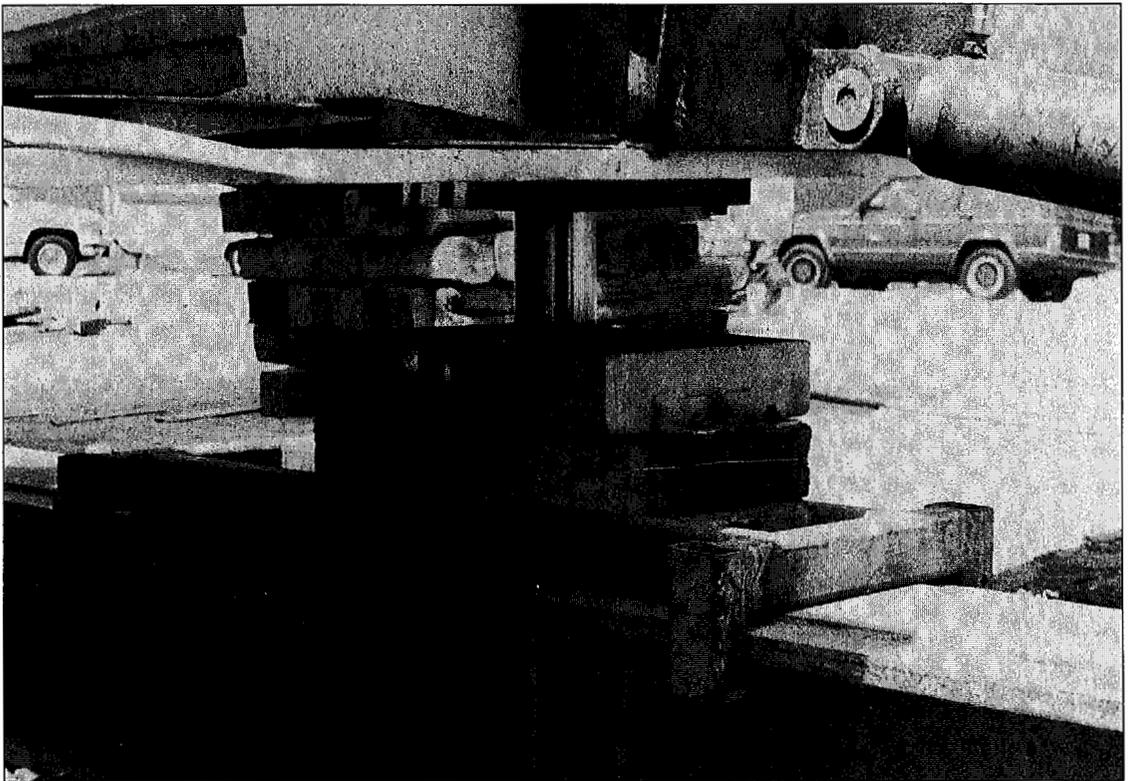
FIGURE 10. Roll beam and crawler dolly under a jack.

tal of 15 feet above grade. To stabilize the building in its temporarily raised position, stacks of cribbing were shimmed under twelve of the jacks. Once this was accomplished, steel "roll" beams and "crawler dollies" were inserted under the remaining fourteen jacks, which would enable the lighthouse to slide laterally across the site (see Figure 10). Each dolly assembly consisted of eighteen steel cylinders (1 inch in diameter and 3 inches long) that were encased in a housing box that resembled the tread configuration of a Sherman tank. The roll beams were then braced with steel tubes in order to maintain their horizontal alignment, while the flanges and webs of the duplex beams were also braced to the cross beams above with diagonal W6 steel sections (see Figure 11).

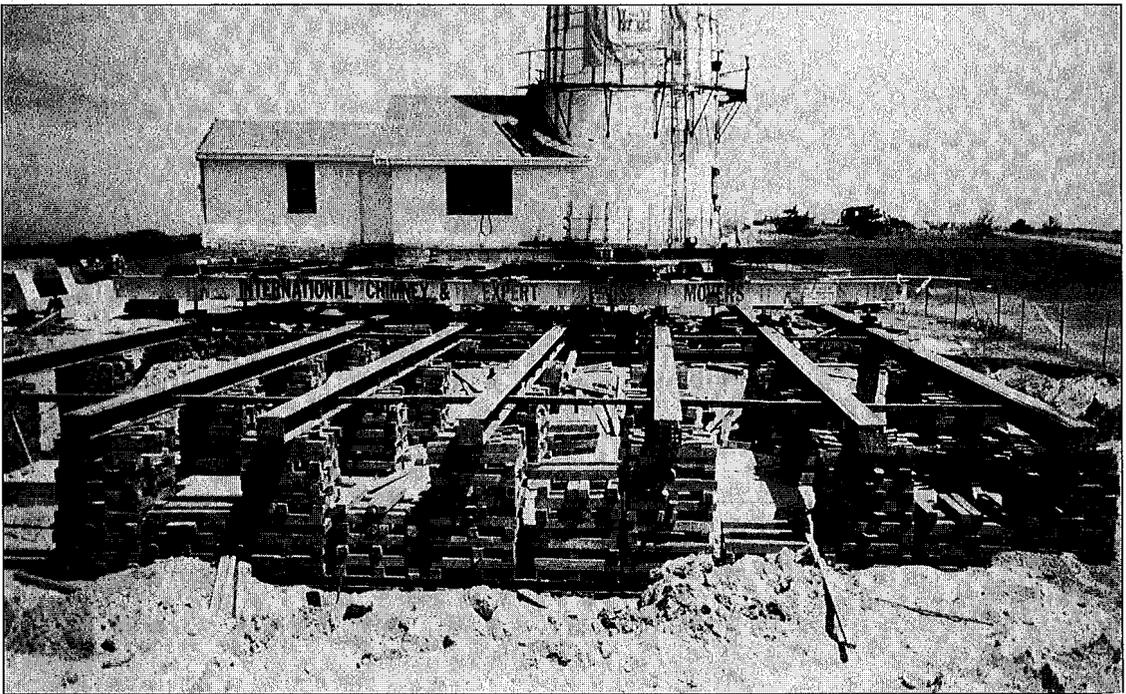
FIGURE 12. The lighthouse structure moved on seven rails.

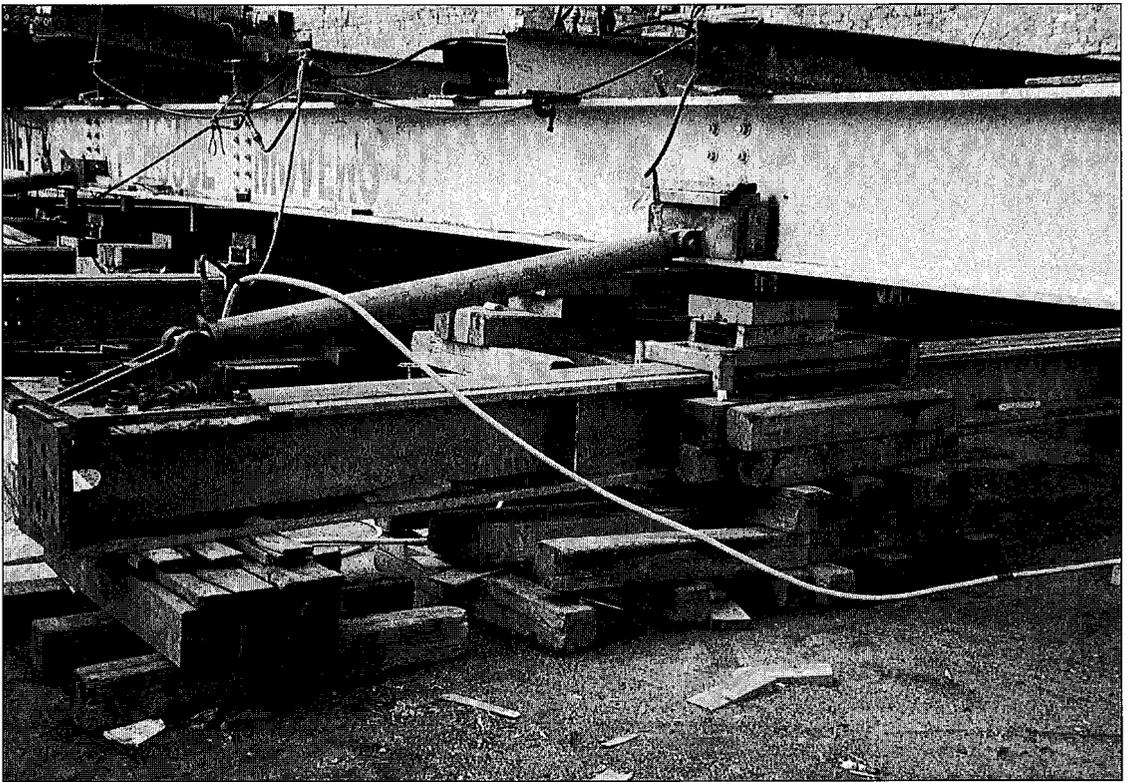
FIGURE 13. A view of the push rams.

nected to the duplex beams (see Figure 13). Prior to the first horizontal push, all hydraulic lines were checked against blockage, and household soap applied to all roll beams. The soap would lubricate the roll beams while also producing a greasy film among the rollers. Using the soap would make the lighthouse structure easier to maneuver along its serpentine route.
