Ultrasonic Inspection of Waterfront Timber Structures: An Economic Advantage to the Marine Facility Owner

Ultrasonic inspection is a viable alternative to traditional means of inspecting underwater wooden structures, which can be misleading and which can result in greater repair and maintenance costs.

CRAIG R. MORIN, SCOTT CHRISTIE
& KURT FEHR

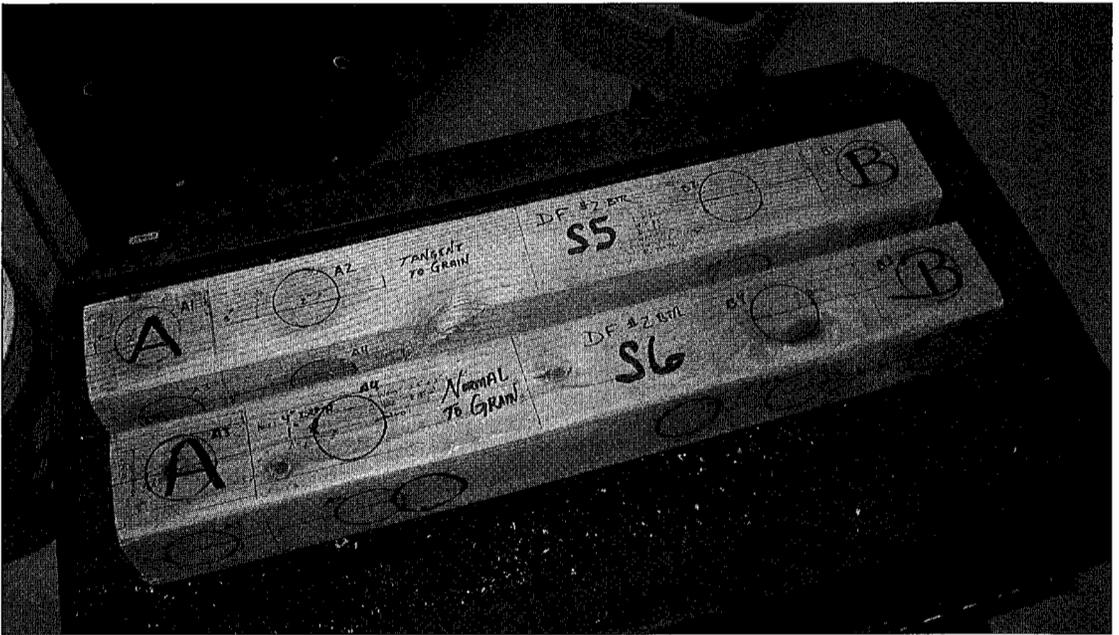
FIGURE 3. Douglas fir sample specimens S5 and S6.

of deterioration (see Figures 3 through 8 on the next three pages). Voids were introduced by drilling holes at the ends of the members at least 4 inches deep that ranged from 0.375-inch-diameter holes to slotted holes 4 by 1.25 inches wide. Where large voids were placed near the ends of a member, a smaller void was placed between 4 and 8 inches from the end to increase the number of tests.

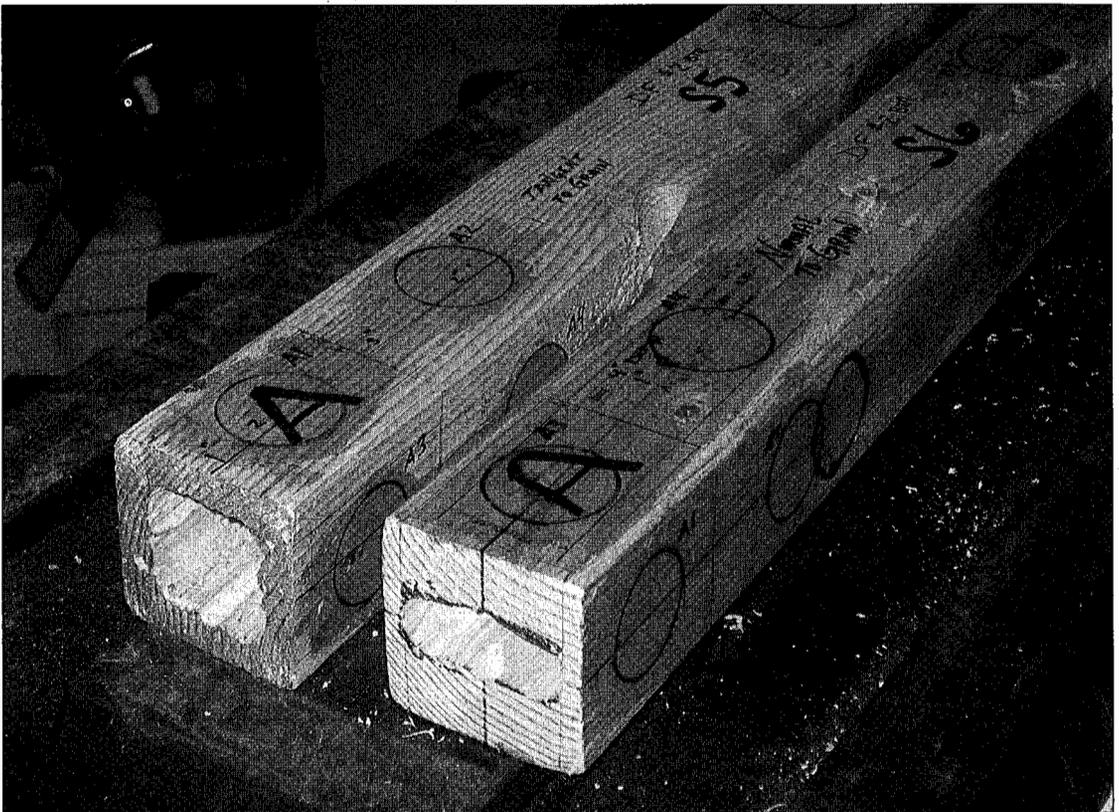
FIGURE 4. Douglas fir sample specimens S5 and S6 at Side A. Voids were created at the ends of the members to simulate internal deterioration. Circles indicate the locations for transducer placement.

Three readings were independently obtained at each test location, and the readings were taken in both directions in order to account for grain directionality. The averages of the three readings are shown in Tables 1 through 4 (on pages 13 to 14), along with the corresponding velocity. Based on these results, a suggested condition rating scale is presented in Table 5 (on page 15).

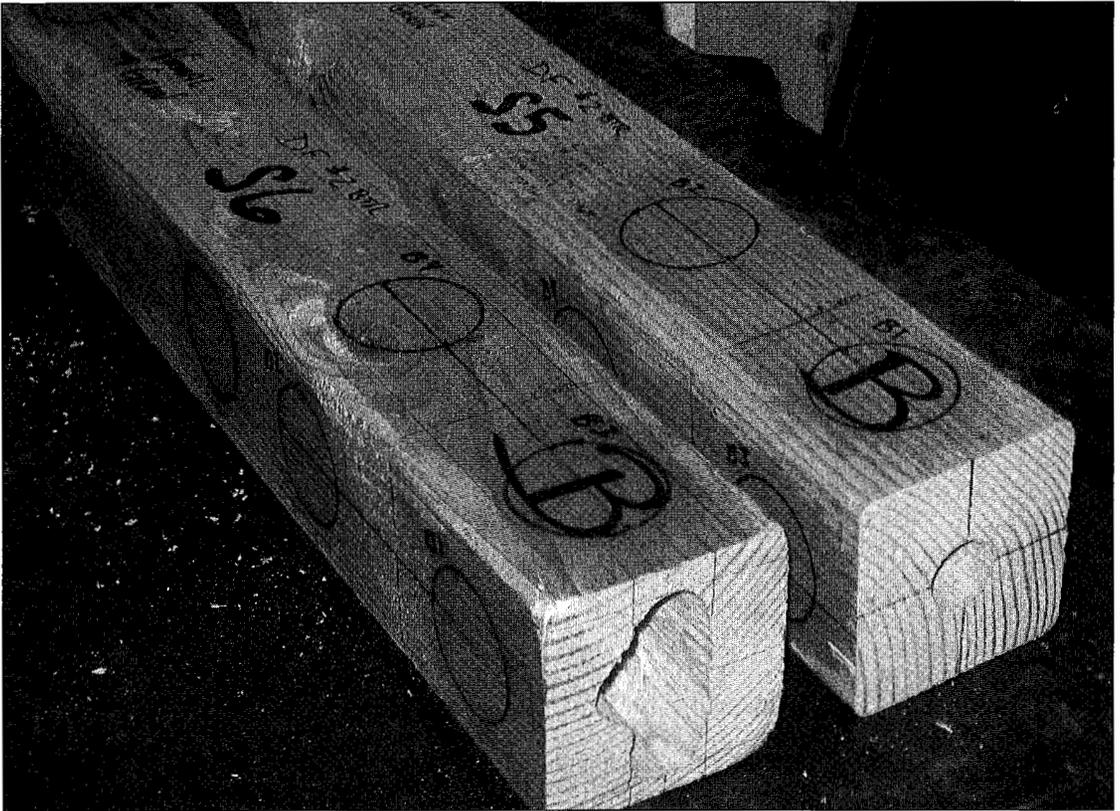
FIGURE 5. Douglas fir sample specimens S5 and S6 at Side B. Similar voids and circles are shown.

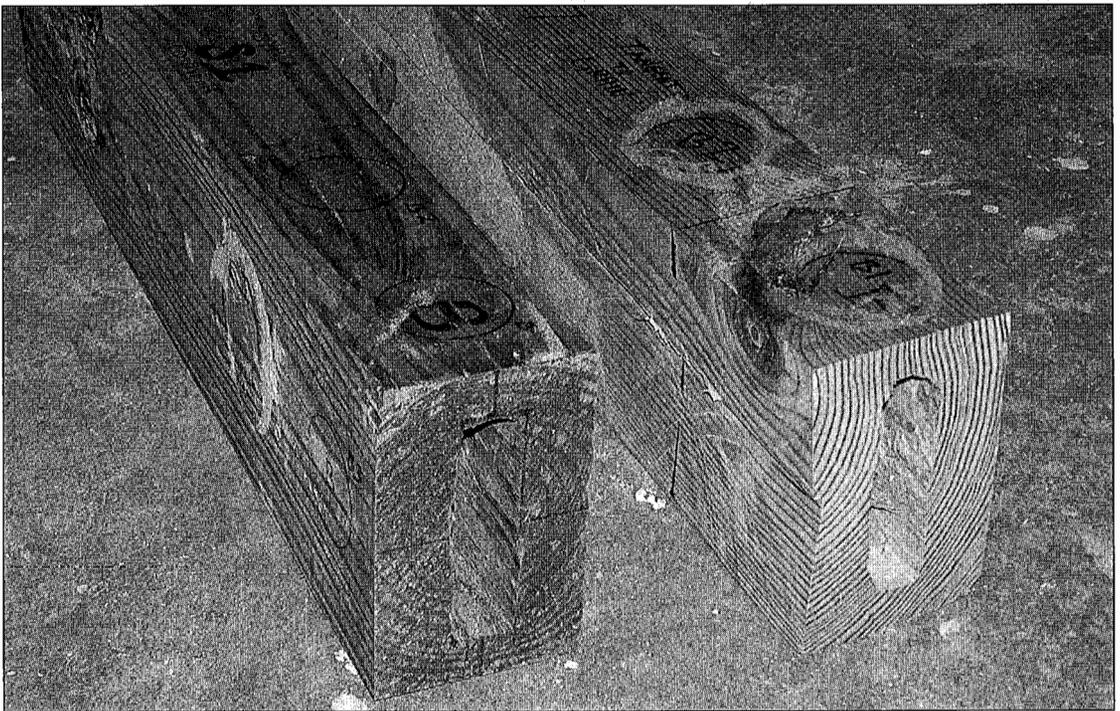
FIGURE 8. Southern yellow pine sample specimens S1 and S7 at Side B. Similar voids and circles are shown.
