PRUDENTIAL CENTER FOUNDATIONS

By DONALD G. BALL,* MEMBER

(Presented at a joint meeting of the Boston Society of Civil Engineers and American Society of Engineers, held on November 18, 1959).

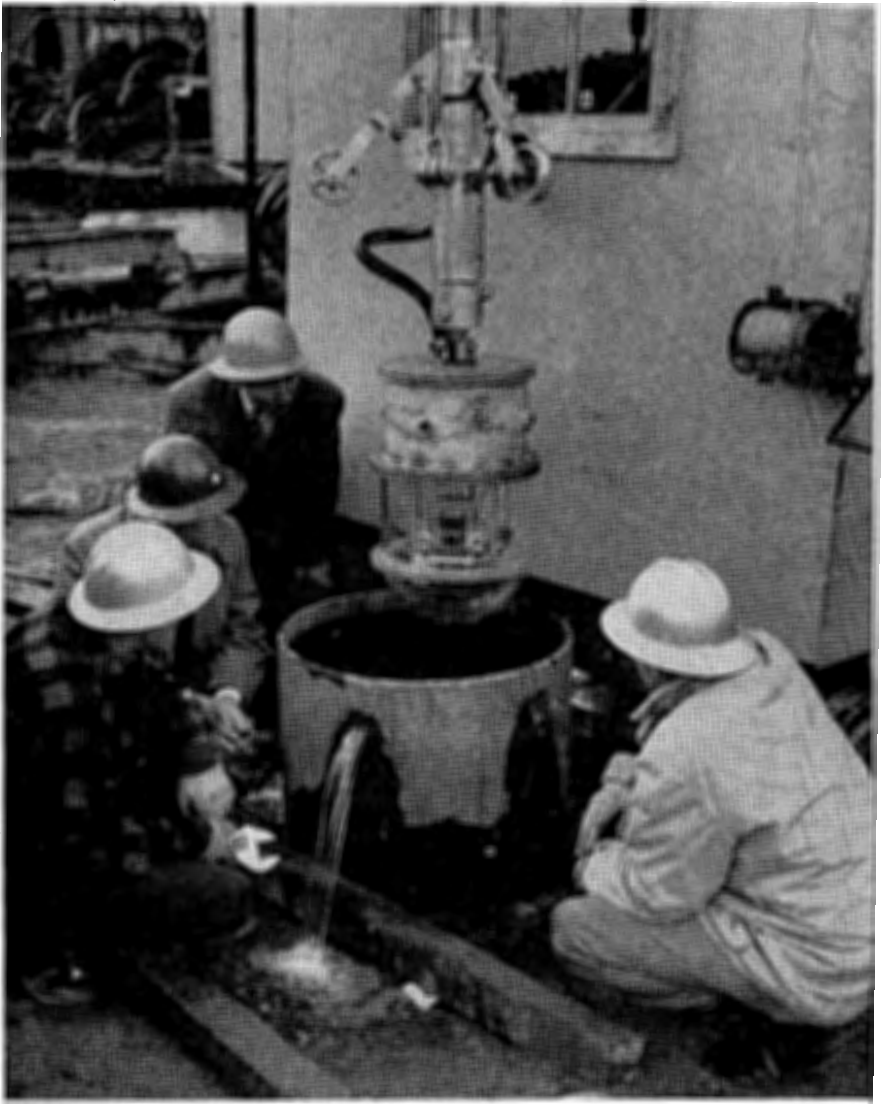
FIGURE 4.—UNDERWATER TELEVISION CAMERA DESIGNED TO OPERATE 160 FEET BELOW WATER SURFACE.

In the caisson construction, a pervious bedrock combined with a high water table has made inspection of the drilled rock sockets impractical to accomplish in the dry. It is expected that a few caissons can be pumped out for direct inspection by a man lowered into the bottom, but in general most of the caissons have too rapid an inflow of water. To carry out a satisfactory inspection of these sockets, an underwater television apparatus, Fig. 4, was specified capable of operating in about 160 feet of water. The use of underwater TV is not new, but we believe that this is the first time it has been used for inspection of caisson sockets. The apparatus has just been given its first trial run. Fig. 5 is a photograph of the TV monitor screen showing the lower edge of a caisson shell and the upper part of the rock socket.
