CIVIL ENGINEERING PRACTICE •

JOURNAL OF THE BOSTON SOCIETY OF CIVIL ENGINEERS SECTION/ASCE

FALL 1990

Bridge Rehabilitation

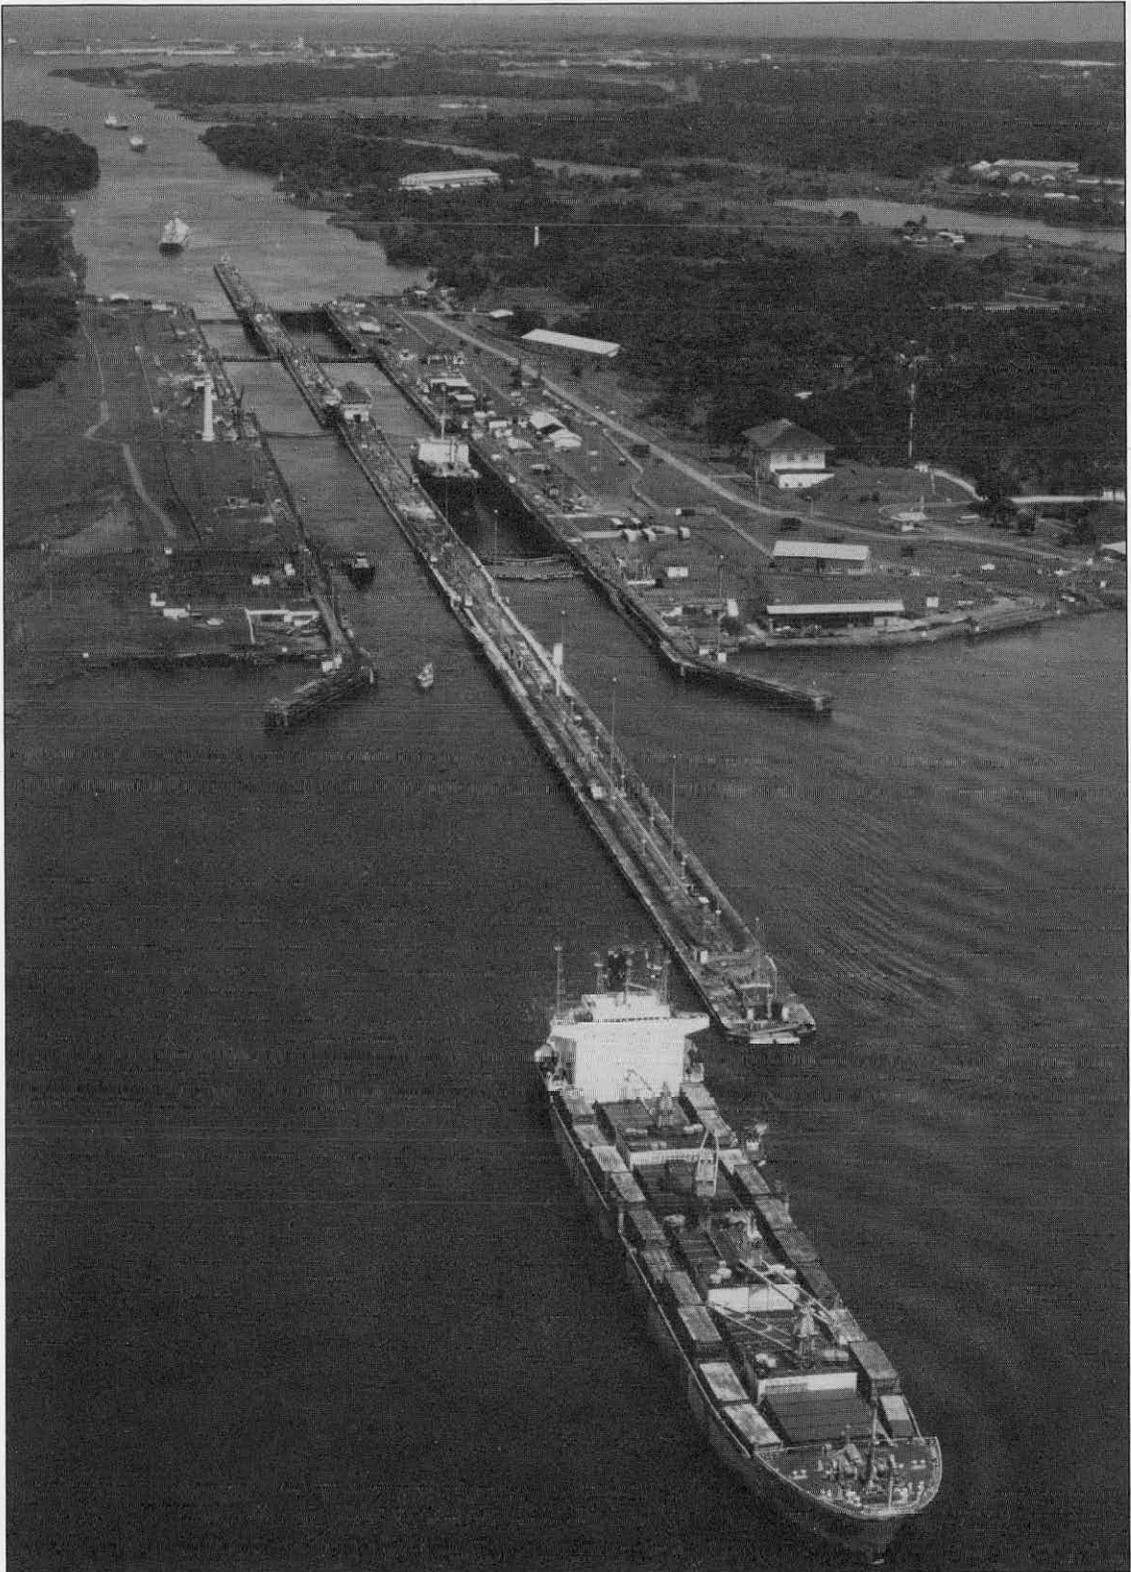
FIGURE 14. Gatun Locks.

The construction of the dam and locks at Gatun was placed in the hands of Colonel Sibert who had worked on the famous Poe Lock on the Soo Canal and had other experience in building locks and dams around Pittsburgh (see Figures 14 and 15). His relations with Goethals were strained, but they never reached the breaking point. He did, however, get his licks in when he collaborated with John Stevens in a book entitled, *The Construction of the Panama Canal*,⁶ in 1915.
