CIVIL ENGINEERING PRACTICE •

JOURNAL OF THE BOSTON SOCIETY
OF CIVIL ENGINEERS SECTION / ASCE

SUMMER 2022

Green Line Extension (GLX) from the Program Manager's Perspective	John Dalton	5
The Gateway Bridge and The Complete City Street: A Merger	Peeyush Rohela Edward T. Baumann	8
Bridge Repair Priority Ranking System	Nasser Yari	17

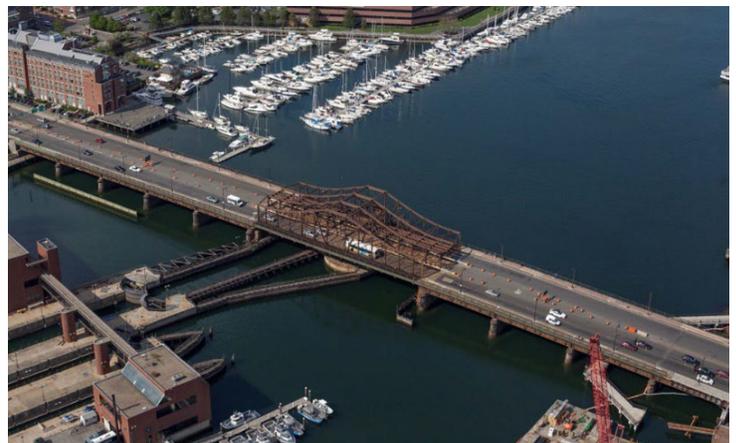
Figure 1 The Old North Washington Street Bridge

The Charlestown Bridge was originally constructed in 1898 to carry North Washington Street, two trolley car tracks and two elevated street railway tracks from Keany Square in Boston to City Square in Charlestown. The elevated railway tracks and their support framing had subsequently been removed and the street railway tracks had been paved over. The Charlestown Bridge (Bridge No. B-16-016) consisted of three different structures and carried North Washington Street over the Charles River, Water Street and the adjacent warehouses underneath the bridge deck in Boston. The focus of this article is the bridge over the Charles River or the Inner Boston Harbor that is being replaced. The other two bridges are being rehabilitated. The existing, now demolished, bridge over water was a twelve span structure with five approach spans on either side of the main, two span swingable structure. The central swing, two span structure consisted of four steel through trusses, floorbeams, stringers and an open steel grid deck. The

swing spans had an overall length of 240 ft. The swing spans were fixed permanently in the closed position in 1962.

The existing fender system was installed on both sides of the pivot pier and along the adjacent piers as seen Figure 1. The fender system was generally in fair to poor condition with minor collision damage, deteriorated wooden and steel piles and the walkways along the fenders had several floorboards missing.

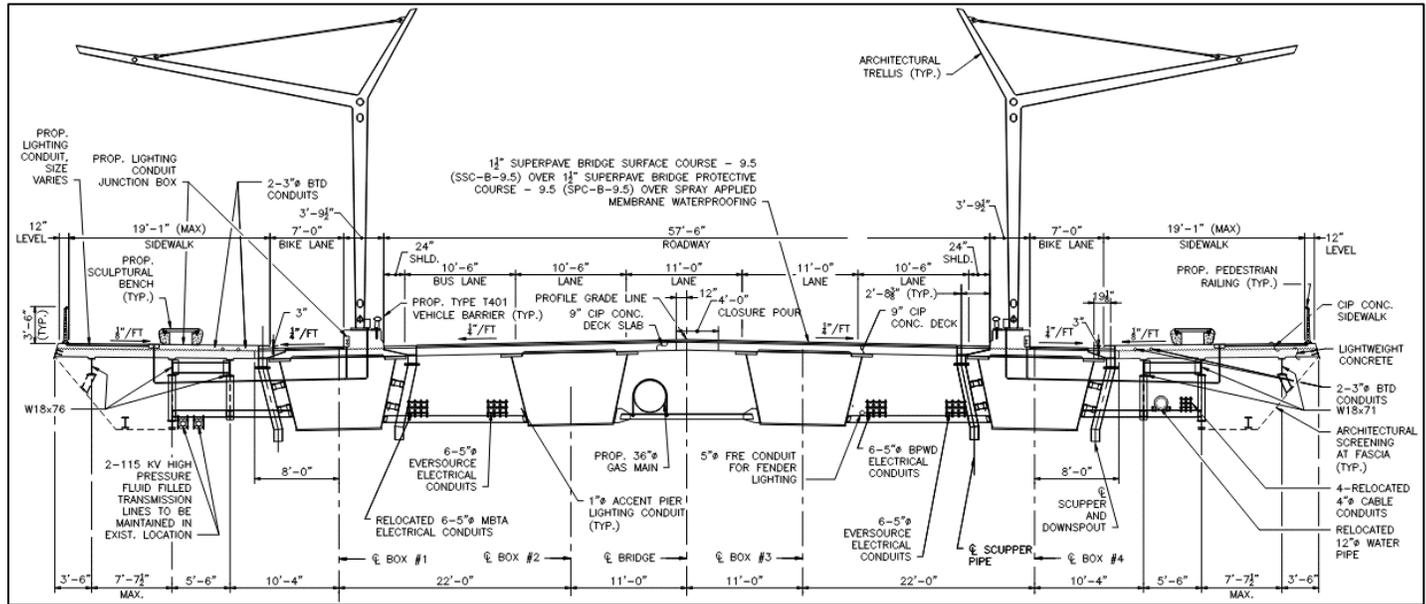
Figure 2 Bridge Cross-Section at Span 7

The design parameters required that the bridge carry five lanes of vehicular traffic totaling 57 ft 6 in in width, two 7 ft wide bicycle lanes separated from the vehicular lanes by 3 ft 6 in wide traffic barrier and two 10 ft 6 in wide sidewalks to comfortably accommodate pedestrian traffic. The sidewalks would be widened to a maximum width of 19 ft at the main span above the navigable channel. This required large overhangs from the exterior girders. The girders themselves could not be spaced further apart because of the constraint imposed by the two high pressure fluid filled 115 kV transmission lines supported from the existing bridge, which were required not only to stay in place throughout the bridge replacement but also needed to be supported every ten feet.

The central swing spans on the existing bridge consisted of four trusses with three two lane roadways located between each truss. The center two lanes were closed to traffic years ago due to deterioration of steel structural members. It would also not have accommodated traffic during construction without requiring extensive repairs. It was also determined that constructing the bridge in three phases was not feasible as it would have resulted in three narrow longitudinal construction zones. Based on the traffic counts, two lanes were needed in the southbound direction and one in the northbound direction throughout construction. Design-phase plans included construction of a temporary bridge to replace the easterly swing spans after demolition of the two easterly trusses in the first stage. After relocating the traffic to the eastern side of the bridge, the western side of the bridge would be demolished entirely and reconstructed while the utilities would be relocated to a temporary utility bridge constructed west of the bridge in the second stage. The third stage proposed demolition of the remaining eastern existing structure along with removal of the central temporary bridge and reconstruction of the entire eastern side of the bridge in the third stage.

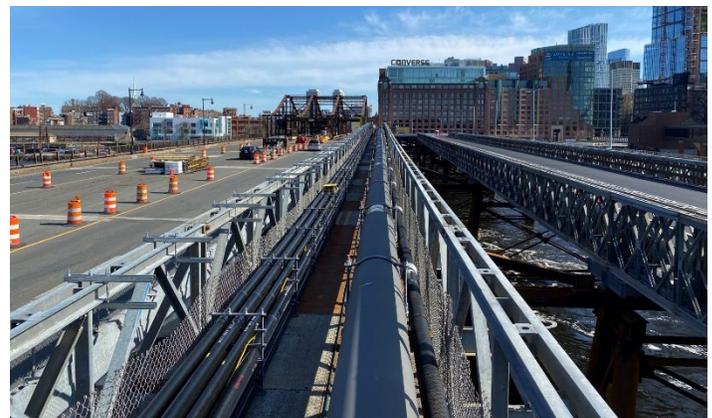
Figure 3 Existing Bridge (Left), Temporary Utility Bridge (Middle) and Temporary Bridge (Right) looking South

This scheme involved the substructure and superstructure to be built in two major stages, each consisting of two lines of box girders and a substructure unit below each of the girders. The box girders were the ideal choice for the proposed construction sequence because of their stability, even in a partial cross-section configuration with two lines of girders, and high torsional rigidity. However, during construction phase, the staging sequence was modified to construct a nearly full length temporary bridge alongside the existing bridge to carry three traffic lanes and one sidewalk. This temporary bridge would lie to the west of the existing bridge on temporary steel pile bents. The temporary steel bents would also support the temporary utility bridge to maintain the numerous utilities crossing the bridge throughout construction. This utility bridge would be adjacent to the existing structure after demolition of west sidewalk of the existing bridge. These two temporary bridges would allow the construction of nearly the entire bridge cross-section to progress from the north abutment to the south abutment (Figure 3).

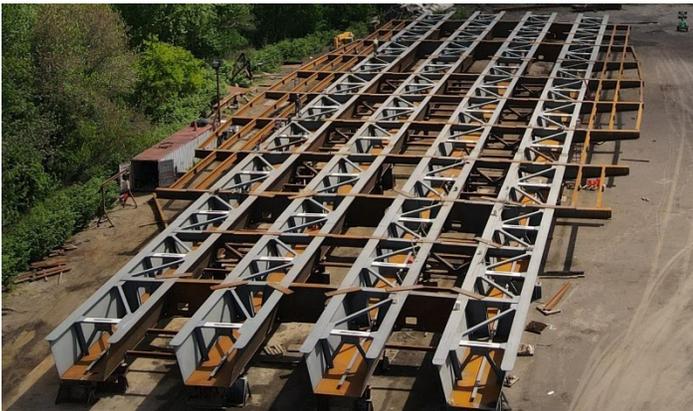
Figure 4 Fit-up of Span 7 Steel Framing in Construction Yard

The framing plan of the bridge shows 36 transverse and continuous floorbeams to support the wide sidewalks proposed on this bridge. The intermediate floorbeams are partial depth in relation to the tub girders while the floorbeams acting as end diaphragms are full depth at intermediate and end bridge supports.

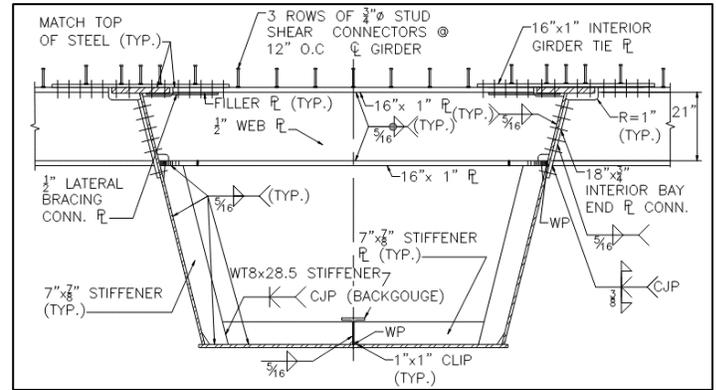
Figure 5 Interior Floorbeam and Interior Girder Connection in Approach Spans

A typical intermediate floorbeam at the interior and exterior tub girder is shown in Figure 5 and Figure 6. A bolted tie plate was designed for the continuity of the top flange of the floorbeam and en plate moment connections were provided for the web and bottom flange connections through the web of the tub girder.

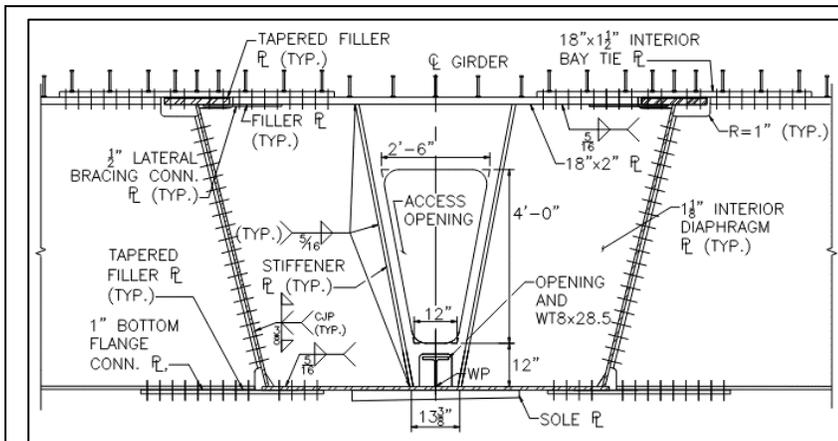
Figure 10. End Floorbeam at Interior Girder at Approach Spans

The floorbeams designed as full depth end diaphragms at the bridge supports are made continuous by utilizing bolted top and bottom flange splices as shown in Figure 9 and Figure 10. Similar to the intermediate floorbeams, the end diaphragms are also connected to the deck with stud shear connectors.

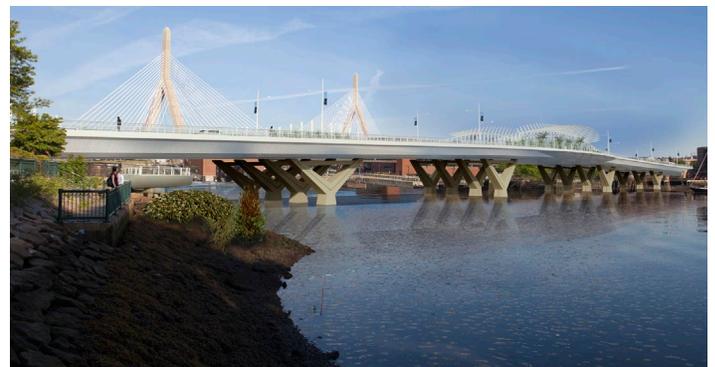
Figure 11. Proposed Bridge Elevation Showing V-Piers Reflecting the Pyloos of the Zakim Bridge (Rendering)

A V-Pier at pier locations 2 through 5 consists of four V-Pier columns (Figure 12 and Figure 13), arms and post-tensioned ties. The arms of each V-Pier extend out 25 ft from the centerline of the column and rise up to 30 ft from the base of the column. Owing to shallow depth of Pier 1, it was designed as a solid V-Pier without the triangular opening between the tie beam and the arms. High performance concrete would be used in the construction of column stem and arms. Connecting the arms together is to be the post-tensioned concrete tie beam.

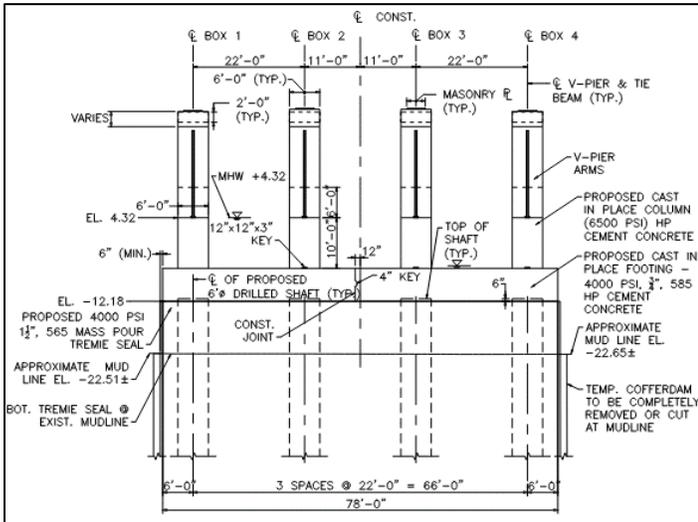
Figure 12. V-Pier 3 Transverse Elevation

The four pier columns at each pier location share a footing which would be supported on eight 6 ft diameter drilled shafts. The drilled shafts extend 40 ft. to 80 ft through layers of silt and till before being socketed into competent bedrock. The length of the rock sockets in competent bedrock vary from 10 ft to 27 ft between different piers.

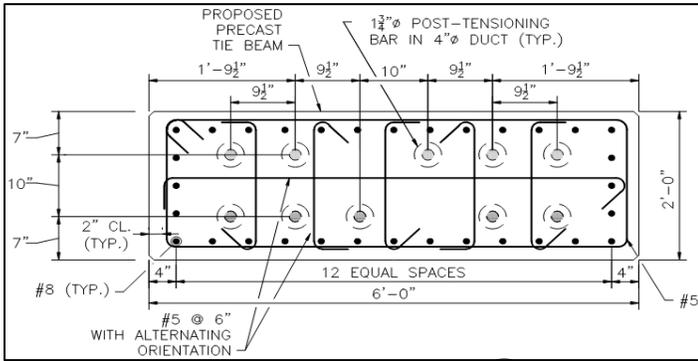
Figure 15. Post-tensioned Concrete Tie Beam

The tie beam is a 6 ft wide and 2 ft deep post-tensioned concrete beam connecting the tops of the north and south pier arms together (Figure 15). Each tie beam has ten 1³/₄ in diameter 150 ksi steel post-tensioning bars placed in 4 in diameter high density polyethylene (HDPE) ducts.

At Pier 1, the entire post-tensioning jacking force of 2200 kips is applied in one stage with estimated post-tensioning loss of 9%. At Piers 2 through 5, the post-tensioning force was applied in two stages (Figure 16). The first stage of post-tensioning force was applied when the precast concrete tie was placed on the ledges constructed at the top of the pier arms and when the concrete in the 12 in gap between the arms and the tie at both ends intended for closure pour was still not poured. The magnitude of initial post-tensioning force was 300 kips at the exterior piers (under exterior girders 1 and 4) and 150 kips at interior piers (under interior girders 2 and 3). This initial post-tensioning had the effect of offsetting the downward pier arm deflection due to self-weight of the arms and the tie beam and pulling the arms closer to induce tension in their bottom fibers such that the arms would be capable of resisting greater magnitude of subsequently applied loads. After the initial post-tensioning, the concrete pour filled the gap between the tie and the arms.

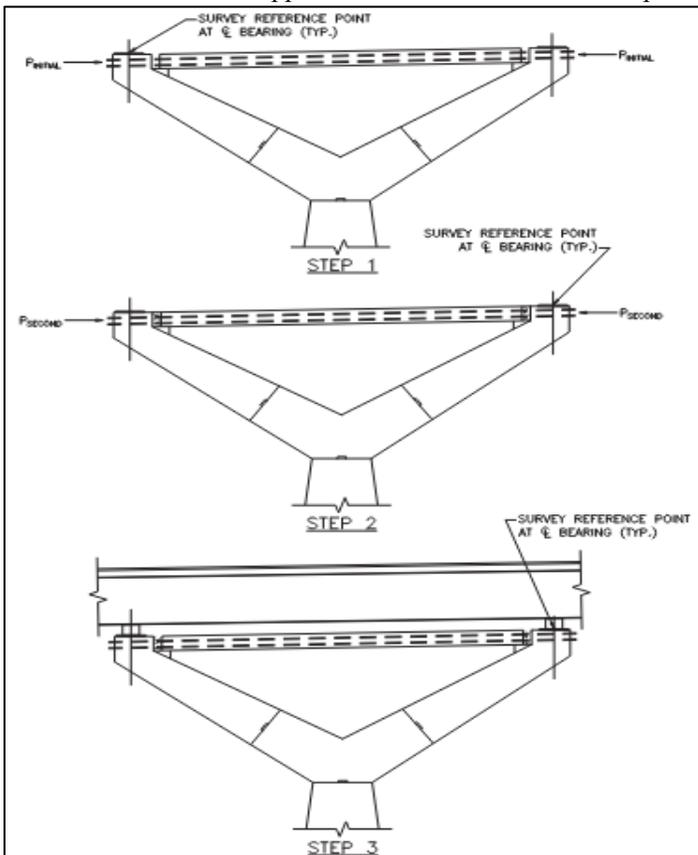
Figure 16. V-Pier Post-tensioning Sequence

After the closure pour had cured, additional post-tensioning force of 2,000 kips was applied to the tie beam at exterior piers and 2,150 kips at interior piers. Total post-tensioning losses were estimated to be no more than 14% at the exterior piers and 20% at the interior piers. The post-tensioning system was required to be designed by the contractor such that no more than 12.5% of the pre-stressing force would be eccentric at any time. All subsequent loads would be applied after the closure pour.

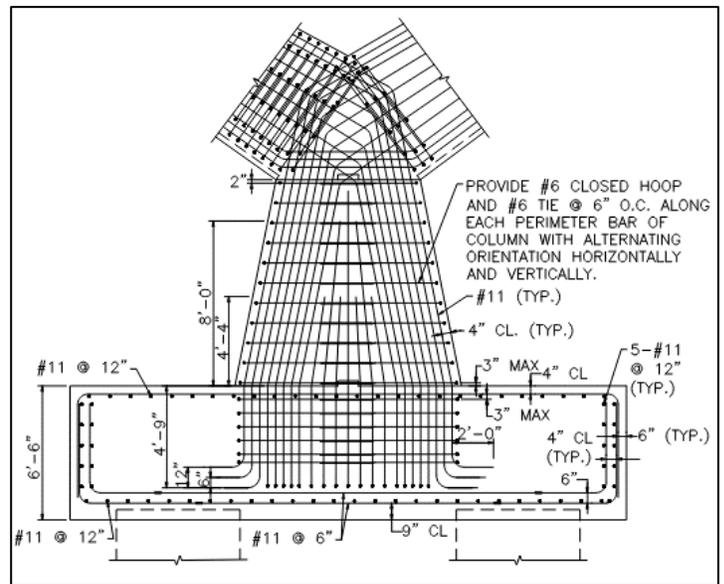
Figure 18. Typical V-Pier Column and Drilled Shaft Cap Reinforcement

The base of the ‘V’ and the pier column were constructed monolithically placing the construction joint in the arms at a distance of 8 ft horizontally at Pier 1 and at 8 ft 6 in to 9 ft 6 in for Piers 2 through 5. The reinforcement in the arms is mechanically spliced to the rebars extending out of the pier column. The reinforcing bars from the ‘south’ of the column section were bent and extend into the north arm of the pier while the rebars from the ‘north’ of the column section bend and enter the south arm (Figure 18). Due to the dense reinforcement at the interface of the arms and the pier column, 3D models of the pier reinforcement had to be developed to detect and avoid clash between the rebars going into the pier column from the arms (Figure 20).

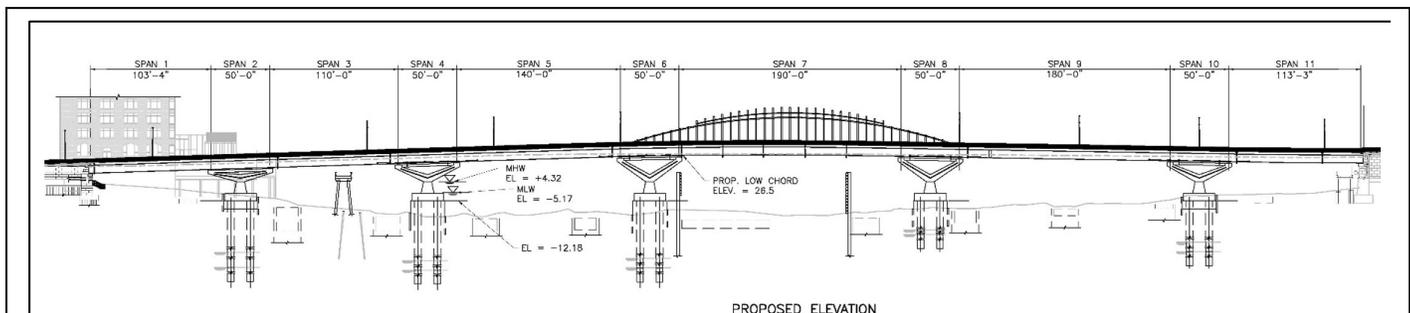
Figure 21. V-Pier Drilled Shaft Caps Below Mean Low Water

The four pier columns at a V-Pier were constructed on a 6 ft 6 in deep drilled shaft cap. In concept and design, it is similar to a pile cap, only with larger drilled shafts instead of piles. It measured 78 ft wide and 27 ft long. The top of the drilled shaft cap were all set to an elevation below mean sea level. The caps of Piers 1 and 5 were in the riverbed, however, the caps for Piers 2 through 4 are perched at 10 ft. to 15 ft. above the riverbed (Figure 21). This design minimized the depth of the cofferdam and dewatering operations in the water and also minimized the handling and removal of contaminated soils from the riverbed. Eight 6 ft diameter drilled shafts supported the cap (Figure 22). The centerline of each pier column matched with the centerline of the two drilled shafts, just north and south of the base of the pier column. The drilled shafts were laid out in two rows with 16 ft 6 in spacing between them longitudinally and 22 ft transverse spacing to match the spacing between the centerline of the box girders and the pier columns.

The drilled shafts were designed to support the proposed vertical loads by a combination of side shear resistance of 2.4 ksf from the glacial till and weathered bedrock layers and a side shear resistance of 7.0 ksf and end bearing resistance of 20.0 ksf from the competent Argillite bedrock layer. Additionally, the geotechnical report also recommended socketing the drilled shafts a minimum of one drilled shaft diameter into the competent bedrock and reducing the diameter of the drilled shafts rock socket by 6 in to 5 ft 6 in.

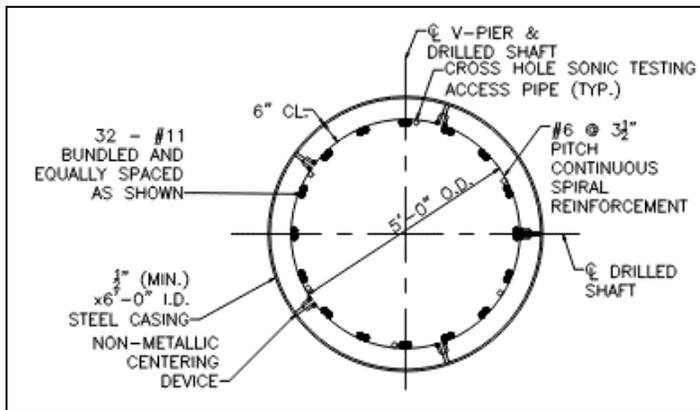
Figure 23. Drilled Shaft Cross-Section

Each drilled shaft is comprised of 32-#11 rebars bundled in pairs of two and arranged in a circular geometry. #6 rebars were used for continuous spiral reinforcement at 3/2 in pitch (Figure 23). Clear cover to the spiral reinforcement was maintained at 6 in which reduced to 3 in (Figure 24) in the rock socket portion of the drilled shafts. Based on the loads, the depth of the rock sockets varied from 10 ft to 27 ft.

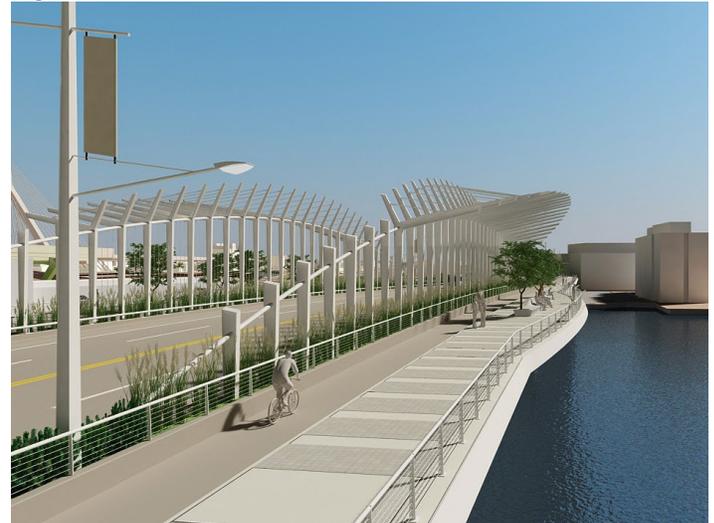
Figure 25. Architectural Trellis (Rendering)

A trellis was located along each side of the bridge in the main span to mark the crossing of the navigable channel underneath. It also provides a physical separation from the vehicular traffic and provides partial shade for the widened overlook areas on the span which contain sculptured benches, tree plantings and landmark plaques describing the views from the bridge. It resembles a circular arch in both plan and elevation as seen in Figure 25 and Figure 27.

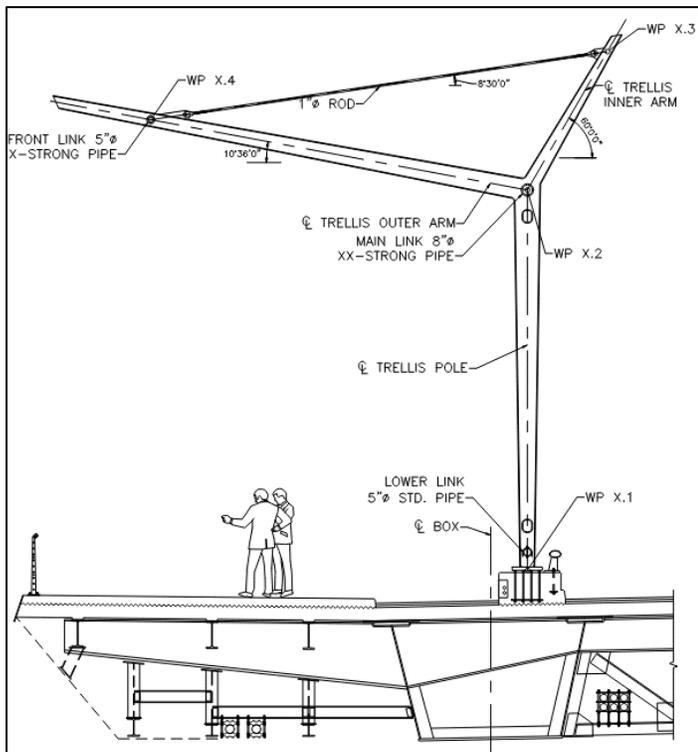
Figure 26. Tallest Trellis Pole

Each trellis is composed of 14 straight and 23 ‘Y’ shaped poles fabricated from welded plate members (AASHTO M270 Grade 50) and main and front linking members fabricated from steel pipe (AASHTO A53 Grade B) and round HSS (ASTM A500 Grade B). The arms of the ‘Y’ shaped poles are tied together by a 3/8 in diameter S.S. Type 316 cable. All structural members would be hot dip galvanized. The tallest pole at the center is over 30 ft high and 32 ft across. The poles are spaced 7 ft 3 in on center and are tied together by 8 in diameter strong pipe main link and a 5 in diameter strong pipe front link.

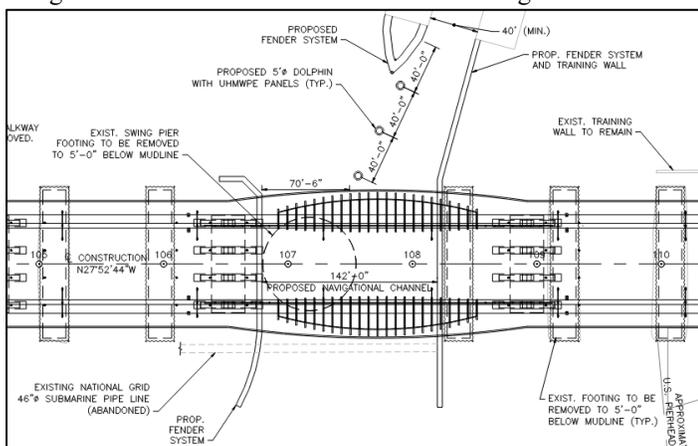
Figure 27. Proposed Fender System Plan

The proposed fender system would be constructed north of Pier 3 and south of Pier 4 with the latter extending further west as a training wall to meet with the large lock of the Charles River Dam (Figure 27). A bullnose fender system would also be constructed at the west wall of the large dam lock in addition to three 5 ft diameter dolphins with UHMWPE panels spaced 40 ft apart. The pipe piles in the fender system will be 20 in diameter ASTM A252 Grade 3 steel with minimum $\frac{1}{2}$ in wall thickness. The 8 in x 10 in

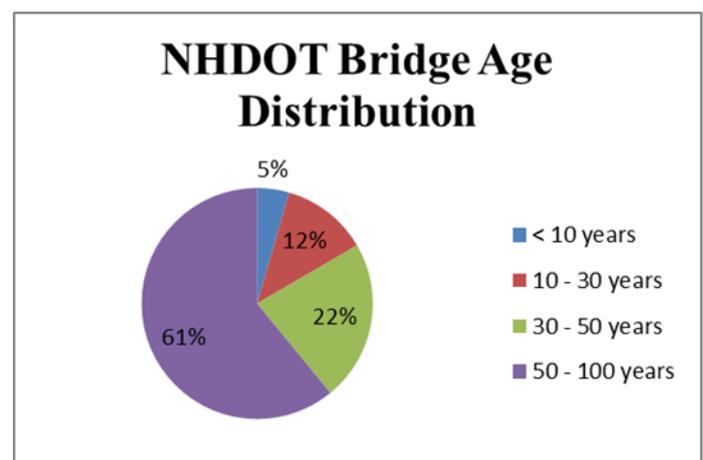
Figure 1. NHDOT bridge age distribution.

Figure 1 illustrates the age distribution of New Hampshire Department of Transportation (NHDOT) bridges. About 95% of NHDOT bridges require some type of maintenance or rehabilitation. New bridges could use some type of proper preventive maintenance to extend their service life.
